C305– Eastern Running Tunnels

Close out report for DLR Royal Victoria Station to VDP

CRL Document Number: C305-DSJ-C-RGN-CRG03-50238

Close out report for DLR Royal Victoria Station to VDP**C305 Crossrail Eastern Running Tunnels**

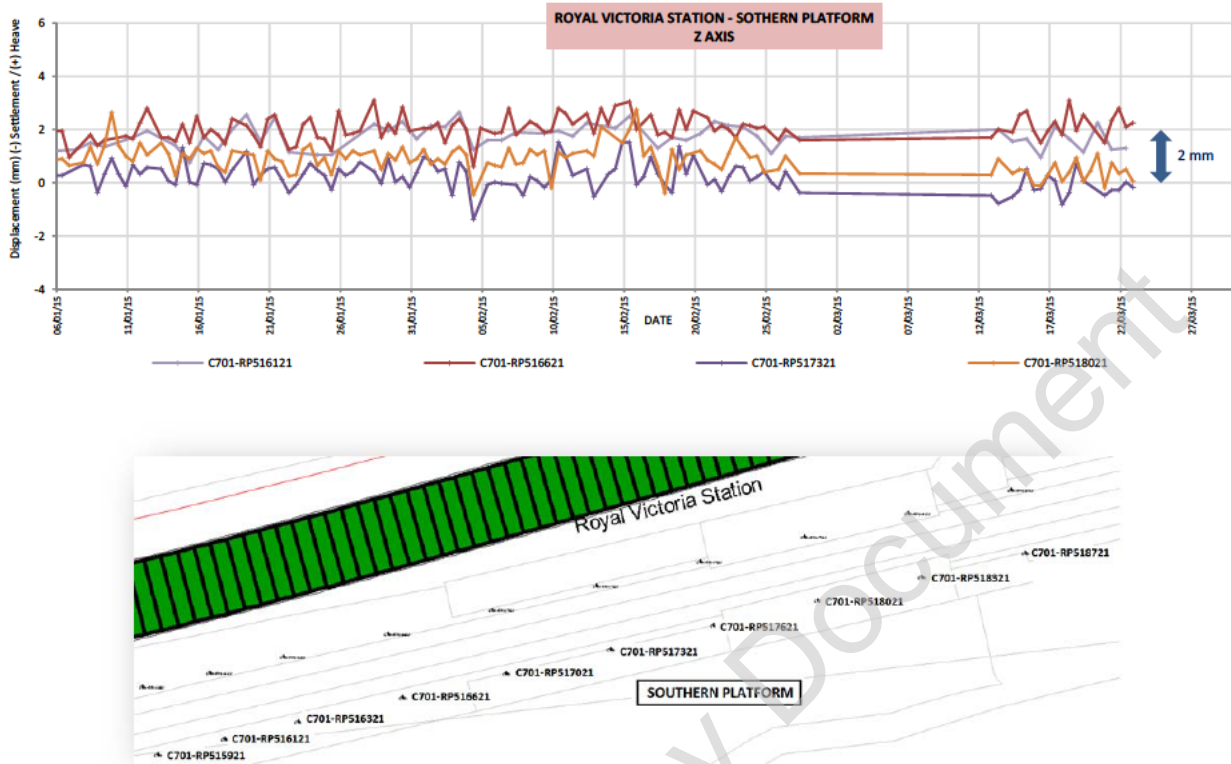
The overall discernible trend in the data shows that settlement has reached steady state following running tunnel construction. This can be seen from the example below that shows the z direction for some of the prisms along the Southern Platform (every 20 meters), from January 2015.

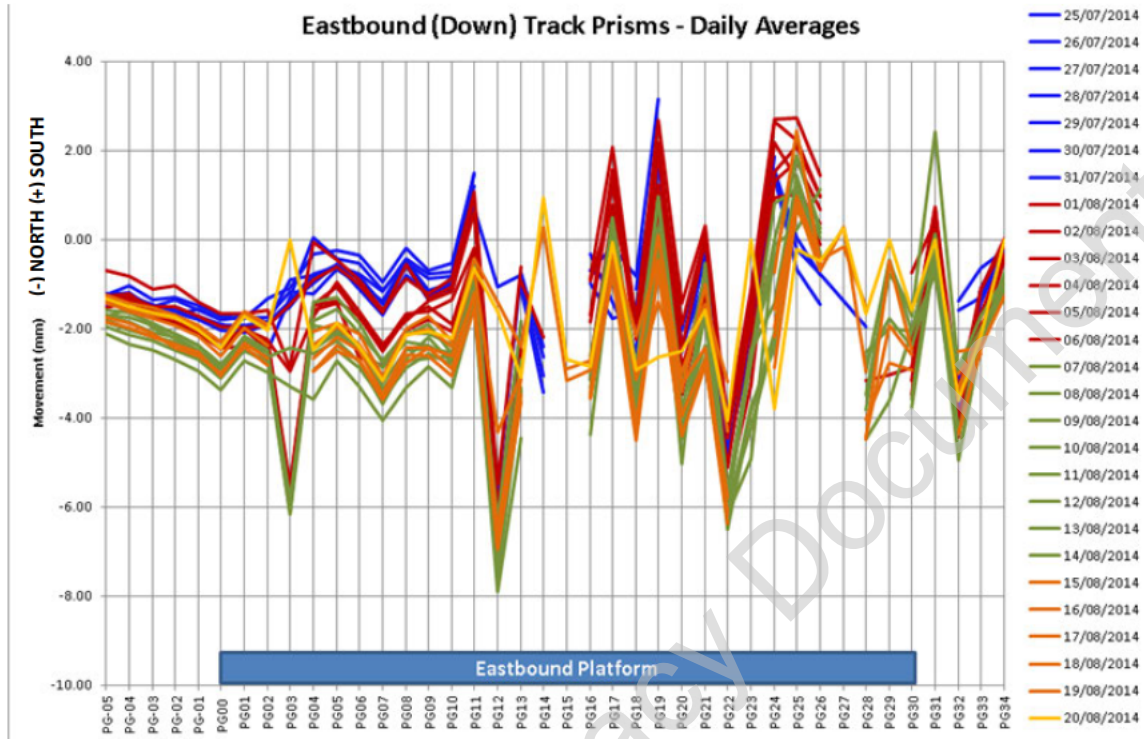
In X axis a negative movement of -4mm can be observed in June 2014 and -1 mm after the Eastbound TBM passage. In Y axis there is also a positive movement between +2 and +3 mm after the Westbound TBM passage and +1 mm more after the second TBM (Eastbound), registering a total movement of +4 between June 2014 and January 2015. In Z axis a settlement of -1 mm is observed after Westbound TBM passage and +1 mm heave after the Eastbound.

Looking at the daily averages of the prisms along the length of the platform over the period of the WB passage it shows movement of approx. 1-4mm movement north towards the platform.

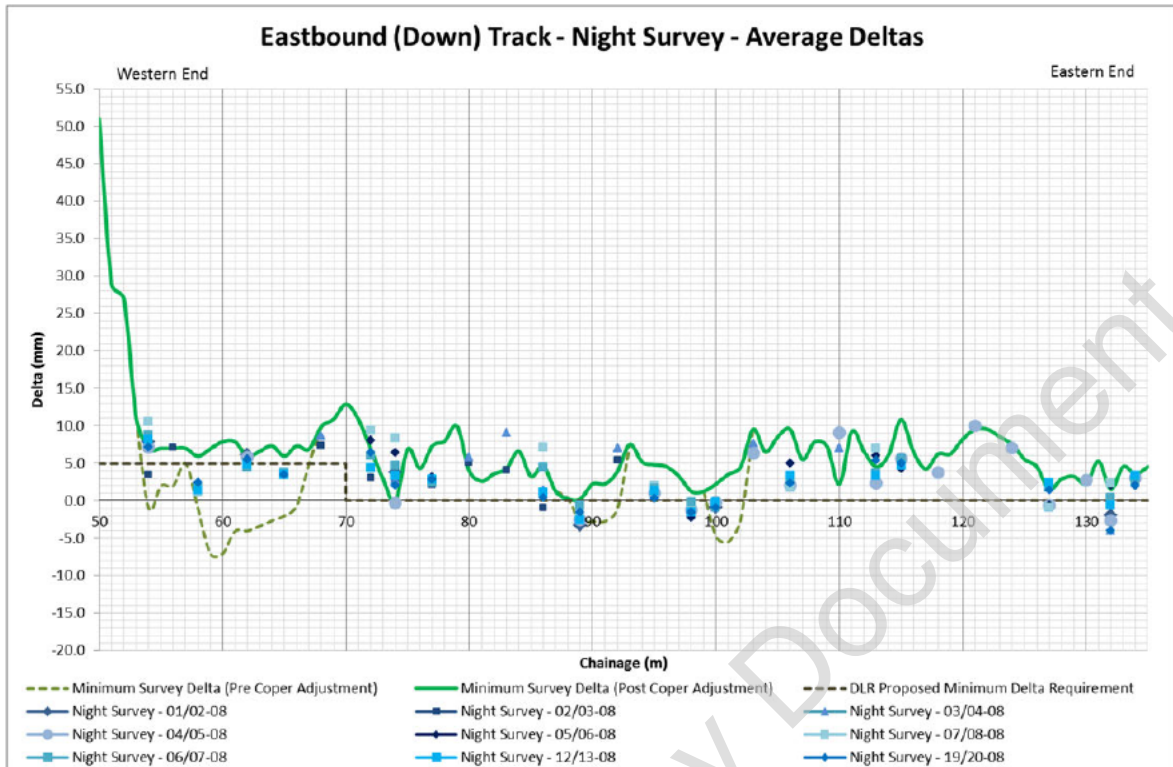
Manual Platform Gauge Surveys

The graph below shows the averages of the 3 readings taken each night during the passage of the Westbound TBM and immediately post passage.

Generally the manual surveys and the C704 data showed similar given the accuracies of the two different systems. The above plots show that the deltas did not exceed the -5mm delta red trigger (once the temporary speed restriction was lifted) and nor did it exceed the worst case position pre-coper adjustments.

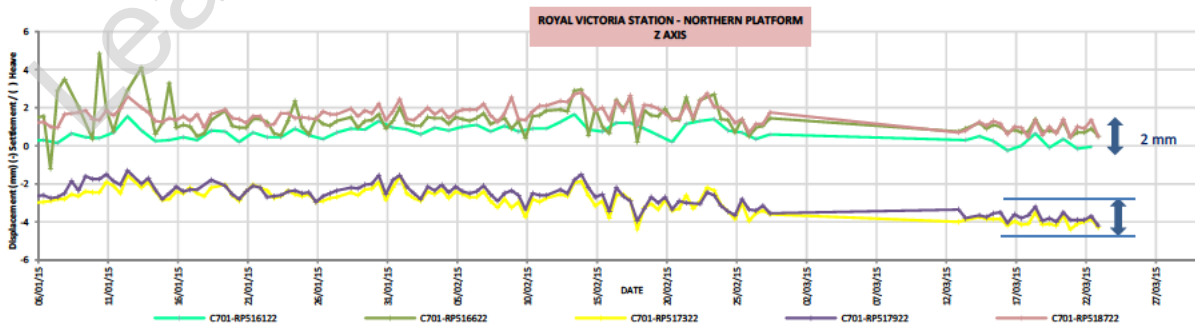
The overall discernible trend in the data shows that settlement has reached steady state following running tunnel construction. This can be seen from the example below that shows the z direction for some of the prisms along the Northern Platform (every 20 meters), from January of 2015.

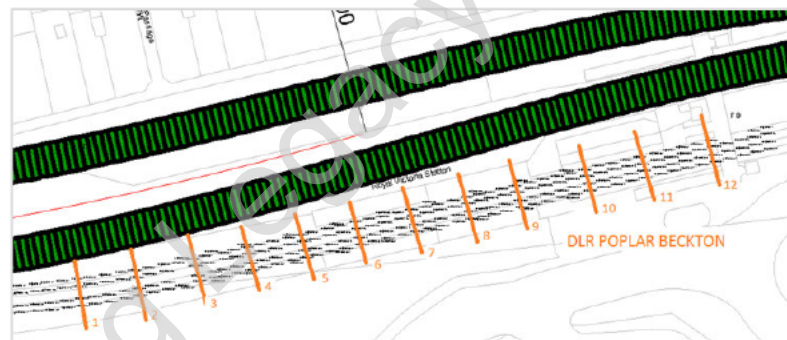
There are 202 prisms installed in this area. To avoid the excess of data and difficulty to discern trends in the plots prisms have been taken every 15 meters to represent the behaviour of the tracks.

The picture above and the list below show the cross sections and the prisms in the graphs of Appendix 2:

CROSS SECTION	UP LEFT	UP RIGTH	DOWN RIGHT	DOWN LEFT
1	C701-RP515111	C701-RP515112	C701-RP515113	C701-RP515114
2	C701-RP515511	C701-RP515512	C701-RP515513	C701-RP515514
3	C701-RP515911	C701-RP515912	C701-RP515913	C701-RP515914
4	C701-RP516311	C701-RP516312	C701-RP516313	C701-RP516314
5	C701-RP516711	C701-RP516712	C701-RP516713	C701-RP516714
6	C701-RP517111	C701-RP517112	C701-RP517113	C701-RP517114
7	C701-RP517511	C701-RP517512	C701-RP517513	C701-RP517514
8	C701-RP517911	C701-RP517912	C701-RP517913	C701-RP517914
9	C701-RP518311	C701-RP518312	C701-RP518313	C701-RP518314
10	C701-RP518811	C701-RP518812	C701-RP518813	C701-RP518814
11	C701-RP519211	C701-RP519212	C701-RP519213	C701-RP519214
12	C701-RP519711	C701-RP519712	C701-RP519713	C701-RP519714

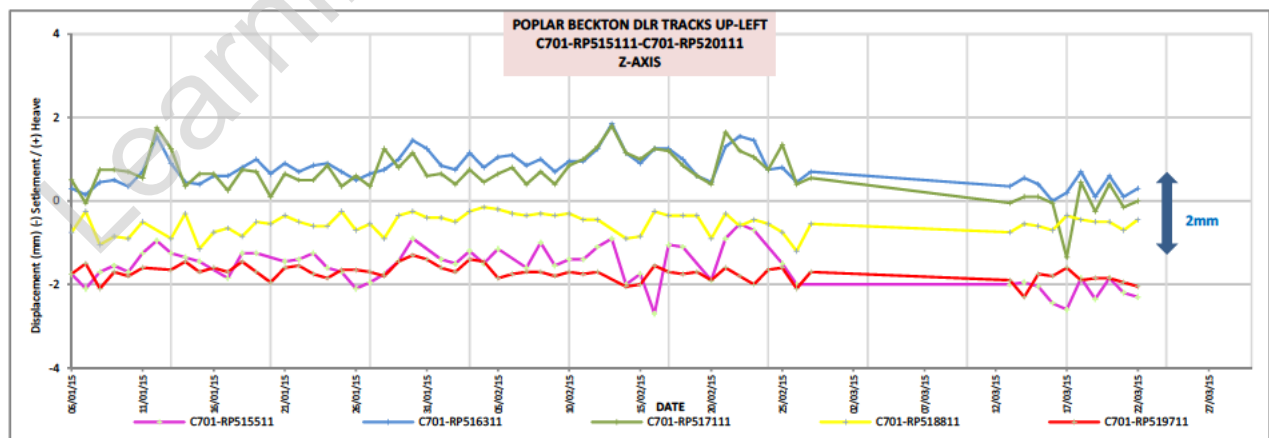
In Z axis no effect is observed due to the TBMs.

There is a range of movement observed due to the inherent noise in the system, which can be disregarded. The overall discernible trend in the data shows that settlement has reached steady state following running tunnel construction. This can be seen from the example below that shows the z direction for some of the prisms along cess area of the track Poplar Beckton Up (every 30 meters), from January of 2015.

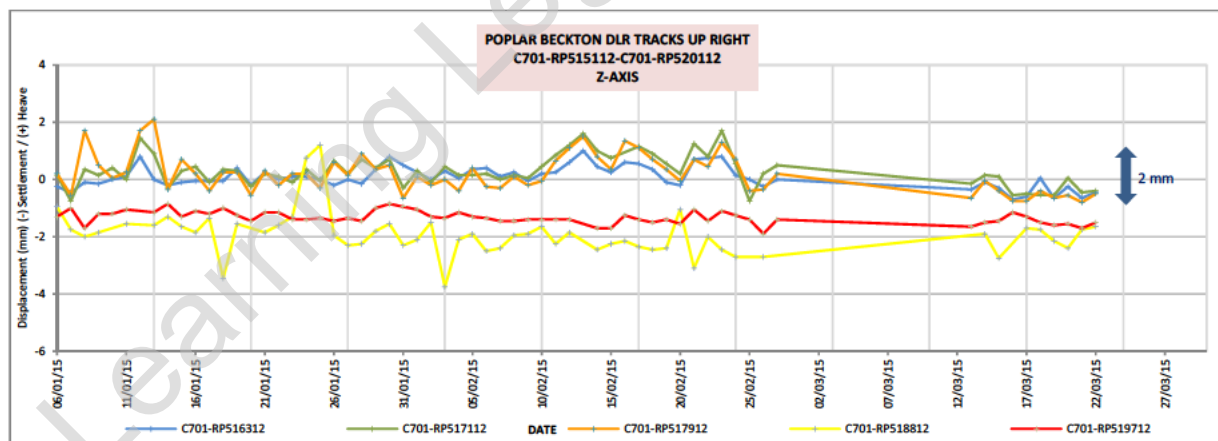
As in the previous axis, readings in Y are spiky and two different trends are appreciable. A continuous positive movement can be observed from the first TBM passage to February 2015.

In Z axis there is a -1mm settlement before the Eastbound TBM passage an +1mm heave after it. The readings have a settlement of -1 mm in the last month.

There is a range of movement observed due to the inherent noise in the system, which can be disregarded. The overall discernible trend in the data shows that settlement has reached steady state following running tunnel construction. This can be seen from the example below that shows the z direction for some of the prisms along 6foot area of the track Poplar Beckton Up (every 30 meters), from January of 2015.

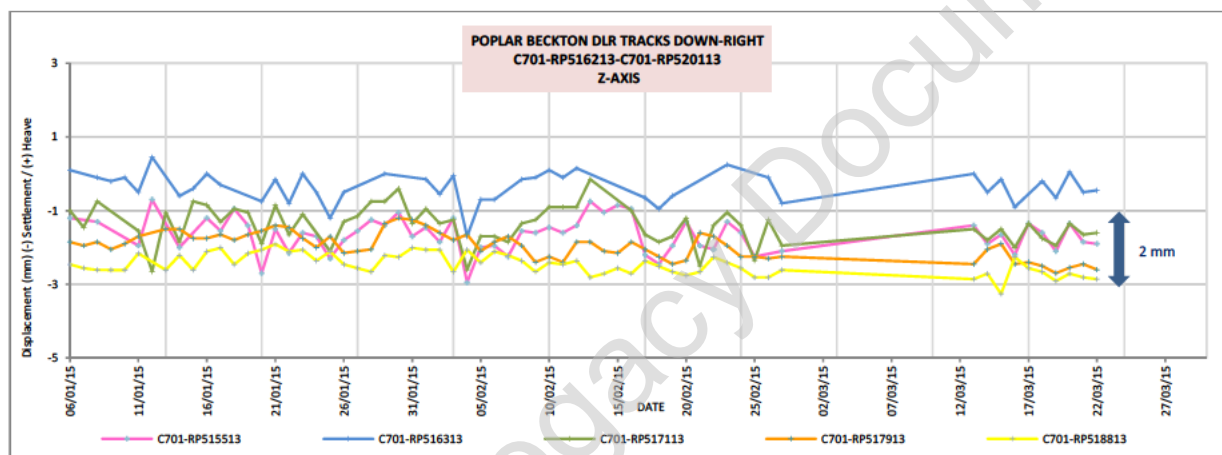
In Z axis there is a -1mm settlement before the Eastbound TBM passage a +1mm heave after it.

There is a range of movement observed due to the inherent noise in the system, which can be disregarded. The overall discernible trend in the data shows that settlement has reached steady state following running tunnel construction. This can be seen from the example below that shows the z direction for some of the prisms along 6foot area of the track Poplar Beckton Down (every 30 meters), from January of 2015.

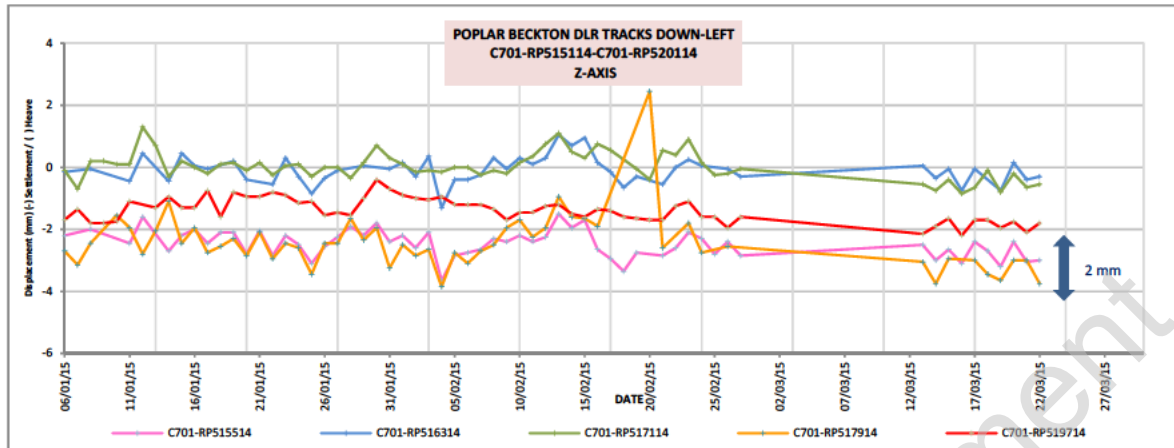
Readings in X and Y axes are spiky and do not show displacements due to the TBMs passages. Some prisms have an unexplained behaviour being out of range.

In Z axis no effect is observed during and post TBMs.

There is a range of movement observed due to the inherent noise in the system, which can be disregarded. The overall discernible trend in the data shows that settlement has reached steady state following running tunnel construction. This can be seen from the example below that shows the z direction for some of the prisms along cess area of the track Poplar Beckton Down (every 30 meters), from January of 2015.

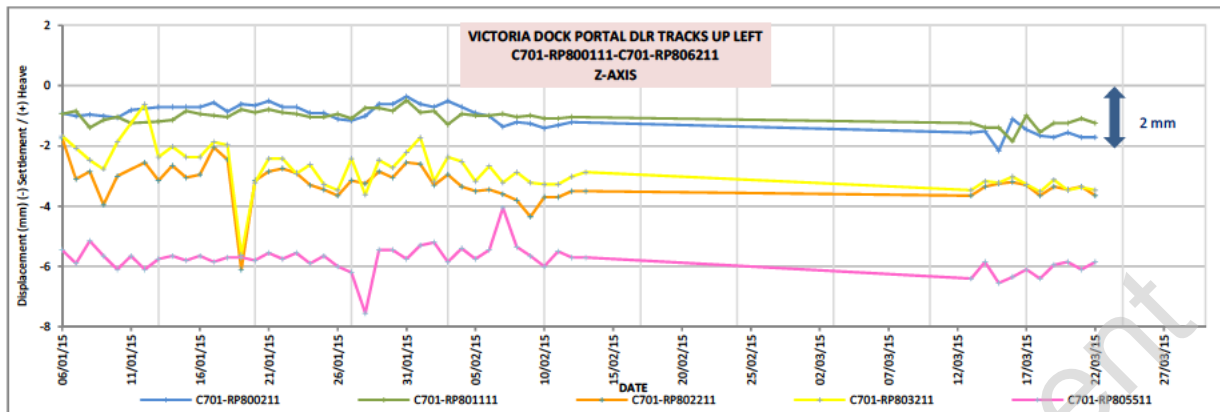
In Z axis no effect is observed due to the TBMs.

There is a range of movement observed due to the inherent noise in the system, which can be disregarded. The overall discernible trend in the data shows that settlement has reached steady state following running tunnel construction. This can be seen from the example below that shows the z direction for some of the prisms along cess area of the track VDP Up (every 30 meters), from January of 2015.

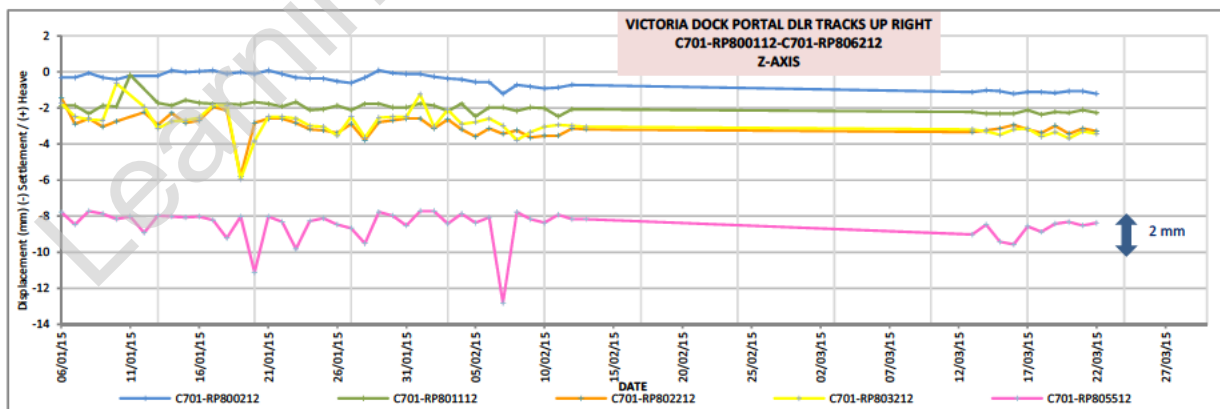
Readings in X show a negative movement of -2 mm between the two TMB passages. A movement of -4 mm is observed from November 2014 to February 2015.

In Z axis no effect is observed due to the TBMs.

There is a range of movement observed due to the inherent noise in the system, which can be disregarded. The overall discernible trend in the data shows that settlement has reached steady state following running tunnel construction. This can be seen from the example below that shows the z direction for some of the prisms along 6foot area of the track VDP Up (every 30 meters), from January of 2015.

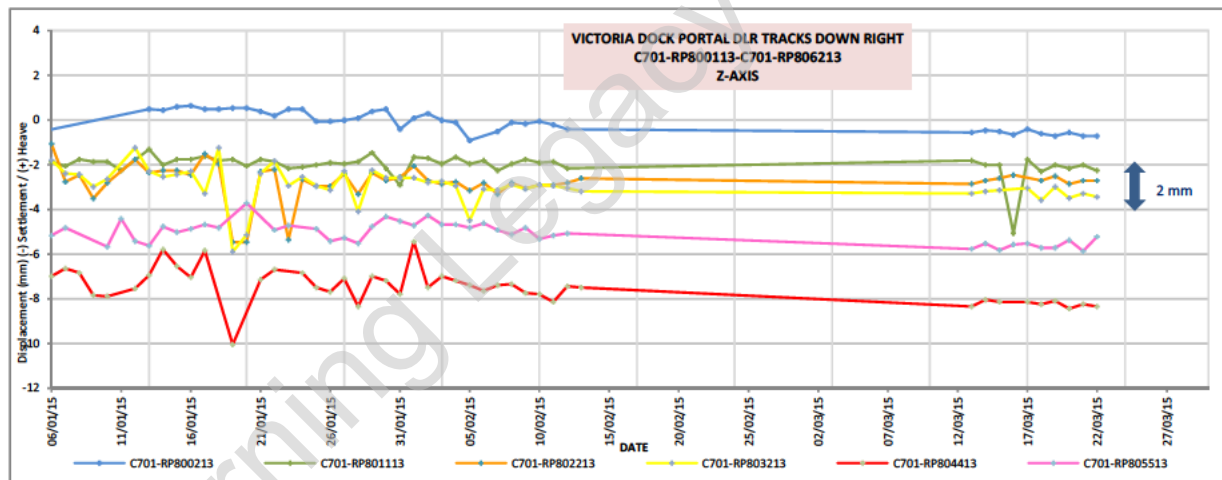
In Z axis no effect is observed due to the TBMs.

There is a range of movement observed due to the inherent noise in the system, which can be disregarded. The overall discernible trend in the data shows that settlement has reached steady state following running tunnel construction. This can be seen from the example below that shows the z direction for some of the prisms along 6foot area of the track VDP Down (every 30 meters), from January of 2015.

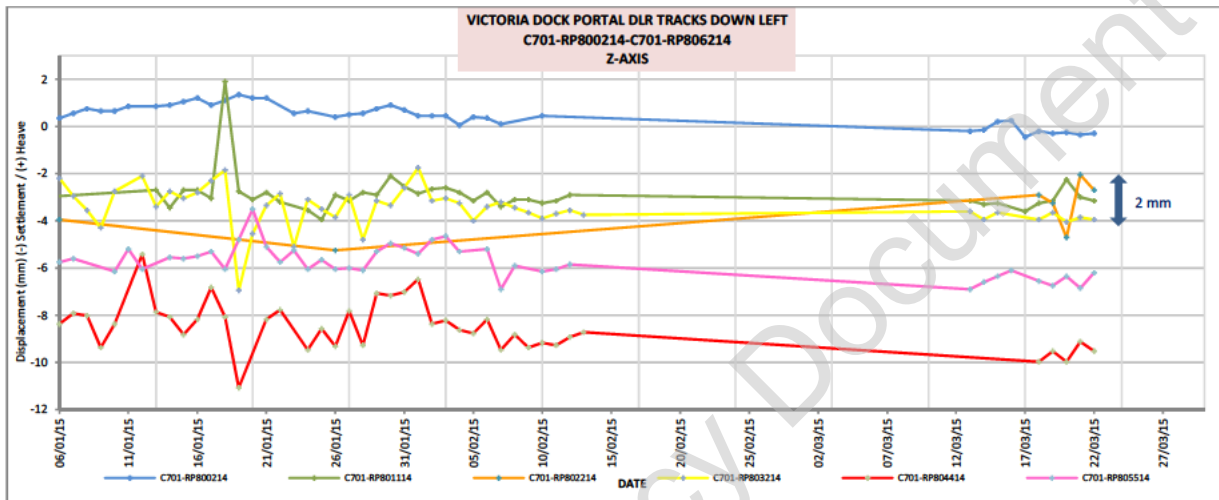
In Z axis no effect is observed due to the TBMs.

There is a range of movement observed due to the inherent noise in the system, which can be disregarded. The overall discernible trend in the data shows that settlement has reached steady state following running tunnel construction. This can be seen from the example below that shows the z direction for some of the prisms along cess area of the track VDP Down (every 30 meters), from January of 2015.

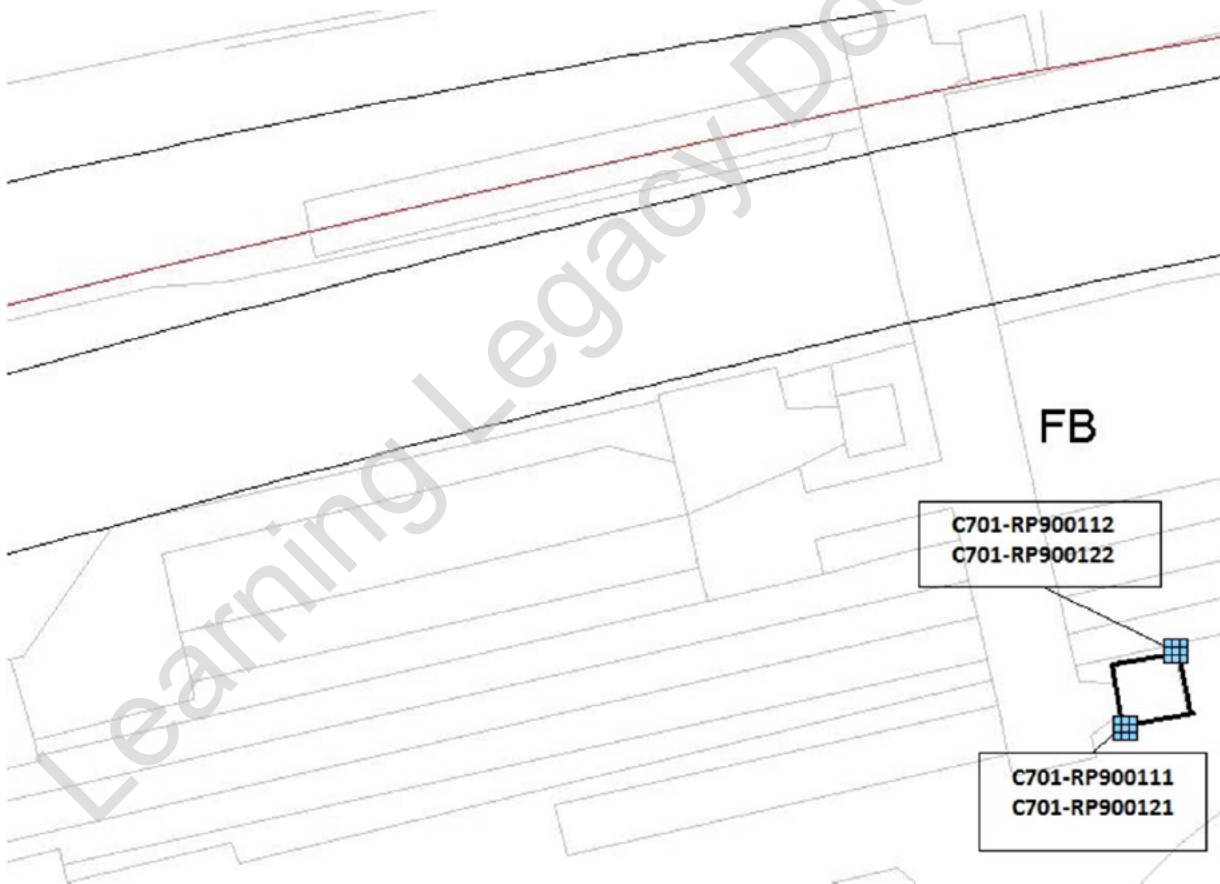
South lift:

No movements are perceptible for the south lift, excepting a -2 mm movement during ground treatments in Y axis.

There are several spikes in all the axes during the ground treatment works between June and July 2014.
