C435 Farringdon Main Station

Monitoring Close-Out Report: Automated Total Station ATS02 and 3D Targets read by ATS02.

CRL Document Number: C435-BFK-C2-RGN-M123-51611

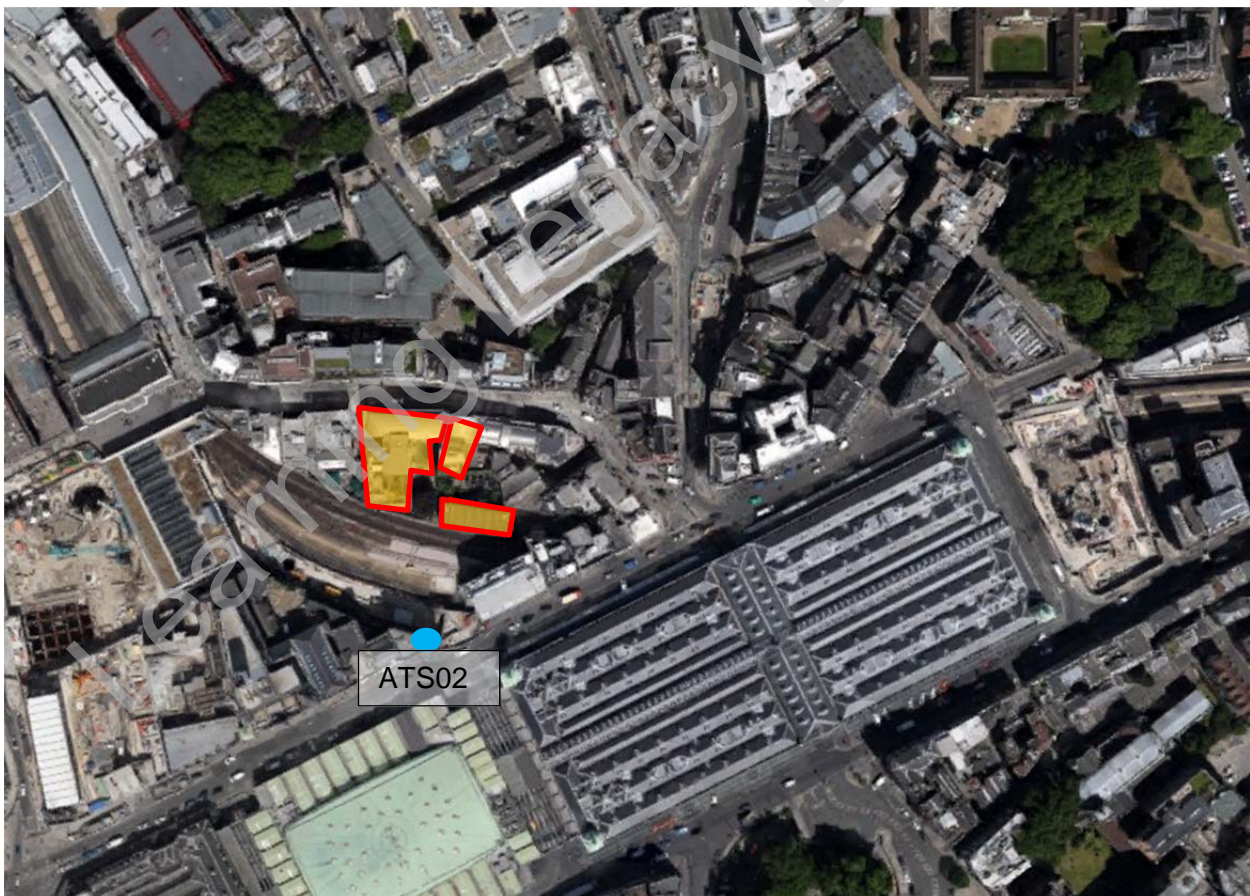
Figure 1 – Plan showing the Location of prisms read by ATS02

Prisms associated with ATS02 are located on the plan below highlighted in yellow.

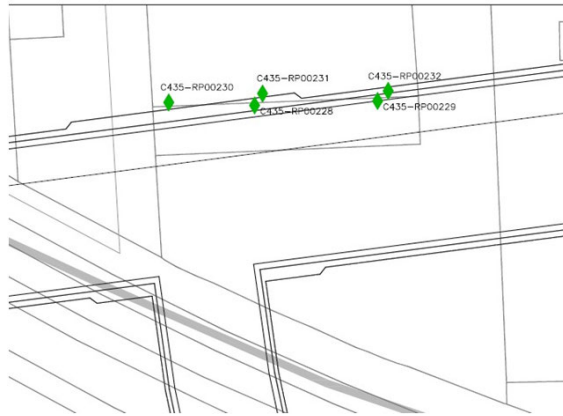
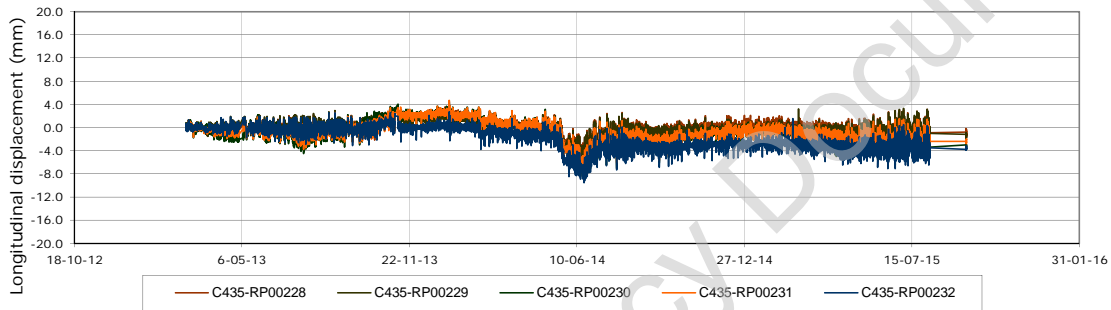
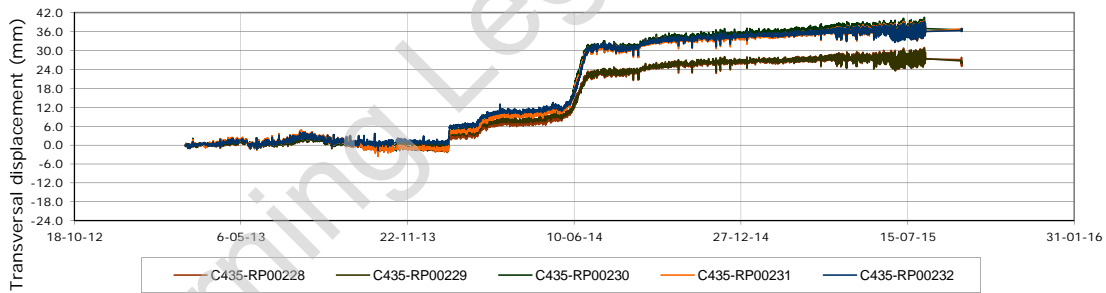
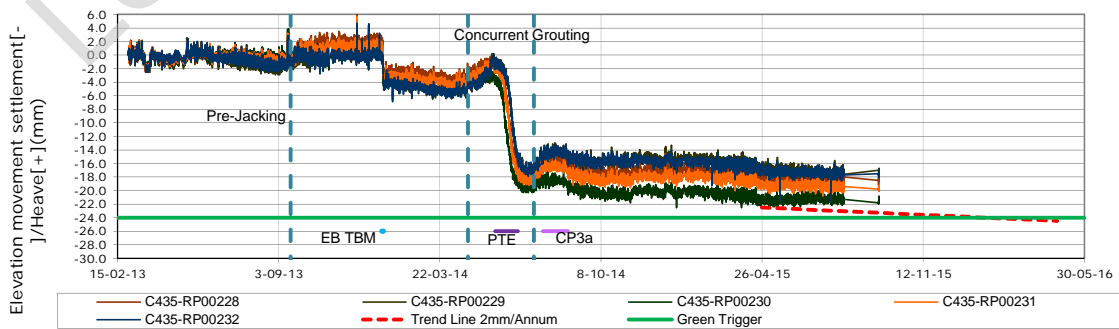
Building: 67 COWCROSS STREET

- Compensation grouting episode from Butchers Ramp in September 2013 caused 2mm of heave.
- EB TBM caused 4-5mm of settlement between 09-01-2014 and 11-01-2014
- Residual settlement for EB TBM of 2mm.
- Concurrent grouting episodes in April 2014 caused 3-4mm of heave.
- PTE enlargement caused 18mm of settlement from 30-05-2014 to 27-06-2014
- Post PTE grouting episodes caused 2-3mm of heave.
- Between 28-07-2014 and 28-08-2014 CP3a caused 2-3mm of settlement.
- Residual settlement after CP3a caused 2mm.
- Maximum longitudinal displacement captured by the prisms was -8mm
- Maximum Transversal displacement captured by the prisms was 36mm.
- Maximum settlement at the end of the works was -22mm

The monitoring data for 67 Cowcross St is shown in Appendix B.

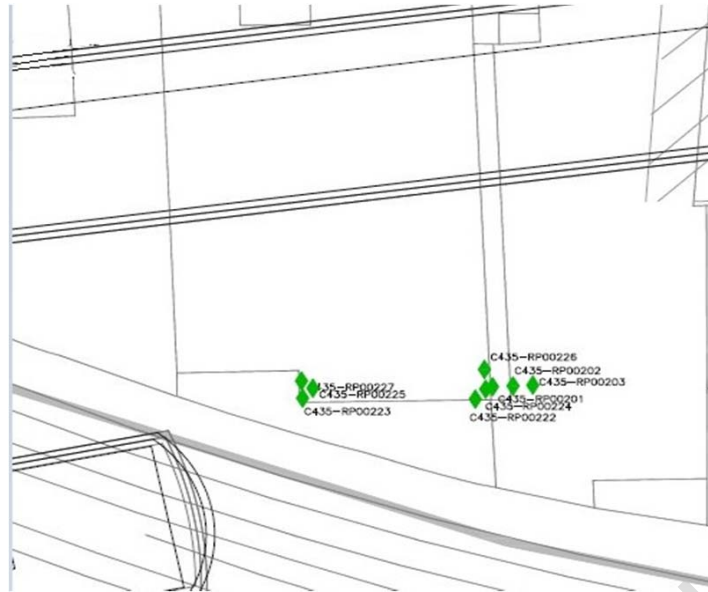
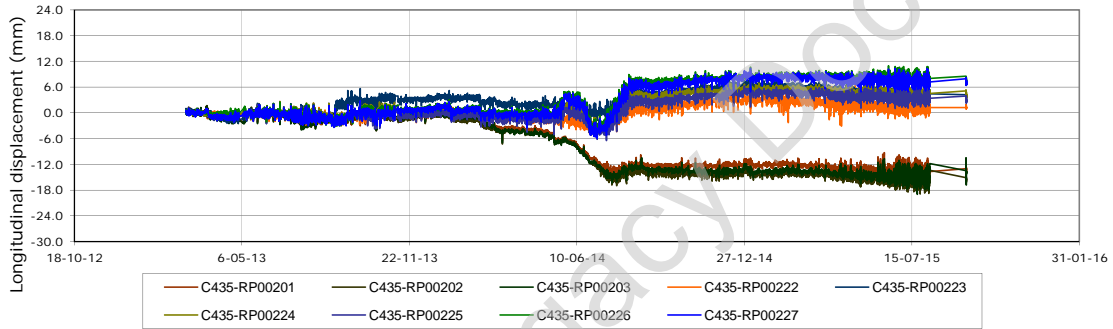
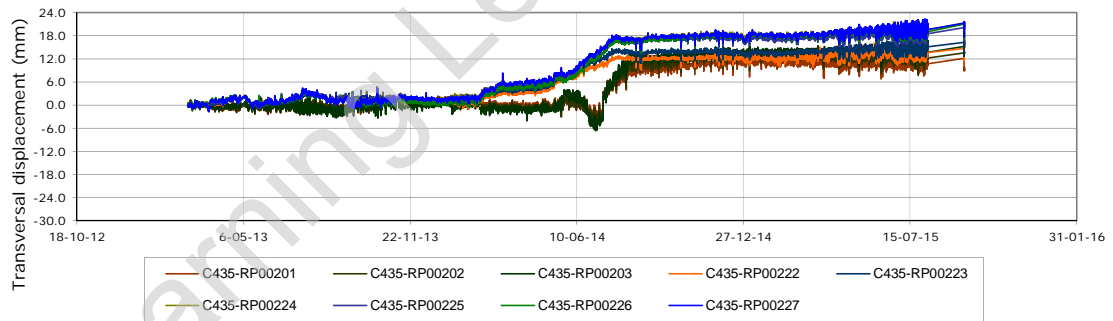
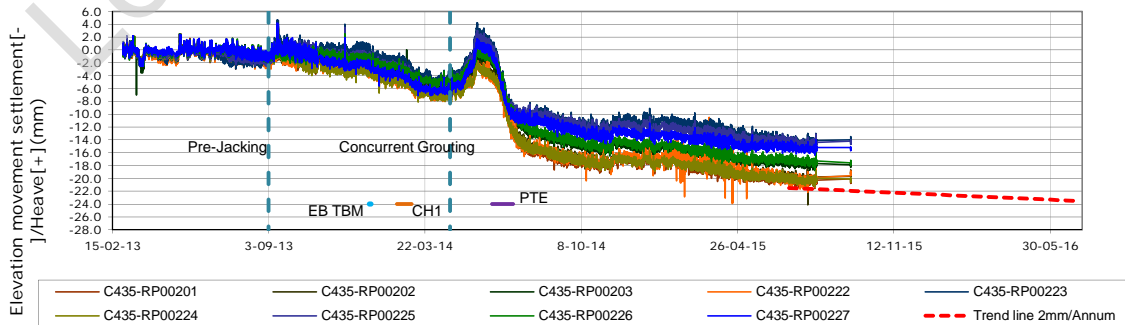
Building: 70-77 COWCROSS STREET

- Compensation grouting from Butchers Ramp caused 2-3mm of heave in September 2014
- EB TBM caused 1-2mm of settlement from 10-01-2014 to 12-01-2014.
- CH1 excavation caused 2-3mm of settlement.
- Concurrent grouting caused maximum 10mm of heave in June 2015
- PTE construction caused 10-12mm maximum of settlement between 16-06-2014 and 13-07-2014
- Residual settlement after PTE caused 4mm maximum.
- Maximum longitudinal displacement captured by the prisms was -18mm
- Maximum Transversal displacement captured by the prisms was 20mm.
- Maximum settlement at the end of the works was -21mm

The monitoring data for 70-77 Cowcross St is shown in Appendix B.

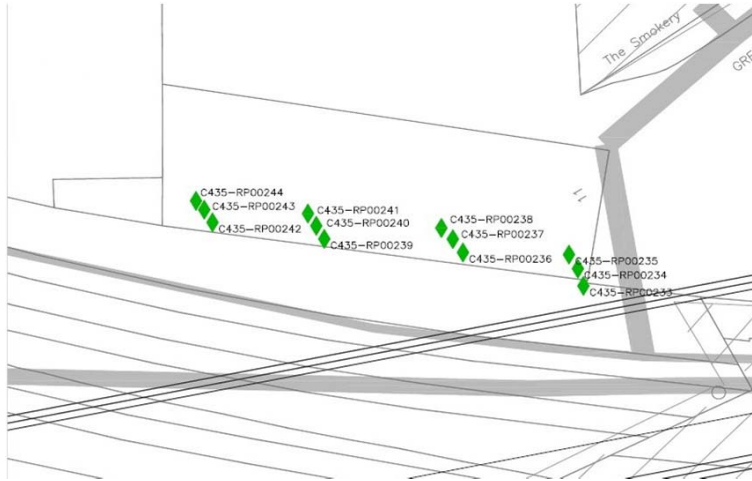
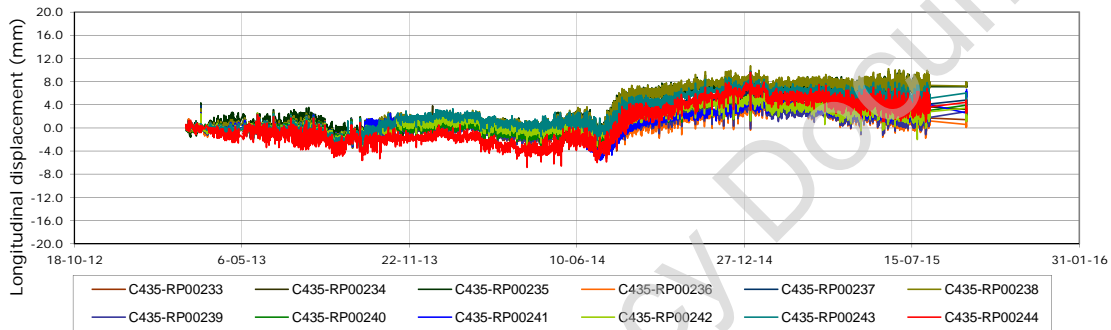
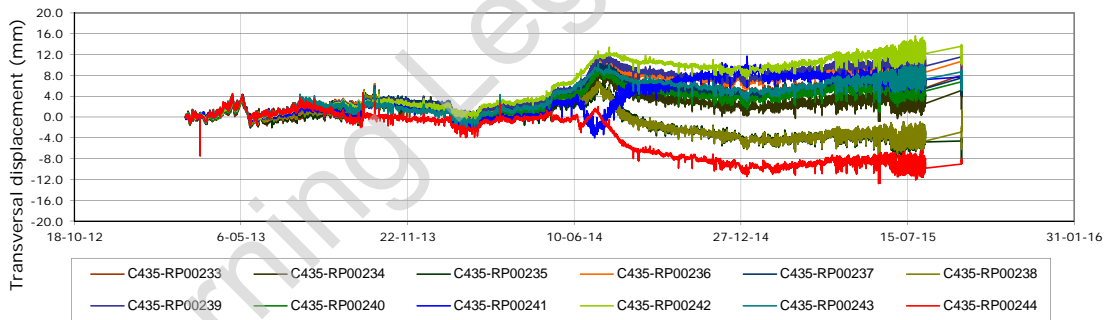
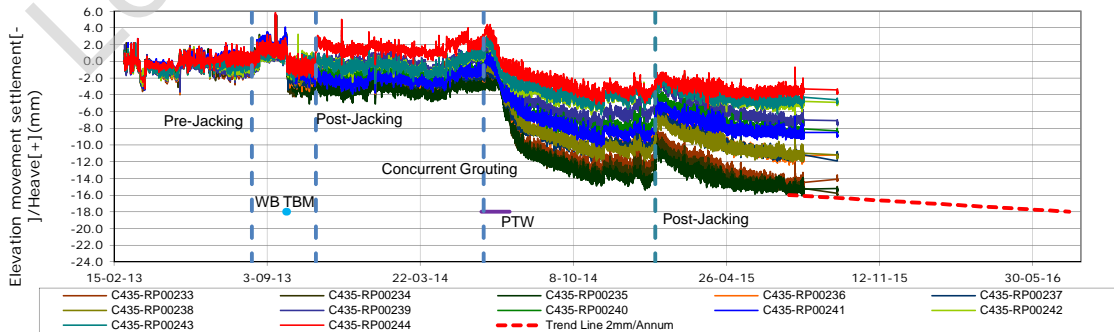
Building: ALBION COURTYARD, GREENHILLS RENTS

- Compensation grouting from Moorgate Spur 3 before the WB TBM caused 2-3mm of heave.
- WB TBM caused 4-5mm of settlement from 28-09-2013 to 29-09-2013
- Compensation grouting caused 2-3mm maximum of heave on 11th November 2013.
- Concurrent grouting caused 2-3mm of heave.
- PTW enlargement caused 8mm maximum of settlement between 10-06-2014 and 17-07-2014.
- Compensation grouting from Moorgate Spur 3 caused 4-5mm of heave on 23rd January 2015.
- Maximum longitudinal displacement captured by the prisms was 10mm
- Maximum Transversal displacement captured by the prisms was 15mm.
- Maximum settlement at the end of the works was -16mm

The result for the data for Albion Courtyard is shown in the Appendix B.
