C435 Farringdon Main Station

Monitoring Close-Out Report: Automated Total Station ATS12 and 3D Targets read by ATS12.

CRL Document Number: C435-BFK-C2-RGN-M123-51612

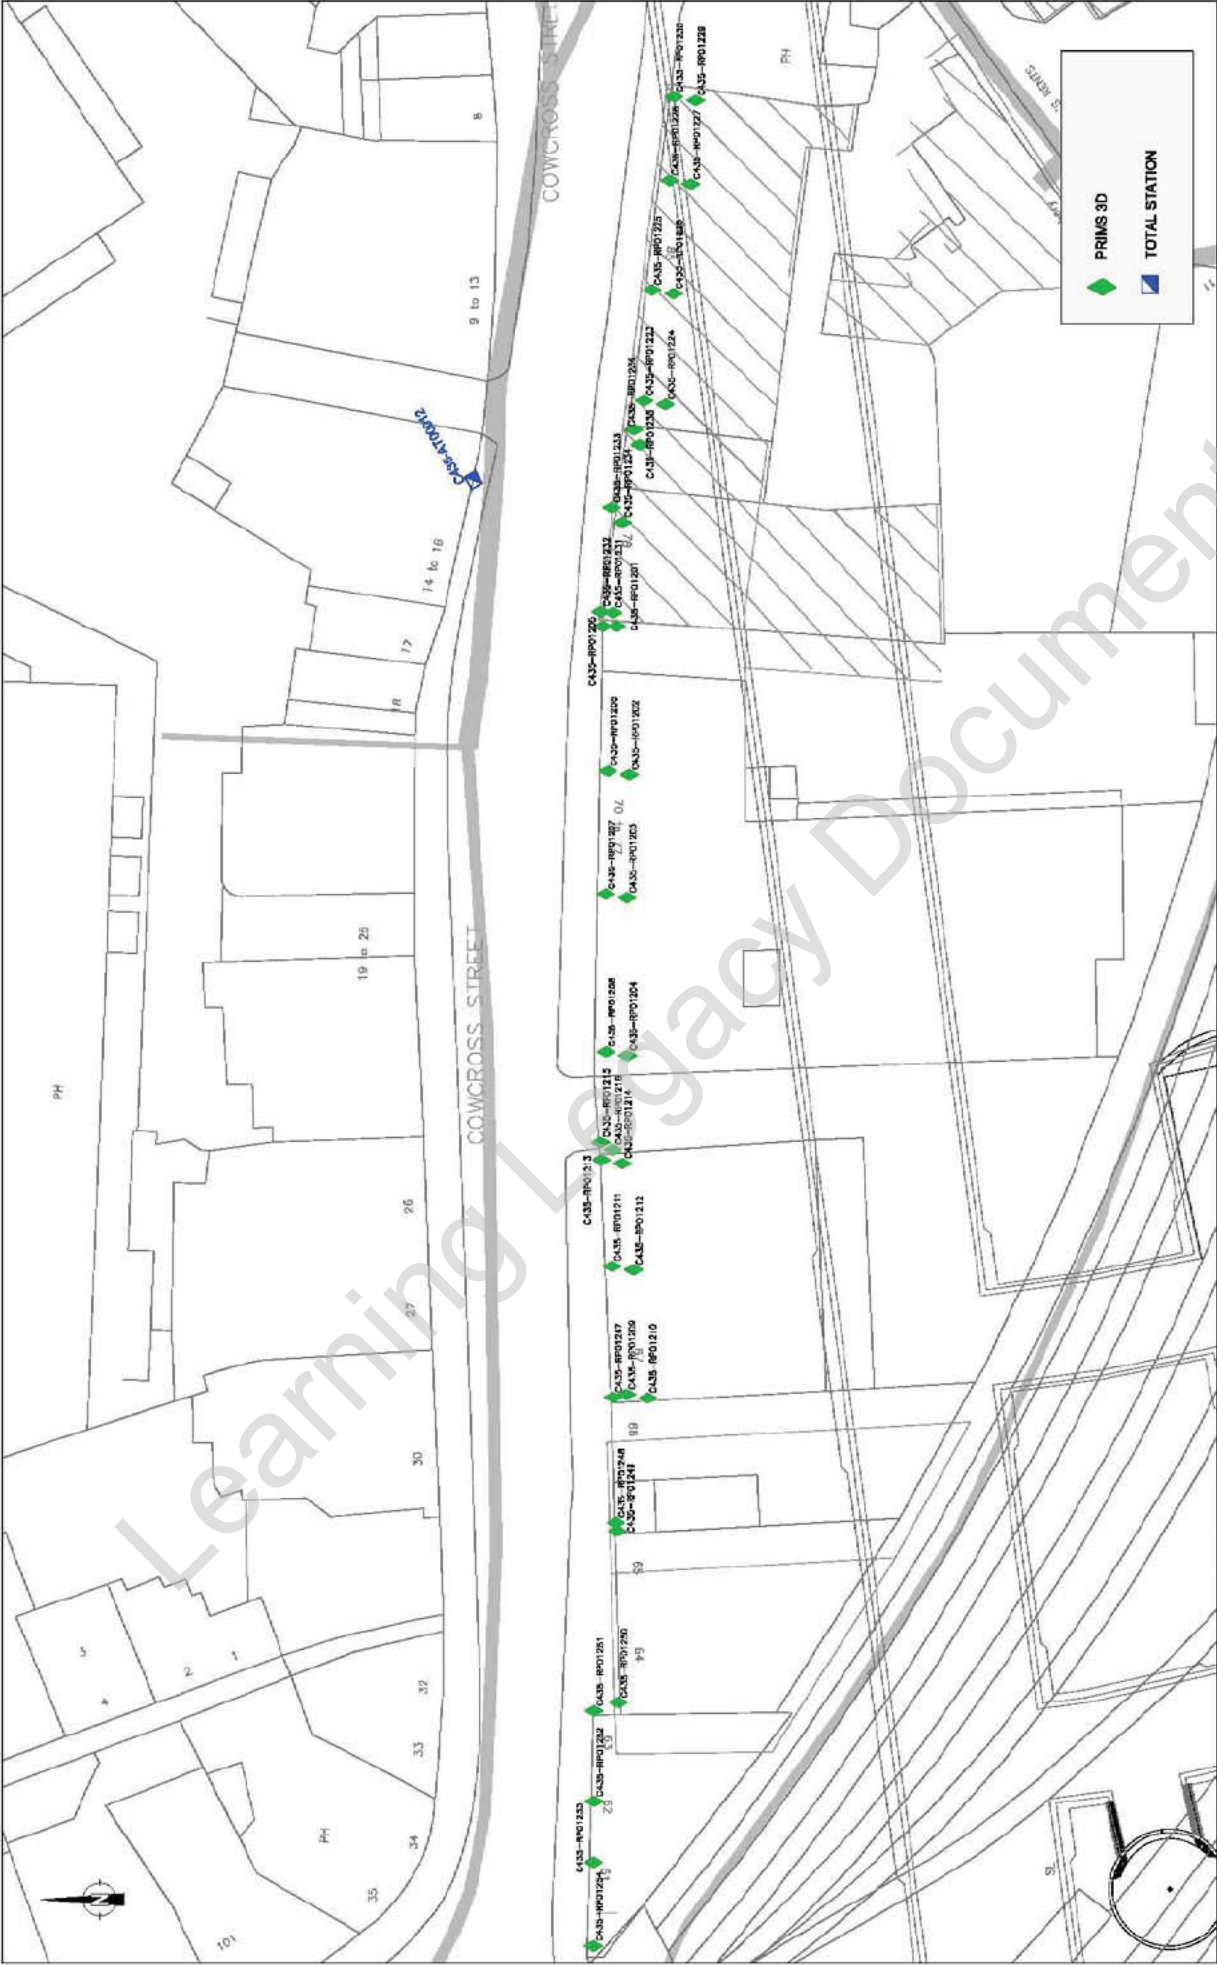
Contract: C435 IRR FARRINGTON
Originator: GEOSIBA
Location: CROSSBURN CENTRAL
Title: 3D PRIMS ATSS12

The prisms reading by ATS12 installed on Cowcross St are shown in the following documents:

- C435-BFK-C2-RGN-M123-50060-IR-RP-ATS12

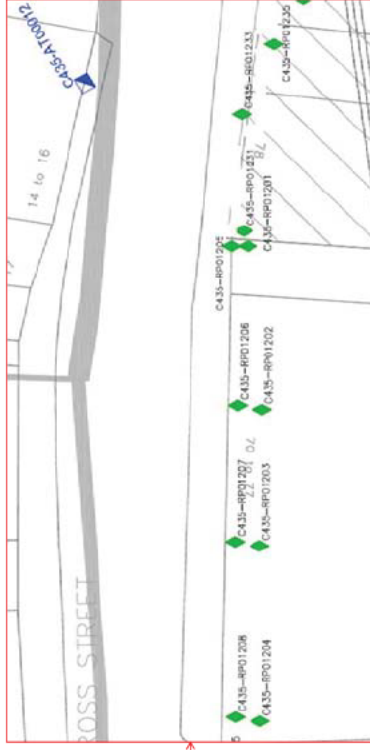
The monitoring data for the first group for the prisms installed on Cowcross St is presented in Appendix B.1

The buildings where the prisms are installed were affected by EB TBM, PTE enlargement, CP3a and CP2a. Although some movement has been recorded by these devices, it has been less than the expected in comparison with the movement recorded in Groups 2 and 3 showing buildings located closer and even above the PTE axis and where the settlement has been bigger.

During EB TBM, the maximum movement was around 2mm settlement on the prisms. After this work, some grouting episode was carried out to improve and to mitigate the movements for the next work, PTE enlargement. The maximum heave on these prisms was 4mm heave.

During PTE enlargement, no significant movements were observed on the buildings.

Is when the CP3a construction was carried out, when the movements were more significant. Some prisms showed in this phase around 4mm of settlement.

During CP2a construction, the prisms didn't show any significant movement.

In this area the prisms show stable conditions, the rate for the movements is less than 2mm/year, from 11-12-2014.

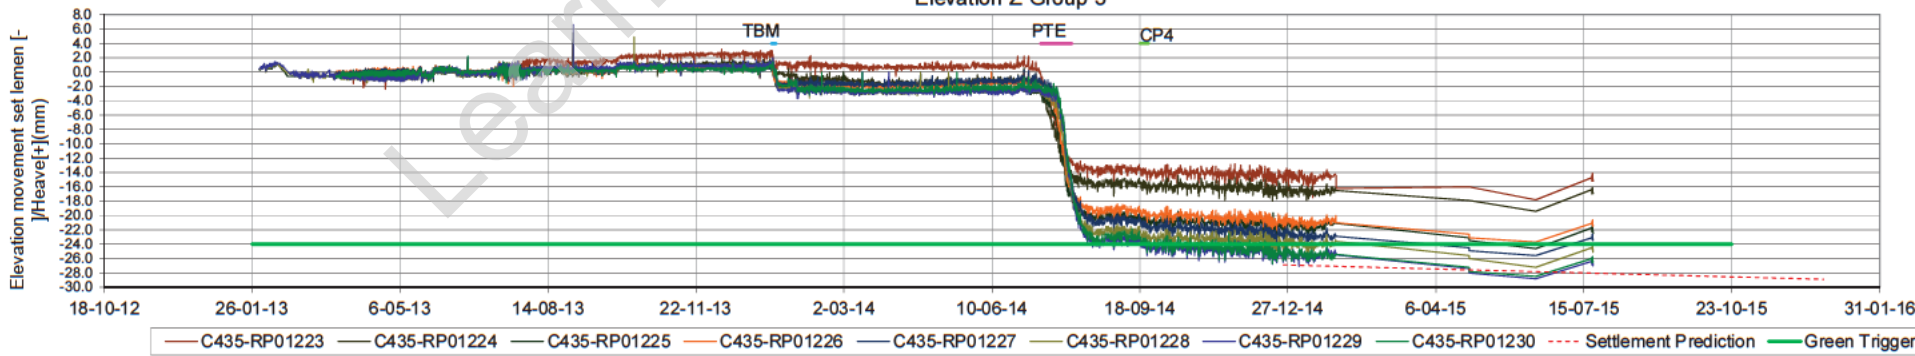
The results for this last group of prisms are shown in the same appendix.

As is reasonable, the prisms on this building show the biggest settlement. All of them are located above the tunnel.

During the TBM passage, the prisms showed maximum 5mm settlement. After TBM, all prisms showed very stable conditions.

The works carried out for the PTE Enlargement construction caused the biggest movement for these prisms read by ATS12.

In particular, the maximum settlement observed has been of 26mm on prisms C435-RP01229 and C435-RP01230, both of them installed on the same vertical of the building. These prisms are the ones installed above the tunnel.

Although this building is located far from the CP4 cross passage, it is inside the zone of influence, showing these prisms a maximum settlement of 2mm affected by this excavation works.

During the three months after the CP4 excavation, these prisms showed a residual settlement, showing stable conditions from December 2014.

From this date on, the ratio for the movements is less than 2mm/year.
