# C435 Farringdon Main Station

## Monitoring Close-Out Report: Automated Total Station ATS 23 and 3D Targets read by ATS 23.

**CRL Document Number: C435-BFK-C2-RGN-M123-51615**

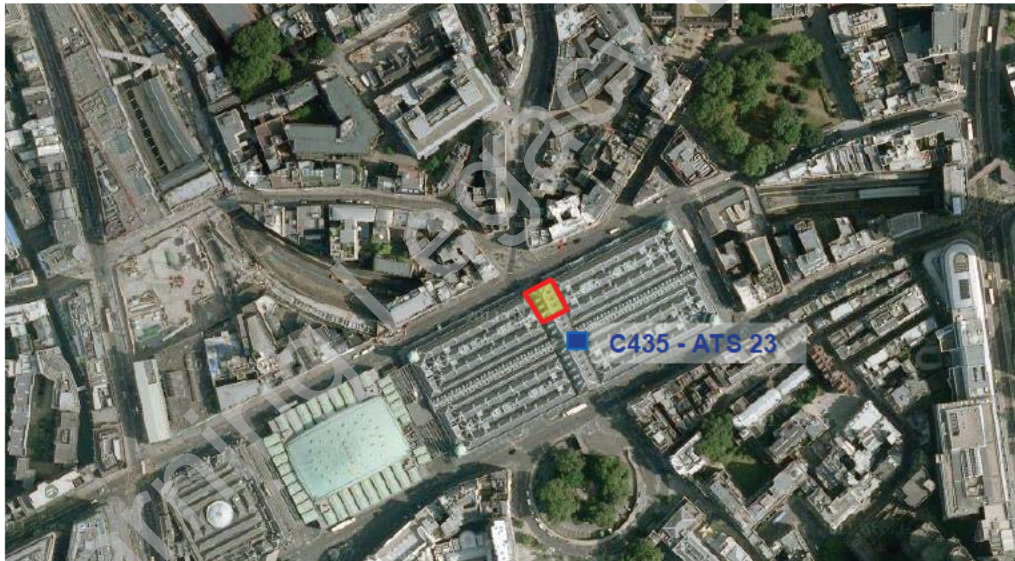
As you can see from the Figure 1 below, the instruments described in Section B.1 are located in Charterhouse Street western area. A drawing showing the location of these devices can be found in the Appendix A.

Figure 1 – Map showing the Location of ATS 23 and 3D Targets read by ATS 23.

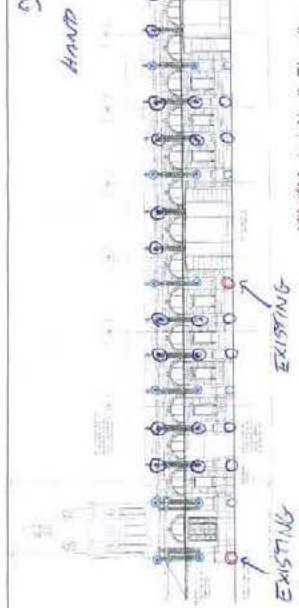
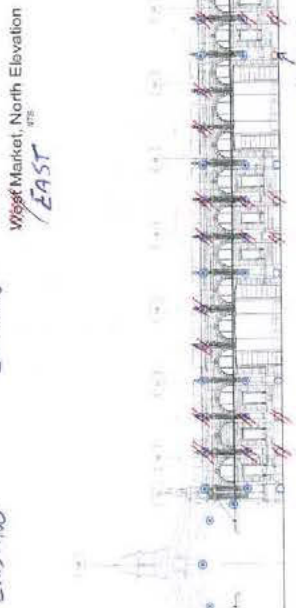
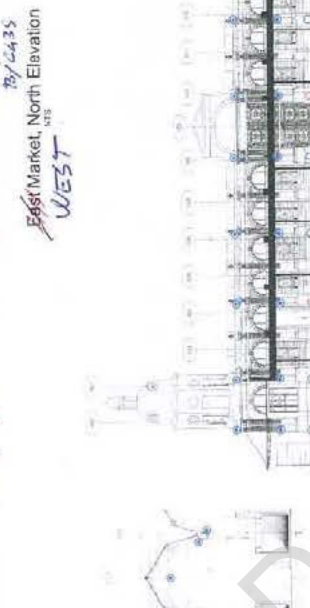
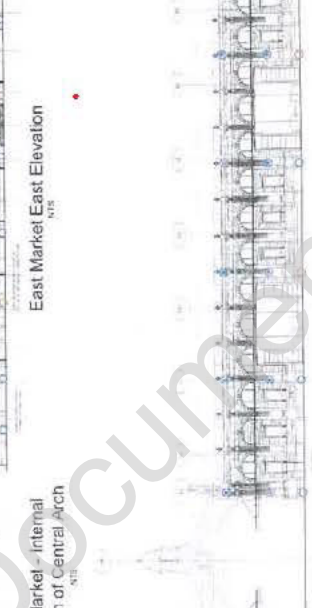
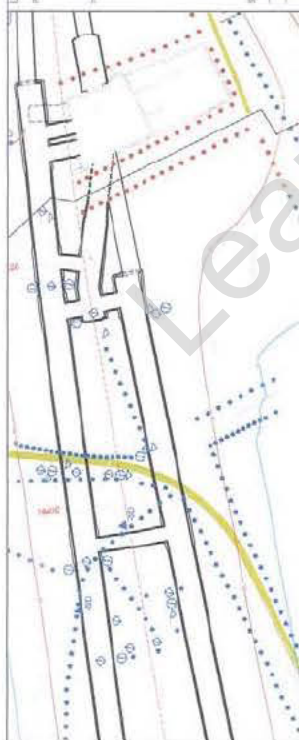
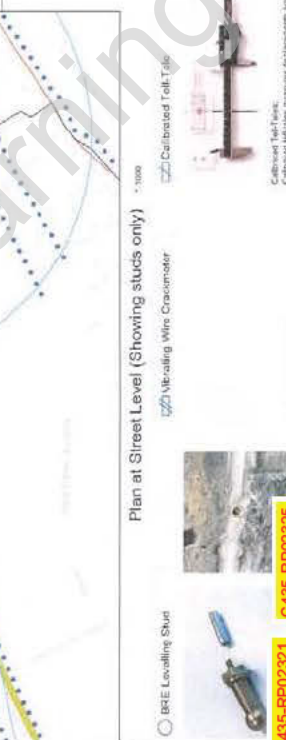
**Plan at Street Level (Showing studs only)**

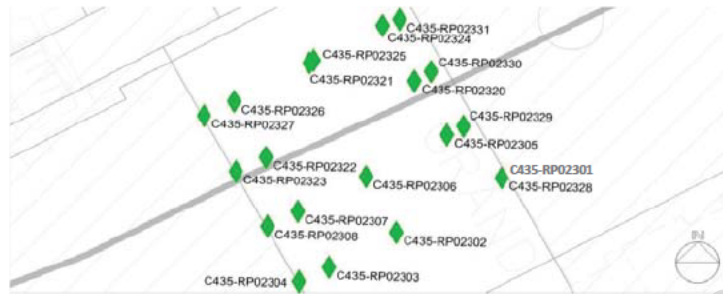
Building: GRAND AVENUE

REPORT Automatic Prisms  
 AREA Farringdon Station  
 DEVICE 3D Target

**REMARKS:**  
 WB TBM passage caused around 4mm settlement. SCL-PTW enlargement works caused a maximum settlement around 3mm.  
 Almost 5mm heave recorded during the TAM installation and 2.5mm because of the Pre-Treatment works carried out from Moorgate Spur Shaft No. 1.  
 From March 2014 to November 2014, compensation grouting works carried out from Moorgate Spur No. 1 movements dispated as result of the PTW enlargement works undertaken at the same time.

- Grand Avenue:  
WB TBM passage caused around 4mm settlement and SCL-PTW enlargement works around 3mm. Almost 5mm heave recorded during the TAM installation and 2.5mm because of the Pre-Treatment works carried out from Moorgate Spur Shaft No.1.  
From March 2014 to November 2014, compensation grouting works were carried out from Moorgate Spur No.1 in line with PTW enlargement works undertaken at the same time.

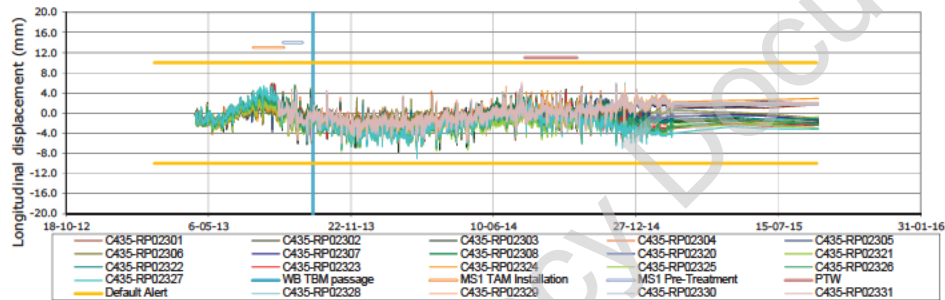
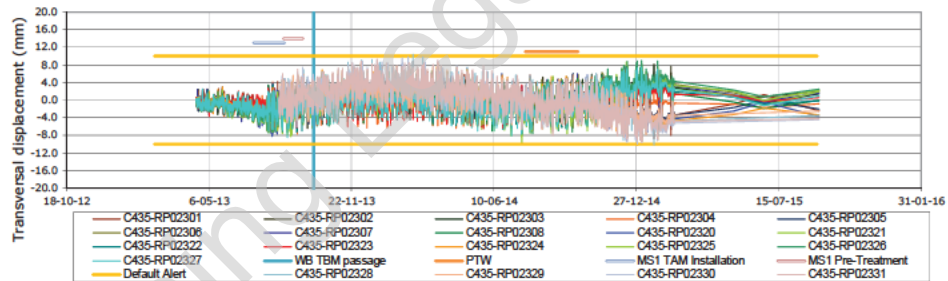
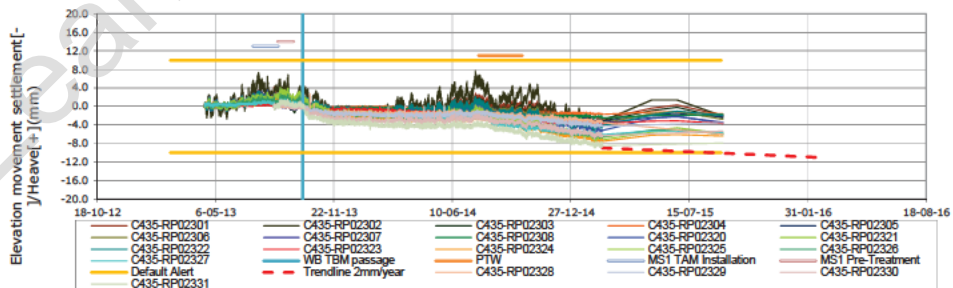
Building: GRAND AVENUE

Following the WB TBMs passage and the SCL enlargement of PTW, the maximum measured settlement for these 3D Targets has been around 8mm, being the maximum horizontal movement recorded in longitudinal and transversal directions of -3.18mm and -3.66mm.

After the works, all devices do not show any significant movement, therefore these devices are considered stabilized.
