C435
Farringdon Main Station

Monitoring Close-Out Report:
External Monitoring

CRL Document Number: C435-BFK-C2-RGN-M123-51617

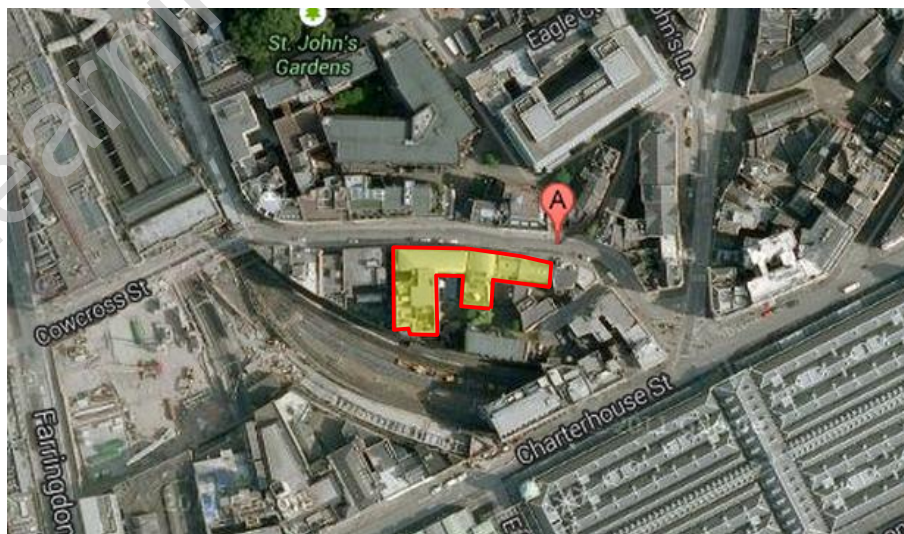
Figure 1 – Map showing the location of monitored buildings.

As you can see from the Figure 1 below, the instruments described in Section B.1 are located in Cowcross Street and Greenhill's Rents area. A drawing showing the location of these devices can be found in the Appendix A.

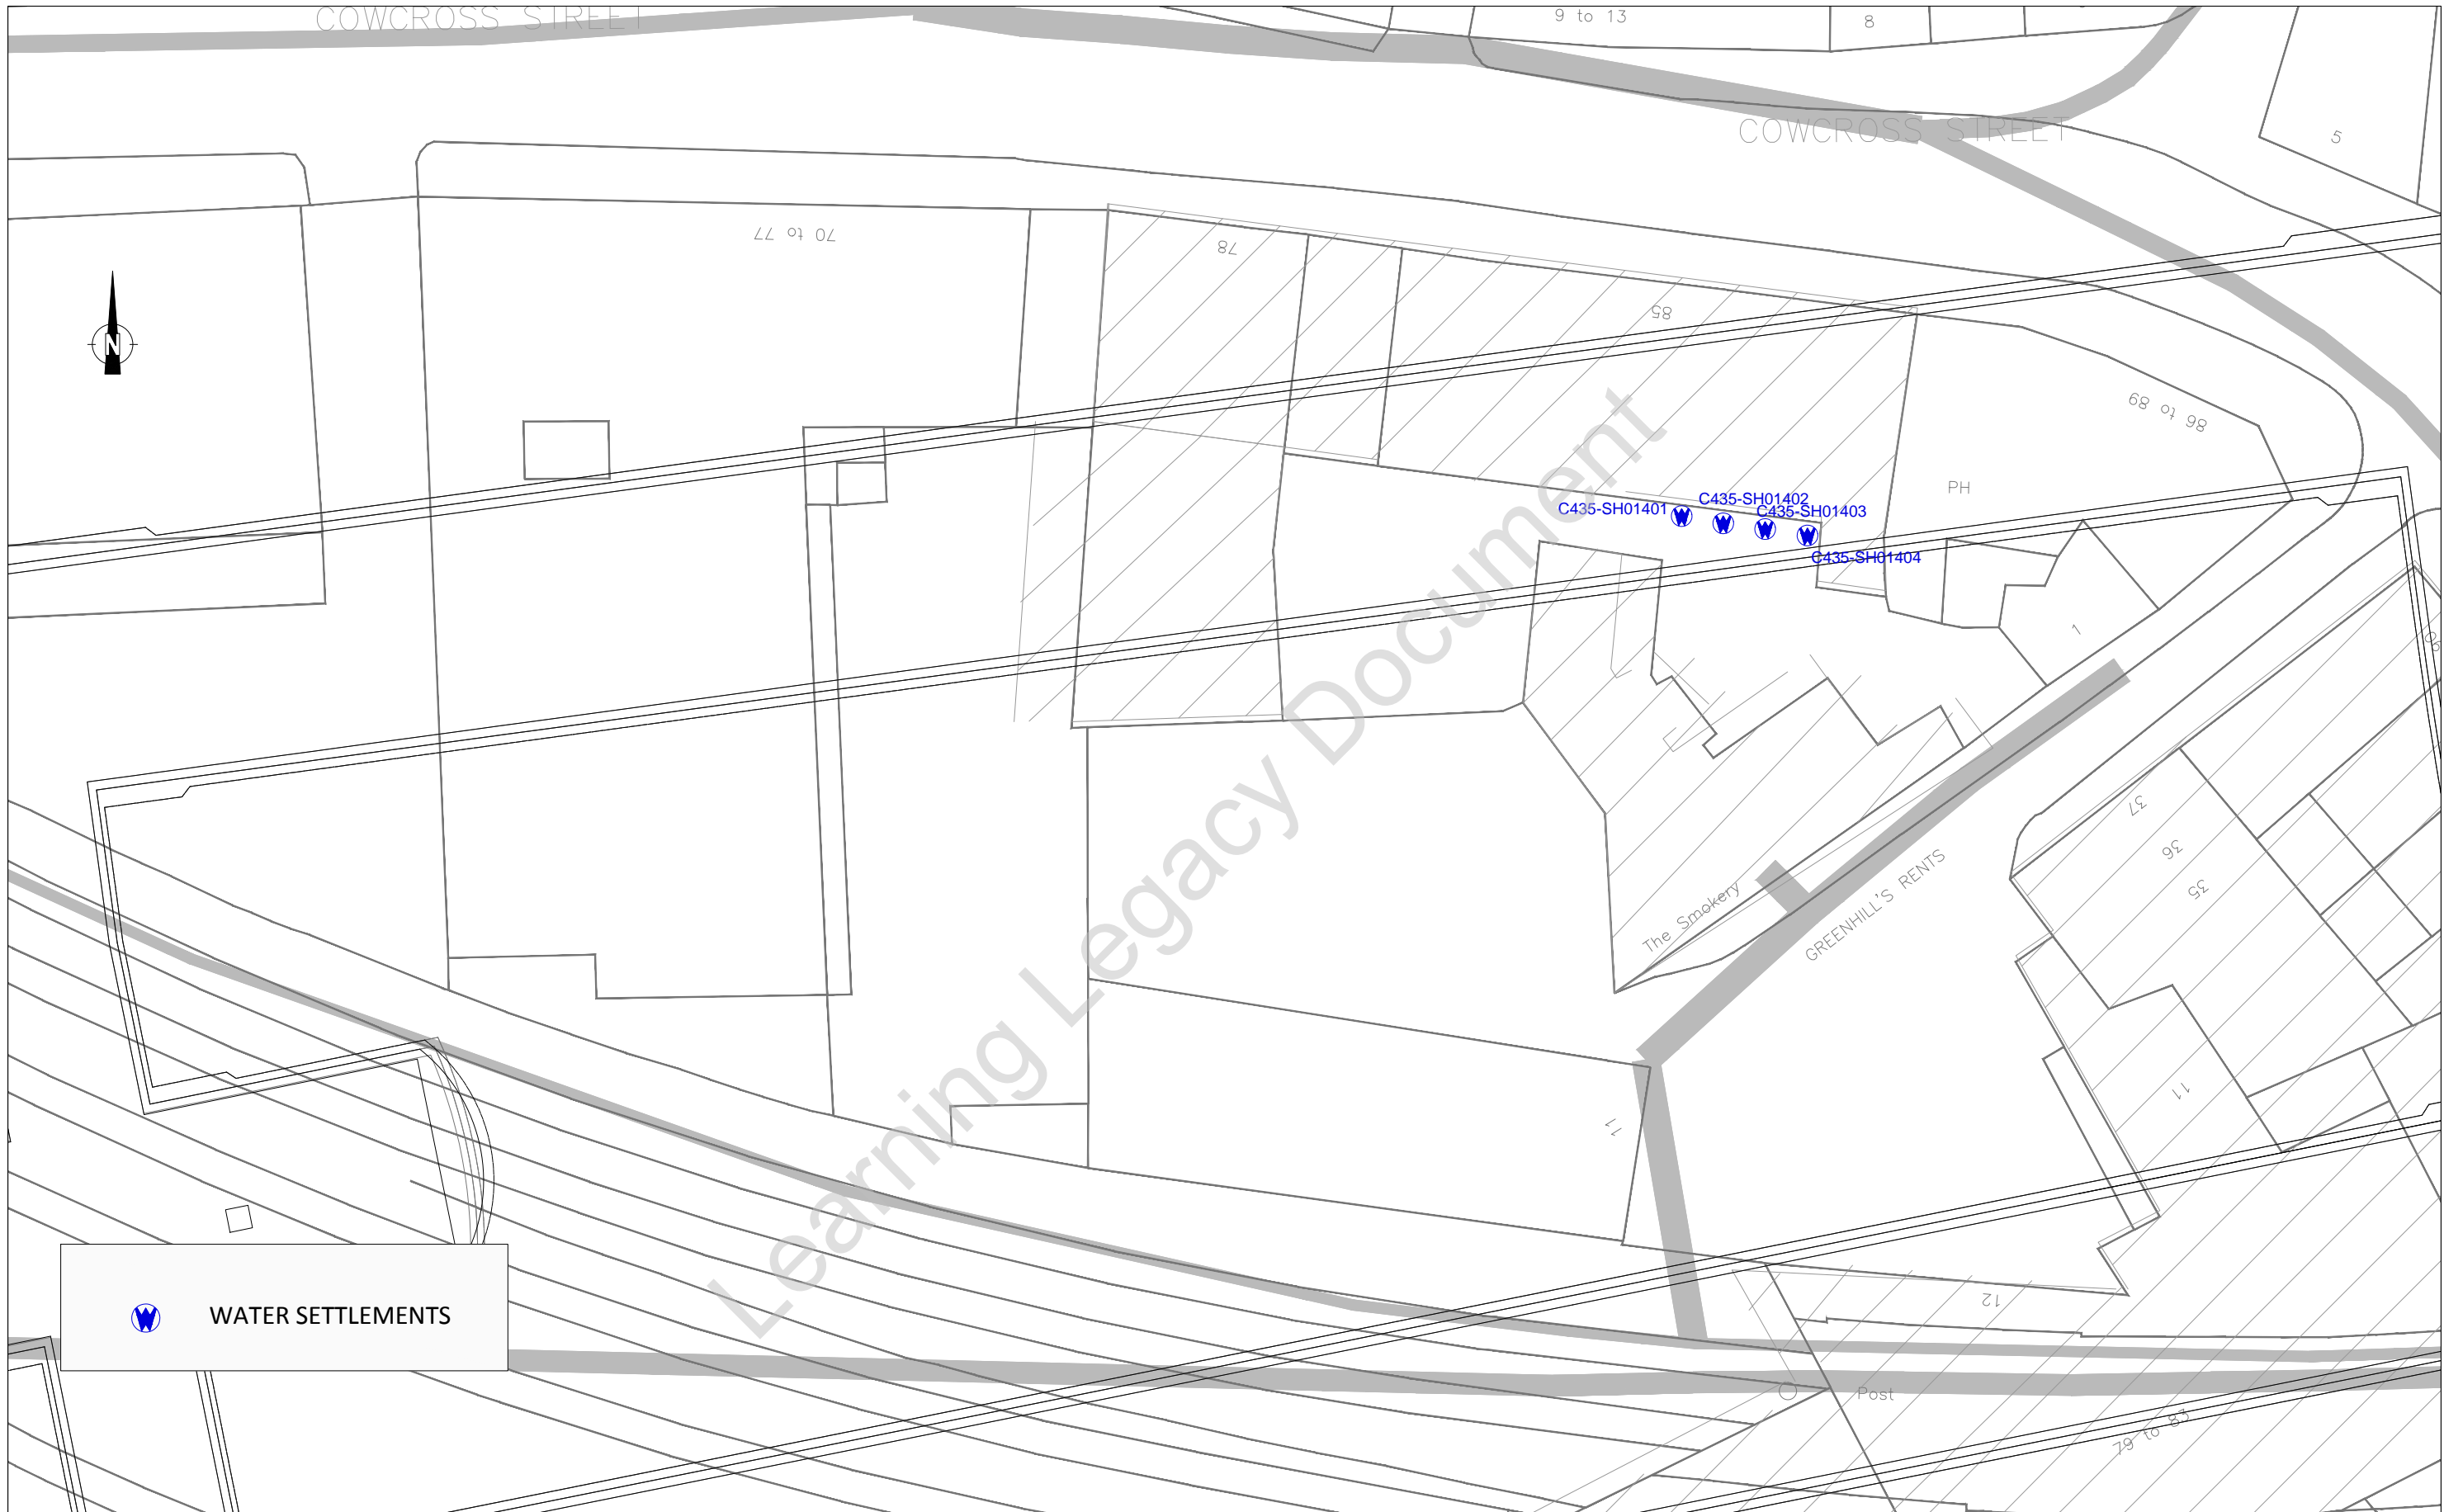
Contract :	C435 I&M FARRINGTON STATION
Originator :	GEOCISA
Location :	CROSSRAIL GENERAL
Title :	Water Settlement Cells- 70-85 Cowcross St
Drg No :	C435-BFK-C2-RGN-M-123-50998-IR-SH-70/85CCR
Rev :	
Suit :	
By :

WATER SETTLEMENTS

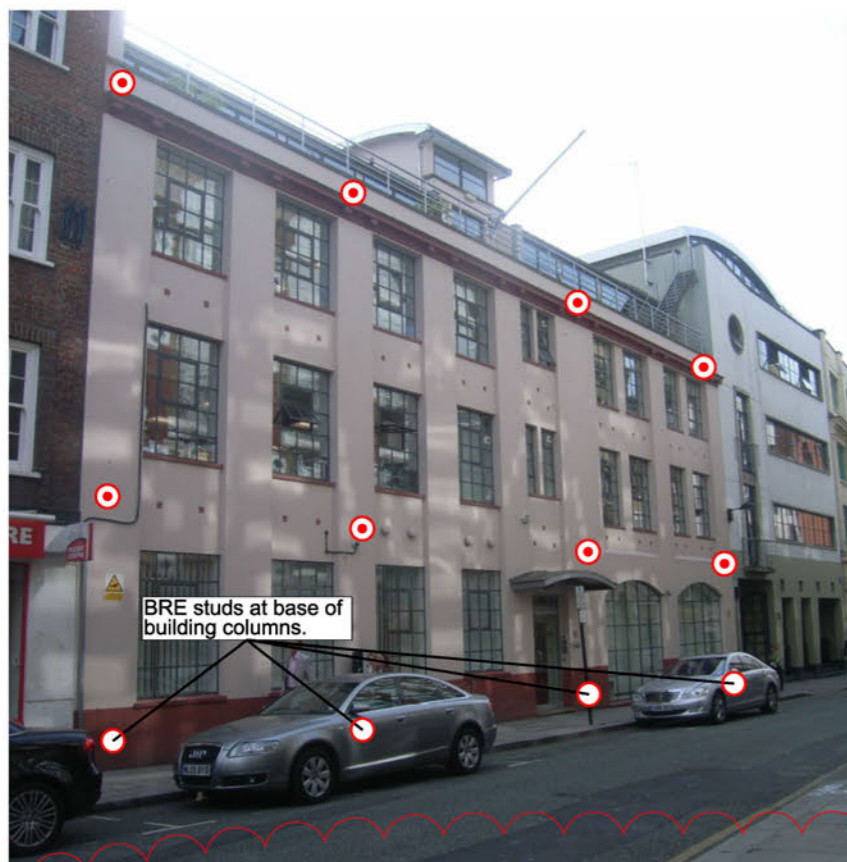
BRE studs at base of building columns.

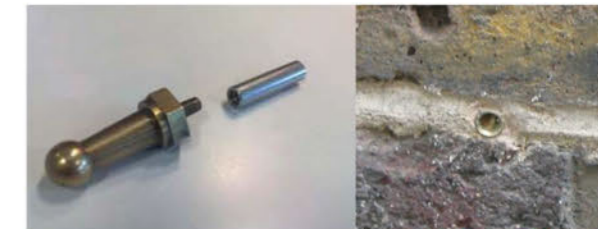
BRE Levelling Stud

BRE Levelling Stud:

Levelling stud screws into BRE socket within wall. Manually read levelling staff placed onto stud.

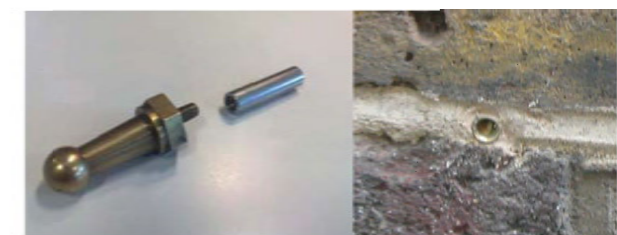
BRE Levelling Stud:

Levelling stud screws into BRE socket within wall. Manually read levelling staff placed onto stud.

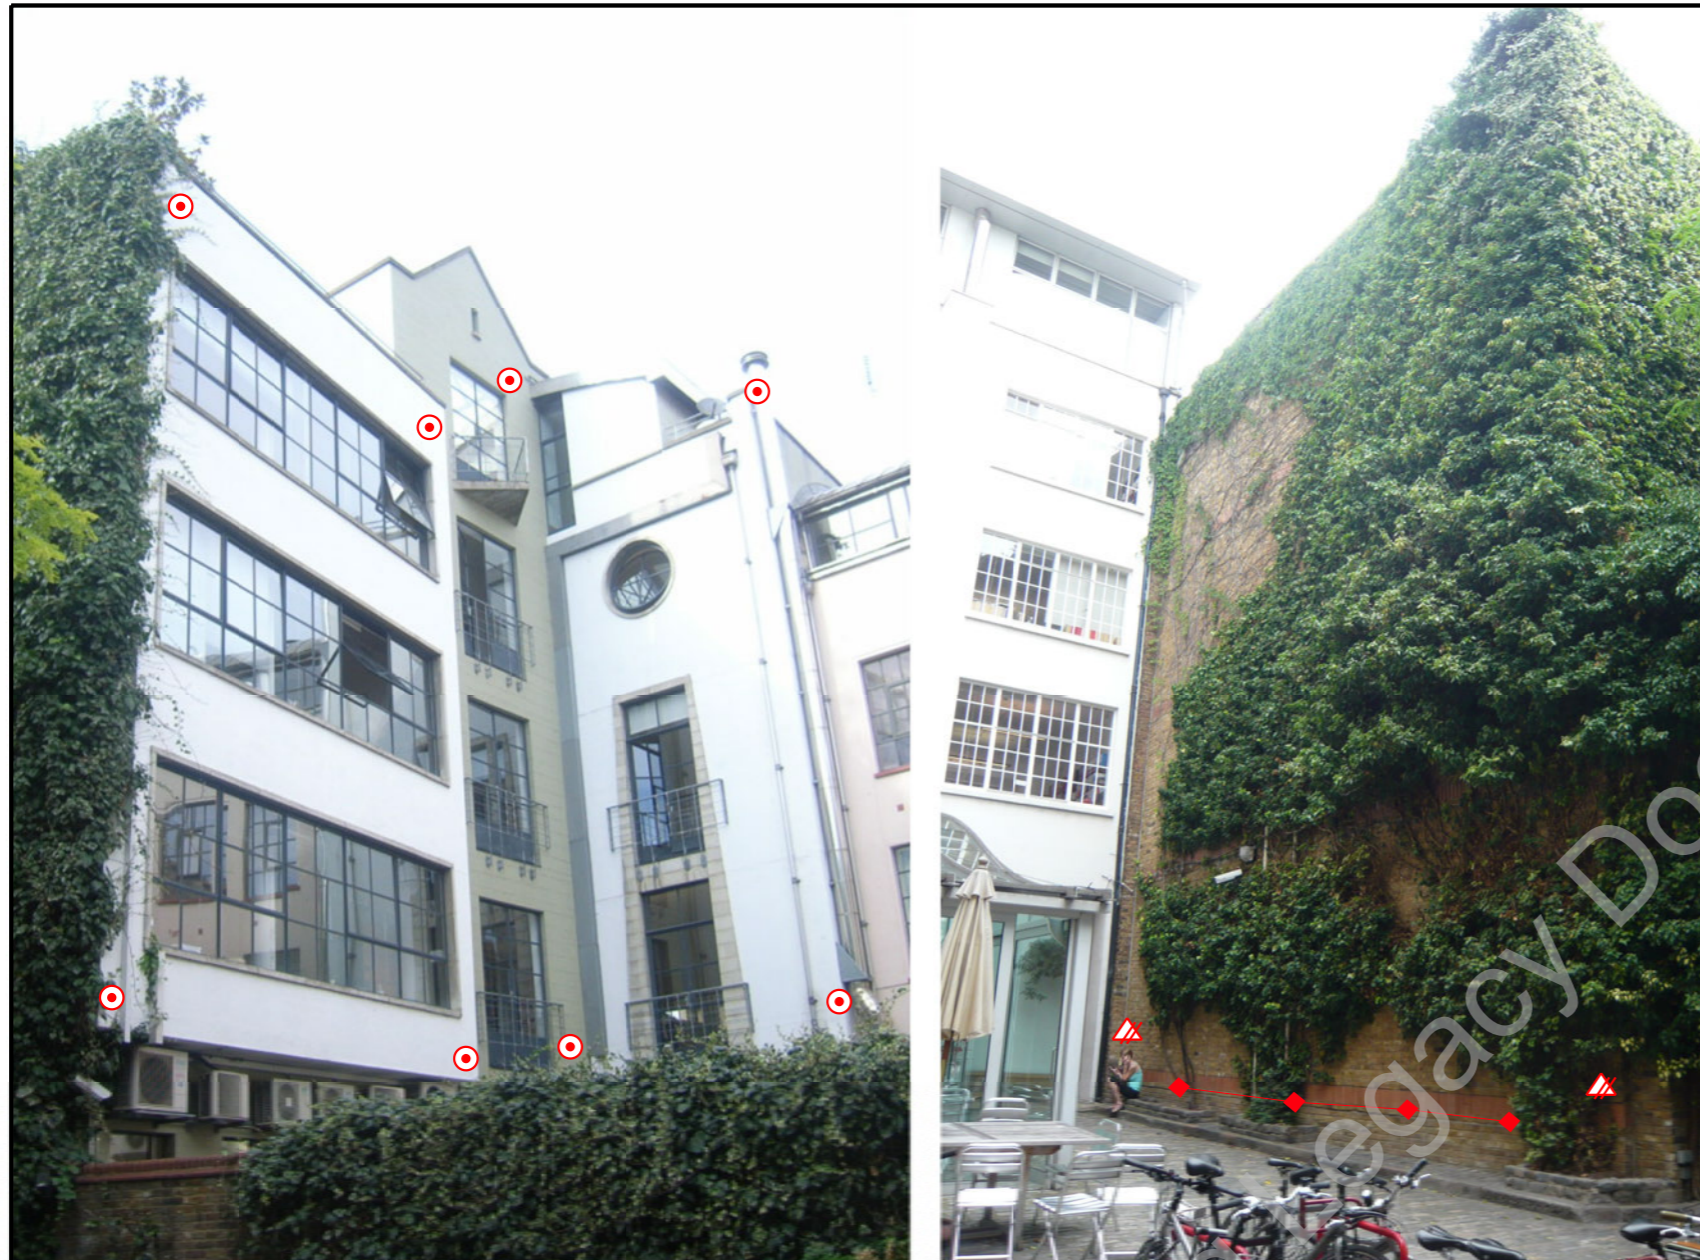
External Monitoring Instrumentation

Monitoring type	Number of Instruments	Fixings per instrument	Fixing details	Making good strategy
Geodetic Prisms	8	1	Brackets screwed into slightly recessed shell anchor fixings approximately 10mm in diameter, inserted into drill holes and expanded to stabilise.	Prism brackets will be removed, and recessed fixing area made good with materials to match the existing façade finish.
Vibrating Wire Crackmeters	TBC on site	TBC on site	Attached by screws with movable ball joints into slightly recessed shell anchor fixings approximately 10mm in diameter, inserted into drill holes and expanded to stabilise. These are attached by a lead to a transmitter box with screw fixings.	Crackmeter and transmitter box will be removed, and recessed fixing areas made good with materials to match the existing façade finish.
Electrolevel Beam	6	2	Beams screwed into slightly recessed shell anchor fixings approximately 10mm in diameter, inserted into drill holes and expanded to stabilise.	Beams will be removed, and recessed fixing area made good with materials to match the existing façade finish

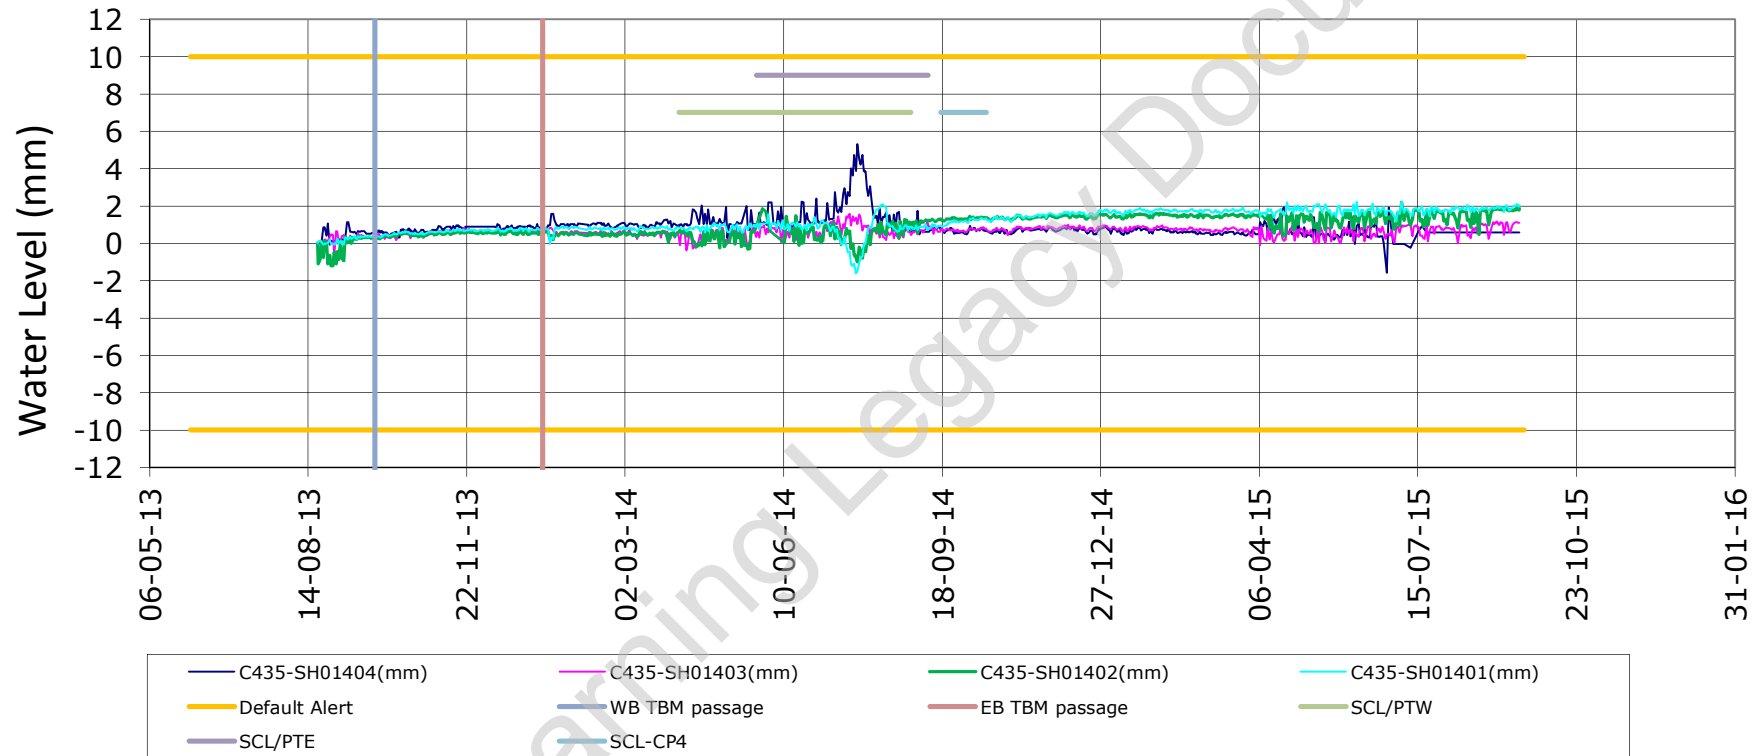
All of the Water Settlement Cells were installed inside the zone of influence being not fixed to any reference absolute value, being that the reason why the movement shown during SCL works has not been the expected one.

- 79-85 Cowcross Street
 data for Waterlevel Settlement Cells and Tiltmeters installed externally on this building is shown in Appendix B. No special movement during WB-TBM passage and approximately 1mm of movement recorded during the EB-TBM one. PTE enlargement caused a maximum of 5mm of movement, being insignificant the movement caused by PTW enlargement and CP4 cross passage excavation. All of the Water Settlement Cells were installed inside the zone of influence being not fixed to any absolute reference value.

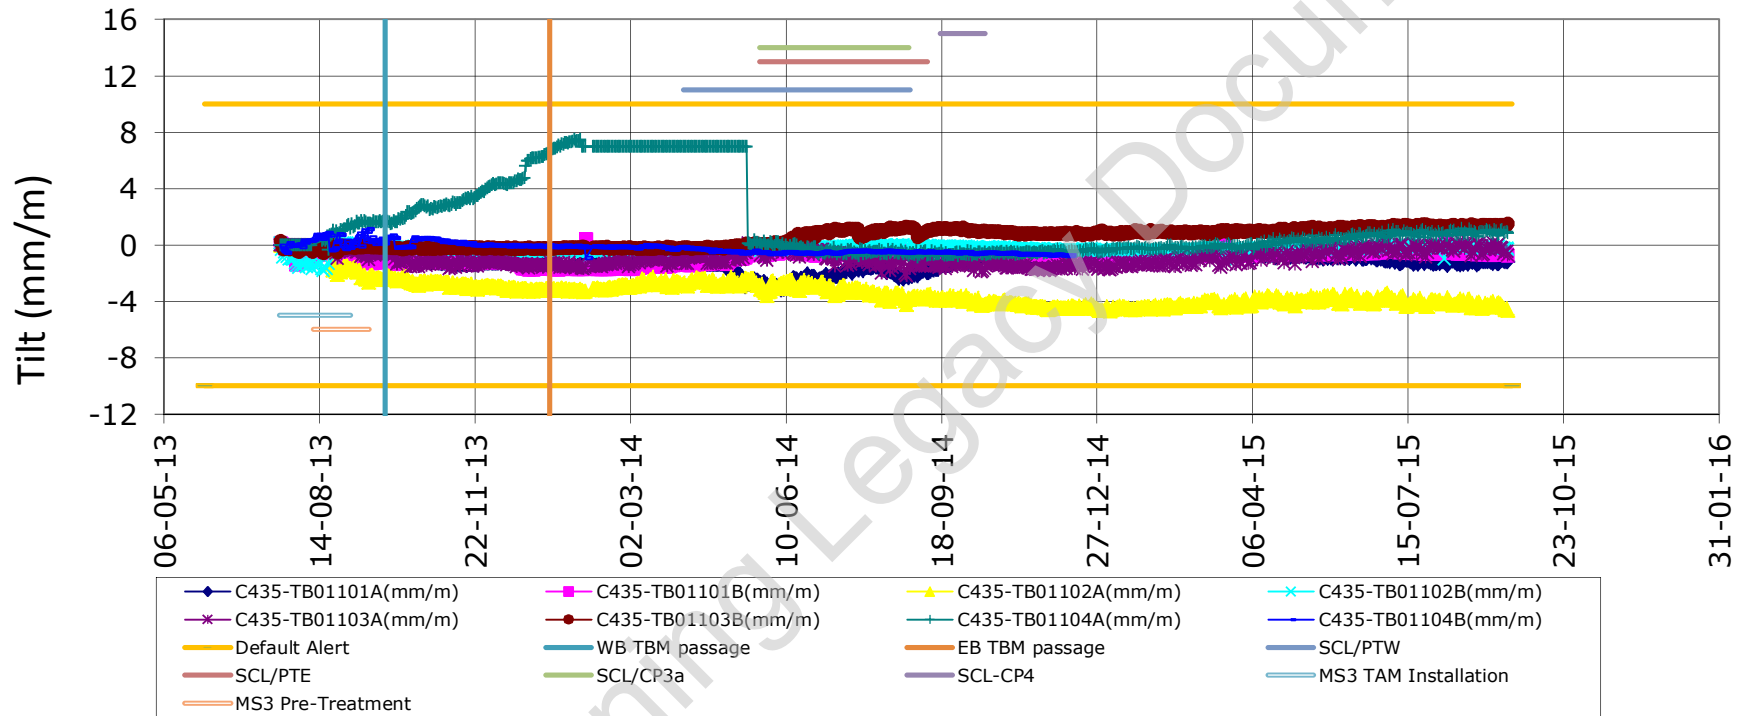
Albion Courtyard, Greenhill's Rents

C435-TB01104A was damaged showing an anomalous behaviour from 25/08/2013. After several investigations and analysis, the drift was amended and the device fixed properly on 16/05/2014 coming the readings back to normal after applying an offset taking into account the movement recorded during these time by surrounding devices.

- Tiltmeter C435-TB01104A installed externally on the Albion Courtyard building was damaged showing an anomalous behaviour from 25/08/2013. After several investigations and analysis, the drift was amended and the device fixed properly on 17/05/2014 coming the readings back to normal after the maintenance works an applying an offset taking into account the movement recorded during this time by surrounding devices.

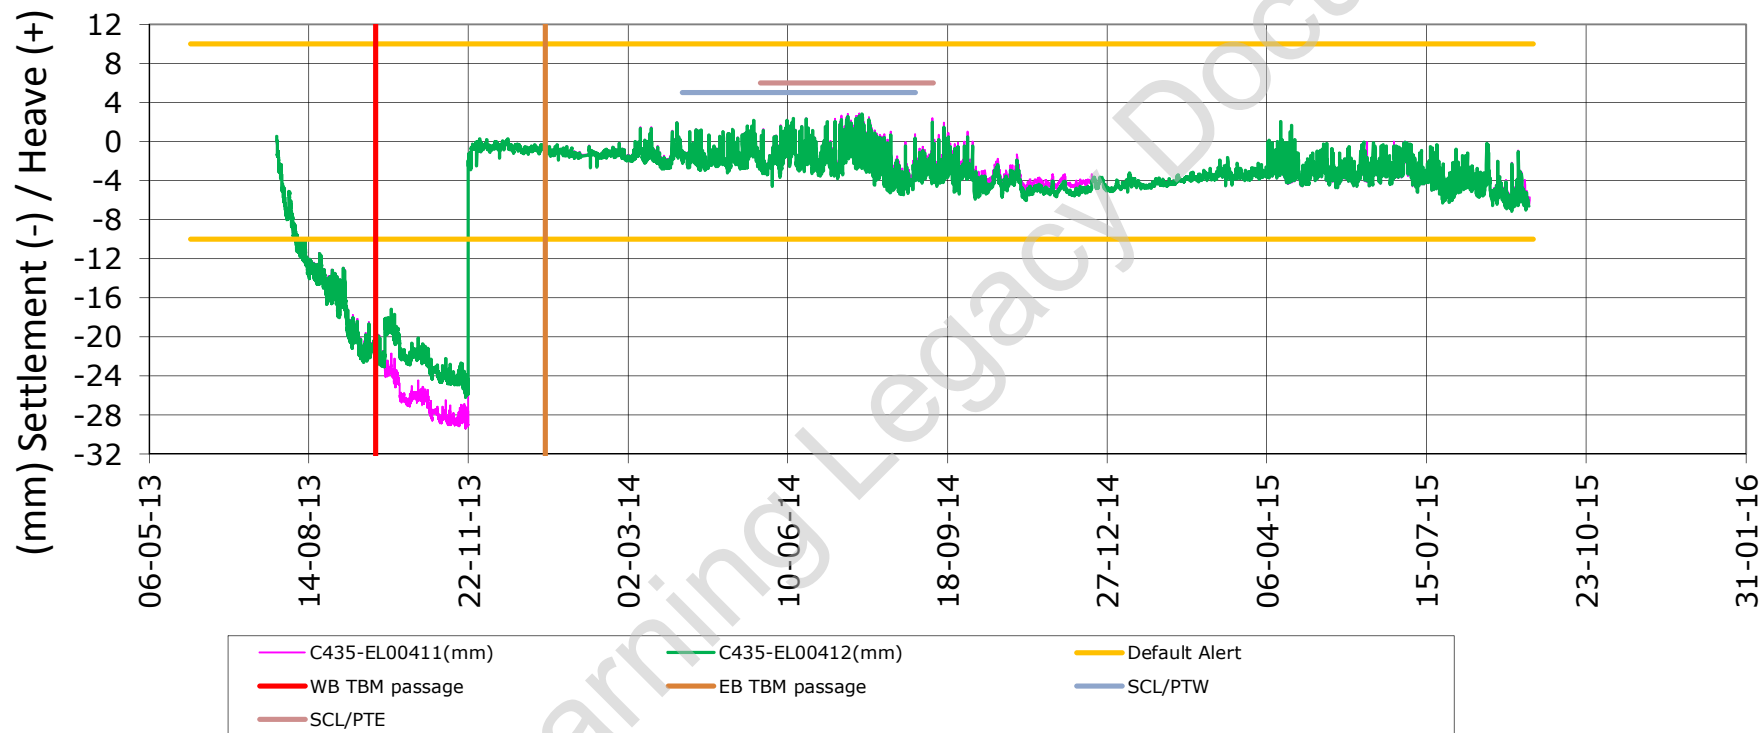
78 Cowcross Street

Inaccurate behaviour and trend of settlement recorded from origin to 17/11/2013, when the devices were fixed and readings amended applying an offset on 17/11/2013 taking into account the behaviour recorded by surrounding devices in this period of time.

- Electrolevels C435-EL00411 and C435-EL00412 show an inaccurate behaviour and trend of settlement recorded from origin to 17/11/2013, when the devices were fixed and readings amended applying an offset on 17/11/2015 taking into account the behaviour recorded by surrounding devices in this period of time.

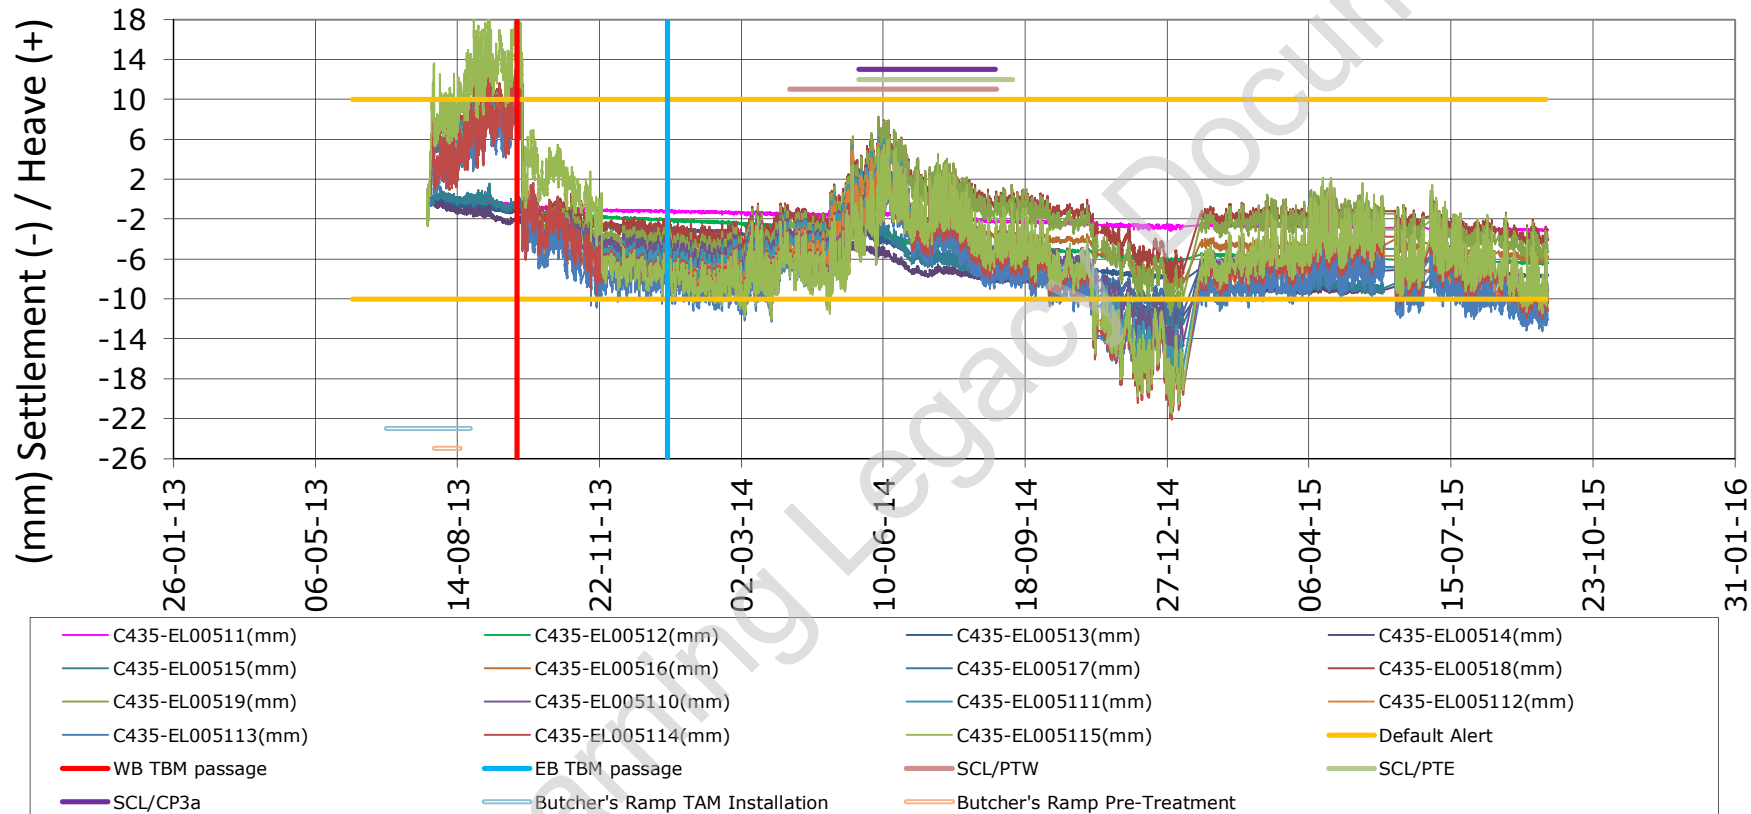
Inaccurate behaviour and trend of heave recorded from origin to 28/09/2013 in devices from C435-EL00516 to C435-EL005115, amended applying an offset on 28/09/2013 after maintenance works carried out taking into account the behaviour recorded by surrounding devices in this period of time.

- Electrolevels from C435-EL00516 to C435-EL005115 installed externally on 70-77 Cowcross Street show an inaccurate behaviour and trend of heave recorded from origin to 28/09/2013, amended applying an offset on 28/09/2013 after maintenance works carried out taking into account the behaviour recorded by surrounding devices in this period of time.
