## C435 Farringdon Main Station

### Monitoring Close-Out Report: Automated Total Station ATS15 and 3D Targets read by ATS15.

**CRL Document Number: C435-BFK-C2-RGN-M123-51620**

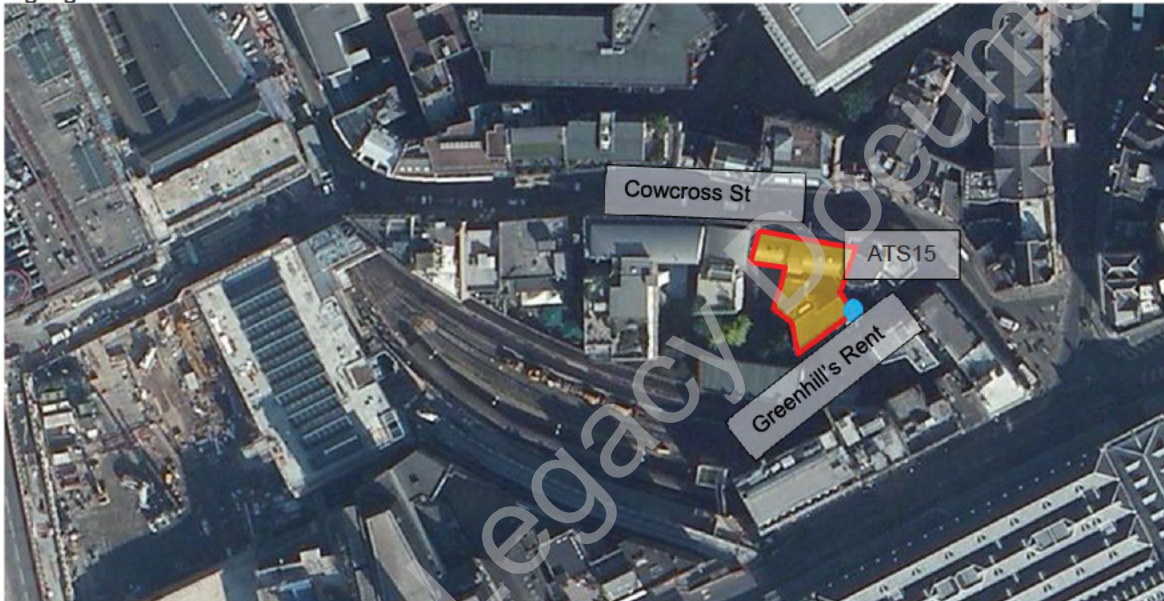
Figure 1 – Plan showing the Location of the prisms read by ATS15 and ATS15.

Prisms associated with ATS15 are located on the plan below highlight in yellow. The location of ATS15 highlight in blue.

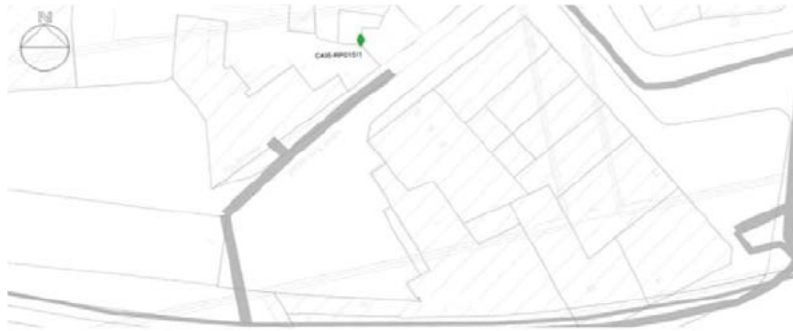
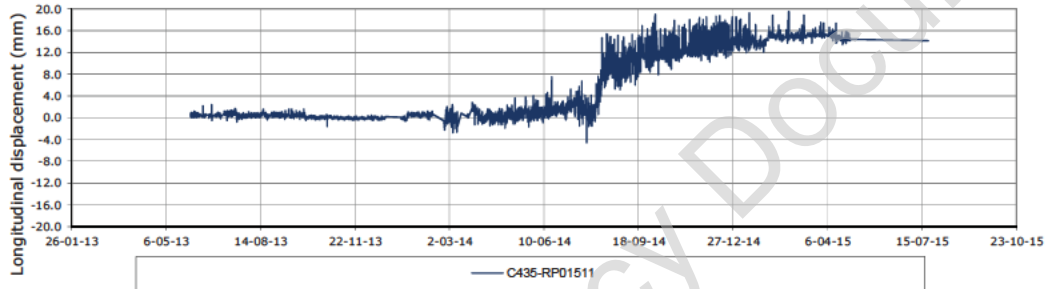
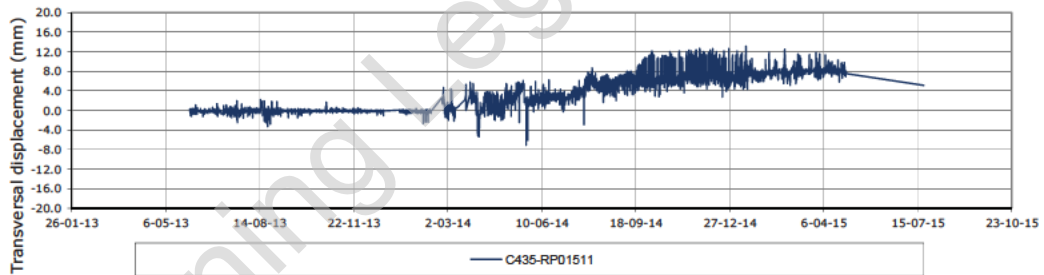
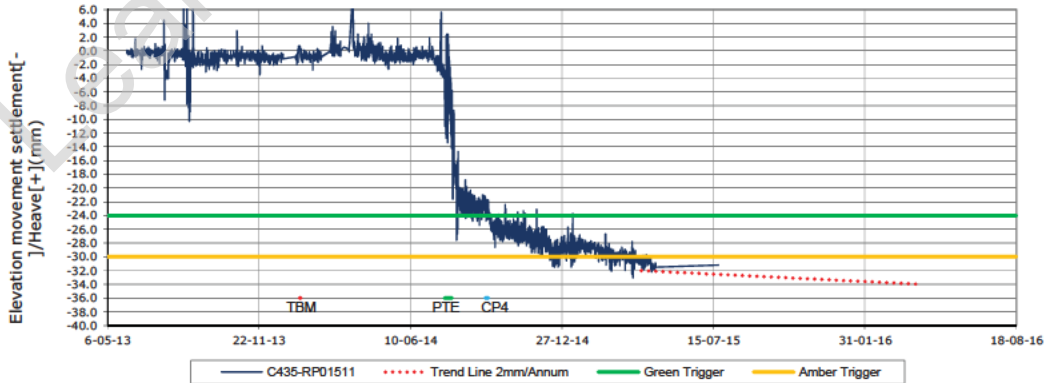
Building: 1 GREENHILL'S RENTS

- Between 25-07-2014 and 04-08-2014 PTE enlargement works caused 22mm maximum of settlement.
- From 17-09-2014 to 21-07-2014 CP4 works caused 3-4mm of settlement maximum.
- Maximum Longitudinal movement +16mm
- Maximum Transversal movement +8mm

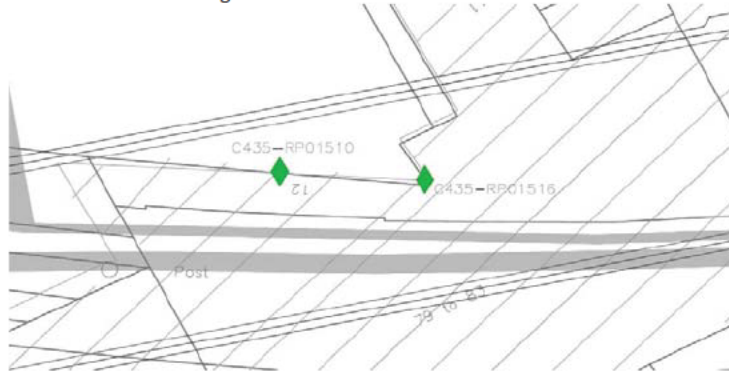
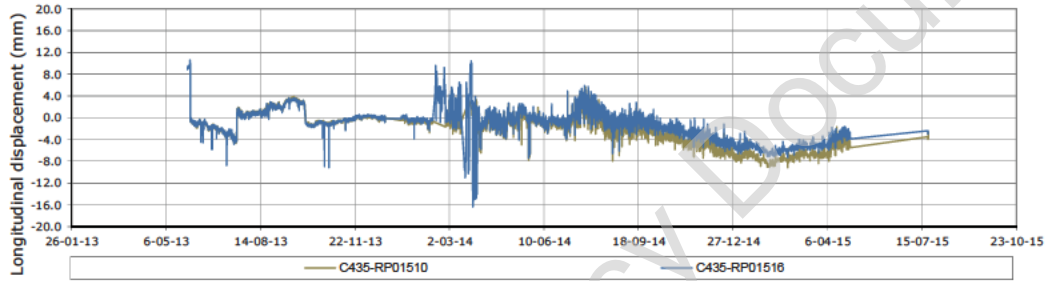
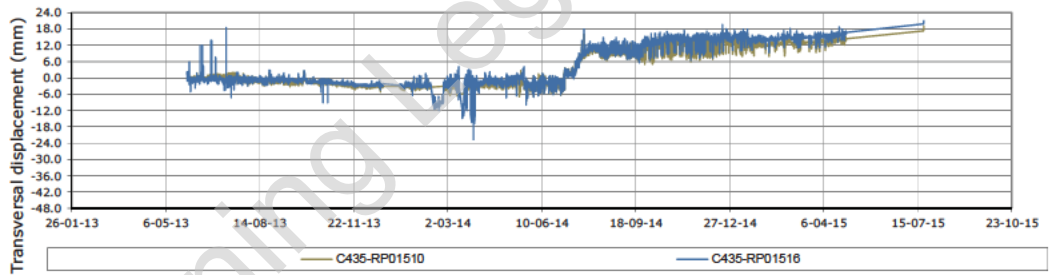
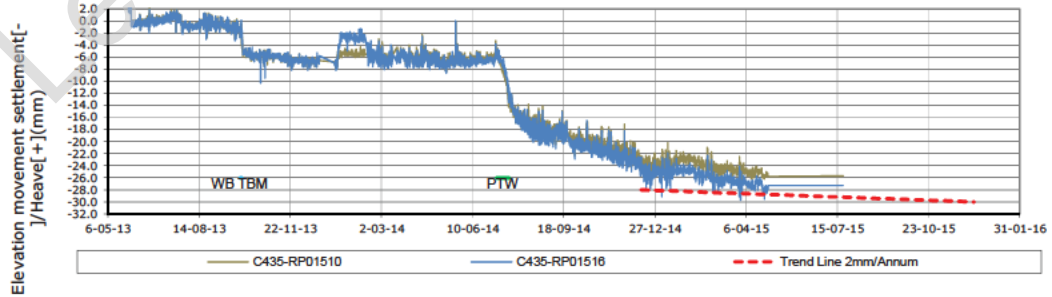
Building: 79-83 CHARTERHOUSE STREET

- From 28-09-2013 to 30-09-2013 WB TBM caused 5-6mm maximum of settlement.
- Residual settlement caused 2mm of settlement.
- In January 2014 compensation grouting episode caused 4mm of heave.
- Concurrent grouting on 4<sup>th</sup> July 2014 caused 4mm of heave.
- Between 06-07-2014 and 20-07-2014 PTW enlargement caused 8mm of settlement.
- Maximum Longitudinal movement -4mm
- Maximum Transversal movement +18mm

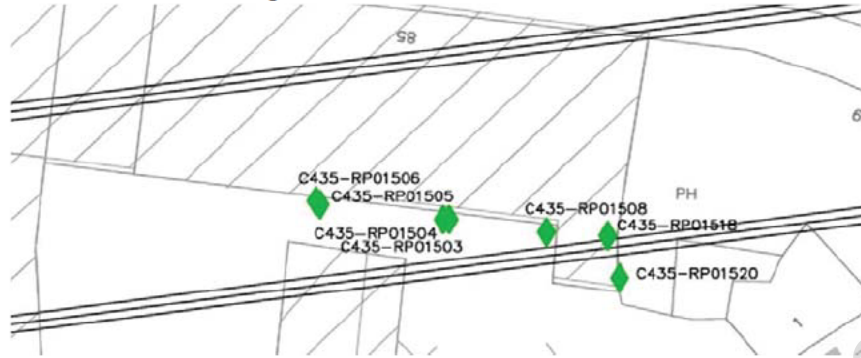
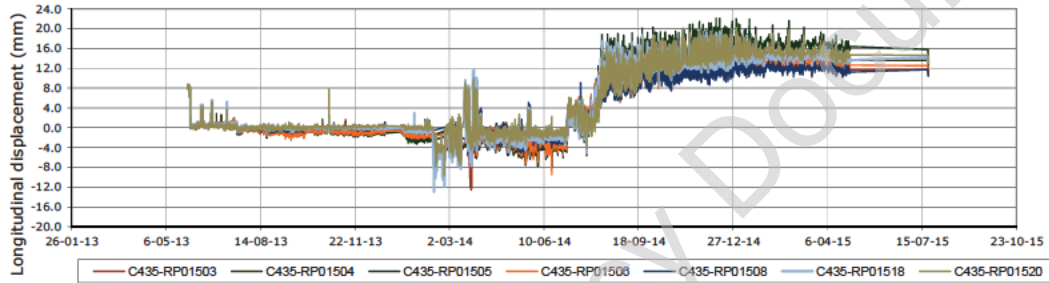
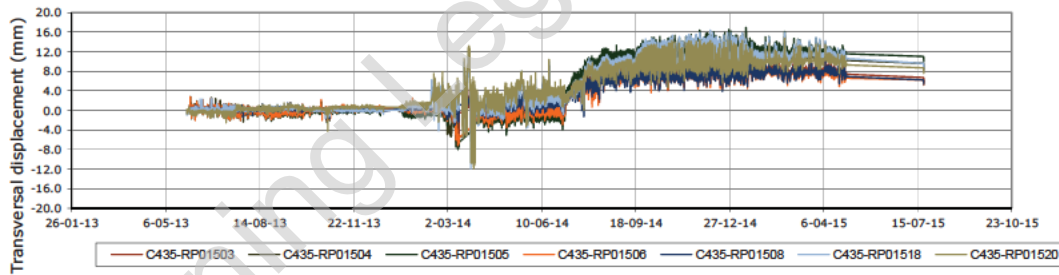
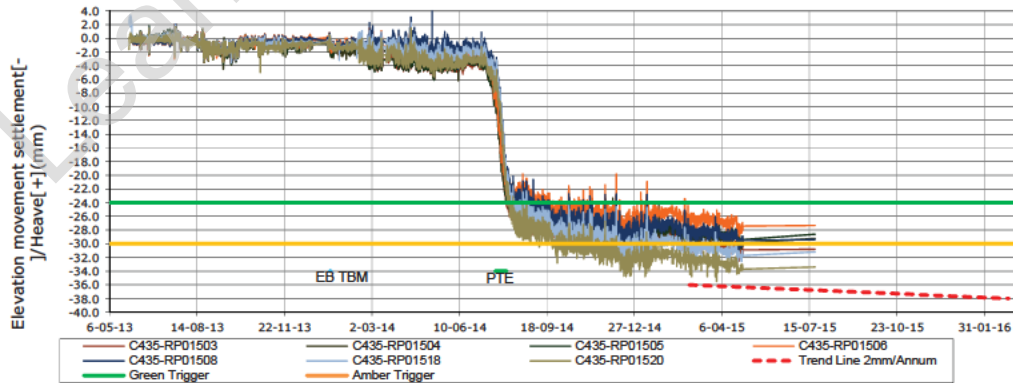
Building: 79-85 COWCROSS STREET

- From 13-01-2014 to 14-01-2014 EB TBM caused 2-3mm maximum of settlement.
- Between 21-07-2014 to 03-08-2014 PTE construction caused 22mm of settlement.
- Residual settlement after PTE works caused 4mm of settlement.
- Maximum Longitudinal movement +16mm
- Maximum Transversal movement +12mm

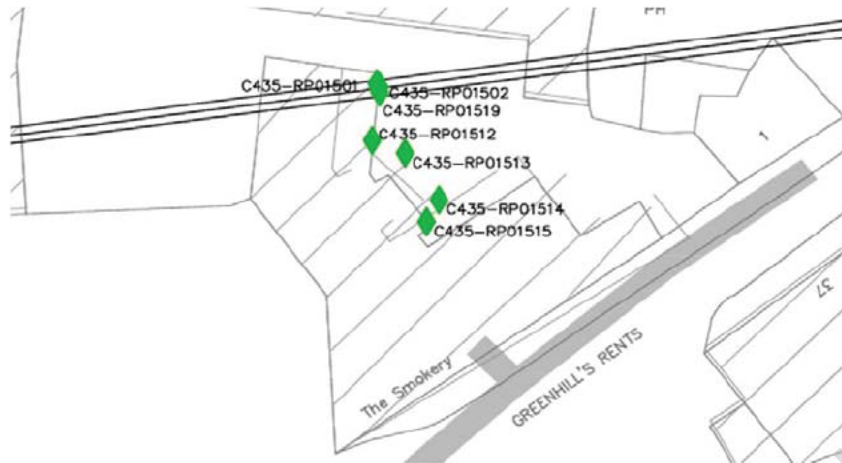
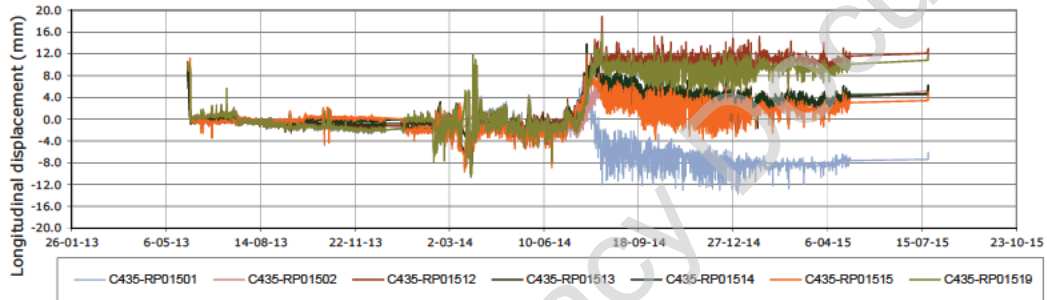
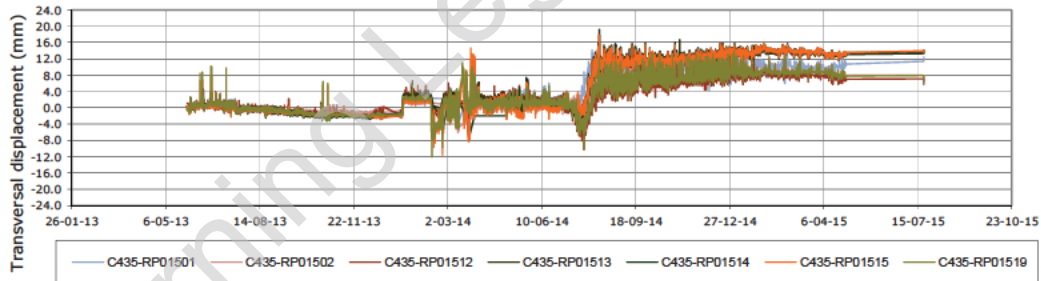
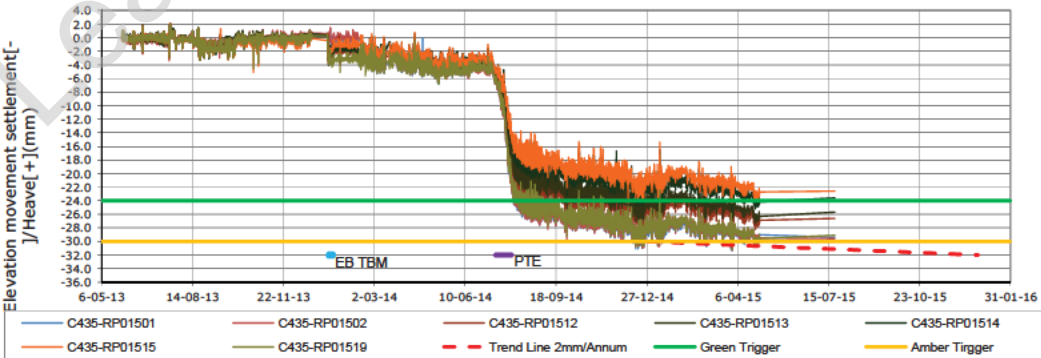
Building: THE SMOKERY-ATS15

- From 12-01-2014 to 15-01-2014 EB TBM caused 2-3mm maximum of settlement.
- Residual settlement caused 2mm of settlement.
- Between 13-07-2014 and 01-08-2014 PTE works caused 22-24mm maximum of settlement.
- No movements during CP4 construction.
- Maximum Longitudinal movement +12mm
- Maximum Transversal movement +14mm
