Learning Legacy Document

## A. INTRODUCTION

In line with the C122 – M&W Specification KX10 – Instrumentation & Monitoring C122-OVE-Z4-RSP-CR001-00007, this Close-Out Report aims to address the following points in relation to the instrumentation defined in Section 2.

This Close-Out Report relates the monitoring devices installed on Section C. See table 1 below with the details for the devices.

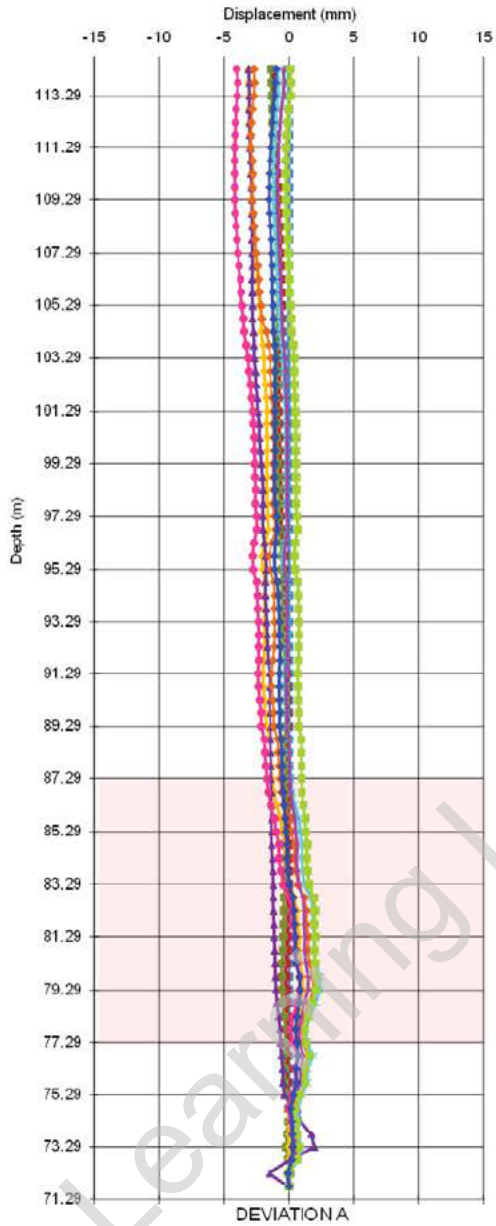
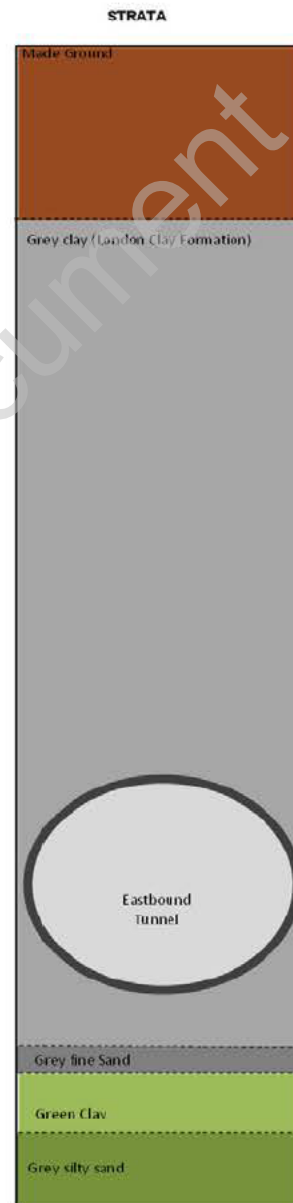
**REPORT:** Manual Inclinometer  
**LOCATION:** The Partners  
**DEVICE:** Inclinometer C435-IM00003  
Before and After TBM

As usual the movements captured during TBM passage are minimums. This is caused because the TBM cross the area very quickly, and tunnel section is done at the same time. In this case the maximum horizontal movement captured by the inclinometer is around 2-3mm into the tunnel at the bottom level of the tunnel in A+ direction. In B+ direction the inclinometer didn't show significant movements.

TBM cross the area where the inclinometer is install on 12-01-2014

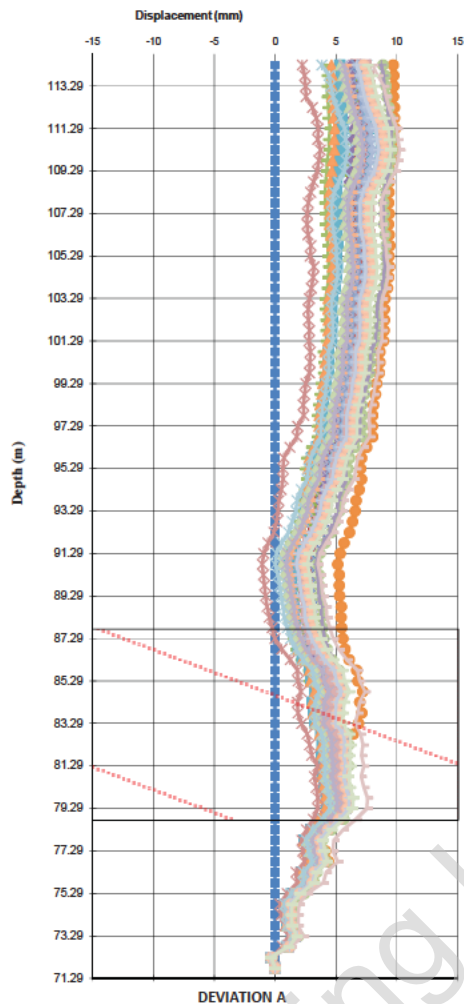
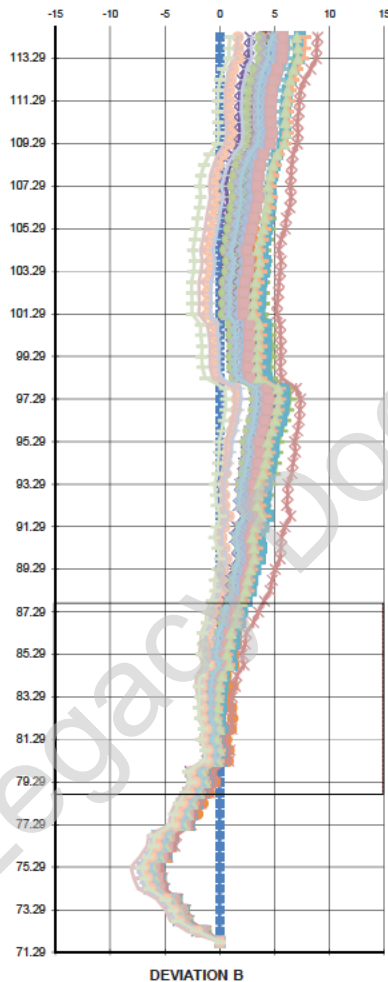
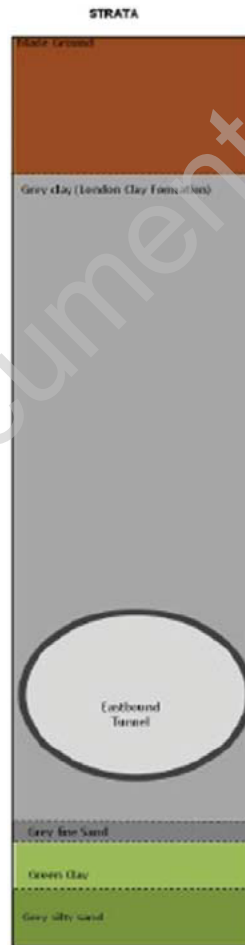
**REPORT:** MANUAL INCLINOMETER  
**LOCATION:** BACKYARD-THE PARTNERS  
**DEVICE:** Inclinometer C430-IM00003  
 During PTE Construction

During the PTE construction, the inclinometer showed the maximum movements. The inclinometer was inside the influence area for the construction around one month, capturing the movement as soon as the inclinometer was inside the PTE influence area. During this period, the maximum movement showed by the inclinometer on A+ direction was 8-9mm into the tunnel at the axis level for PTE. The movement on B- direction looks like a kink, but the trend for the movement is slowly and the direction of the movement is the correct because the inclinometer was moving to the tunnel. So, for this reason, the movement on B- is real, in this case, the maximum on this direction was 6-7mm.

The inclinometer was inside the influence area for PTE construction from 08-07-2014 to 25-07-2014

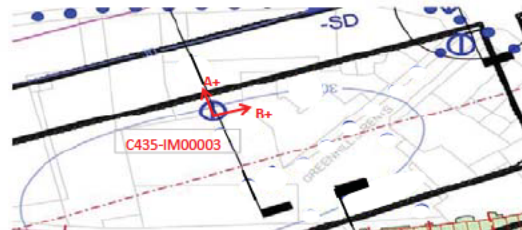
**REMARKS:**

Once the inclinometer was outside the influence area for PTE, the movements captured showed stable conditions. Also, in the last readings the trend of the movements showing how the inclinometer moves to the original position, in both directions.

At the end, the maximum movement captured by this inclinometer was caused by the PTE construction was 7-8mm at the tunnel axis level.

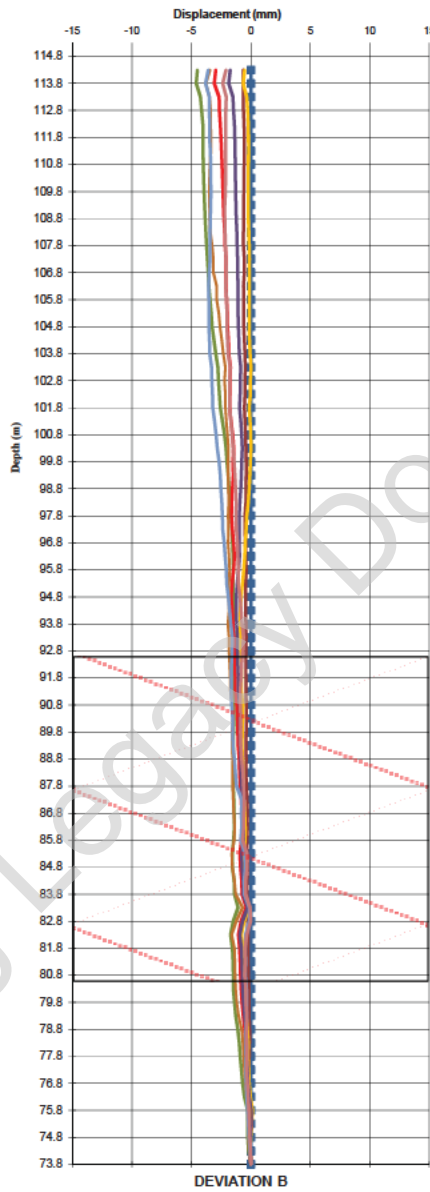
**REPORT:** MANUAL INCLINOMETER  
**LOCATION:** GRENNHILL'S RENT  
**DEVICE:** Inclinometer C435-IM00004  
 Before and After TBM

The first graph for this inclinometer is showing the movements before and after the TBM. As is usual, the inclinometers didn't capture significant movements caused by the TBM. The reason for this is the construction method. The maximum movement is 2-3mm.

The inclinometer was inside influence area for WB TBM from 29-09-2013
