C435 Farringdon Main Station

Monitoring Close-Out Report: Automated Total Station ATS11 and 3D Targets read by ATS11.

CRL Document Number: C435-BFK-C2-RGN-M123-51629

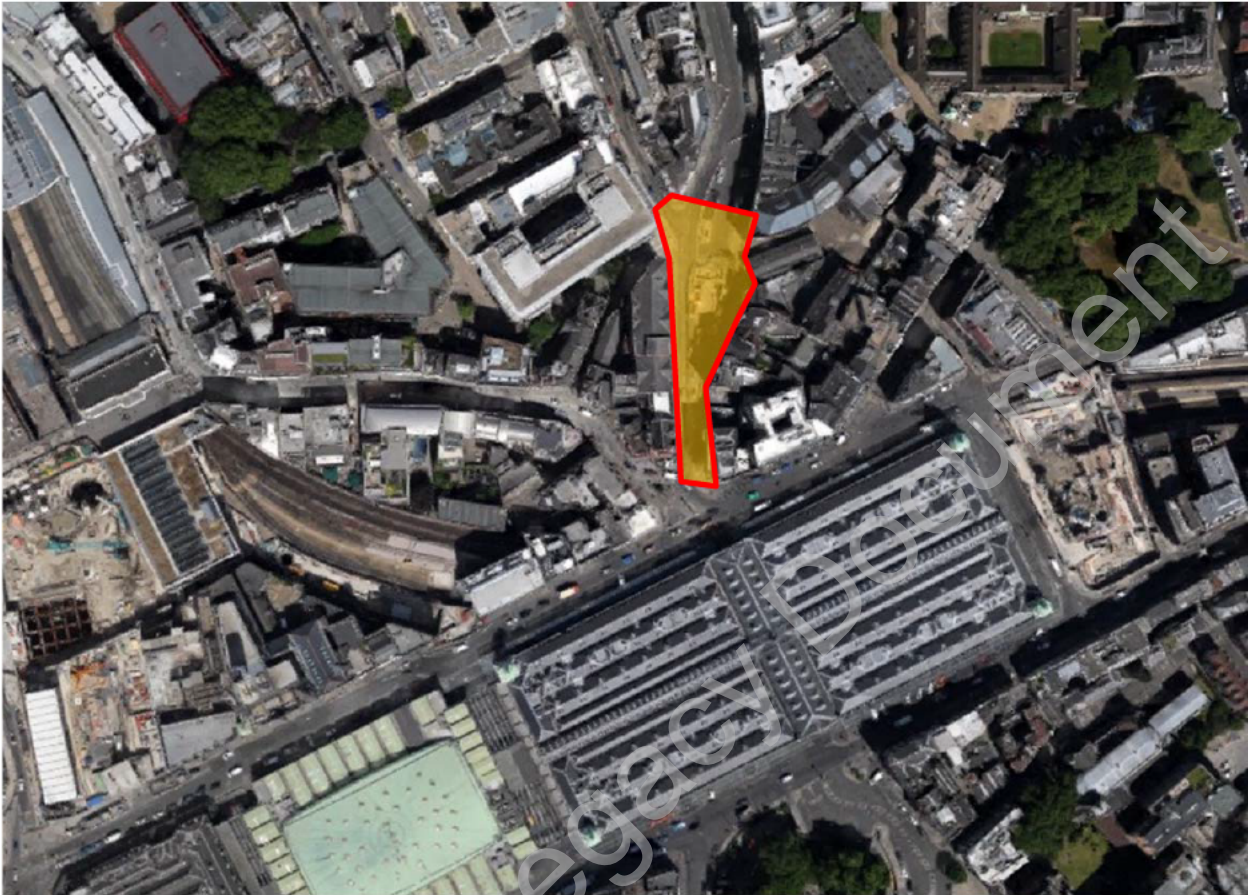
Figure 1 – Map showing the Location for the device on St John St

The buildings where the prisms are installed are located along St John St. The prisms are installed on the façade for the building. In some case there are prisms in the same vertical but, different levels.

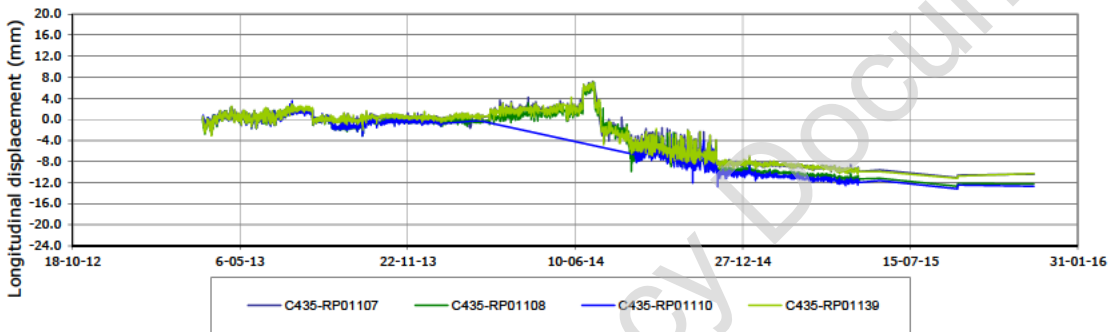
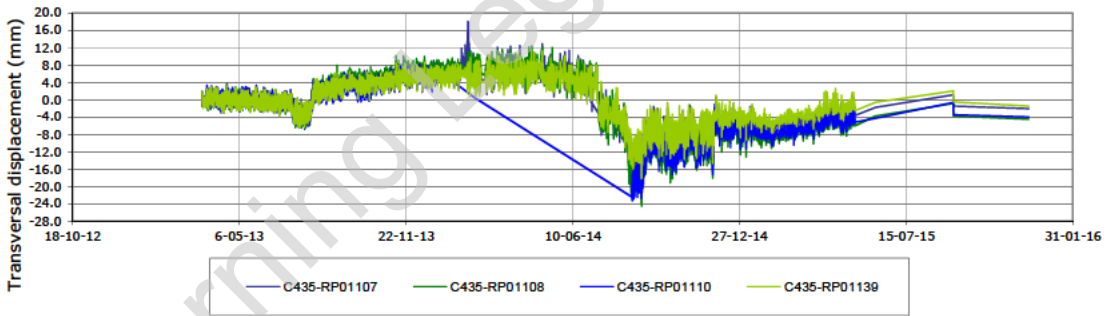
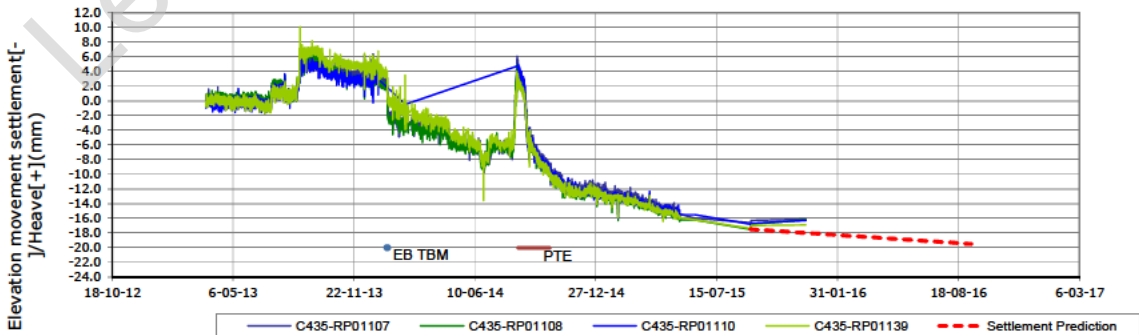
Building: 3-5 ST JOHN STREET

The monitoring data for this building is showing in Appendix B. The prisms installed on this building are in two different levels.

The movements captured by the prisms installed on this building, show the different works that has been carried out closer to the building.

Before TBM affected to this building some grouting episode was carried out from Moorgate Shaft 1. The first episode was carried out on July 2013. This grouting caused 2mm maximum. The second one was carried out on August 2013 caused 4-5mm of heave. After these two episodes the movement captured by the prisms show a settlement trend. During this trending the prisms show 2mm settlement. When the building was inside the influence area for EB TBM, the prisms captured 4-5mm of settlement. After the TBM, the trend for the building was continued during 4 months, adding another 6mm of settlement, until a new grouting episode was carried out. For this episode on July 2014, 2 mm of heave was captured. After this episode, the movement for the building was stable, until a new episode was carried out on August 2014. During this episode, 10-12mm of heave was captured by the prisms. On this point in time, the building condition was proximally similar to the Pre-TBM passing.

After this episode, the building was inside of the influence area for PTE enlargement. During this construction works, the maximum settlement captured by the prisms was 16mm maximum.

At the end of the PE construction works, a grouting episode was carried out, causing 2mm of heave. After this episode, the trend of settlement was continuing adding 4mm, until September 2015. From this date, the data for the prisms show stable conditions, the rate for the movements is less than 2mm/year.

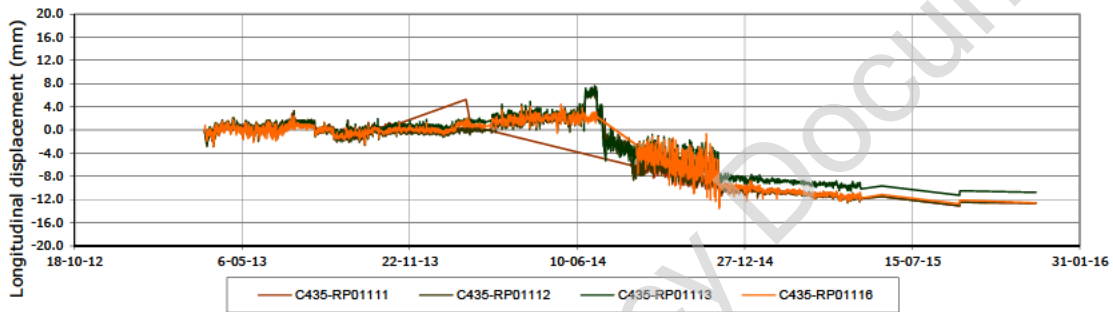
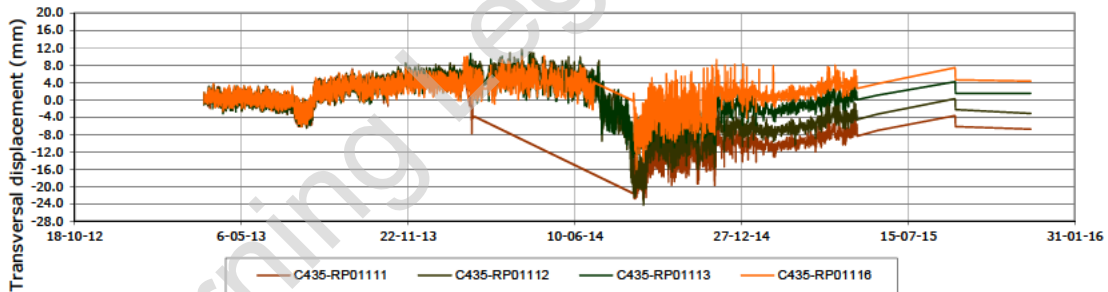
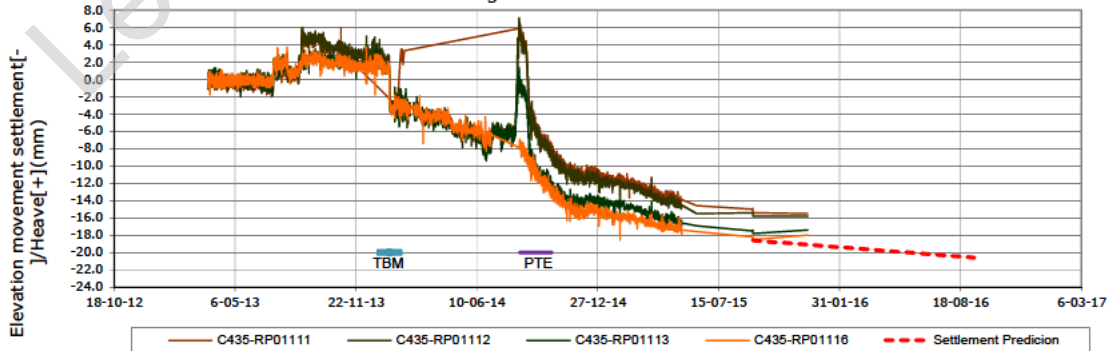
Building: 7-9 ST JOHN STREET

The movement captured by the prisms installed on this building is showing in Appendix B.

The behaviour of the prisms installed, is very similar to the 3-5 St John St, because both buildings were affected for the same works.

Before BM arrive to the area where the prisms are installed, two grouting episode was carried out to improve the ground conditions. The prisms captured in total for both episodes, 5-6mm of heave. After these episodes, the prisms show a settlement trend, showing 2mm of settlement.

During the TBM, the prisms show 4-5mm of settlement. After the TBM, the building continues settling during 7 months, until a new grouting episode was carried out on August (before PTE works). This grouting episode caused 12mm maximum of heave.

When the building was inside the influence area for PTE, the prisms show the maximum settlement. In total, during this period, the maximum settlement was -16mm. Once the building was outside for the PTE, a new grouting episode was carried out, causing 2mm of heave.

After finish all works closer to this building, a trend of settlement was captured by the prisms, adding 2mm more, until September 2015. From this date, the prisms show stable conditions.

At the end, and with the combination for all works, the maximum movement on this building (settlement) was -18mm.

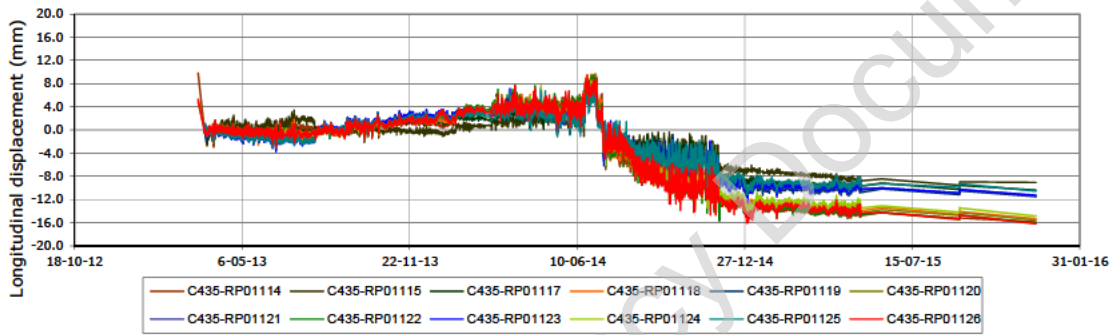
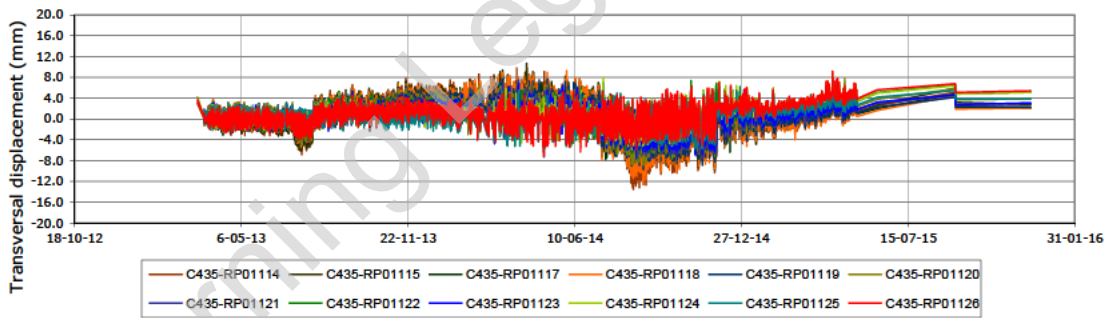
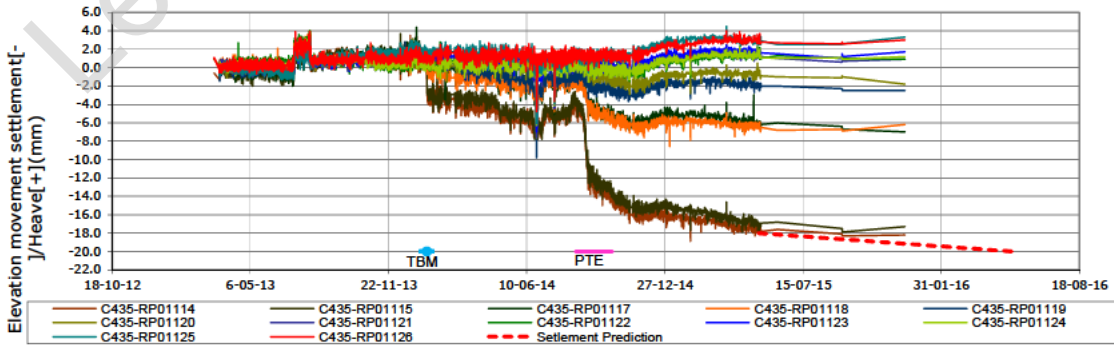
Building: 11-33 ST JOHN STREET

The result for the data for the prisms installed on this building is showing in the Appendix B.

The behaviour for the prisms installed in this building is different depending how close the prisms to the tunnel are. This building is too long, and some prisms are installed just in the tunnel limit, and the other ones are installed too far.

Before TBM arrived, some grouting episode was carried out to improve the ground conditions. The maximum movement caused by the grouting was 3-4mm of heave. After this episode, all prisms show stable conditions until the TBM cross the building. During the TBM, the prisms closer to the tunnel are the prisms that show more settlement, in this case the maximum settlement was 4-5mm. The rest of the prisms didn't show significant movements.

The prisms closer to the tunnel, after the TBM, show a settlement trend adding 2mm more.

Before the building was inside the influence area for PTE, two grouting's episodes was carried out. For the first one, the maximum movement captured by the prisms was 2mm, and for the second one was another 2mm.

The second episode was captured only by the prisms closer to the tunnel.

When the building was inside the PTE influence area, the closer prisms to the tunnel showed 12mm. The prisms installed in the middle way between the further a closer, show 4mm maximum.

After PTE, a new grouting episode was carried out to stop the trend of the movements. On the further prisms, the trend was stopped, but no on the prisms closer to the tunnel. These prisms continue settling during 6 months, until May 2015. From this date, the prisms show stable conditions. The rate for the movements is less than 2mm/year.

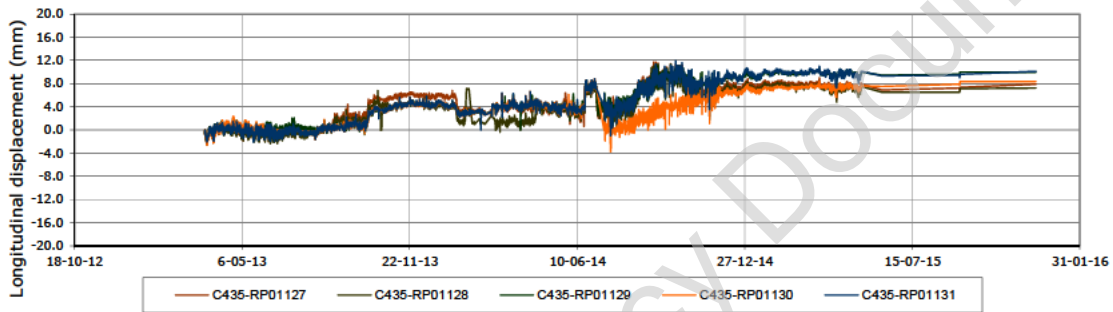
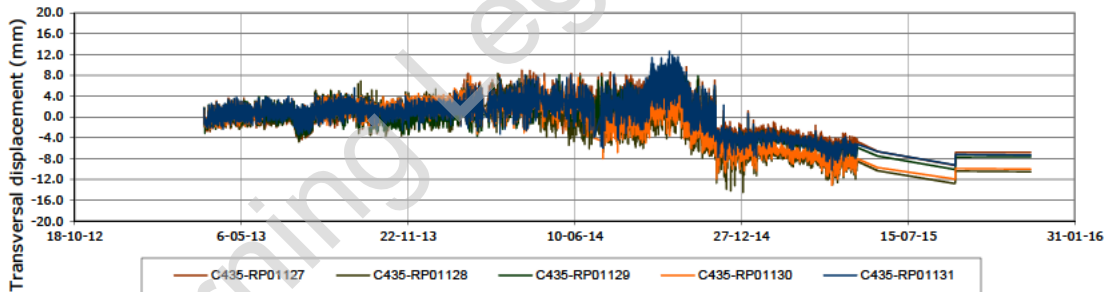
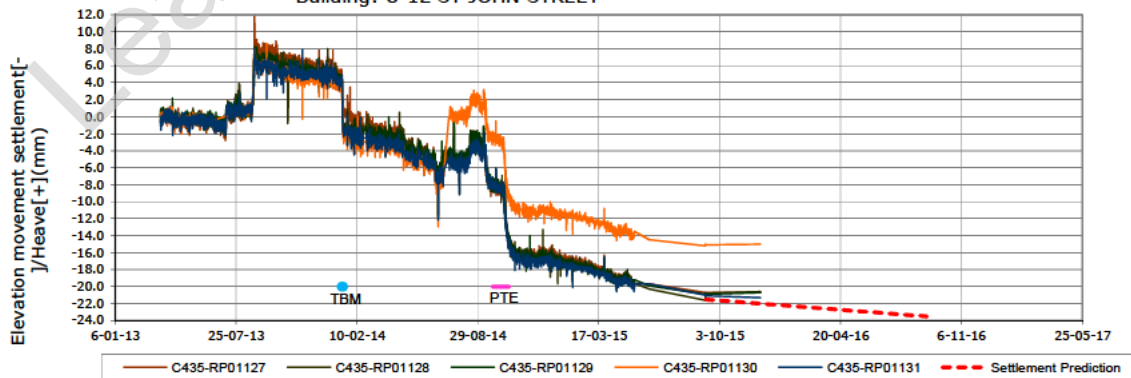
Building: 8-12 ST JOHN STREET

The data for the prisms installed on this building is showing in Appendix B.

As the graphic shows, some grouting episode was carried out before the TBM in order to improve the settlement. During the first episode, 2mm was captured by the prisms. For the second episode, the prisms show another 6mm. After these episodes, the prisms show a settlement trend before the TBM. During this trend, 2mm was disappearing.

During the TBM on January 2014, 5-6mm of settlement was captured by the prisms. In this case, all the prisms show the same movement. After the TBM, the building continues settling during 4 months, adding another 6mm, until June, when a new grouting episode was carried out. During this episode, the prisms show maximum 6mm of heave in one prism. For the rest of the prisms the maximum heave was 2mm. After this episode, the prisms show stable conditions, until a new episode was carried out. For this episode, another 2mm of heave was captured by the prisms. After this episode, all heave was disappearing.

Is when the building was affected by the PTE enlargement, the movement was important. During this period, the prisms captured 8-10mm of settlement. Once the building was outside for the influence area for the PTE, all prisms shows stable conditions during 2 months. After these two months, the prisms started to show a settlement trend, adding 4mm more. No SCL works were carried out on this period to produce the trend.

On May 2015, the ATS start the long term period. The following readings during long term period confirm the trend of the movements, until September 2015, when the prisms start to show stable conditions. The last readings for the prisms carried out on December 2015 confirm that the prisms show stable conditions. From this date, the rate for the movements is less than 2mm per year.

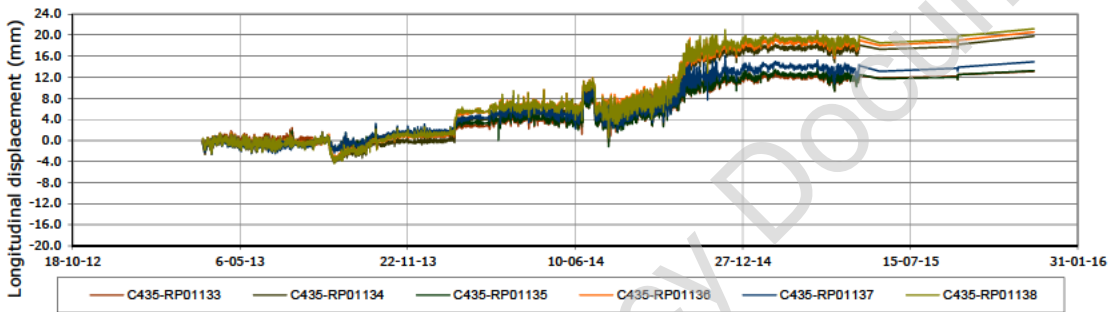
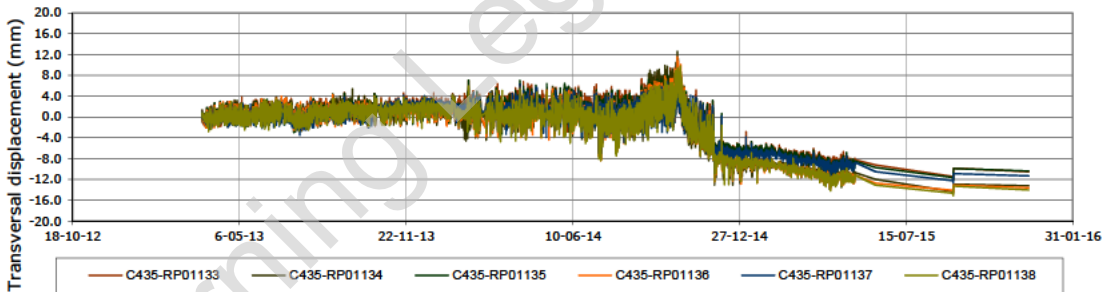
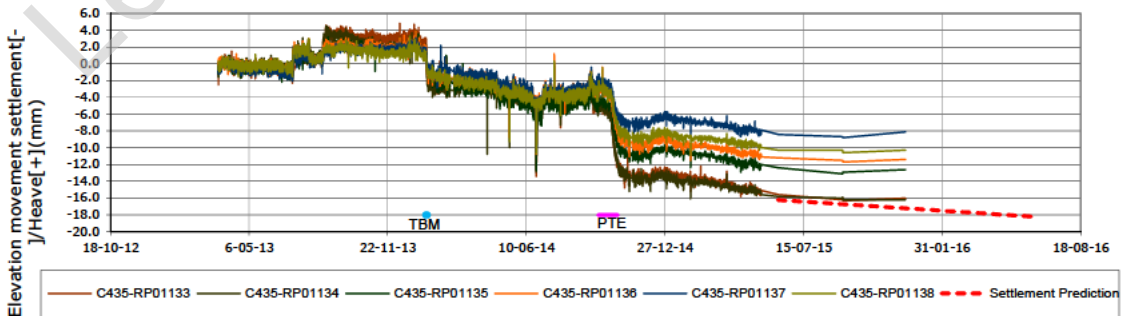
Building: 16 ST JOHN STREET

The result, for the prisms installed on 16 St John St is presented in Appendix B.

The behaviour for this group of prisms is similar than the prisms installed on 8-10 St John St. The difference is that the movements for this prisms is less, because is quiet far from the tunnel.

Before the TBM, some grouting episode was carried out to improve the ground conditions. These episodes, caused in total 4mm of heave in all prisms installed on this building. After these episodes, all prisms show stable conditions, until TBM arrived. When the building was inside the influence area for the TBM, 3mm of settlement was captured by the prisms. After the TBM, a trend on the movements was observed, adding another 4mm more on settlement. On July, a grouting episode was carried out to try to stop the trend, caused 2mm of heave. After this episode, the prisms show stable conditions until PTE enlargement works.

During PTE works, 15-16mm of settlement maximum was captured by the prisms. The prisms that show the maximum movements are the prisms closer to the axis of the tunnel. The rest of the prisms show around 8-12mm.

After the PTE, a grouting episode was carried out to compensate the settlement, caused 2mm of heave in all prisms. After this episode, a trend was captured by the prisms, adding 2mm maximum on settlement.

After all works, and from June 2015, the prisms show stable conditions. From this date, the rates on the movements are less than 2mm/year.

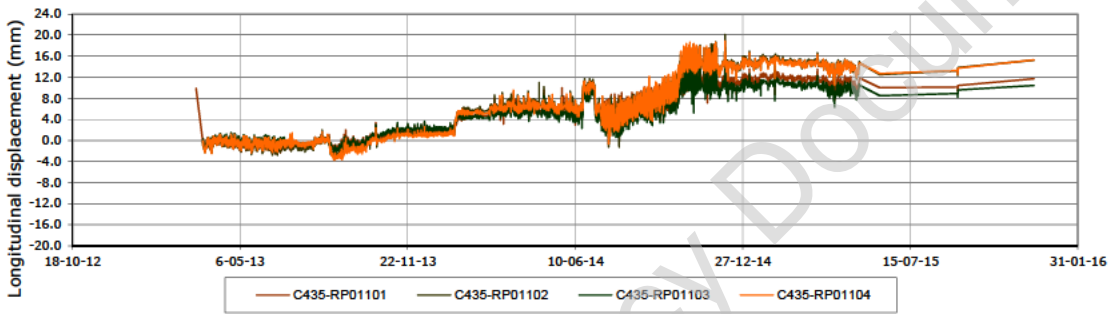
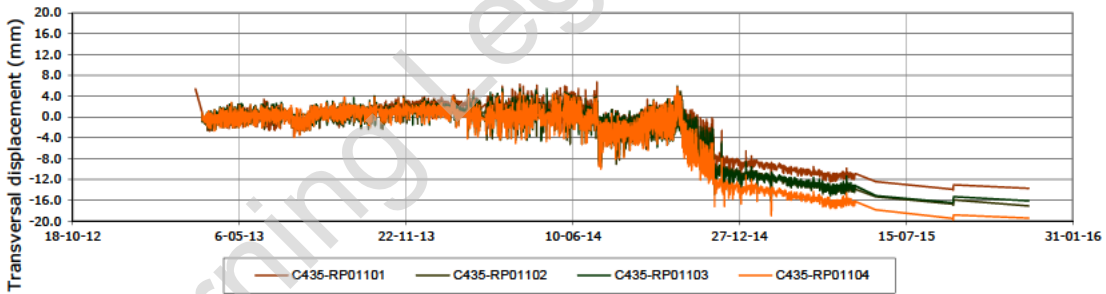
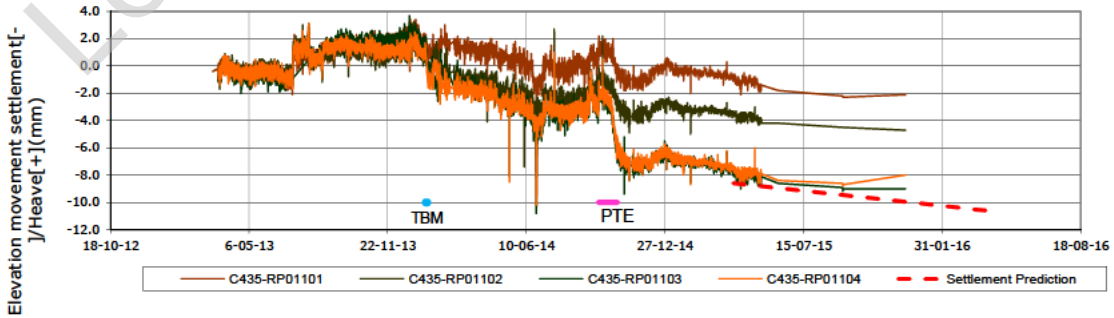
Building: 20 ST JOHN STREET

The result, for the prisms installed on 20 St John St is presented in Appendix B.

The behaviour for this group of prisms is similar than the prisms installed on 16 St John St., but the magnitude for the movements are less because the building is too far for the tunnel.

Before the TBM, the grouting episode was carried out to improve the ground conditions, caused around 2-3mm of heave. After this episode, all prisms show stable conditions, until TBM arrived. When the building was inside the influence area for the TBM, 3-4mm of settlement was captured by the prisms. After the TBM, a trend on the movements was observed, adding another 5mm more on settlement. On July, a grouting episode was carried out to try to stop the trend, caused 2mm of heave. After this episode, and before the PTE, the prisms show stable conditions, until a new grouting episode was carried out, caused 2-3mm of heave.

During PTE works, 4-5mm of settlement maximum was captured by the prisms. The prisms that show the maximum movements are the prisms closer to the axis of the tunnel. The rest of the prisms show around 2-3mm.

After the PTE, a grouting episode was carried out on December 2014 to compensate the settlement, caused 1-2mm of heave in all prisms. After this episode, a trend was captured by the prisms, adding 2mm maximum on settlement.

After all works, and from April 2015, the prisms show stable conditions. From this date, the rates on the movements are less than 2mm/year.
