C435 Farringdon Main Station

Monitoring Close-Out Report: Automated Total Station ATS04 and 3D Targets read by ATS04.

CRL Document Number: C435-BFK-C2-RGN-M123-51639

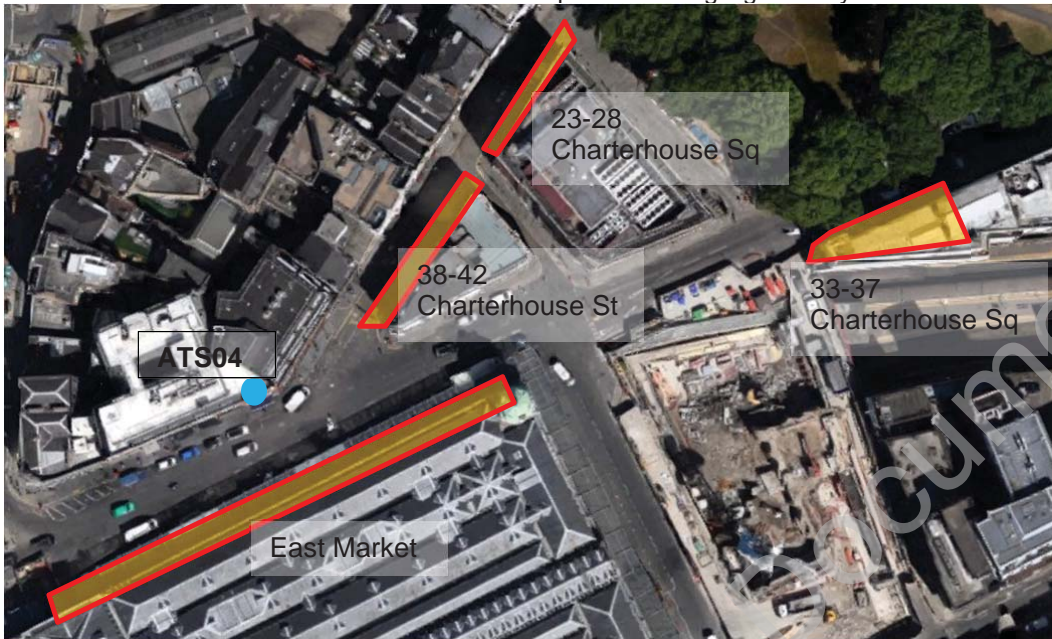
Figure 1 – Plan showing the Location prisms read by ATS04.

Prisms associated with ATS04 are located on the plan below highlighted in yellow.

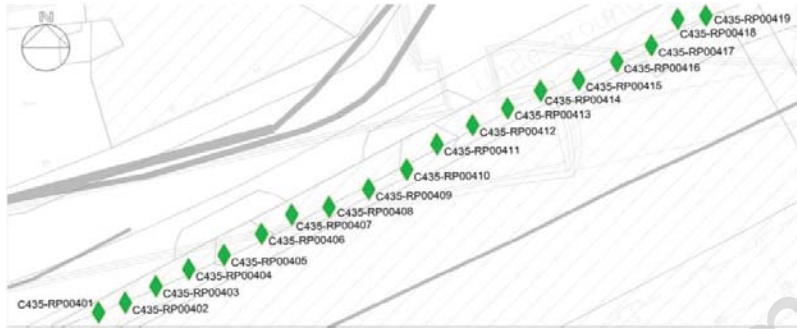
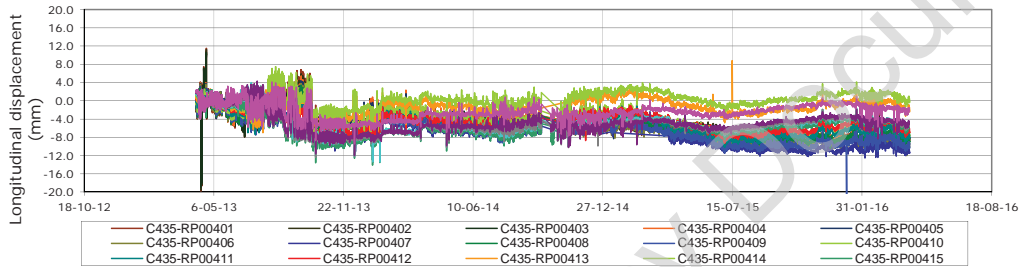
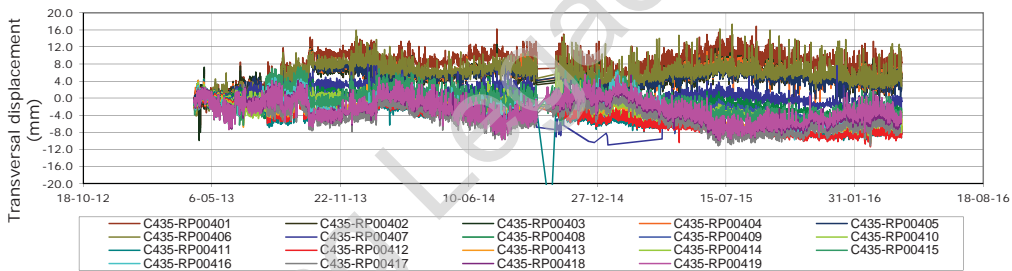
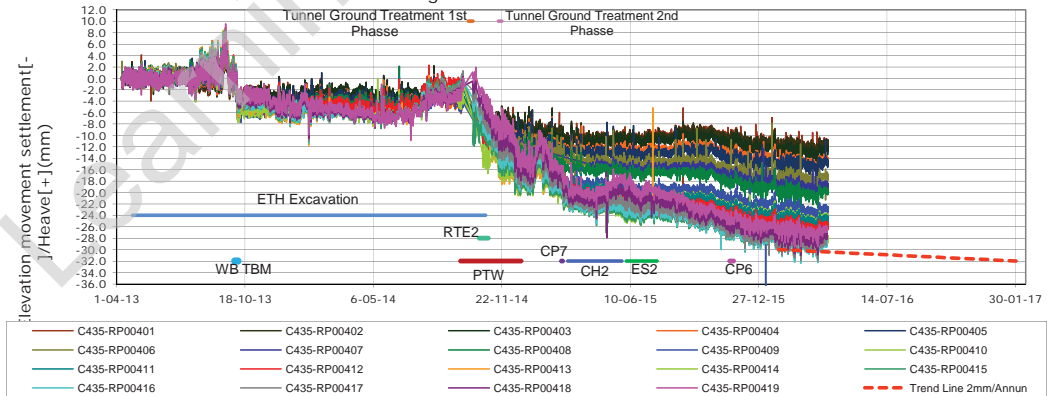
Building: EAST MARKET NORTH ELEVATION

- TAM's drilling from Moorgate Shaft 2 caused 8mm of heave in September 2013
- WB TBM passage from 02-10-2013 to 07-10-2013 caused a settlement of 3-4mm.
- Compensation grouting episodes from July 2014 to November 2014 caused maximum 6mm of heave.
- PTW enlargement works caused 18mm maximum of settlement between 19-09-2014 and 22-12-2014
- Compensation grouting on January 2015 caused 8mm of heave.
- From 23-02-2015 to 25-02-2015 CP7 construction caused maximum 4mm of settlement.
- 4-5mm maximum of settlement due to ES2 and CH2 from 05-03-2015 to 04-06-2015.
- Maximum Longitudinal movement -12mm
- Maximum Transversal movement -10mm

The gap in the data for the prisms installed on the Market was caused by a scaffold being erected where ATS04 was installed. This occurred during the period of 23-09-2014 to 22-10-2014, covering the visual between the prisms and the ATS04. The prisms that show the gap are from C435-RP00401 to C435-RP00415.

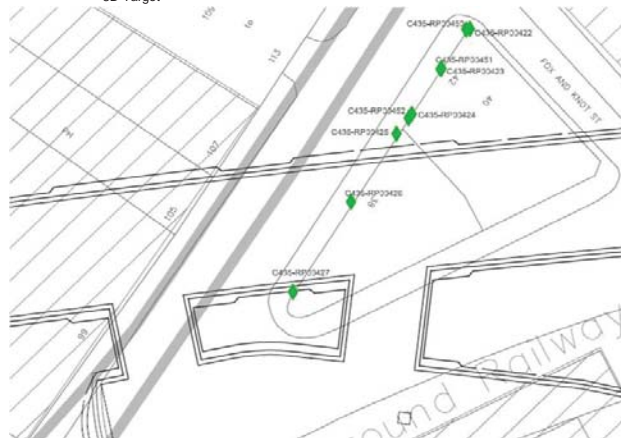
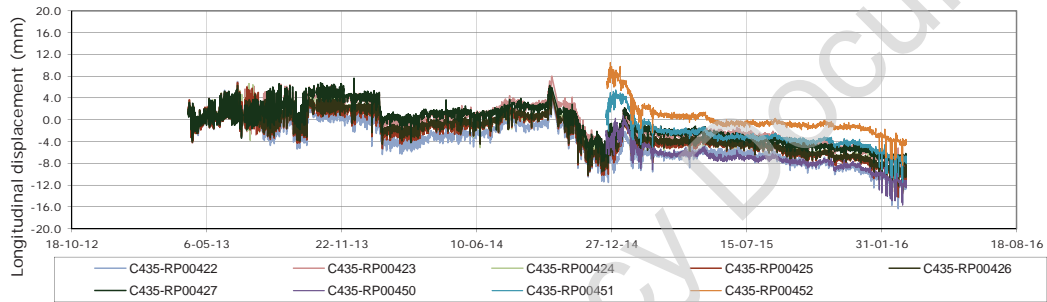
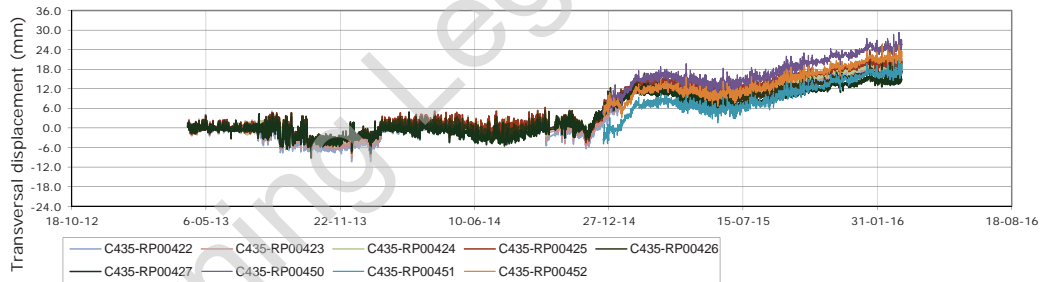
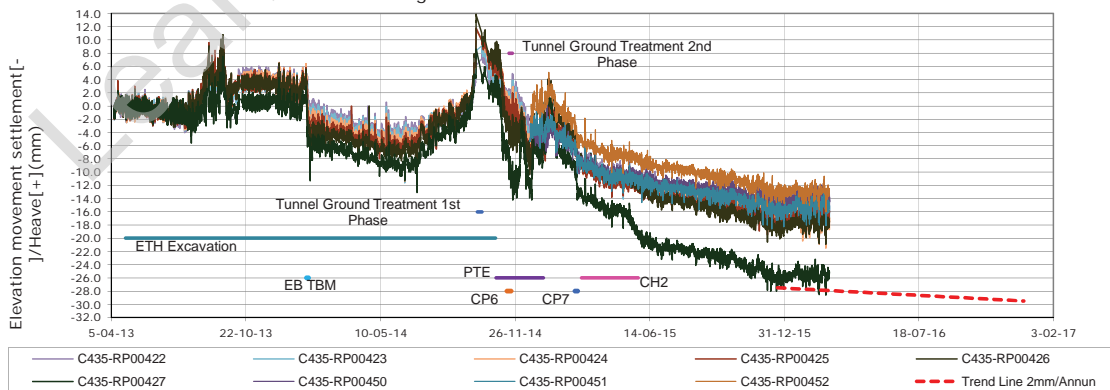
Building: 38-42 CHARTERHOUSE STREET

- Compensation Grouting between August 2013 and September 2013 caused 4-5mm maximum of heave.
- EB TBM caused 6-8mm maximum of settlement between 20-01-2014 and 23-01-2014.
- Residual settlement after the EB TBM caused 4mm of settlement.
- Compensation grouting between July 2014 and November 2014 caused 14mm maximum of heave.
- PTE enlargement works caused 12-14mm maximum of settlement from 29-10-2014 to 07-01-2015
- Compensation grouting episodes on January 2015 caused 8mm maximum of heave.
- CP7 construction caused 4-5mm of settlement between 23-02-2015 and 27-02-2015.
- Between 05-03-2015 and 10-04-2015 CH2 pilot caused 2-3mm maximum of settlement.
- CH2 enlargement caused 4-5mm of settlement from 06-05-2015 to 28-05-2015.
- Maximum Longitudinal movement -12mm
- Maximum Transversal movement +24mm

Some prisms installed on 38-42 Charterhouse St were installed by C430. At the beginning these prisms was reading manually. As per the works information the prisms were then orientated to be read automatically on December 2014. The offsets for the movements were calculated using the sockets and the rest of the prisms.

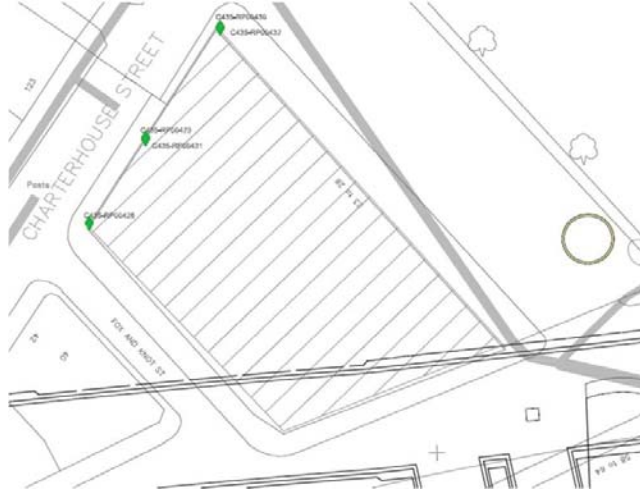
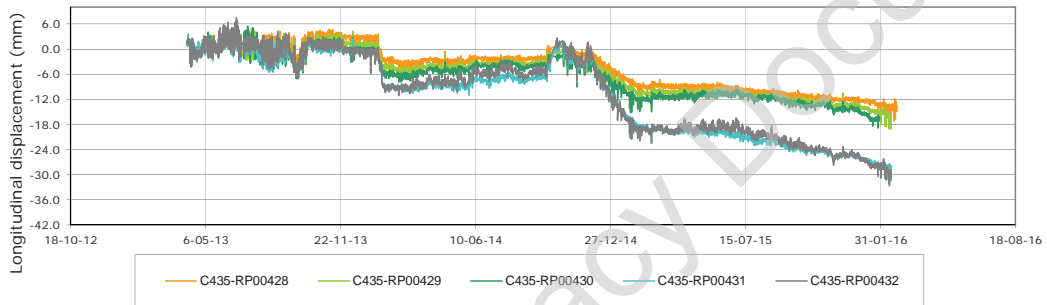
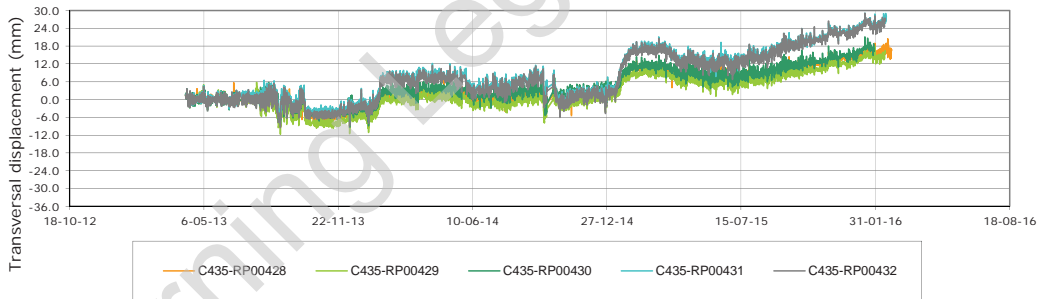
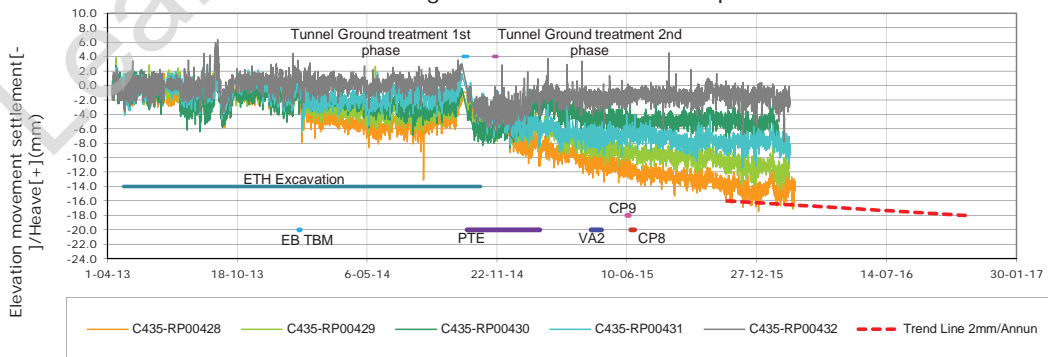
Building: 23-28 Charterhouse Sq.

- Eastbound TBM caused 2-3mm maximum of settlement from 21-01-2014 to 23-01-2014.
- Residual settlement after the EB TBM caused 2mm of settlement.
- Compensation grouting episodes from October 2014 to November 2014 caused 4-6mm of heave.
- From 07-10-2014 to 27-01-2015 PTE construction caused 8-10mm maximum of settlement.
- VA2 (Ventilation Adit) caused 2mm of settlement from 16-04-2015 to 02-05-2015

- The combination between CP8 and CP9 construction caused 4-6mm maximum settlement.
- Maximum Longitudinal movement -30mm
- Maximum Transversal movement +26mm

The prisms installed in 23-28 Charterhouse Sq. are covered by a scaffold due the refurbishment works carried out on the building.

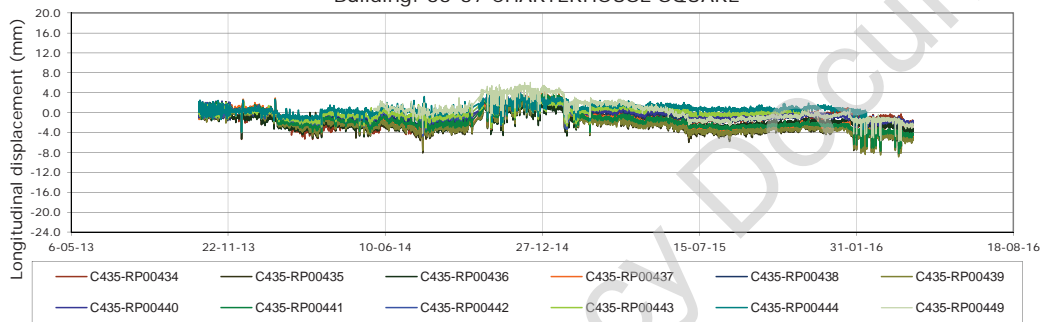
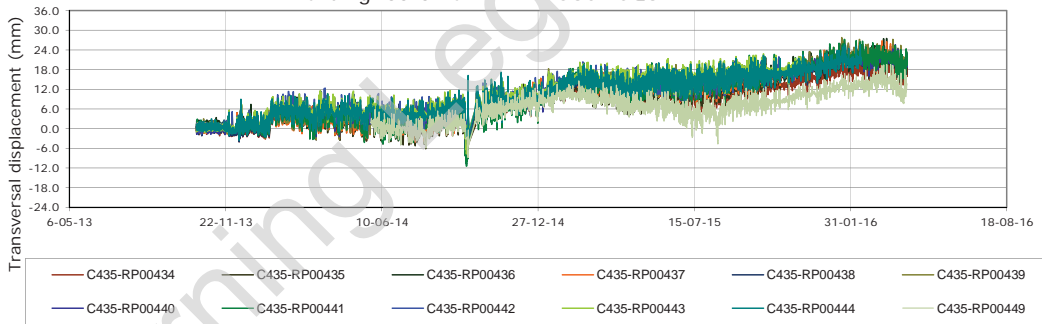
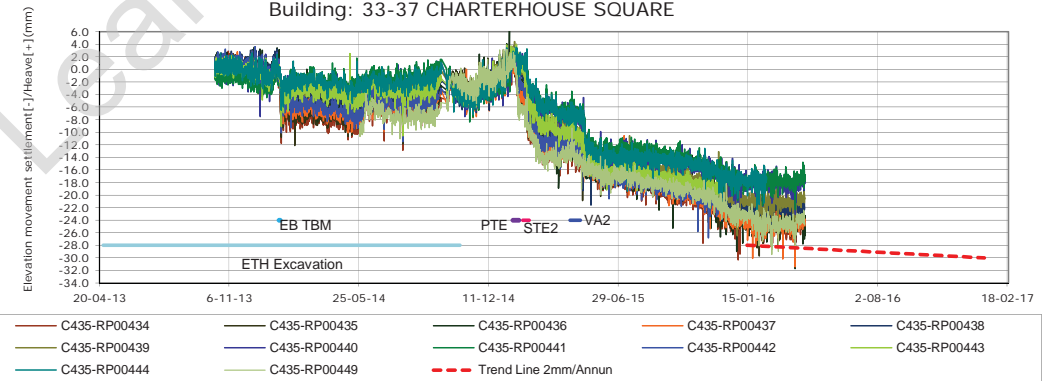
Building: 33-37 CHARTERHOUSE SQUARE

- Compensation grouting episodes in January 2014 caused 2-3mm of heave.
- Between 22-01-2014 and 24-01-2014 EB TBM caused maximum 7-8mm of settlement.
- Compensation grouting on June 2014 caused 4-5mm of heave.
- Compensation grouting on September 2014 caused 2-3mm of heave.
- In November 2014 a compensation grouting caused 2-3mm maximum of heave.
- Concurrent grouting in January 2015 caused 6-8mm of heave.
- From 18-01-2015 to 27-01-2015 PTE enlargement works caused 6-7mm of settlement.
- VA2 construction from 16-04-2015 to 02-05-2015, caused 3-4mm of settlement.
- Maximum Longitudinal movement -4mm
- Maximum Transversal movement +18mm
