C510 – Whitechapel and Liverpool Street Station Tunnels

Instrumentation and Monitoring Close Out Report

Block 07 Liverpool Street

CRL Document Number: C510-BBM-C2-RGN-C101-50236

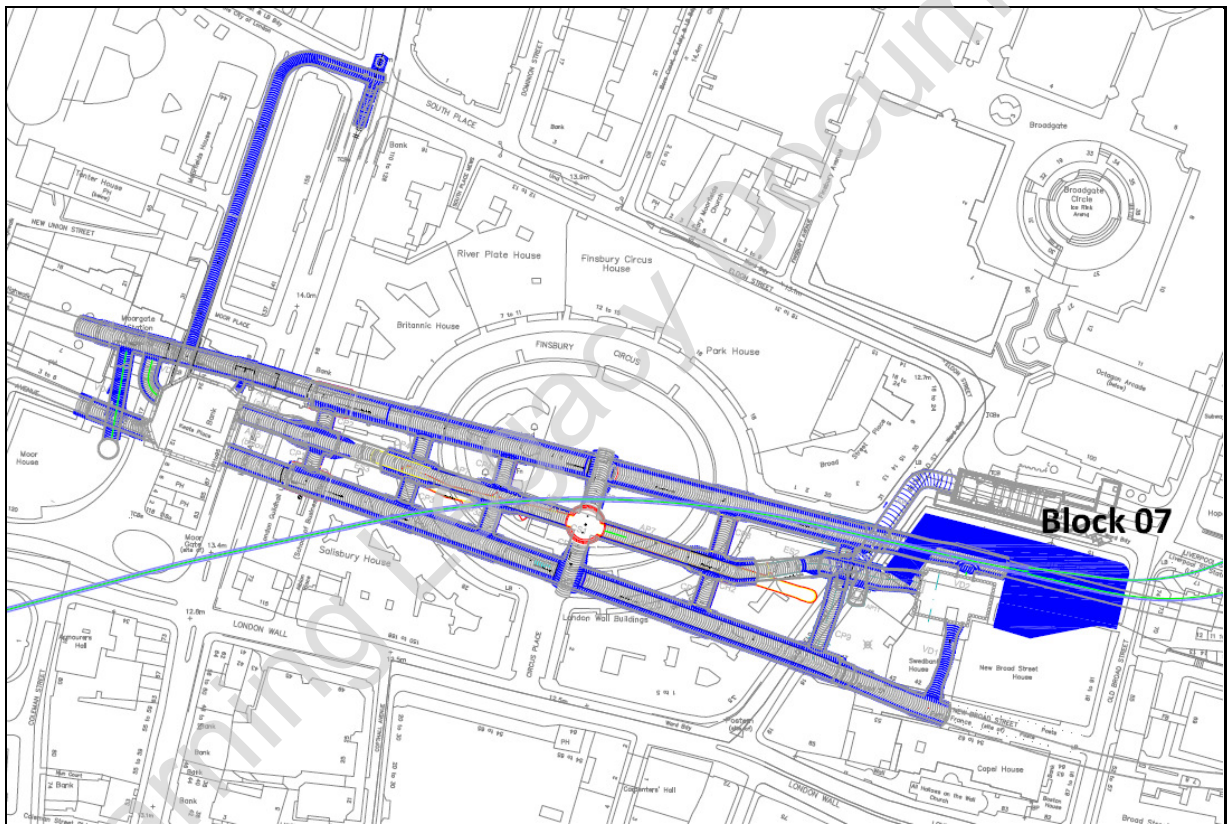
Figure 1- Liverpool St General Location Plan - including Block 07 monitoring area

Figure 1 shows the Liverpool St general location plan, C510 tunnel construction and where Block 07 is situated. Detailed location plans can be found within the installation reports and photomontages as listed in Section 3.2. Each monitoring sensor’s location is shown within the assessment plans (Section 5.4).

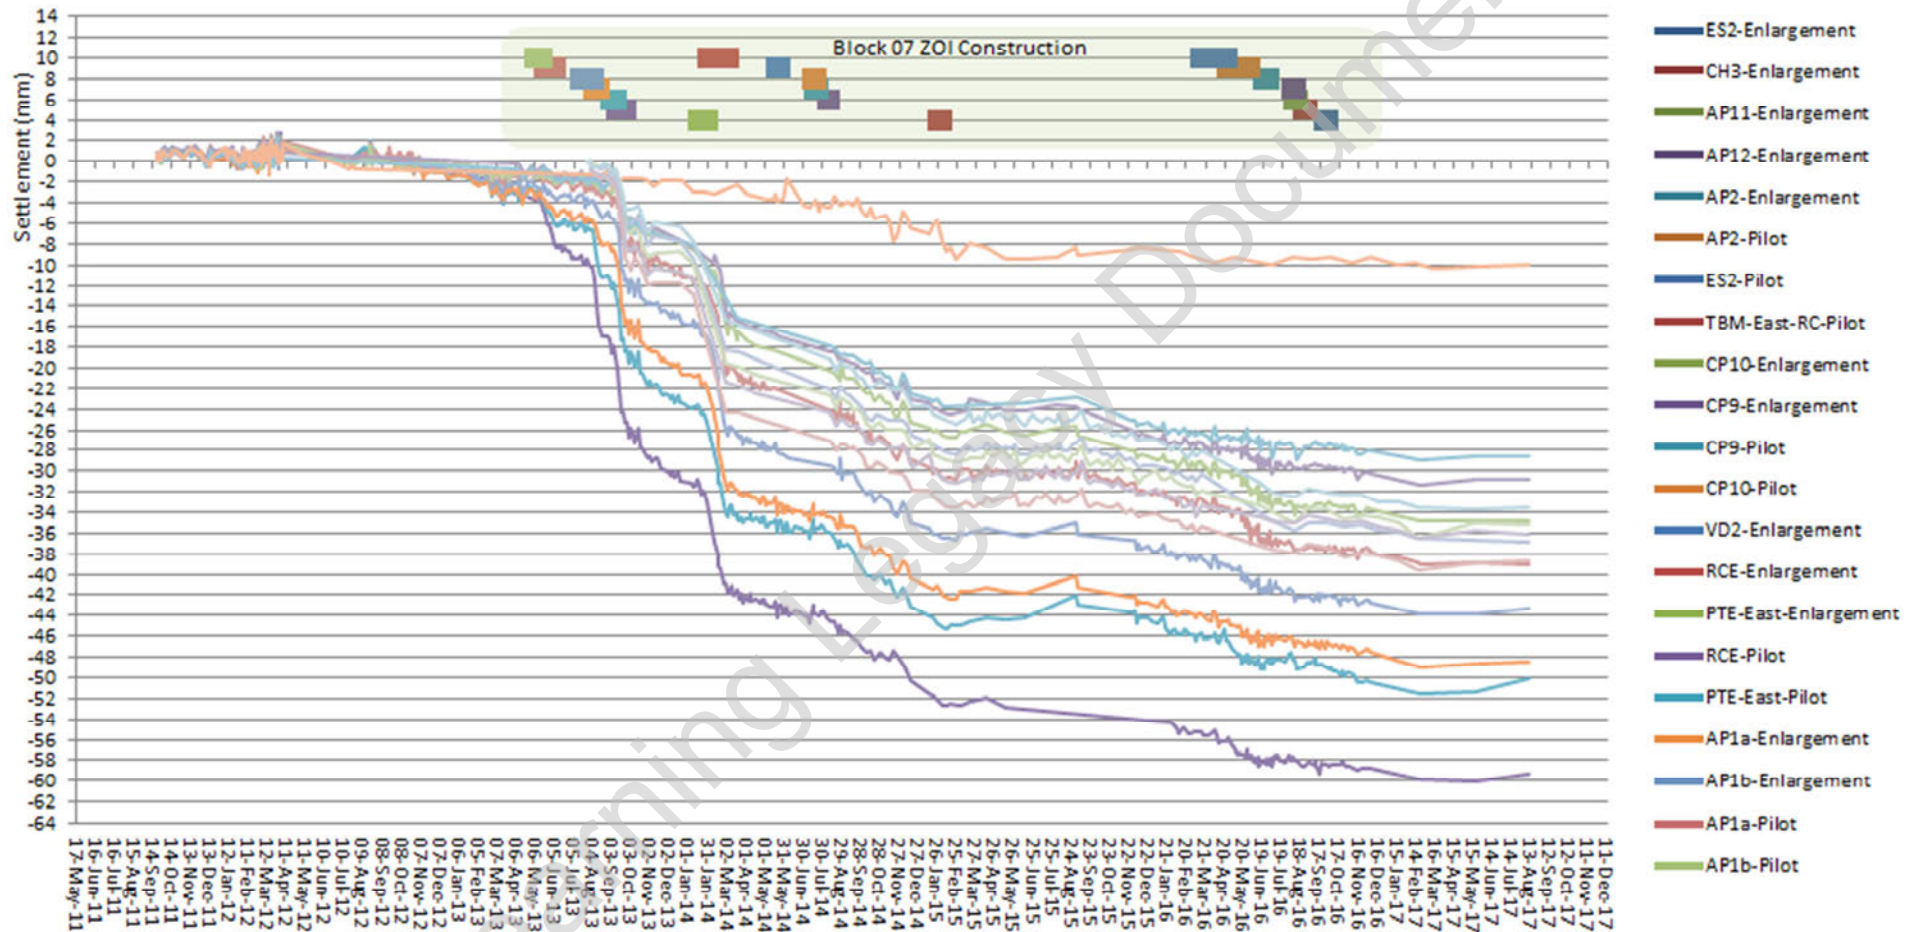
Graph 1- All Remaining Block 07 BREs (LB) Manual Monitoring History in Relation to Construction

To assess the movement of Block 07 monitoring sensors; each monitoring sensor data type is displayed in a line graph, with a gantt chart (bar) representing the construction identified in Section 4:

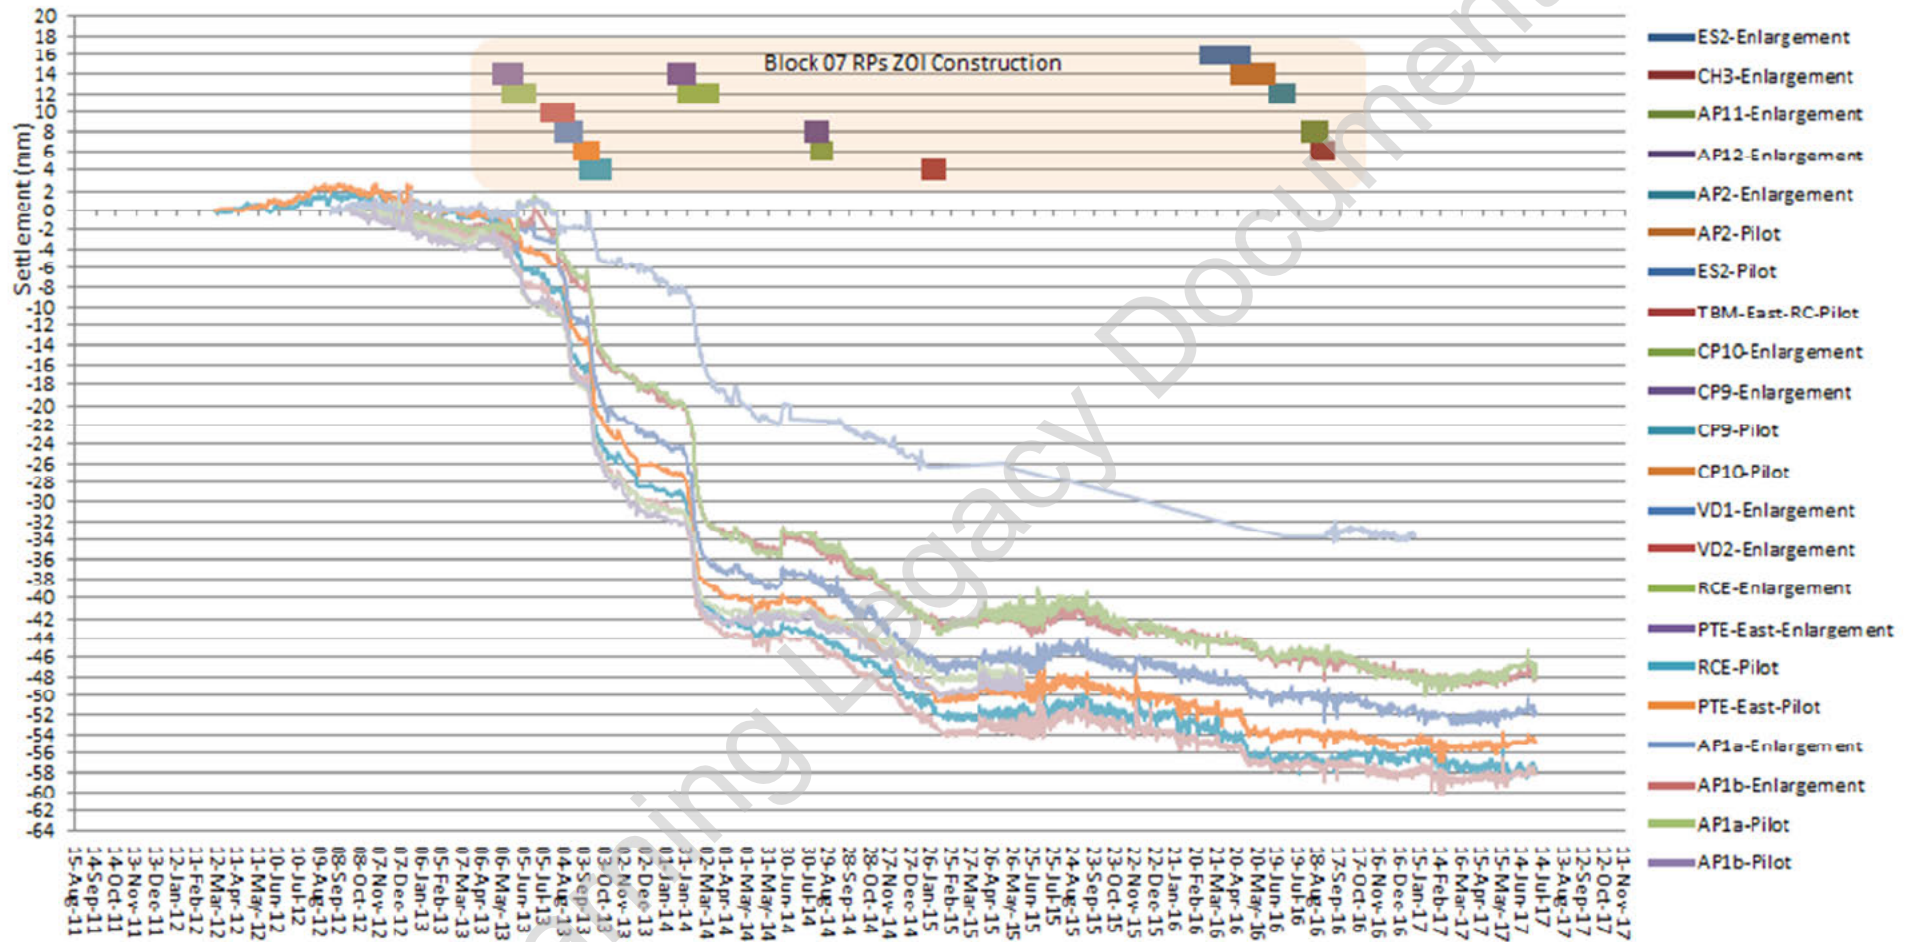
Graph 3- All Remaining Block 07 3d Geodetic Prisms (RP) Automated Monitoring History in Relation to Construction

Crossrail agreed at the ERP meeting held on the 20/06/2017 to decommission that grouting facilities within GAD2 tunnel and Blomfield Grout Box. As such, this allowed for decommissioning of all automated sensors within the influence area. It is therefore proposed that all remaining automated sensors within Block 07 be removed. See graphs, tables and plans for further details on the automated sensors.

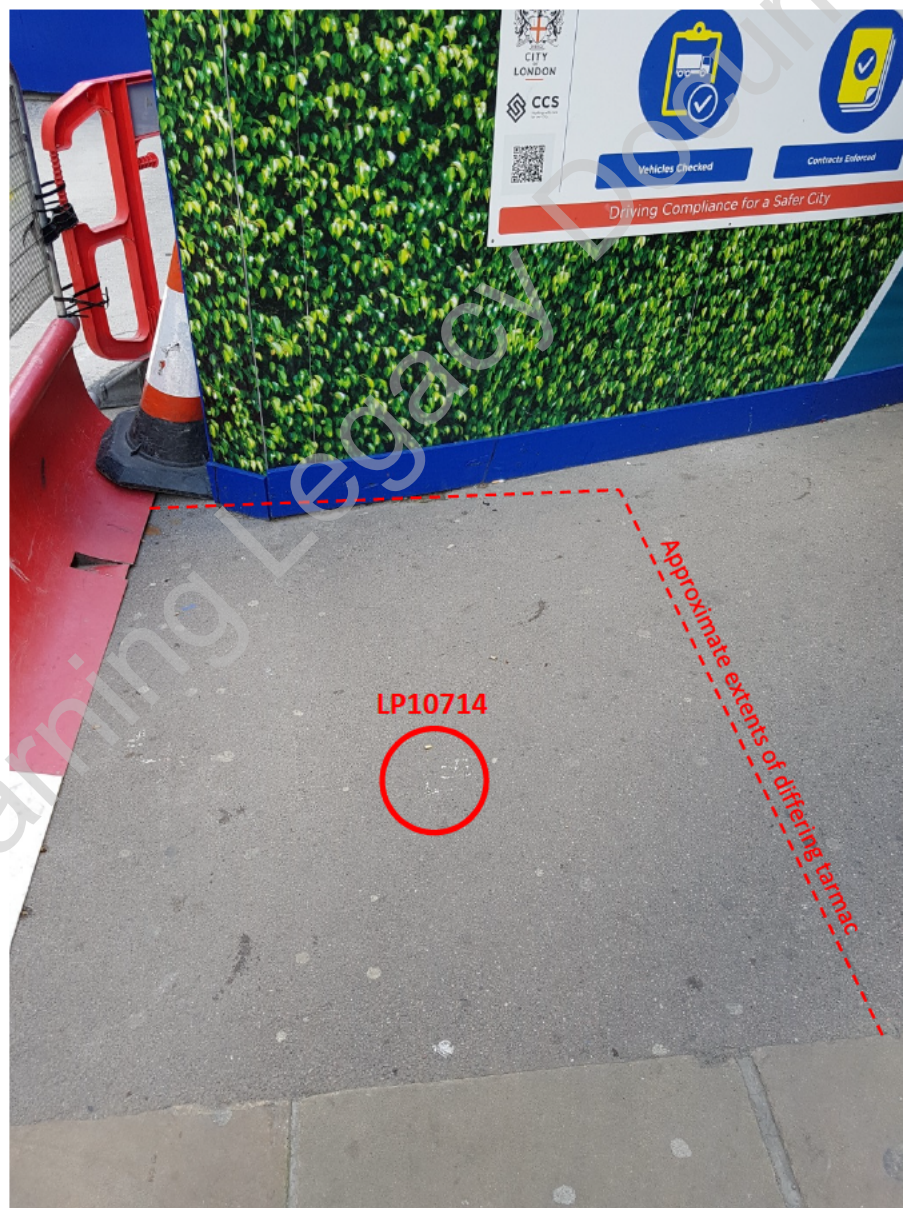
Figure 3- LP10714 Located on Unstable Pavement

Road Stud LP10714

LP10714 has not met any trend requirements; however, the surrounding studs have all met the allowable trend for a minimum of 180/365 days. It can be seen in *Figure 3* below that the circled road stud is located on a section of asphaltic concrete pavement. It is likely that the small area of differing pavement is within a vicinity of recent utility works, and in turn, may have led to greater settlement than the adjacent area (e.g. due to poor compaction). Therefore, the settlement trend may not be a true reflection of the absolute ground movement caused by Crossrail works in the area. It should be noted that the sensor has met stable trend requirements for 90 days.

Based on the adjacent road studs' settlement trends, it is proposed that LP10714 should be considered as unreliable with regards to settlement trends caused by tunnelling construction and that the sensor should be decommissioned.

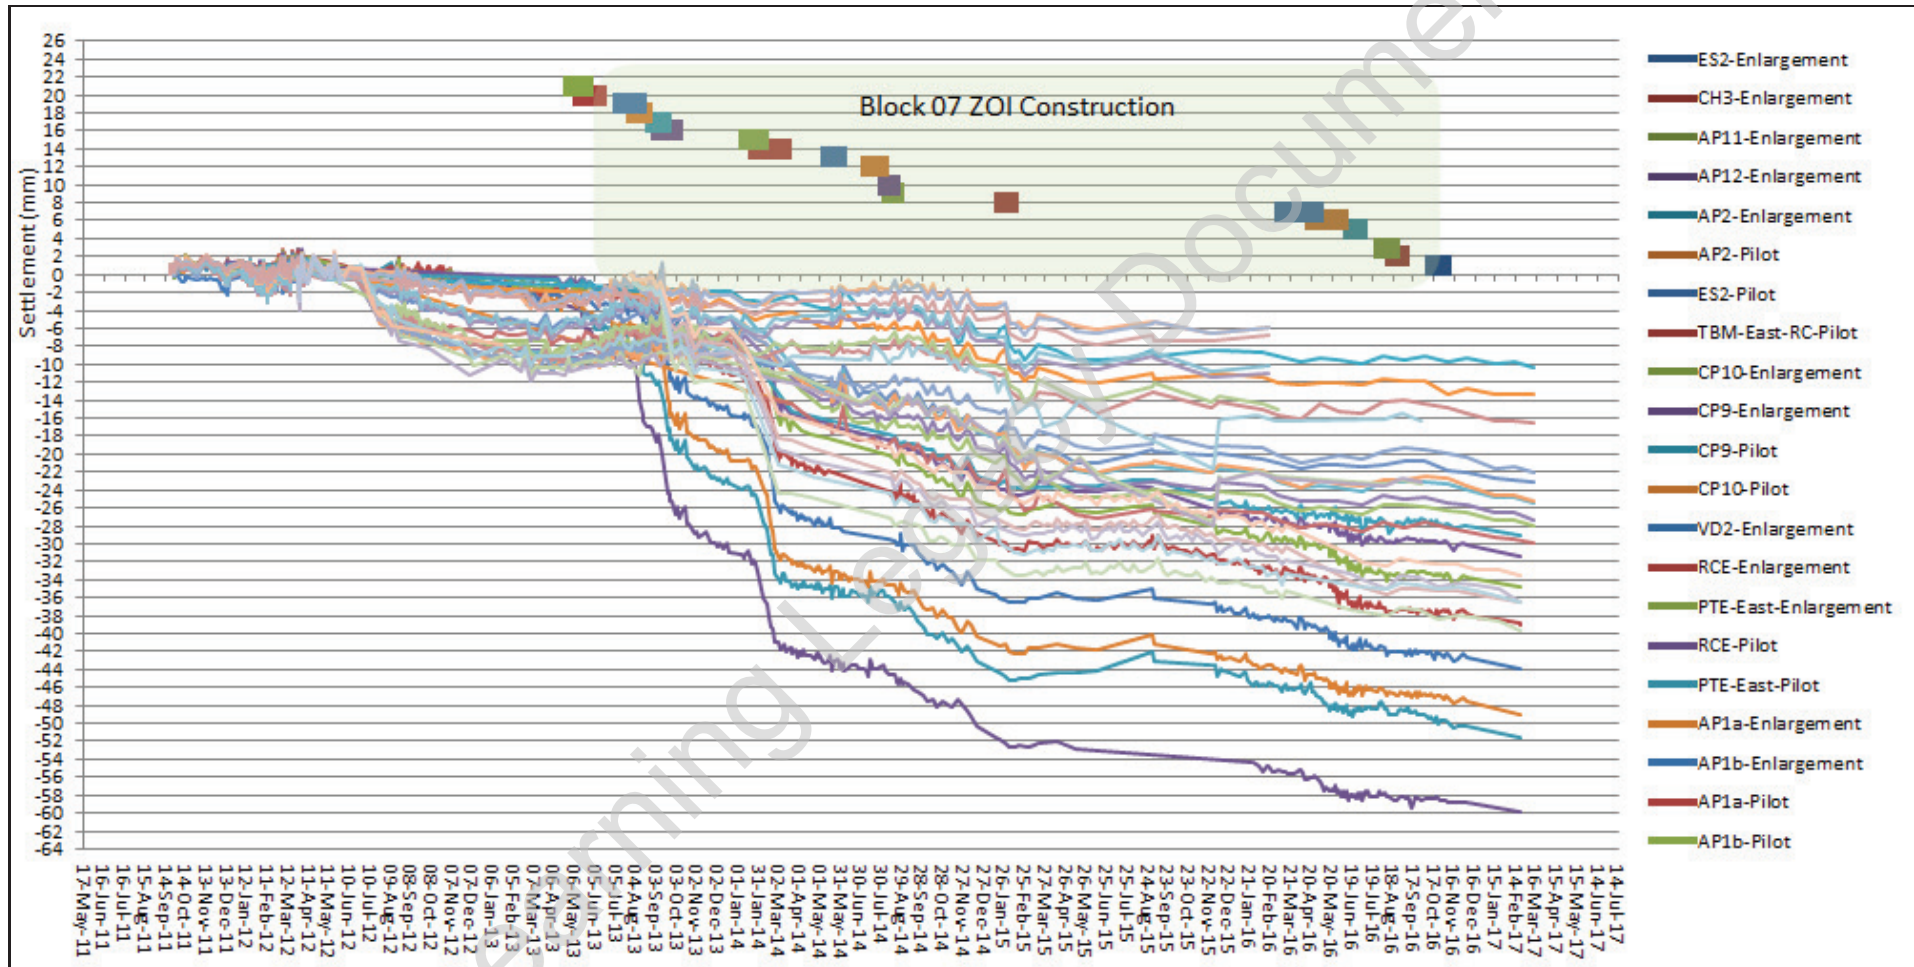
Graph 1- All Block 07 BREs (LB) Manual Monitoring History in Relation to Construction

Appendix 1 includes the decommissioning tracker table, plots and graphs that were used as evidence to agree decommissioning in Revision 1 of Block 07 close out report.
