## C510 – Whitechapel and Liverpool Street Station Tunnels

### Instrumentation and Monitoring Close Out Report Block 16 Liverpool Street

CRL Document Number: C510-BBM-C2-RGN-C101-50237

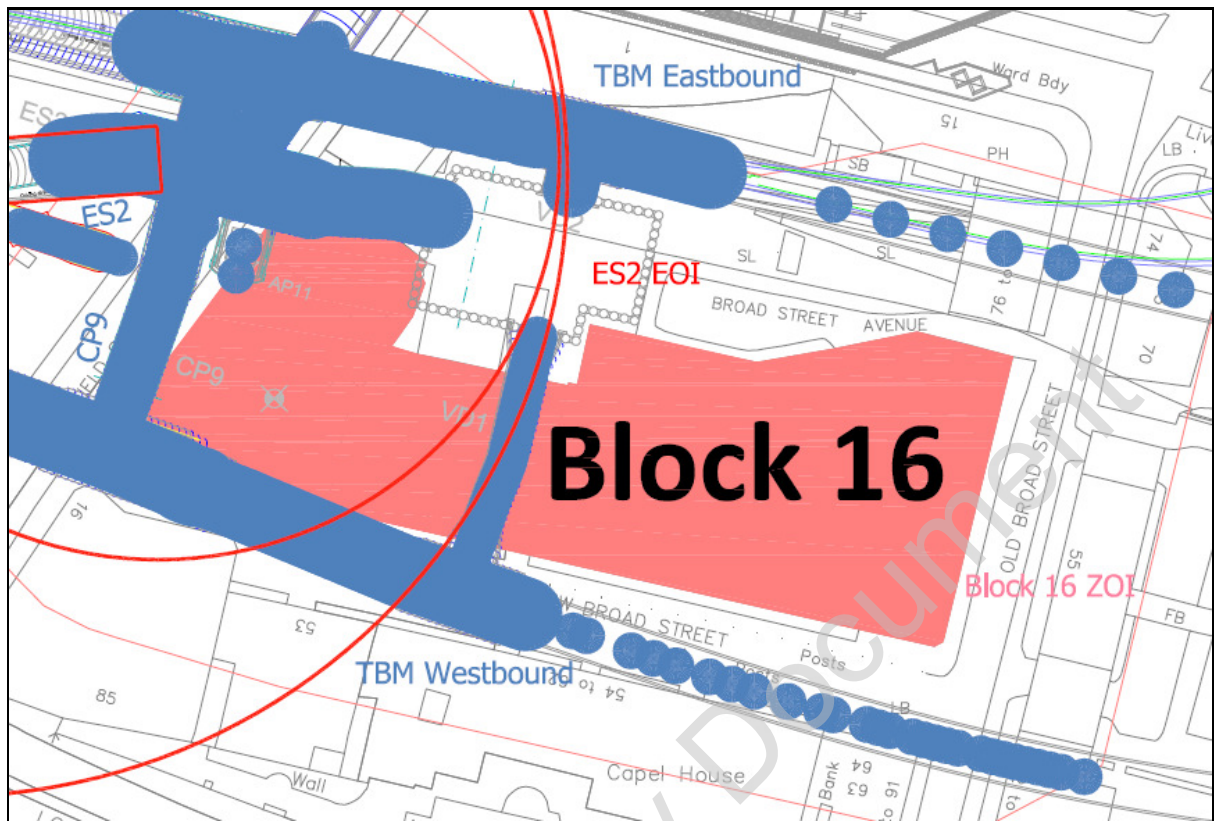
**Figure 2 - Block 16 ZOI Constructions**

**N.B.** ES2 EOI is represented in *Figure 2* to show the area of Block 16 that is within its boundary.

*Figure 2* shows the Block 16 ZOI and the tunnel advances that occurred within its boundary. The construction advances within the ZOI that have the potential to affect Block 16 are listed and summarised in *Table 1*. Further evidence for construction dates can be seen in *Table 2* which lists the latest tunnel advances for each point.

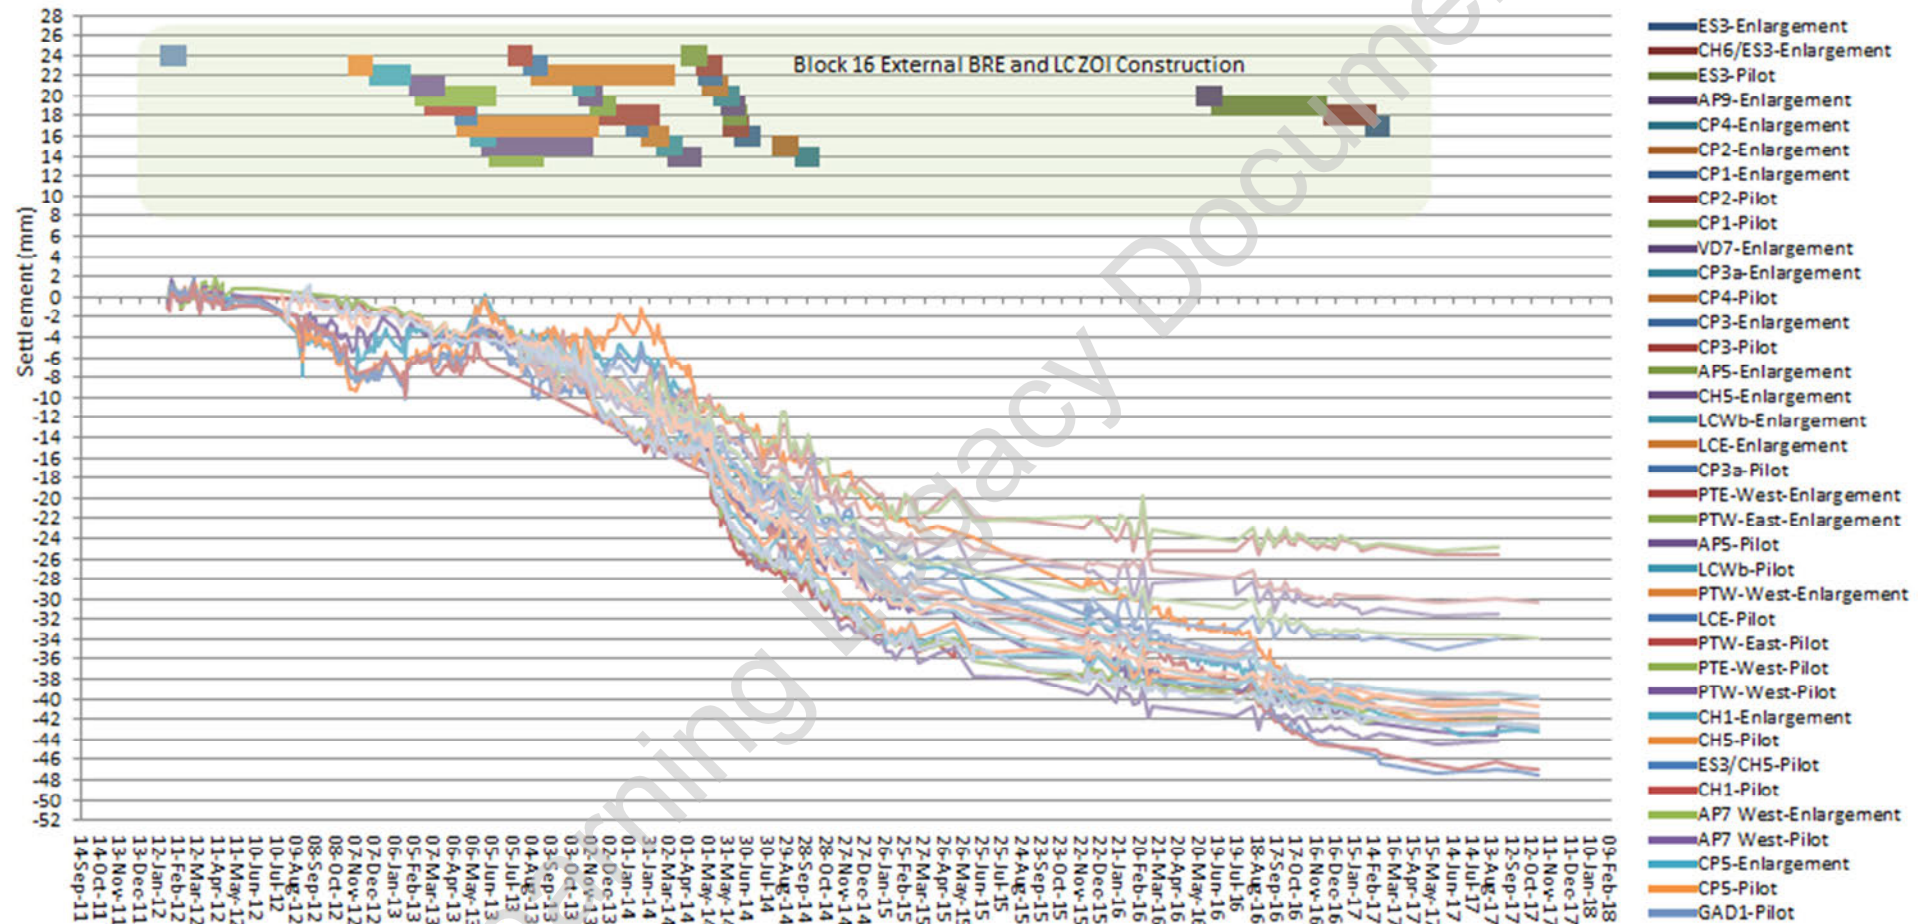
**Graph 1- All Remaining Block 16 BREs & Invar Scales (LB & LC) Manual Monitoring History in Relation to Construction**

To assess the movement of Block 16 monitoring sensors; each monitoring sensor data type is displayed in a line graph, with a gantt chart (bar) representing the construction identified in Section 4:

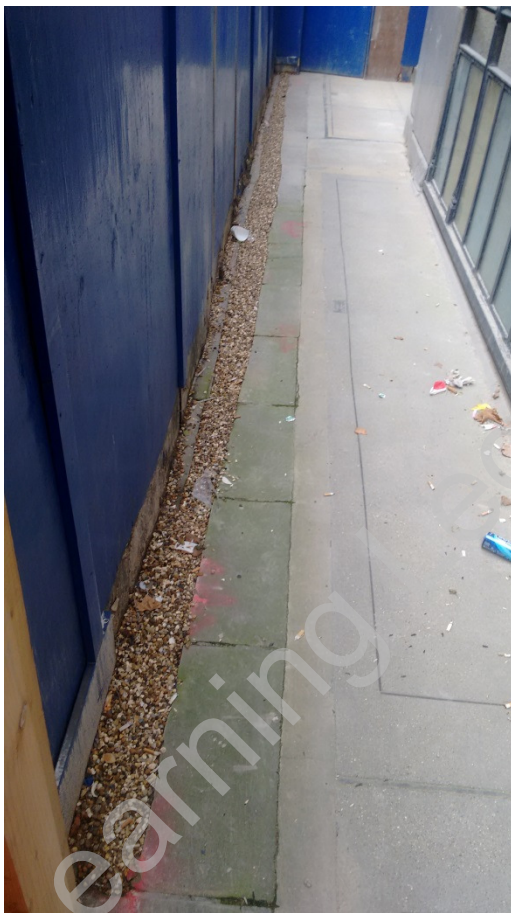
**Figure 4- Blomfield Street Site Hoarding**

LP11604-05 have not been measured since 22/06/2017. The road studs have been destroyed and access has been blocked by another contractor's site hoarding on Blomfield St. *Figure 4* shows the site hoarding on Blomfield St. Ground was changed when the blue hoarding was installed so road studs cannot be replaced. It is therefore proposed to decommission C510-LP11604-05.
