# C510 – Whitechapel and Liverpool Street Station Tunnels

## Instrumentation and Monitoring Close Out Report NESRS

CRL Document Number: C510-BBM-C2-RGN-D061-50137

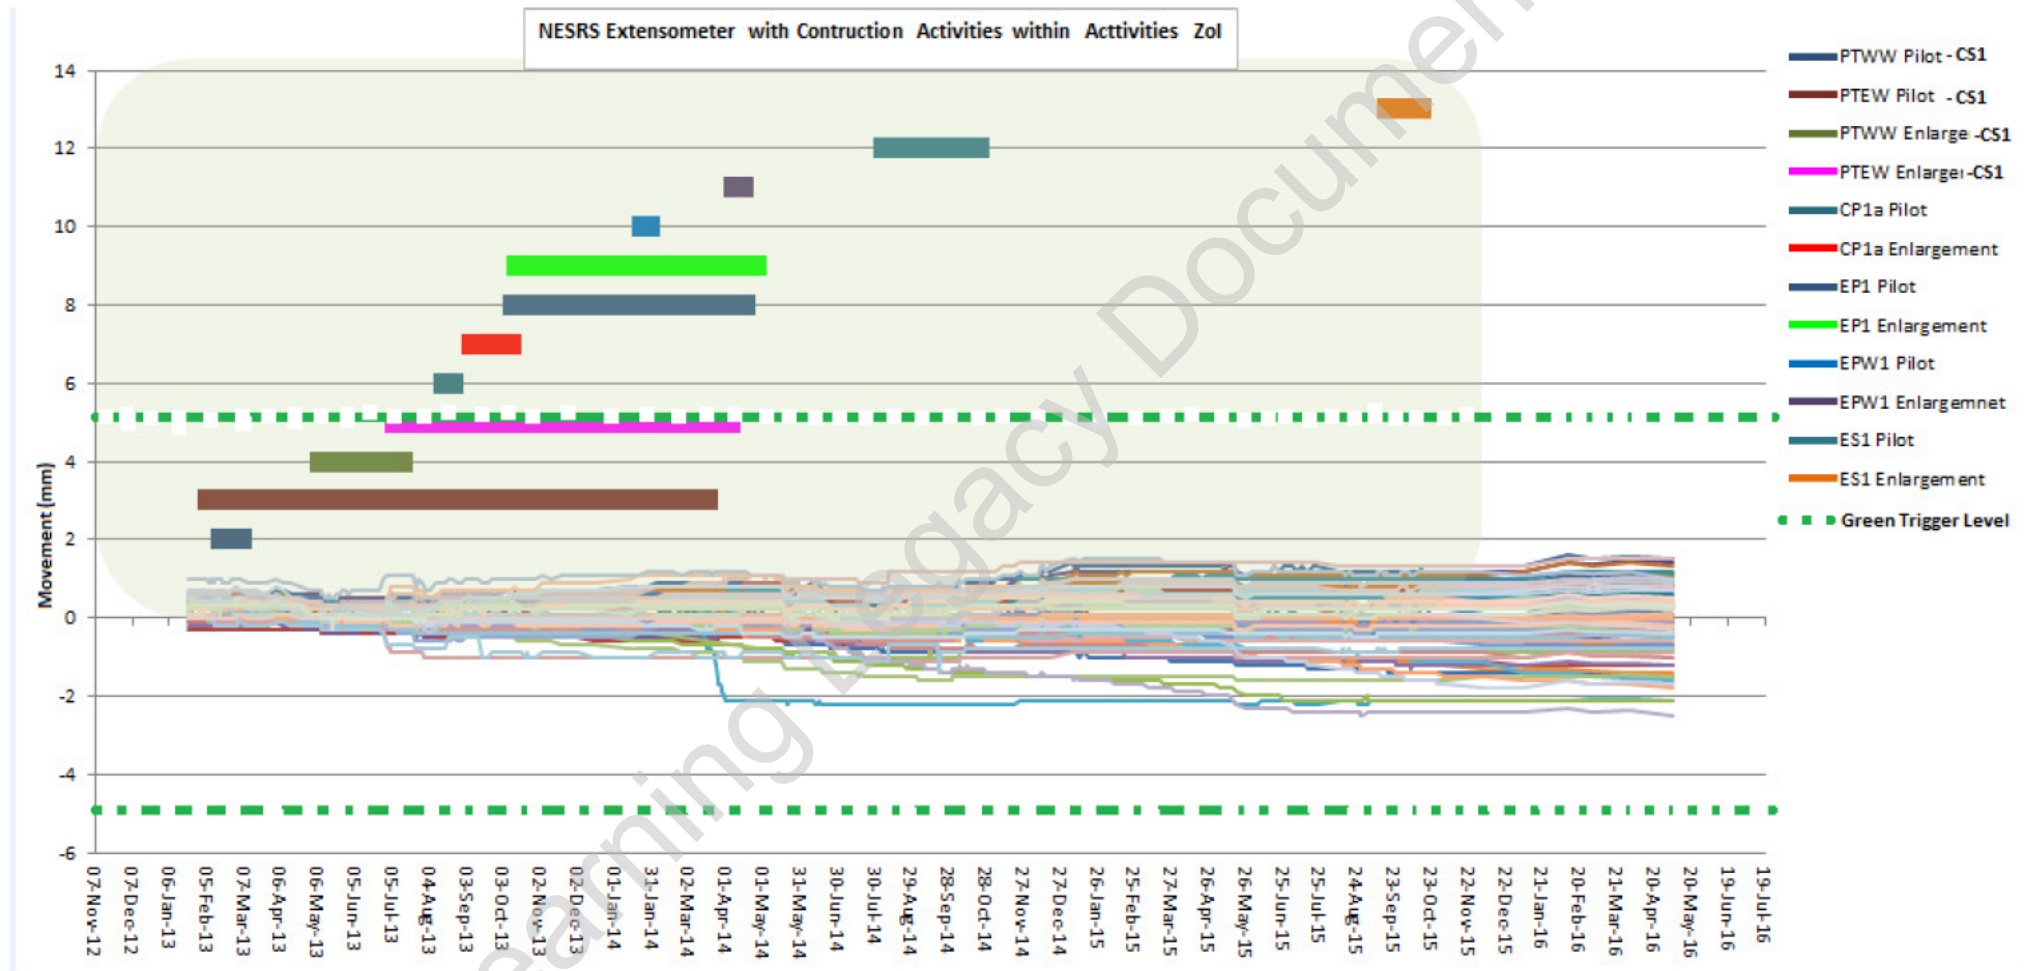
Graph 1 - All Extensometers (XR) monitoring sensors within the NESRS in Relation to Construction

The monitoring sensors within the sewer were extensometers, Crackmeters (automated), prisms and manual DEMEC studs to verify the automated system. Extensometers and Crackmeters (automated) have been assessed through the graphs and tables stated in section 5.1. Table 2 and 3 highlights monitoring sensors that are within the sewer showing their stability within the green trigger level of 5mm over two years.

Note that, the in-sewer instruments stopped providing data as of May 2016 due vibrating wire interface (in the logger enclosure) has failed.

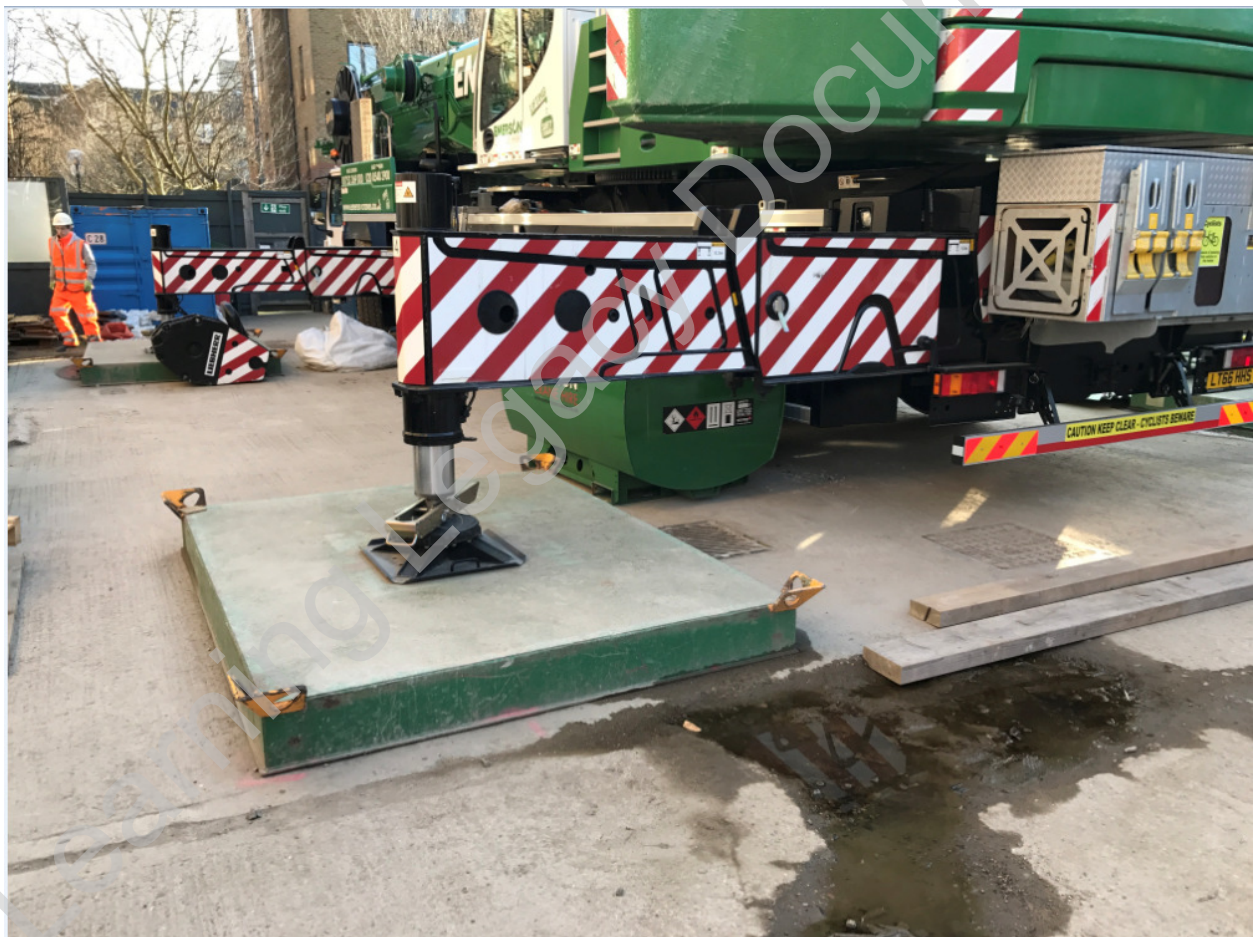
Some road studs have not been measured for extended periods of time due to C512 site resurface concrete slab. These sensors are no longer accessible and provide no monitoring data in relation to recent construction. Figure7 shows the C512 site resurface concrete slab and the occupying crane where C510-50552 - C510-50557 installed. However, adjacent sensors C510-50547 - C510-50551 have met 2mm per annum as shown in Decommissioning Tracker Table 4.

Figure 7 -C512 Site Obstruction resurface concrete slab

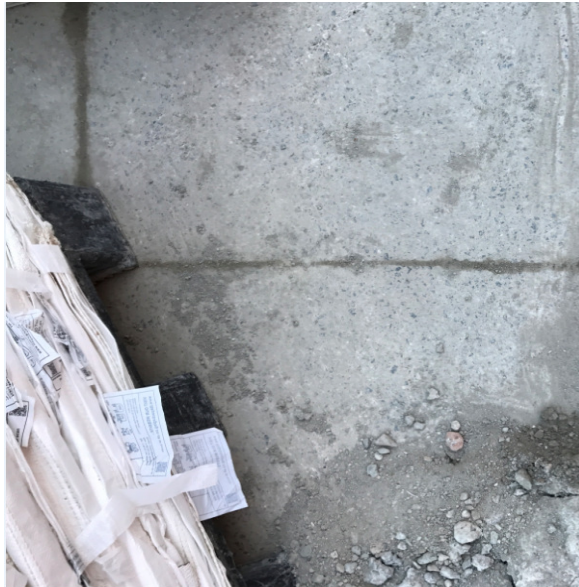
**Figure 8- C510-LP50805**

C510-LP50805 sensors were covered by C512 site materials. Is shown in figure 8, and it is not possible to continue to monitoring.

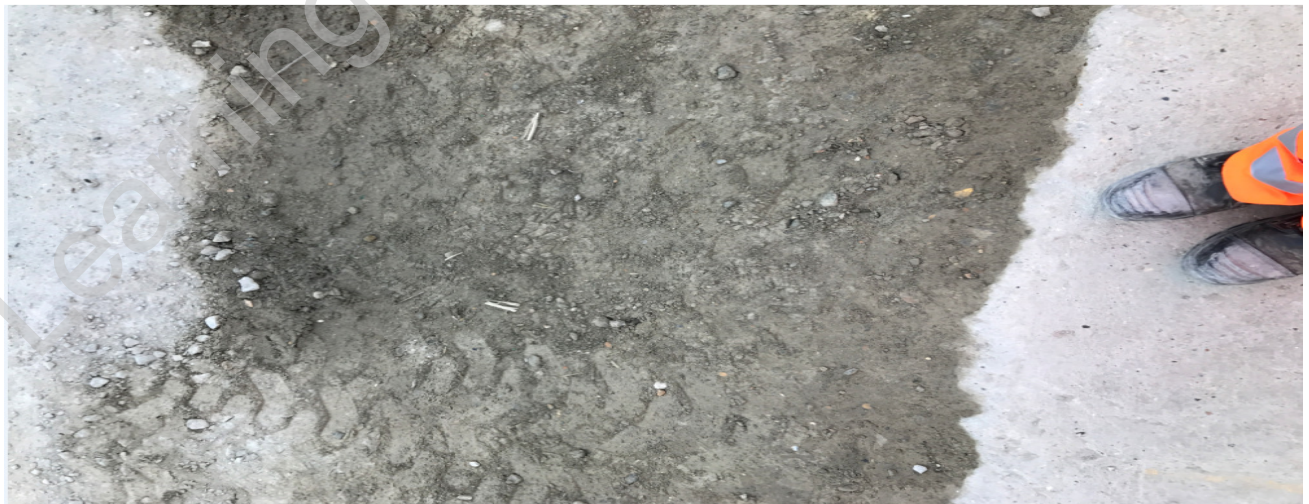
**Figure 9- C510-LP50806 and C510-LP508034**

C510-LP50806 and C510-LP50834, these sensors are been obstructed by C512 site entrance and equipment as of October 2014; it is not possible to continue to monitoring. Recently the site is now cleared from obstruction but the sensors were destroyed, is shown in figure 9. However, as numbers of studs in this vicinity are destroyed, the adjacent sensor C511-XR00004 the head showed stability: shown in APPENDIX A.

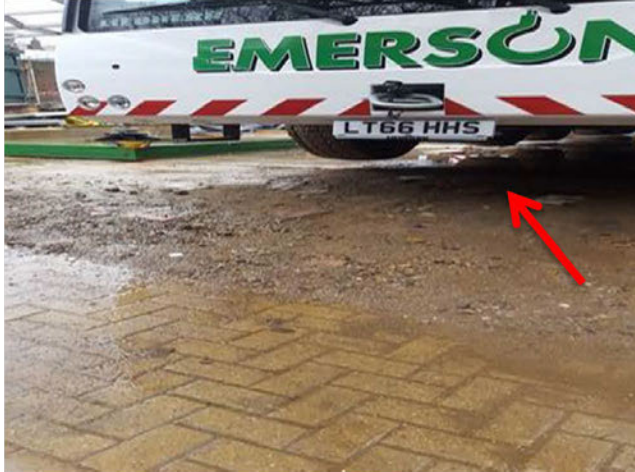
Figure 10- XR50501

XR50501 has not met the 2mm per annum specification and it is not possible to continue monitoring as the sensor is obstructed by C512 crane, is shows in figure 10.

The sensors that do not meet the specification will continue to be monitored until the specified criteria is met; (**highlighted in red in the above**) are to be continuing monitor.

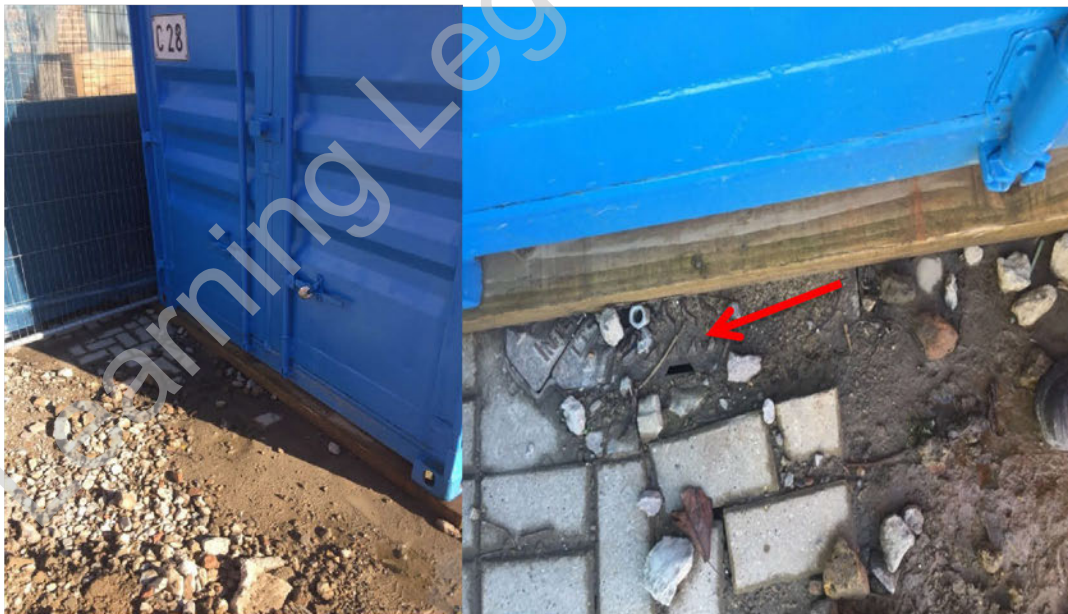
Figure 11- XR50502

XR50502, has not met the 2mm per annum specification, and it is not possible to continue monitoring as the sensor is underneath C512 site container, is shows in figure 11.
