# ◀ HEALTH & SAFETY ALERT ▶

## Lifting Operation Fatality – Non Crossrail Site

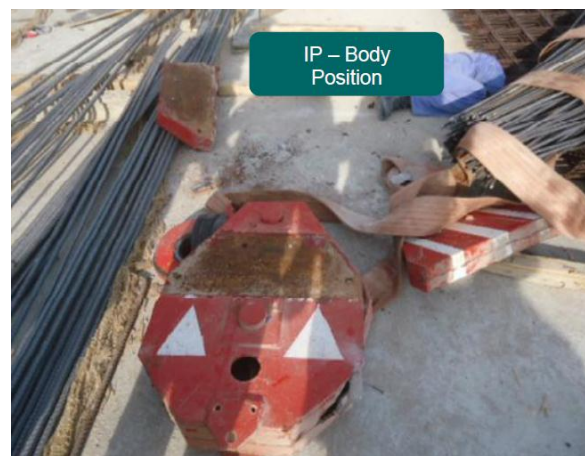
- The incident investigation determined that the key factor in the event was the incorrect termination of the hoisting cable at the jib end. Despite the use of non-recommended, non-complaint termination, the tower crane was inspected and certified safe to use by a **third party**.

Image shows the failed hoist and fallen the load

- The operative had no formal training as a slinger and therefore may not have been fully aware of the risks, leading him to stand too close to the elevated load.
- The only available manufacturer's manual for the tower crane was in German, making it difficult to review the recommended method of erection and rigging.
- The weekly checks documented by the contractor did not cover the hoisting cable termination.
