◀ HEALTH & SAFETY ALERT ▶

Whip Arrestors

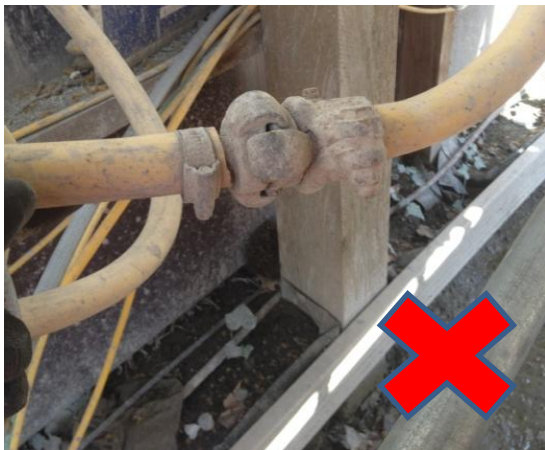
Picture A

In several of these a common factor has been the lack of whip arrestors see (Picture A).

All sites are reminded of the importance of fitting whip arrestors (see Picture B) particularly at extension points.
