# ◀ HEALTH & SAFETY ALERT ▶

## Dangerous Occurrence – Temporary Power Supply

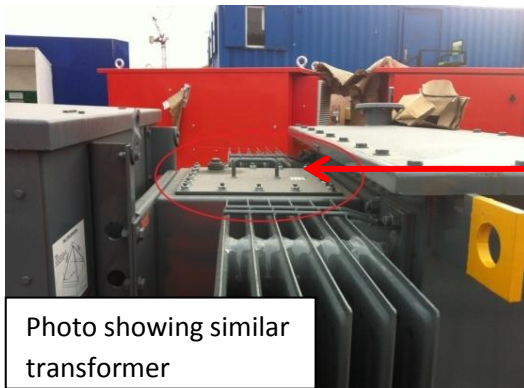
Photo showing similar transformer

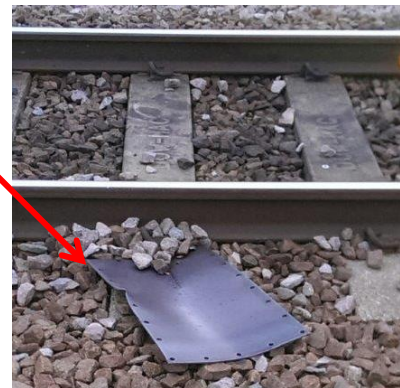
Cover Plate

Following substation isolation by DSJV Electrical systems an initial check of the transformer identified that the inter connection chamber between the transformer main switch gear and transformer tank had sustained damaged during an internal build-up of pressure. The cover plate had sheared and was blown off and came to rest adjacent to the neighbouring NR tracks.
