◀ HEALTH & SAFETY ALERT ▶

Failure of Lifting Accessory

Following an incident where the hook failed on a forklift lifting accessory, this alert is to highlight the issue and to remind all sites to check the suitability of their lifting equipment and accessories.

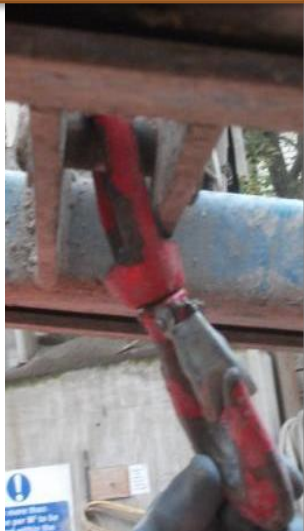
Lateral pressure was applied to the lifting hook as per the adjacent image.

As shown, the configuration of the accessories did not allow for such lateral movements without the hook being damaged.

As a result, the swivel joint sheared (no other damage was caused).

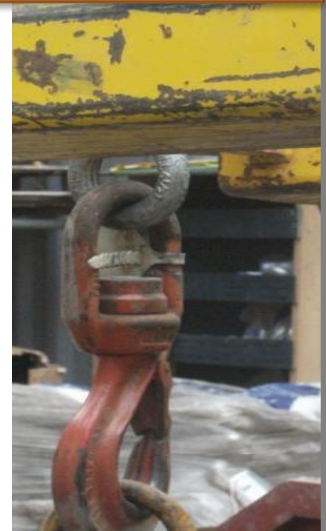
Following a review of the configuration, an additional lifting eye was installed, which allows for increased lateral movement.
