# ◀ HEALTH & SAFETY ALERT ▶

## Fly Jib Sheared on Pick and Carry Crane

This alert has been provided by our colleagues at Canary Wharf Contractors.

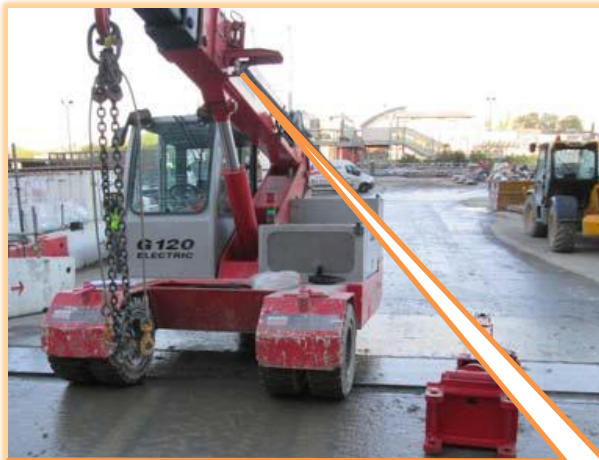
A Trade Contractor had hired a G120 pick and carry crane and its operator from a hire company for the purpose of transporting precast slabs. As the crane was travelling across the yard from the welfare area, the 6 bolts connecting the fly jib onto the main boom sheared off and it fell onto the marine deck (see photo). There was no load attached at the time of the incident. The fly jib had never been used during the hire for any lifting operations. It was folded back, along the main boom and secured into position.

Fly jib was located adjacent to this boom

Root Cause: The crane does not have any suspension and was driven repeatedly over uneven ground conditions, which included the yard and a road plate along the route. The driver was also using the crane to drive back and forth from the welfare facilities to the place of work. The yard has a number of potholes, cobbled areas and rough concrete areas. This caused the fly jib to bounce excessively and as a result loosen the bolts over time, eventually causing them to shear.

Contributory causes: The driver had not undertaken daily inspections for 2 weeks. The daily checks may have identified any obvious defects associated with the fly jib.

- Undertake regular surveys of vehicle routes to ensure ground conditions are suitable for specific plant in use
- Ensure relevant thorough examinations, weekly inspections and daily checks are in place and monitored
