C261 Early East
Non-Listed Built Heritage Walkover
Assessment
Instone Wharf (XRW10)

Document Number: C261-MLA-X-RGN-CR140-50095

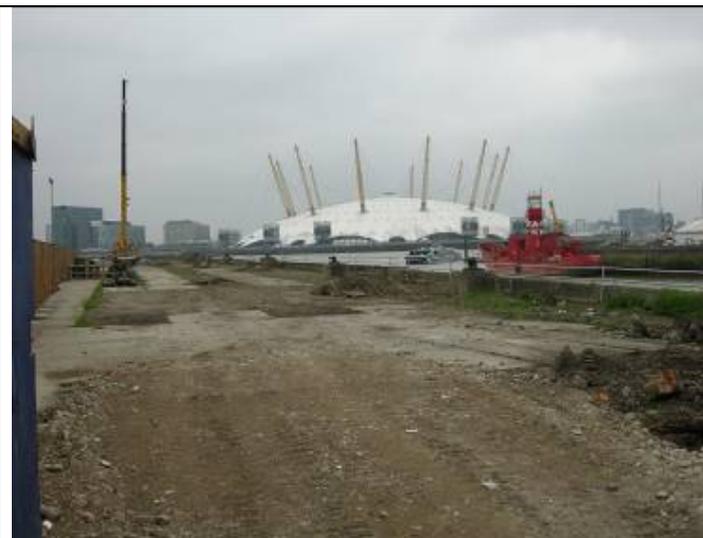
Fig 1 View of the mooring posts, looking south

A series of eight mooring posts was built along the western edge of the Instone Wharf to allow the mooring of barges/boats (Fig 1). The posts are composed of concrete bases supporting iron bollards. The bases of the posts (125 x 84 x 152 cm) are built at roughly 1m from the river wall (Fig 2), although the base of the southernmost post is abutting the river wall, possibly the result of a later rebuilding of the wall itself.

The eight mooring posts are considered of local importance (see 6.1), and if they are to be removed, or are likely to be damaged by the Crossrail works, it is recommended that the bollards (excluding the concrete plinths) should be recovered, stored safely, and either reinstated, or relocated (either on the site following Crossrail works, or elsewhere).

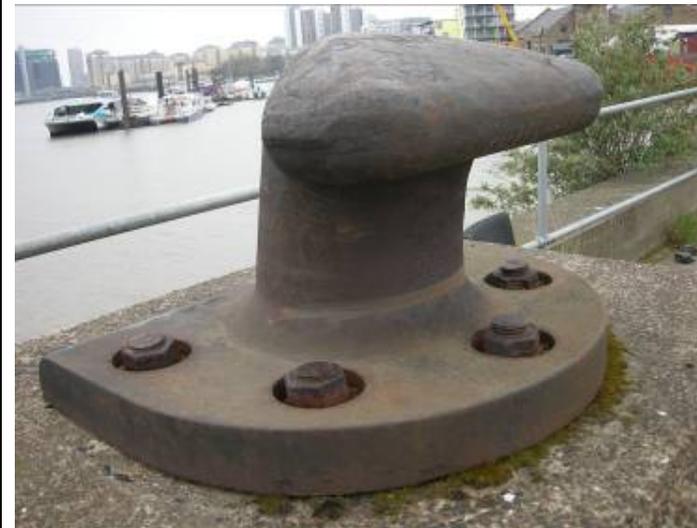
Fig 3 Detail of an iron bollard, looking west

Each T-head bollard is a vertical post attached on an iron base (base measuring 80 x 65 x 8 cm) bolted to the concrete plinth with 5 bolts (Fig 3). The bollard has a wider T-shaped head which discourages docklines from coming loose and is hollow. These bollards are suitable for steep rope angles which would be expected in an area of heavy fluctuation of the water level due to the Thames tide.

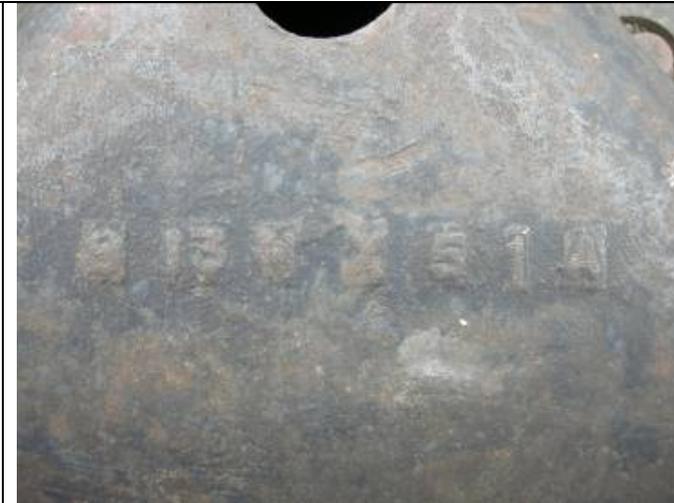
Fig 4 Possible manufacturer's identification number at the top of the bollards

Each bollard presented manufacturer code stamped on the top: 813HX51A which was identically reproduced on each bollard (Fig 4).

It has not been possible in this initial documentary research to identify the manufacturer, although it possible that any further work might be able to trace this, through the identification number. It is possible that they were made in the Thames Ironworks for one of the nearby slipways or wharves, and later reused.

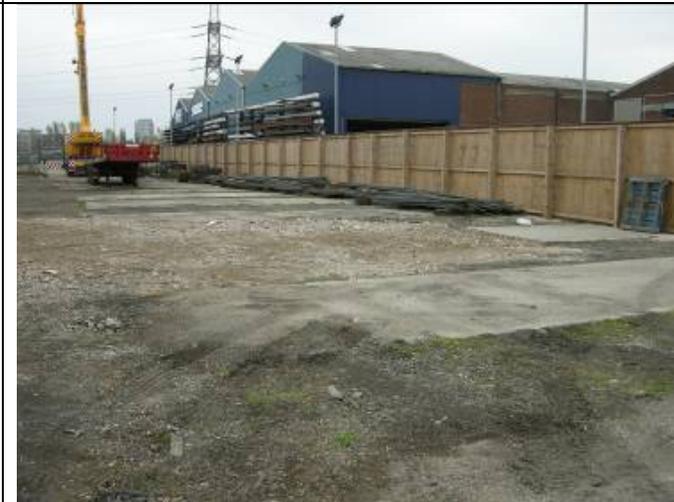
Fig 5 View of the southern section of the railway paved surfaces

A series of railway paved surfaces was present on the site and dates probably to the 1950s when the site was used as a freight terminal. The series of paved surfaces, a succession of concrete rectangles, can be sub-divided into two sections:

- Northern section of railway paved surfaces, occupying 2/3rds of the site and oriented north–south. The first cartographic evidence of those features dates back to the 1952 OS map (see section 5, Fig 11)
- Southern section of railway paved surfaces, occupying the southernmost area of the site, oriented east–west.

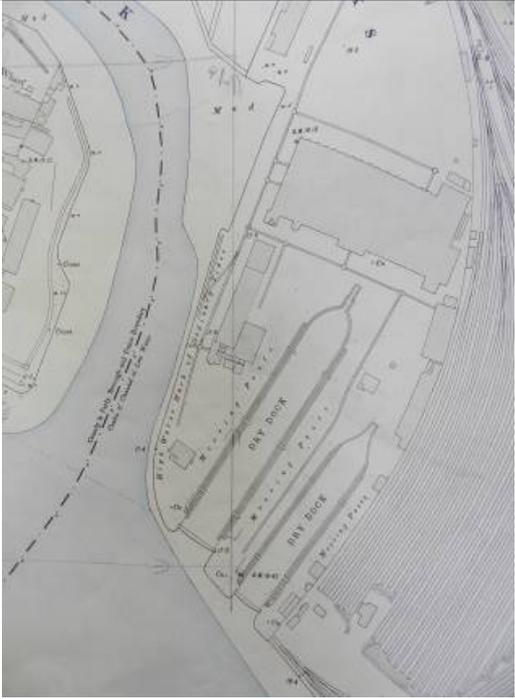
<p data-bbox="188 1016 735 1084">Fig 7 OS 1894-95, 1:1056, London Sheet V111.73</p>	<p data-bbox="826 304 1027 338">DSCN0830 (2)</p>	<p data-bbox="1093 304 1453 539">No mooring posts along the river wall, two tracks going into the wharf and one turntable linking them. Only existing mooring posts are along the two dry docks to the south-east</p>

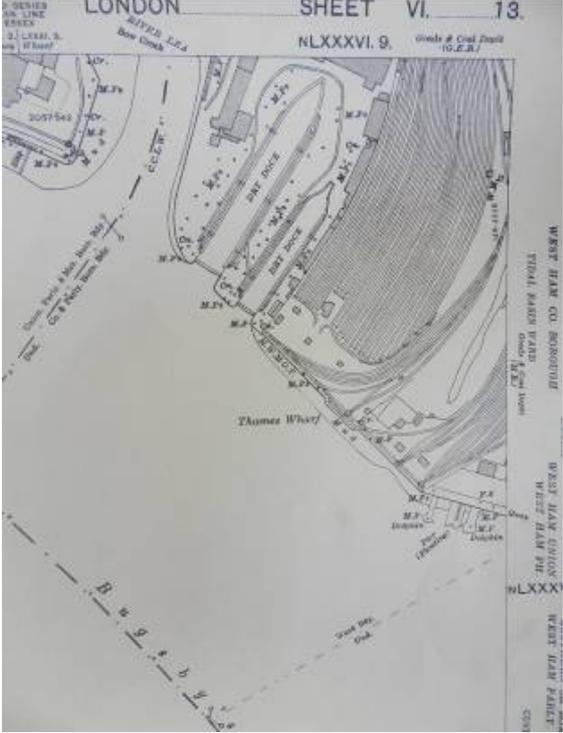
<p data-bbox="188 1852 772 1886">Fig 8 OS 1916, 1:2500, London sheet V1.13</p>	<p data-bbox="826 1106 1027 1140">DSCN0832 (3)</p>	<p data-bbox="1093 1106 1430 1173">No significant changes to the site area</p>

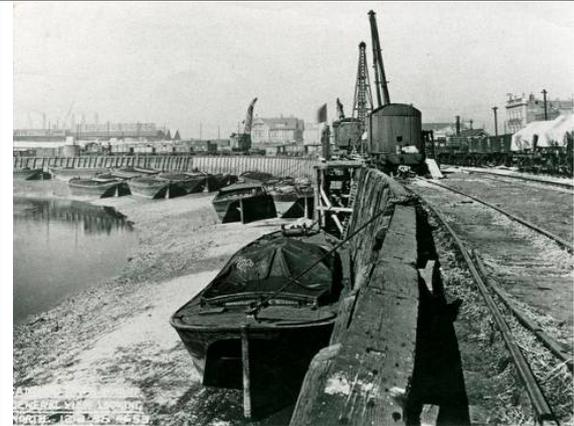
<p>Photo from www.newhamstory.com/node/1624</p>	<p>The old timber wall was being replaced from north to south (note staging for pile driver adjacent to river wall), the whole wall was redone between 1933 and 1935. A likely date for the installation of the surviving mooring posts. Railway Wharf of London and North-Eastern railway. The older mooring posts are on the old wall in the foreground.</p>
<p><i>Fig 9 Unknown provenance, looking north</i></p>

Although the map progression left a gap between 1916 and 1952, information on a LB Newham website (www.newhamstory.com/node/1624) explains that the earlier timber-made river wall was replaced between 1933 and 1935. It is possible that, as part of the same refurbishment, the mooring posts were installed. They first appear on the OS map of 1952 and are indicated with the letters MP.

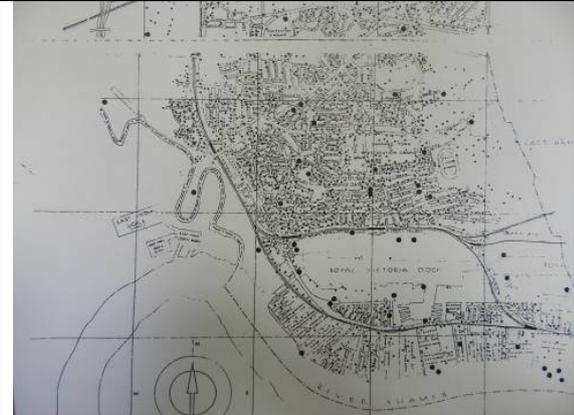
<p>DSCN0840 (5)</p>	<p>A high explosive bomb landed in the north-east corner of the Instone Wharf</p>
<p><i>Fig 10 Bomb map circa 1945 West-Ham war damage map from The west-ham air raid incident register</i></p>

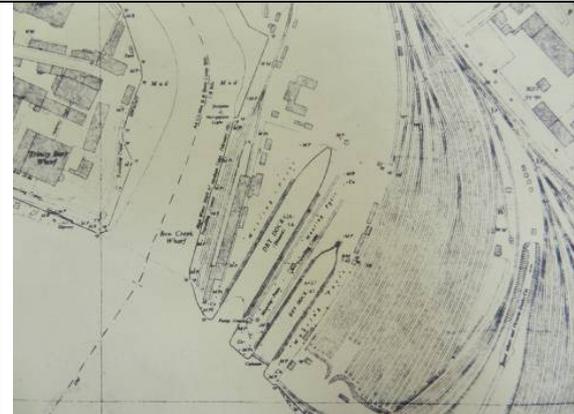
<p>DSCN0824 (1)</p>	<p>First cartographic evidence for the mooring posts</p>
<p><i>Fig 11 OS 1952, 1:2500, plan TQ 3980</i></p>

The concrete surfaces associated with the presence of the railway on the site of the Instone Wharf probably date to the 1950s. The OS map of 1952 also shows travelling cranes present on the site which might have needed concrete foundations and supports.

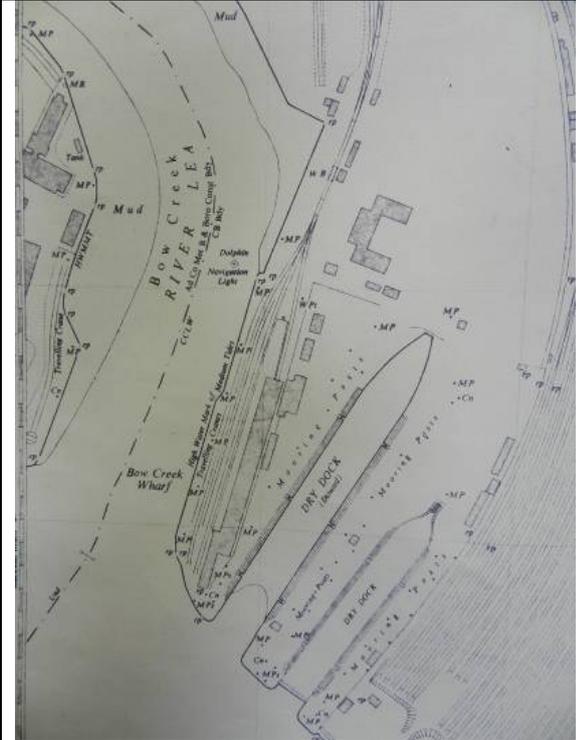
<p>DSCN0835 (4)</p>	<p>Better detailed than the previous OS map</p>
<p>Fig 12 OS 1953, 1:1250, plan TQ 3980 NE</p>

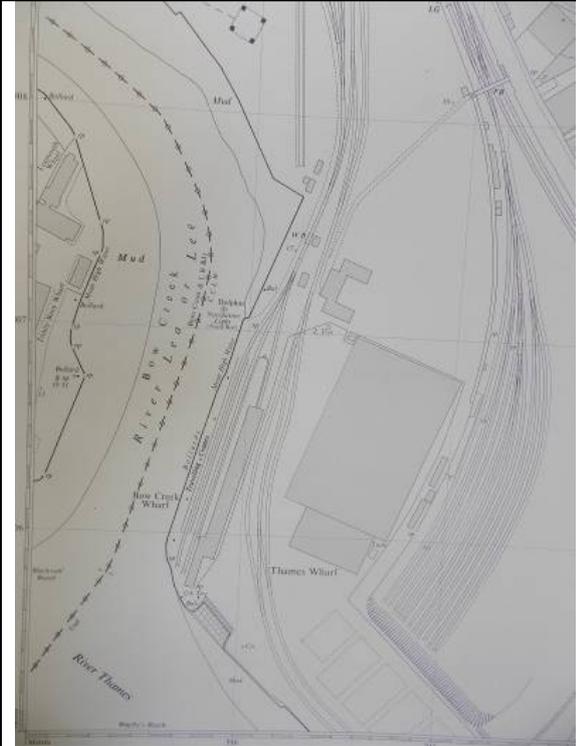
<p>DSCN0842 (6)</p>	<p>Travelling cranes, two main tracks coming in and a covered track line to the east of the other ones. The line is coming from the north. To the east there is a building possibly called Thames Wharf, but there is a boundary dividing the Instone Wharf from this area. Instone Wharf is called Bow Creek Wharf at that time.</p>
<p>Fig 13 OS 1969, 1:1250, Plan TQ 3980 NE</p>		
<p>Not reproduced OS 1981, 1:1250, plan TQ 3980 NE</p>	<p>(7)</p>	<p>The building to the east has extended towards west, the shore, the tracks and the covered area remain</p>

the same

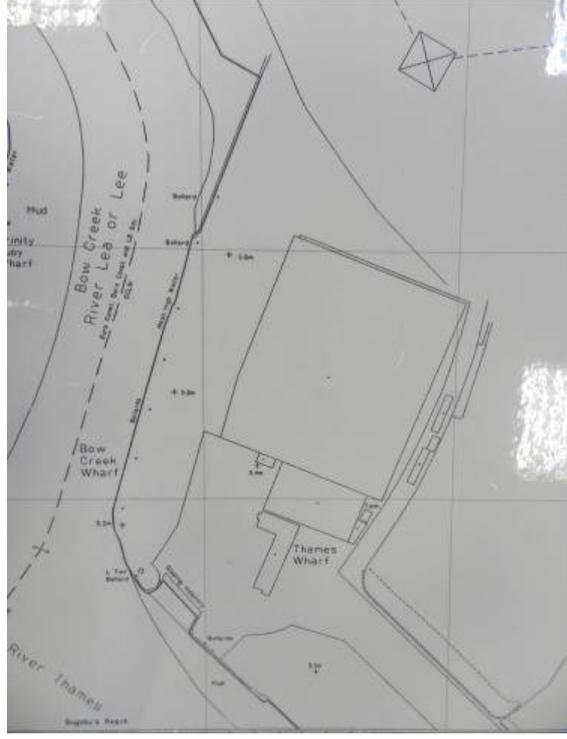
<p>Fig 14 OS 1992, 1:1250, TQ 3980NE</p>	(8)	The area has been cleared and looks vacant. The eight mooring posts are present on the map.
NS 3031, box 12	9	'Arrival of the King of Sweden at the Thames Iron Works' 1900. shows there was no river wall above ground level, train track visible
NS 1417, box 13	10	'Thames Ironworks: HMS Duncan ready for launch' 1901
Box 23	-	Examples of bollards from other docks. Different types, all without a plinth. Possibility for further research
Box 22	-	-
Box 24	-	Examples of bollards from other docks. Different types, all without a plinth. Possibility for further research
Box 25	-	-
Box 166	-	-
Box 166	-	-
NS 2708, Box 92	11	Picture of the Bow Creek showing the river wall and

See Fig 14 for locations.
