C263 LATE EAST
The Connaught Tunnel, Pumphouse
and Air Vents:
Non-Listed Built Heritage Recording

Document Number: C263-MLA-X-RGN-CRG07-50039

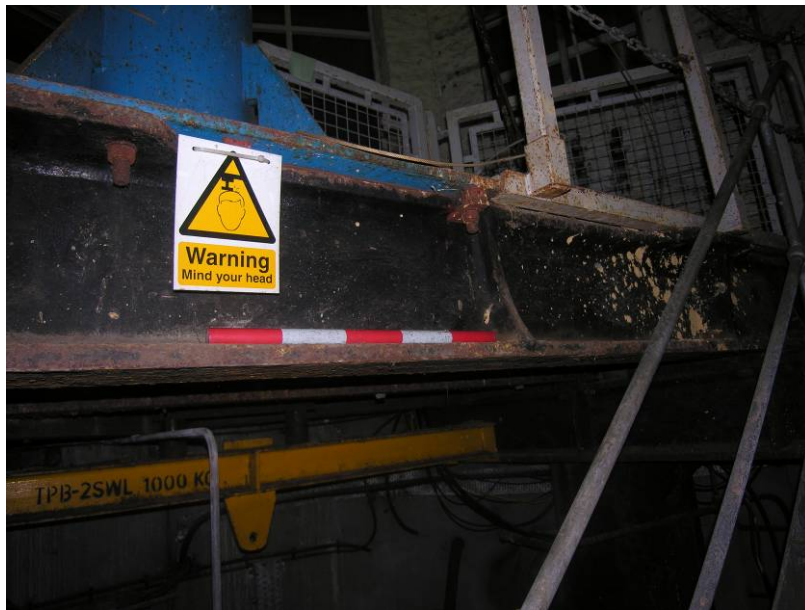
The interior of the building was undecorated and a simple frame had been inserted into each of the arched window spaces to support the opaque plastic glazing (Photo 14). The timber floor, supported by large timber joists ran around the opening of the shaft with a width of approximately 0.88m. A modern staircase ran down into the shaft from the north west (Photo 14). The south-western part of the shaft opening had been covered over in order to enable the instillation of a modern hoist (Photo 15). This was supported from below the floor by a joist, probably of wrought iron, which had tapered vertical flanges along its length suggesting a 19th century date (Photo 16).

Photo 16. The possible 19th century wrought iron joist across the centre of the shaft opening, used to support the modern hoist.

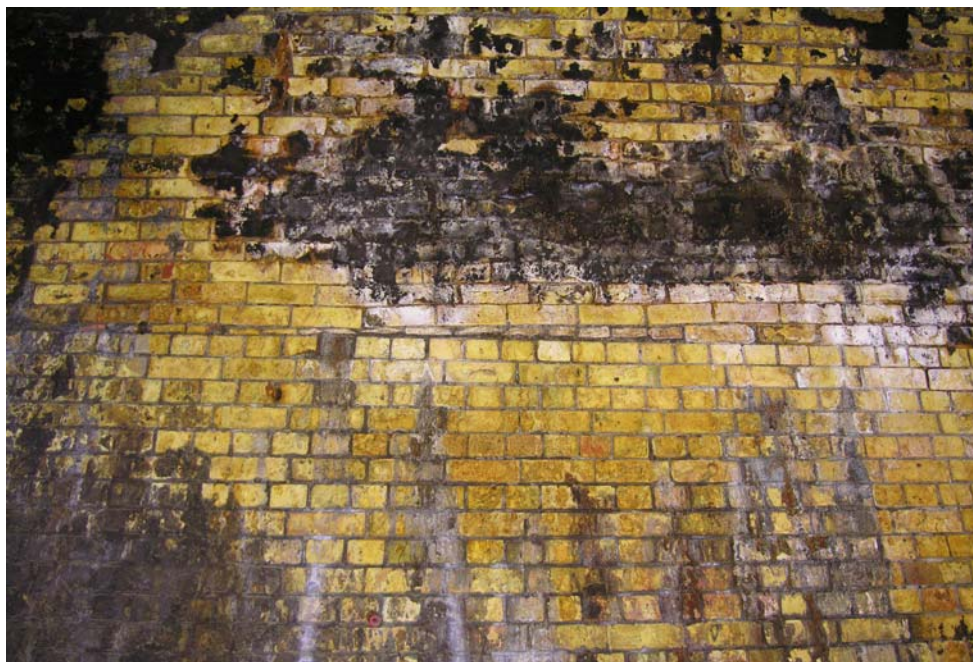
Photo 29. The change in brick bonding from English to stretcher in the northern single tunnel section and the gradual insertion of an extra course of stretcher bricks from left to right.

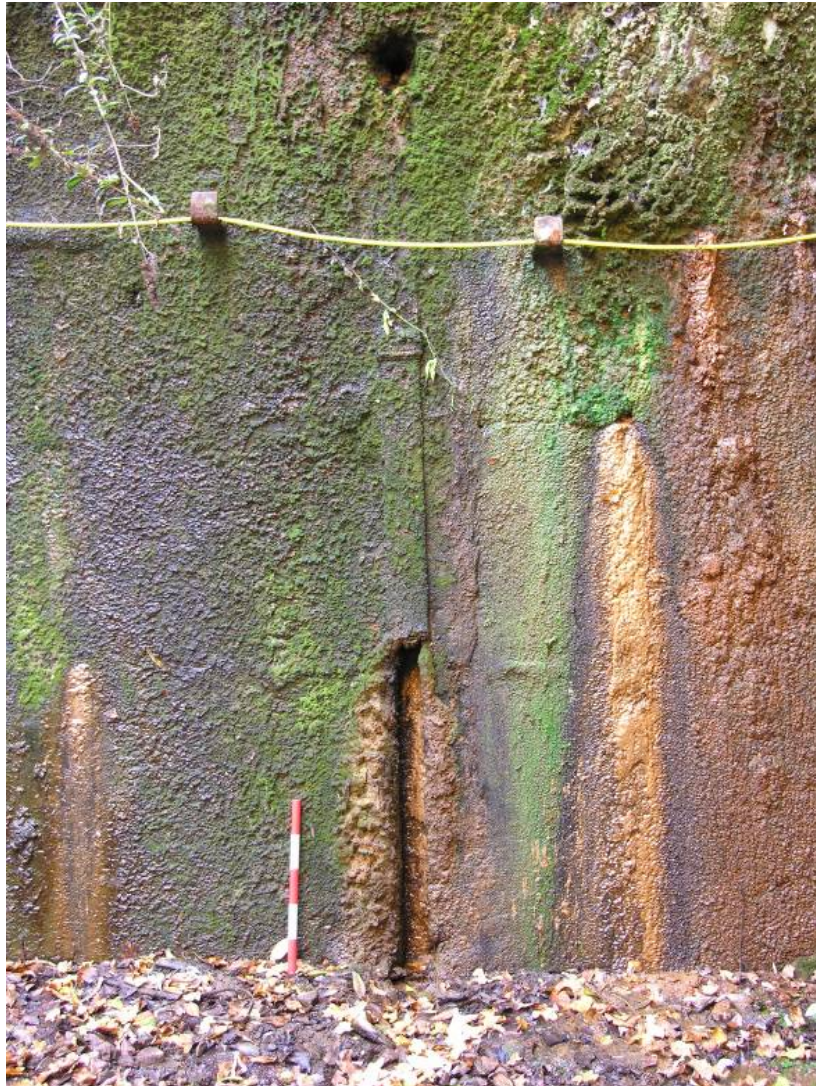
On the south wall of the south cutting, 0.66m outside the south portal are the remnants of a recessed drain pipe (Photo 48), now broken and much covered by moss. No other recessed pipes were noted either within the tunnel or in the cuttings. Due to the fact that the pipe is recessed within the concrete this may be an original feature intended to resolve a localised drainage issue.

Photo 48 The recessed drain pipe outside the south portal looking south.

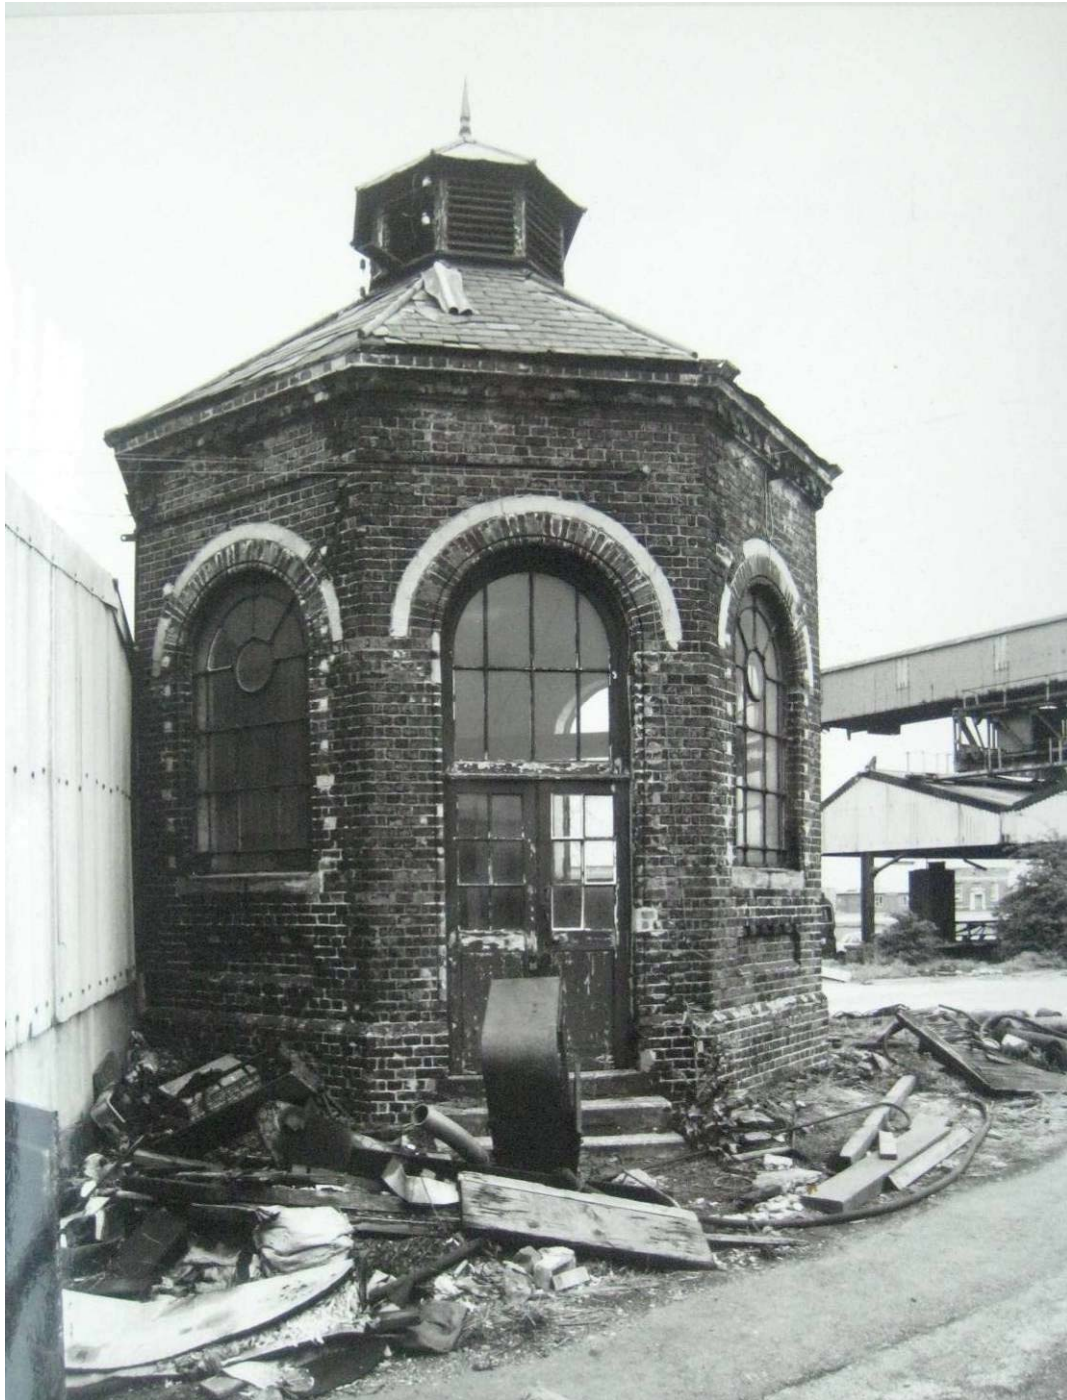
Fig 9 The pumphouse entrance from the south, taken 1977. (LMA SC/PHL/02-SSo4 0921-30)

A series of photographs taken in 1977 and held at the London Metropolitan Archive, show the pumphouse from various angles (Fig 9, Fig 10 and Fig 11) and illustrate the poor state of repair of the building at this time. The Crossrail document, *Connaught Tunnel Scope of Works: Pump Shaft Condition Survey* reproduces a series of drawings of the pumphouse made for the London Docklands Development Corporation by Halcrow in 1992, when various repairs and refurbishments were made to the building, possibly the first repairs since the photographs were taken in 1977. The changes include the removal and replacement of the render above the window arches (though the render removed in 1992 was probably that shown in the photos of 1977 which was not original, as the photograph from 1935 (Fig 8) shows that the dentil pattern was originally repeated over the arch), the replacement of the north east window with the louvers, the removal of an original fanlight above the

double entrance door (visible in Fig 9) and its replacement with the present timber louvered fanlight visible in Photo 5. The 1992 drawings show the earlier (but probably not original) entrance door was also replaced with the four panelled double doors visible in Photo 5. Timbers adjoining the window on the west elevation were removed as were unspecified redundant external fittings. The brickwork repaired and the surfaces were made good in which may explain why the scar of a former pitched roof of an adjoining single storey structure on the north elevation that is visible in the 1935 photograph (Fig 8), is no longer clearly visible today (Photo 7) .
