C254 Archaeology West

Paddington New Yard, Westbourne Park, London W9

Archaeological Fieldwork Report

CRL Document Number: C254-OXF-T1-RGN-CRG03-50251 rev2

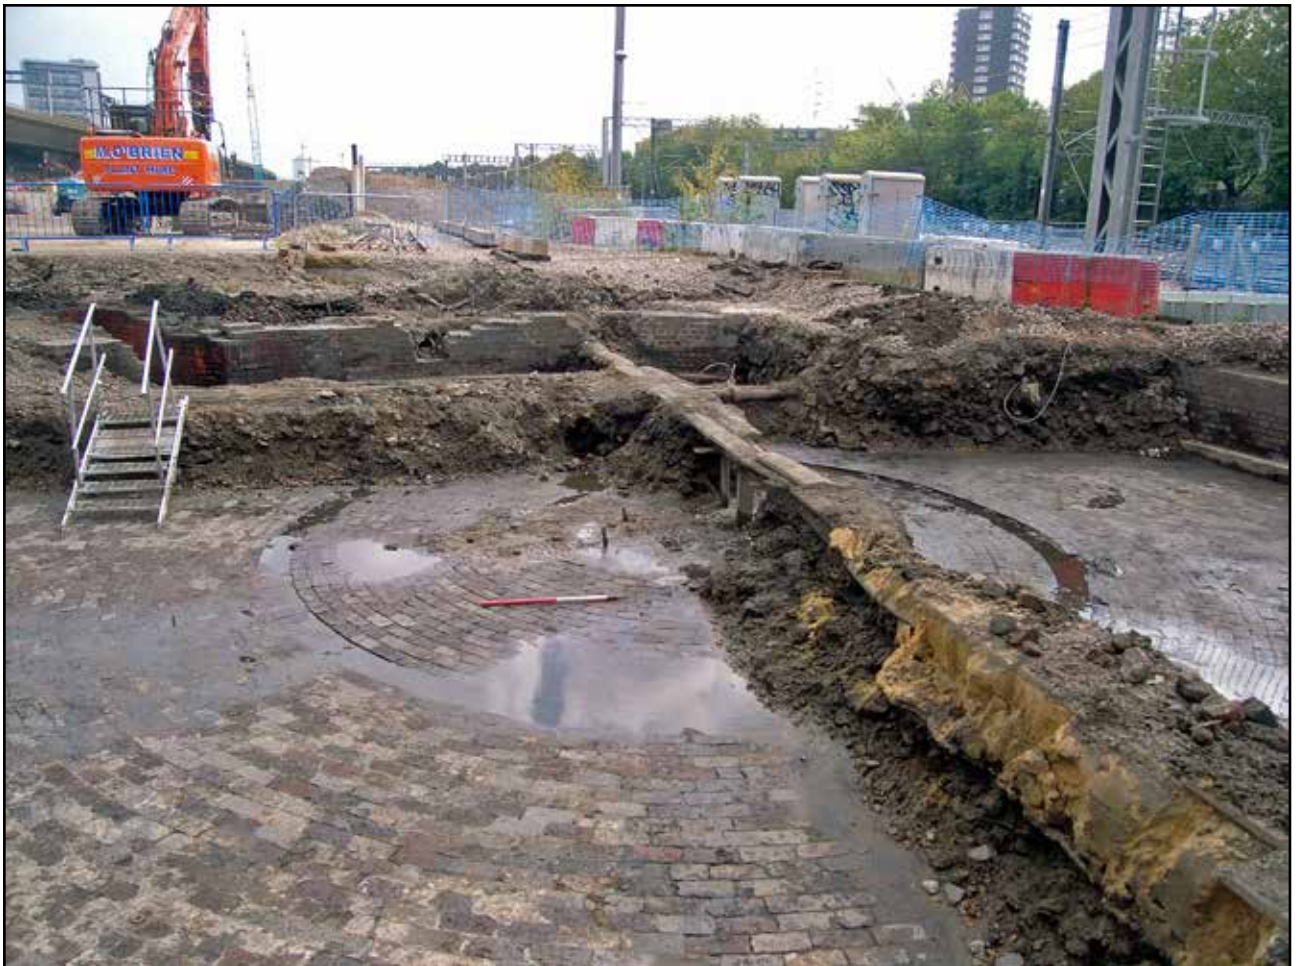
Plate 2: Turntable pit floor [8524] and drainage gully [8525]

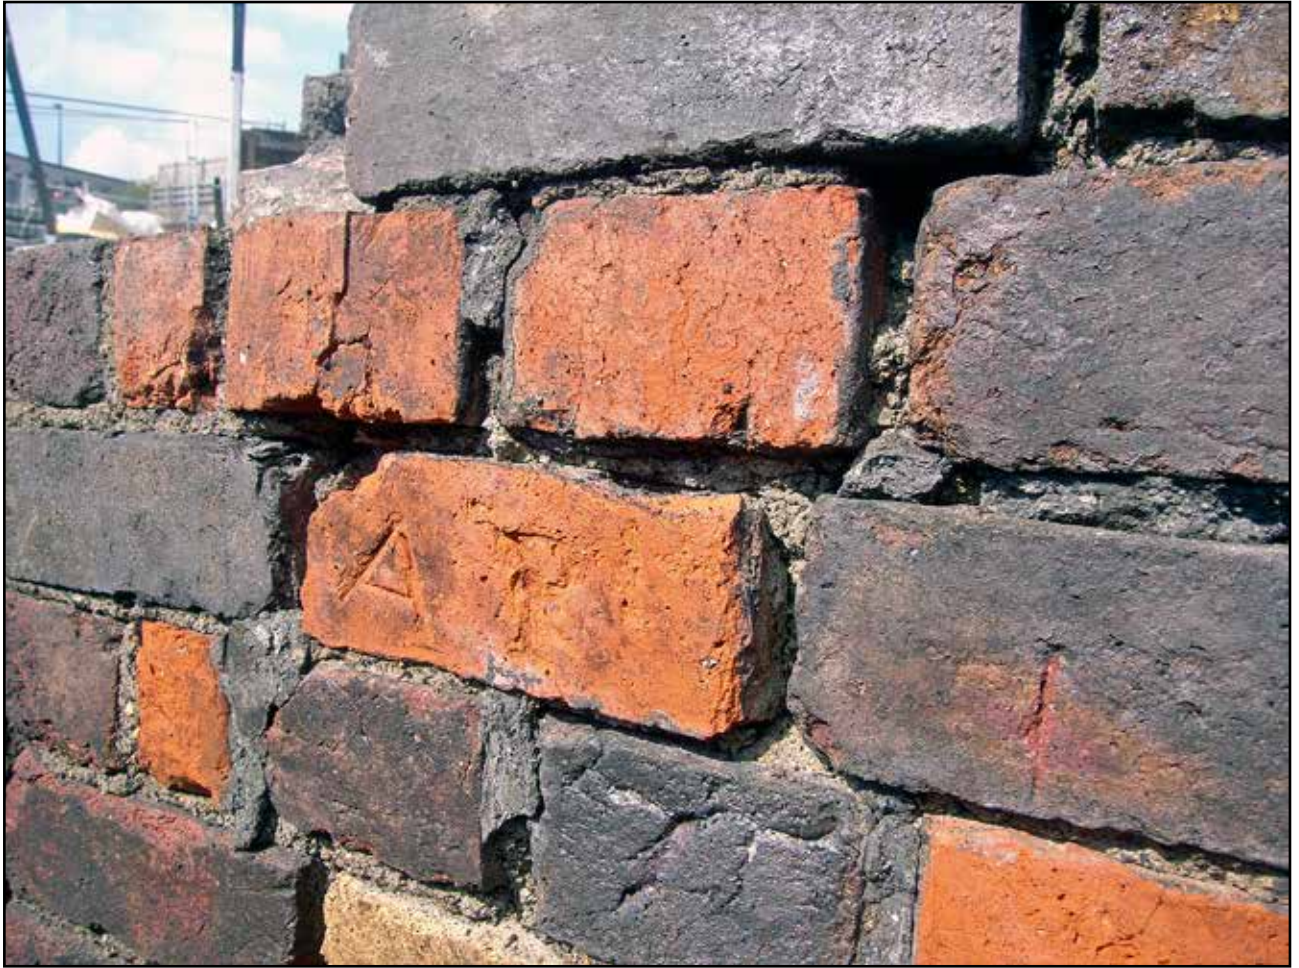
Plate 9: Graffiti on northern wall of engine house [8528]

- 6.3.14 A number of graffiti were carved into the northwest wall of this structure (Plate: 9).
- 6.3.15 Most of the turntable's pit remained intact, aside from some holes in the wall caused by later service trenches. However, none of the turntable platform/deck, structural ironwork or working mechanism survived, although a number of metal bolts and the base of the central metal pivot set into the turntable's floor survived. The turntable deck and any movable parts of its running mechanism had presumably been removed when the turntable was dismantled and its pit backfilled.

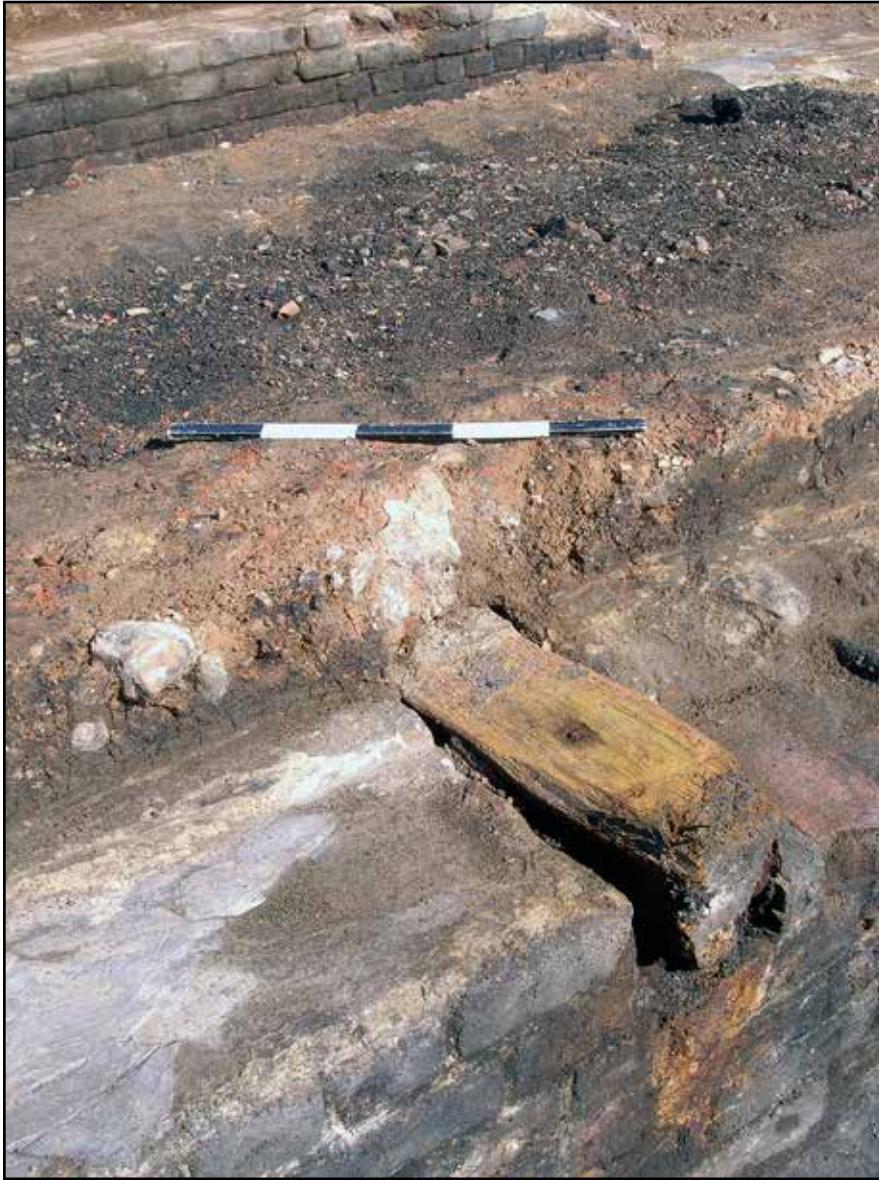
Plate 15: Sleeper cut into top of inspection pit wall [8693]

- 6.4.7 The pits' sidewalls were largely intact with only the upper capping course missing. A row of 6" deep rectangular cuts, containing 10" long metal nails and short timber sleepers were cut into the top of the pits' walls. These ran along both sides of the pits and were the remains of the pads for the bulk rail, which must have formed the standard gauge roads in the shed (Plate: 15).

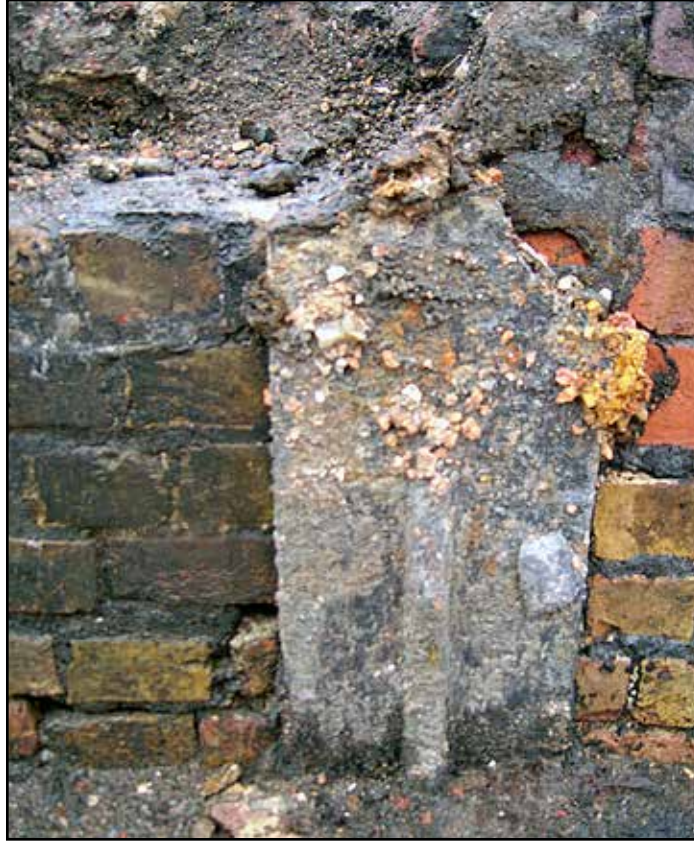
Plate 23: Metal fixtures on pit sidewall [8746]

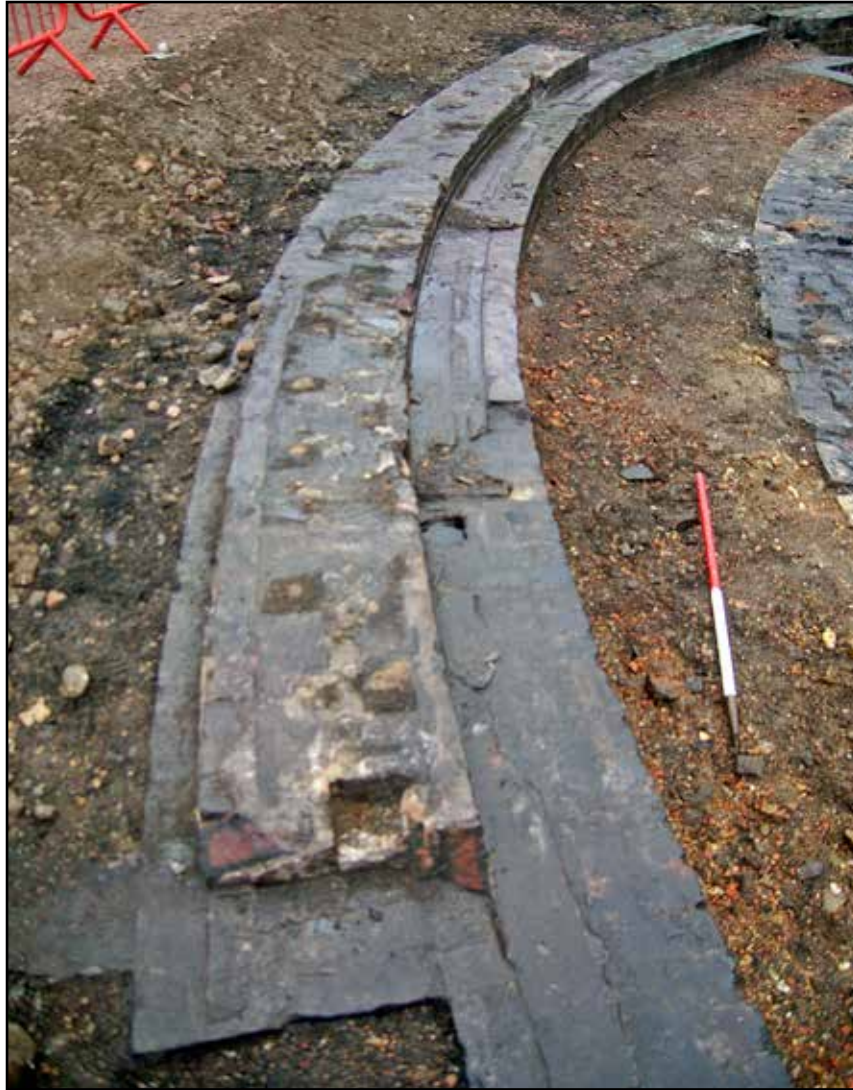
Plate 25: Outer wall [8752] of second phase of Turntable

- 6.5.8 Wall 8752 was 0.47m wide and built of blue grey engineering bricks set in a hard white mortar (See Table 6). Wall 8752 survived for most of its original height (0.6m) and comprised five courses of stretcher bond, with a single course lain on edge at its top. Monitoring of its demolition by OA/R showed that it had stepped foundations set on substantial concrete footings.

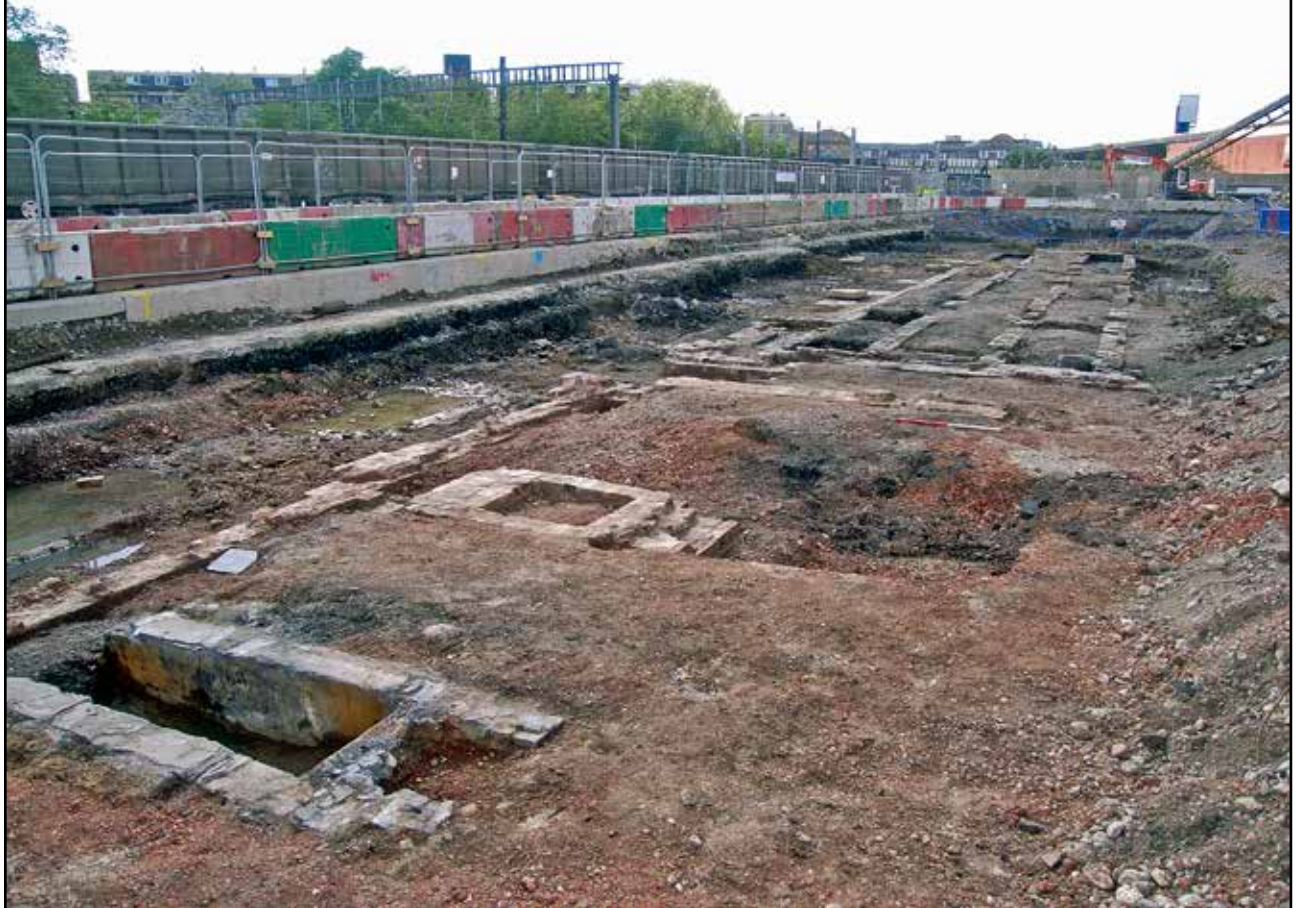
Plate 28: "Smiths shop" of 1852 Workshop showing forges base [8029] and quenching pit [8027]

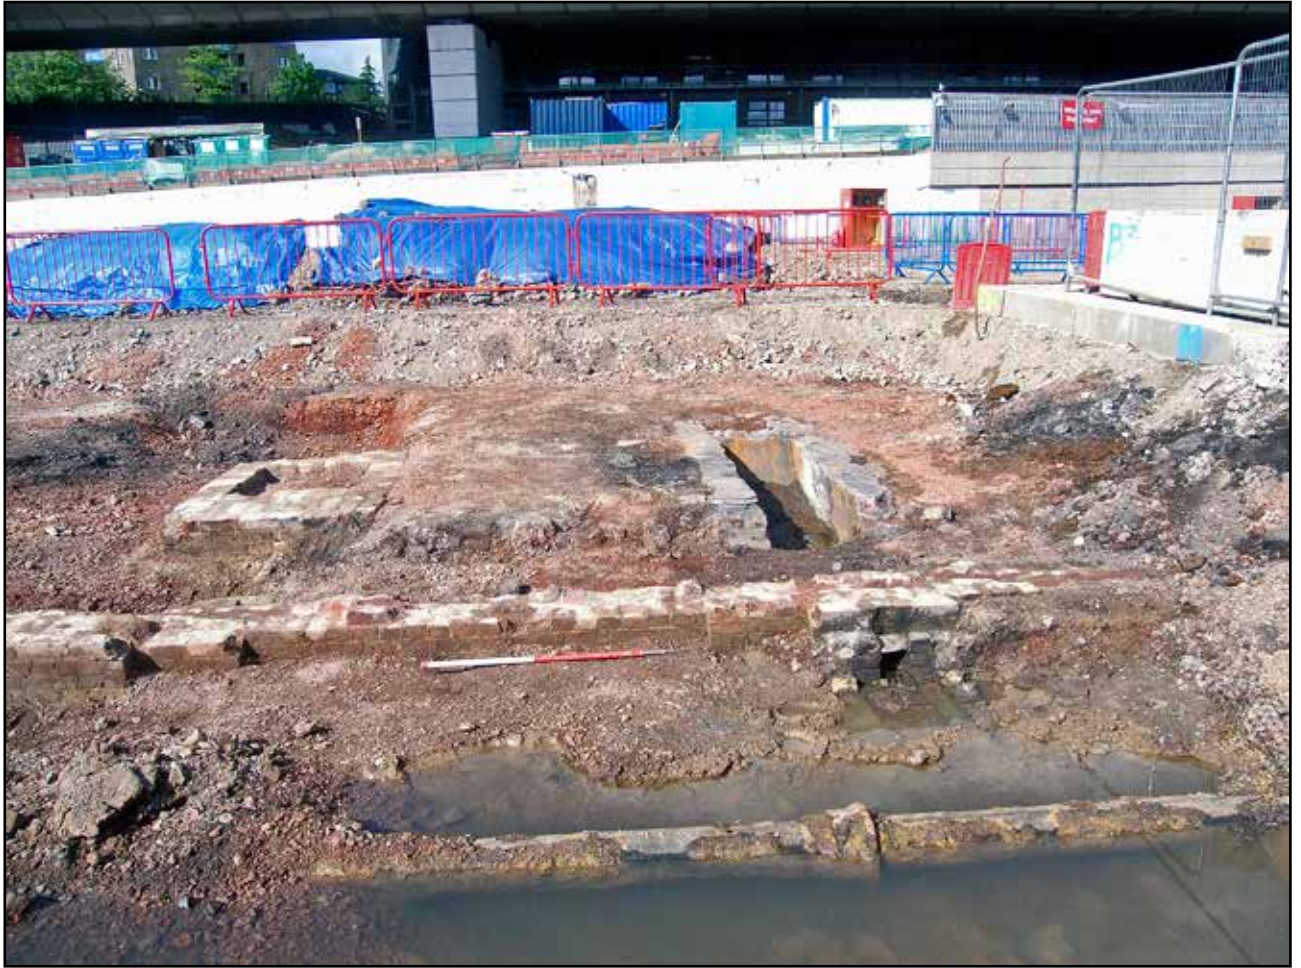
Plate 29: Southern wall [8030] of 1853 Workshop showing metal hydraulic pipe [8062]

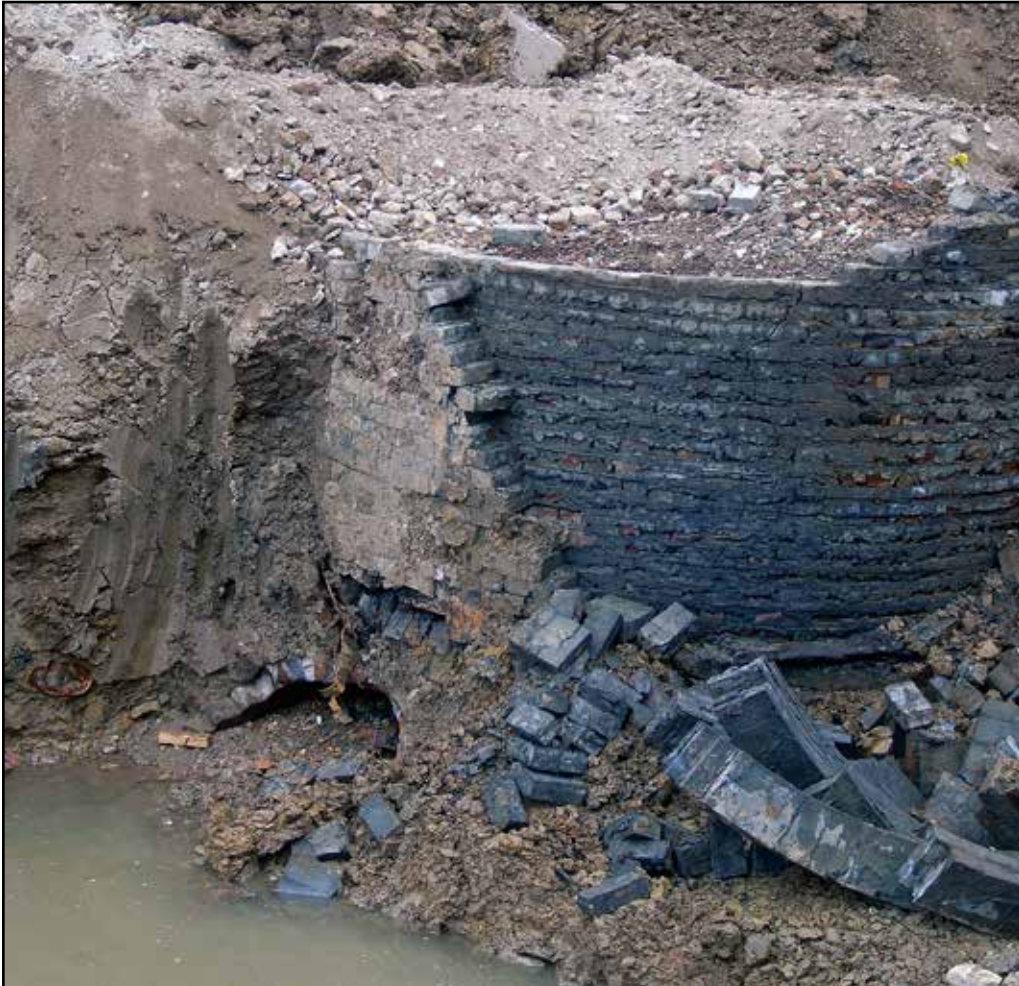
Plate 43: Shaft 8206 showing double skinned wall

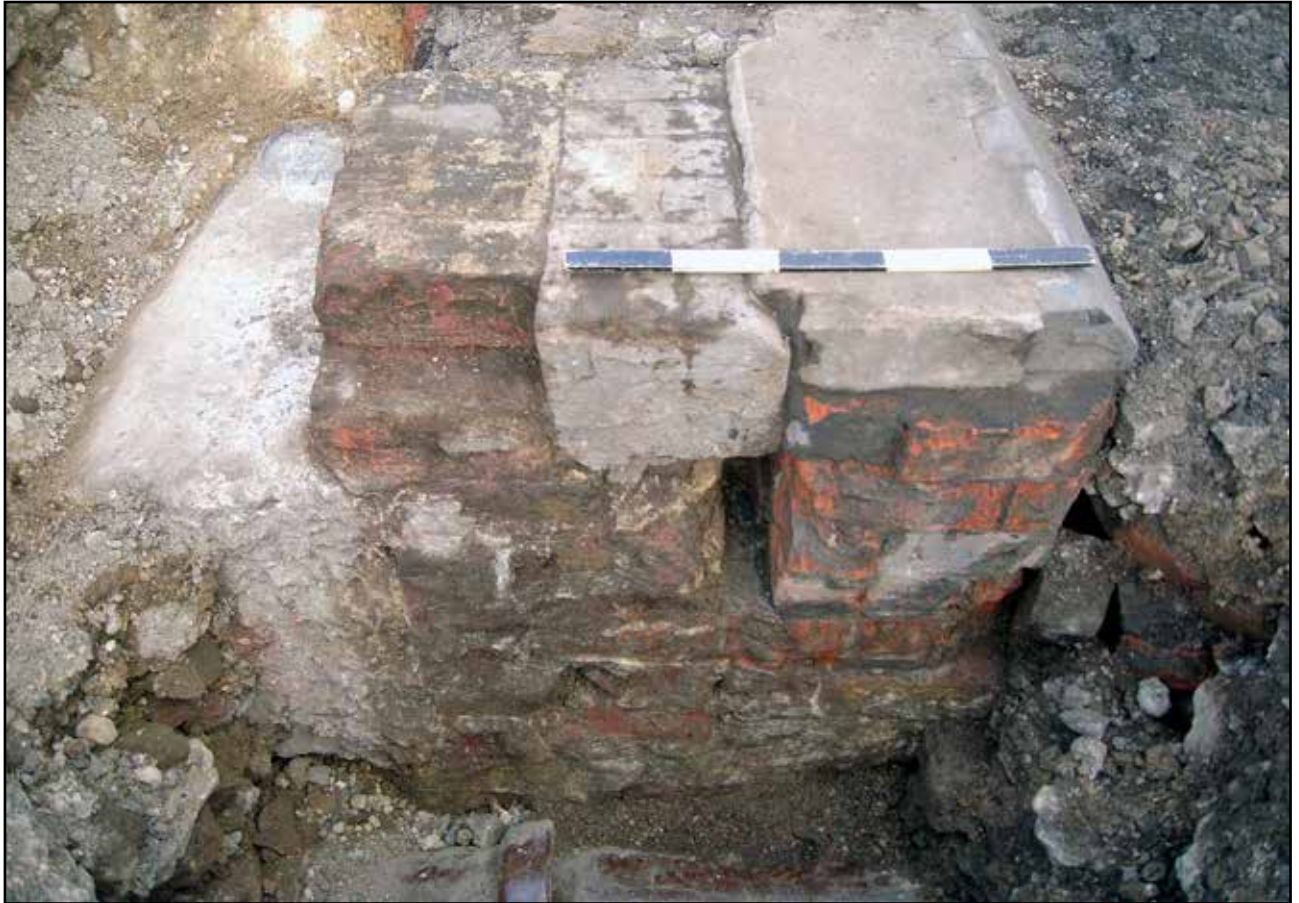
Plate 51: Section through inspection pit sidewalls the southern wall of broad gauge pit on southern sidewall of standard gauge pit

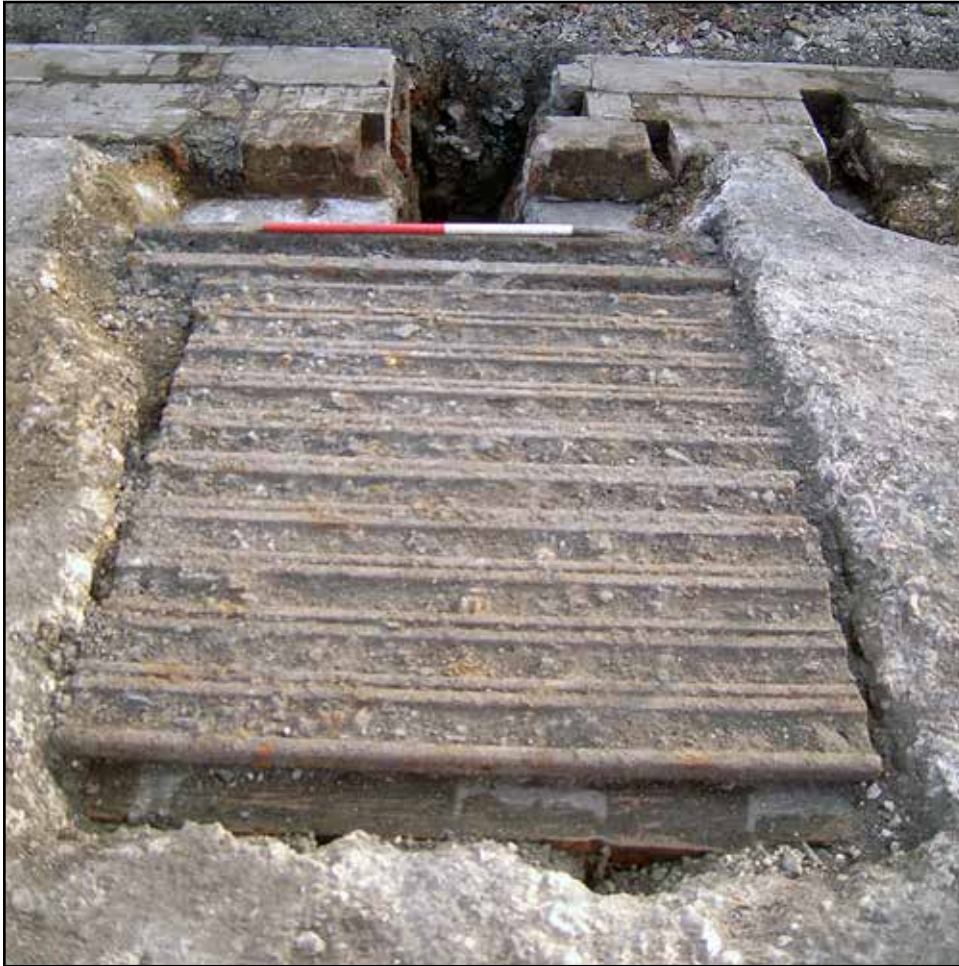
Plate 53: Access chamber [8448] into Marcon Sewer covered by sections of bridge rail [8447]

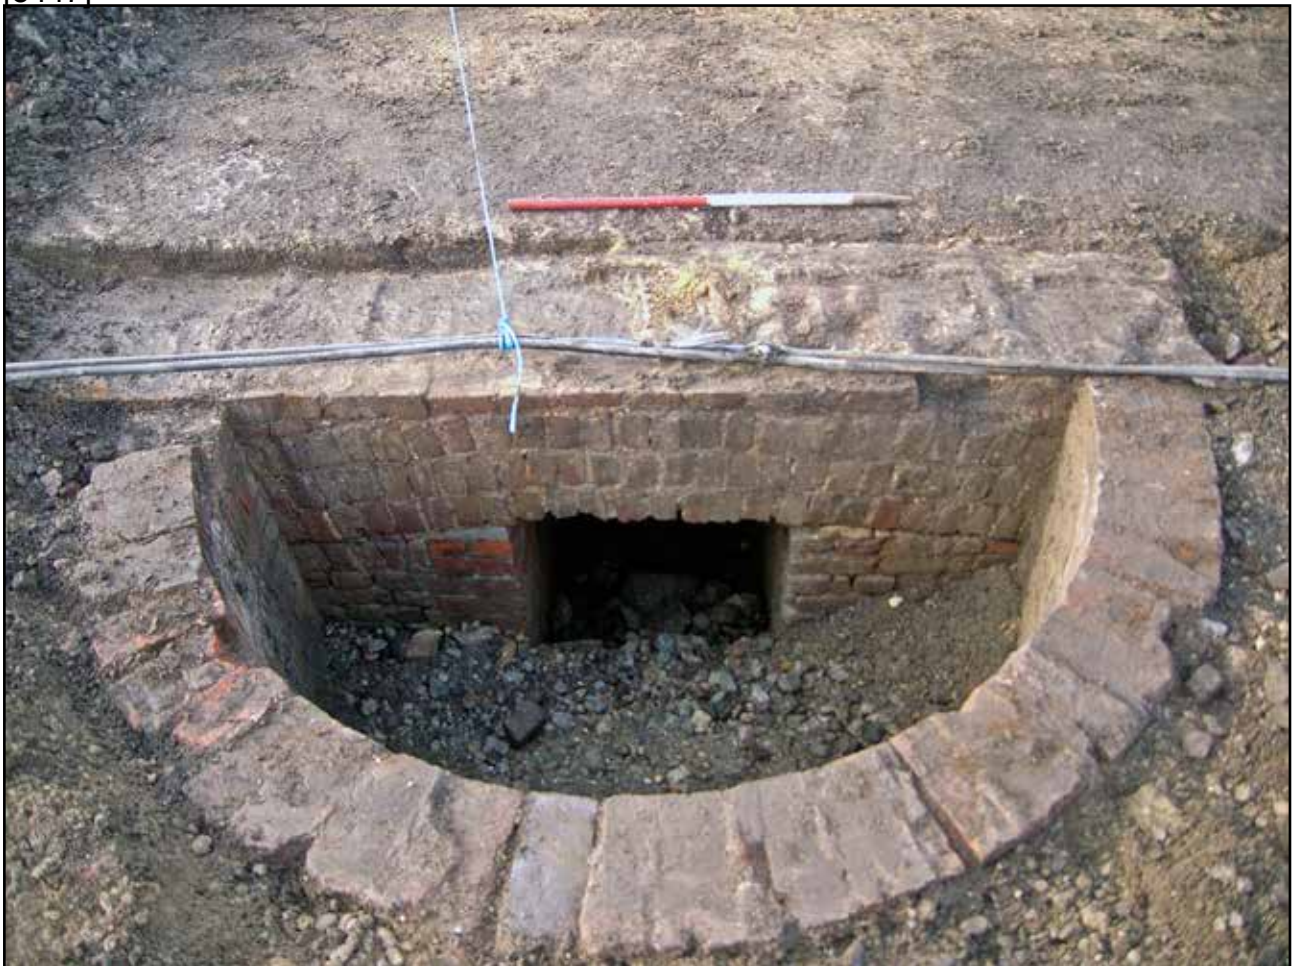
Plate 54: Semi circular inspection chamber [8854] into Marcon Sewer added to outside of northern wall of Broad gauge shed
