◀ HEALTH & SAFETY ALERT ▶

Fire Incident Involving Acetylene

Date: 27th July 2015

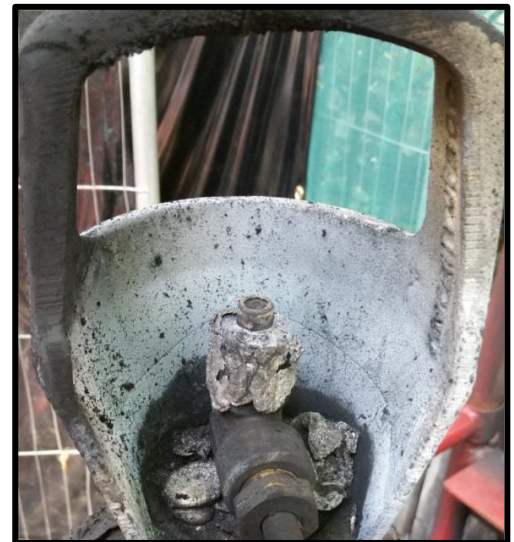
On the 2nd July 2015 at Barhale's Sussex Gardens site, an acetylene cylinder caught fire resulting in a 16 hour exclusion zone being set-up by the London Fire Brigade. To support the investigation, an independent gas safety expert was commissioned to inspect the equipment and determine the causes which led to the incident. This alert confirms lessons to be learned followed the detailed investigation.

Top of a badly burned acetylene cylinder

- Hoses should be kept to the minimum length required, coiled hoses provide extra fuel for a fire should it occur.
- Operators must follow the correct lighting-up procedure which includes purging of hoses.
- The correct hose clips should be used, as per the manufacturers' specifications.
- After connecting the equipment the operator should complete a leak test.
- Burning equipment should be:
 - Inspected every 7 days in line with PUWER 98
 - Visually inspected before use
 - Receive a functional inspection every twelve months by a competent person
 - Items such as the flashback arrestors and regulators should be replaced every 5 years.
