C131 - PADDINGTON INTEGRATED PROJECT

BUILDING RECORDING – PADDINGTON STATION MILK RAMP

Document Number: C131-MMD-T1-RAN-B071-00001

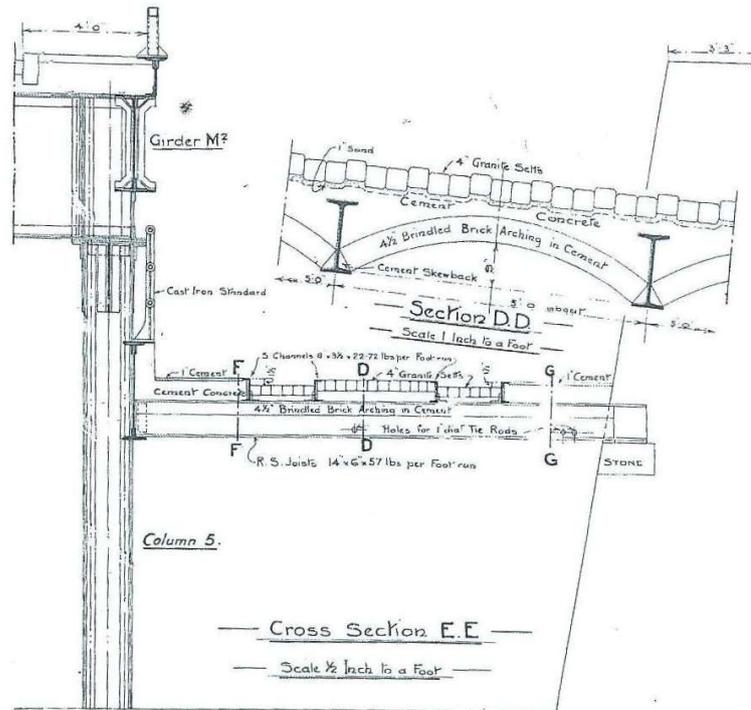
Plate E: Section through the milk ramp showing sett surface

Surface access from platform 12 was provided by a steel frame ramp, the milk ramp, which emerged along the north side of London Street at the junction with South Wharf Road. This was in-laid with channel irons to guide wagons, and a stone sett surface to provide foot-holds for horses (Matthews 1917, 175) (Plate E).

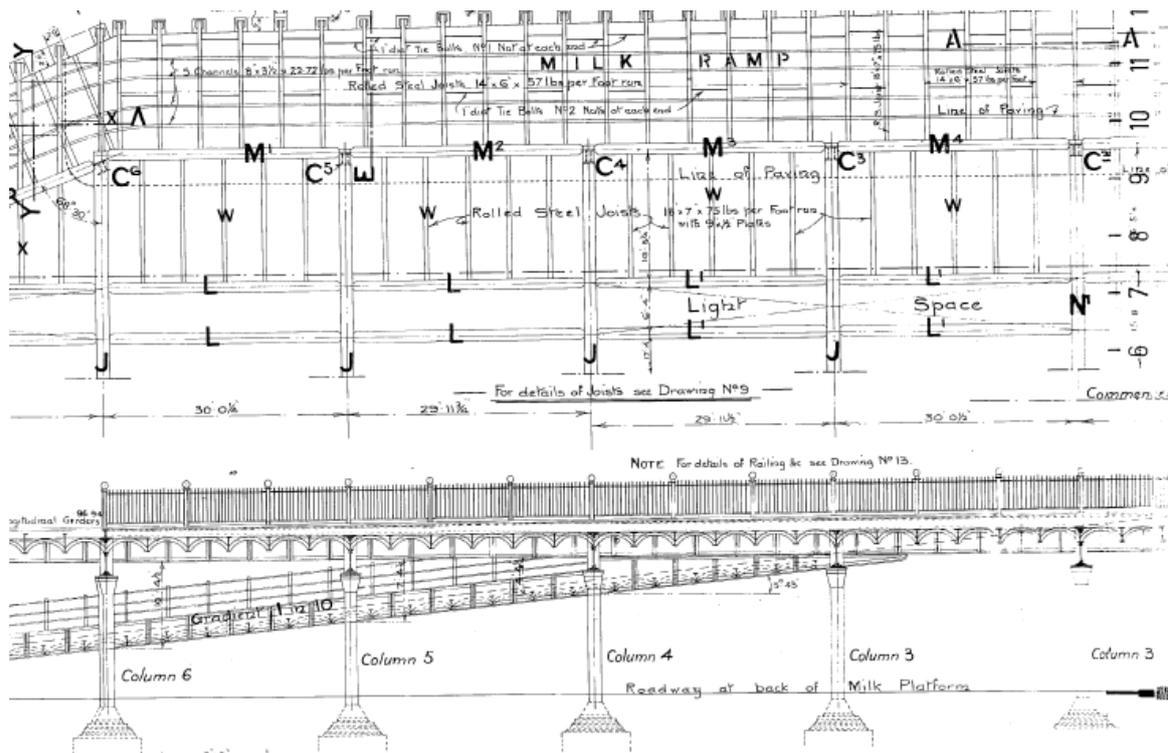
Plate F: Plan and section of London Street Deck showing milk ramp

The drawings show the road supported on a steel frame comprising longitudinal beams and cross girders with intervening brick jack arches. The whole structure was supported on a grid of steel girder stanchions. The milk ramp is a separate structure which cuts through the north side of the deck. The Contract plan of the steel frame shows a section of beams running at right-angles to the main, north-south arrangement of jack-arches, intended for the inclusion of a 'light-space', over the area adjacent to the milk-ramp (Plate F). In addition it also depicts railings at street level to enclose the void.

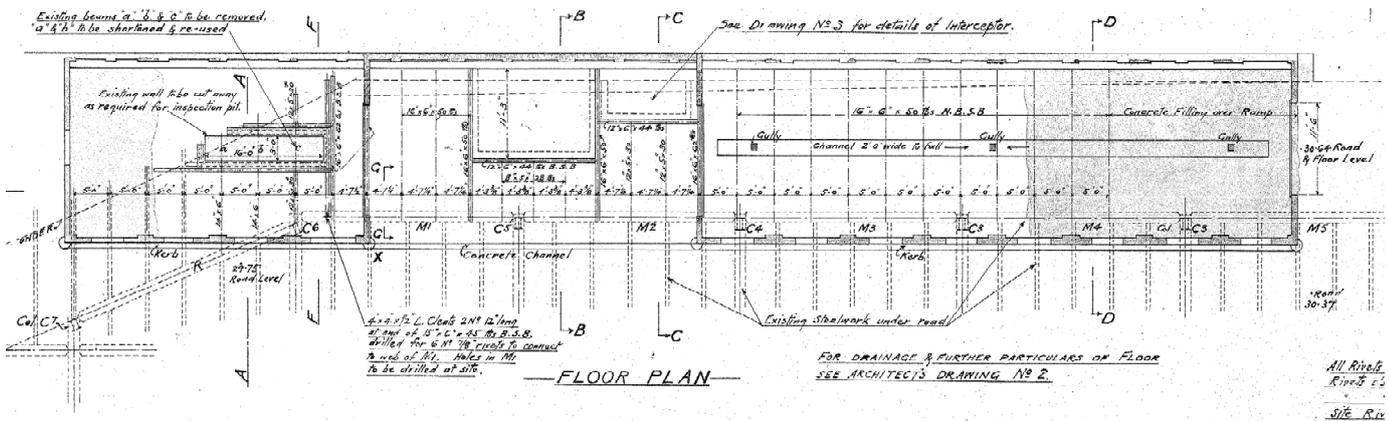
Plate J: Extract showing detail of plan of 'New Transport Service Station' including supporting structure below London Street Deck

These alterations included the siting of a petrol tank on the milk ramp, accessed from the building above via a manhole cover. This necessitated the reinforcement of the central element of the milk ramp, to support the additional loads of the tank and its contents. Similarly the guttering from the new building ran into downpipes which continued through London Street Deck and were attached to the stanchions below.

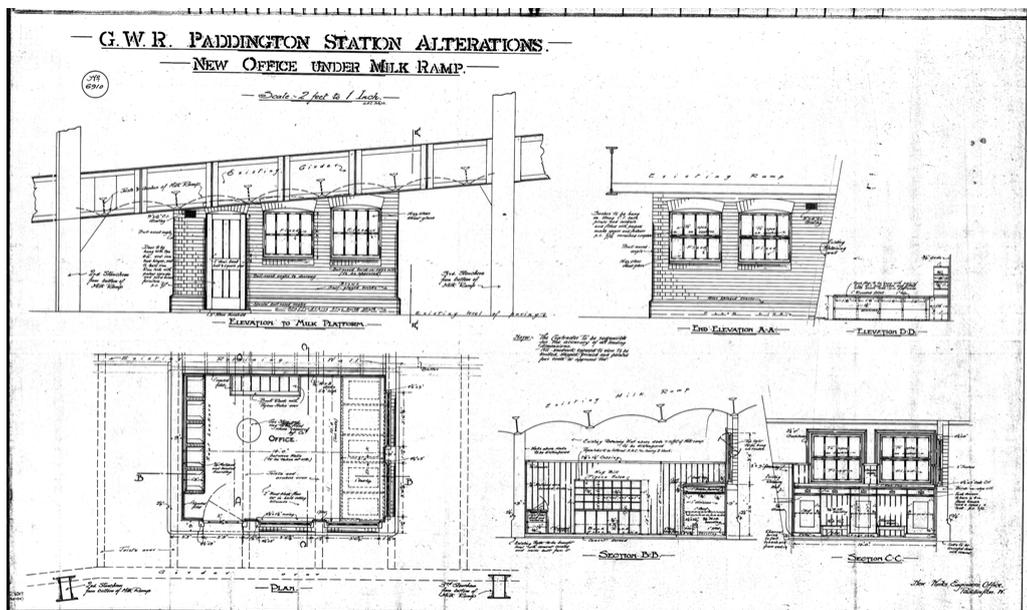
Plate K: Contract drawing for a new office below the Milk Ramp

The contract drawings also make reference to the removal of 'the existing office below ramp'. Archive drawings have been found which depict a small brick office below the Milk Ramp (Plate K); however, it is unlikely that this was ever constructed. The position marked between the second and third stanchion would not have provided adequate headroom or allowed for the architectural features depicted, even allowing for an apparent subsequent raising of the floor level. It is possible that the position was altered; however, there is no physical evidence surviving on site to suggest a brick structure was erected. Evidence of a timber office has been identified (see discussion below).

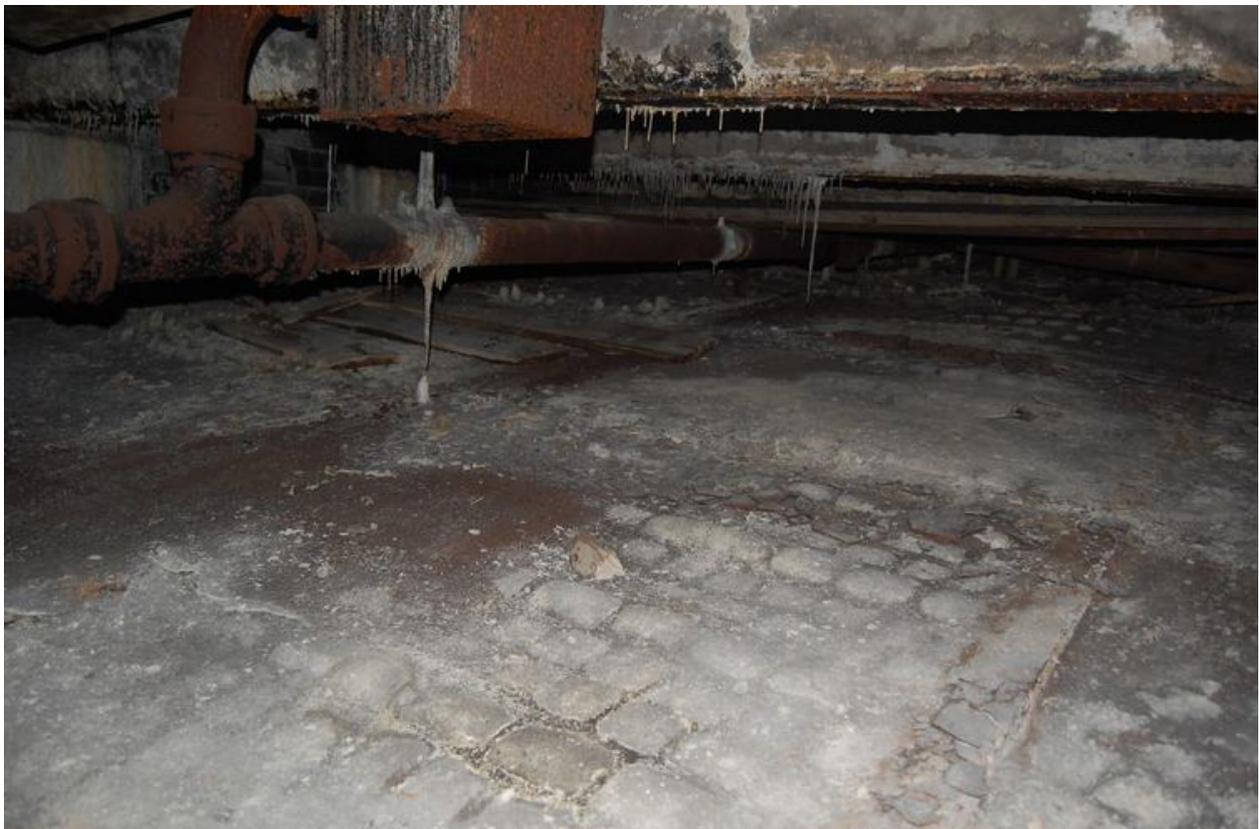
Plate 4: View south along ramp – south end showing concrete cap

The arches are seen throughout the London Street Deck; however, they were never installed above the ramp which remained an open space to allow the flow of traffic. The ceiling of this area has been infilled using narrow 'I' beams (Plate 4). These are partly encased in concrete with concrete infilling between. The brick arches appear again at the original termination of the ramp; however the area beyond stanchion S7 has been significantly altered to provide an inspection pit for the former repair works, added in the early 20th century (Plate 23). Associated with the pit is a small sump with connecting pipework continuing to the south running centrally along the ramp.

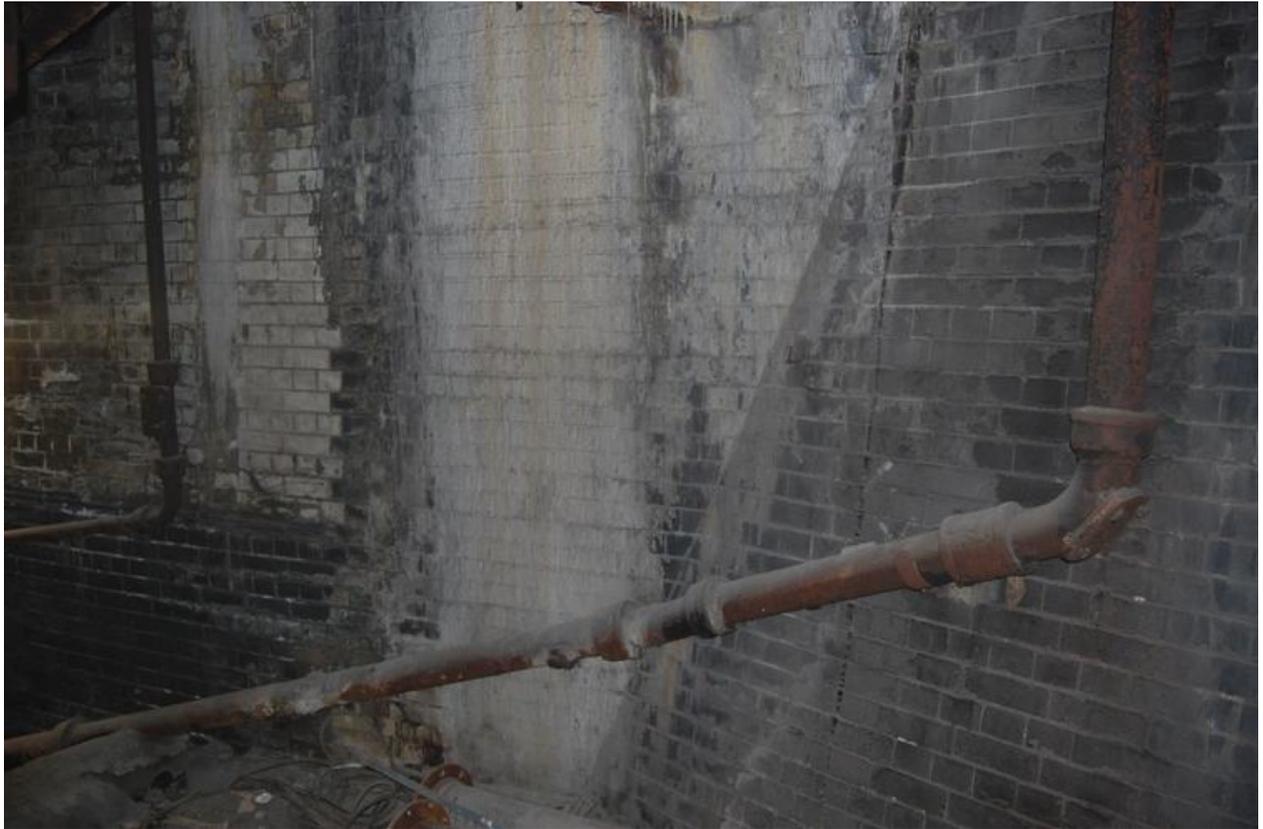
Plate 21: Detail of sett surface - edge

The ramp itself is formed by a sett surface with flanking concrete pavements, edged with iron (Plate 21). Running through the centre of the sett surface are two rails 1m apart (Plate 20). The surface is interrupted half way along by a large metal petrol tank with adjacent brick interceptor added in the 1930s (Plate 1). Running adjacent to this is a large iron pipe, a continuation of that associated with the inspection pit. Also extant on the ramp is the remains of a former stanchion, situated adjacent to the western edge (Plates 11 and 12). This is formed from two inverted gusted plates encasing a squared timber column which has been cut off at the height of the plate. The function of the column is unclear and there are no other structural elements associated with it.

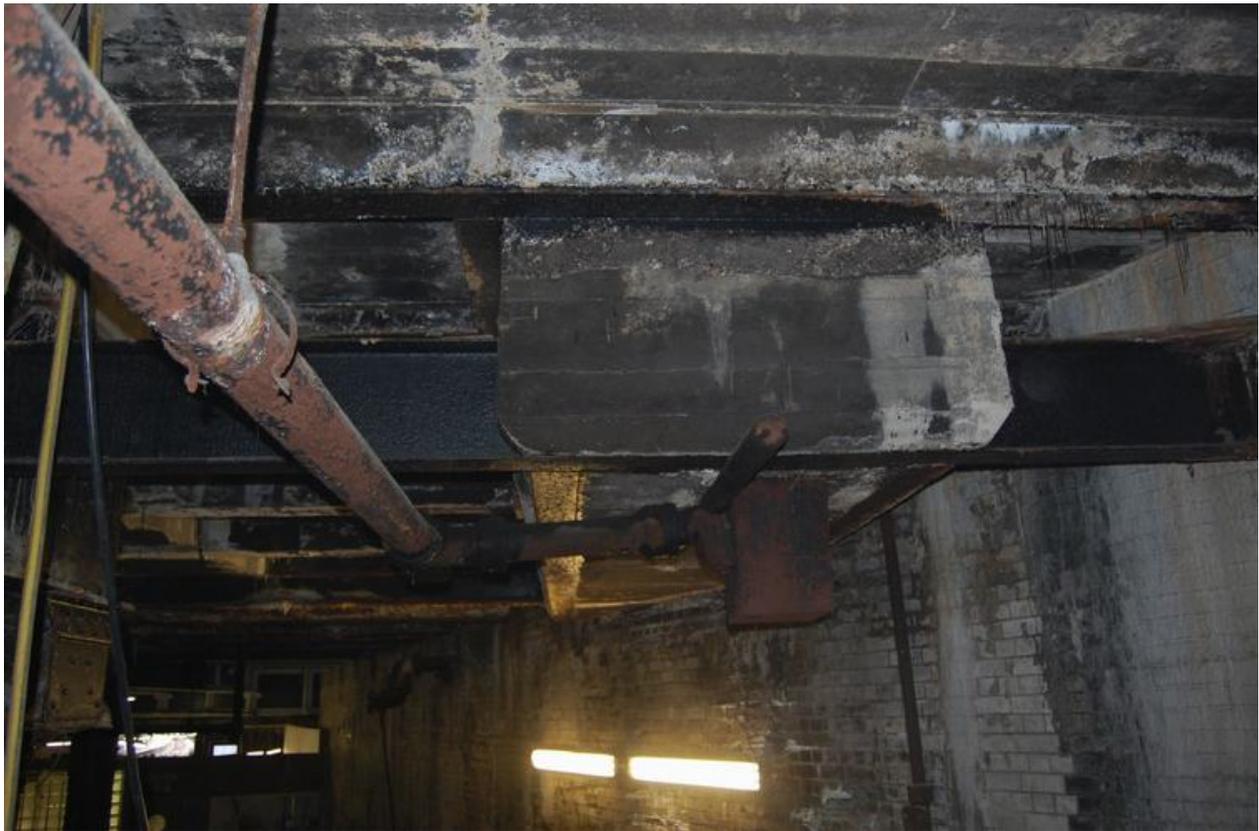
Plate 23: Detail of inserted inspection pit

The infilling of the space has had a significant impact on the historic fabric of the ramp. Much of the ceiling has been infilled with concrete, obscuring the structural elements. The introduction of the inspection pit has caused considerable disruption with the breaking through of the retaining wall. However, the most substantial damage has been caused by the insertion of the petrol tank and interceptor which necessitated the removal of both the sett surface and the brick jack arches.

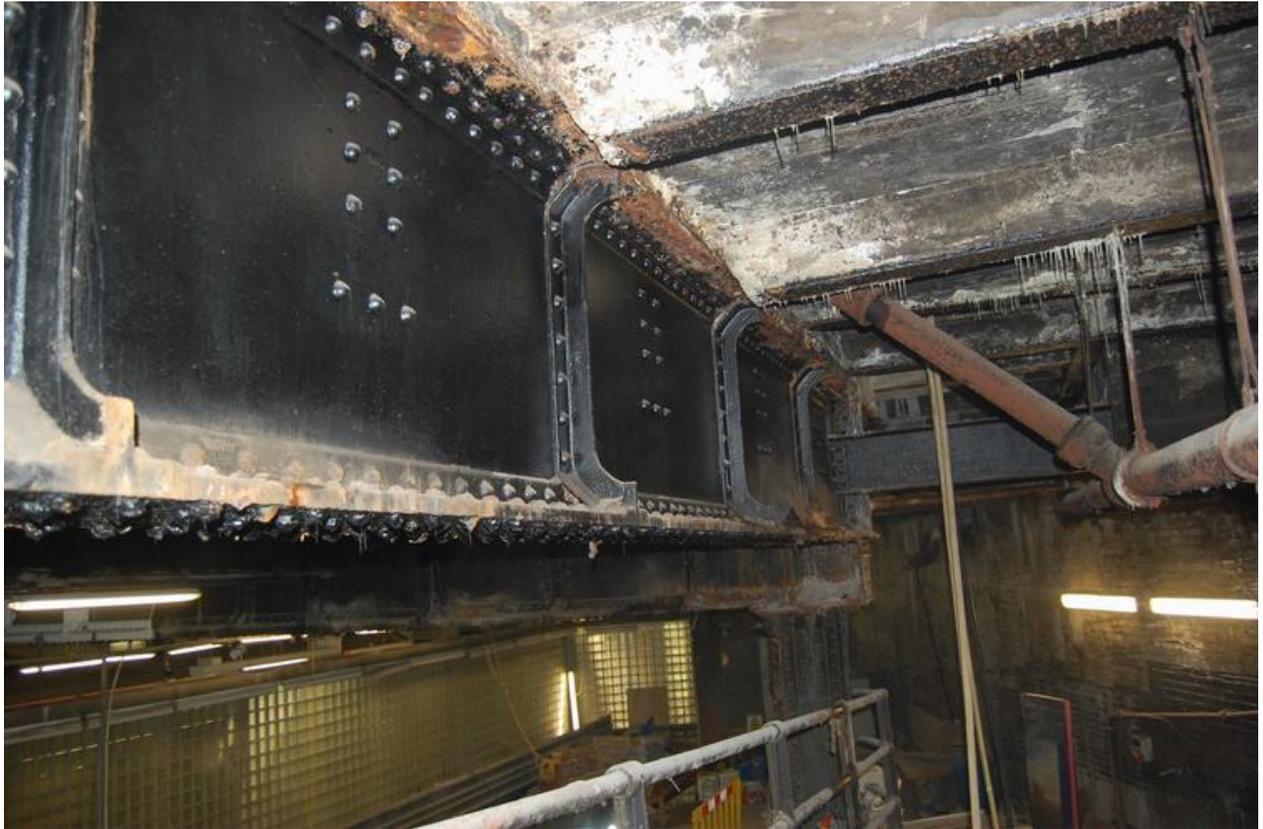
Plate 25: detail of concrete reinforcement of jack arches over ramp

Girder G2 represents an 'I' beam braced by a series of flange plates (Plate 26). The base of the 'I' is formed by a series of overlapping plates riveted to the upright. Projecting at regular intervals are a series of perpendicular RSJs, attached by means of short brackets riveted in place (Plate 15). These form the basis of the jack arches which extend to the east. To the north, where they extend over the ramp, the jack arches have been replaced with concrete (Plate 25).

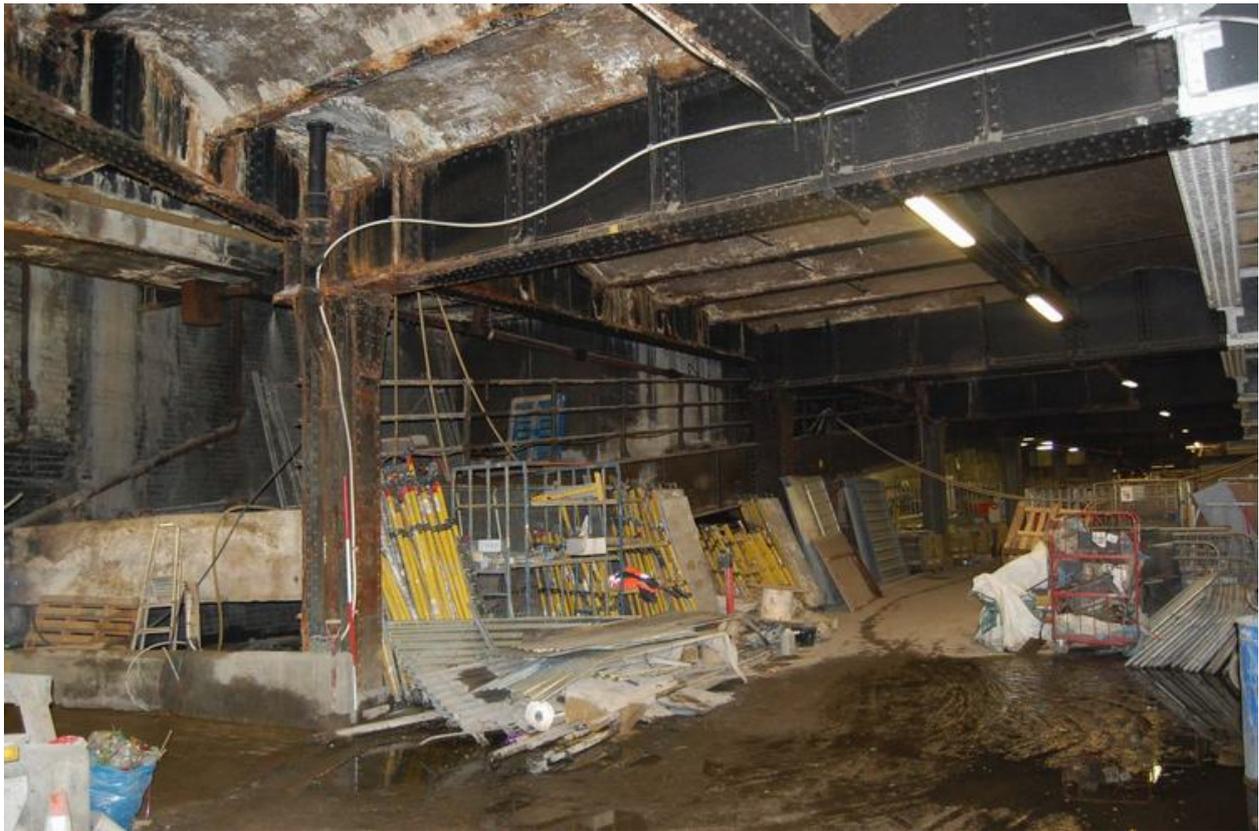
Plate 32 – general view of ramp from southeast

The milk ramp comprises a short ramp following the eastern boundary of the station (Plate 32). It rises to the south, being closed off at street level and truncated to the north to form a floating surface. The ramp is constructed on a simple grid with short east-west girders supported on a large north-south girder to the west and brick retaining wall to the east (Plate 45).

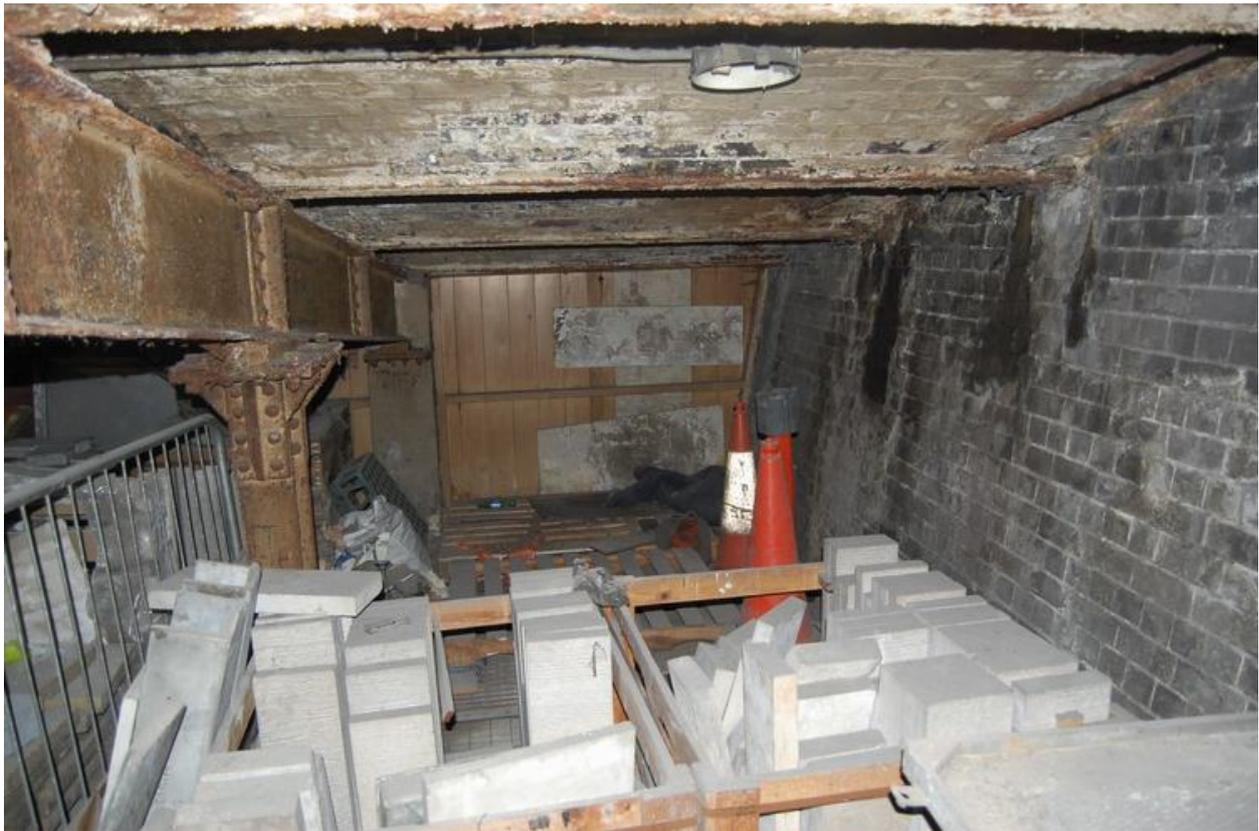
Plate 55: Angle-poise lamp within office

Below the ramp, the area is defined by a concrete floor surface with the brick jack arches above. One feature of note is an additional iron beam inserted to support the petrol tank. This represents a simple girder with regular brace plates corresponding to the RSJs of the jack arches (Plate 50). The girder is supported on stanchions of decreasing height as they follow the slope of the ramp. The stanchions are simple RSJs with gusseted plates affixed with rivets (Plate 52). That to the north has subsequently been encased in concrete (Plate 61). Flanking the area are inserted timber partitions creating a small office space (Plate 56). This function is suggested by a surviving angle-poise lamp located on the south internal elevation (Plate 55).

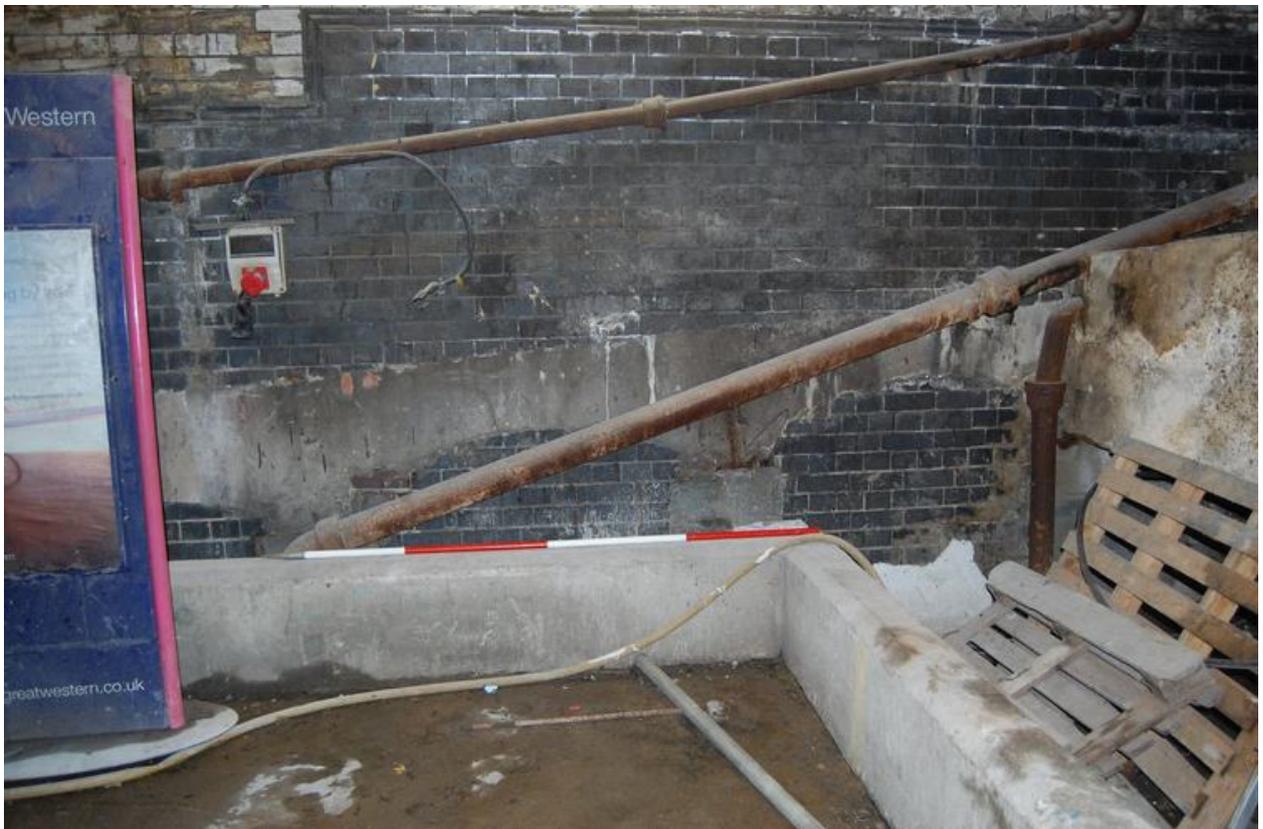
Plate 65: Detail of scar for continuation of ramp

Creating the eastern elevation of the office is the brick retaining wall which continues across the London Street Deck. Within the area of the milk ramp the wall is constructed from blue brick and slopes out towards the base (Plate 22). Below the ramp, the RSJ padstones are visible with the joists themselves continuing into the wall (Plate 49). To the north the wall angles to follow the alignment of the former ramp extension. Within this area the construction changes with glazed white tile to the upper levels to provide reflected light to the platform (Plate 68). The blue brick continues below in a stepped pattern to follow the slope of the ramp. Within this area is surviving evidence of the ramp itself with concrete infill highlighting the position of the ramp surface and a further five jack arches, including the padstones (Plate 65). In some cases the cut off ends of the RSJs are visible.

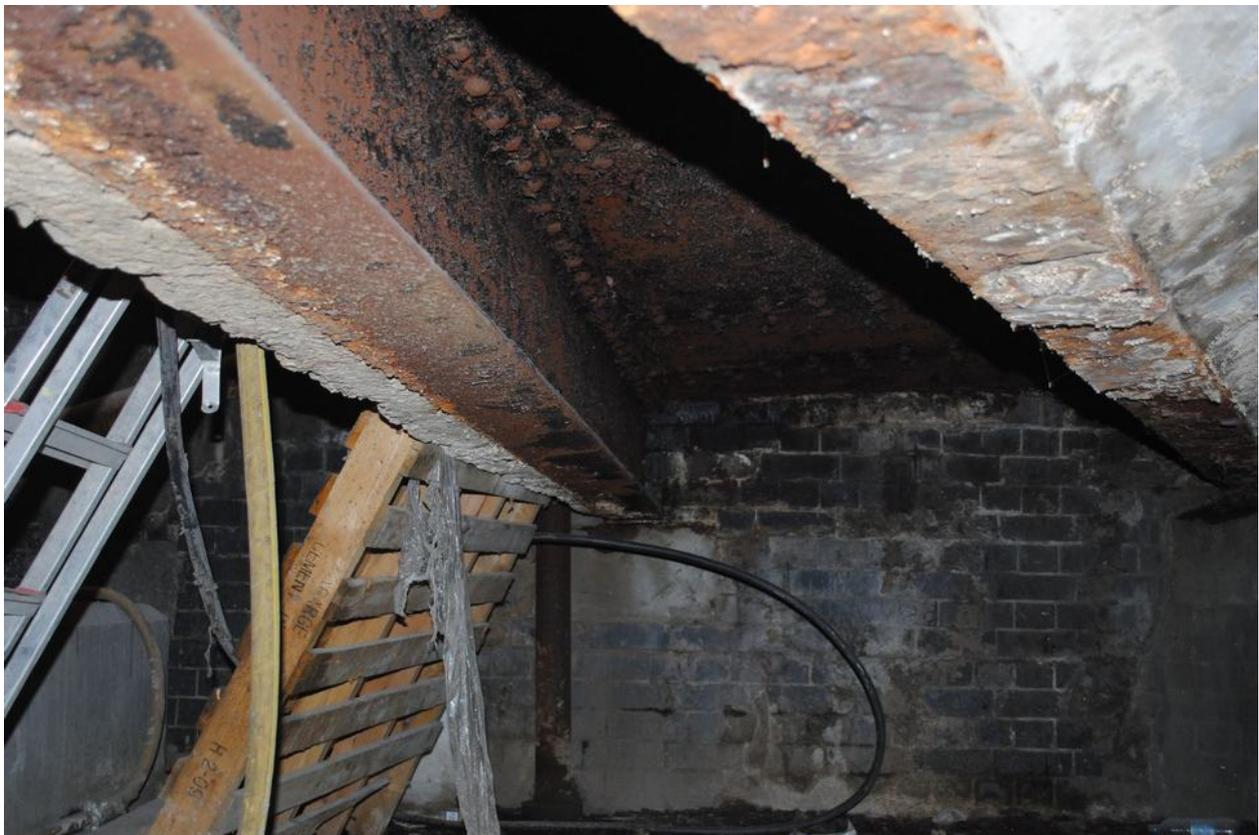
Plate 75: Underside of ramp showing change in angle

Girders G3 and G4 form the milk ramp proper. The connection between G2 and G3 is created by a series of rivets with both girders supported on stanchion S4, in contrast to the rest of the stanchions which only provide support to G2 (Plate 46). G3 and G4 represent a continual structural element, both tied into Stanchion S5 (Plate 47). Girder G3 forms a single element deepening to the north to follow the slope of the ramp (Plate 72). G4, in contrast, represents a simple 'I' shaped girder set at an angle (Plate 78). Running off from G3 and G4 are a series of RSJs. These are connected to the main girder by a small narrow 'L-plate', visible in the west elevation (Plate 76). The RSJs provide support to the brick jack arches which run under the ramp, continuing into the retaining wall to the east where they sit upon an embedded padstone (Plate 66). Variation exists at the northern end of the ramp where it turns towards the northwest. The change in angle is created by a steel plate flanked by horizontal RSJs (Plate 75).
