C254 Archaeology West
Building Recording at No 5a Great Chapel Street,
Tottenham Court Road Station
Event Code XRY10
CRL Document Number: C254-OXF-T1-RGN-CRG03-50135

A rapid programme of building recording has been undertaken at No 5a Great Chapel Street in Soho, London prior to its demolition as part of the redevelopment of Tottenham Court Road Station for Crossrail.

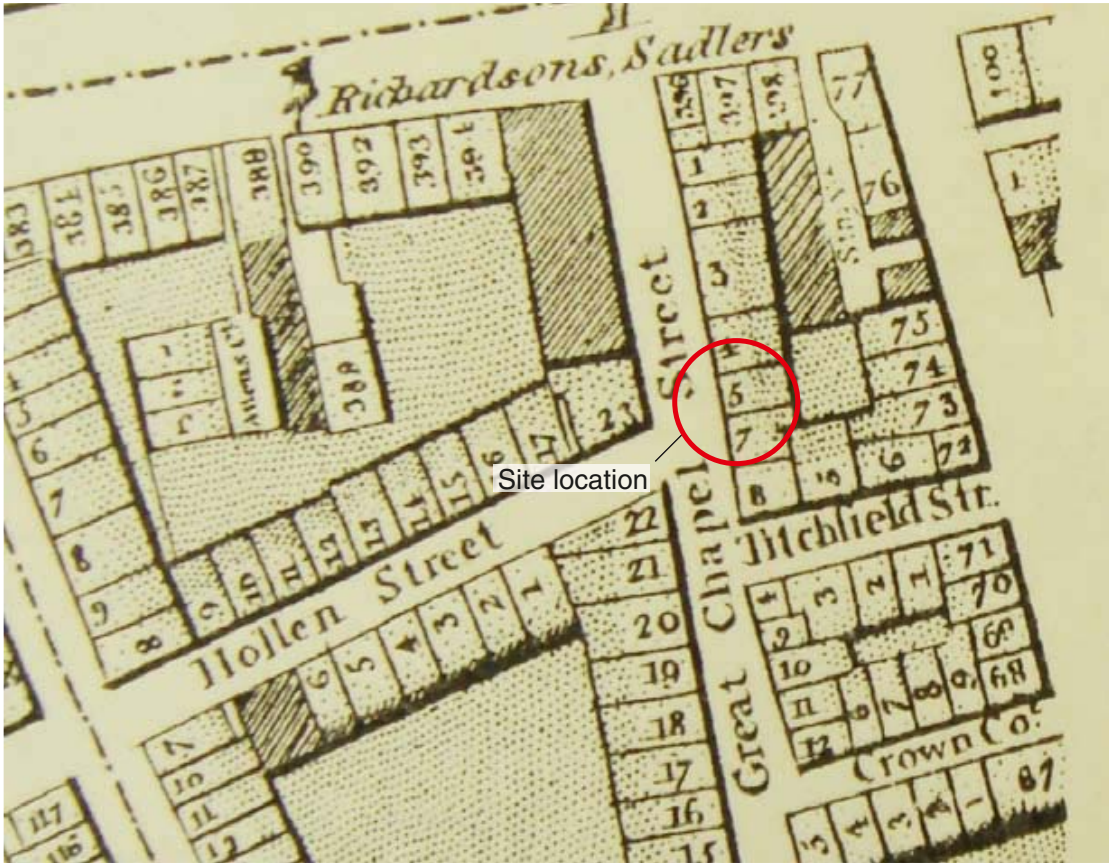
Figure 3: Horwood's plan of 1792

- 2.1.9 ***Evidence relating to Number 5a Great Chapel Street:*** Number 5a Great Chapel Street is shown on Horwood's map dated 1792 and it is also shown on the 1870 OS map with a similar footprint to that which survived into the 21st century.

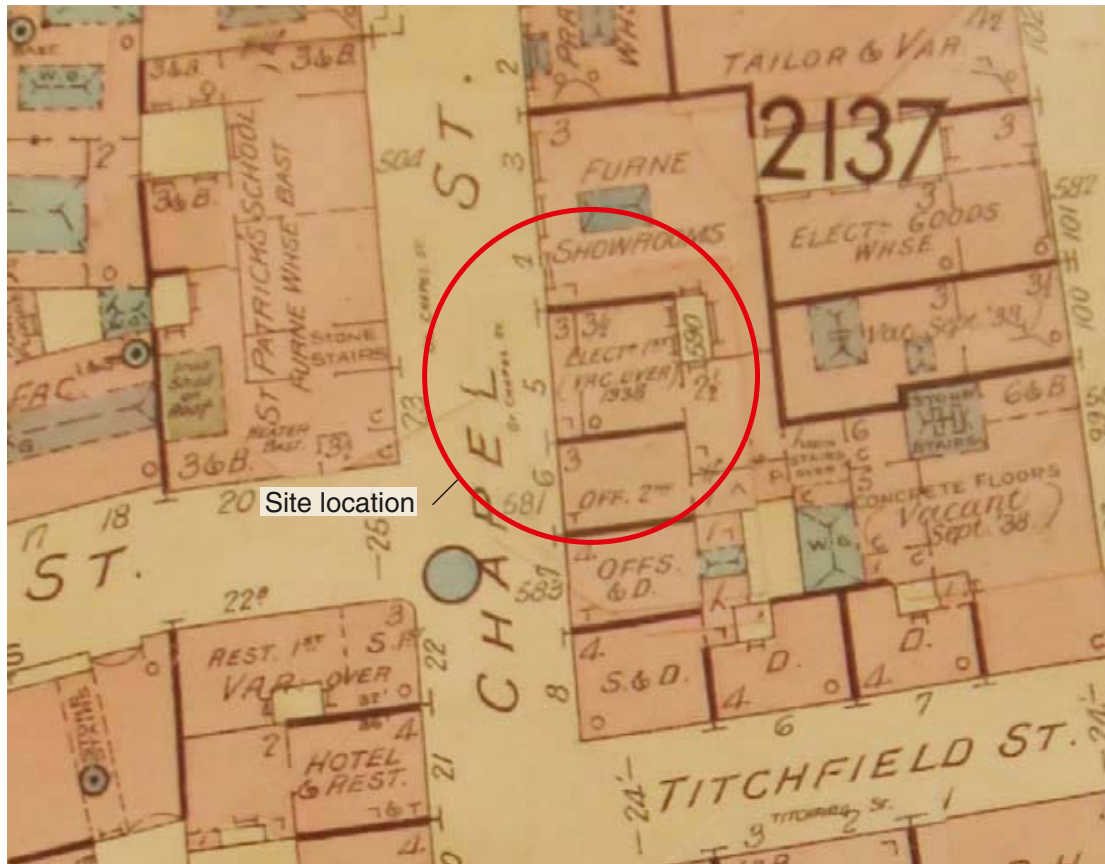
Figure 4: Goad's Insurance plan of 1938

- 2.1.11 Goad's Fire Insurance Map of 1938 suggests that there was an electrician based on the first floor of the building and that there was an extension to the rear with two and a half storeys (presumably two storeys and an attic). The main roof was identified as being clad in slate and the building was three and a half storeys tall. The map also shows 'VAC over' labelled on 5a Great Chapel Street but it is unclear to what this refers.

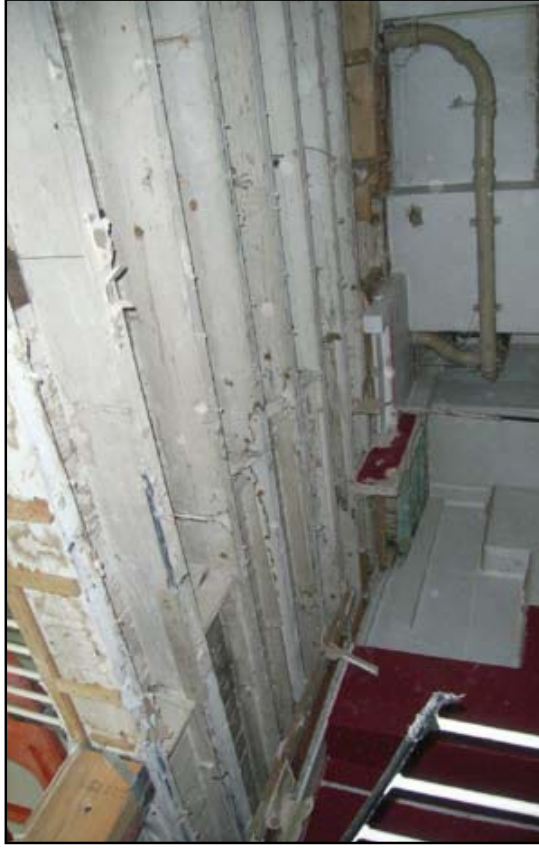
3.2.16 The Basement extended across the northern two-thirds of 5a Great Chapel Street rather than the full footprint and it is interesting to note that in this area the joists were painted and visible from beneath rather than being hidden by a ceiling as on the other floors. The joists appear to be of the same date as the rest of the building however and incorporate similar scissors struts. The basement had plastered walls, painted red and no surviving features of interest.

Plate 1: Basement of 5 Great Chapel Street

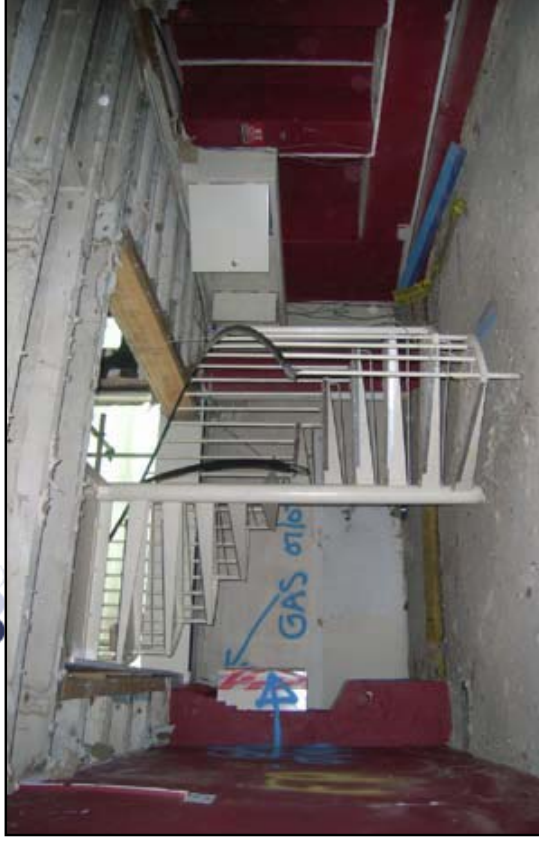
3.2.14 The basement was accessed by a modern spiral staircase located towards the front of the building.

Plate 2: Basement showing secondary spiral staircase

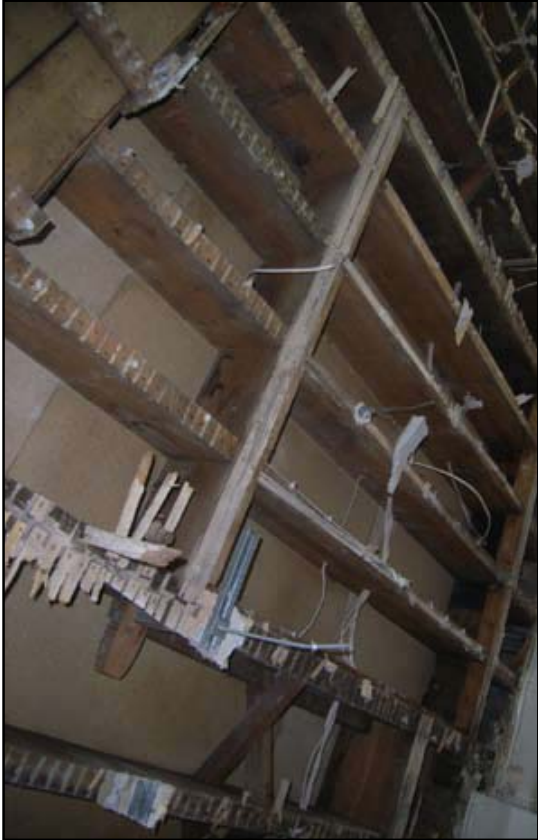
- 3.2.3 There is evidence of a hatch at each floor level, towards the south-west corner of the building, which would have allowed vertical movement of goods/materials through the building (possibly the building materials dealer referred to above, listed here in 1895). This evidence comprises trimmers and distinct areas (c.1.5 m²) of slightly later joists without lath marks to their underside, within the area of the former hatch. There is a full line of scissors struts in the northern half of the building and a half line in the southern half interrupted by the hatch.

Plate 5: Underside of former hatch in floor joists

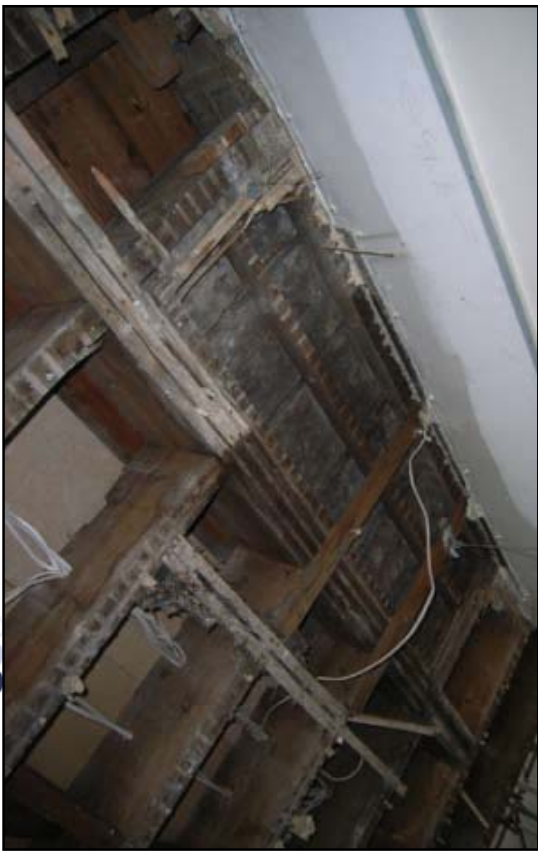
Plate 6: Underside of hearth in floor

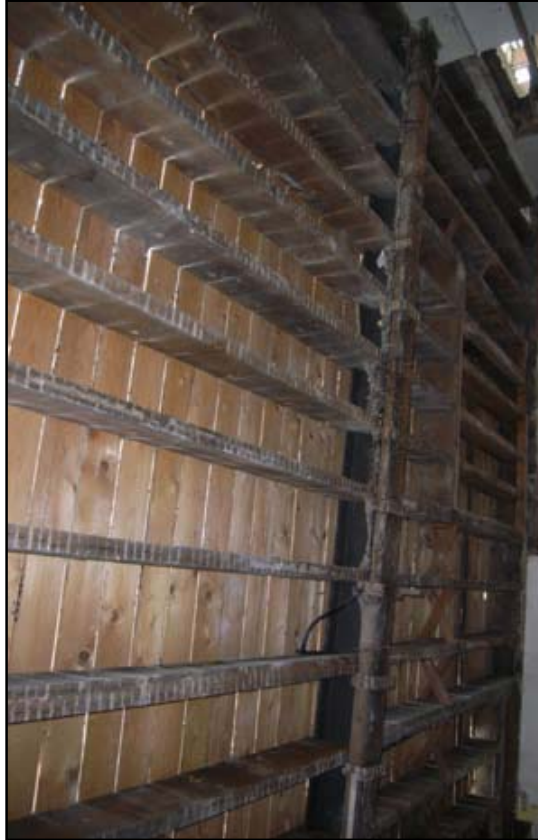
- 3.2.2 The building had a rectangular plan, c.7 m wide (E-W; inner wall to inner wall) and the general layout was similar on each of the floors as well as with very similar floor construction visible from the underside. Each floor appears to have been very similar at first, second and third floors comprising tall joists of probable late 19th-century date, braced by scissors struts and with lath and plaster ceiling but no evidence of paintwork to the sides of the joists. The lack of paint to the joists is in contrast to adjacent buildings and it confirms that in 5a Great Chapel Street these joists would always have been hidden behind the joists.

Plate 7: General view of exposed floor joists

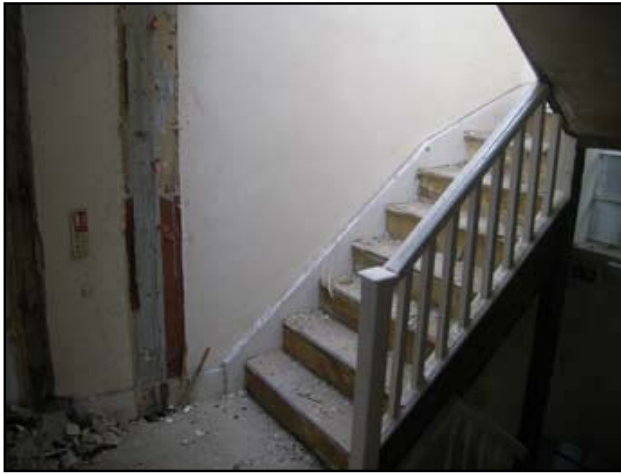
Plate 9: Plainer stairs rising up to 3rd floor

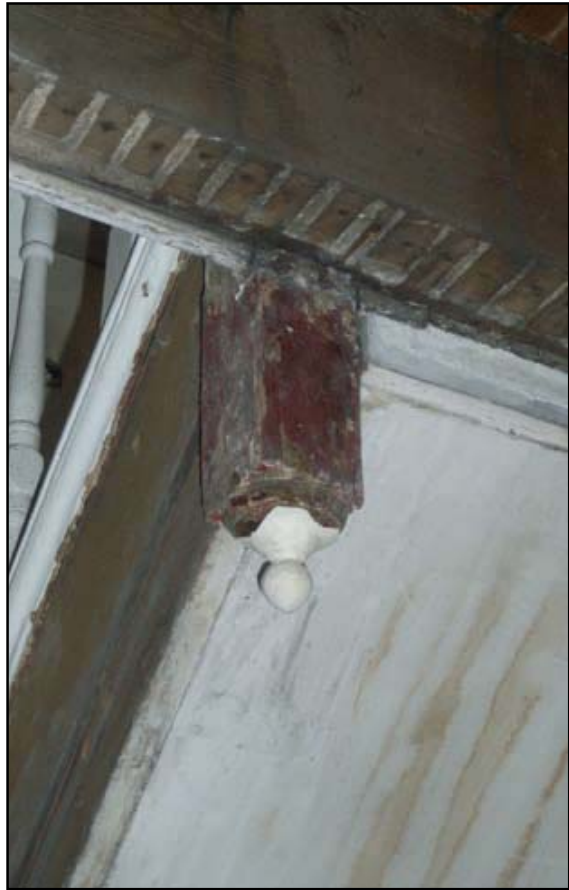
Plate 10: Drop detail to underside of stair post

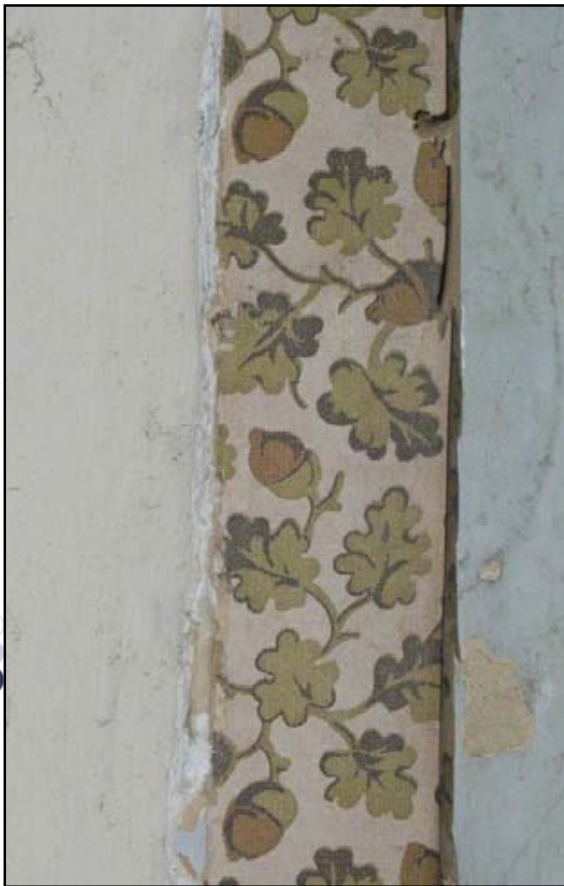
3.2.12 Another interesting feature exposed by the works include fragments of an attractive floral wallpaper (acorns and oak leaves; see Plate 13), exposed by the removal of later abutting features (probably boxing to hide pipes/cables), at ground, first and second floor levels within the hall adjacent to the stairs. There is no evidence of the wallpaper continuing up to third floor which may again be evidence of the upper storey's relatively low status. The wall paper is more suggestive of a 19th-century date than a 20th century one or an 18th-century one and it is likely that it was part of an early decorative scheme after the major reconstruction of the building, probably undertaken in the later 19th century. The plaster on which the paper is set is contemporary with the reconstruction.

Plate 13: Exposed floor fragment of wallpaper where stair partition removed

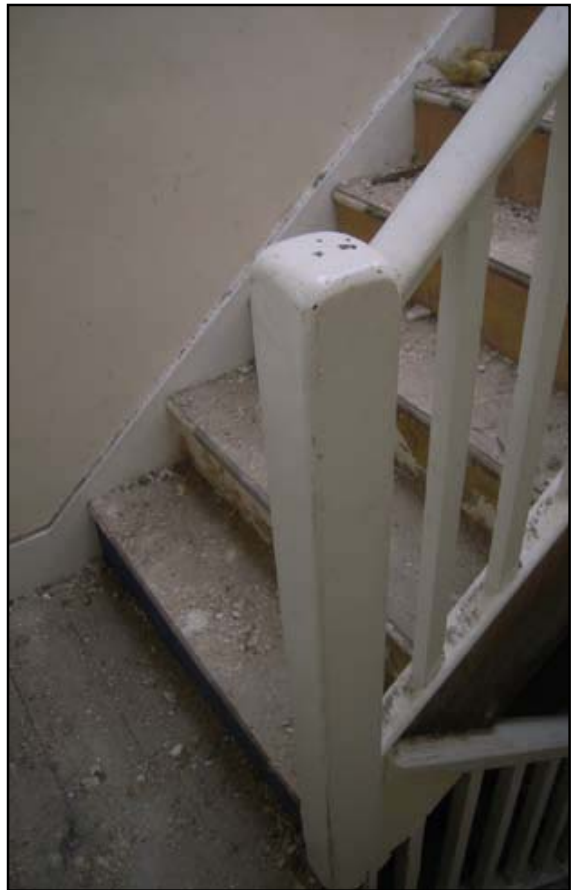
3.2.10 The uppermost section of the staircase (up to 3rd floor) was plainer than the staircase below, presumably reflecting the lower status of the rooms in the upper part of the house (Plate 16). At this level the balusters had a square section unlike the turned balusters in the lower flights and it had a slightly smaller handrail although the whole structure appears integral and primary.

Plate 16: Plainer stairs rising towards 3rd floor

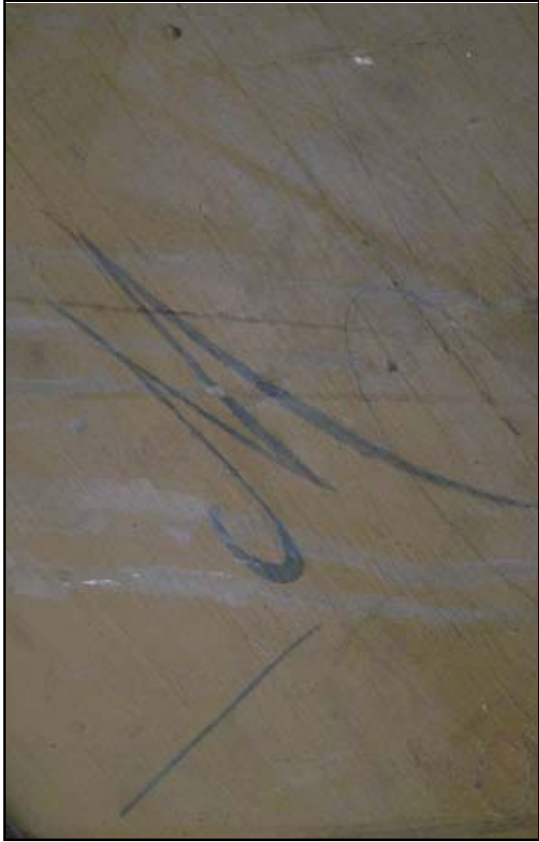
3.2.11 There was also an attractive and distinctive 'M' written on the uppermost side rail (Plate 17-18). This had been exposed by the removal of a covering board and it had an elaborate form with curled flourishes. The structural rail would have been behind a facing board and the letter would almost certainly never have been visible so it may well be that this 'M' is the initial of the original carpenter who wanted to add his signature.

Plate 17: Initial uncovered on board to side of stairs

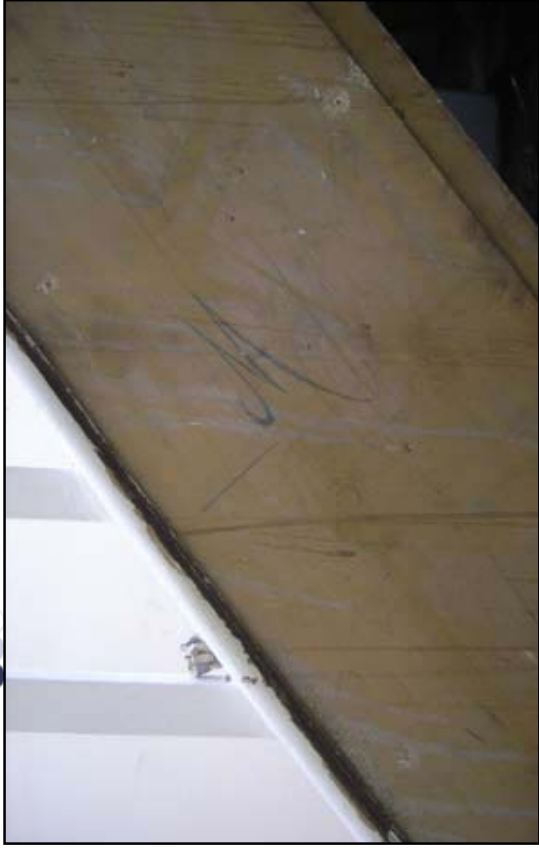
Plate 18: Initial uncovered on board to side of stairs
