Crossrail Archaeology Framework

**C254 – Archaeology West**  
**Archaeological Works at Paddington**  
**Building Recording - Paddington Station Milk Ramp**  
**CRL Document Number: C254-OXF-T1-RGN-CRG03-50215rev3**  
**Contract MDL reference CXX.XXX**

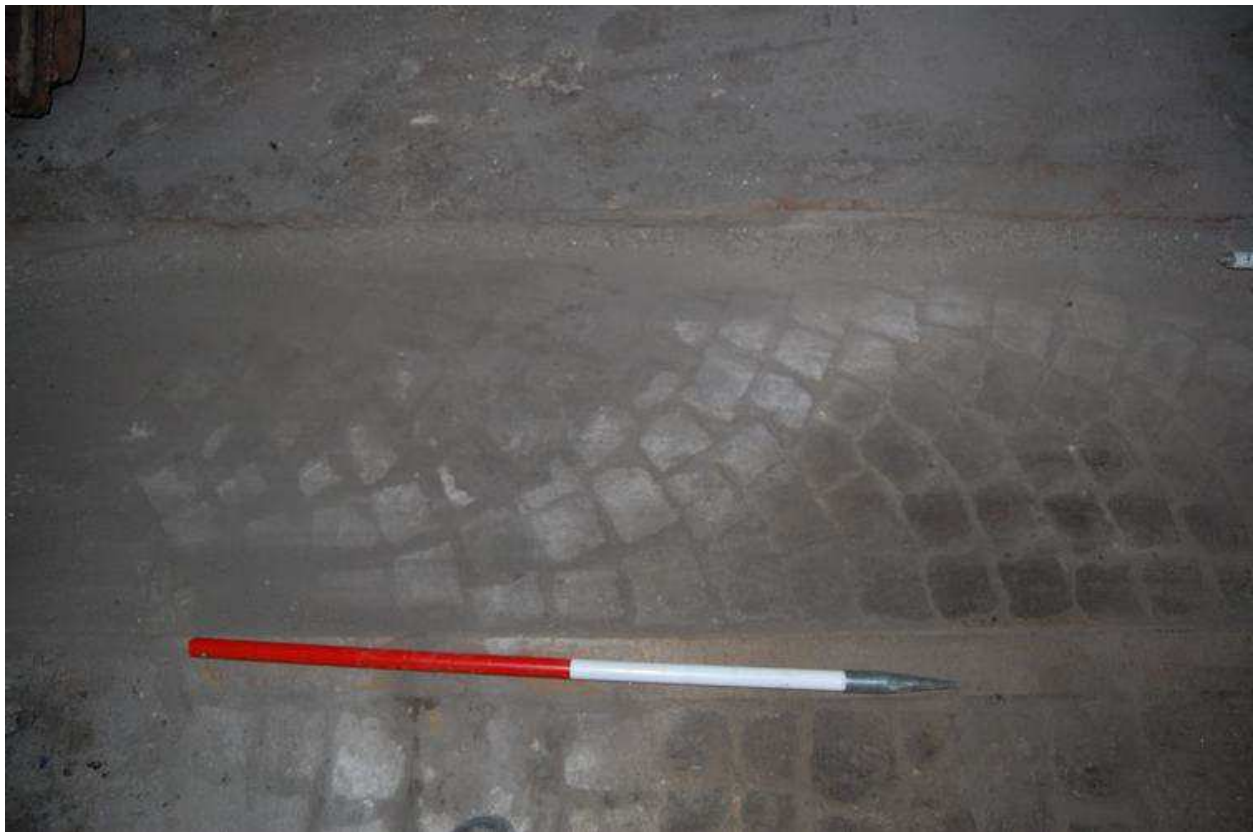
**Plate 21: Detail of sett surface - edge**

- 1.8.8 The ramp itself is formed by a sett surface with flanking concrete pavements, edged with iron (Plate 21). Running through the centre of the sett surface are two rails 1m apart (Plate 20). The surface is interrupted half way along by a large metal petrol tank with adjacent brick interceptor added in the 1930s (Plate 1). Running adjacent to this is a large iron pipe, a continuation of that associated with the inspection pit. Also extant on the ramp is the remains of a former stanchion, situated adjacent to the western edge (Plates 11 and 12). This is formed from two inverted gusted plates encasing a squared timber column which has been cut off at the height of the plate. The function of the column is unclear and there are no other structural elements associated with it.

- 1.11.17 The surface of the Milk Ramp was largely formed from squared granite setts, smaller and quite different to those of the main road surface above<sup>1</sup>. The setts on the Milk Ramp are bedded directly onto a concrete foundation set on the east-to-west RSJs and brick jack-arches. The east-to-west RSJs were riveted to the main north-to-south girder. The cobbles in the central 'spine' of the ramp were laid in clear east-to-west rows, with every third row across the ramp slightly raised (by c.5 cm), and these would have helped give footholds for the horses climbing the ramp (Pl. 14, 15, 18 and Fig 1). Either side of this there were two further long strips up the ramp where the cobbles were set in slightly irregular concentric rings (Pl. 13, 16) and clearly these strips were for the wheels of the wagons (or drays). The pattern of setts in these areas would have allowed for a smoother surface for the wagon wheels rather than the central walkway for the horses. To either side of these strips were smooth, slightly raised concrete pavements along either edge of the ramp.

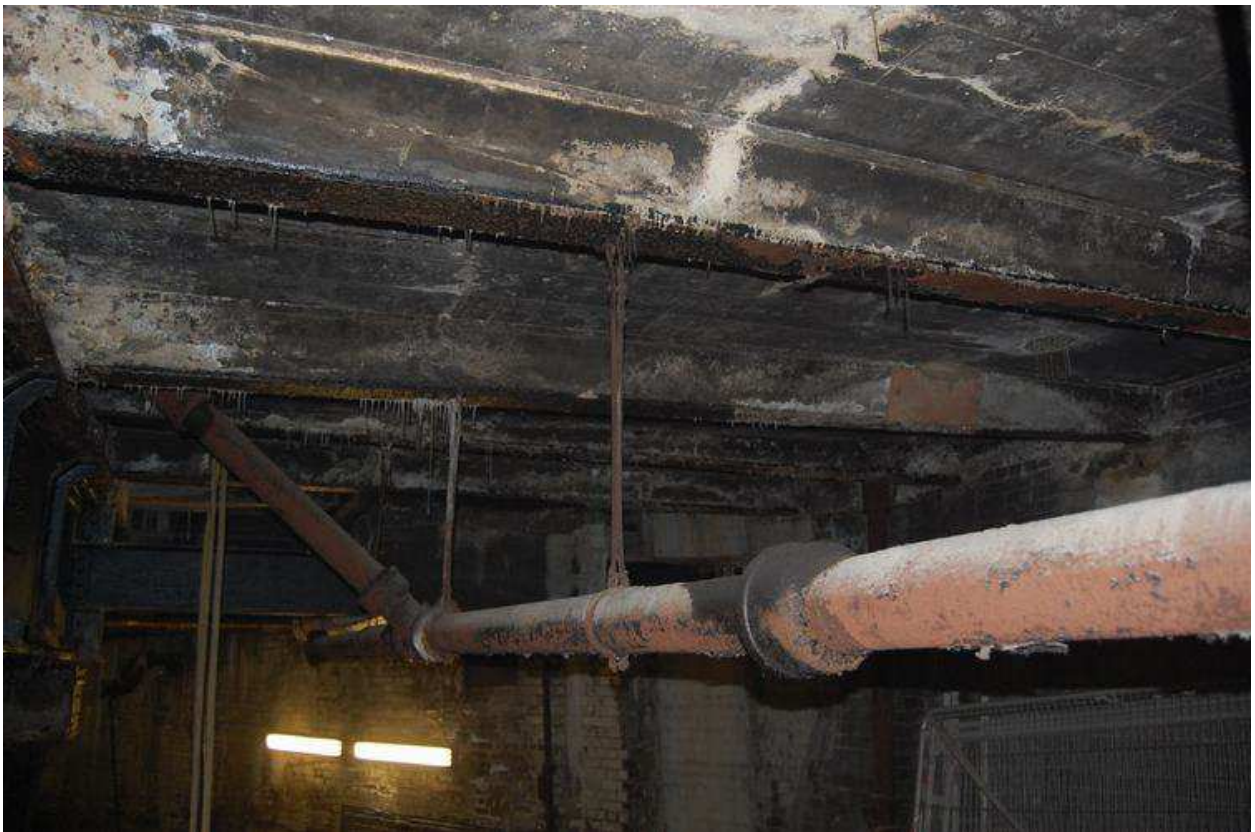
**Plate 25: detail of concrete reinforcement of jack arches over ramp**

1.8.3 Girder G2 represents an 'I' beam braced by a series of flange plates (Plate 26). The base of the 'I' is formed by a series of overlapping plates riveted to the upright. Projecting at regular intervals are a series of perpendicular RSJs, attached by means of short brackets riveted in place (Plate 15). These form the basis of the jack arches which extend to the east. To the north, where they extend over the ramp, the jack arches have been replaced with concrete (Plate 25).

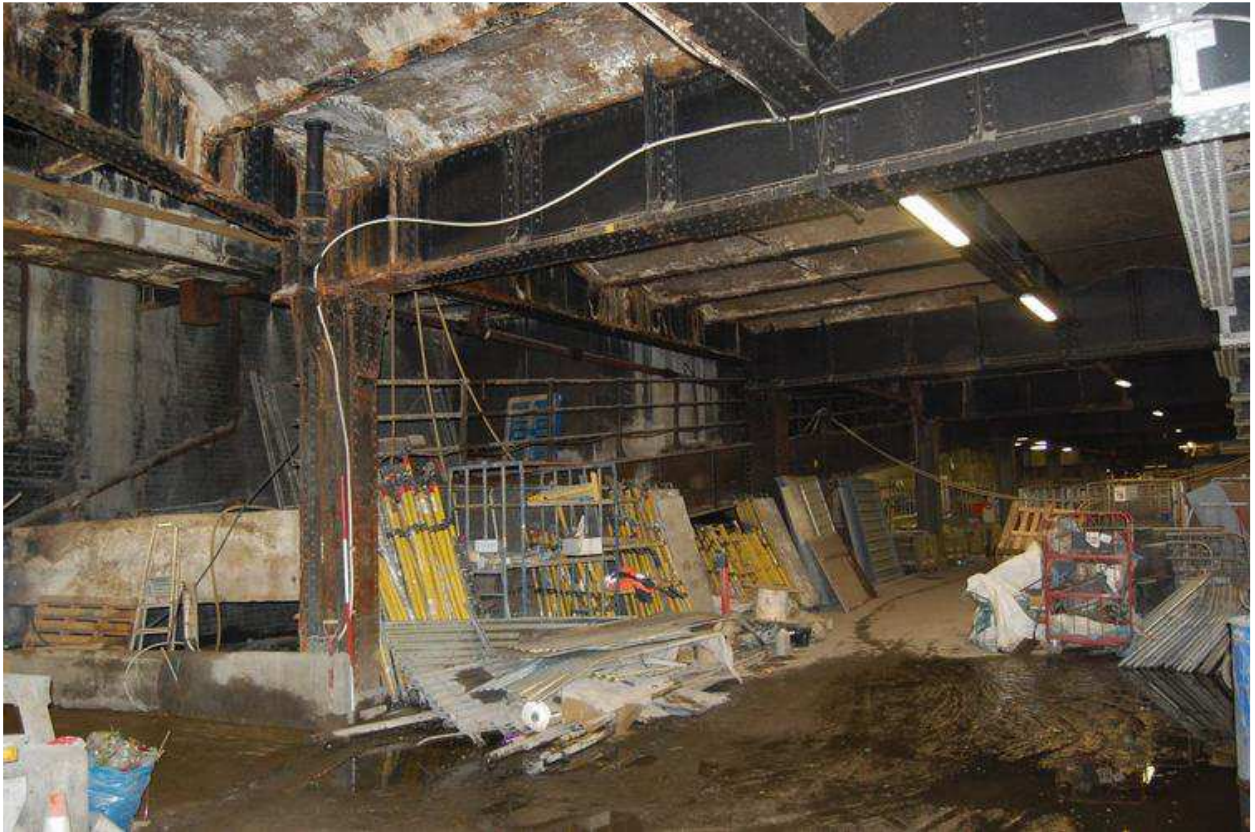
Plate 32 – general view of ramp from southeast

1.8.1 The Milk Ramp comprises a short ramp following the eastern boundary of the station (Plate 32). It rises to the south, being closed off at street level and truncated to the north to form a floating surface. The ramp is constructed on a simple grid with short east-west girders supported on a large north-south girder to the west and brick retaining wall to the east (Plate 45).

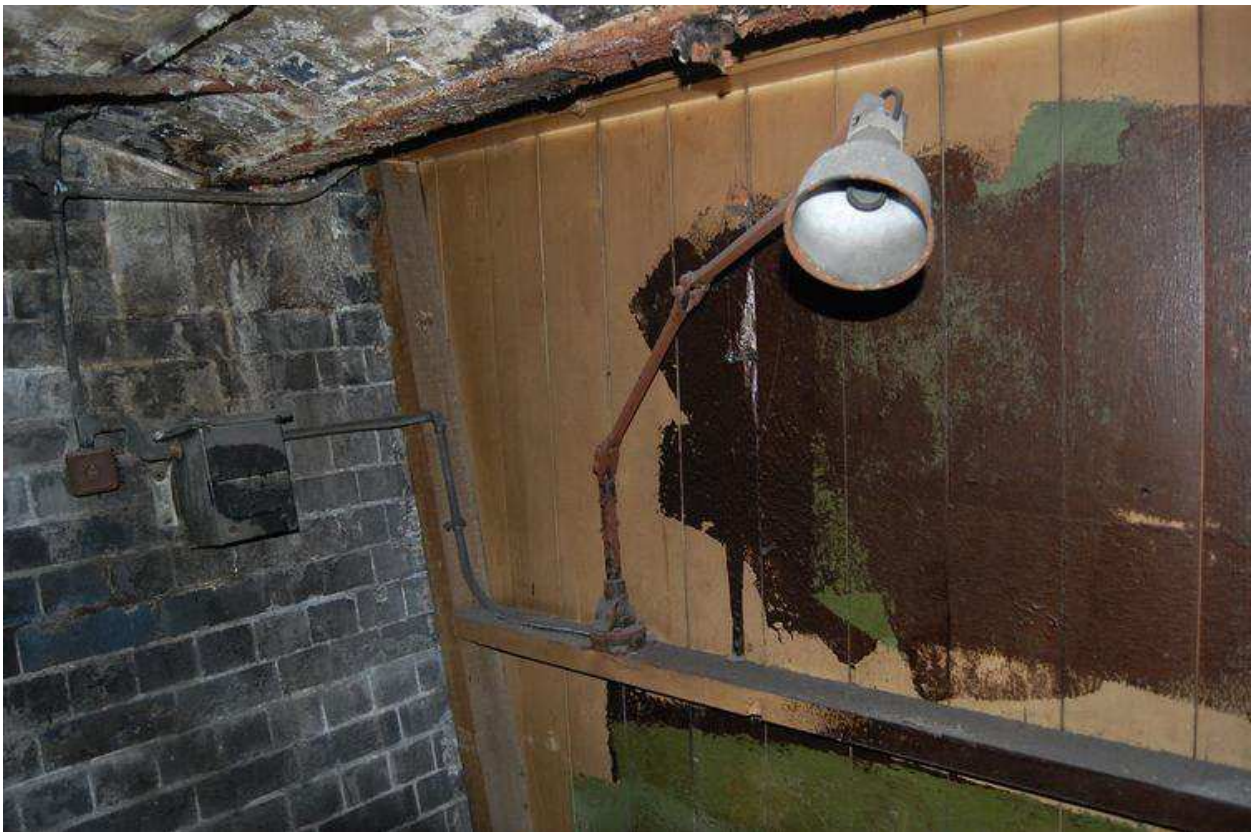
**Plate 55: Angle-poise lamp within office**

- 1.8.9 Below the ramp, the area is defined by a concrete floor surface with the brick jack arches above. One feature of note is an additional iron beam inserted to support the petrol tank. This represents a simple girder with regular brace plates corresponding to the RSJs of the jack arches (Plate 50). The girder is supported on stanchions of decreasing height as they follow the slope of the ramp. The stanchions are simple RSJs with gusseted plates affixed with rivets (Plate 52). That to the north has subsequently been encased in concrete (Plate 61). Flanking the area are inserted timber partitions creating a small office space (Plate 56). This function is suggested by a surviving angle-poise lamp located on the south internal elevation (Plate 55).

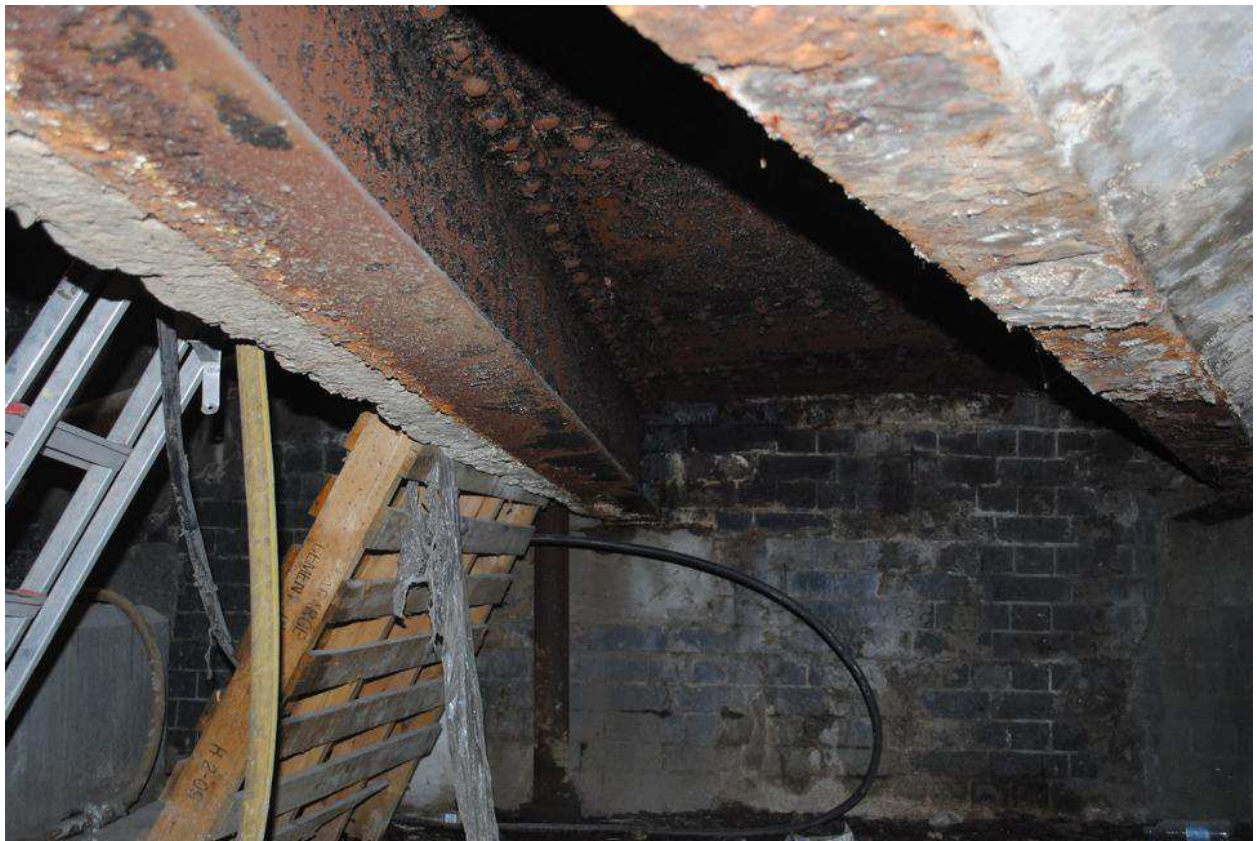
**Plate 75: Underside of ramp showing change in angle**

1.8.4 Girders G3 and G4 form the Milk Ramp proper. The connection between G2 and G3 is created by a series of rivets with both girders supported on stanchion S4, in contrast to the rest of the stanchions which only provide support to G2 (Plate 46). G3 and G4 represent a continual structural element, both tied into Stanchion S5 (Plate 47). Girder G3 forms a single element deepening to the north to follow the slope of the ramp (Plate 72). G4, in contrast, represents a simple 'I' shaped girder set at an angle (Plate 78). Running off from G3 and G4 are a series of RSJs. These are connected to the main girder by a small narrow 'L-plate', visible in the west elevation (Plate 76). The RSJs provide support to the brick jack arches which run under the ramp, continuing into the retaining wall to the east where they sit upon an embedded pad stone (Plate 66). Variation exists at the northern end of the ramp where it turns towards the northwest. The change in angle is created by a steel plate flanked by horizontal RSJs (Plate 75).
