C257 WORK PACKAGE ARCHAEOLOGY CENTRAL

Fieldwork Report

Archaeological Targeted Watching Brief Charterhouse Square Boreholes (XTE12)

CRL Document Number: C257-MLA-T1-RGN-CRG03-50075

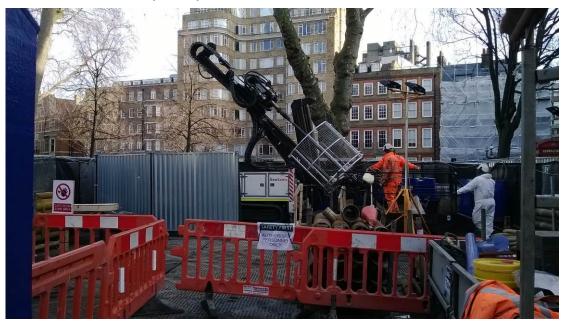
Photo 1 Showing Borehole drilling rig, drilling Borehole at 45° angle, looking east

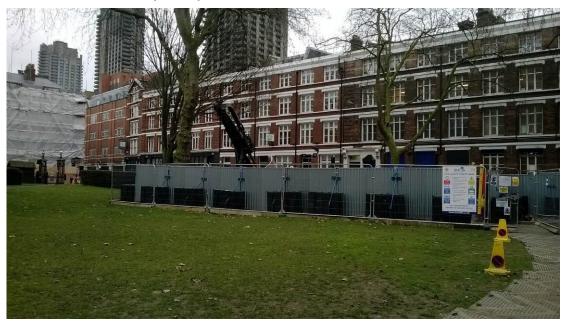
Photo 2 View of site showing area of borehole drilling works, looking south-east

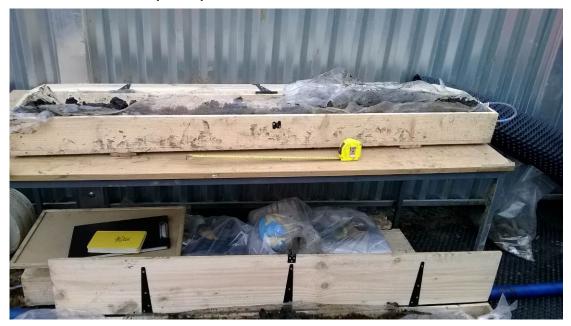
Photo 3 Column sample from borehole, laid out ready to be inspected

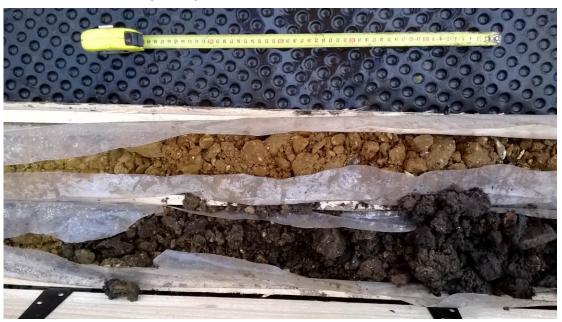
Photo 4 Showing contents of column sample from borehole 4

Natural geology was probably cut by a quarry pit or ditch, or possibly grave fill, similar to [3] in BH1 (see 10.1). No human remains were present within the risings of the borehole.

This was in turn overlain by a series of post-medieval silty clay levelling layers with crushed brick and tile inclusions, probably to landscape or level the previous ground surface of the square. The large blackish garden soil deposit overlying this could then suggest a reasonably long period of undisturbed cultivation in the open square. This interpretation must, however, remain tentative due to the very small area observed in a borehole.

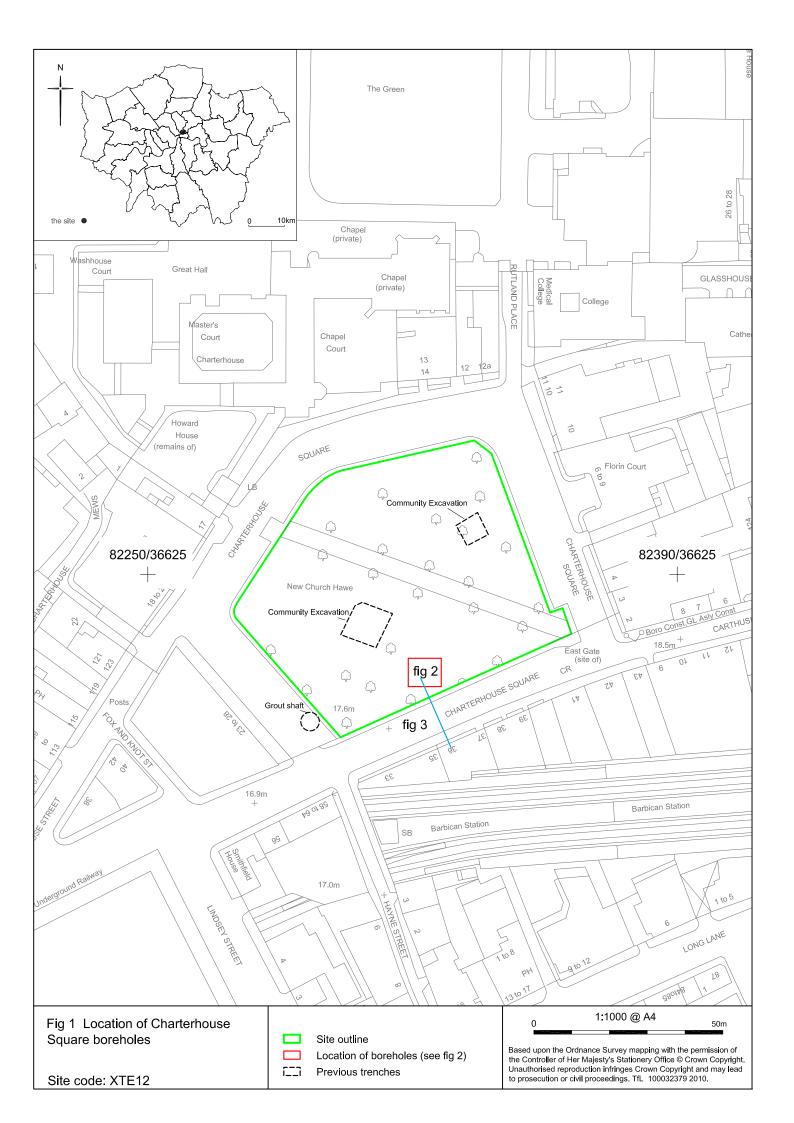
Fig. 1	1 Location	of Charterh	ובווח2 בפווח	re boreholes
rıa ı	Localion	oi Crianem	iouse sauai	e porenoies

The Charterhouse Square boreholes were located in the south-eastern part of Charterhouse Square, a private park maintained and run by Charterhouse; the park is bounded on all sides by the roads of Charterhouse Square, in the London Borough of Islington (Fig 1).

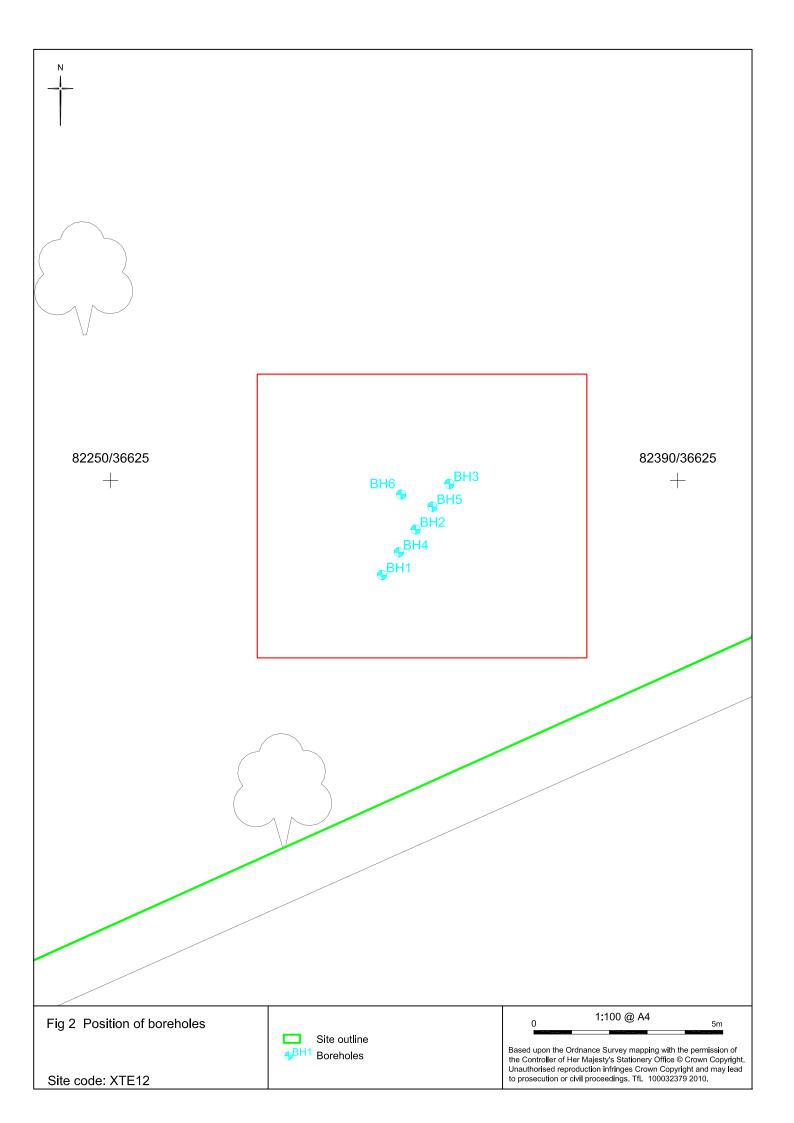
- Fig 2 Position of boreholes
- Fig 3 Section across boreholes and roadway, with comparative results from other fieldwork

Six inclined boreholes were drilled in the south-eastern area of Charterhouse Square to assess the nature of deposits ahead of construction (Fig 2).

- The C257 Principal Contractor set up the drill rig and drilled each of the boreholes, numbers 1 to 6 (BH01 to BH06).
- The first 6m of each borehole being drilled was monitored by the MOLA on site supervisor.
- The first 6m of each borehole column was set aside for inspection and recording by the MOLA on site supervisor.
- The location of each borehole was surveyed by the Principal contractor (Fig 2).

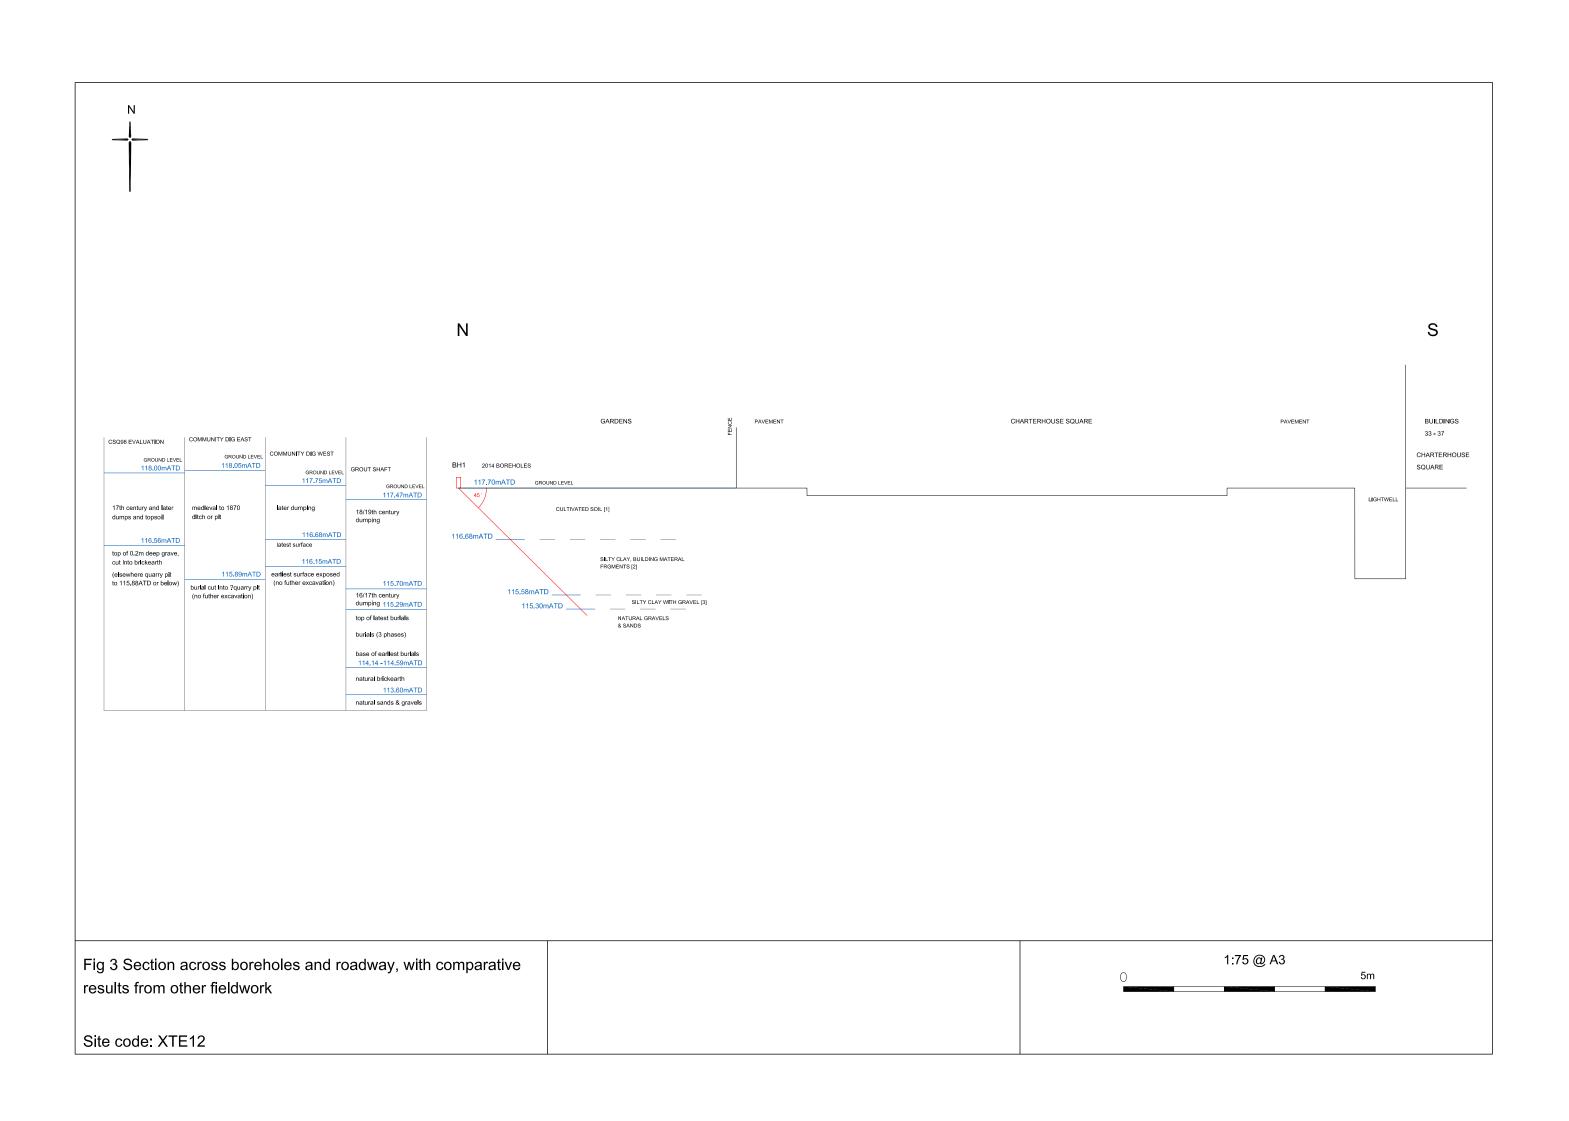
This material, at c 115.6m ATD, was at least 0.8m or more lower than the burial found in the 1998 trial trench in the north-eastern part of the gardens (CSQ98, c 116.46 to 116.56m ATD), and its base was immediately above the level of the latest burials in the Crossrail grout shaft (114.14 to 115.29m ATD). It was at a similar level to the burial found in the eastern trench of the 2014 community excavation (115.89m ATD), where it was cut into material that was not excavated. However, it was also to the 16/17th-century dumping (over the burials) in the grout shaft, and to the possible quarry pit fills in both the 1998 trench and the eastern community excavation trench (Fig 3).

This borehole was the closest one to the road on the southern side of Charterhouse Square, but Fig 3 demonstrates that the archaeological sequence in the boreholes did not approach the boundary of the gardens and roadway.
