C257 ARCHAEOLOGY CENTRAL

Heritage Survey Report 11-12 Blomfield Street

NON-LISTED BUILT HERITAGE RECORDING

Document Number: C257-MLA-X-RGN-CRG03-50001

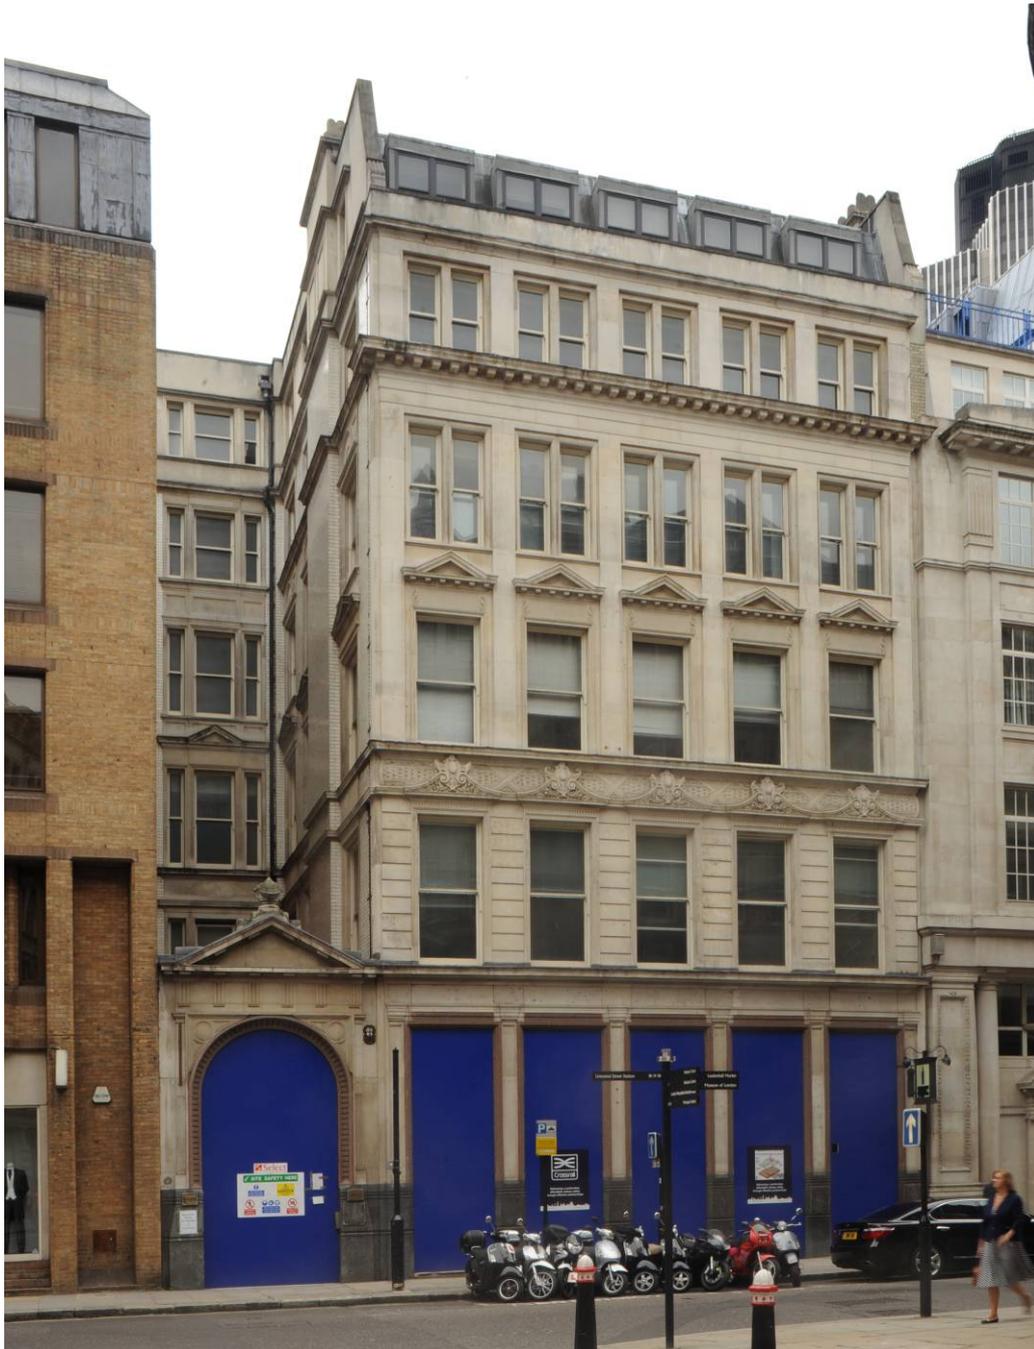
Fig 14 The western Blomfield Street elevation, looking east

The building was constructed as a purpose built office block with five storeys to the west, plus attic and lower ground floor. The western facade was constructed from stone with a glazed tile return into the entrance area, (which alone occupies the whole space of former No. 11 Blomfield Street) (Fig 14). The ground floor was the tallest element of the western facade, whilst on the 1st floor the sash windows were flanked by rusticated stone piers, topped by scrolled pediments with central cartouches, which are set within a carved bay leaf decorative band.

The five 1st-floor windows on the western facade were topped with pediments supported by six small corbels each. Between the pediment and the top of the window was a panel of fluting carved into the stone. The 2nd-floor windows were arranged in five pairs of smaller sashes, with a central stone mullion and no ornamentation, whilst above these, between the 3rd and 4th floors there was a moulded cornice, supported by small corbels. The 4th floor was slightly set back above the cornice and the pattern of five pairs of sash windows with a central stone mullion was repeated. Above the 4th-floor windows was a parapet with drip-moulding along its base. Behind this there were five 5th-floor dormer windows, set in pairs,

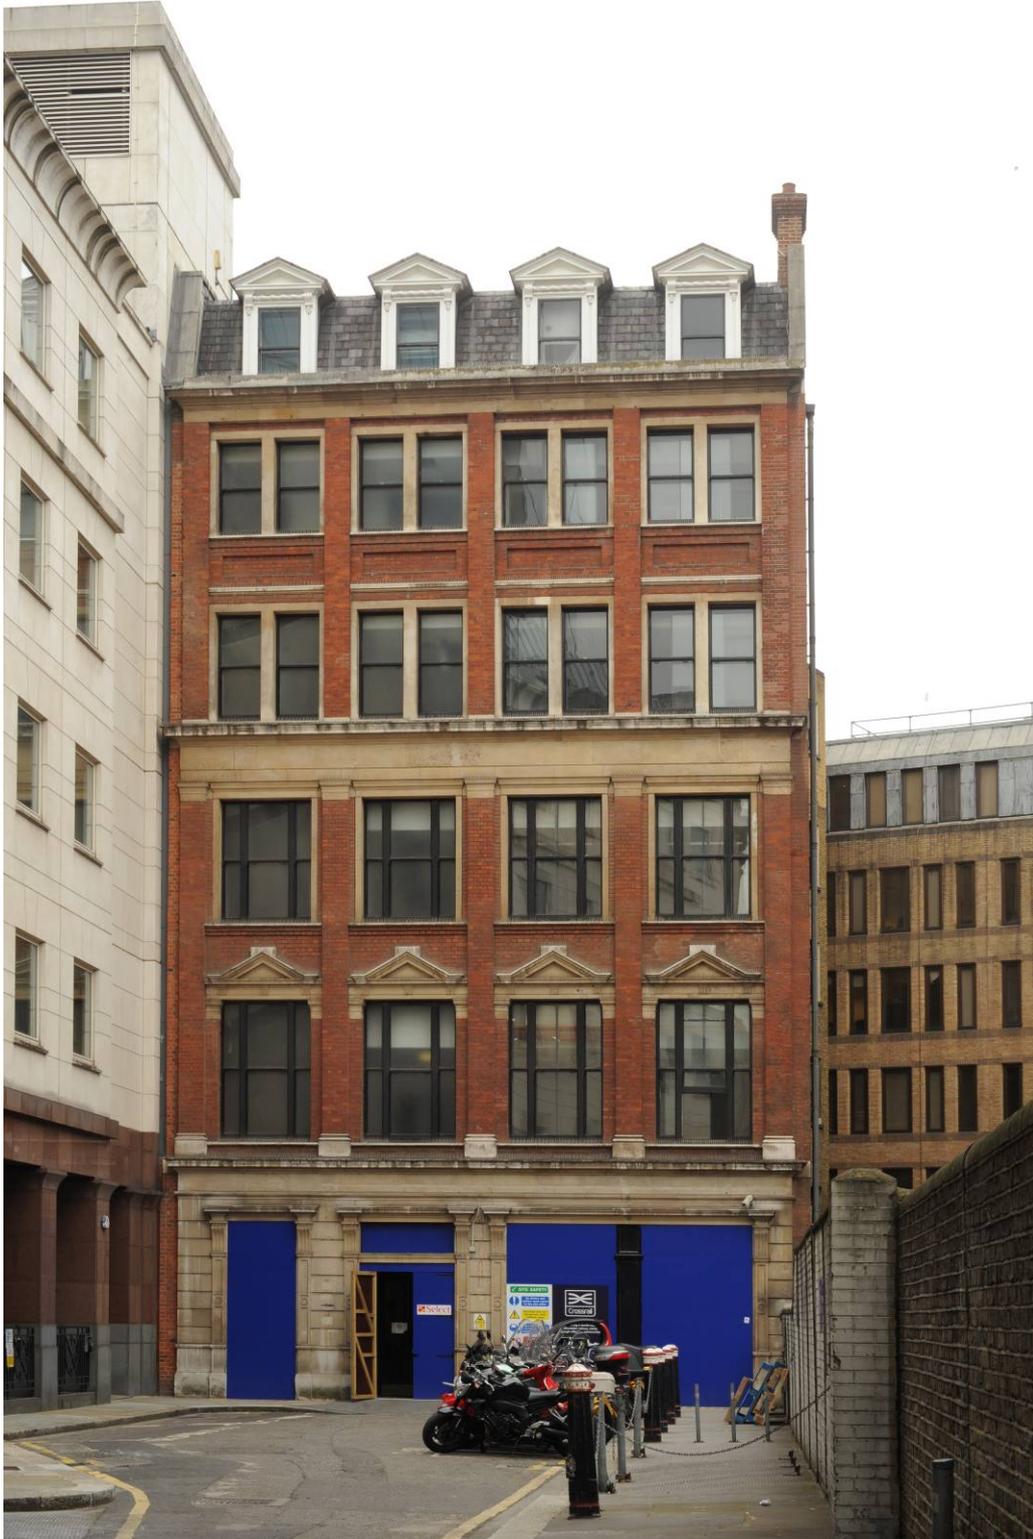
Fig 17 The eastern Broad Street Avenue elevation, looking west

The eastern facade of the building that faces onto Broad Street Avenue was very different from the western facade, although there were some subtle similarities in the decorative treatment (Fig 17). In general there were four bays facing east, and on this side the building had six storeys, plus a lower ground and basement level, whilst red brick was the predominant building material. The ground floor had a stone plinth with rusticated stone above. There was an entrance door, with a window to the south and a pair of windows to the north. All of these features were surrounded by a decorative stone architrave, which took the form of pilasters, with a single circular decoration (similar to that seen on the Blomfield Street arched entrance). The pilasters were topped with fluted consoles below a capital. Above this a plain freeze, topped with a cornice separated the ground floor from the 1st floor, as well as the stone from the brick elements of the building. The four 1st-floor windows were tripartite, with a central sash, flanked by thinner glass panes. Each window was topped with a simple pediment, whilst the 2nd-floor windows, also tripartite had a stone architrave and were topped by a stone freeze and projecting cornice below 3rd floor level. The brick built piers between the windows were continuous from the 1st to 2nd floor, springing from a stone plinth above the ground floor cornice and terminating in a stone capital below the 2nd floor freeze.

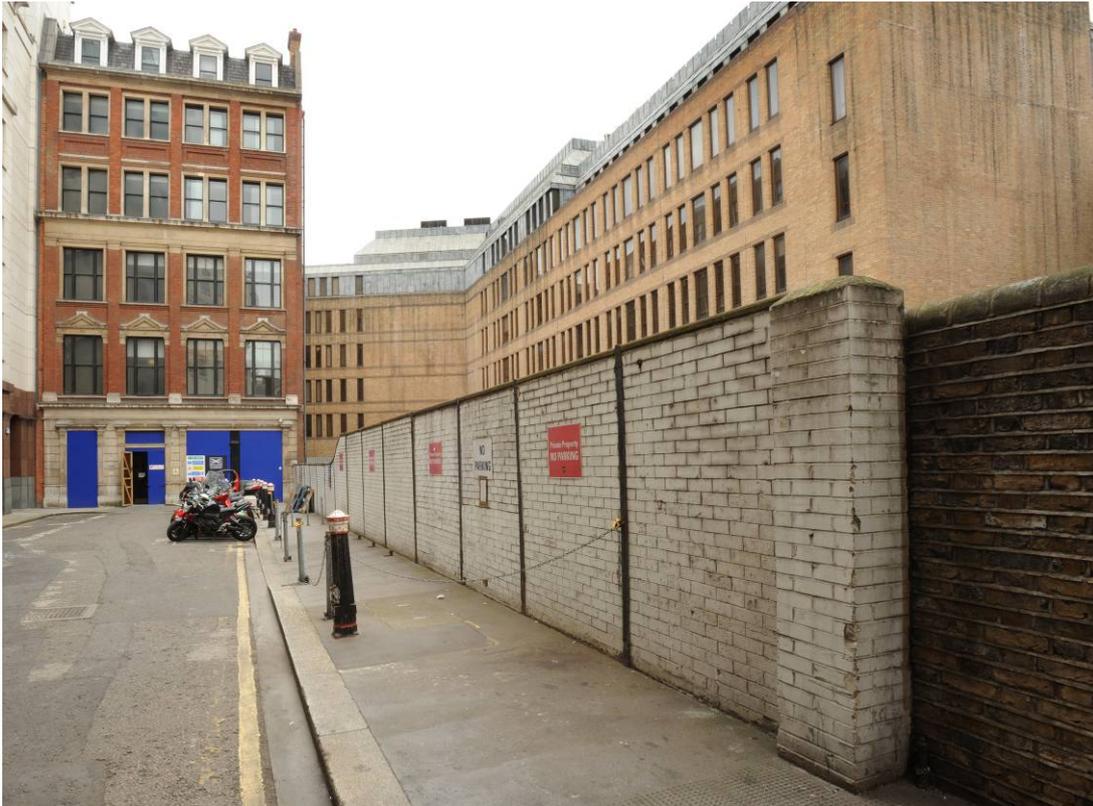
Fig 20 The retaining wall along the north edge of Broad Street avenue looking west

To the east of the building was a wall, constructed with a facade of white glazed brick in stretcher bond (Fig 20), which partially formed the north wall of Broad Street Avenue (the eastern end of the wall being constructed separately of plain brick). The wall was constructed using upright iron stanchions as supporting elements, with the panels of glazed brick in between. One of these panels had been rebuilt using plain brick and painted white to match the remainder of the wall. The wall was topped with stone slabs, some of which again had been replaced or repaired, with matching slabs of concrete.

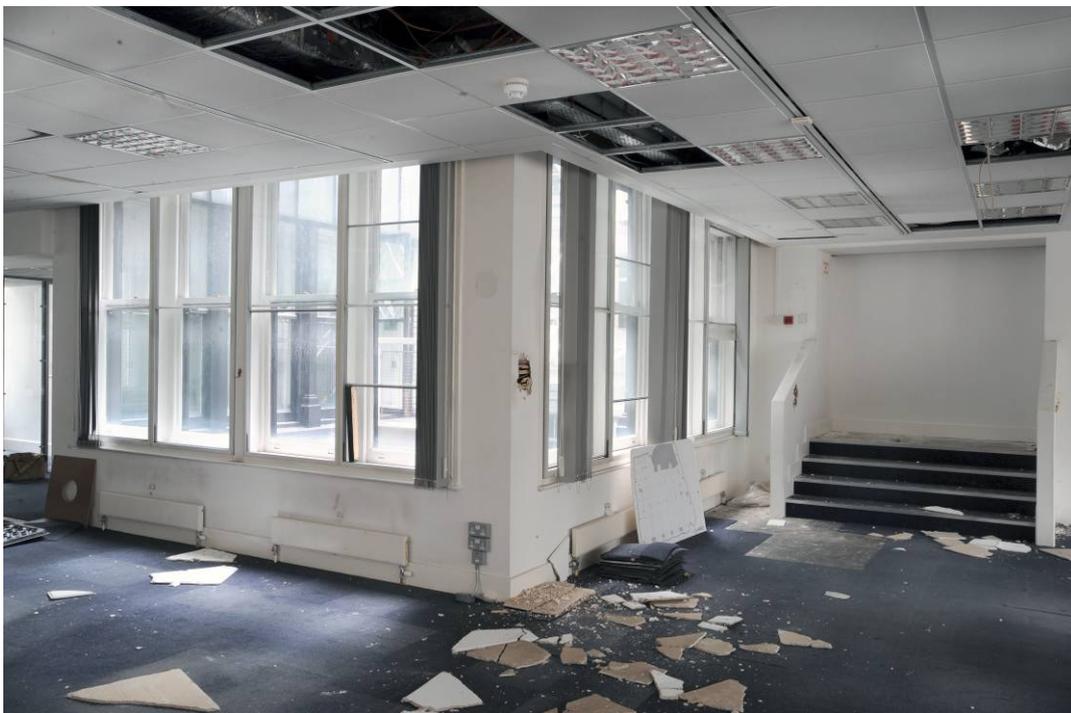
Fig 21 The 1st floor interior, looking south west towards the west light well of the Blomfield Street building

As described above (section 4.2) the site of 11/12 Blomfield Street has two separate facades. The western facade occupies the plots of Nos11/12 Blomfield Street, whilst the eastern facade faces Broad Street Avenue. As with the exterior of the building internally the building's form was that of two buildings on different alignments, joined together, that of the west, occupying the plots of Nos11 and 12 Blomfield Street and that of the building fronting Broad Street Avenue to the east. The westernmost was rectangular in plan and situated within the 11/12 Blomfield Street building (Fig 21). The light well did not reach the ground floor level, although it is possible that a skylight at its base may have illuminated the ground floor rooms at one stage. The rooms on the upper floors illuminated by this light well were all open in plan with the exception of some minor modern partitions on the 4th and 5th floors. The light well was also shared by the adjacent property to the south, Nos46–47 New Broad Street. Interestingly on the 1st floor of the 11/12 Blomfield Street building there was a set of steps that led up to a blocked internal entrance to 46–47 New Broad Street and it seems that despite the difference in floor levels, the 1st floor of both buildings had at one time been linked (Fig 21).

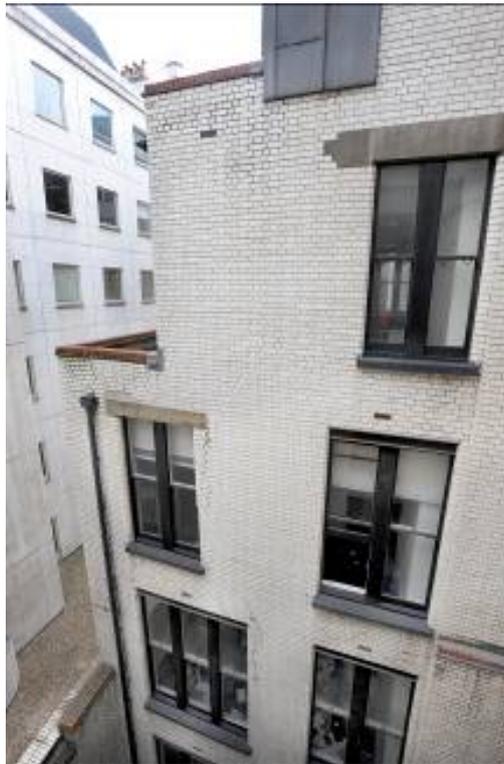
Fig 23 The eastern light well in the Broad Street Avenue building looking west

The easternmost light well was rectangular in plan and situated in a central position in the Broad Street Avenue building (Fig 23), on the southern side of the corridor. In extent, it reached the lower ground floor level rooms where skylights allowed in the

size to those floors below. The original stepped nature of the building in height on its southern side could still be seen at the easternmost light well (Fig 23) where the 3rd and 4th floors were set back, although the 4th floor had a modern extension, indicated by lead sheeting.

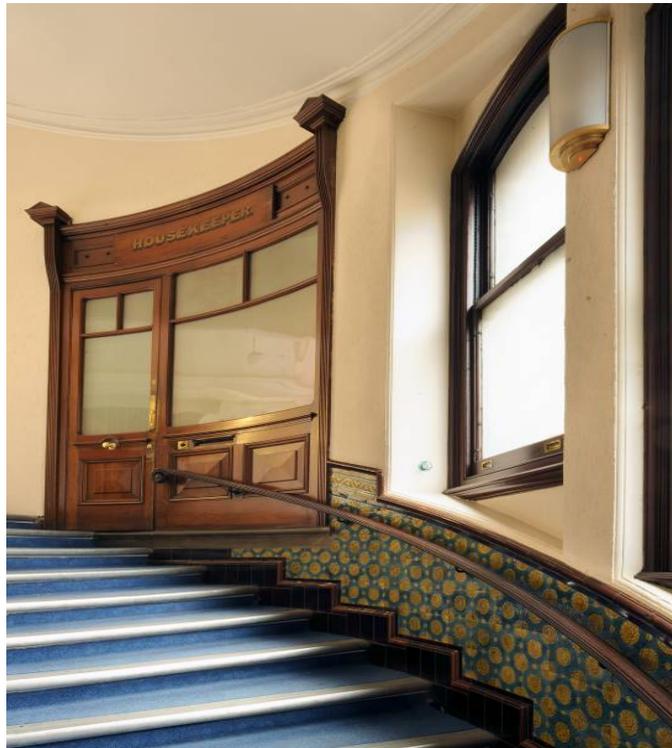
Fig 29 The housekeeper's lodge on the ground floor level of the geometric staircase looking west

At ground floor level, where the staircase began to descend to the lower ground floor, accommodation had been provided for a housekeeper (Fig 29). A small room or lodge, that occupied the space left between the curve of the stairs and the right angled corner of the building, was partitioned off from the stairs by timber joinery with a window and door containing frosted glass. A slot for a drop box, presumably for keys was present to the right of the door.

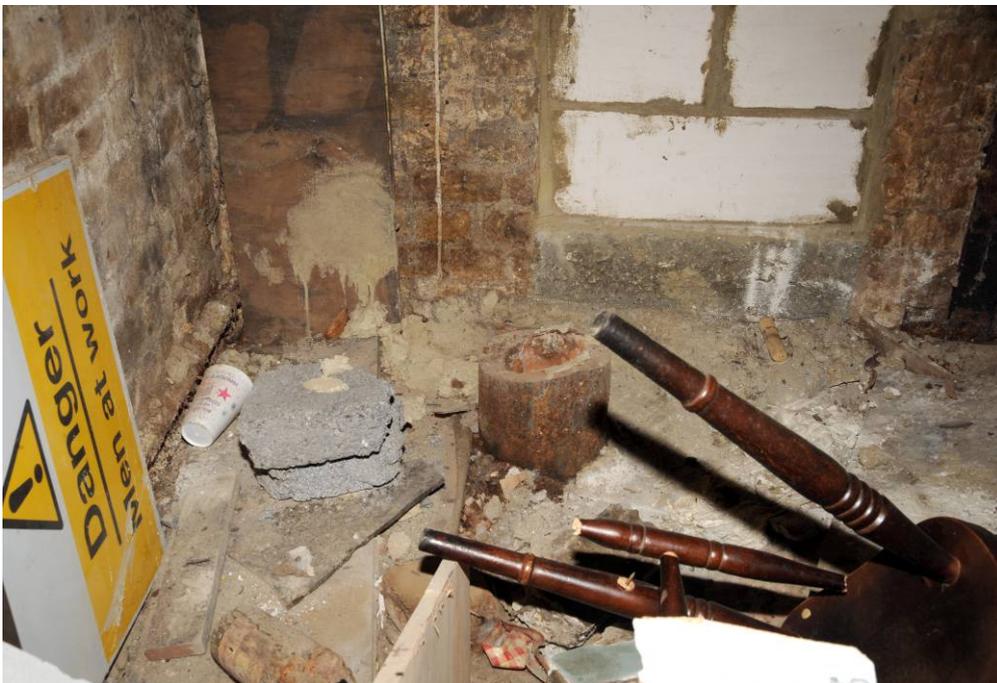
Fig 31 The surviving stump of the direct acting hydraulic lift piston beneath the geometric staircase, lower ground floor level looking west

At lower ground floor level below the western geometric staircase of the Blomfield Street building was a small space, directly below the stone steps and accessible via a small door. From the doorway steps led down to a void beneath the centre of the stairs. Within this space were found traces of a hydraulic mechanism for a direct acting lift. At a central point rising from the floor of the void was the stump of a large iron piston (Fig 31). This would have been the central component of a direct acting lift, powered by water under pressure, which would have extended or contracted the iron piston, to the top of which was fixed the lift cage. Further traces of the hydraulic mechanism were noted in the form of a hand crank, adjacent to the door to this area (Fig 32). This may have been in order to increase or decrease the water pressure manually if necessary. Unfortunately no maker's name was visible on any of the surviving parts of the mechanism. The area also had glazed tiles decorating the walls including a band with a key pattern (Fig 33). The lift, long since removed, would have provided access to the upper floors of the Blomfield Street part of the building (excluding the later added 5th floor). It was noted that on the 1st–4th floors, the straight edge of the D shaped geometric staircase had originally been open, allowing access to the lifts. It had since been blocked off with a partition, which was then decorated with painted and embossed wall paper that was intended to match the ceramic tile scheme on each floor. A description of the mechanism of a direct acting lift and a discussion of its significance in the Blomfield Street building is given below in section 5.8.

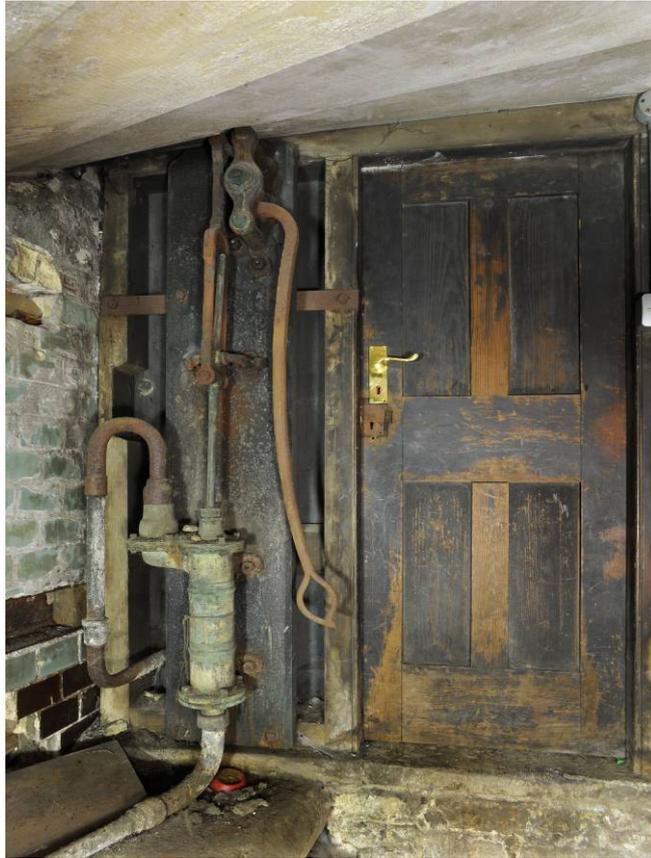
Fig 32 The hydraulic hand crank, below the geometric staircase, lower ground floor level looking west

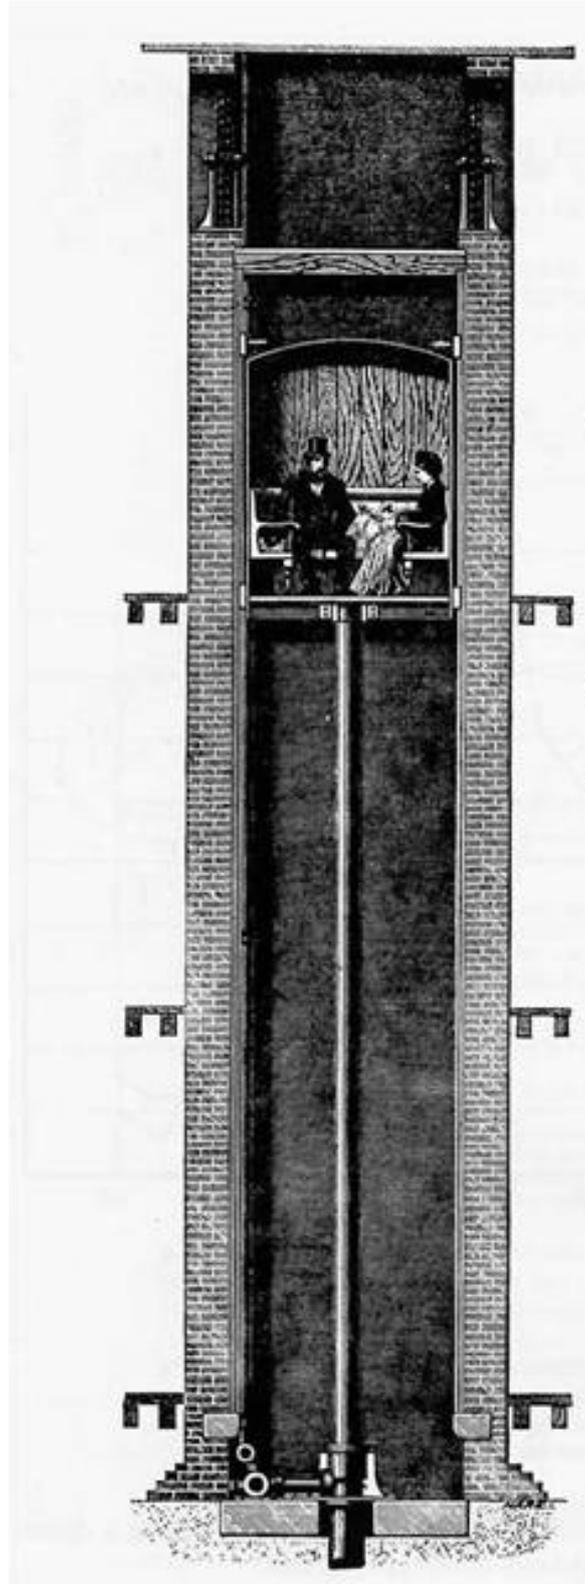
Fig 37 A Direct acting hydraulic lift c1870–80 (Image from Charles Sturt University)

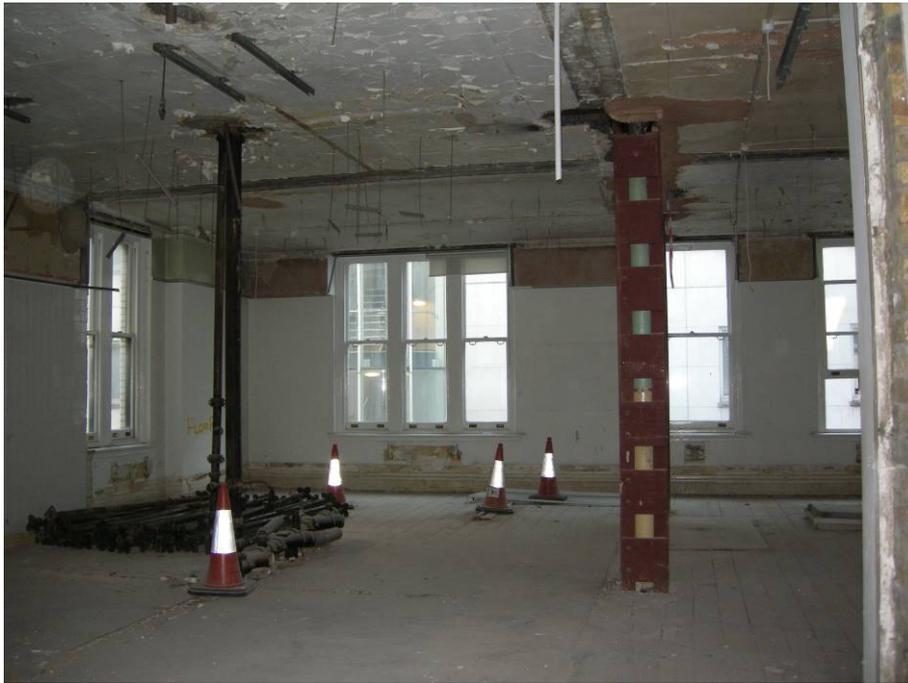
Fig 41 Sewage pipe and covered column in first room to the west, along the south of the corridor, looking north

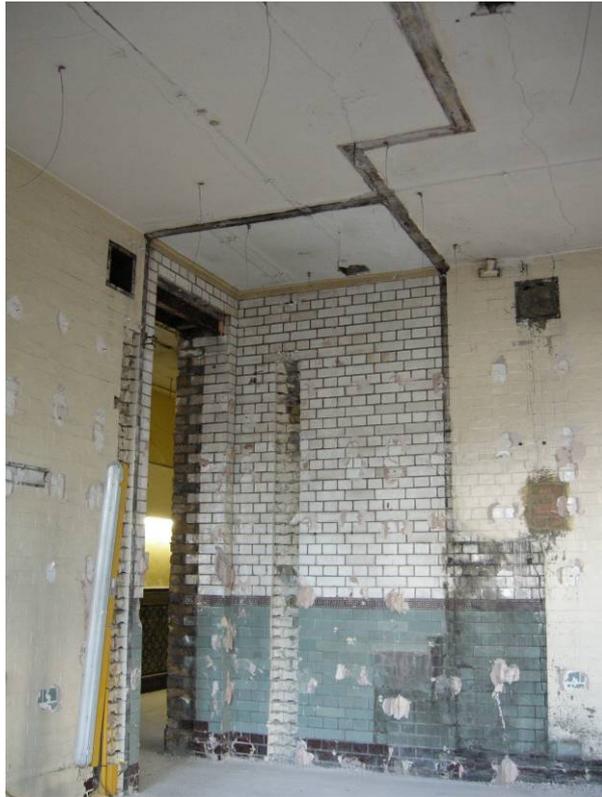
Fig 42 Details of the easternmost room along the track side

On the second floor the same type of blue tiles were observed in the easternmost room at the corner (Fig 42) and the foot print of the internal partitions on the ceiling and wall confirmed that the room wall originally subdivided in small spaces (WCs). On the same room the windows facing on to the track side have been altered recently (Fig 43). The original mosaic floor was observed under a later covering (Fig 44) on the landing by the west staircase.

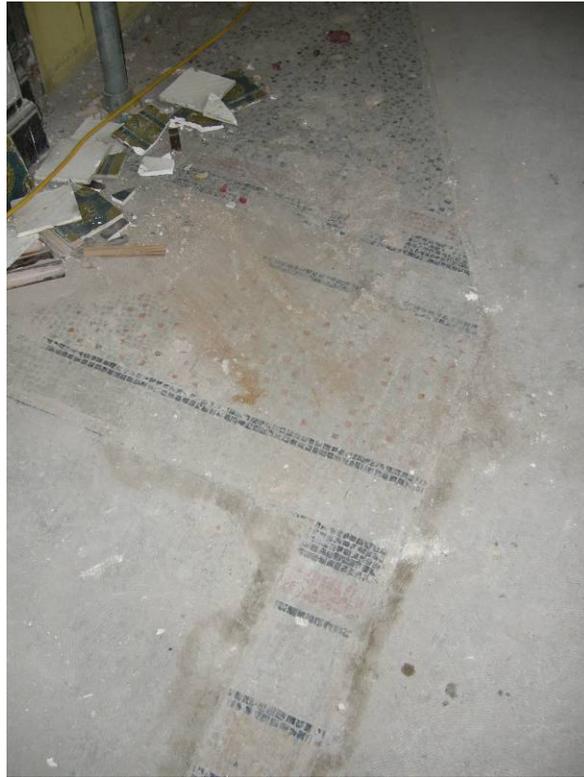
Fig 44 Remnant mosaic floor by the staircase

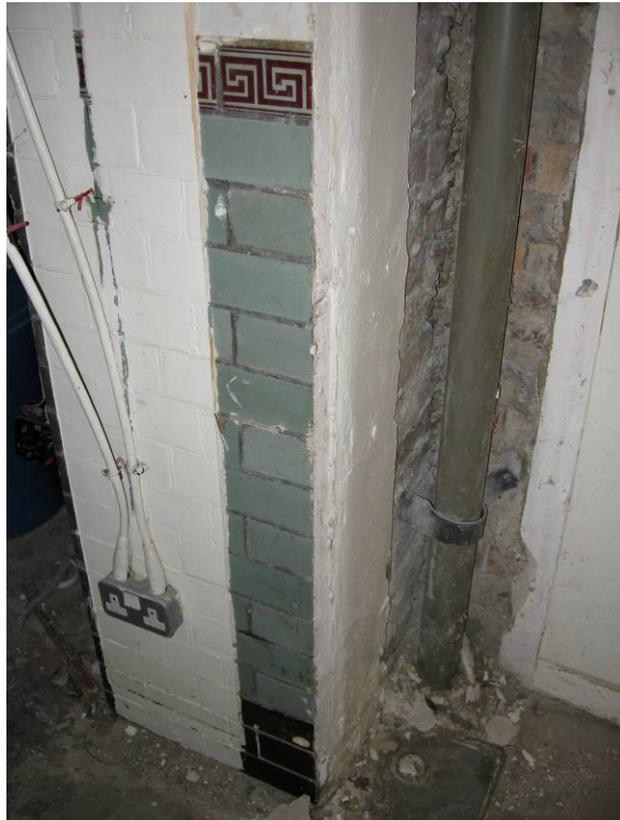
Fig 51 Room to the north of the Mecca restaurant, detail of decoration

The soft-strip of the upper basement exposed the colourful tiles decorating the walls. The room to the north of the Mecca restaurant showed a different type of decoration (Fig 51), along with some other interesting details. The curved wall previously noted in the adjacent service room carried on along the south wall of this room, whilst the section of the same wall visible inside the fire place (Fig 52) confirms that the wall had two phases of construction. This wall was likely to have been part of an earlier building on the site. On the other side of the building at the east end, the north wall of the vaults under the pavement in front of the east entrance door was blocked off with a layer of breeze blocks indicating recent alterations.

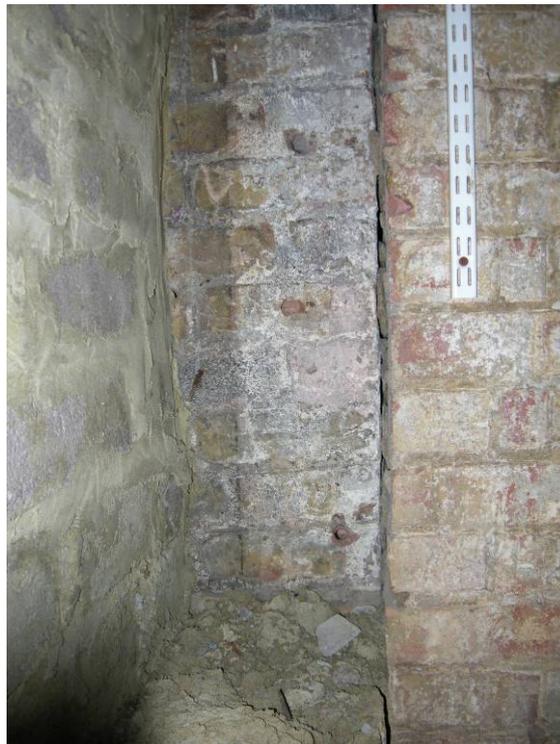
Fig 53 Straight joint between trackside wall and later room partition, in second room from east, looking east

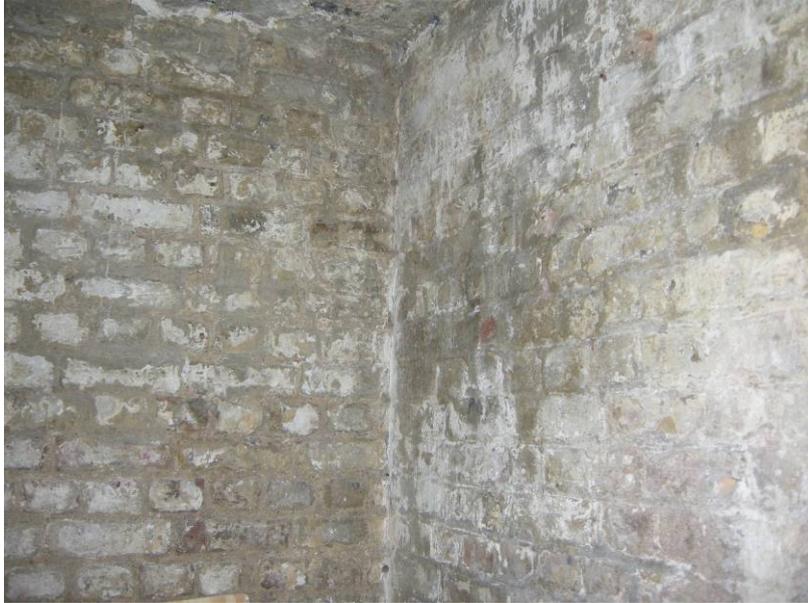
Fig 54 Straight joint between trackside wall and later room partition, in second room from east, looking west
