C261 ARCHAEOLOGY EARLY EAST
Interim Statement
Archaeological Evaluation
Eleanor Street Shaft XTJ13

Document Number: C261-MLA-X-RGN-CRG03-50040

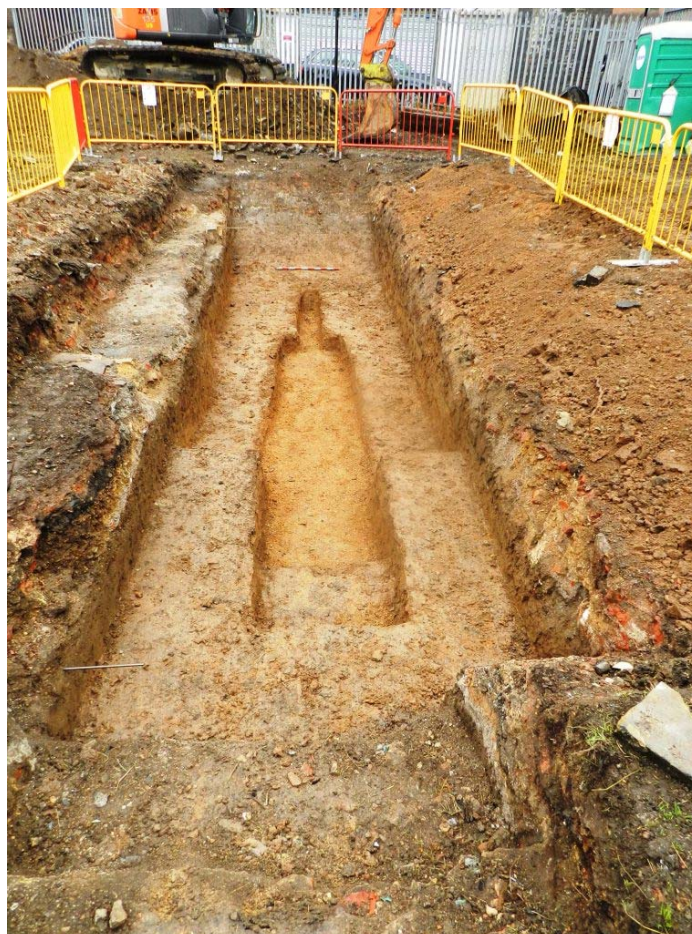
Temporary Shaft Evaluation Trench, looking north

Temporary Shaft Evaluation Trench	
Location	Off Rounston road
Dimensions	10m x 2m x 2m deep.
LSG coordinates	87773.00 37075.65
OS National grid coordinates	537402.288,182500.609
Modern Ground Level/top of the slab	110.2m ATD
Modern subsurface deposits	Modern crushed concrete and brick over 19 th -c building remains
Level of base of archaeological deposits observed and/or base of trench	108.28m ATD
Natural observed (truncated/not truncated ?)	.Gravel [1] (slopes 108.73m – 108.28m ATD) Not Truncated

Extent of modern truncation	<0.5m
Archaeological remains	Dating Evidence, Finds, and Samples
Reworked brickearth [2] above a buried soil [3]	1700–70 from tobacco pipe in [2], pottery and brick also (see below)
Interpretation and summary	
The results conform to historic maps which show the area being converted from agriculture and market-oriented grazing, to horticulture in the 18 th century. This appears to have included reworking deposits to the top of natural terrace gravel, thereby removing or destroying evidence of earlier archaeological remains. Building remains of the 19 th century were also exposed, however the nature of these remains indicate nothing that would warrant further archaeological investigation
