**C263 LATE EAST**  
**Non-listed Built Heritage Recording Report**  
**North Woolwich Railway Footbridge**

**Document Number: C263-MLA-X-RGN-CRG07-50024**

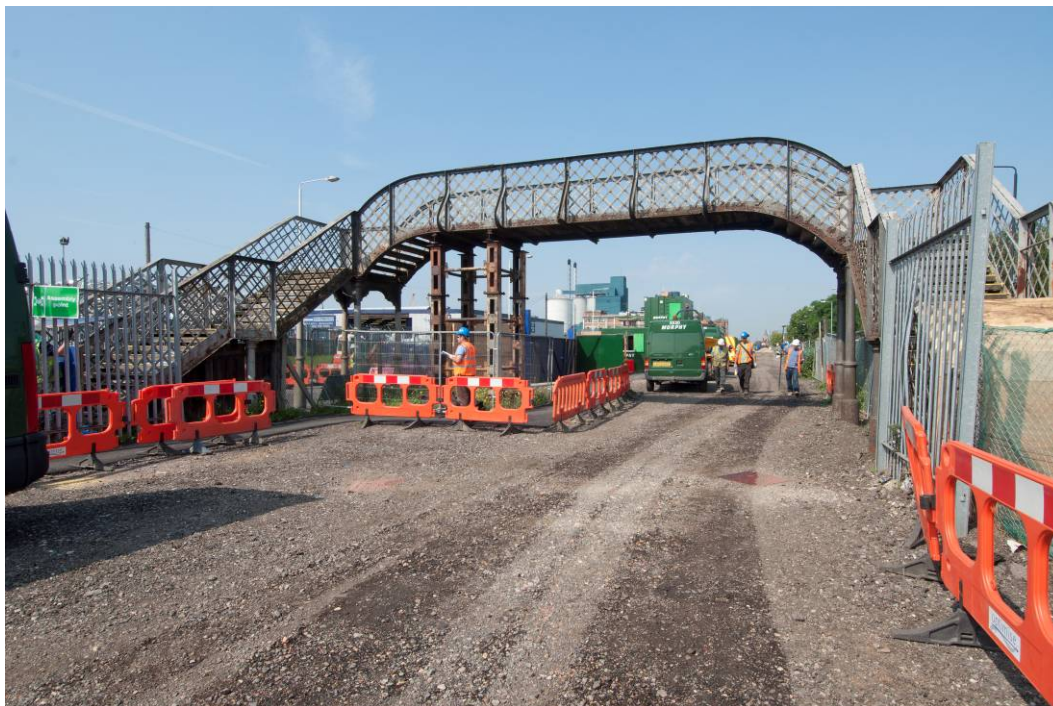
*Photo 1 A general view of the late 19th century footbridge looking west*

In appearance the structure is one of a typical type of late 19th century wrought iron foot bridges on cast iron columns which were once commonplace on Britain's railways, (Photo 1). The designs for such structures were often standard, with the same basic design being produced time and time again. The structure is supported on twelve ornate Tuscan cast-iron columns, four large versions of these support the winder (the platform between the two sets of steps, where the direction turns 90°) onto the foot bridge at the top of the staircases on each side whilst two smaller versions are present supporting the staircases on each side (Photo 2).

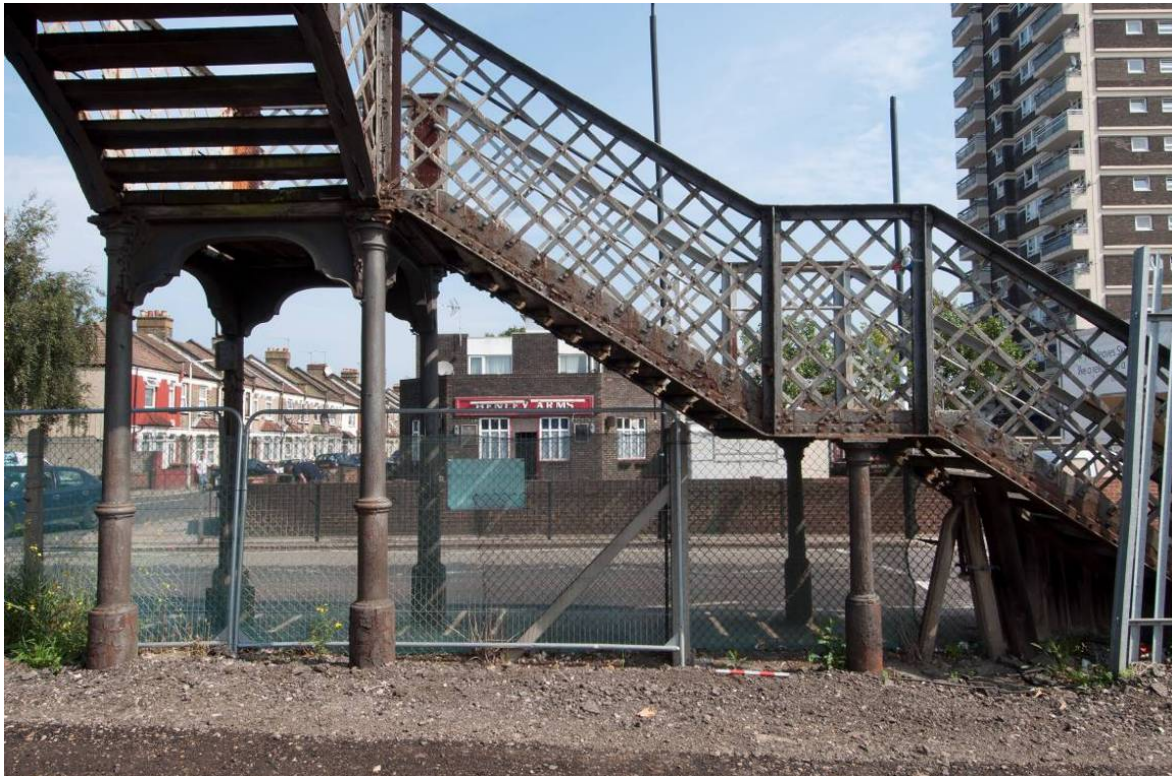
*Photo 2 A view of the columns and staircase on the north side of the foot bridge, looking north*

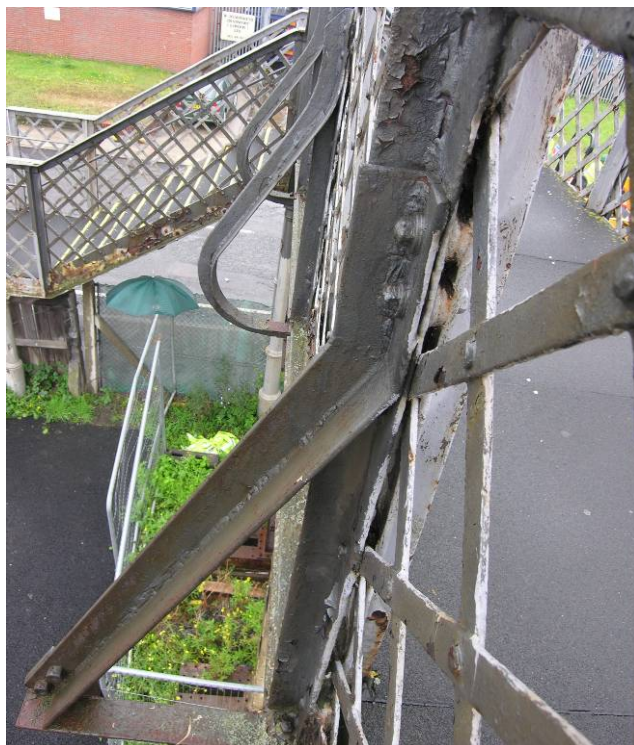
The western and eastern sides of this central area are identical. On the exterior of the four central panels are brackets attached to the five upright elements. All of these are curved and formed from a single 'L' bar, with the exception of the central bracket on each side, which is an angled bracket, formed from 2 straight 'L' bars bolted together (Photo 3). The use of bolts instead of rivets suggests this is an alteration and the central position and identical arrangement of this bracket on both the western and eastern is not likely to be coincidental. The angled bracket may have held a lamp, semaphore signal or overhead cable, though it may have been a simple modern replacement for the original curved brackets that were lost or damaged.

*Photo 3 The central angled bracket on the eastern side, bolted onto the structure, looking south.*

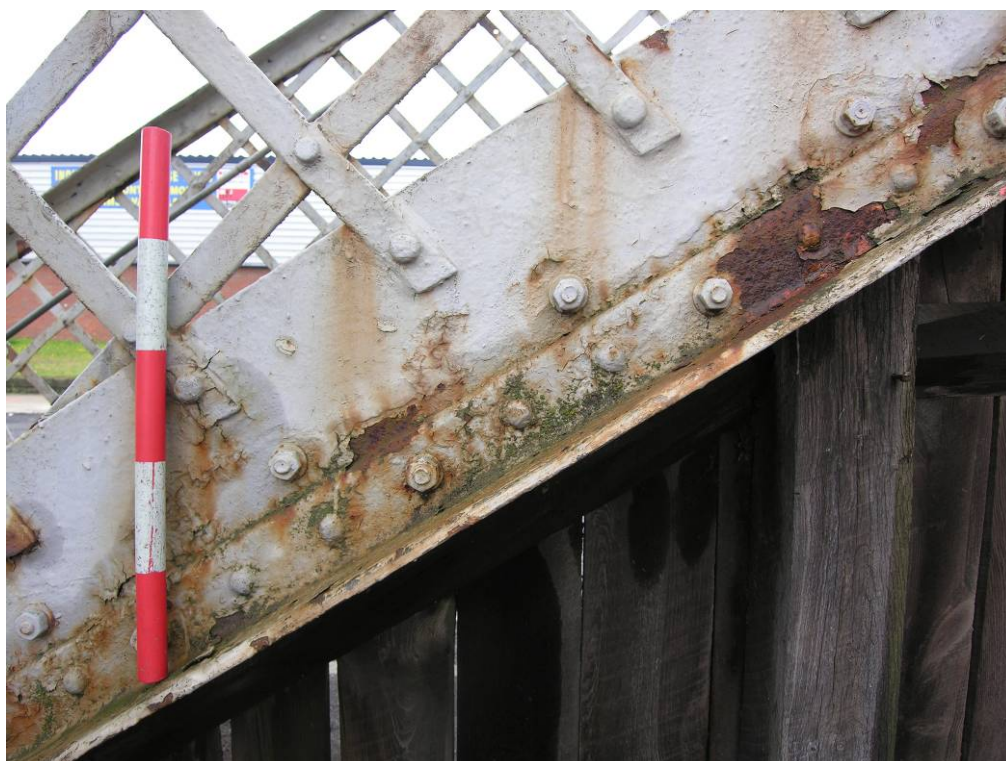
large and the entire structure, with the exception of the brackets that support the timber steps, has been riveted together (Photo 4), the step brackets being bolted (Photo 5). The common method of manufacture and construction for composite iron structures was usually to rivet panels and other elements together off site during the manufacturing process and transport these components to the site, where they would be bolted together and assembled. Although the transportation of large ready-made elements of the structure to the site by rail is highly likely, it seems probable that the on-site assembly also required rivets to be heated and applied to the footbridge during its assembly, by today's standards a particularly labour intensive construction method, in particular riveting by hand which required at least two or three workmen.

*Photo 5 Rivets and bolts in the string panel of the southern steps, the rivets securing the lattice bars, whilst the pairs of bolts secure the brackets for each of the timber steps.*

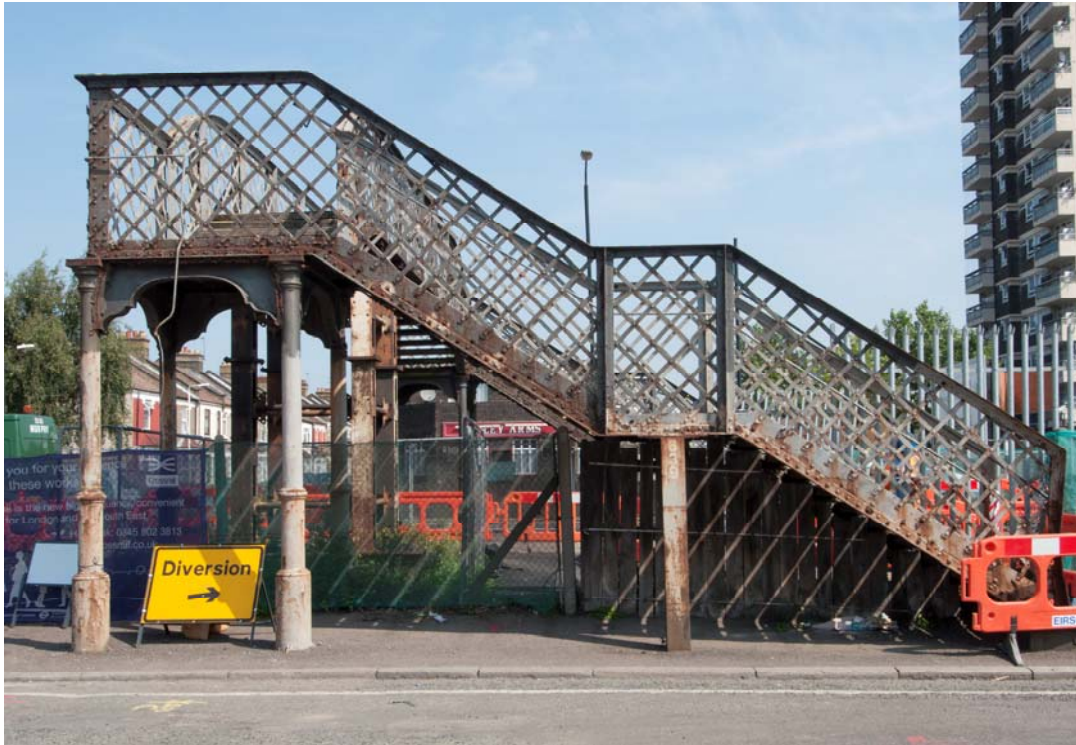
Repairs were noted to the structure during the survey, such as the replacement of one of the smaller columns with an RSJ on the south side of the structure (Photo 6), probably as a result of a vehicle strike. The hand-rail had also been entirely replaced within the stairs on the south side, probably during the mid 20th century, whilst on the north site the original hand-rail remained, with some modern repairs and a small section replaced at the top (Photo 7). The addition of electrical lighting or illuminated signage seem likely at some stage in the structure's history, with the probable position of former lamps being marked by scars on the upper surface of the foot bridge top-rail (Photo 8), whilst an electrical supply box and a conduit remain attached to a column at the north end of the bridge.

Photo 6 The southern façade of the structure, looking north. Note the RSJ replacing the small column.

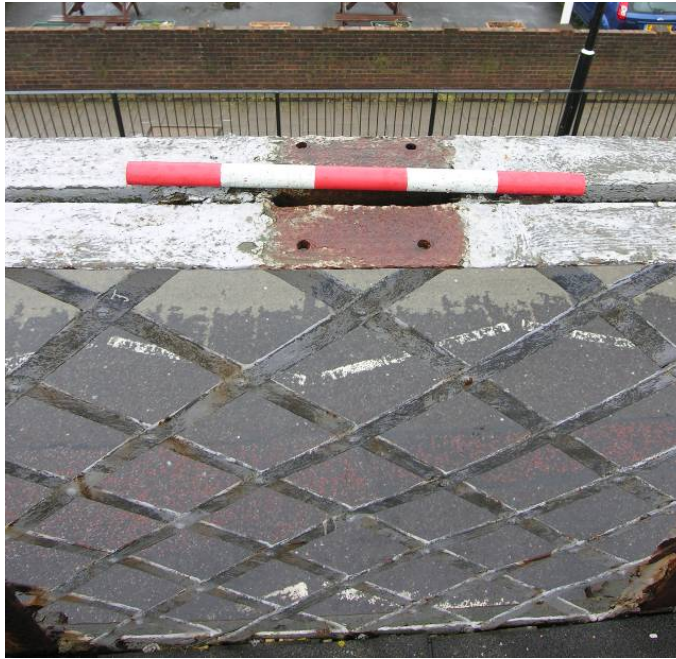
*Photo 8 A scar on the upper surface of the foot bridge top-rail looking north, possibly from a lamp fixing or illuminated sign*

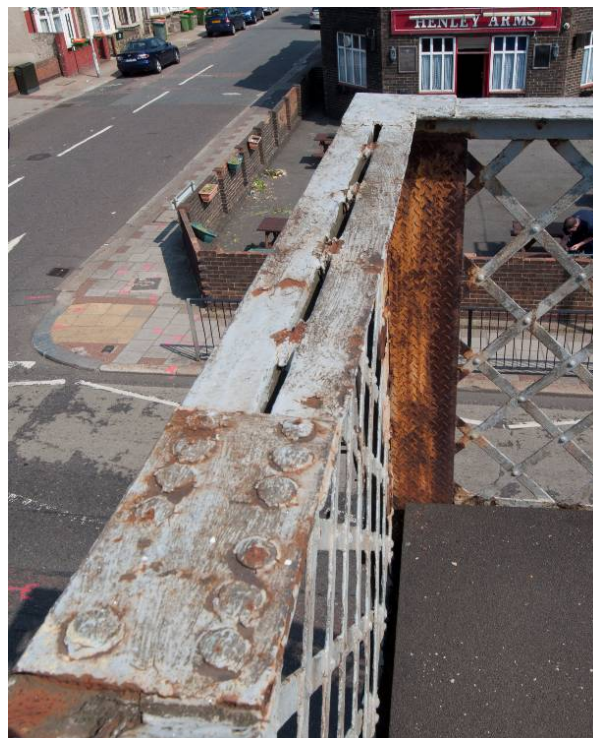
The northern end of the foot bridge had two steel panels added, one at the top of the stairs (Photo 7) and the other in the north-west corner (Photo 9). The depiction of the foot bridge on the OS map of 1894 (Fig 3) suggests there has been an alteration in the orientation of the steps from their original position, on the north-western side of the structure, to the north-eastern side (There are two footbridges shown on the 1894 OS map, the North Woolwich Portal foot bridge is marked *F.B.* above the words *Electric Cable Works*). The steel plate repairs to the north area of the bridge may correspond to an alteration in the orientation of the steps from their original position, on the north-western side of the structure, to the north-eastern side. However there is no clear reason as to why the position of the north steps would have been altered in this way.

*Photo 9 A fish plate securing two 'L' bars the foreground, and a steel plate added to the north-west corner of the structure, in the centre right of the photograph. Note the textured tread surface.*
