## Liverpool Street

# Method statement for Verizon works at Old Broad Street in relation to the Scheduled Monument City Wall (LO26N)

Document Number: CRL1-XRL-Z7-GMS-C101-50001

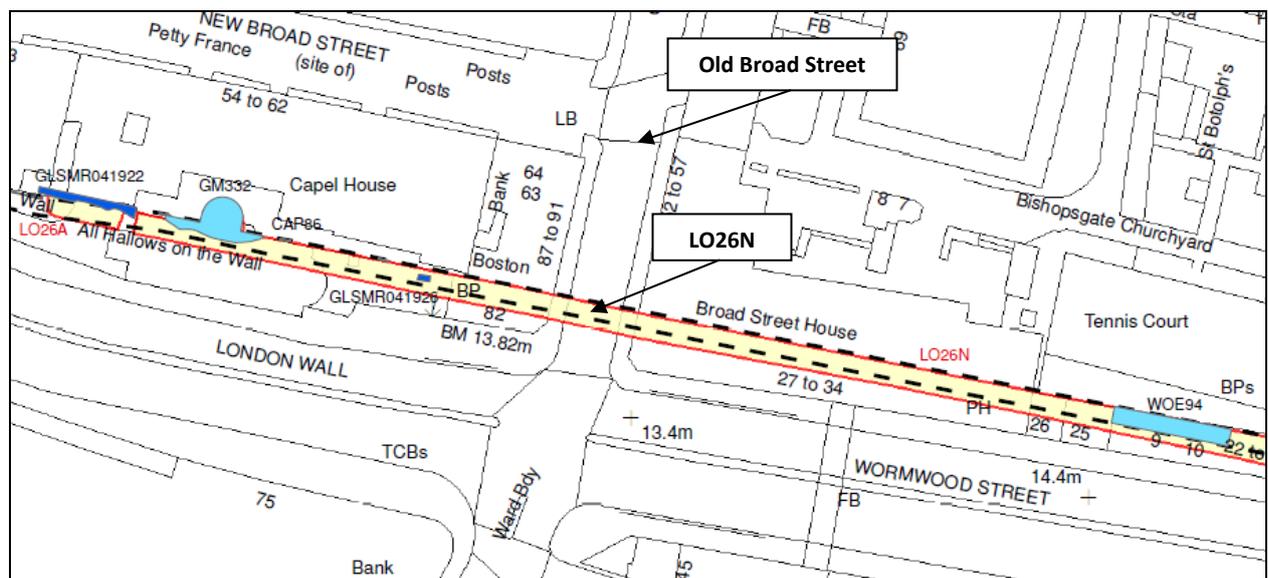
**Figure 1 Alignment of the LO26N City Wall (Crossrail 2009a)**

- A survey in 1991-92 observed the outer face of the City Wall to the east of Old Broad Street in the basement of 54-62 New Broad Street.
- The external face of the City Wall was identified in test pits to the east and west of the All Hallows on the Wall church (CAP86) to the east of Old Broad Street (figure 1)

- The City Wall was observed to its full width in the basement of 23-24 Wormwood Street, to the east of Old Broad Street during investigations in 1994 (WOE94 – figure 1).

- The alignment of the City Wall that constitutes section LO26N of the Scheduled Monument is extrapolated from observations at All Hallows on the Wall and at 23-24 Wormwood Street, to the west and east of Old Broad Street respectively. This alignment runs beneath Old Broad Street, however, the preservation of the City Wall in Old Broad Street is unknown.

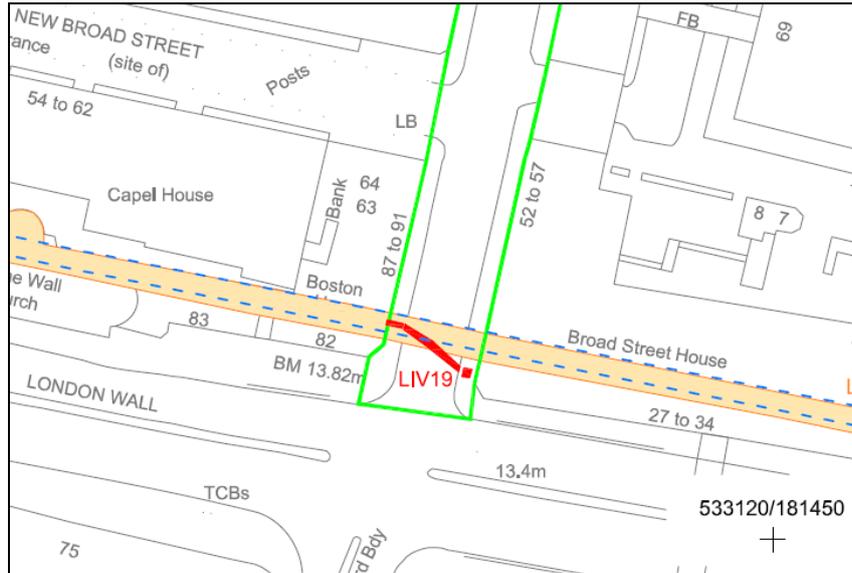
Figure 2 LIV19 trial trench at the southern end of Old Broad Street (Crossrail 2009b)

- 2.2.8 Refer to Appendix E for the full evaluation report prepared by MoLA. The results relating to LIV19 are summarised below:
- Trench excavated to 1.5m below ground level.

- Existing utilities occupied the full 1.5m deep trench; also the remains of an 18th or 19th century cellar were identified.
  - The Scheduled Monument was not encountered.

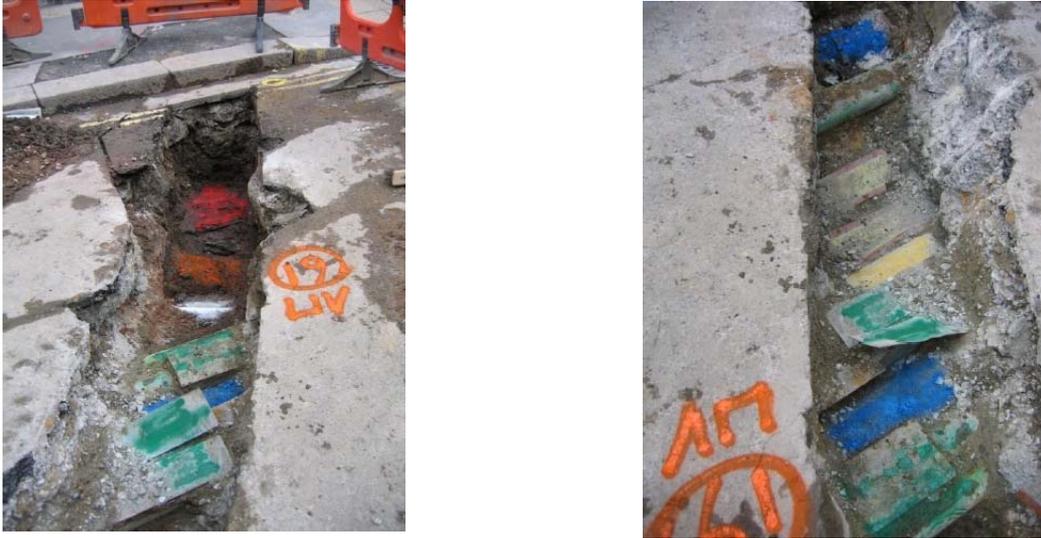
**Figure 4 Photographs of the exposed utilities in trench LIV19 (JB Riney 2009)**

2.2.9 Figure 4 and 5 (not to scale) show the concentration and depths of existing utilities and obstructions exposed in trench LIV19 in the section of Old Broad Street through which the Verizon ducts will be installed. Figure 5 shows modern disturbance to a minimum of 850mm below ground level, which is deeper than the proposed Verizon works. Figure 4 shows photographs of the exposed utilities in trench LIV19.

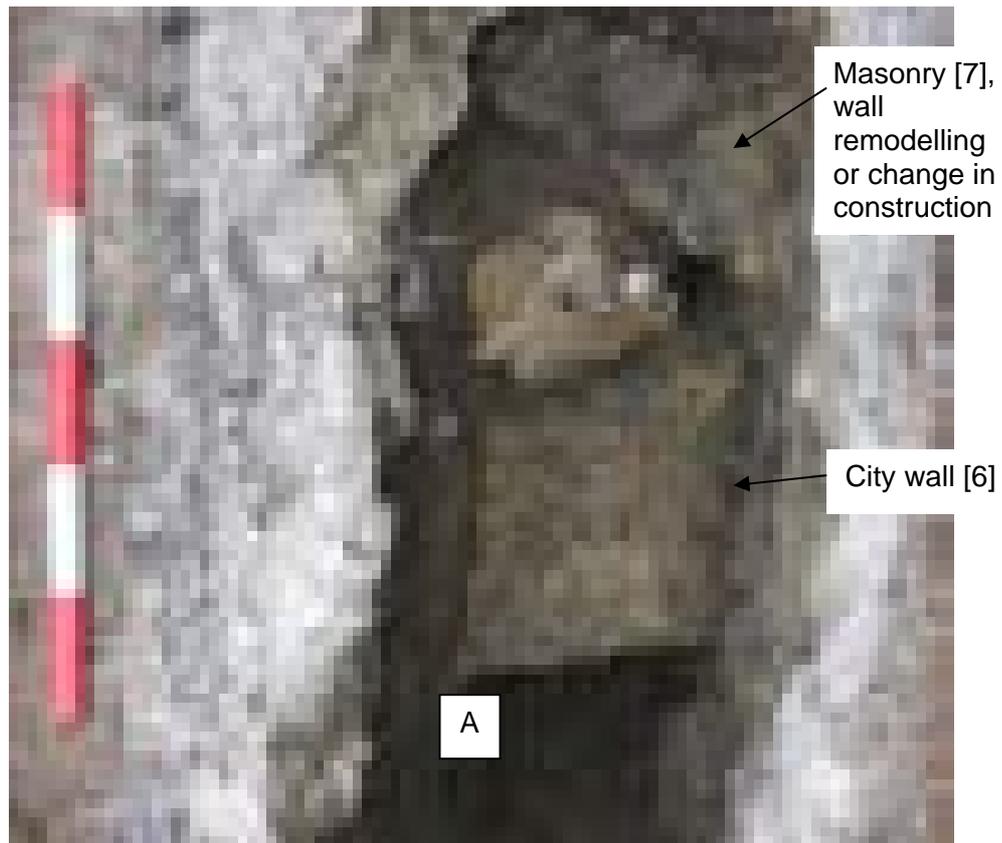
Fig 9 Vertical view of the city wall in LIV16, looking north

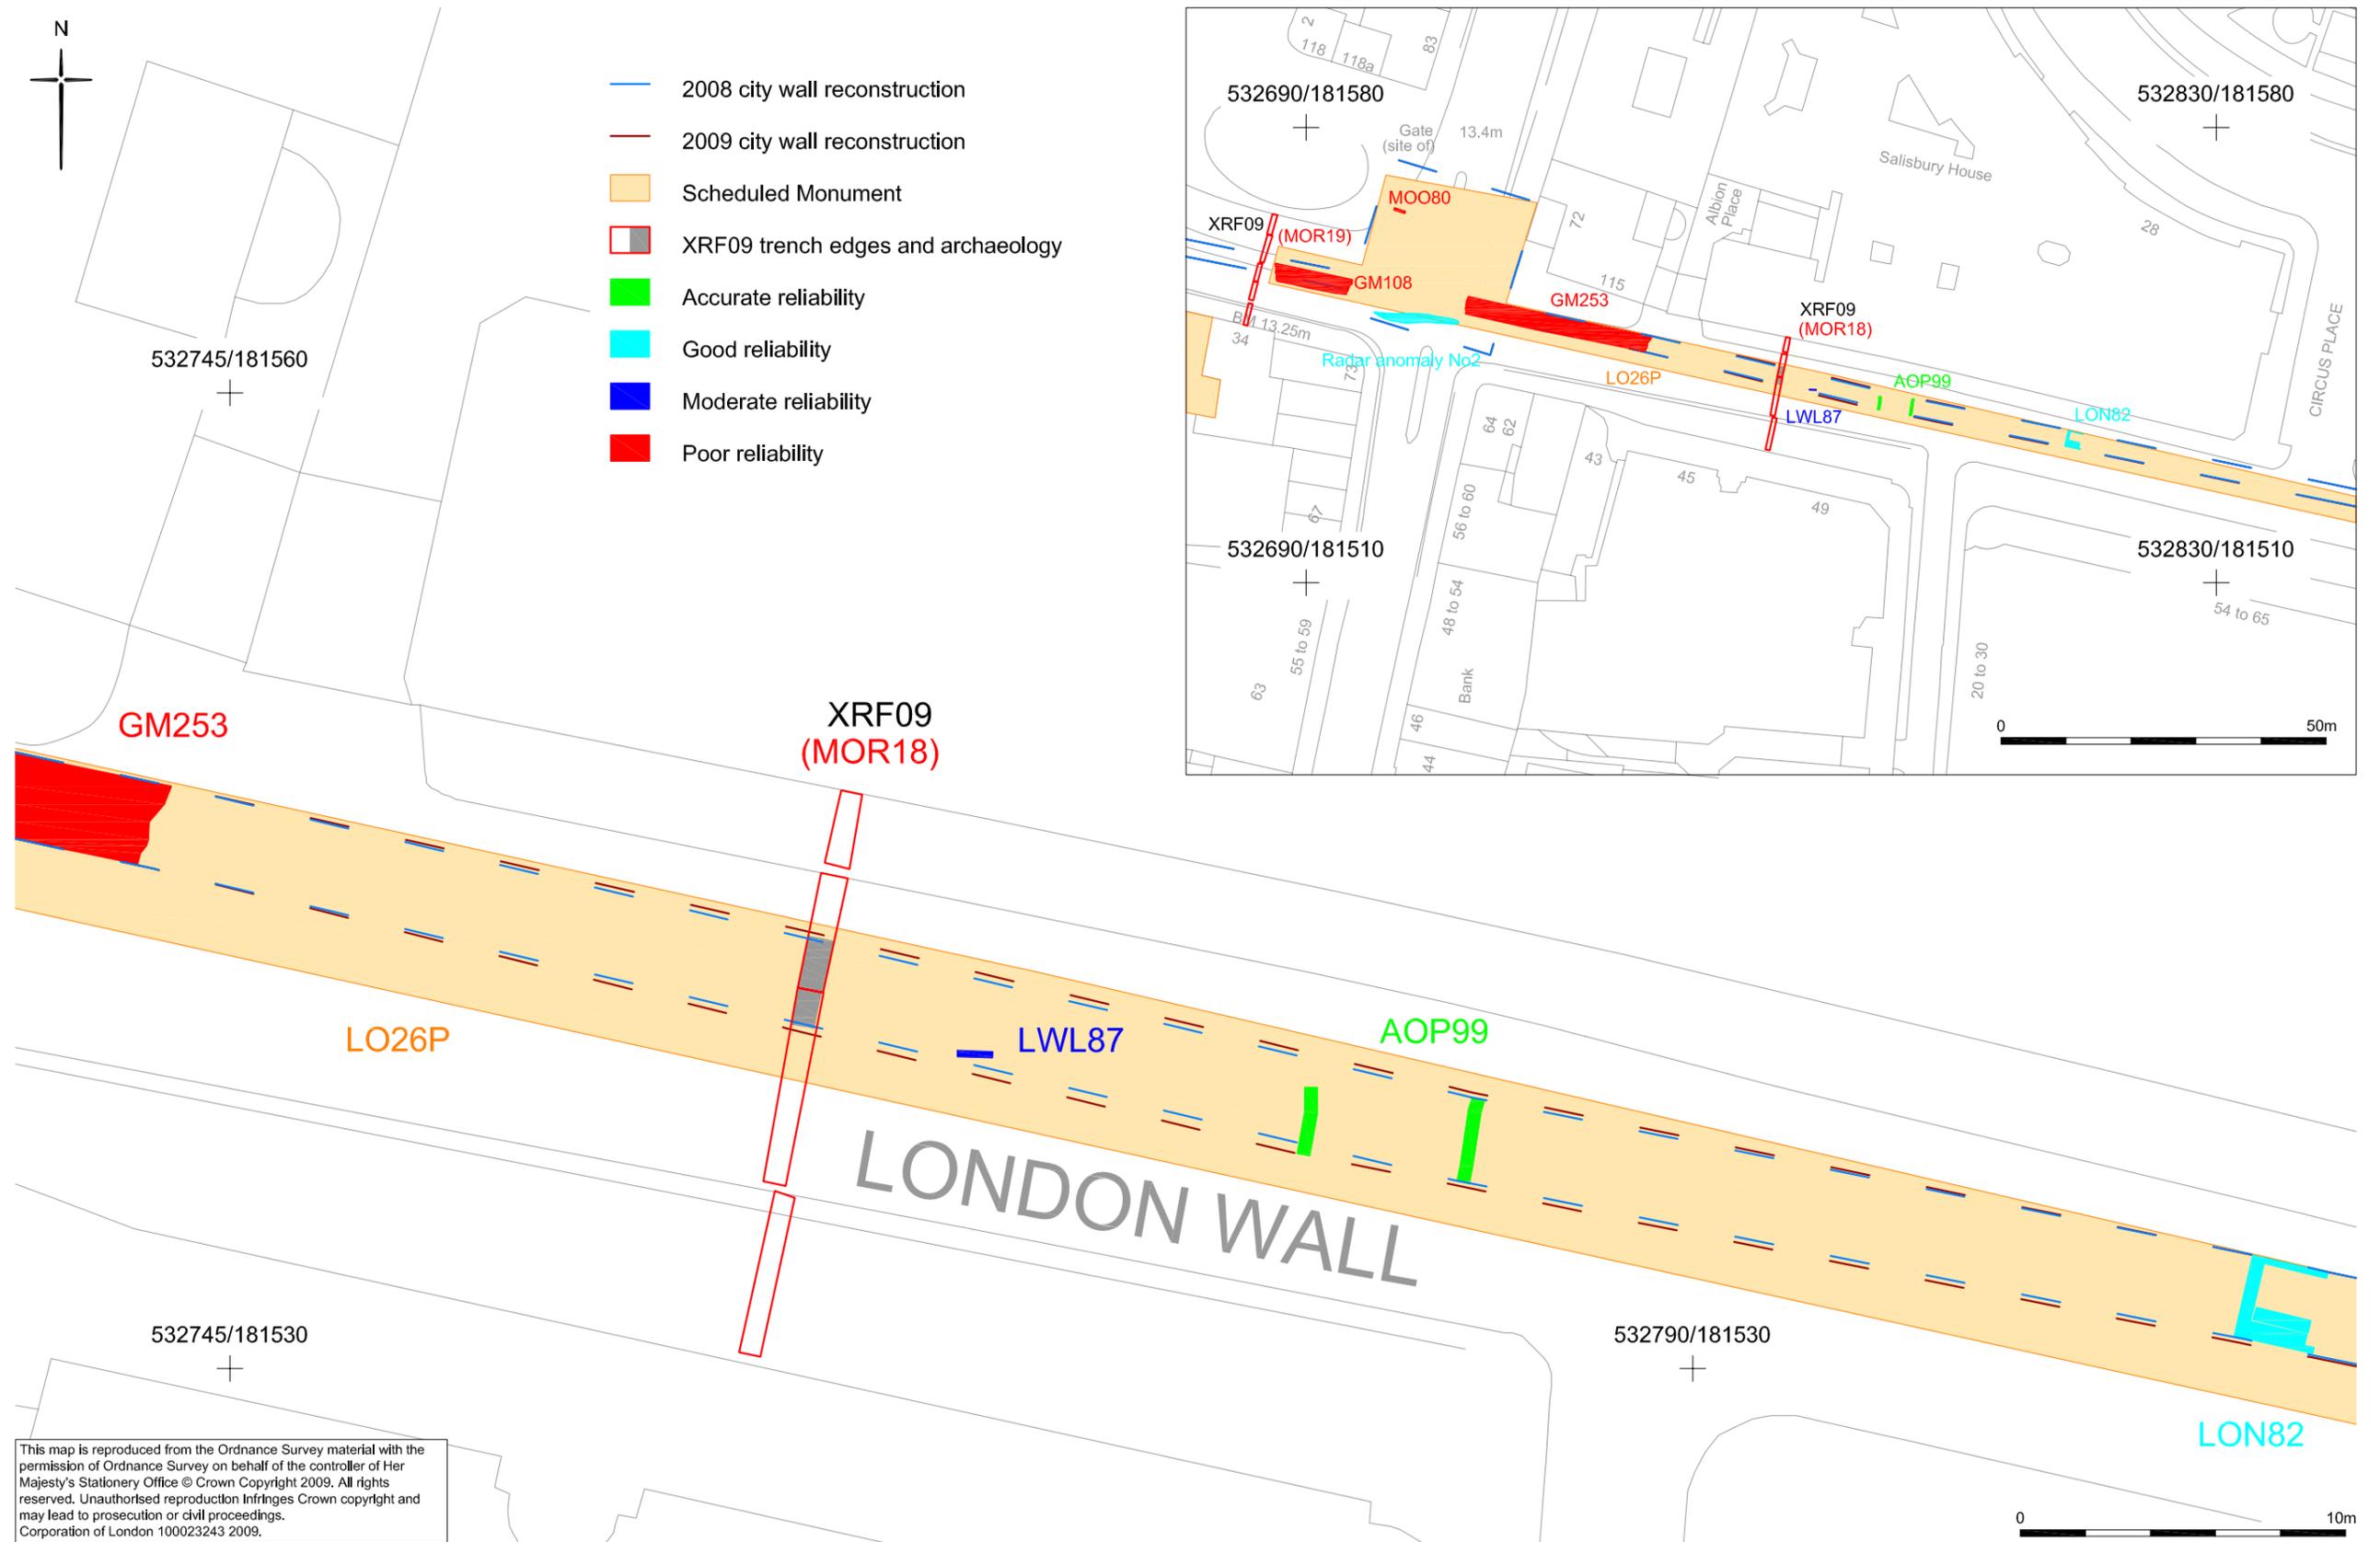
Fig 12 Revised reconstruction of City Wall location (inset shows revised reconstruction in relation to surrounding area)

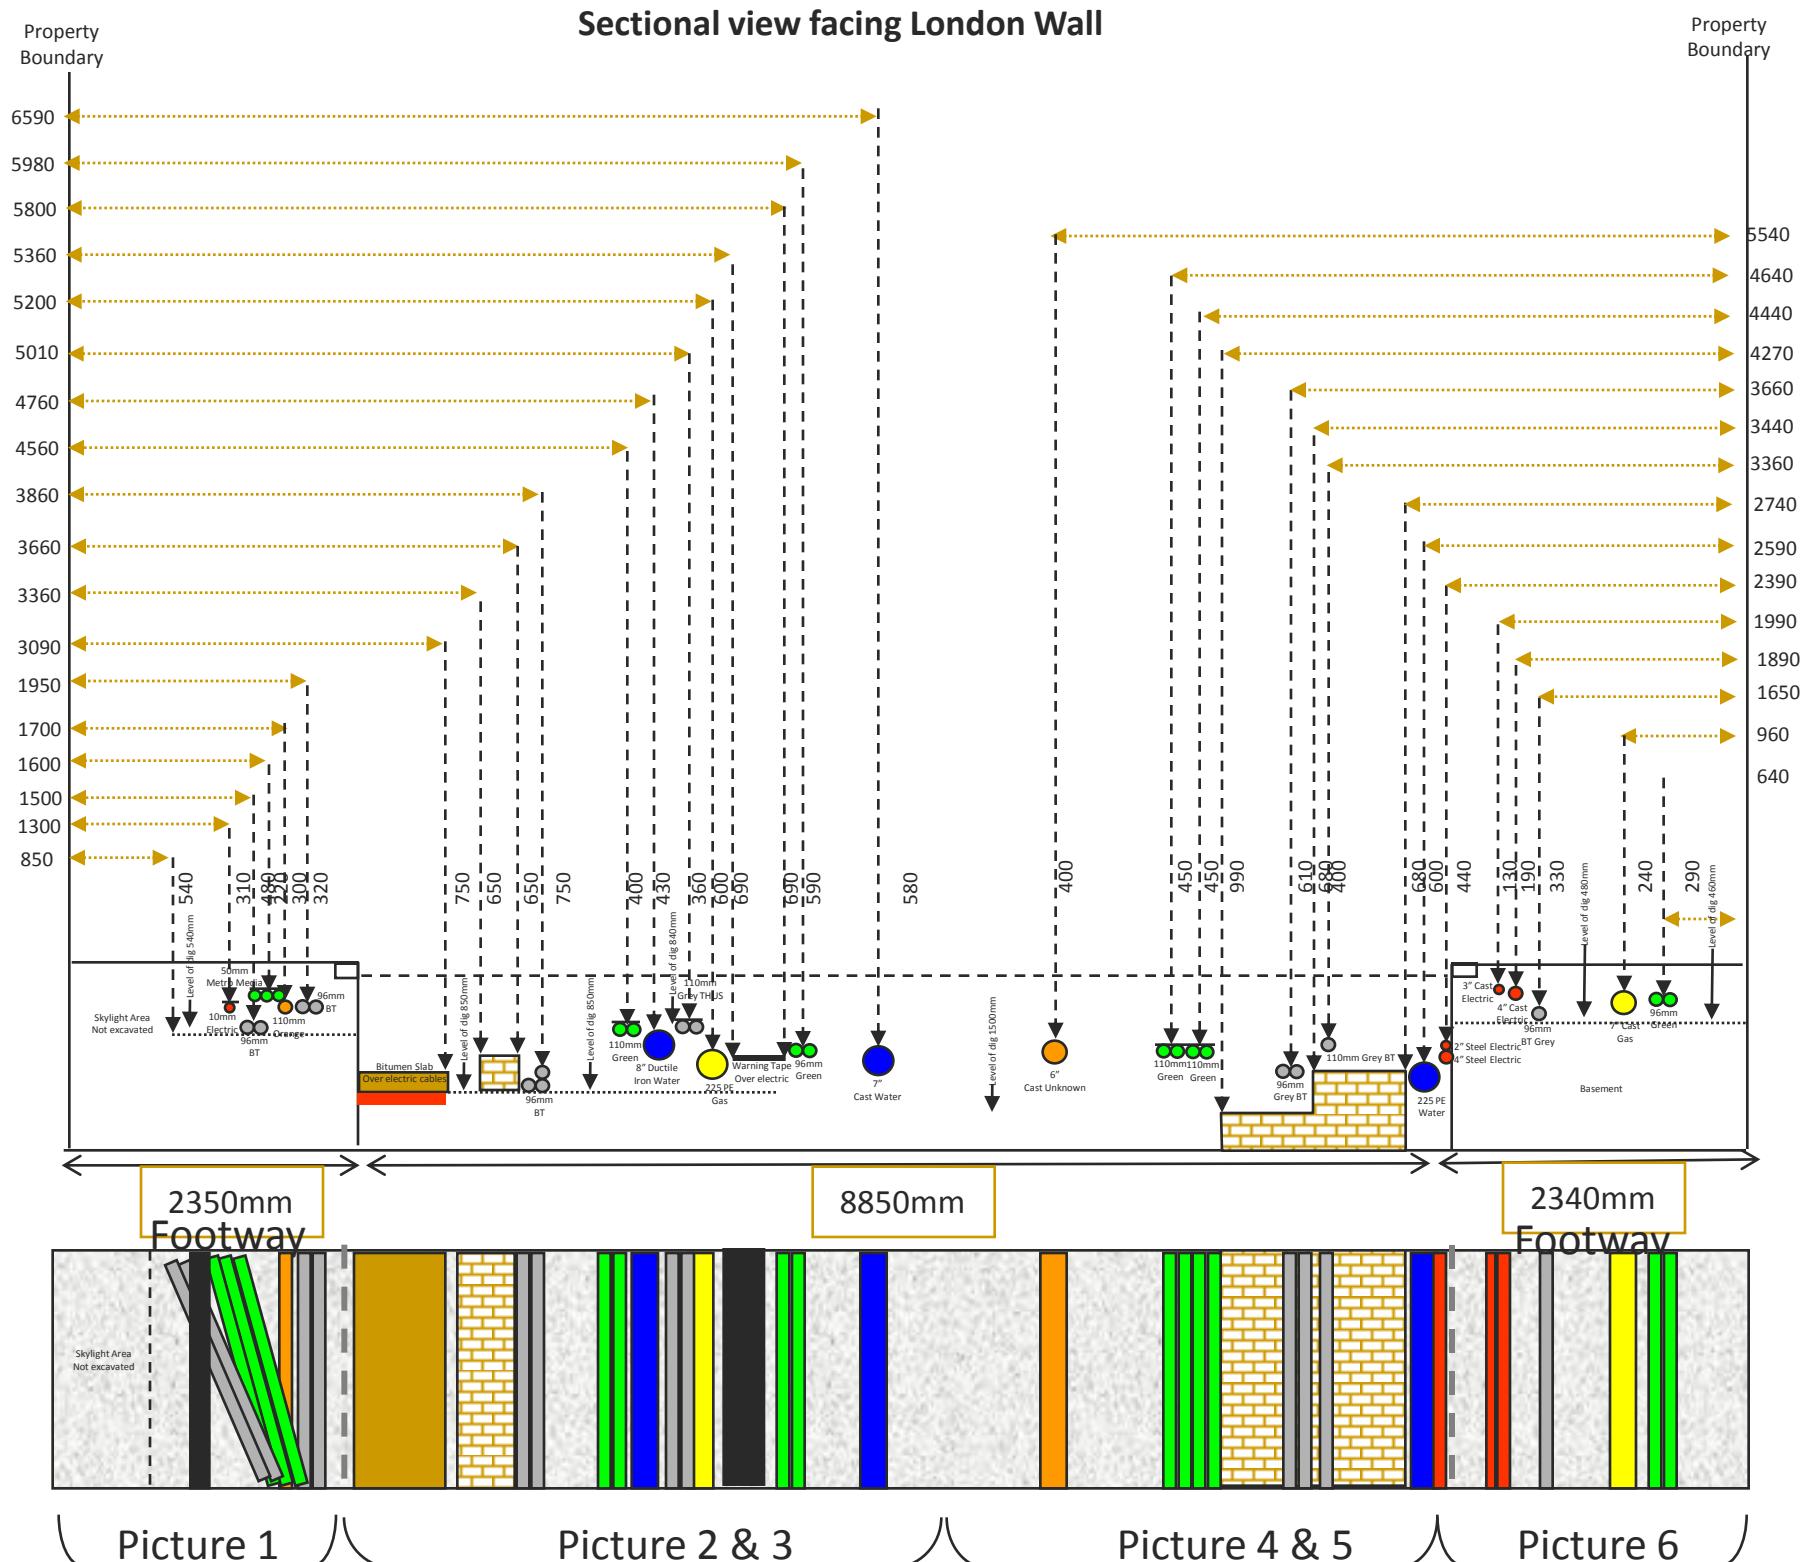
Not to scale

All measurements in MM, Utility ownership is assumed only and should be verified

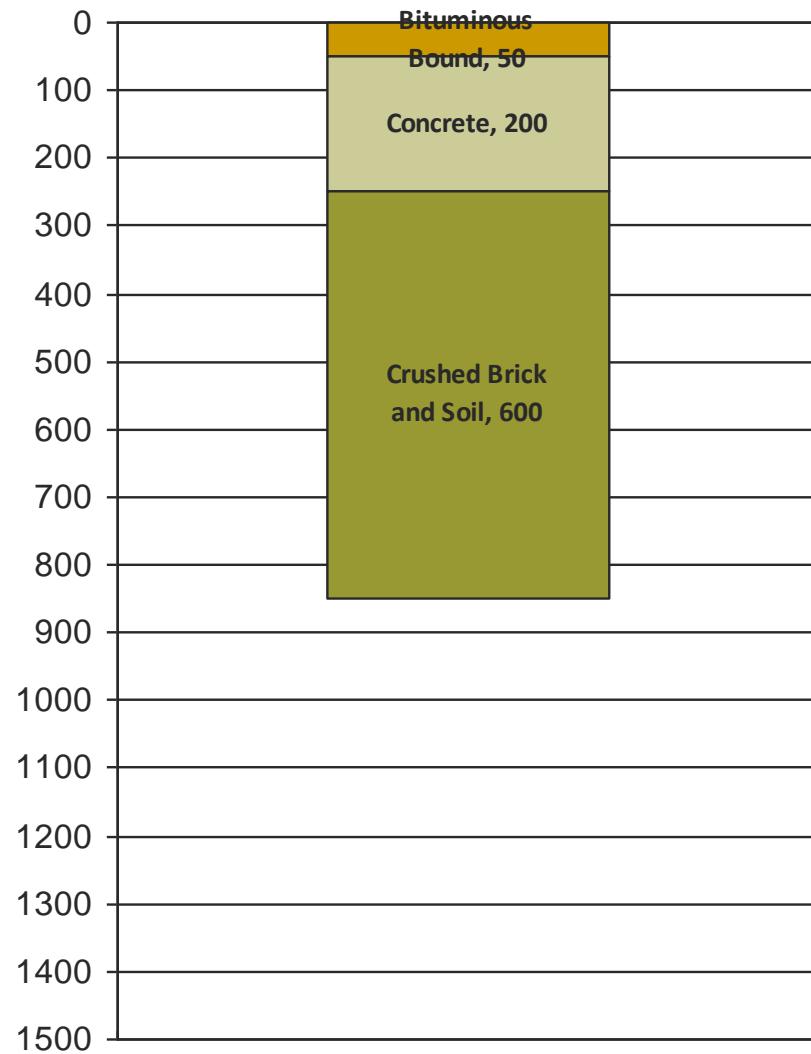
Road Structure

<b>Surface Type :</b>	Bituminous Bound Material
<b>Ground Conditions :</b>	
<b>Ground water (m) :</b>	N/A
<b>Excavation stopped (m) :</b>	850mm
<b>Ground Contamination :</b>	None
<b>Tree Roots :</b>	None Found
<b>Composition (m) :</b>	
<b>0 – 50mm</b>	Bituminous Bound Materials
<b>50 – 250mm</b>	Concrete
<b>250 – 850mm</b>	Crushed Brick and Soil
