# CENTRAL SECTION PROJECT

## C150 ROYAL OAK PORTAL

### NON-LISTED BUILT HERITAGE RECORDING

**Document Number: C150-CSY-T1-RGN-CR076\_PT001-00010**

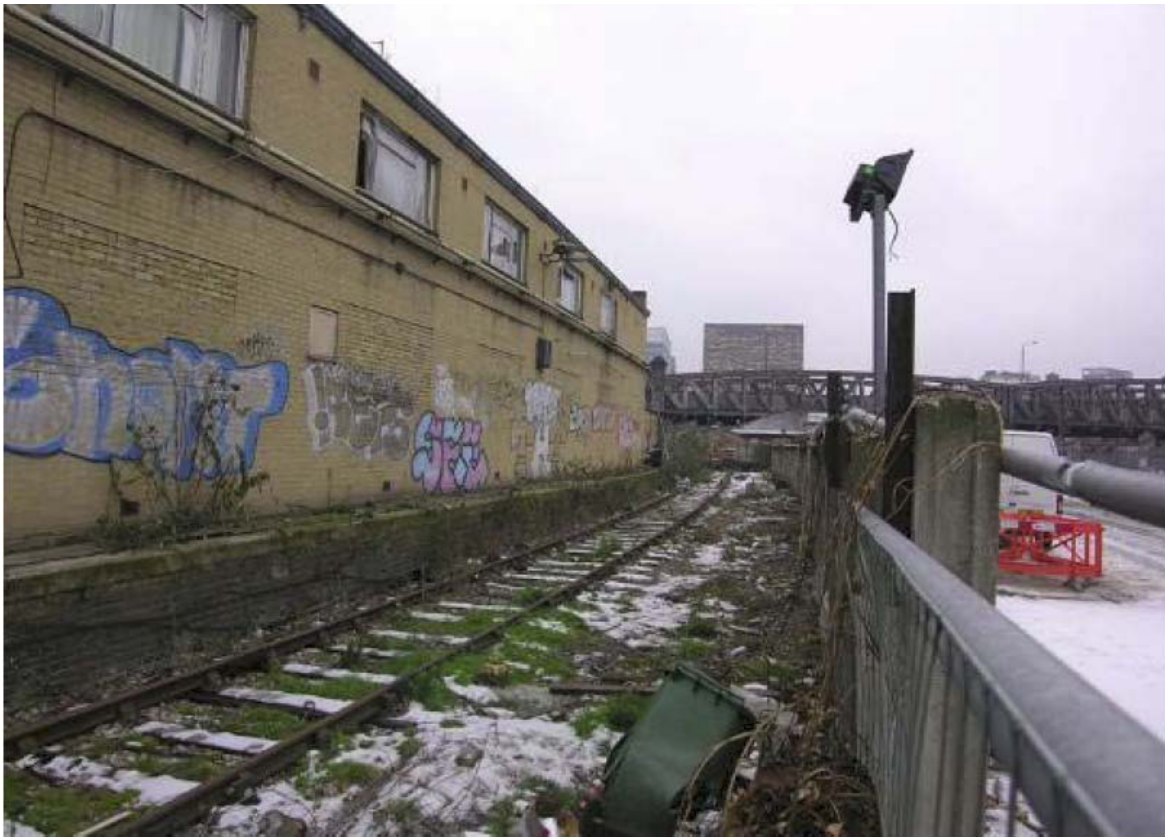
*Fig 2 Photo taken in December 2009, showing the track and sleepers in place (item 1).*

During the survey it was found that the 19th-century railway sleepers, along with the accompanying tracks, had been removed prior to the enabling works. However they were present when the site was visited by MOLA in December 2009 for the assessment included in the WSI (Crossrail 2010a), when a reference photograph was made. This is reproduced in this report (Fig 2), along with the same area photographed on 12th May 2010 (Fig 3). None of the timber sleepers remained in situ, and none were noted discarded to the side of the area nearby. The rails had also been removed. This stretch of 19th-century track had originally allowed trains access to the goods shed and cattle pens (Crossrail 2010b).

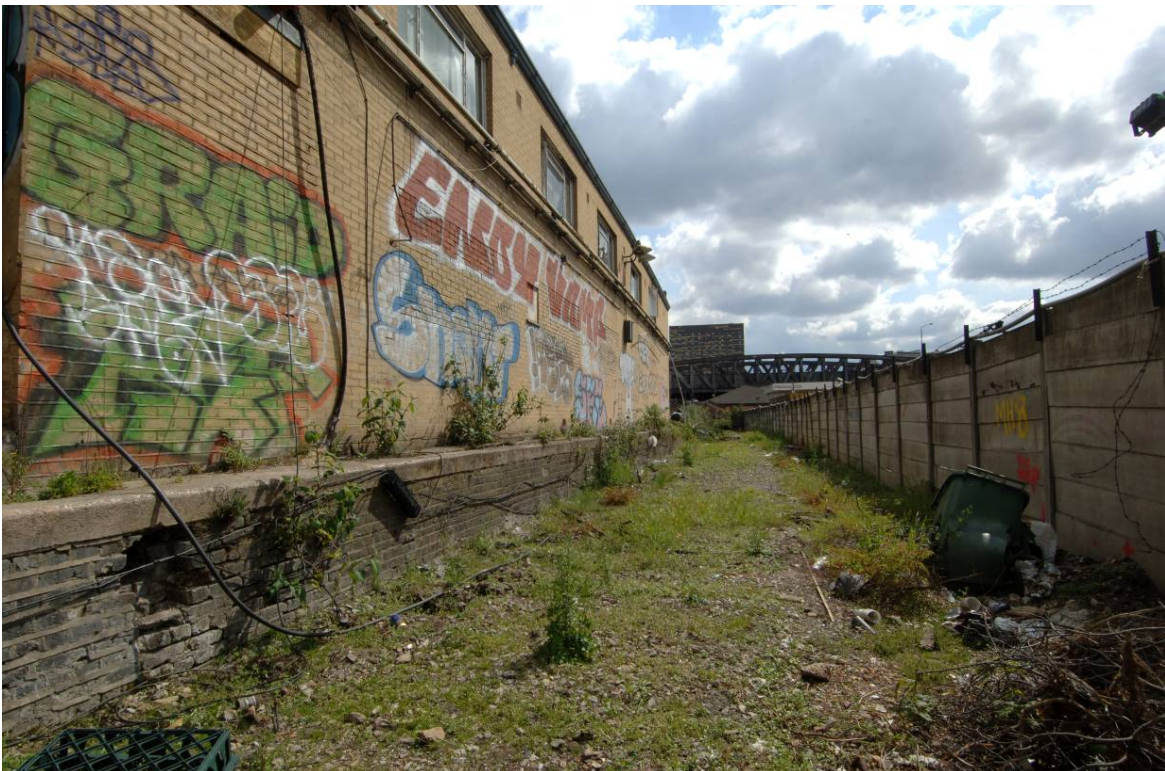
*Fig 3 Photo taken in May 2010 during the survey with the track and sleepers removed.*

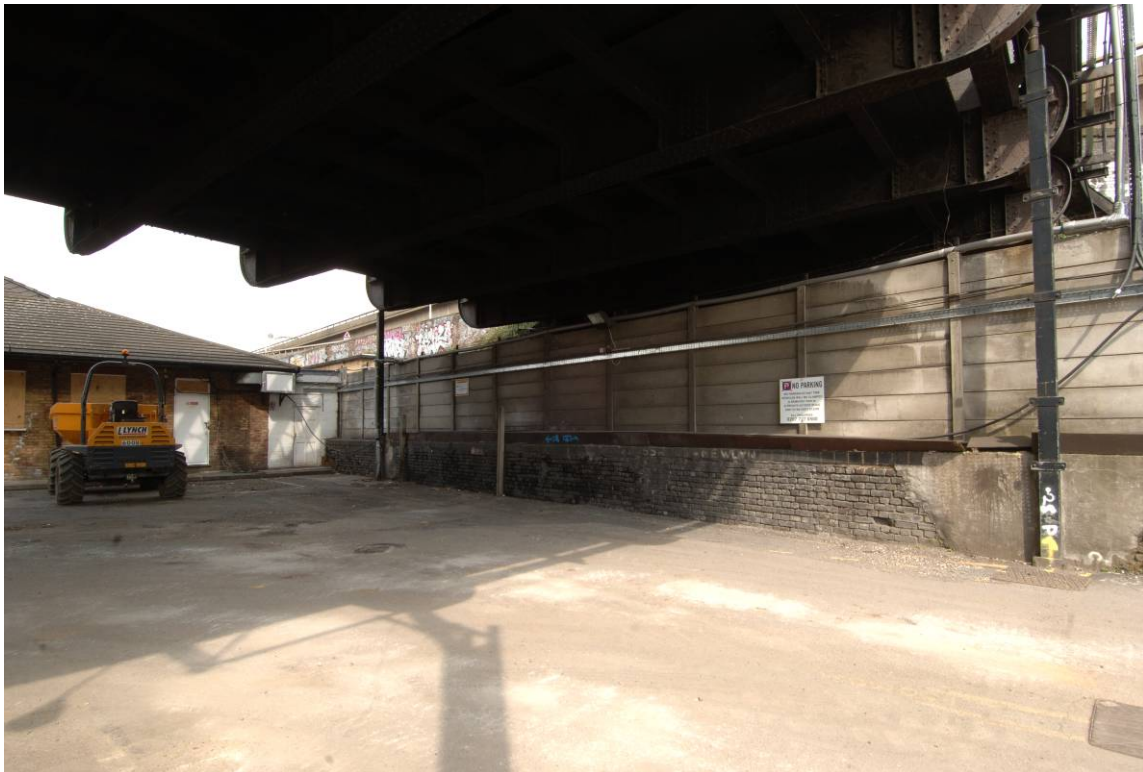
*Fig 4 The western end of the brick retaining wall looking north-west (item 2)*

Within the southern part of the site was a brick retaining wall running west to east for approximately 250m from the northernmost support of Westbourne Bridge in the east up to Lord Hill's Bridge in the west. It apparently formed a retaining wall, beyond which was the former goods yard and cattle pen areas and was approximately 1.05m in height above the present ground surface. (Fig 4, Fig 5 and Fig 6) The wall also appears to have formed the platform edge of the former goods yard area and the cobbled platform surface to the north.

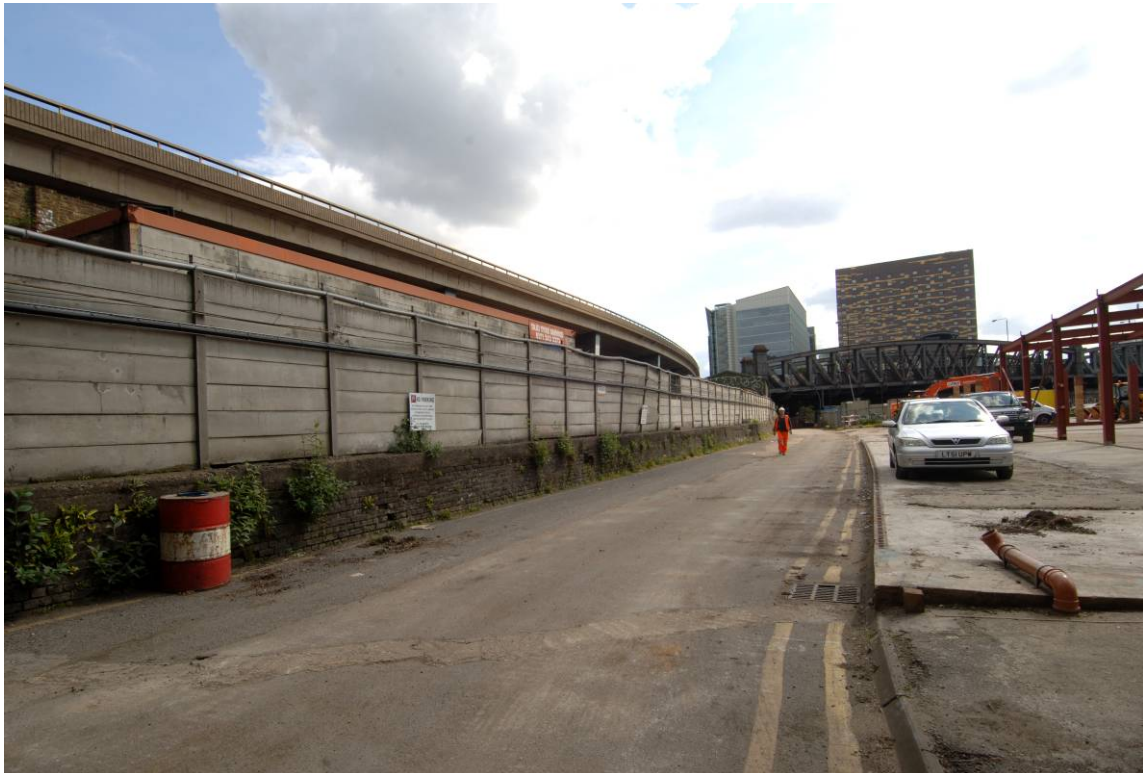
*Fig 5 The brick retaining wall looking north-east (item 2)*

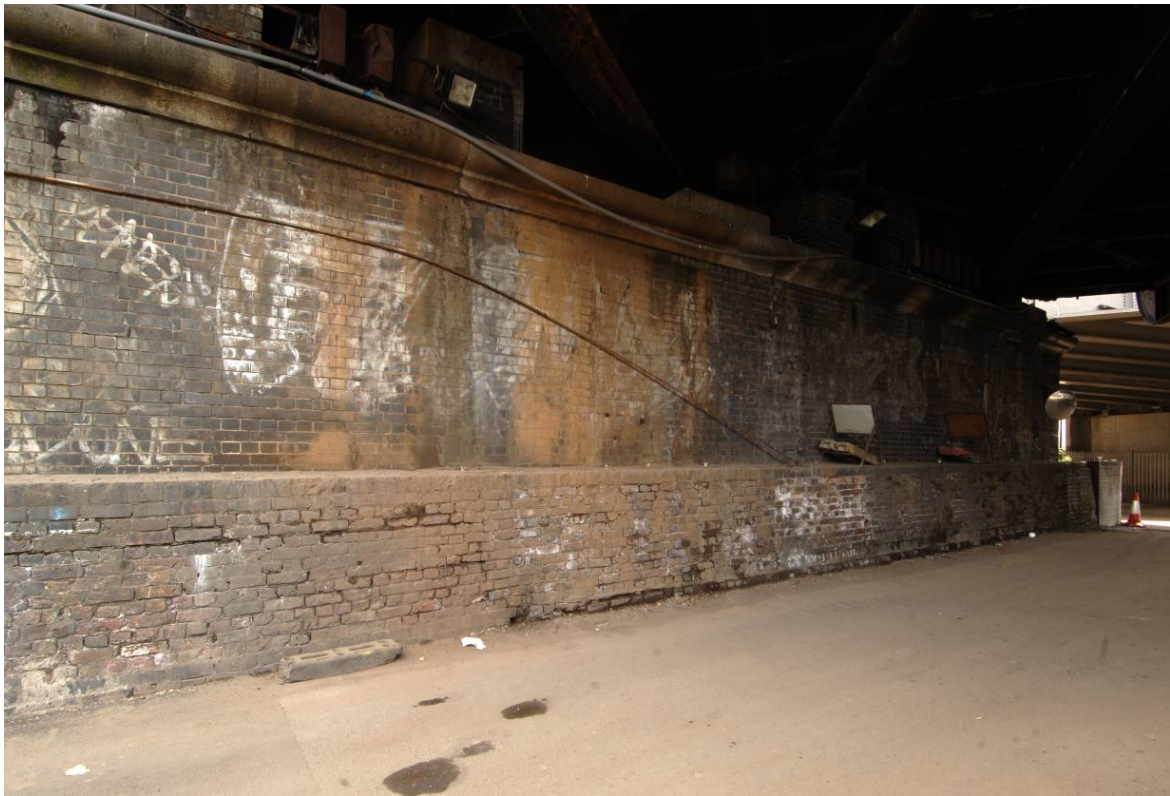
*Fig 6 The eastern end of the brick retaining wall continuing below Westbourne Bridge, looking east (item 2).*

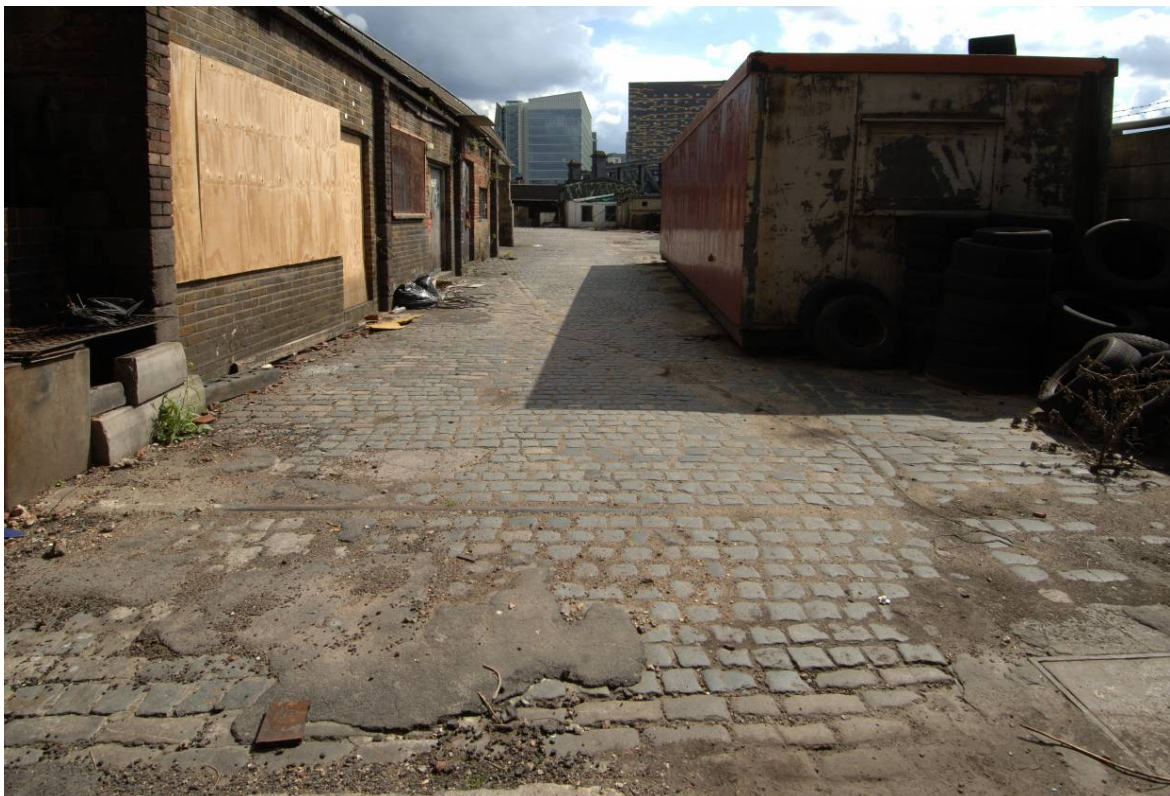
To the north of the brick retaining wall to the north-east of Ranelagh Bridge the surface of the former goods and cattle pen area was cobbled (Fig 7). At least three separate sizes of cobble stones were used in specific and separate areas. The larger cobble stones were used in areas closest to the former platform edge and the northernmost limit of the area, with a central strip of smaller cobbles, separated by cobbles arranged in a line (Fig 8). Variations in cobble size may

*Fig 7 The western end of the cobbled area, looking east (item 3)*

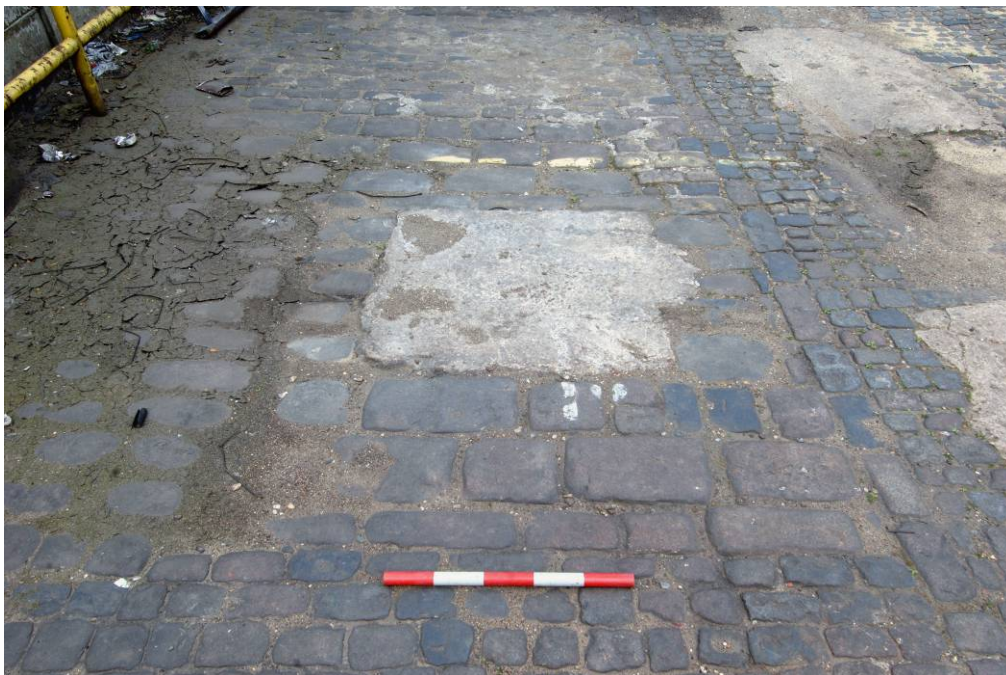
Along the southernmost edge (ie along the platform edge) an area of cobbles had been laid in a square approximately 1.5m wide, the central area of which had been replaced and resurfaced in concrete (Fig 9). This may indicate where an object or piece of machinery set into the cobbles, such as a crane, winch or gate, had been removed and the area resurfaced.

*Fig 9 The square in the cobbles, with the concrete infill of replacing a removed item, possibly a crane or other piece of machinery (item 3).*

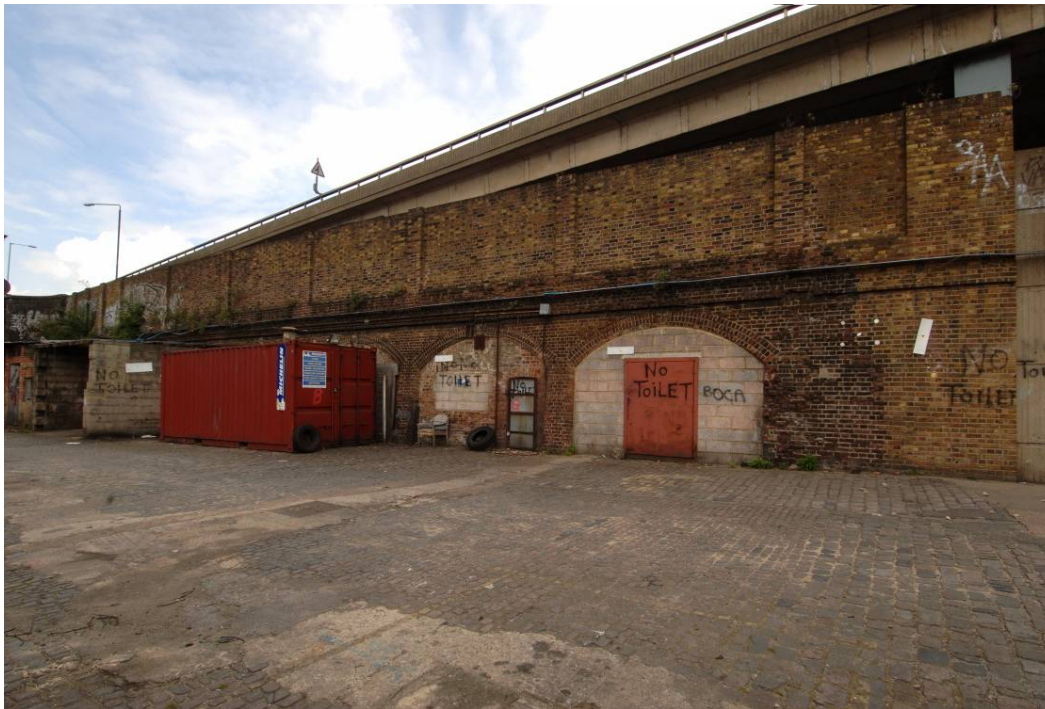
Along the northern edge of the site, in the eastern area between Ranelagh Bridge and Westbourne Bridge was a retaining wall (Fig 10), the upper portion of which, along with the extreme eastern end, showed signs of having been rebuilt. The wall itself continued to the west as far as Lord Hill's Bridge, with the upper portion having been rebuilt throughout. However in the eastern area were a series of five small arches. These had been used until recently, some being bricked up with cement blocks, whilst others were filled with used tyres and other debris (Fig 11). In depth they were shallow and extended no more than 2m beneath the vault. This wall and the arches are likely to have formed the boundary between the goods yard and the Harrow Road.

Fig 10 The arches along the northern edge of the goods yard area, running adjacent to Ranelagh Road, with the Westway behind looking north-west (item 4).

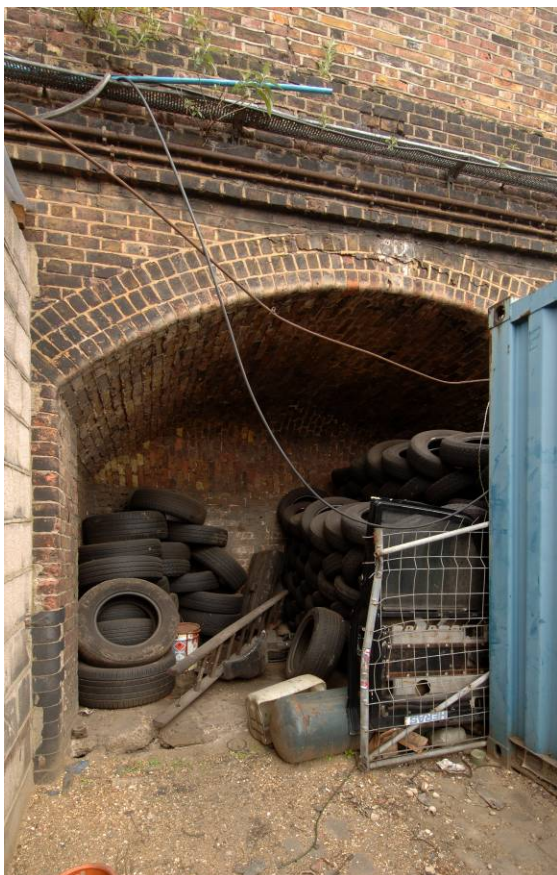
Fig 11 The westernmost accessible arch, looking north (item 4).
