Archaeological Investigations at The Royal Arsenal, Woolwich. Crossrail Station Box

Interim Statement

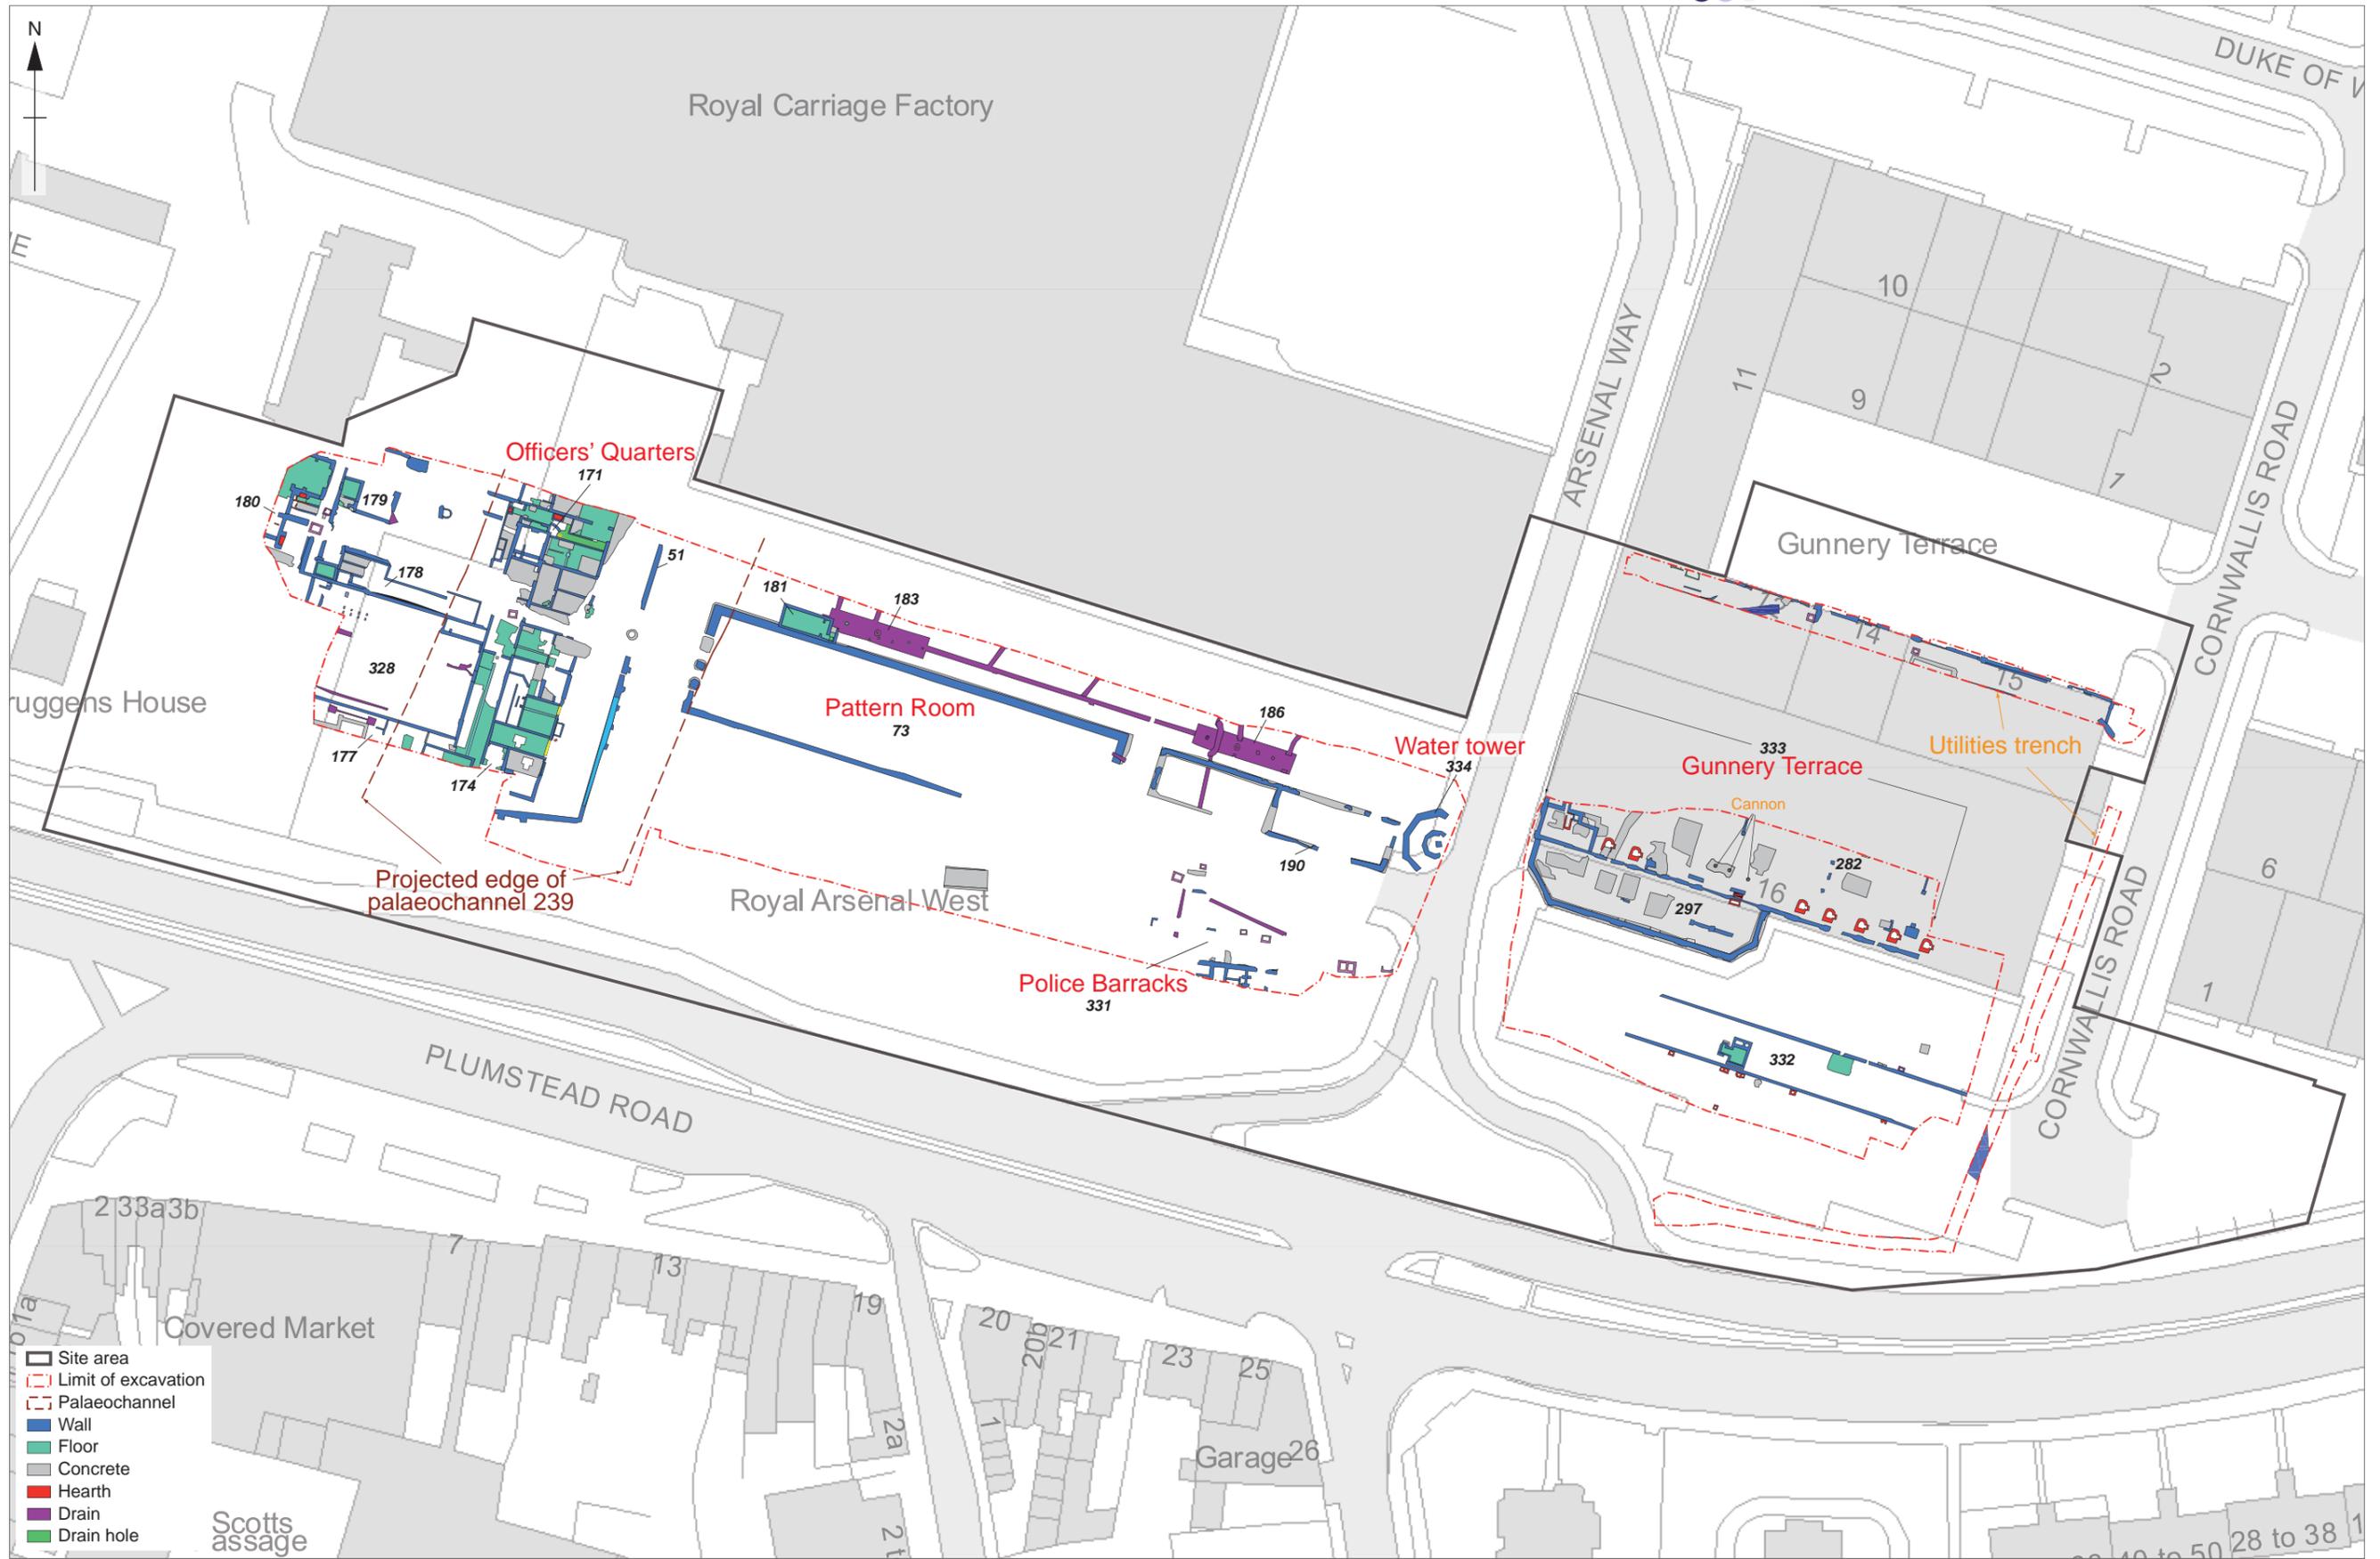
Figure 2: Site Plan

- 5.1.1 The main features recorded on the site are described below and illustrated on the site plan (Fig.2).
- 5.1.2 Natural river terrace mid orange sand and gravel was observed throughout the site. This was overlain by 18th and 19th century made ground deposits which in turn were overlain by 20th century demolition layers and the make up and concrete and tarmac surfaces of the modern temporary car park. The upper horizon of the natural gravel was extensively truncated by the post medieval activity and with the exception of the channel described below no earlier features pre-dating the Royal Arsenal were identified. The natural was generally approximately 1-1.5m below the current ground surface although at the western end of the site the truncation was more extensive and the natural horizon was 3-3.5m below current ground level, roughly coinciding with the 105m ATD formation level for this phase of works.

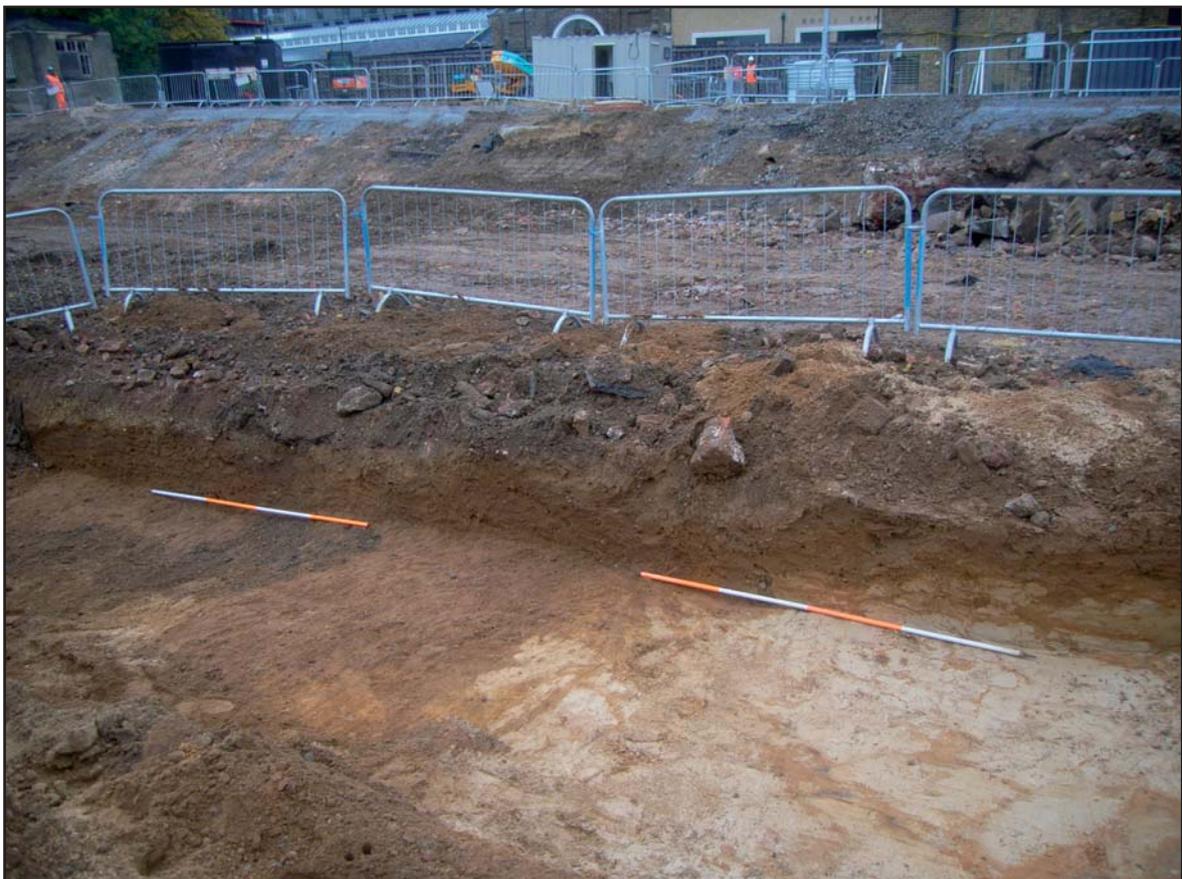
Plate 2 - Eastern edge of palaeochannel 239

- 5.2.1 Towards the western end of the site a NE-SW aligned feature (239) was revealed cutting through the natural sand and gravel at approximately the 105 ATD formation level (Plate 2).

- 5.2.2 This roughly 40m wide feature corresponds with a channel shown on historic mapping and indications of channel deposits recorded in a borehole (WP142R) just to the north of the excavation which suggest the presence of an ancient watercourse running across the site. This area had been heavily truncated by the construction of Royal Arsenal buildings but the surviving uppermost deposits of this feature were recorded. A brick culvert in the upper fills appears to represent an attempt to contain the water from the channel prior to Arsenal related construction. A further stage of work is planned to take place during the further bulk reduction of the area in 2012 to examine earlier fills of the channel. The results of this future investigation will be reported in a further interim statement following completion of the work.

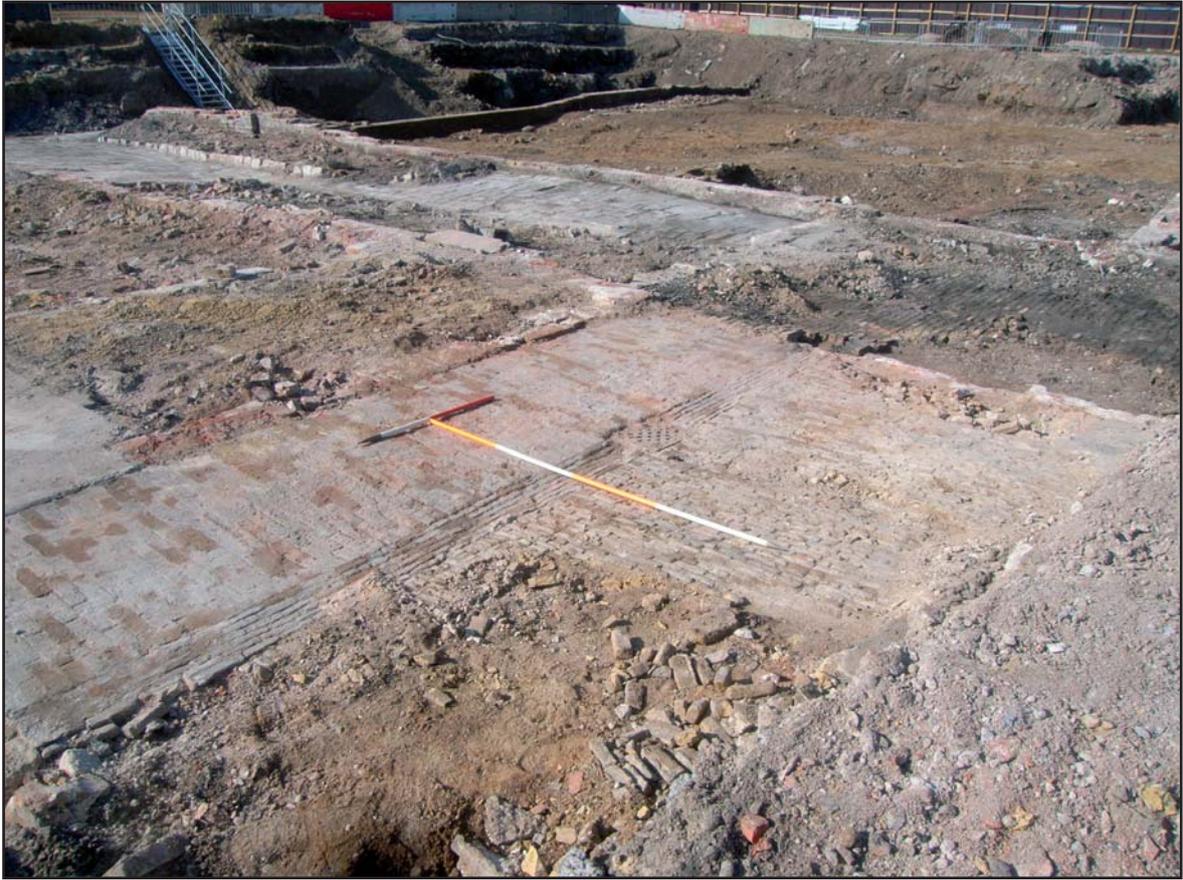
Plate 3 - Floor surfaces within Officers' Quarters (Structure 174)

- 5.3.3 Structure 174 was recorded as being 10m in width NW-SE, directly over the footprint of foundation 119 and for the most part was constructed of red brick with a lime mortar bonding. The average level of the revealed walls and floors was between 105.6 and 105.76m ATD. All interior partition walls ran parallel or at right angles with the outer walls except dog-legged wall 17 which may have served as a stairwell. The floor surfaces were probably all originally of yellow Flemish brick, laid on edge, aligned with the outer walls (floors 14, 19, 20, 24 and 26) or in a herringbone pattern (16) or as gullies (15 and 25). At a later date these floors had mainly been overlain or replaced with concrete screed floors or concrete floor tiles.

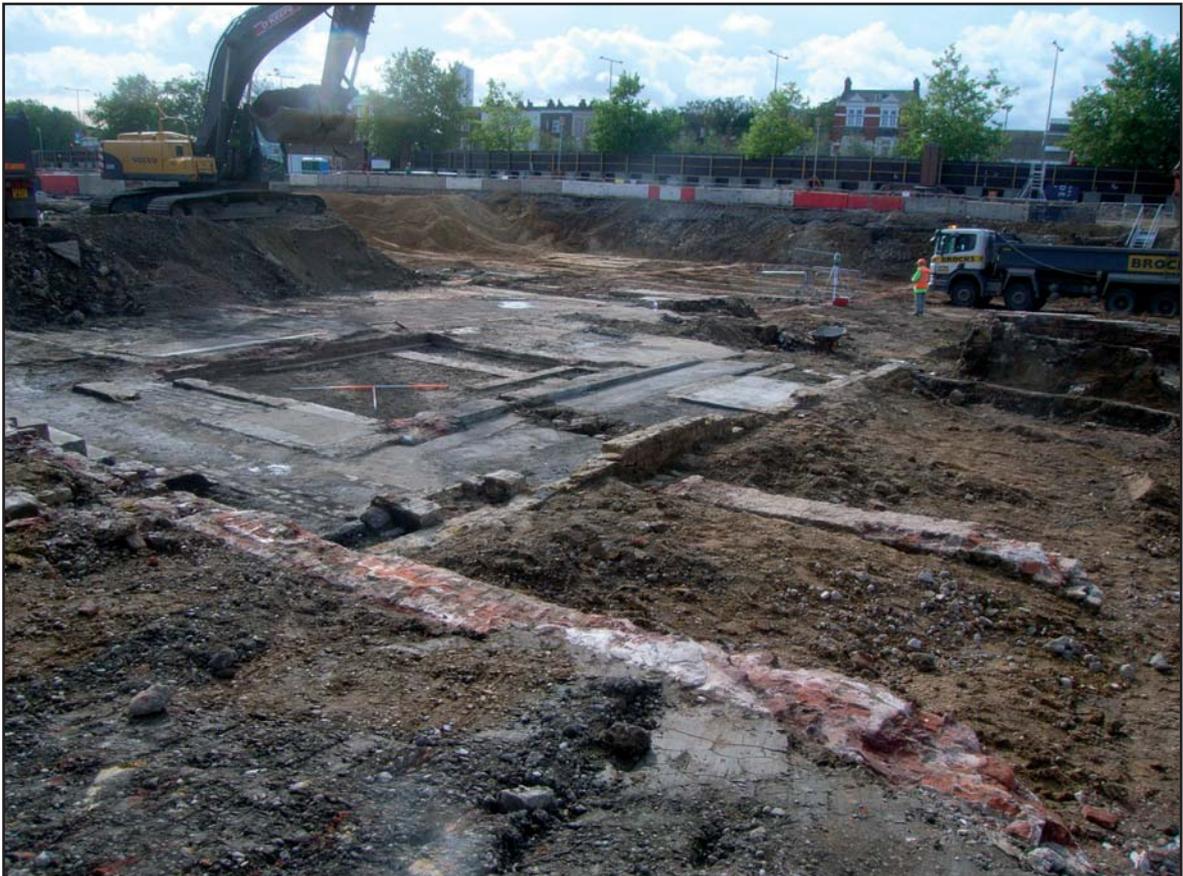
Plate 4 - Officers' Quarters (Structure 171)

- 5.3.6 The northern area of the Officers' Quarters (Structure 171) showed more evidence of remodelling of the building over time. Mixtures of floor surfaces, often within the same room, were observed: Flemish brick (172), possibly original, granite setts (131, 132 and 133), flagstones (128 and 147), 'chocolate block' concrete tiles and patches and whole floors of concrete screed. Three hearth/fireplaces were observed (134, 145 and 152) as were three toilet cubicles (137, 148 and 161).

- 5.3.7 The northern extent of the building (171) was 7.5m wider in plan to the west than the central/southern extent (174). It seems likely that this is a result of extensions being made to the original footprint over time, although interpreting the progression of walls or even the original layout is complicated by the fact that the main load-bearing walls (124, 126, 127, 130, 151 and 167) differ from both each other, in terms of brick size and colour and bonding mortars, and from the underlying foundation (176).

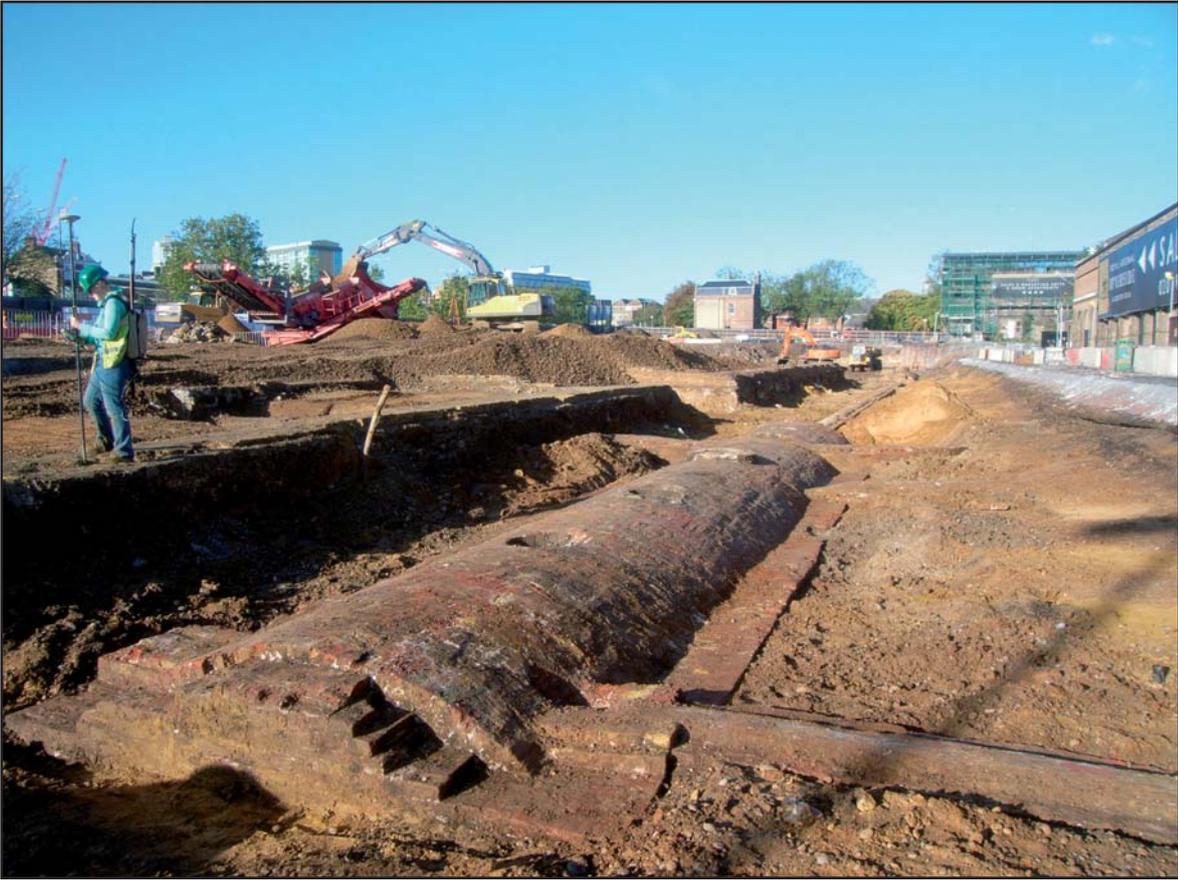
Plate 5 - Pattern Room and drainage tank 186

- 5.4.1 In the central area of the site a number of structures which could be recognised on historic mapping were recorded. Structure 73 ('Pattern Room'), orientated NW-SE, measured 68m in length by 18m in width and consisted of a stepped brick foundation laid on a concrete footing. No interior walls or floors survived previous site remediation. The northern side of this building was abutted by Structure 181, a likely 20th century addition which consisted of a concrete floored sub-basement room accessed by a stairwell at its eastern side.

- 5.4.3 A series of culverts ran on the north side of Structures 73 and 190 and linked with two large brick-built settling tanks, (183 and 186). Both tanks measured 16 x 3m and featured vaulted roofs with access hatches. They were approximately 2m deep (Plate 5).

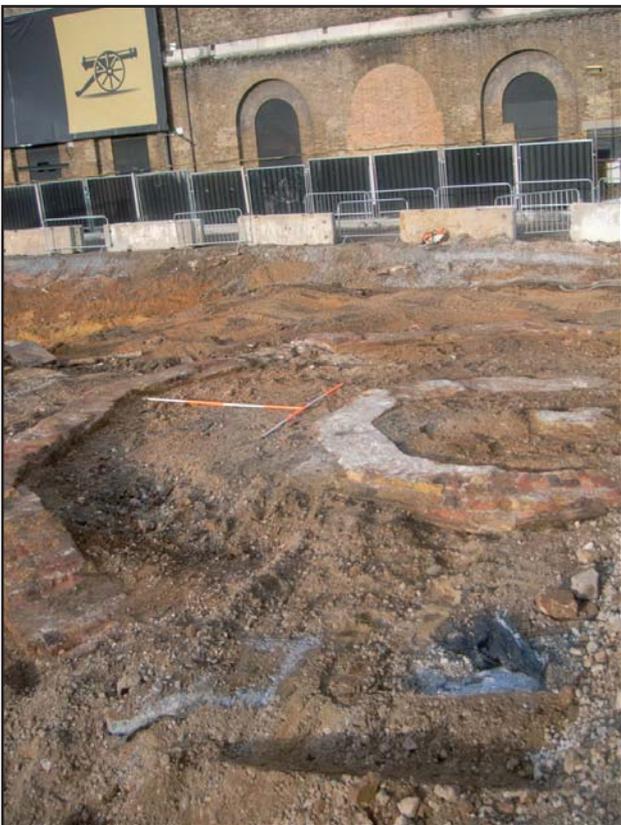
Plate 6 - Base of octagonal water tower 334

- 5.4.4 Immediately to the east of Structure 190 the remains of an octagonal Water Tower were revealed (Structure 334). This measured 10.6m in diameter and consisted of 2 concentric octagonal yellow brick walls overlying a concrete footing (Plate 6).

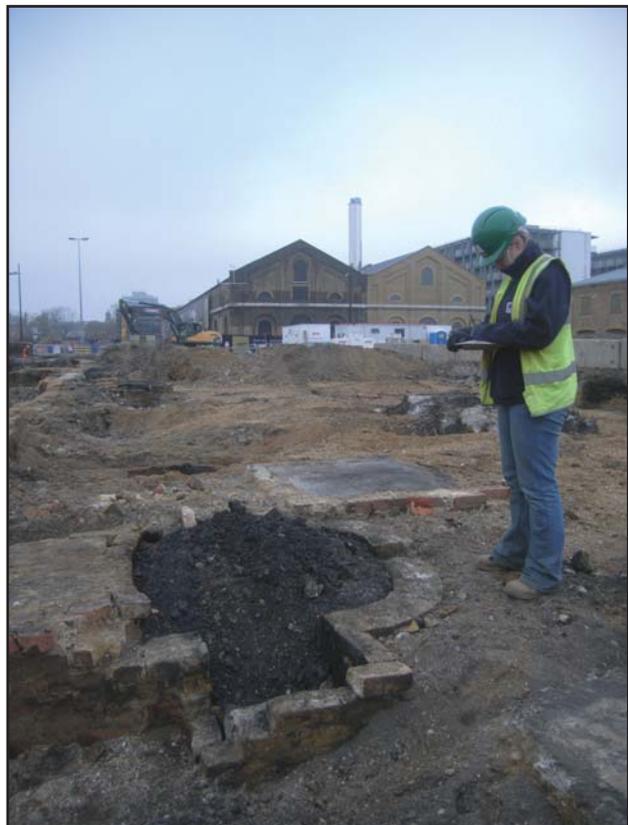
Plate 7 - Recording of furnace/hearth features within structure 282

- 5.5.5 A series of furnace/hearth structures (283 - 286, 302, 315 and 316) (Plate 7) were recorded along the southern wall of Structure 282. These were all similar in form, having an apsidal northern end and a sloping stoke-hole to the east and measured 2 x 1.5m in plan. All contained a black clinker-like deposit. Structure 313, partially revealed beneath later concrete and Structure 293, partially exposed at the northern limit of excavation, are likely to have been similar features. A larger furnace-like construction (Structure 317) was also partially uncovered in the south-western corner of the building. A series of concrete, probable machine bases, some displaying fixing bolts were recorded. The most interesting of these contained a row of 3 naval cannon, aligned NW-SE. The Cannon (324 (Plate 8), 325 and 326) had been set vertically within a 4m deep block of concrete with their muzzles uppermost and level with each other.

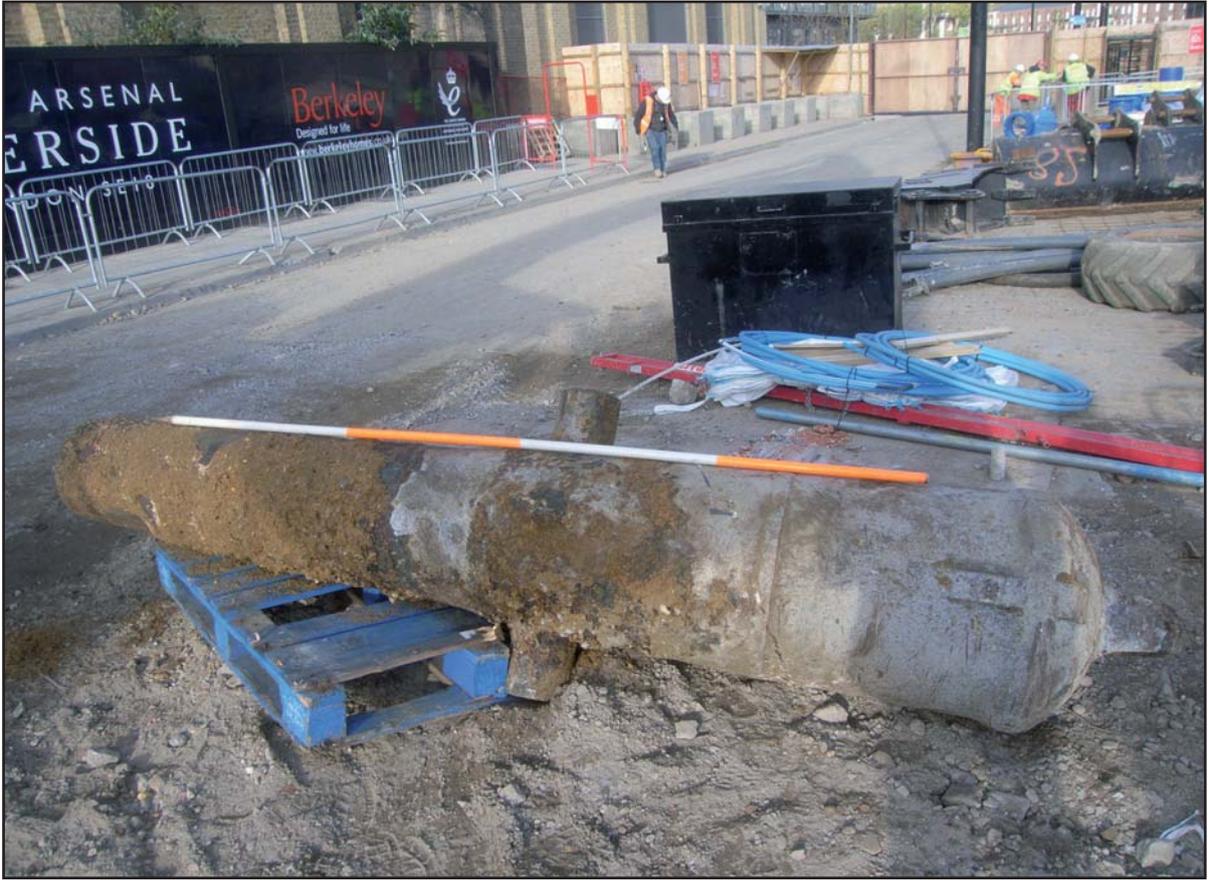
Plate 8 - Cannon 324

- 4.1.2 The cannon (324, 325 and 326) were all 32 pounders and of sea service issue. They dated from 1834 to the late 1850s and had their muzzles truncated as part of their decommissioning from active service. Cannon 324 (Plate 8) featured a V.R. inscription uppermost = Victoria Regina (pers.comm. Paul Evans, Library and Archives: Firepower Museum).
- 4.1.3 A 24lb/12kg, 8" diameter cannon ball was retrieved from the ground reduction works around Structure 73. It was hollow with an open filler sprue and dated from c.1789-1815. (Pers. comm.-Allan Marcuson, Explosive Ordnance Supervisor: Macc International).
- 4.1.4 Pottery retrieved from backfill 242 of the Palaeochannel has been dated to 1720-1780 (Pers. Comm. J.Cotter, OA) and is consistent with the infilling of the upper levels of the palaeochannel and the subsequent construction of the Officer's Quarters in that area from 1749 onwards.
