◀ GOOD PRACTICE INFORMATION ▶

Don't Be a Melon

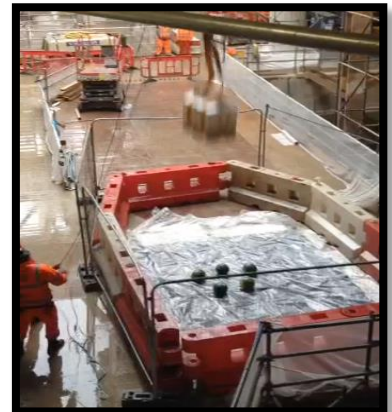
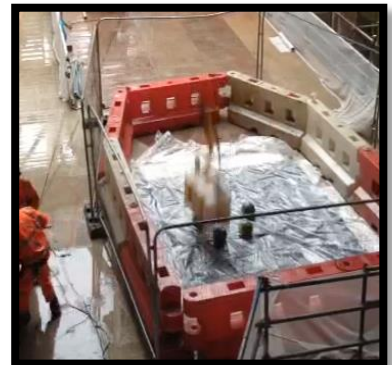
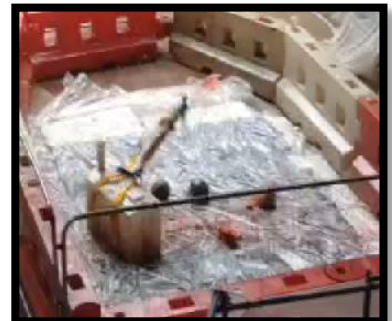
A 'failed lift', demonstration was set up to show the potential impact a 45 Kg load could have on a person standing underneath, when released from just 8 metres. 6 watermelons were used to represent individuals stood under the lift. The load comprised of a traffic barrier, half-filled with water.

The demonstration was carried out under controlled conditions, with exclusion zones in place and a risk assessment / task briefing created and briefed out prior to the demonstration. C405 have agreed to share these with anyone interested in undertaking a similar demonstration (e-mail targetzero@crossrail.co.uk for a copy). A quick release shackle was used to drop the load. The results can be seen in the series of pictures to the right. The potential for harm to anyone stood underneath is clear, represented by the fragments of watermelon splayed across the ground.
