Western Tunnels & Caverns Project

Final Monitoring Report

TBM DRIVES ~ from Paddington Station to Bond Street Station

CRL Document No. **C300-BFK-C4-RGN-CRT00_ST005-51015**

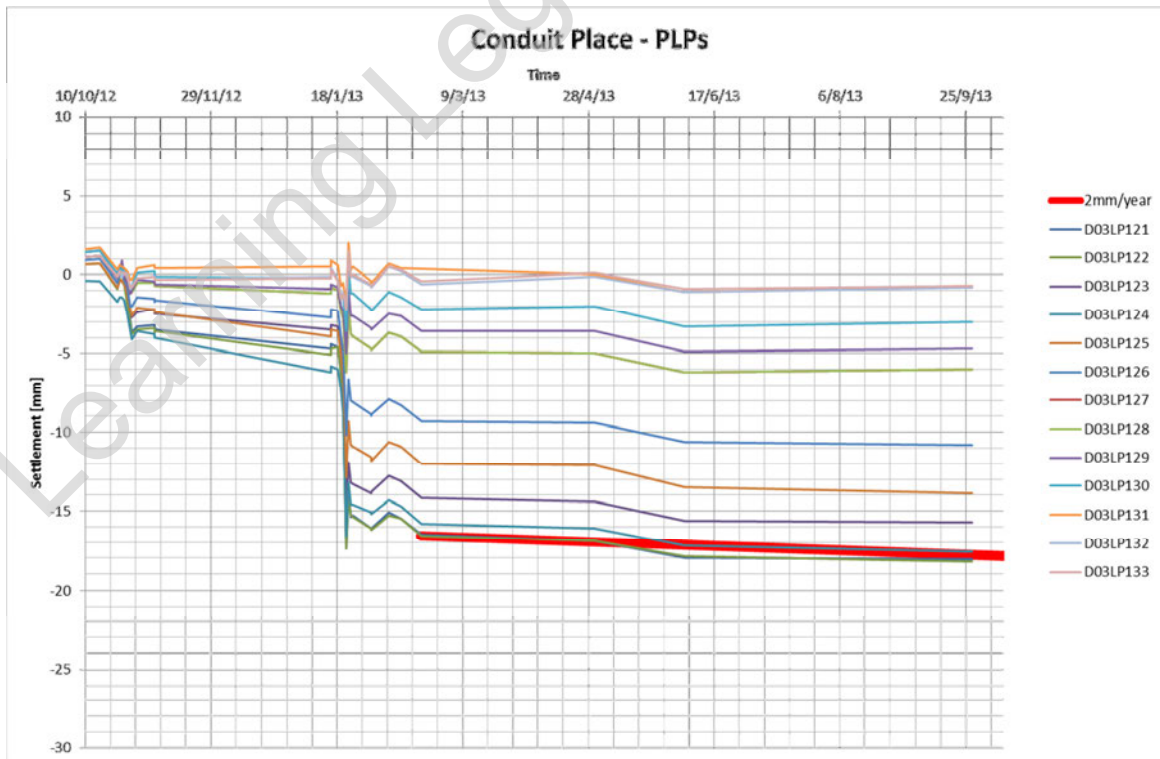
Figure 3: data time-plots - comparison against 2mm/year settlement rate (long-term)

The PLPs in Conduit Place settled up to approx. 18mm due to the C300 running tunnels excavation. The effect of the WB and EB TBMs is clearly visible from the settlement time-plots. Three points breached green trigger and one point breached amber trigger. The long-term trend is approximately around 2mm/year, and appears to stabilise with the last readings.

The residual risk associated with long-term settlements is considered to be negligible.

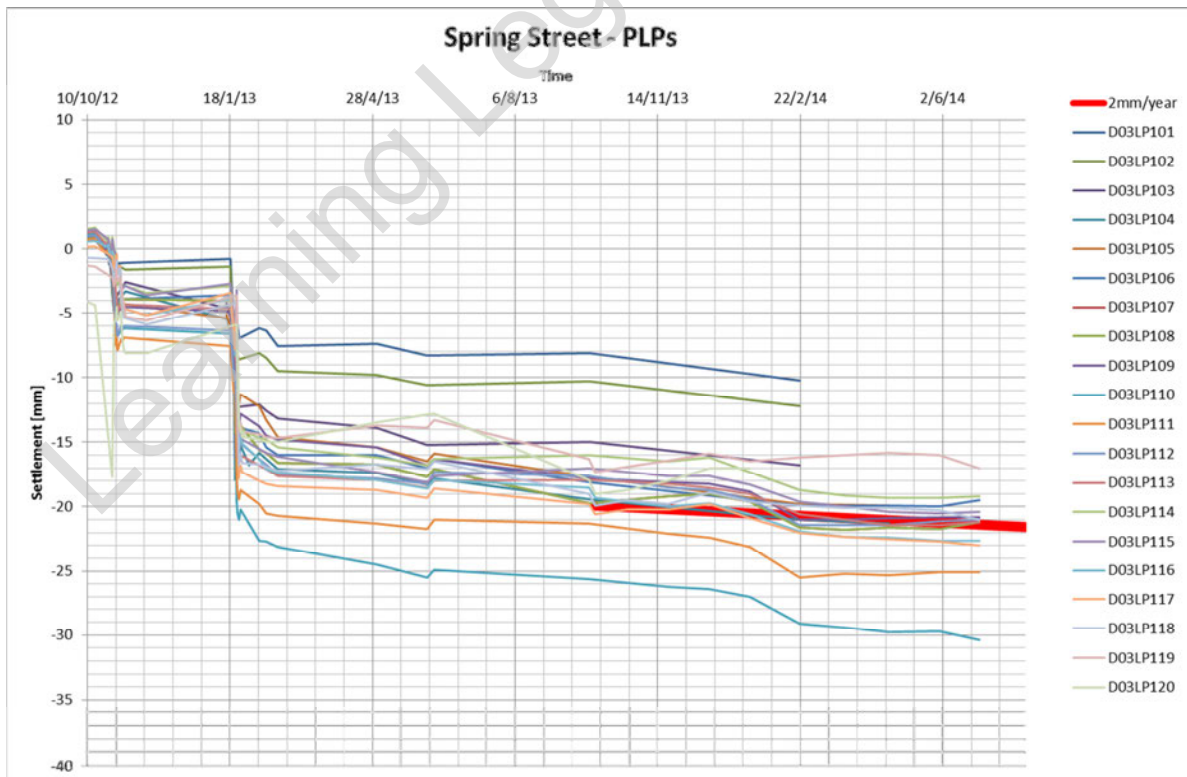
Figure 8: data time-plots - comparison against 2mm/year settlement rate (long-term)

The PLPs in Spring Street settled up to approx. 30mm and the BREs up to approx. 20mm due to the C300 running tunnels excavation. The effect of the WB and EB TBMs is clearly visible from the settlement time-plots. There has been a post-construction increase in settlement of up to 10mm on PLP and 5mm on BRE. The most recent readings show a stabilising trend.

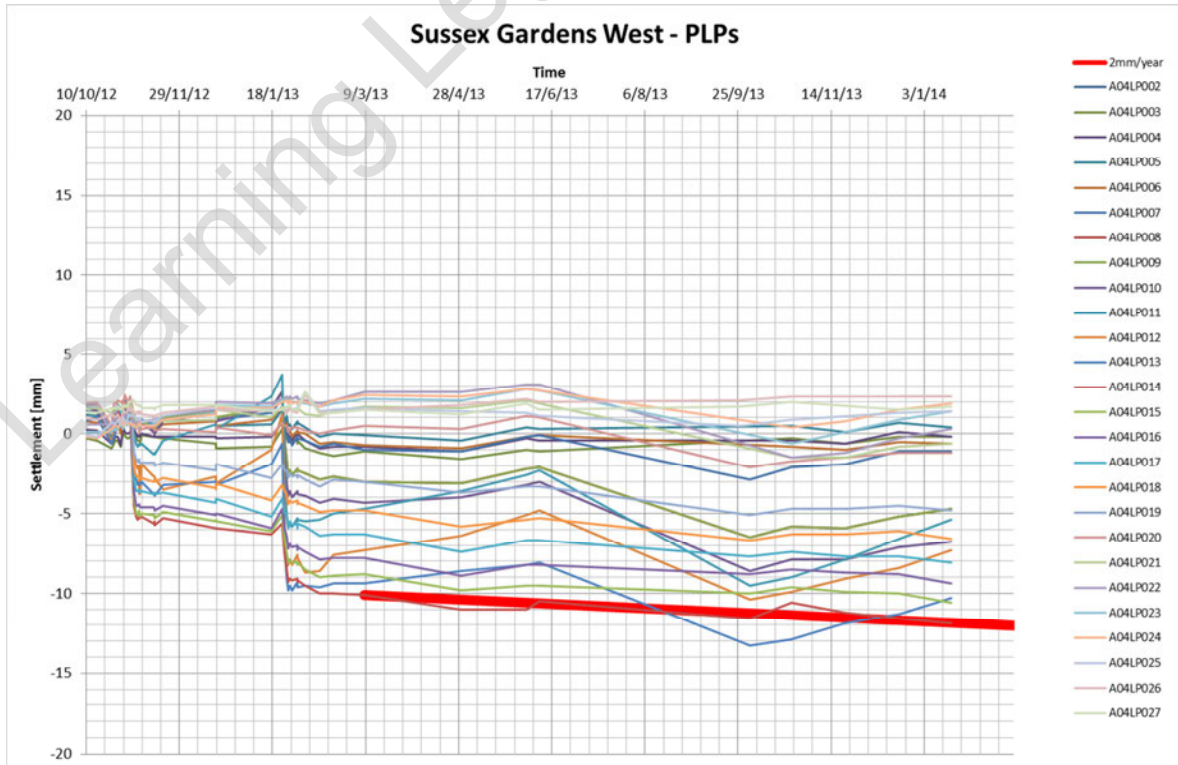
Figure 12: data time-plots - comparison against 2mm/year settlement rate (long-term)

The PLPs in Sussex Gardens settled up to approx. 13mm due to the C300 running tunnels works. The effect of the WB and EB TBMs is clearly visible from the settlement time plots. Three points breached the green trigger and two points breached the amber trigger. The long-term behaviour shows stability over a period of 1 year.

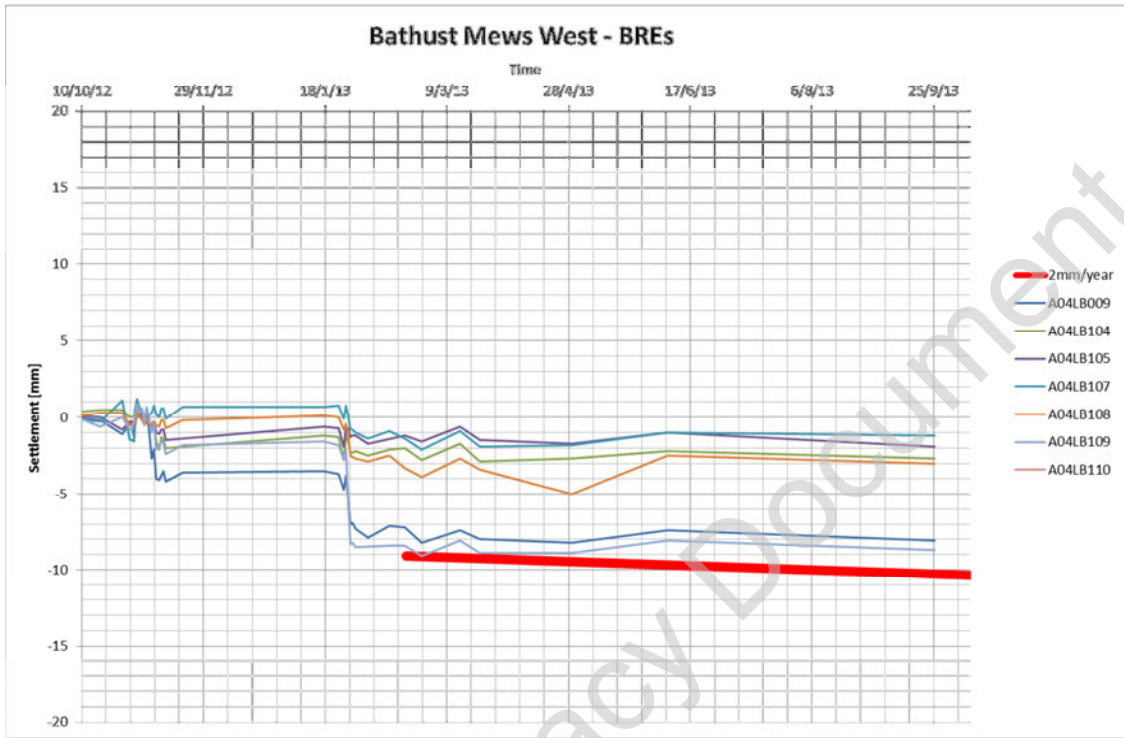
Figure 18: data time-plots - comparison against 2mm/year settlement rate (long-term)

The PLPs in Bathurst Mews settled up to approx. 8mm due to the C300 running tunnels works. The effect of the WB and EB TBMs is clearly visible from the settlement time plots. No triggers breached. The long-term behaviour shows no increase in settlement with stable reading over a period of over 7 months.

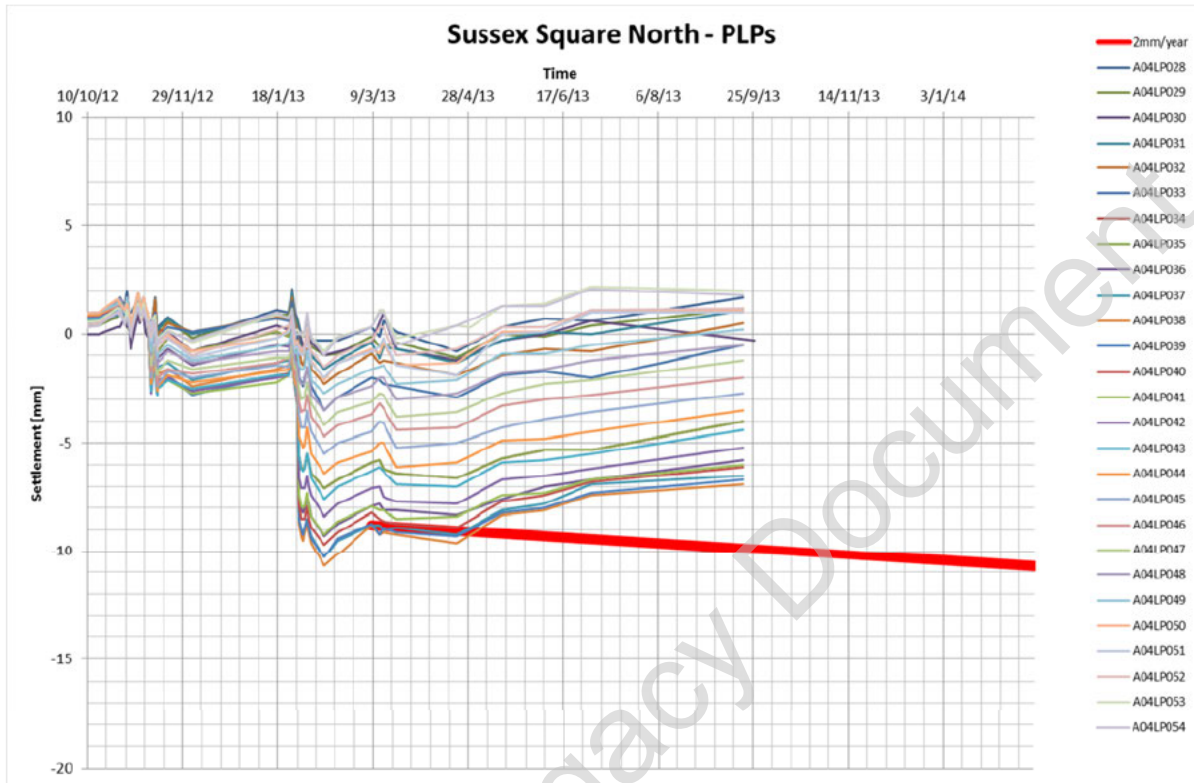
Figure 23: data time-plots - comparison against 2mm/year settlement rate (long-term)

The PLPs in Sussex Gardens settled up to approx. 20mm due to the C300 running tunnels works. The effect of the WB and EB TBMs is clearly visible from the settlement time plots. Three points breached the amber triggers. The long-term behaviour shows no increase in settlement with stable or decreasing readings over a period of over 7 months.

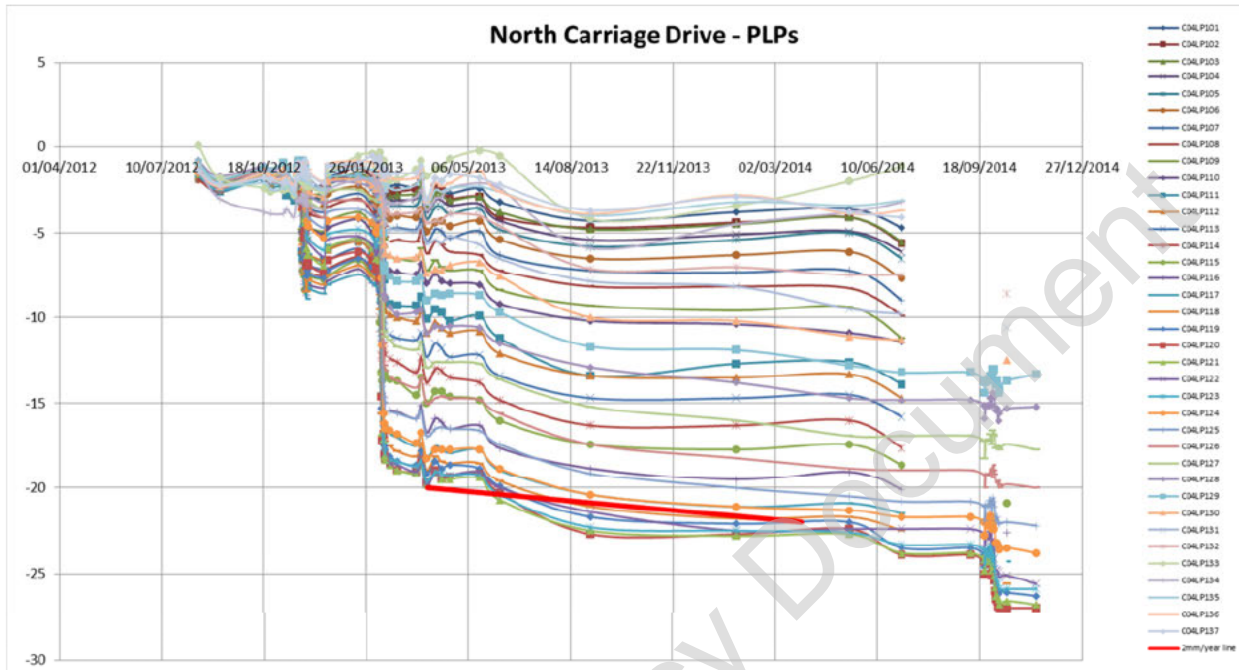
Figure 30: data time-plots - comparison against 2mm/year settlement rate (long-term)

The PLPs in North Carriage Drive settled up to approx. 23mm due to the C300 running tunnels works. The effect of the WB and EB TBMs is clearly visible from the settlement time plots. Eight points breached the amber triggers and four points breached the green trigger. The apparent on-going displacements that can be observed from the time-plots are most probably due to ambient temperature or variation in soil moisture deficit within Hyde Park (see Sections 2.8) since they apply to all the points of the transect and their increment is similar on all points.

Additional displacements were generated by the construction of Cross Passage 2 below this transect (refer to Section 2.14 for details).
