Western Tunnels & Caverns Project

Final Monitoring Report

TBM DRIVES ~ Tottenham Court Road Station to Fisher Street

CRL Document No. **C300-BFK-C4-RGN-CRT00_ST005-51129**

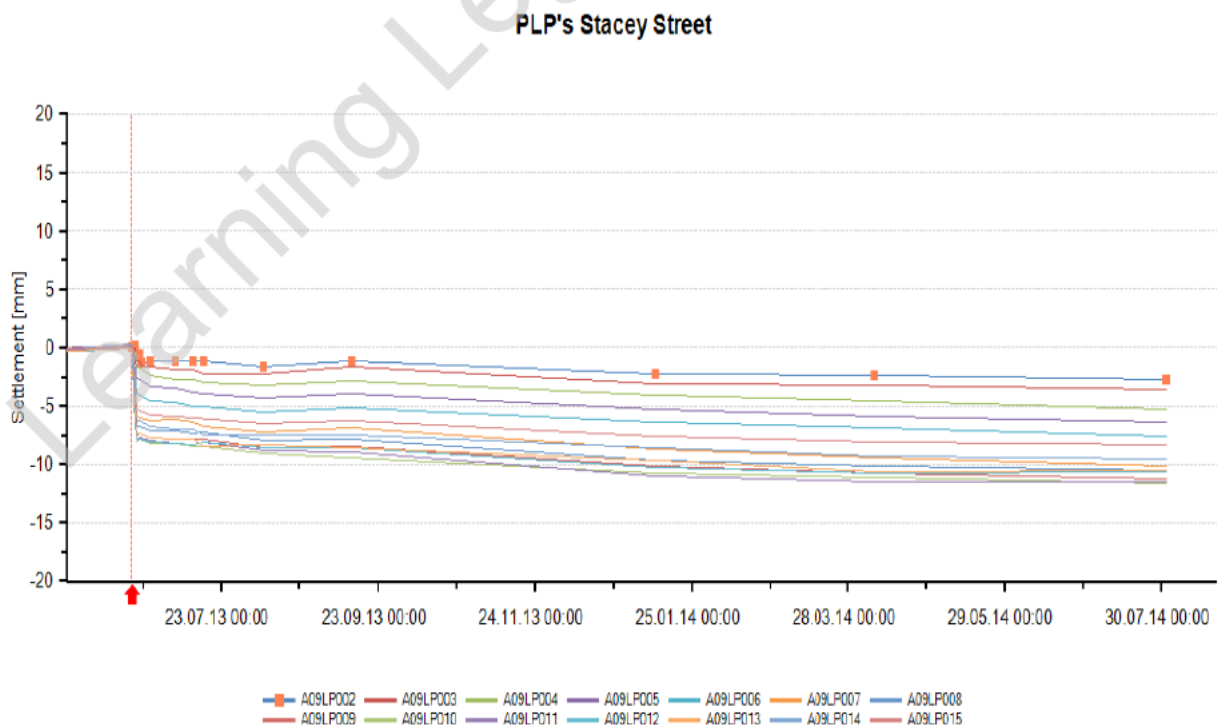
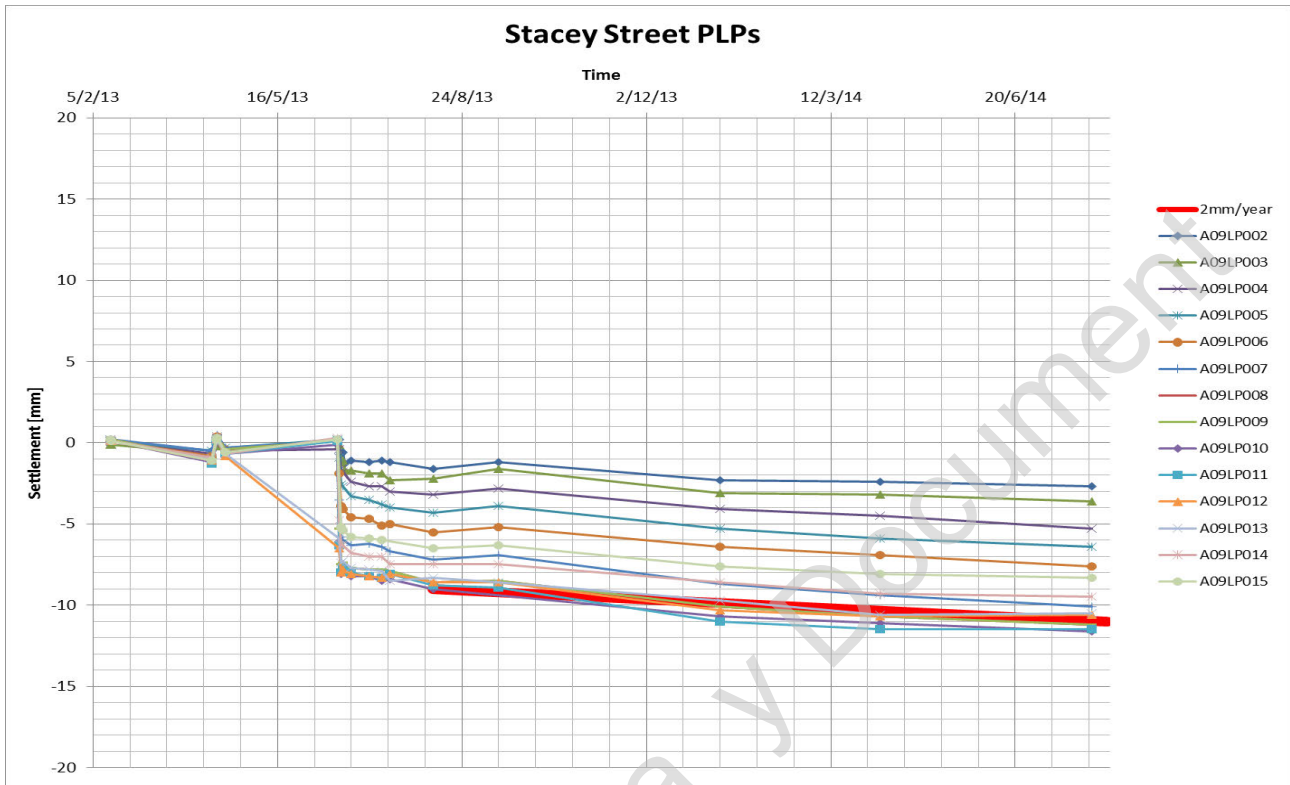
Figure 2: data time-plots: comparison against settlement triggers

The points in Stacey Street settled up to approx. 11mm due to the C300 running tunnels excavation. The effect of the WB TBM is visible from the settlement time-plots. Green settlement triggers have been breached on three points, as per Table 3.

The overall long term behaviour appears to be slightly over the 2mm/year, however, the time-plots show a stabilising settlement trend.

The residual risk associated with long term settlements is considered to be negligible.

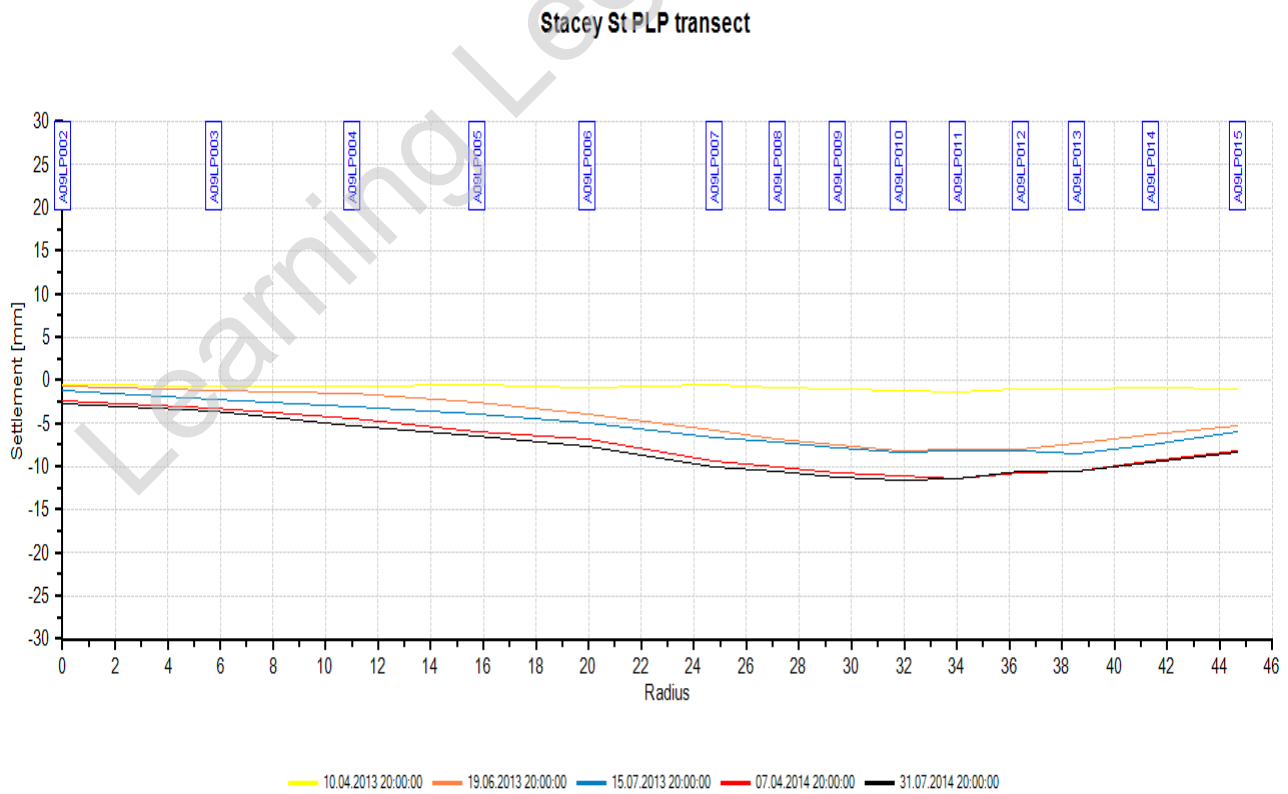
Figure 4: cut

Worst case deflection ratio (average of 3 values) [1/-]	Trigger
38,700	no

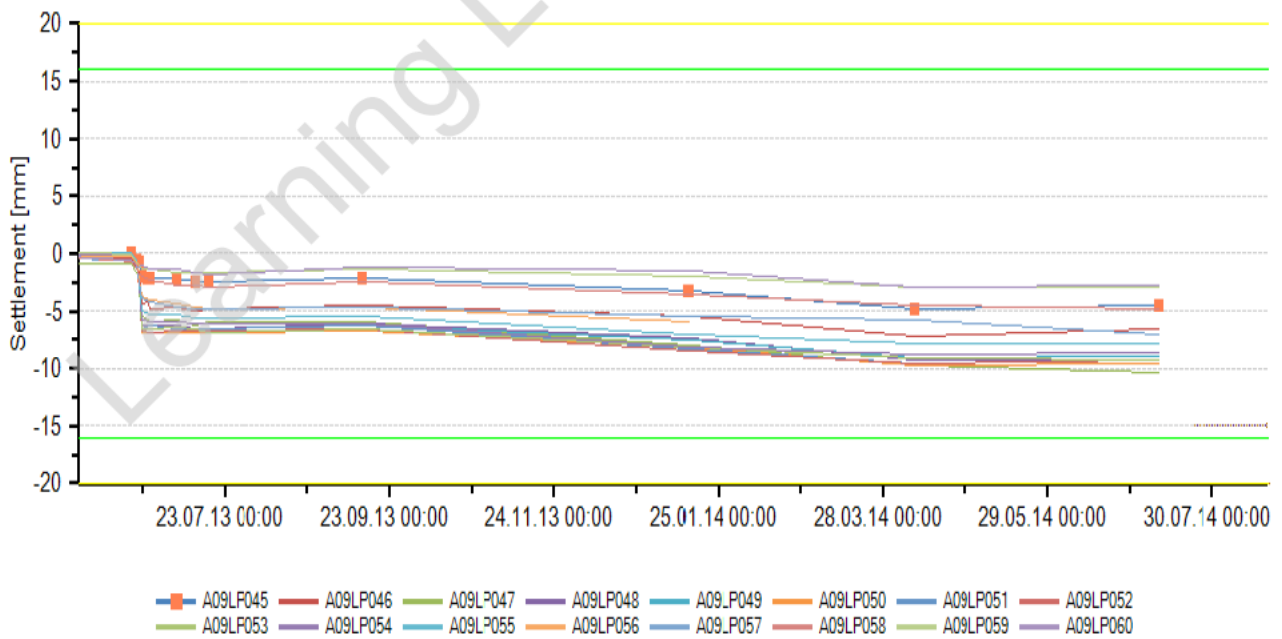
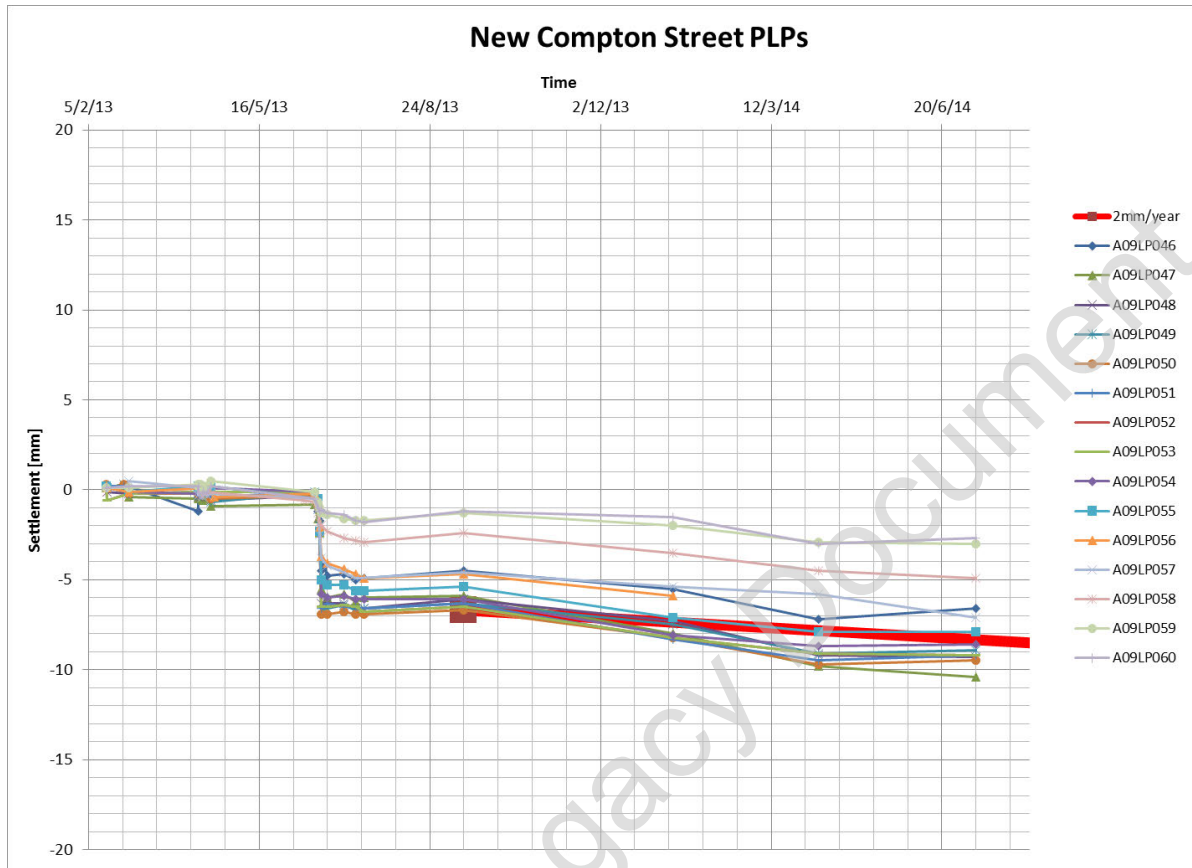
Figure 6: data time-plots: comparison against settlement triggers

The points in New Compton Street settled up to approx. 11mm due to the C300 running tunnels excavation. The effect of the WB TBM is visible from the settlement time plots. Settlement triggers have not been breached.

The overall long term behaviour appears to be slightly over the 2mm/year, however, the time-plots show a stabilising settlement trend.

The residual risk associated with long-term settlements is considered to be negligible.

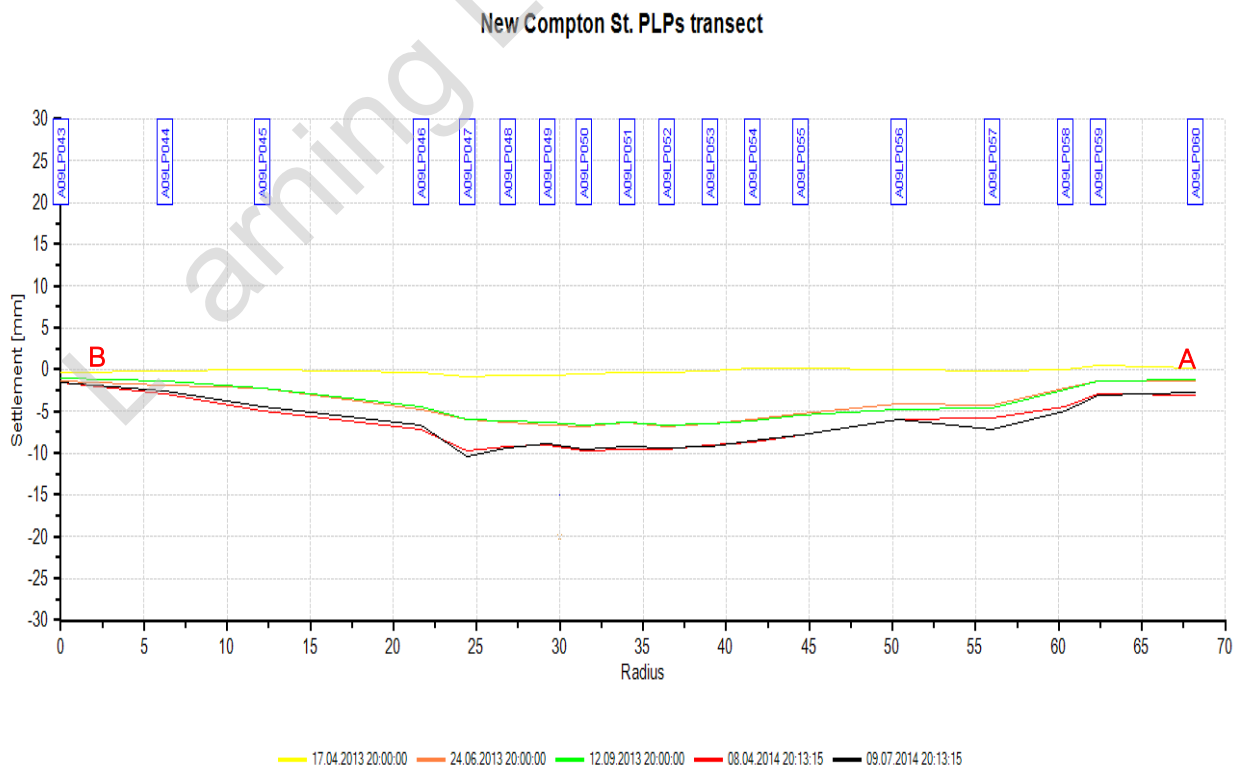
Figure 8: cut

Worst case deflection ratio (average of 3 values) [1/-]	Trigger
9,000	no

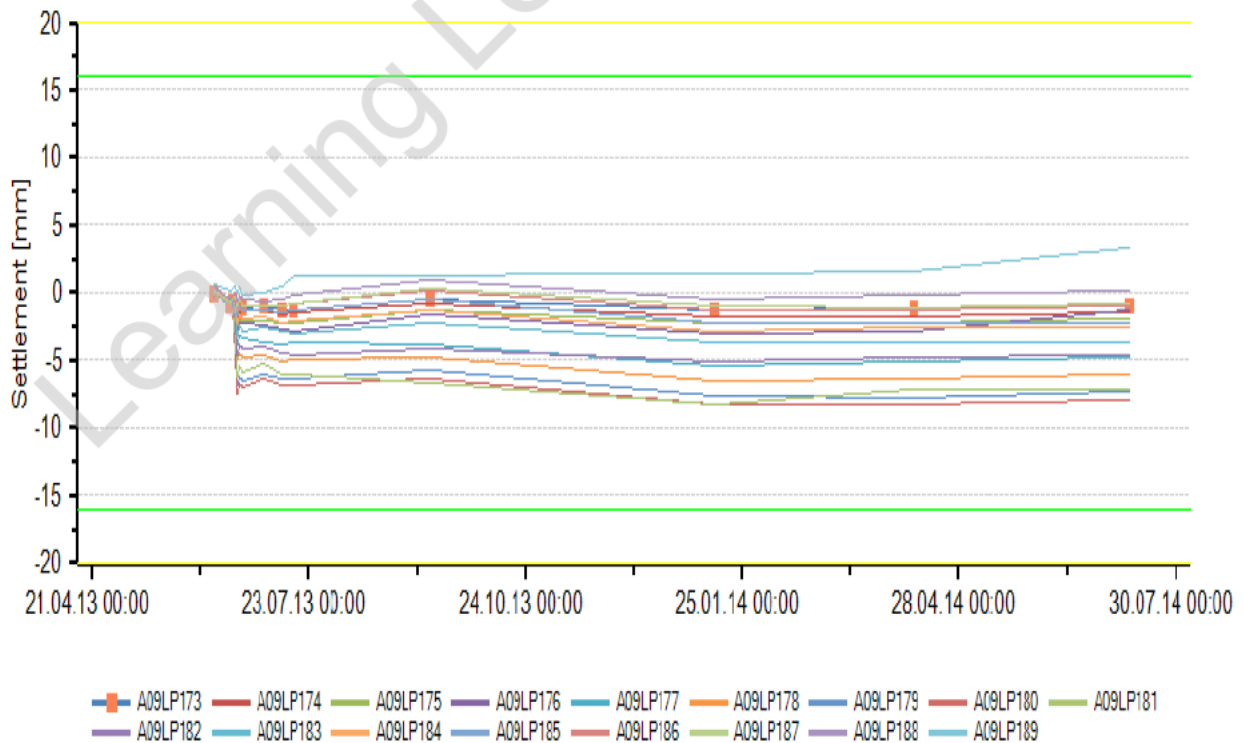
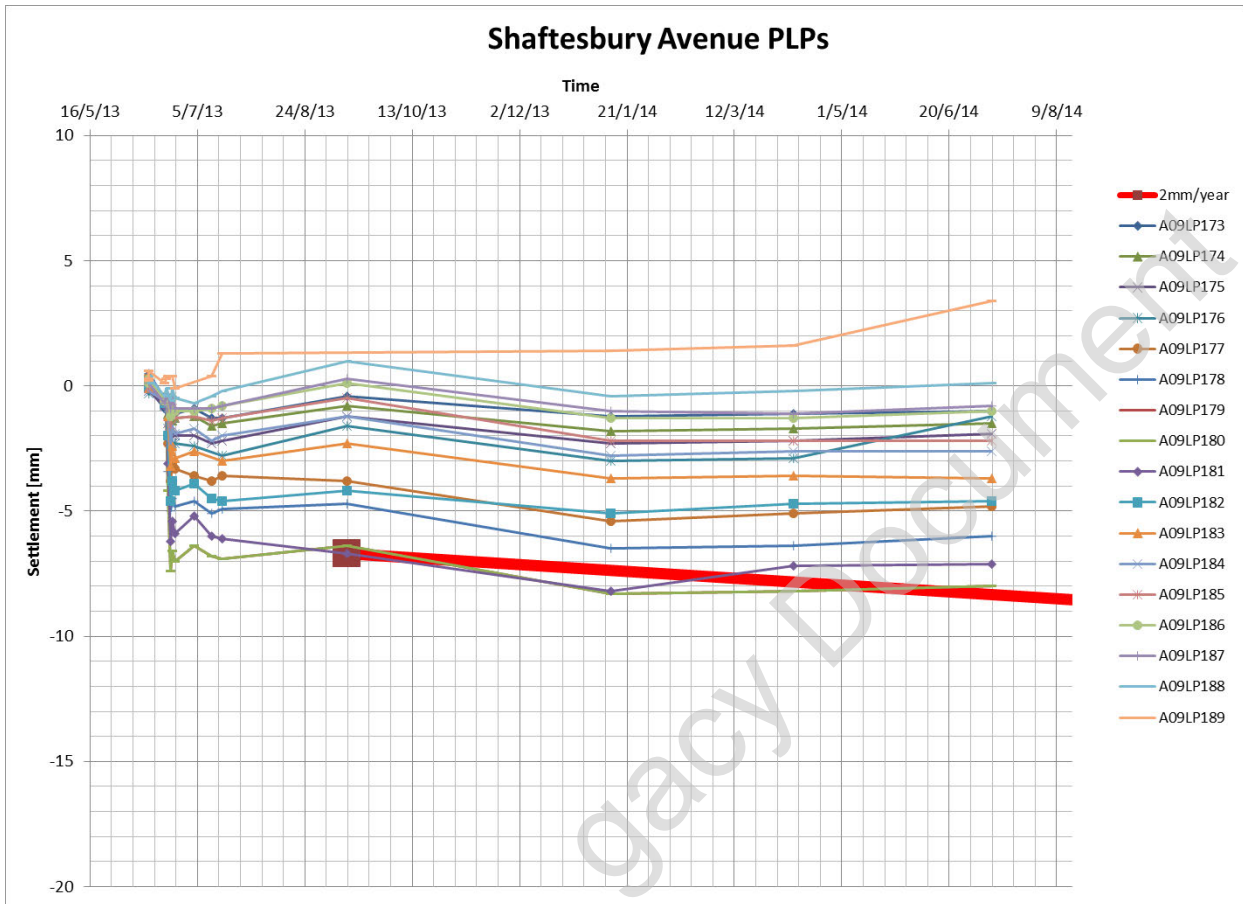
Figure 10: data time-plots - comparison against settlement triggers

The points in Shaftesbury Avenue settled up to approx. 8mm due to the C300 running tunnels excavation. The effect of the WB TBM is visible from the settlement time-plots. Settlement triggers have not been breached.

The time-plots are generally showing stabilising settlement trend, and the long term behaviour appears to be less than 2mm/year.

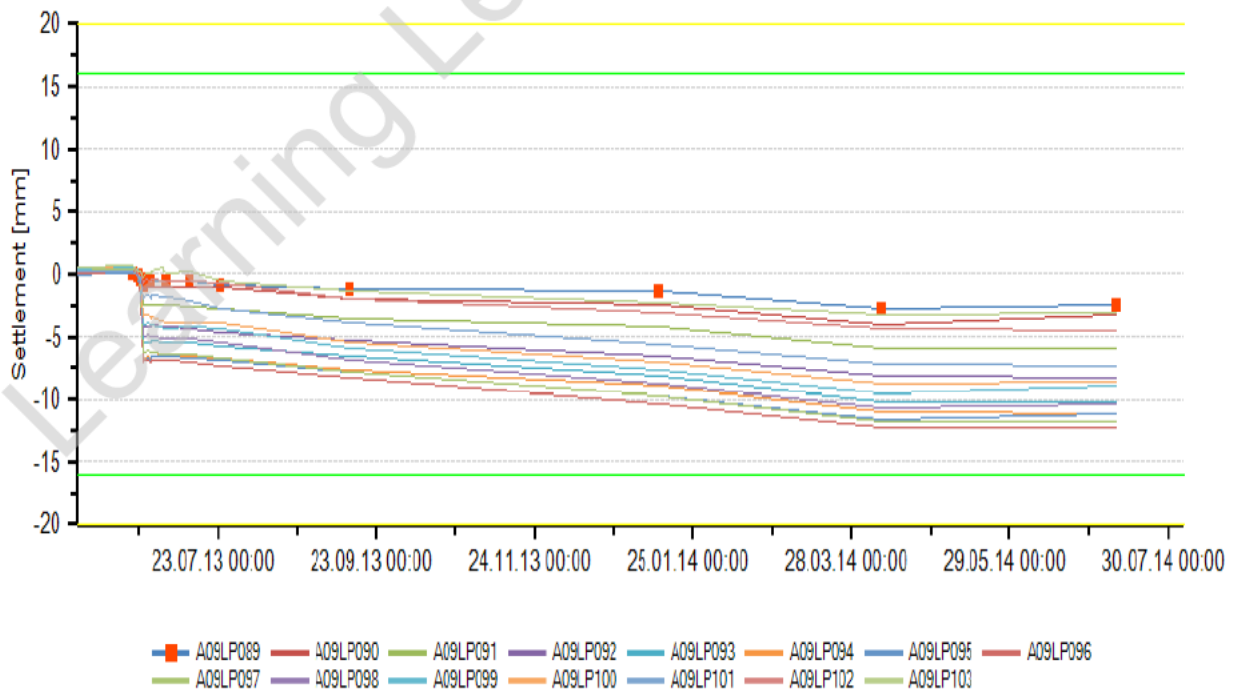
Figure 10: data time-plots - comparison against settlement triggers

The points in Monmouth Street settled up to approx. 13mm due to the C300 running tunnels excavation. The effect of the WB TBM is visible from the settlement time-plots. Settlement triggers have not been breached.

The overall long term behaviour appears to be slightly over the 2mm/year, however, the time-plots show a stabilising settlement trend.

The residual risk associated with long-term settlements is considered to be negligible.

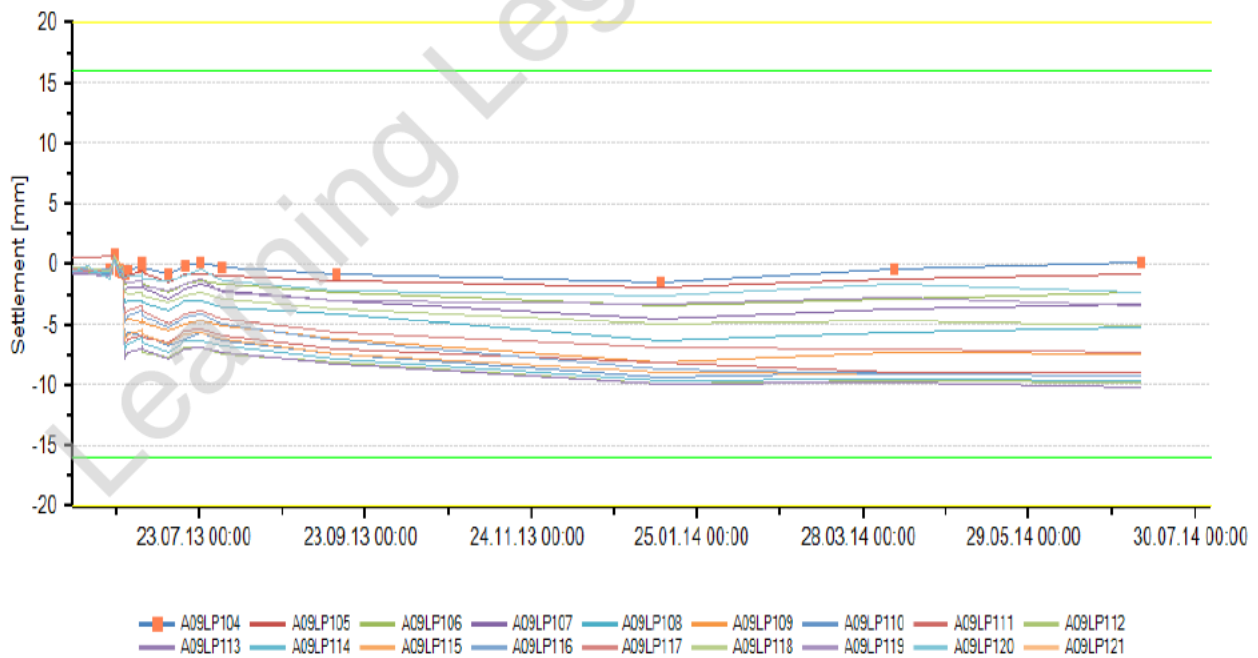
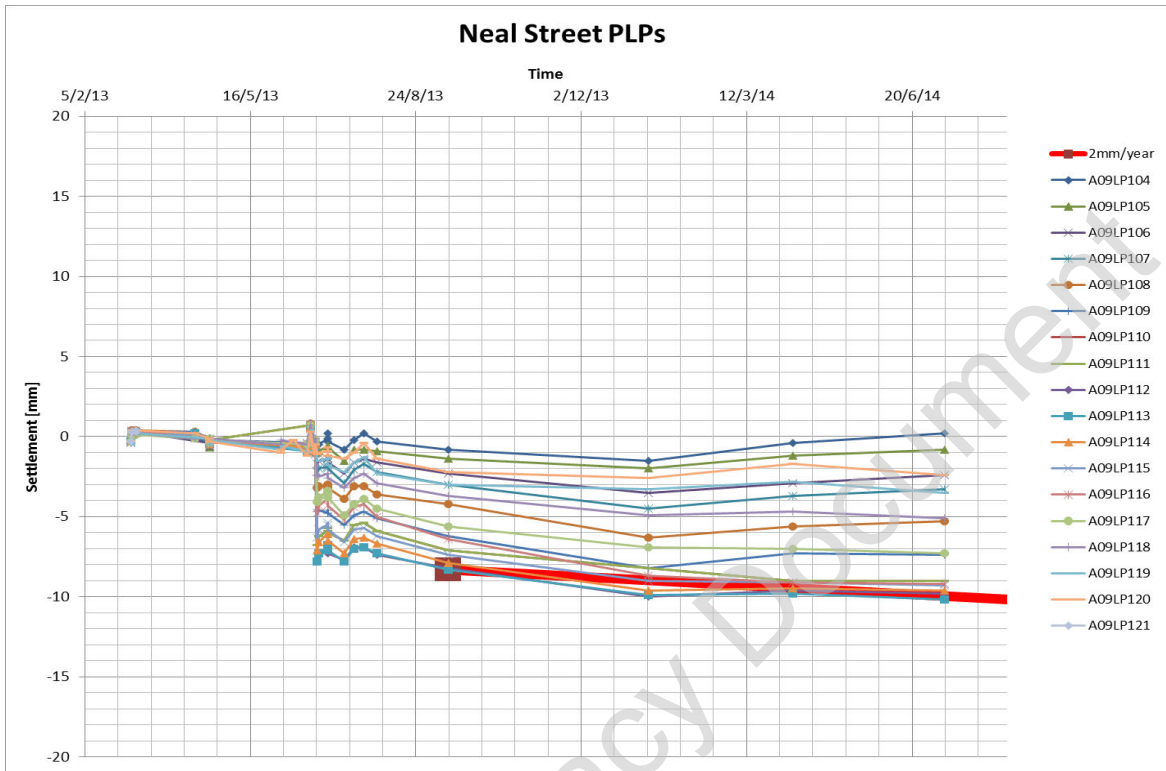
Figure 14: data time-plots - comparison against settlement triggers

The points in Neal Street settled up to approx. 10mm due to the C300 running tunnels excavation. The effect of the WB TBM is visible from the settlement time-plots. Settlement triggers have not been breached.

The time-plots are generally showing stabilising settlement trend, and the long term behaviour appears to be less than 2mm/year.

The residual risk associated with long-term settlements is considered to be negligible.

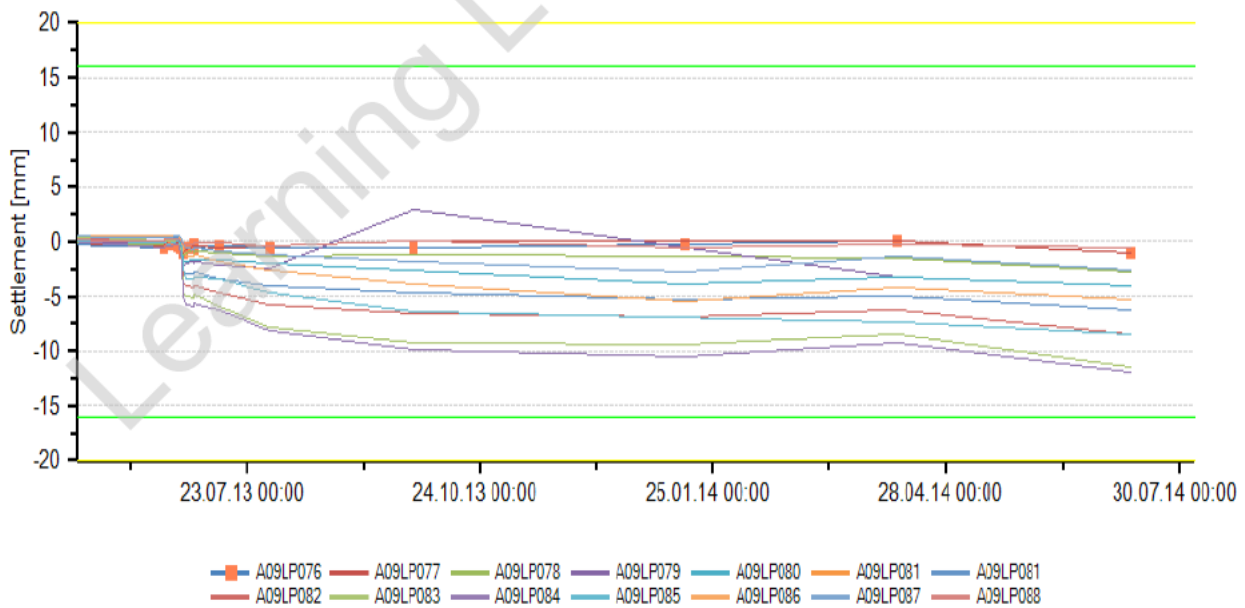
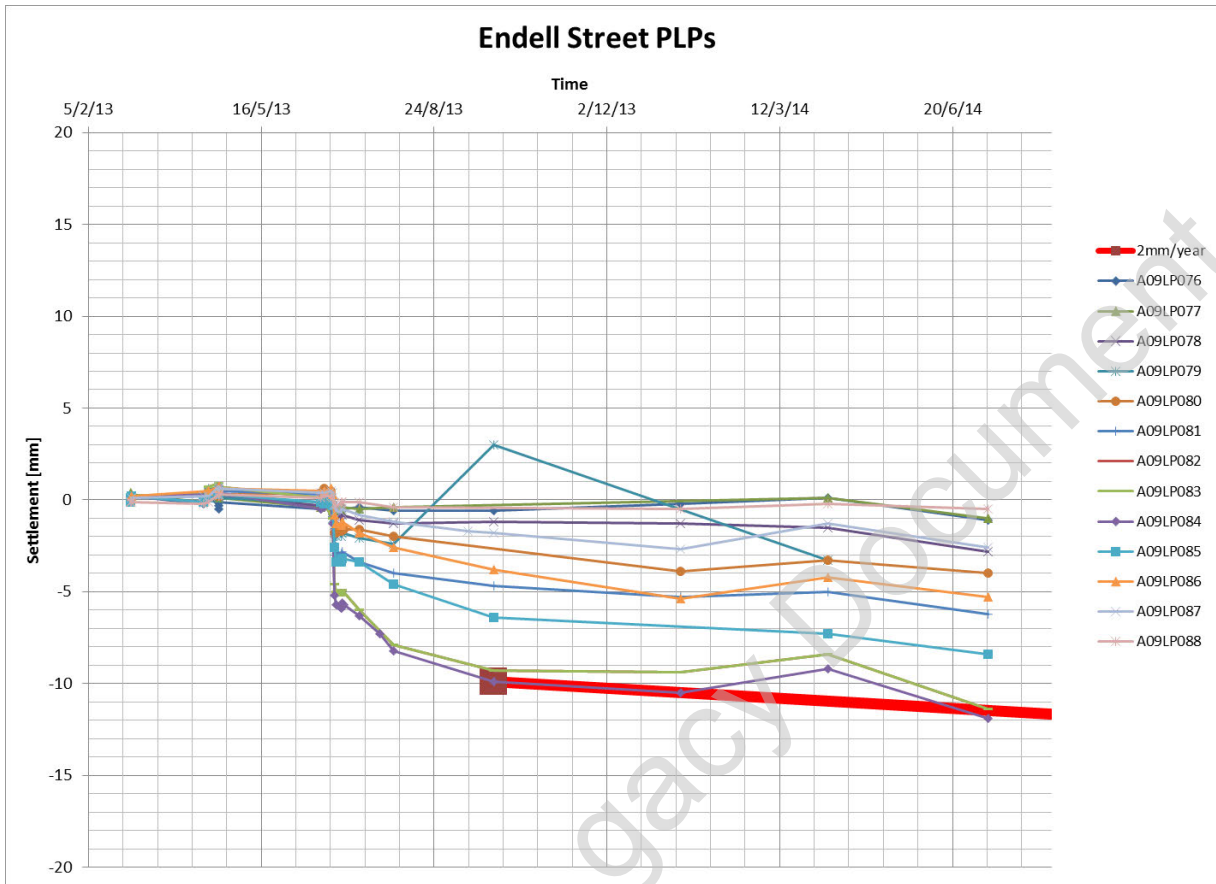
Figure 17: data time-plots - comparison against settlement triggers

The points in Endell Street settled up to approx. 12mm due to the C300 running tunnels excavation. The effect of the WB TBM is visible from the settlement time-plots. Settlement triggers have not been breached.

The overall long term behaviour appears to be slightly over the 2mm/year, however, the time-plots show a stabilising settlement trend.

The residual risk associated with long-term settlements is considered to be negligible.

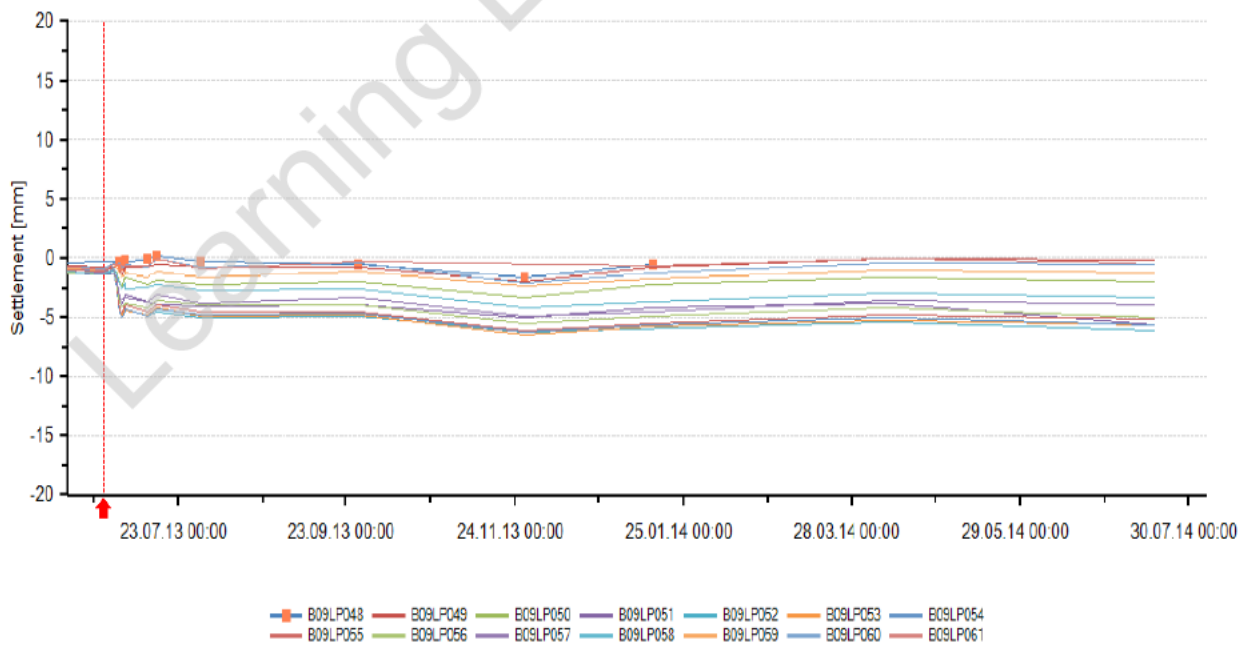
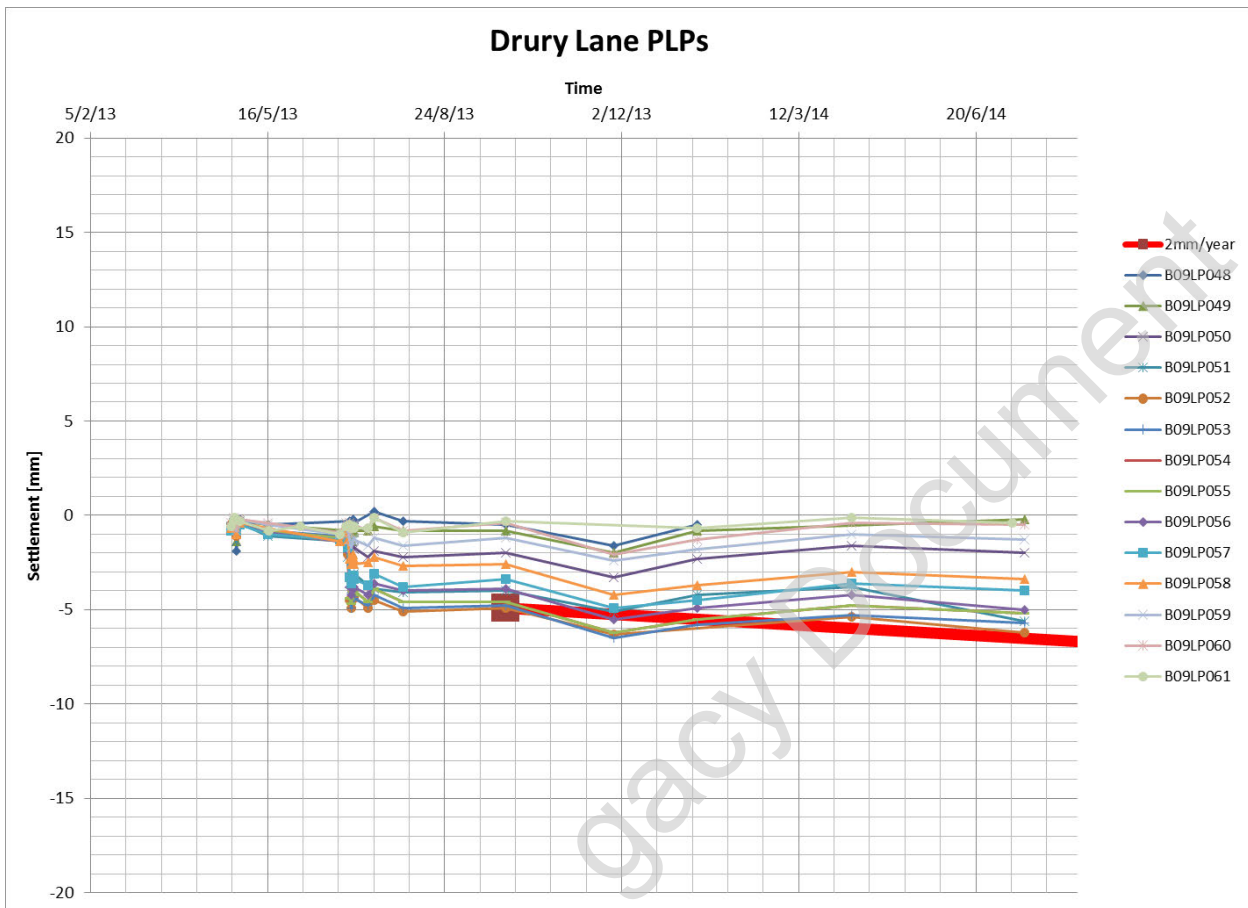
Figure 20: data time-plots - comparison against settlement triggers

The points in Drury Lane settled up to approx. 7mm due to the C300 running tunnels excavation. The effect of the WB TBM is visible from the settlement time-plots. Settlement triggers have not been breached.

The time plots are generally showing stability, and the long term behaviour appears to be less than 2mm/year.

The residual risk associated with long-term settlements is considered to be negligible.

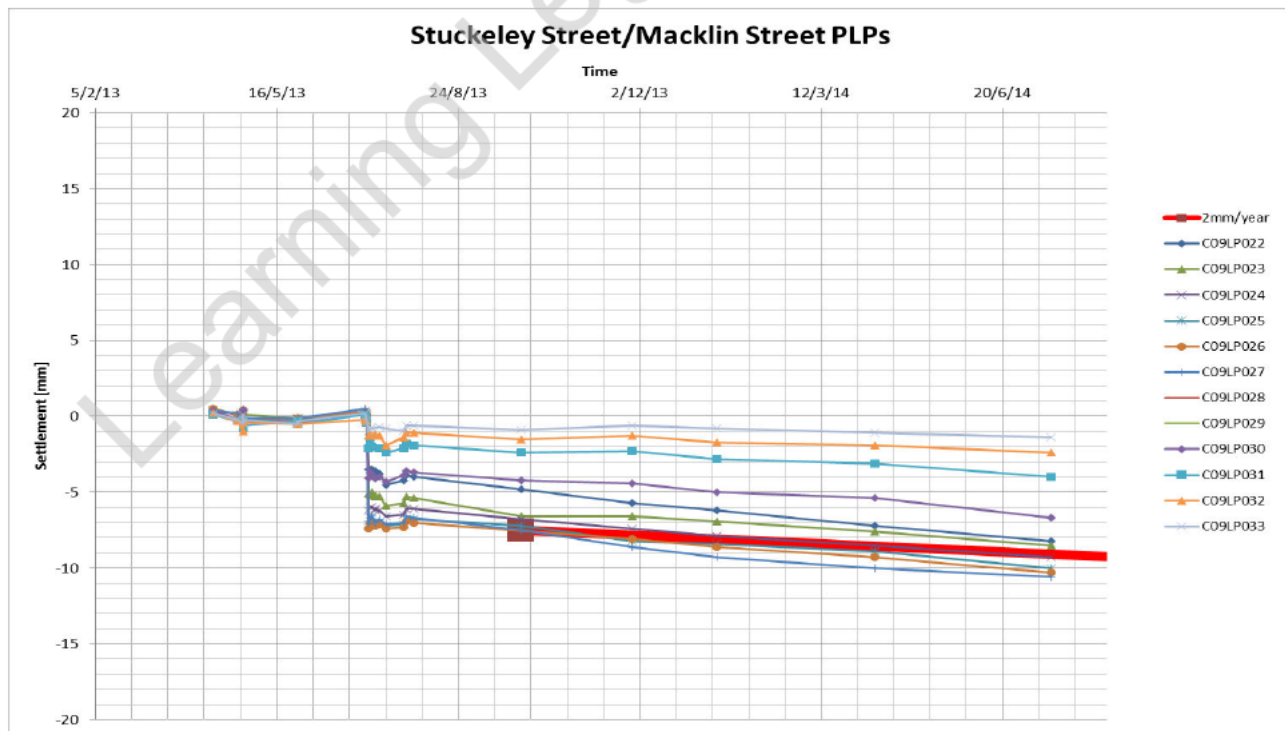
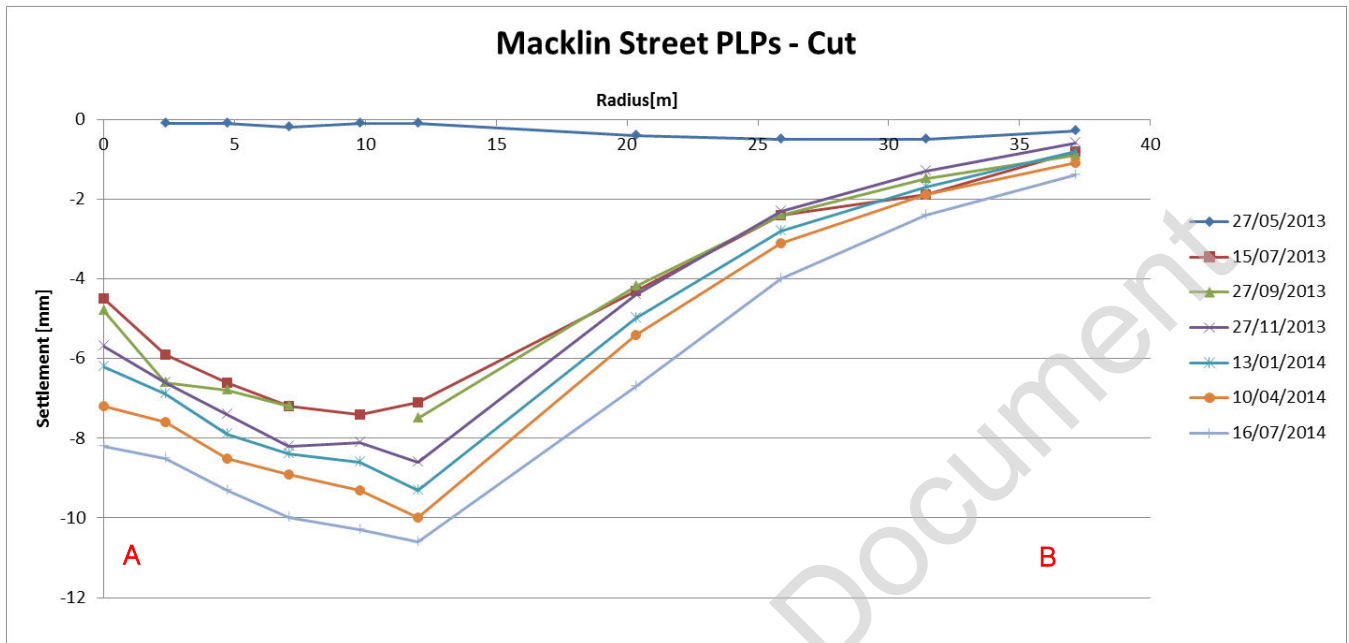
Figure 23: data time-plots - comparison against 2mm/year settlement rate (long-term)

The points in Macklin Street settled up to approx. 11mm due to the C300 running tunnels excavation. The effect of the WB TBM is visible from the settlement time-plots. Settlement triggers have not been breached.

The time plots are generally showing stability, and the long term behaviour appears to be slightly over 2mm/year.

The residual risk associated with long-term settlements is considered to be negligible.

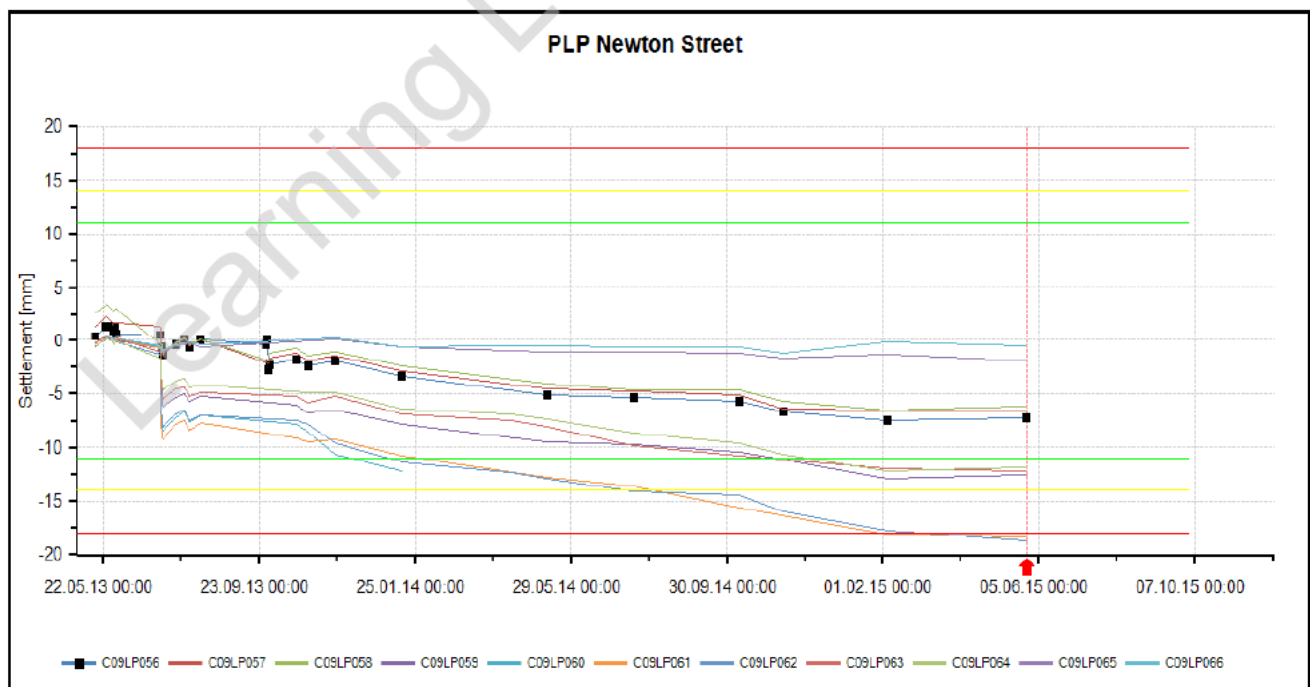
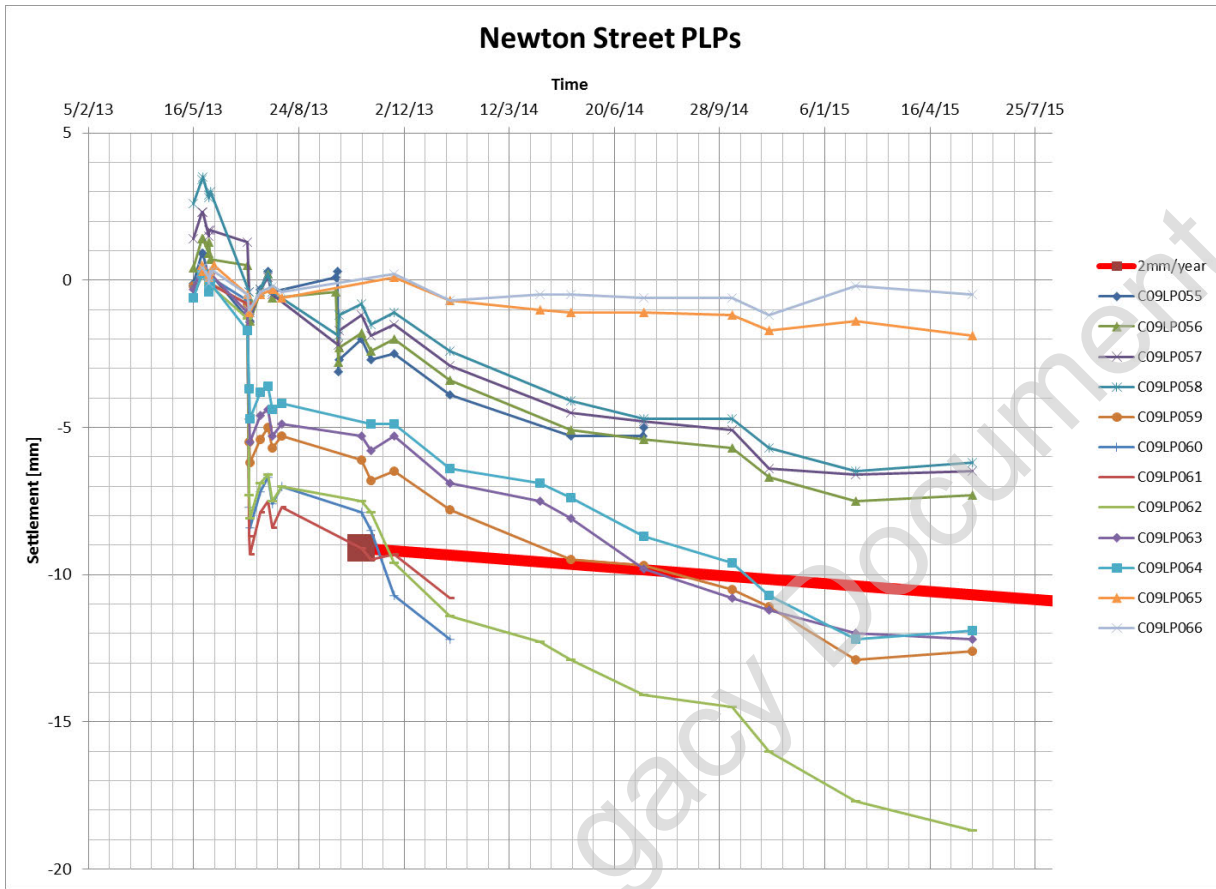
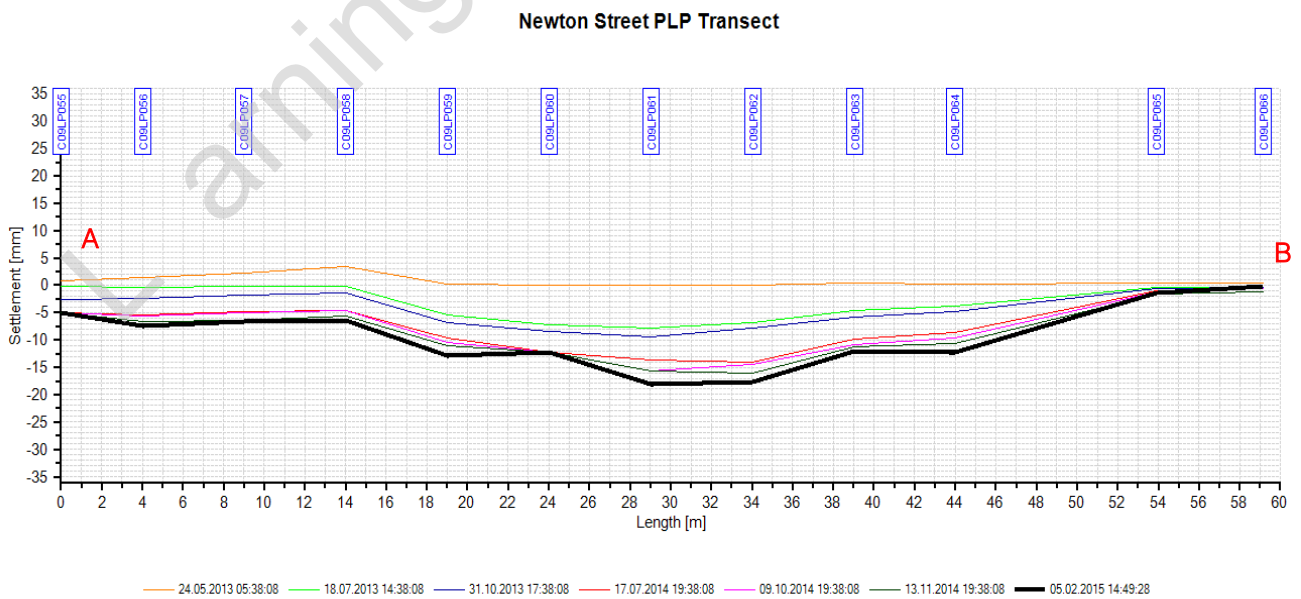
Figure 26: data time-plots - comparison against settlement triggers

The points in Newton Street settled up to approx. 1mm due to the C300 running tunnels excavation. The effect of the WB TBM is visible from the settlement time-plots. Settlement triggers have been breached in three points.

The time-plots are generally showing some settlement trend, and the long term behaviour appears to be still over 2mm/year.

The residual risk associated with long-term settlements is considered to be negligible. It should be noted some renovation works were on-going within the building on the east side of the road at the corner with High Holborn during the long-term monitoring period.

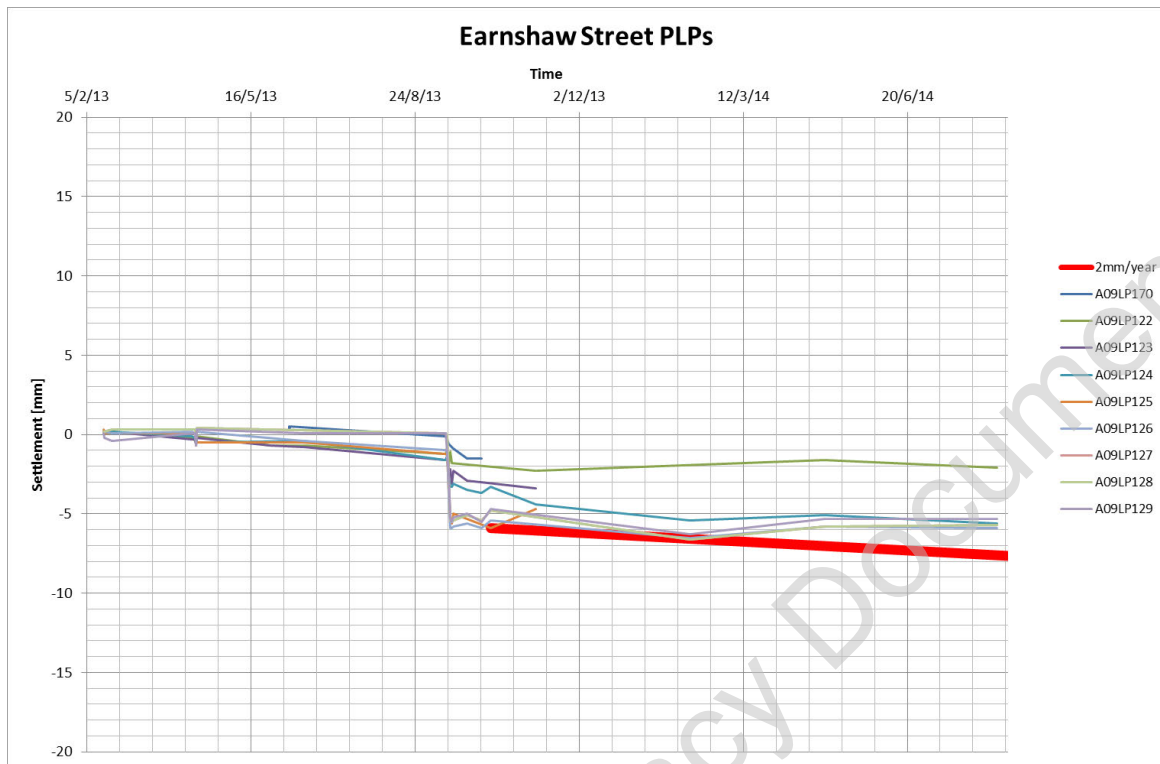
Figure 31: data time-plots - comparison against 2mm/year settlement rate (long-term)

The points in Earnshaw Street settled up to approx. 6mm due to the C300 running tunnels excavation. The effect of the EB TBM is visible from the settlement time-plots. Settlement triggers have not been breached

The time-plots are generally showing stability, and the long term behaviour appears therefore to be within 2mm/year

The residual risk associated with long-term settlements is considered to be negligible.
