Western Tunnels & Caverns Project

Final Monitoring Report

TBM DRIVES ~ Tottenham Court Road Station to Fisher Street

CRL Document No. **C300-BFK-C4-RGN-CRT00_ST005-51129**

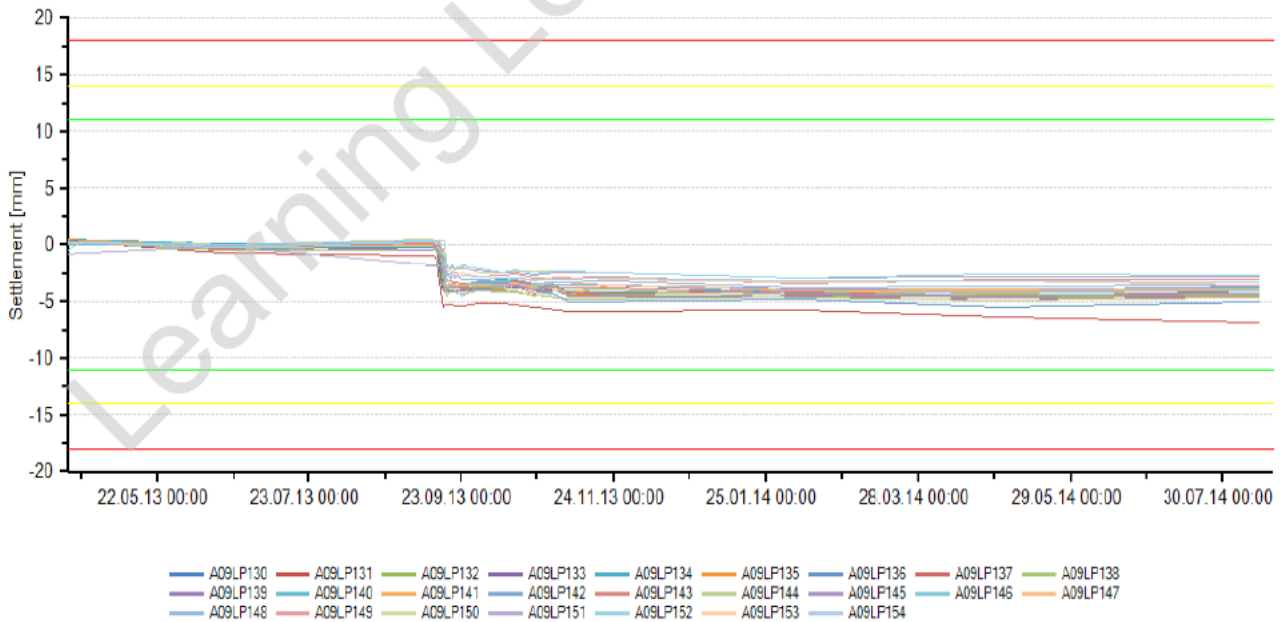
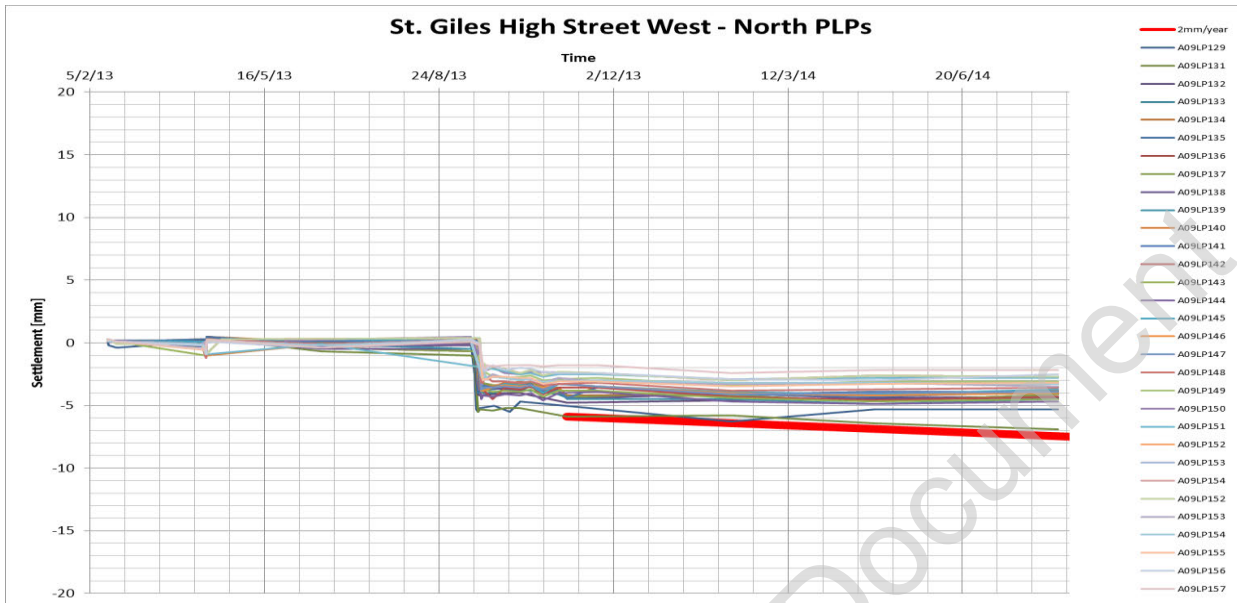
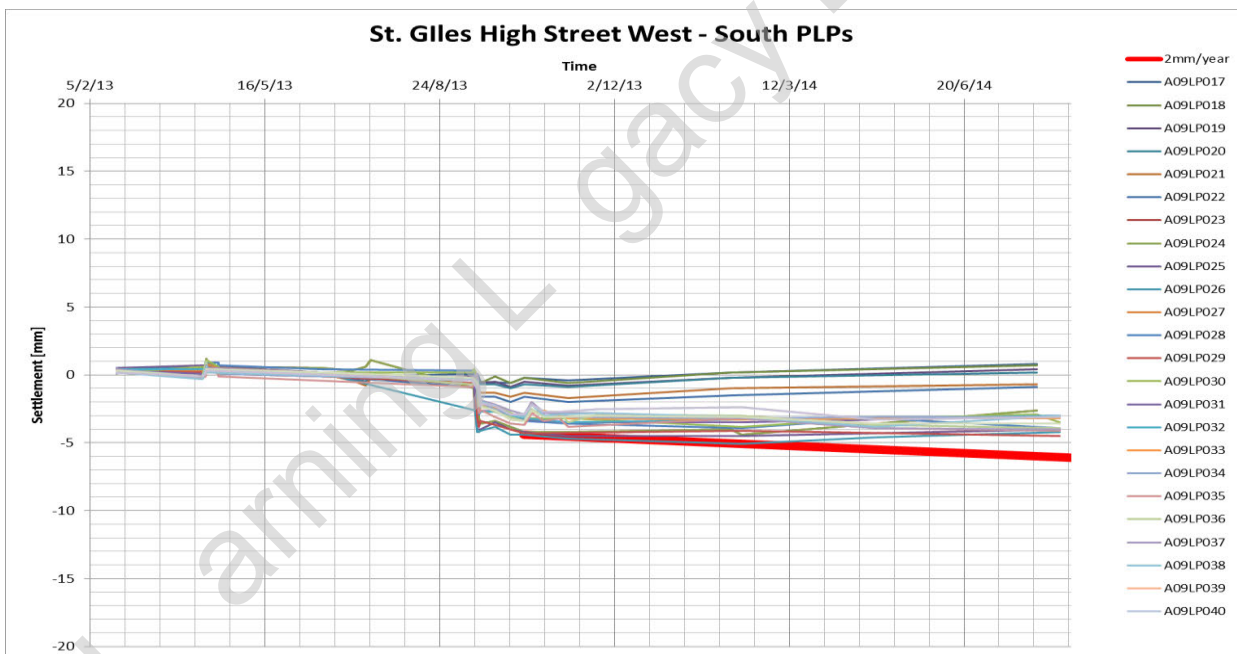
Figure 33: data time-plots - comparison against settlement triggers

The points in Saint Giles High Street West settled up to approx. 5mm due to the C300 running tunnels excavation. The effect of the EB TBM is visible from the settlement time-plots. Settlement triggers have not been breached

The time-plots are generally showing stability, and the long term behaviour appears therefore to be within 2mm/year.

The residual risk associated with long-term settlements is considered to be negligible.

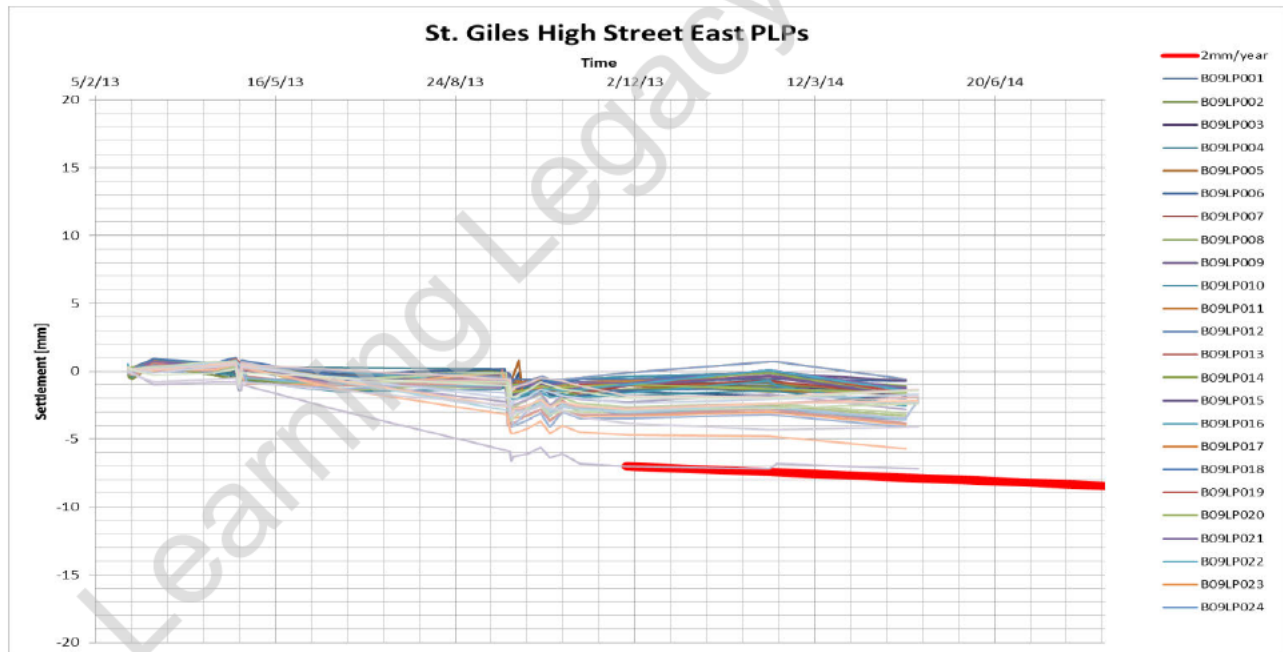
Figure 37: data time-plots - comparison against 2mm/year settlement rate (long-term)

The points in Saint Giles High Street East settled up to approx. 7mm due to the C300 running tunnels excavation. The effect of the EB TBM is visible from the settlement time-plots. Settlement triggers have not been breached

The time-plots are generally showing very slow settlement trend on some point; the long term behaviour is within 2mm/year.

The residual risk associated with long-term settlements is considered to be negligible.

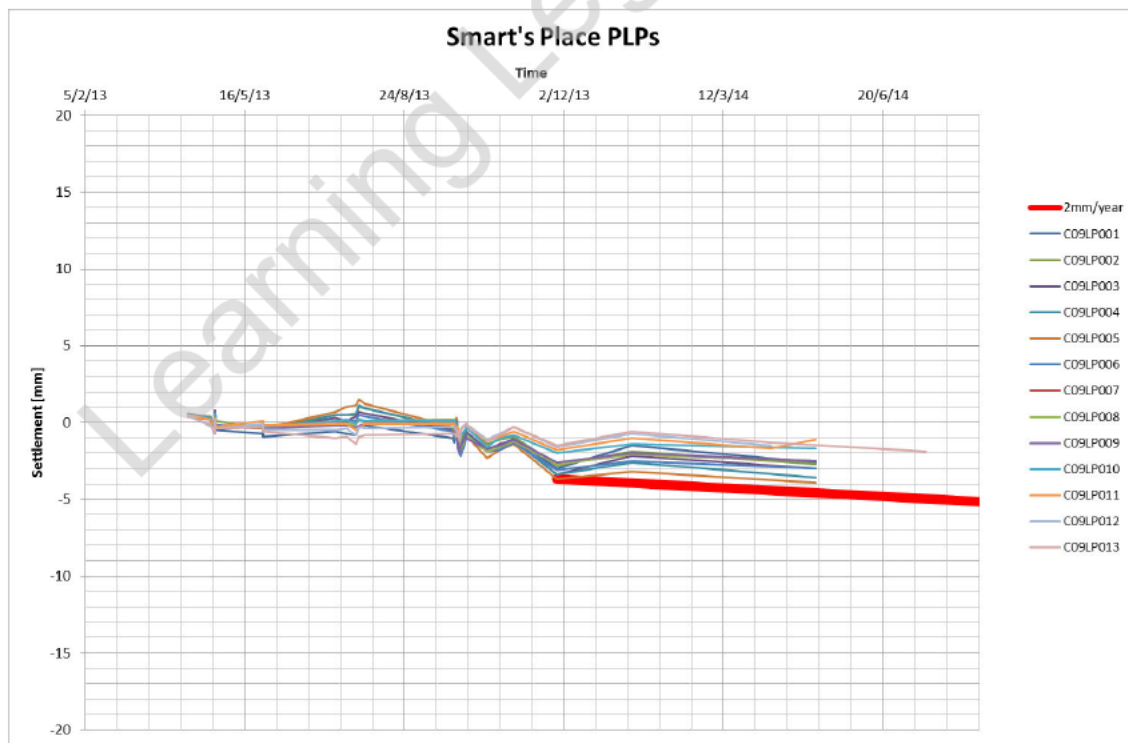
Figure 39: data time-plots - comparison against 2mm/year settlement rate (long-term)

The points in Smart's Place settled up to approx. 5mm due to the C300 running tunnels excavation. The effect of the EB TBM is visible from the settlement time-plots. Settlement triggers have not been breached

The time-plots are generally showing very slow settlement trend on some point; the long term behaviour is within 2mm/year.

The residual risk associated with long-term settlements is considered to be negligible.

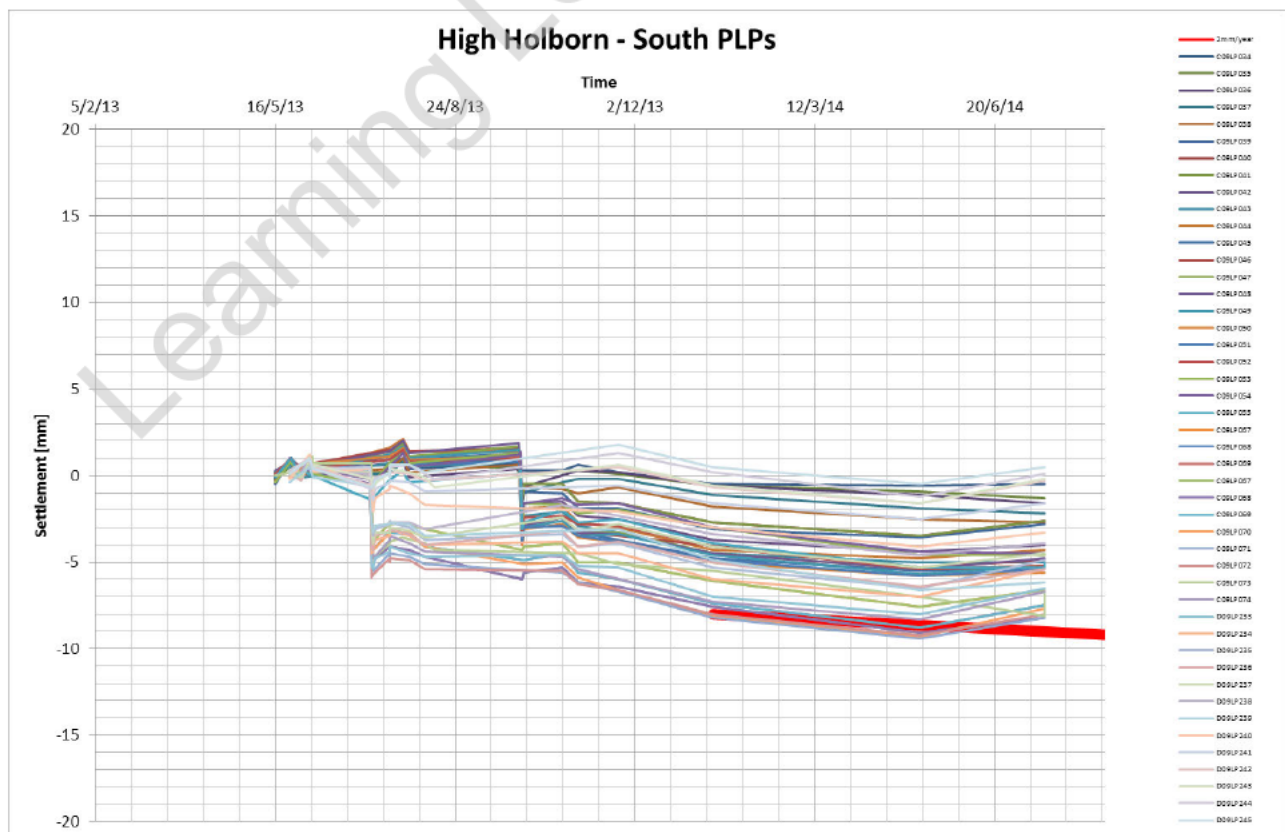
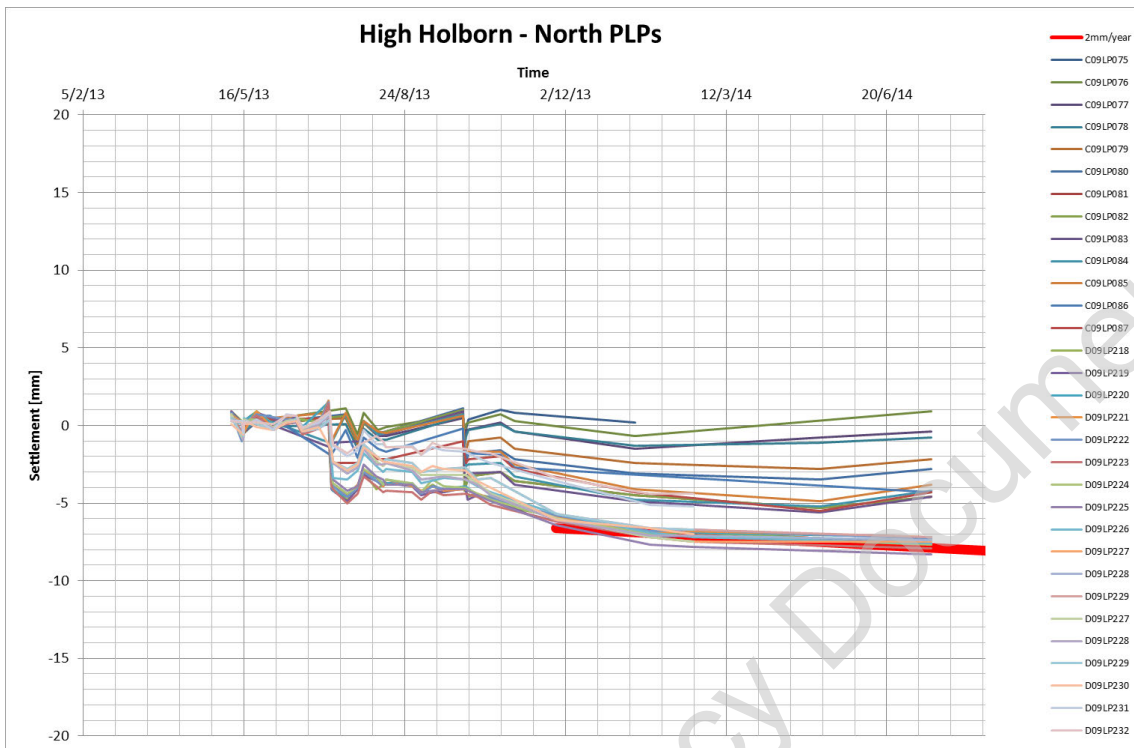
Figure 41a,b: data time-plots - comparison against 2mm/year settlement rate (long-term)

The points in High Holborn settled up to approx. 9mm due to the C300 running tunnels excavation. The effect of the WB and EB TBMs is visible from the settlement time-plots. Settlement triggers have not been breached

The time-plots are generally showing stabilising data; the long term behaviour is within 2mm/year.

The residual risk associated with long-term settlements is considered to be negligible.

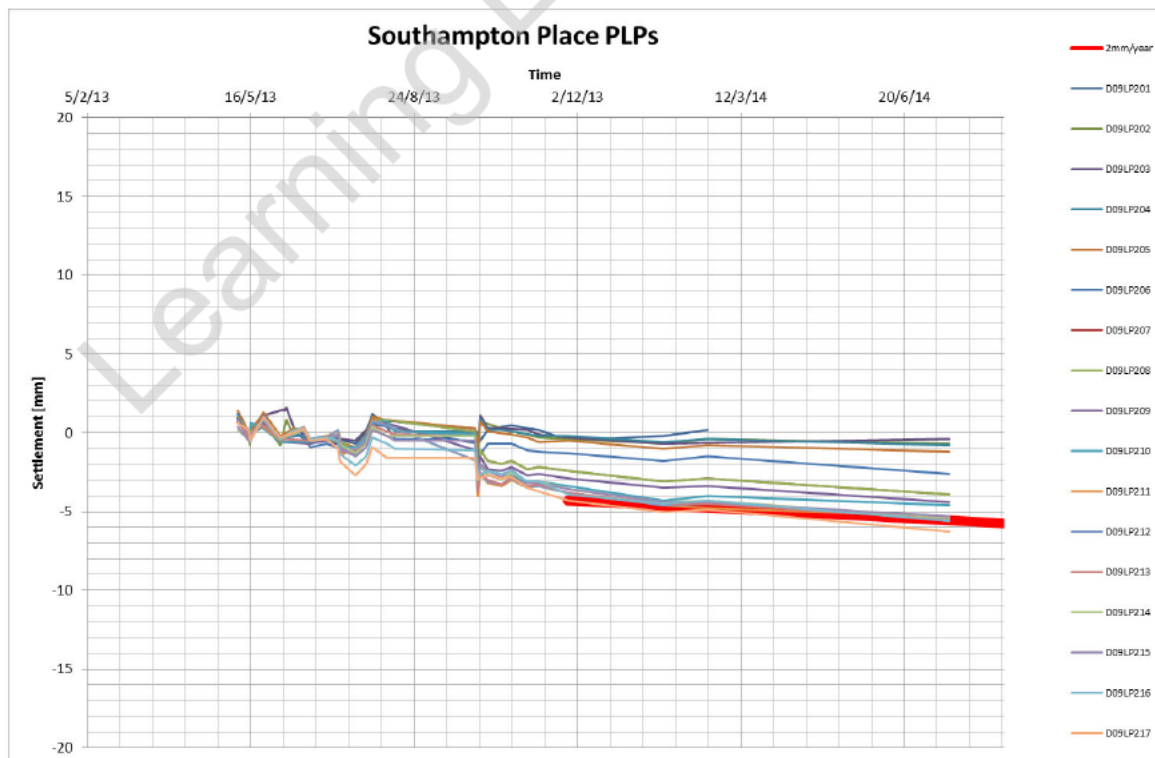
Figure 43: data time-plots - comparison against 2mm/year settlement rate (long-term)

The time-plots are generally showing stabilising data; the long term behaviour is within 2mm/year.
