Western Tunnels & Caverns Project

# Final Monitoring Report

TBM DRIVES ~ Fisher Street to Farringdon

CRL Document No. **C300-BFK-C4-RGN-CRT00\_ST005-51130**

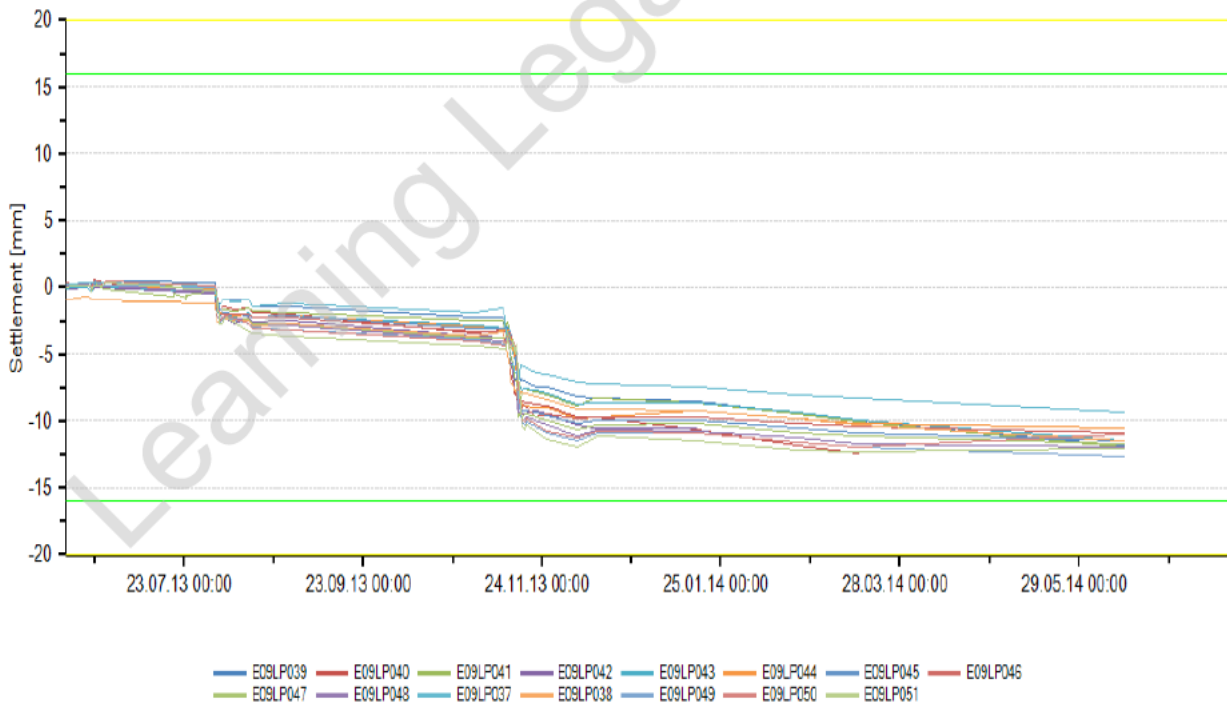
Figure 2 - data time-plots: comparison against settlement triggers

The points in Princeton Street settled up to approx. 13mm due to the C300 running tunnels excavation. The effect of the WB and EB TBMs is visible from the settlement time-plots.

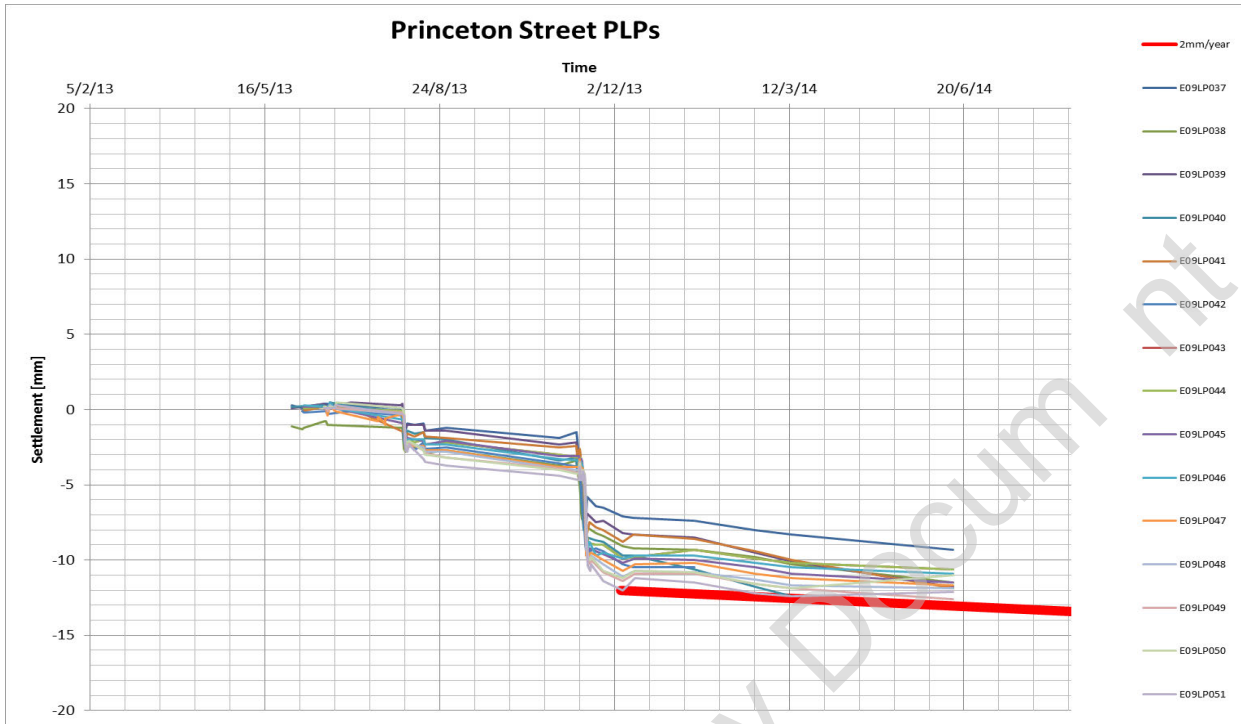
Figure 3: data time-plots - comparison against 2mm/year settlement rate (long-term)

The time plots are showing stabilising settlement trend, and the long term behaviour appears to be less than 2mm/year.

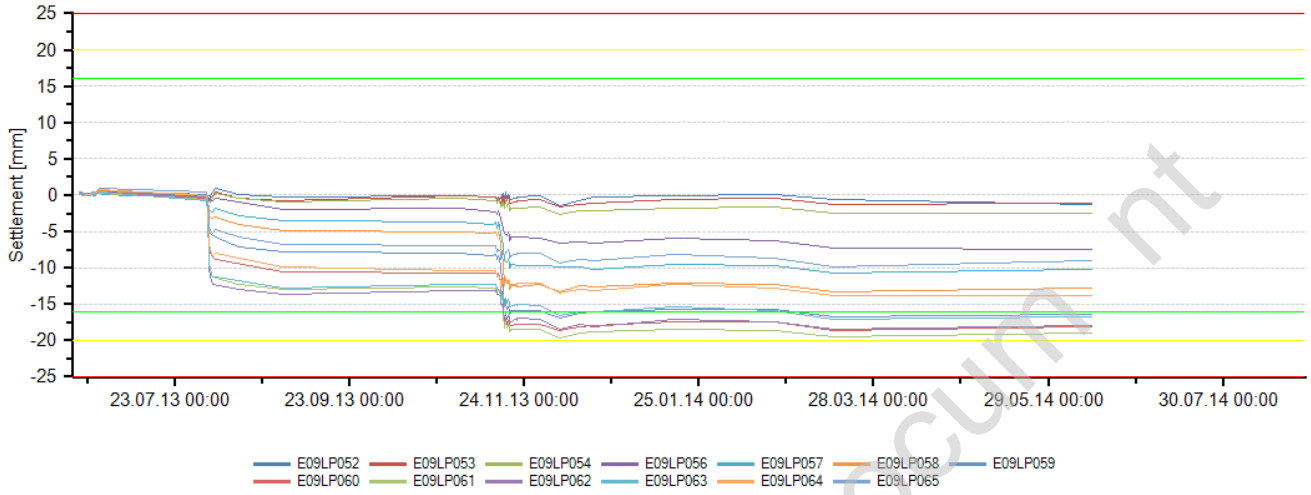
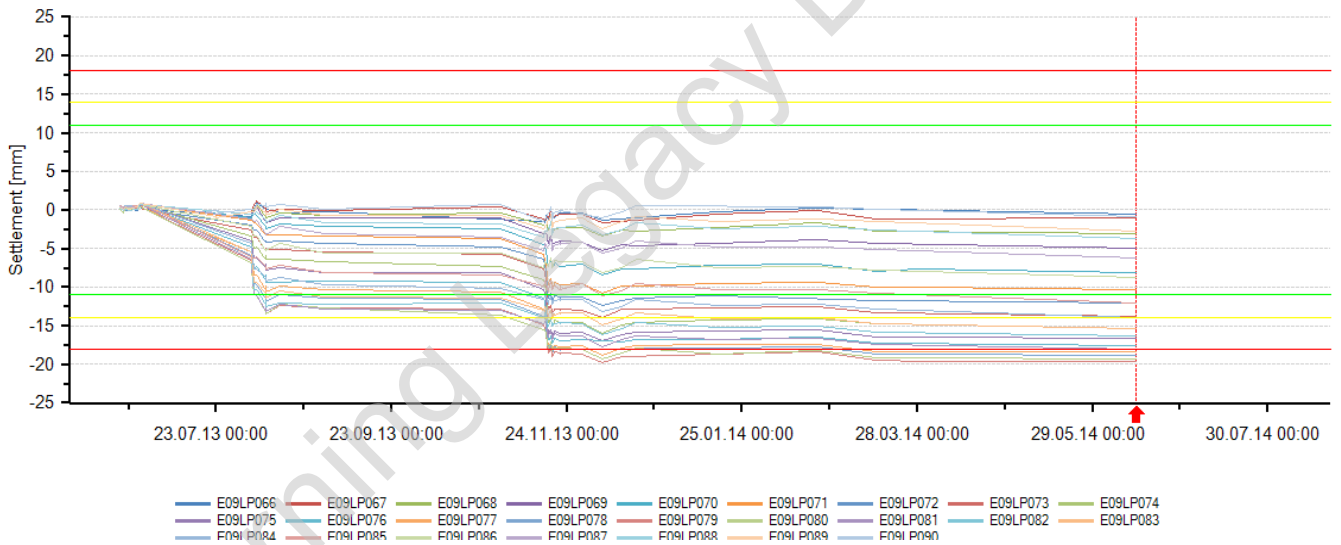
Figure 5a, b, c: data time-plots: comparison against settlement triggers

The points in Bedford Row settled up to approx. 20mm due to the C300 running tunnels excavation. The effect of the WB and EB TBMs is visible from the settlement time-plots. Settlement triggers have been breached as per Table 4.

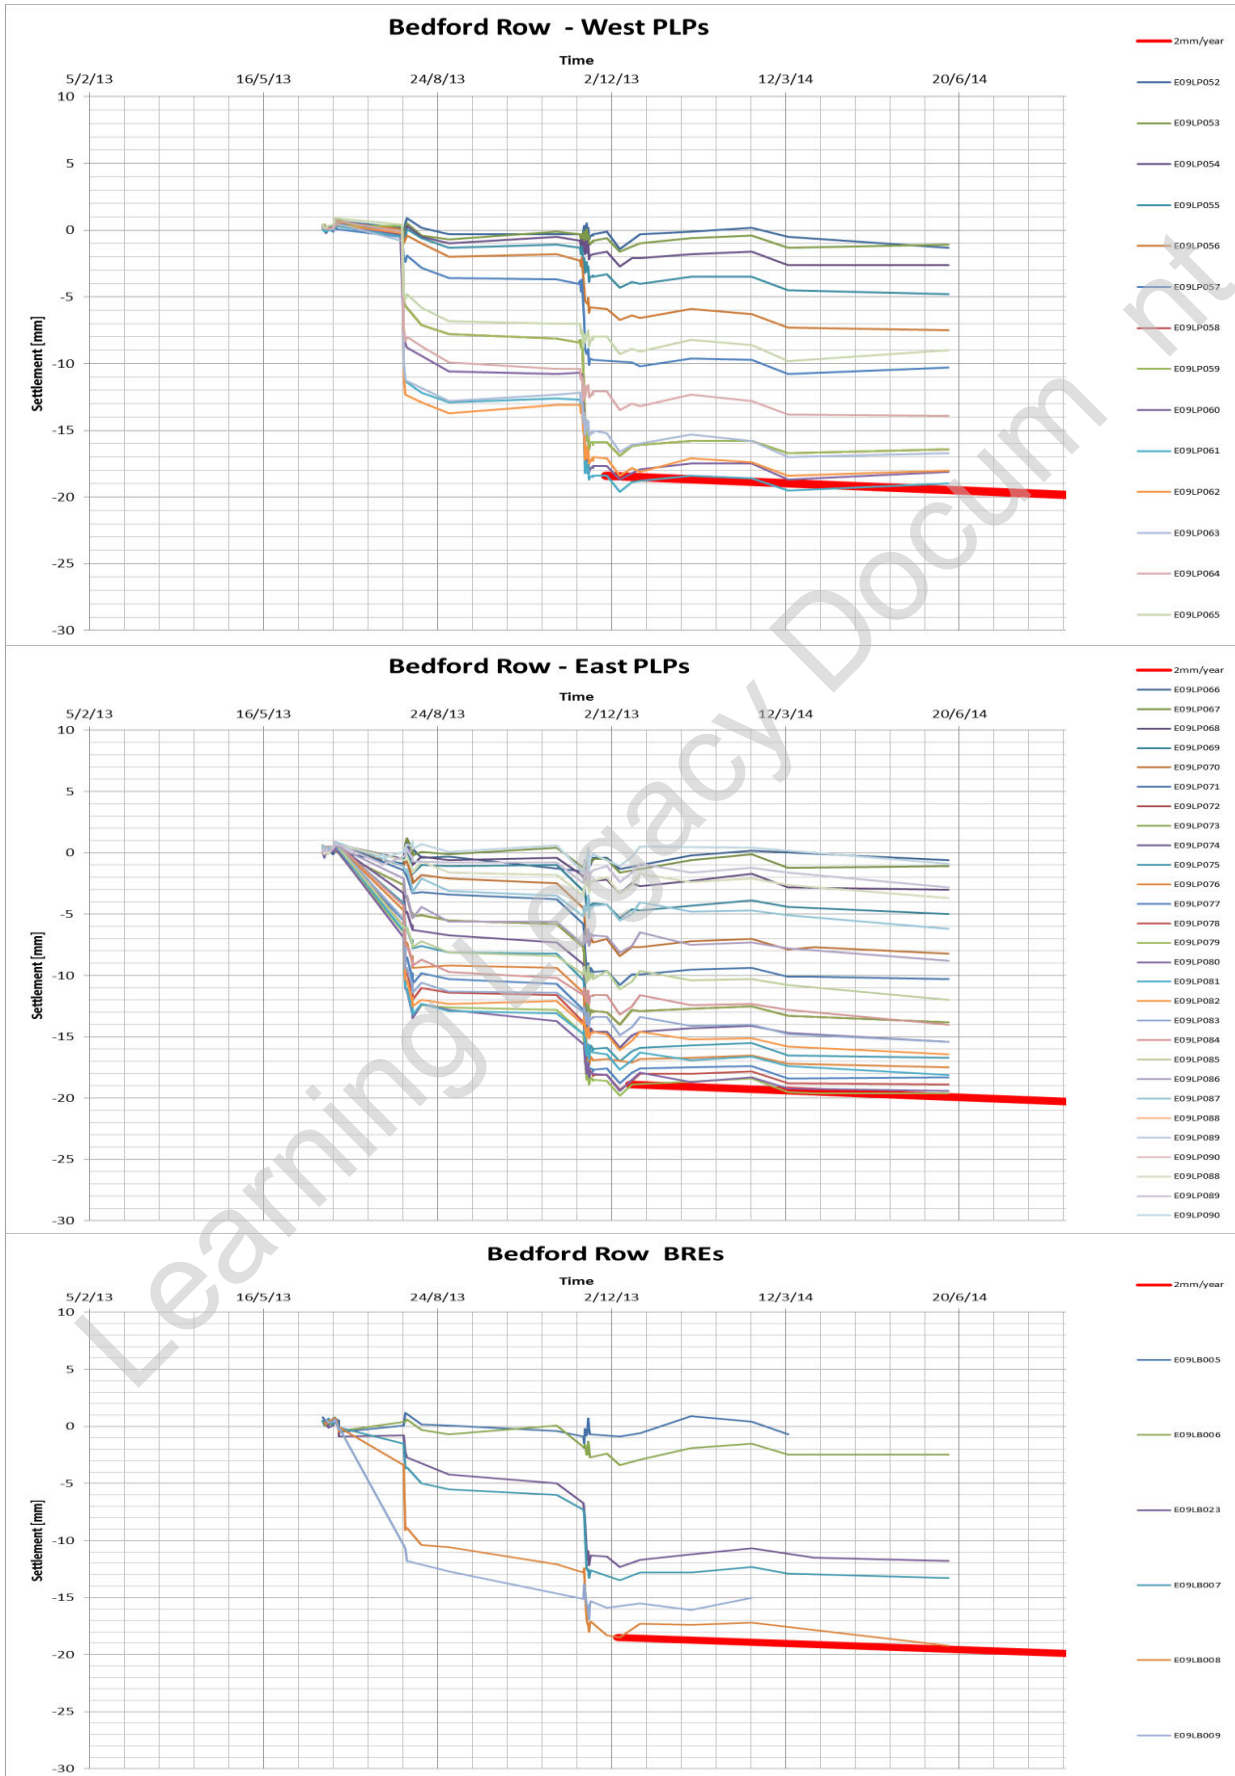
Figure 6: data time-plots - comparison against 2mm/year settlement rate (long-term)

The time-plots are generally showing stabilising settlement trends, and the long term behaviour appears to be about 2mm/year.

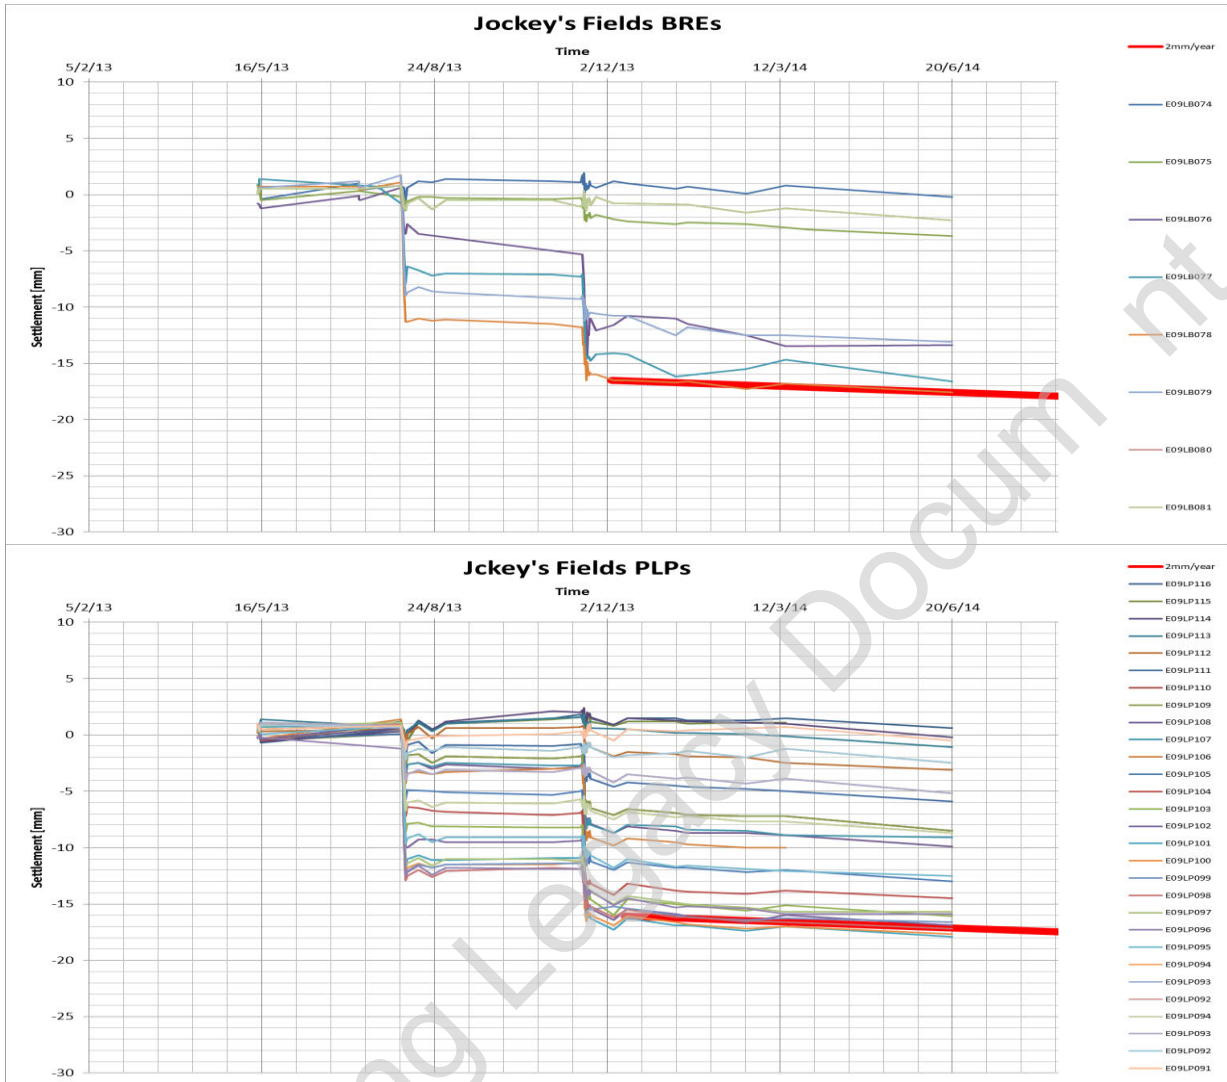
Figure 9: data time-plots - comparison against 2mm/year settlement rate (long-term)

The time-plots are generally showing stabilising settlement trend, and the long term behaviour appears to be at or below 2mm/year.

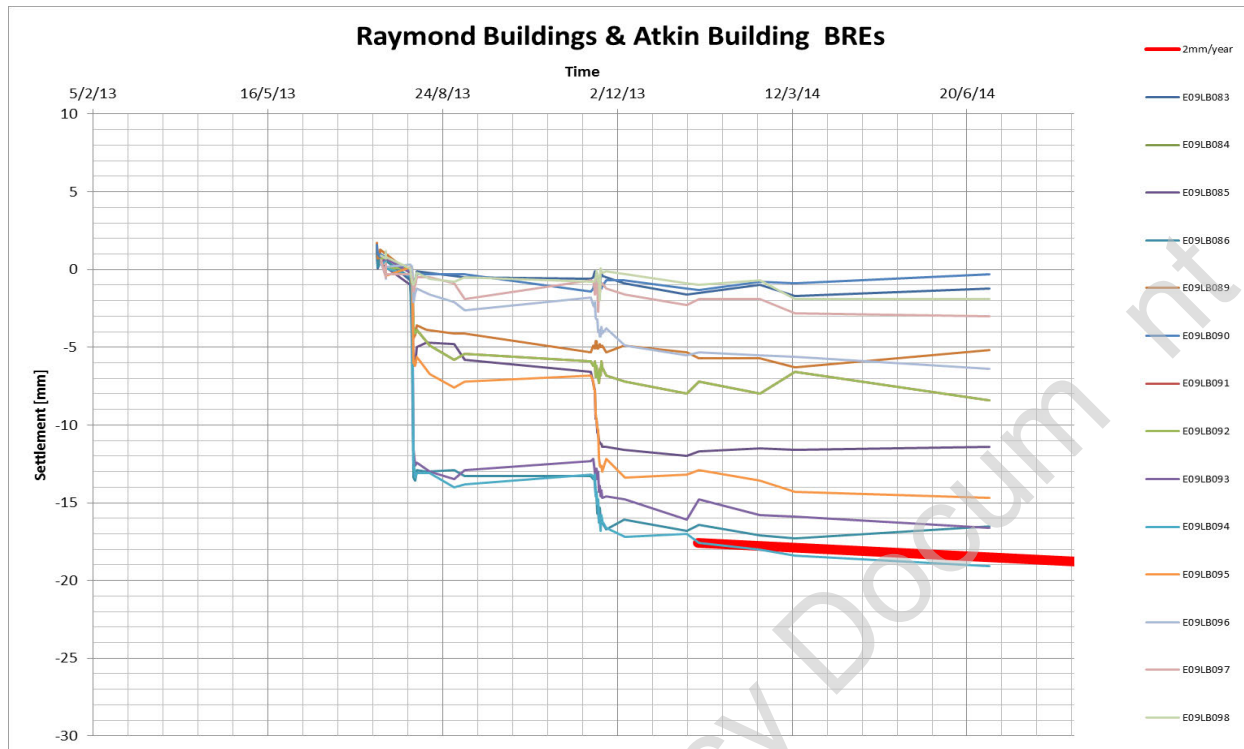
Figure 13: data time-plots - comparison against 2mm/year settlement rate (ong-term)

The time-plots are generally showing stabilising settlement trend, and the long term behaviour appears to be slightly over 2mm/year.

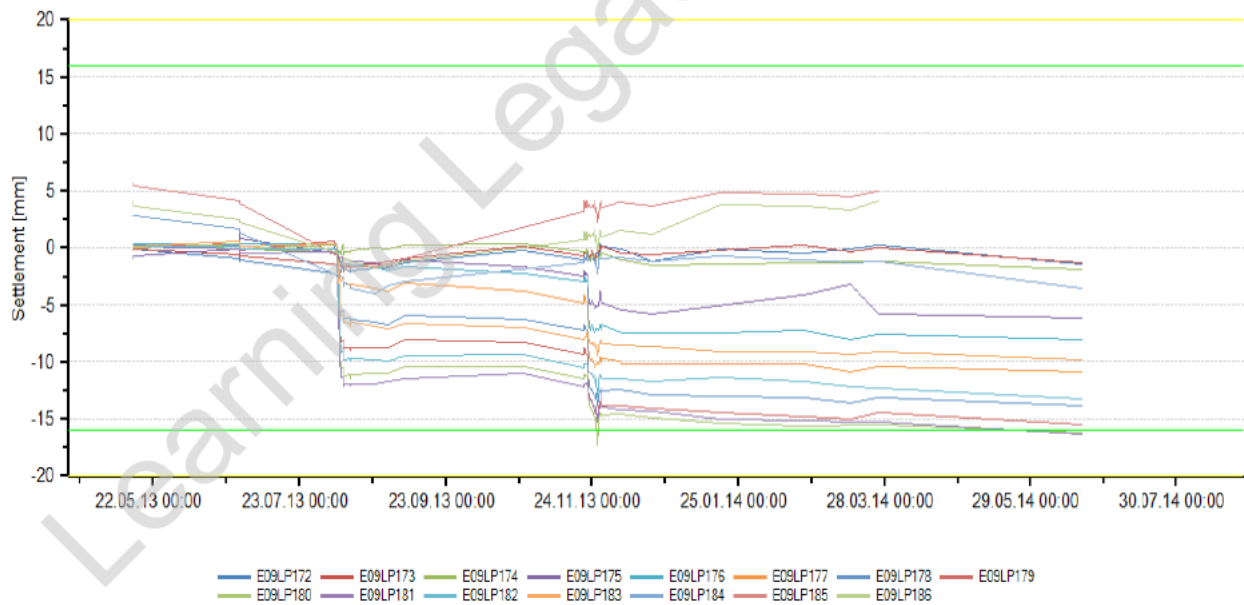
Figure 15: data time-plots - comparison against settlement triggers

The points in Gray's Inn Gardens settled up to approx. 16mm due to the C300 running tunnels excavation. The effect of the WB and EB TBMs is visible from the settlement time-plots. Settlement triggers have been breached as per Table 7.

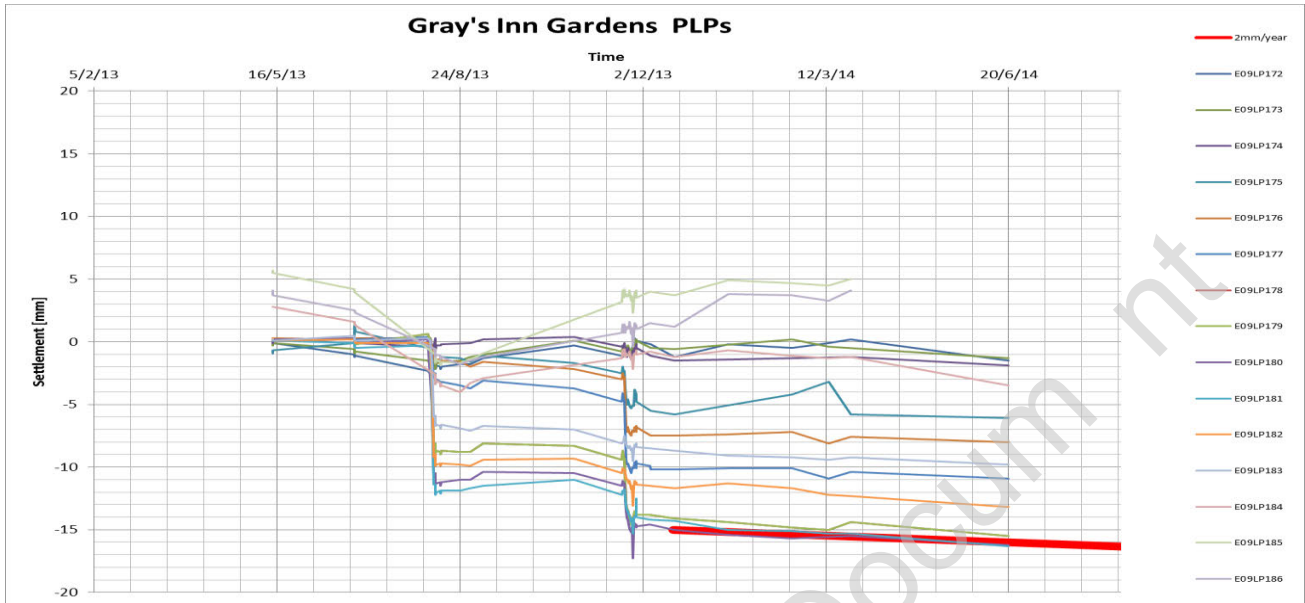
Figure 16: data time-plots - comparison against 2mm/year settlement rate (long-term)

The time-plots are generally showing stabilising settlement trend, and the long term behaviour appears to be about or below 2mm/year.

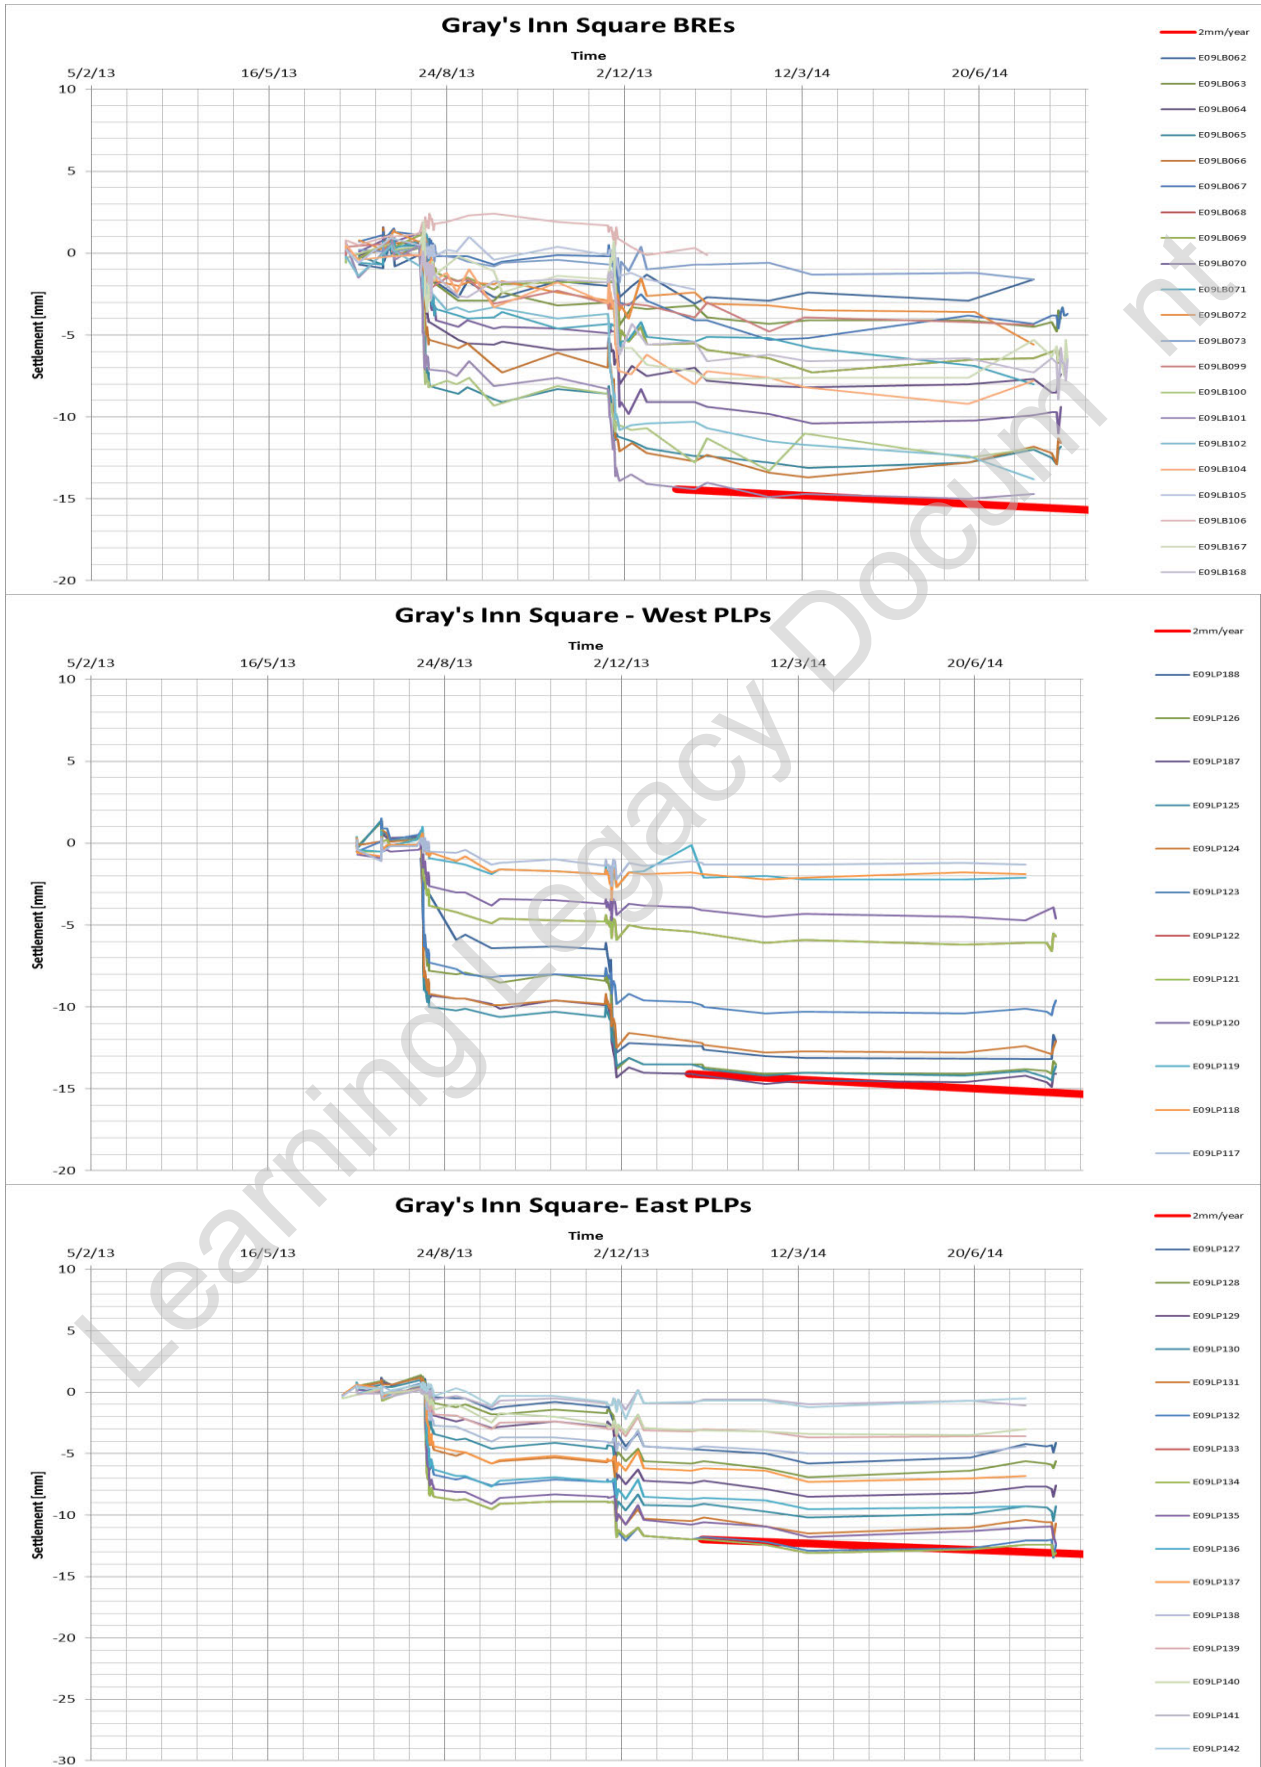
Figure 20a, b, c: data time-plots - comparison against 2mm/year settlement rate (long-term)

The time-plots are generally showing stabilising settlement trend, and the long term behaviour appears to be less than 2mm/year.

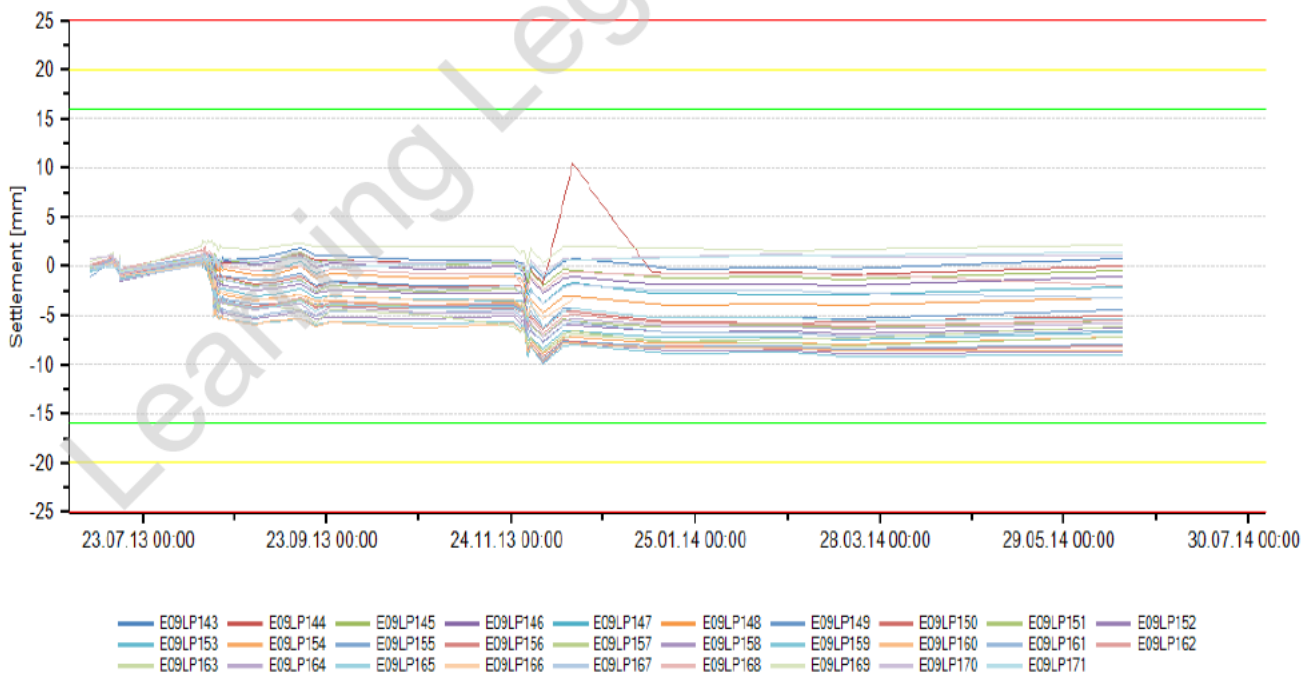
Figure 22: data time-plots - comparison against settlement triggers

The points in Gray's Inn Road settled up to approx. 10mm due to the C300 running tunnels excavation. The effect of the WB and EB TBMs is visible from the settlement time-plots. Settlement triggers have not been breached.

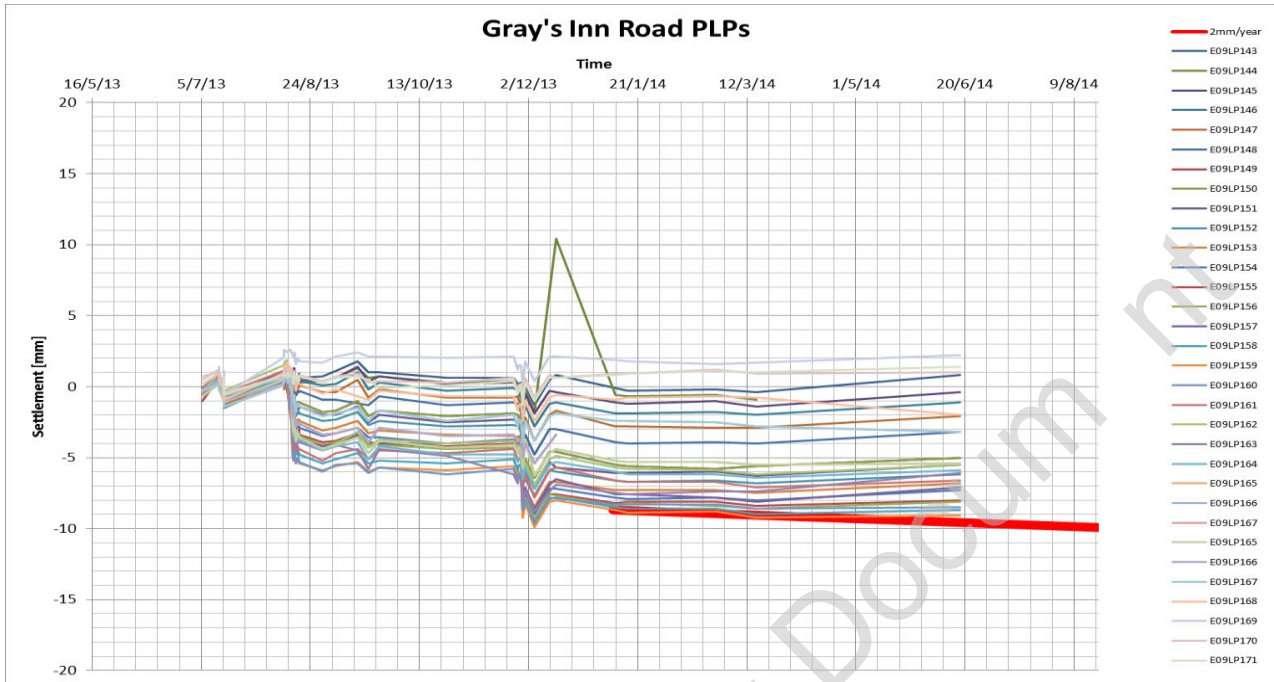
Figure 23: data time-plots - comparison against 2mm/year settlement rate (long-term)

The time-plots are generally showing stabilising settlement trend, and the long term behaviour appears to be less than 2mm/year.

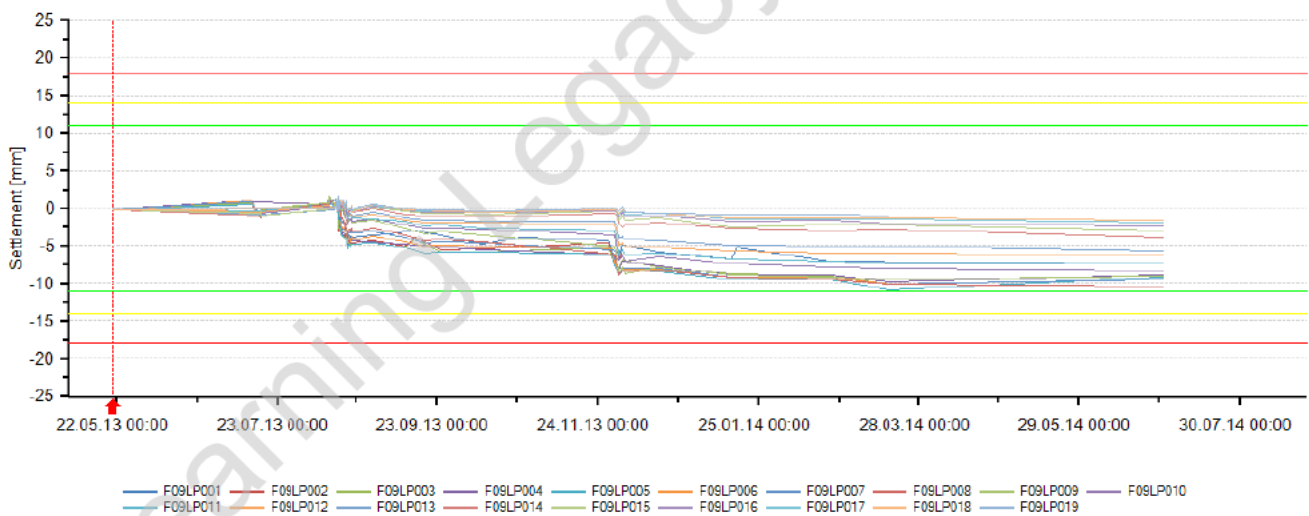
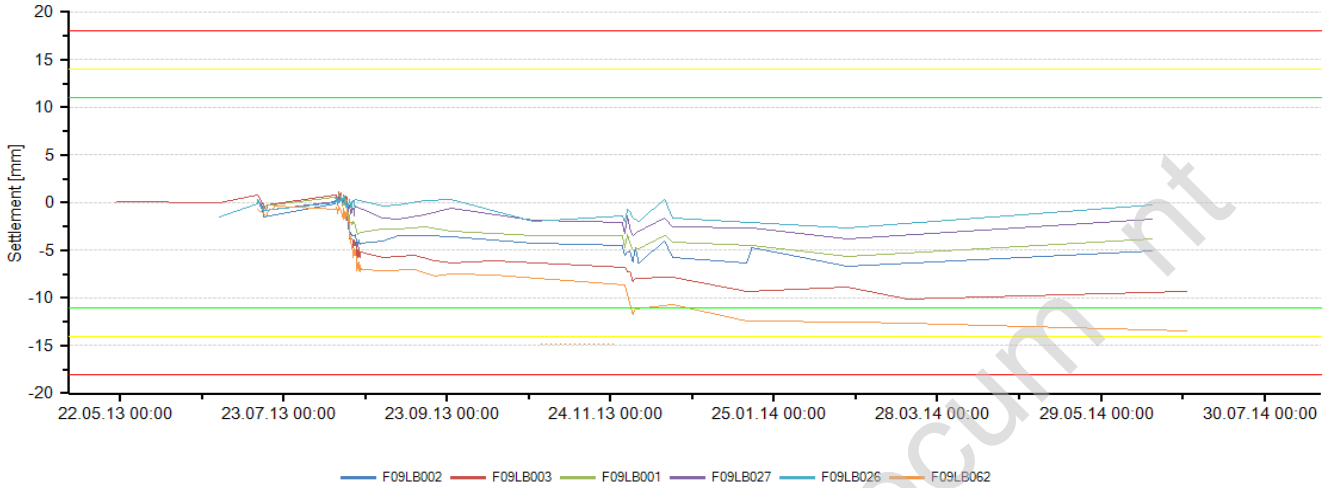
The points in Baldwin’s Gardens settled up to approx. 14mm due to the C300 running tunnels excavation. The effect of the WB and EB TBMs is visible from the settlement time-plots. Settlement triggers have been breached as per Table 8.

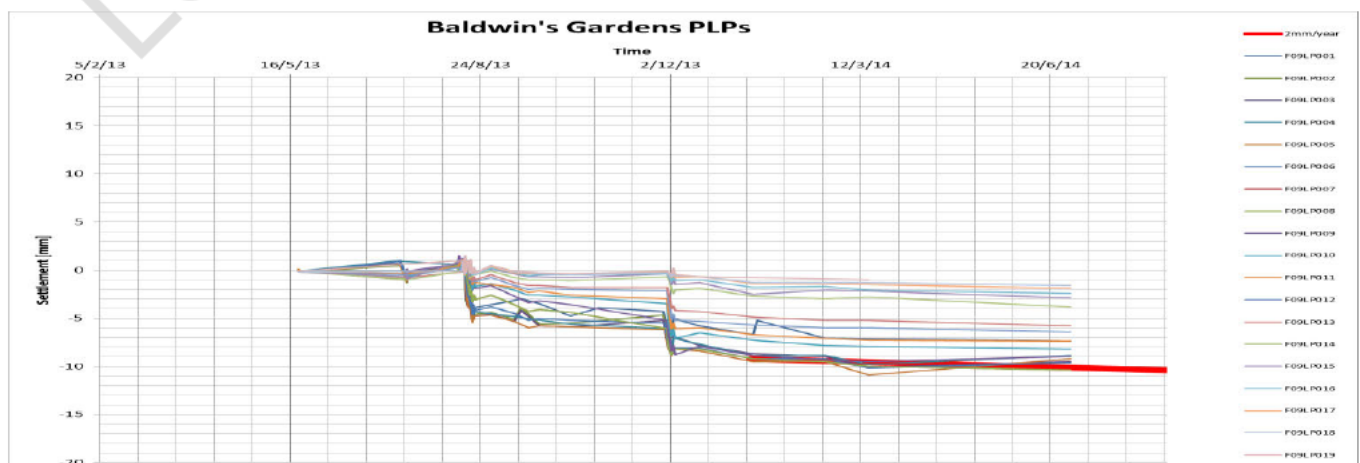
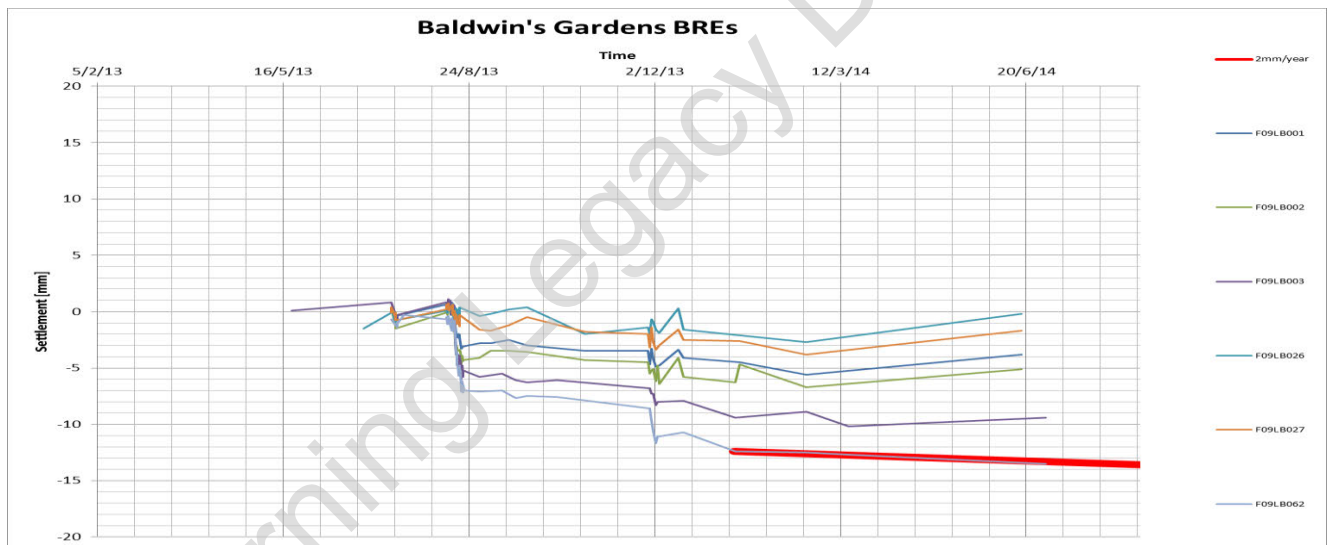
The time-plots are generally showing stabilising settlement trend, and the long term behaviour appears to be less than 2mm/year.

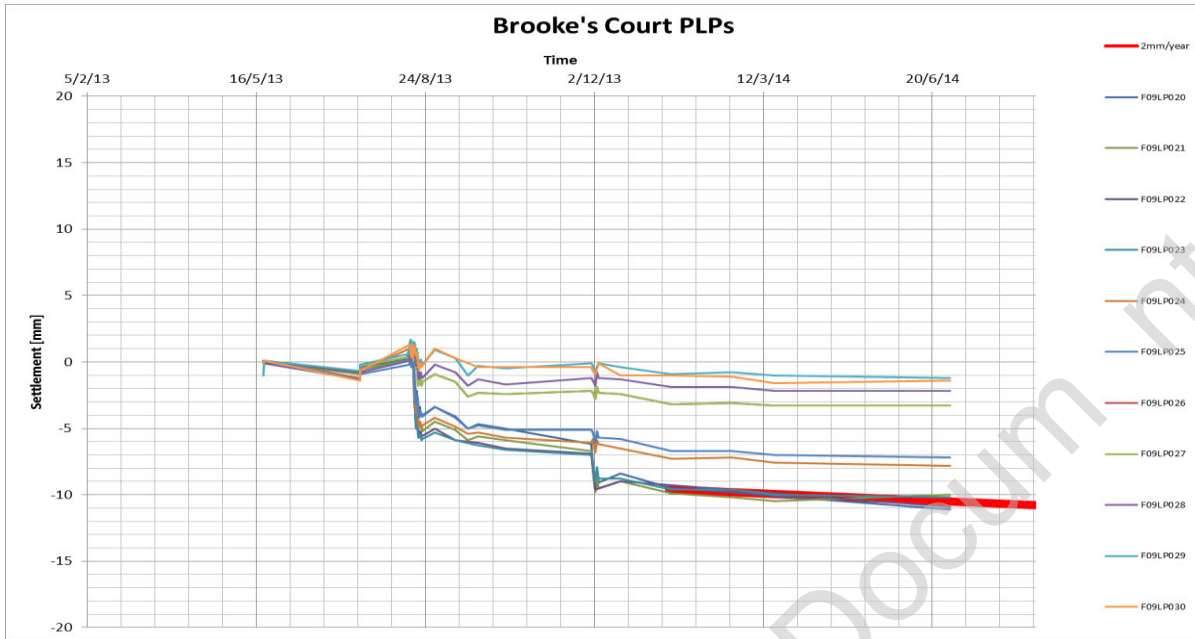
Figure 31: data time-plots - comparison against 2mm/year settlement rate (long-term)

The time-plots are generally showing stabilising settlement trend, and the long term behaviour appears to be approximately 2mm/year.

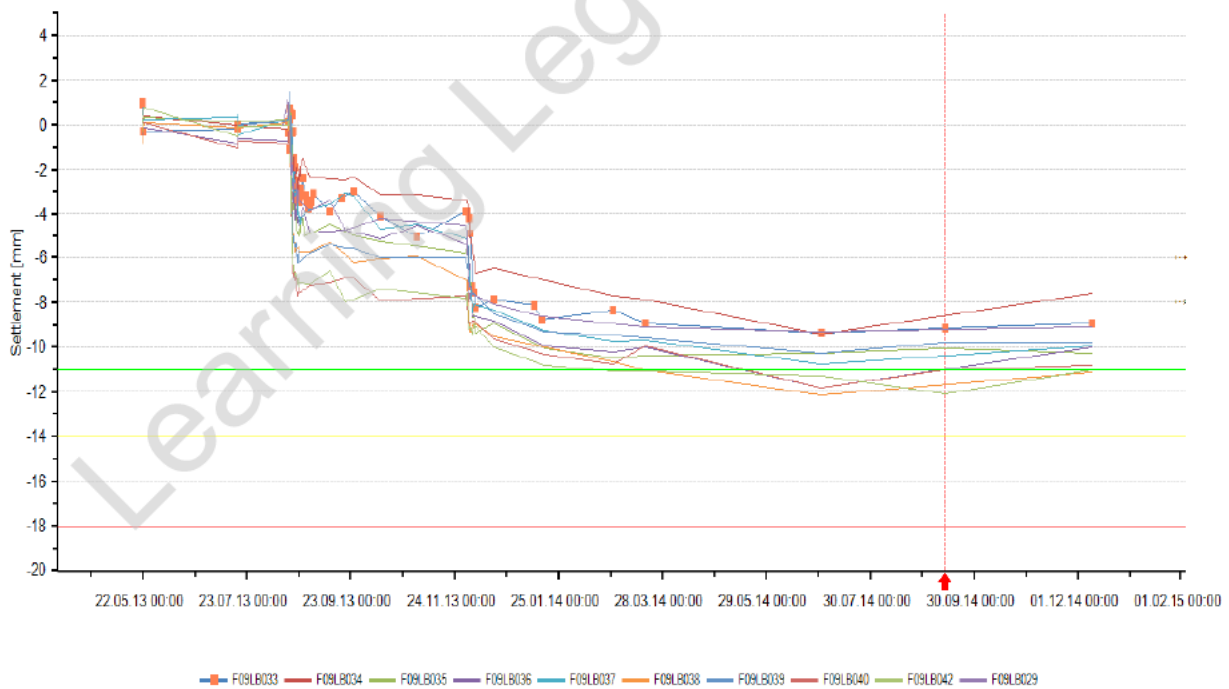
Figure 34: data time-plots - comparison against settlement triggers

The points in St. Alban's Church settled up to approx. 12mm due to the C300 running tunnels excavation. The effect of the WB and EB TBMs is visible from the settlement time-plots. Settlement triggers have been breached as per Table 10.

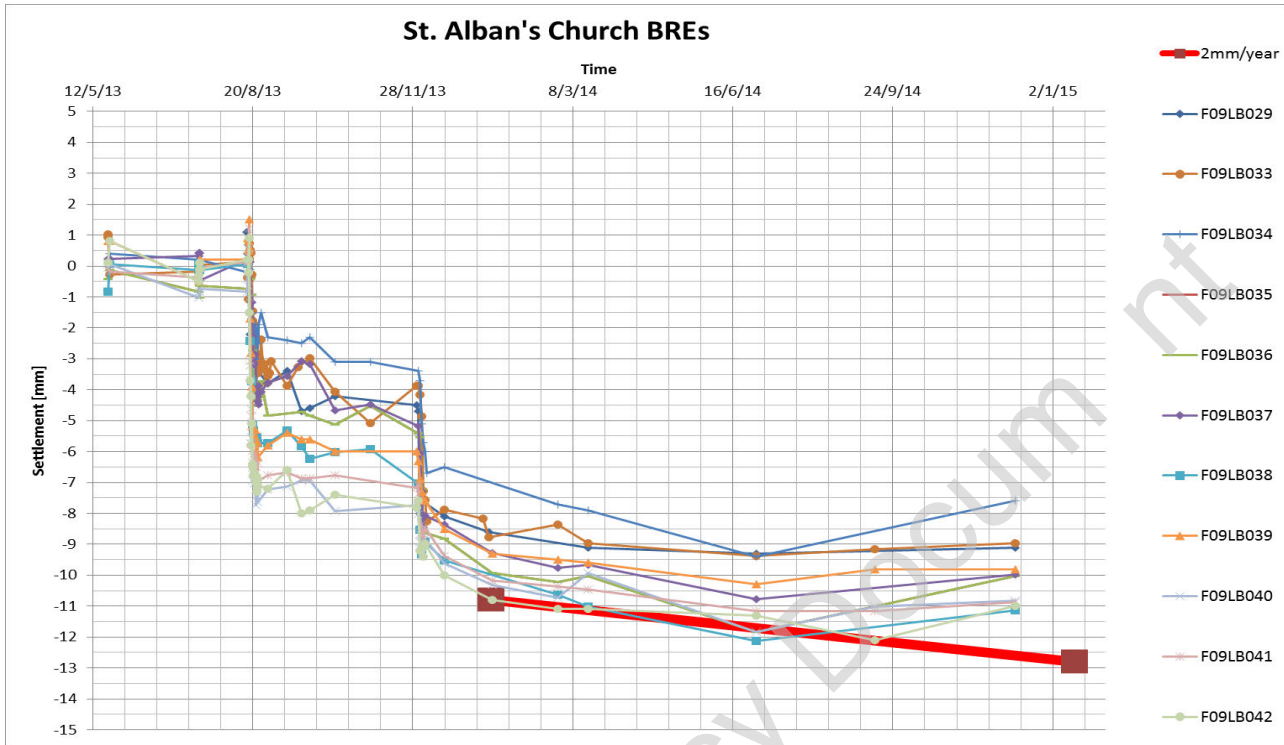
Figure 35: data time-plots - comparison against 2mm/year settlement rate (ong-term)

The time-plots are generally showing a settlement trend of less than 2mm/year.

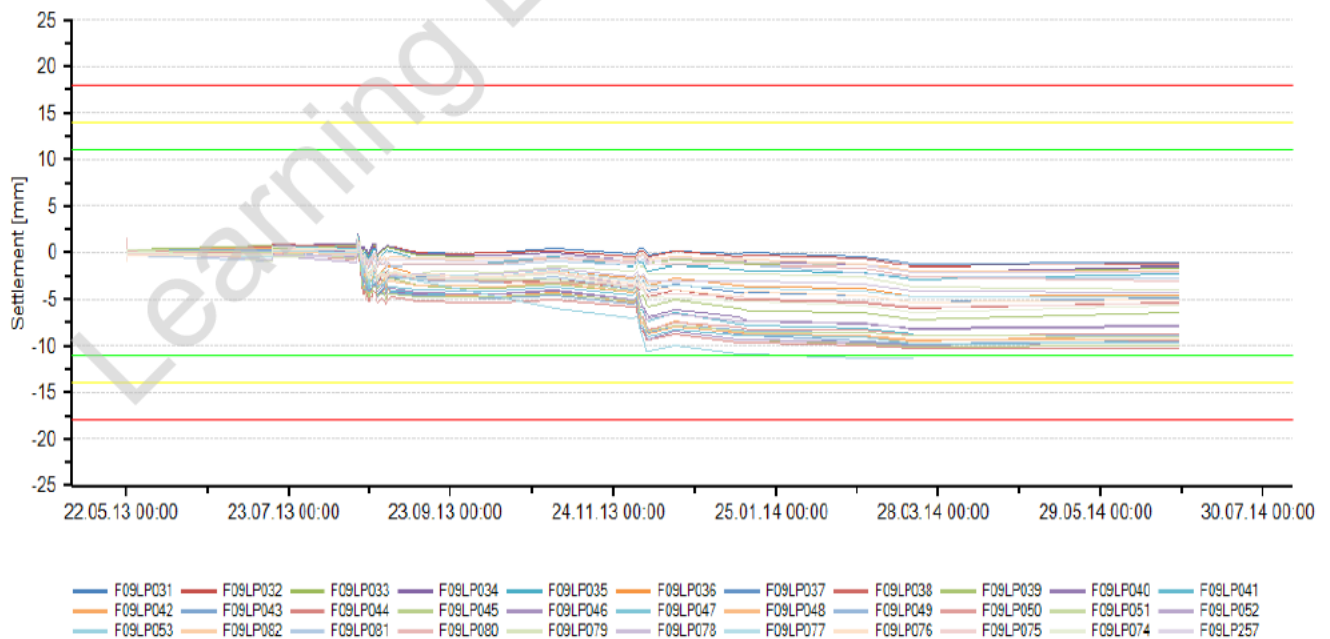
Figure 37: data time-plots - comparison against settlement triggers

The points in Brooke Street & Dorrington Street settled up to approx. 12mm due to the C300 running tunnels excavation. The effect of the WB and EB TBMs is visible from the settlement time-plots. Settlement triggers have been breached as per Table 11.

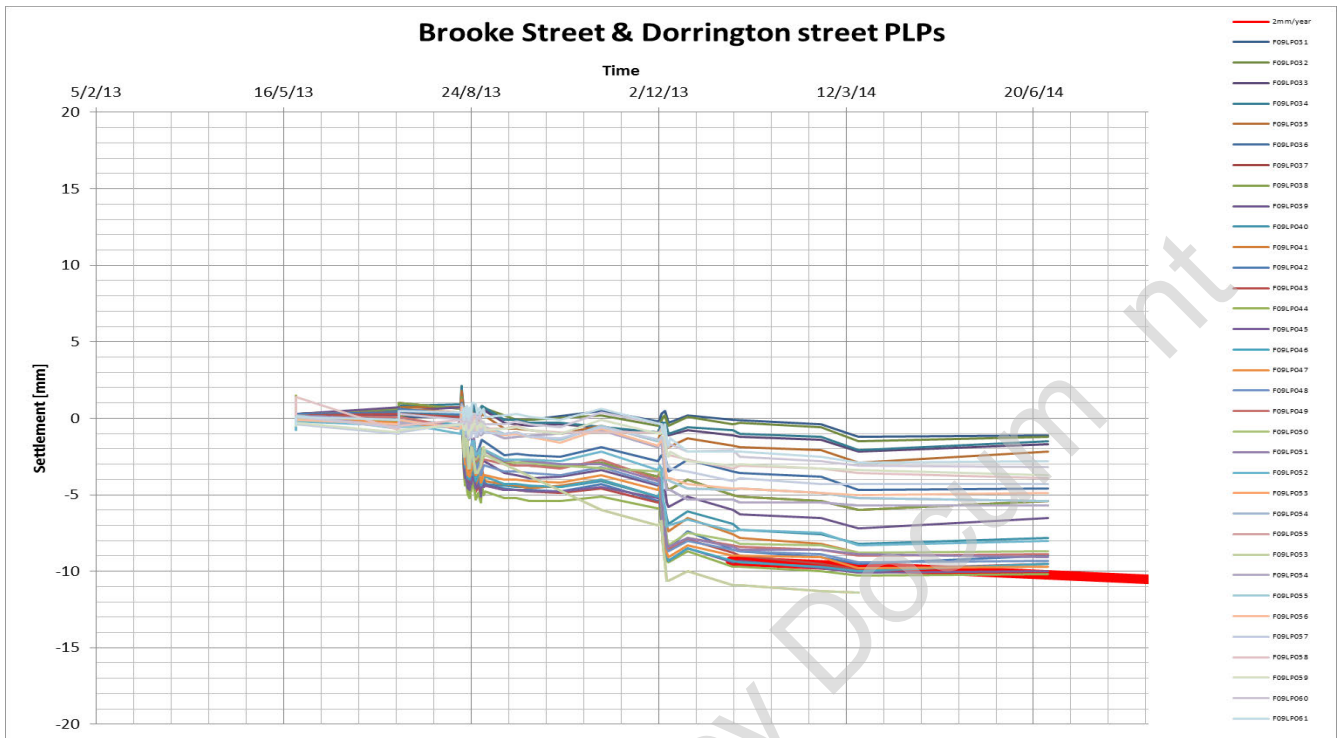
Figure 38: data time-plots - comparison against 2mm/year settlement rate (long-term)

The time plots are generally showing a settlement trend of less than 2mm/year.

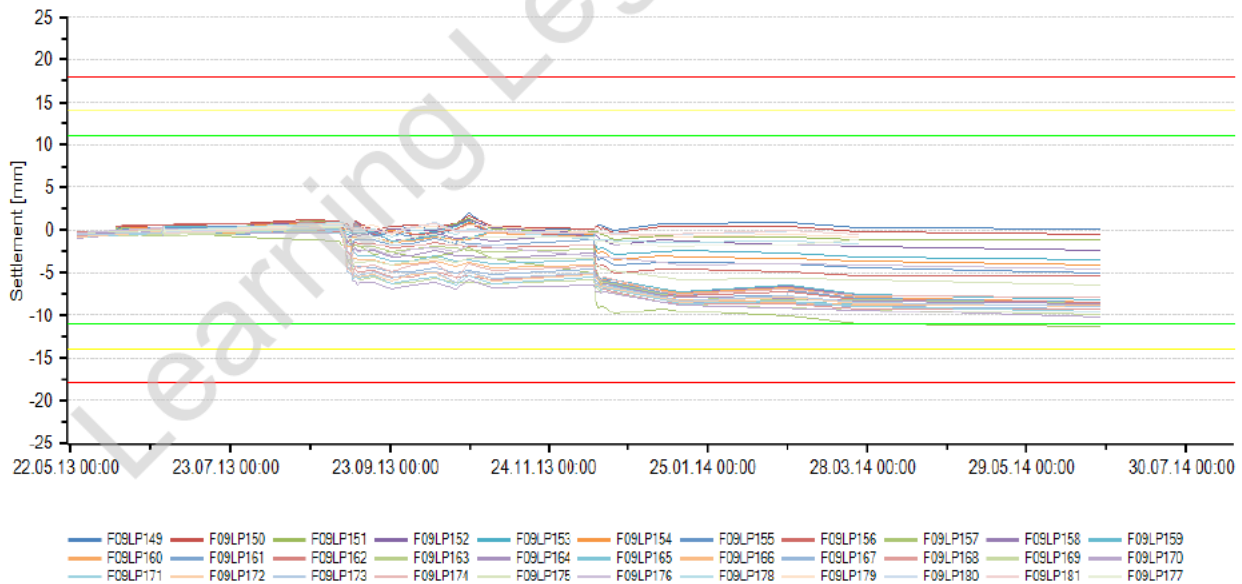
Figure 54: data time-plots - comparison against settlement triggers

The points in Kirby Street and Bleeding Heart Yard settled up to approx. 12mm due to the C300 running tunnels excavation. The effect of the WB and EB TBMs is visible from the settlement time-plots. Settlement triggers have been breached as per Table 12: it is noted that the behaviour of this point diverged from adjacent points both before and between the TBM drives and it is considered that this is probably due to external factors.
