Western Tunnels & Caverns Project

# Final Monitoring Report

TBM DRIVES ~ Fisher Street to Farringdon

CRL Document No. **C300-BFK-C4-RGN-CRT00\_ST005-51130**

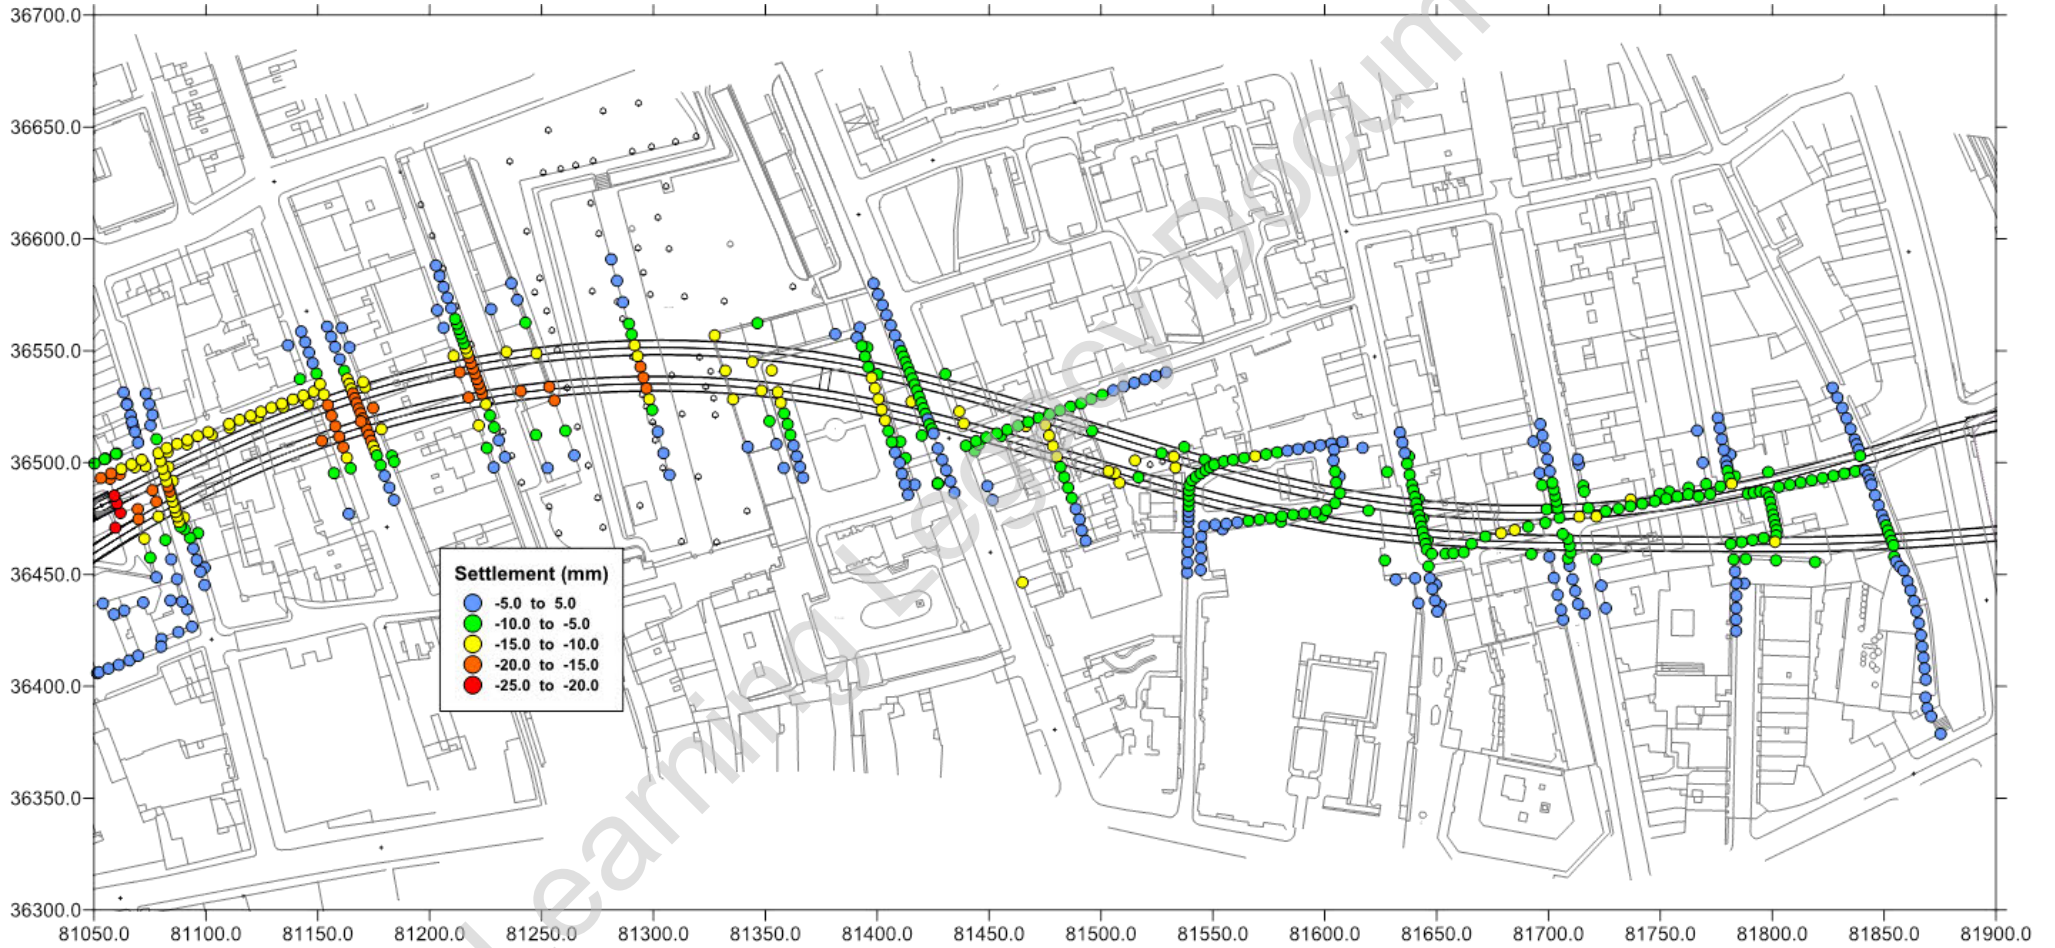
Summary of final recorded settlement

final settlements recorded on all BRE and PLP is also given in Appendix 7. The maximum recorded settlement between Fisher Street Shaft and Farringdon Station is **20mm**.
