Grouting Summary & I &M Final Report - BOS GS4

Western Tunnels & Caverns Project

C300-BFK-C4-RGN-CRT00_ST005-51215 Rev 3.0

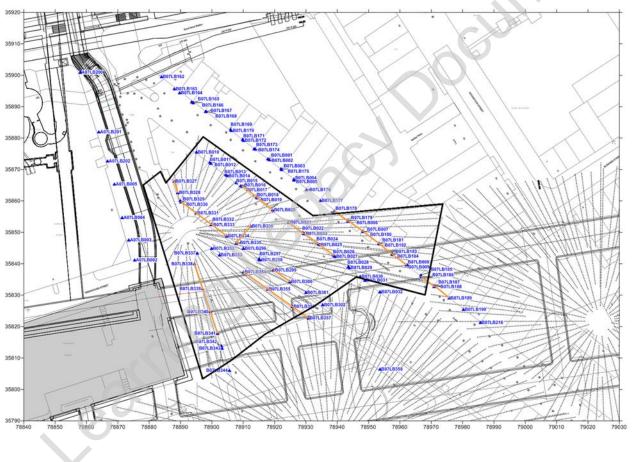
٠	GREEN	1:1250	0.8mm/m
•	AMBER	1:1000	1.0mm/m
•	RED	1:500	2.0mm/m

Figure 4.1.1 Locations where building slope triggers have been exceeded.

- The northern part of the South Molton Street east façade lies partly within the plan extent of the GS4 array (from distance 70 to 105m): data from all points shown on Figure 4.1.1 are presented.

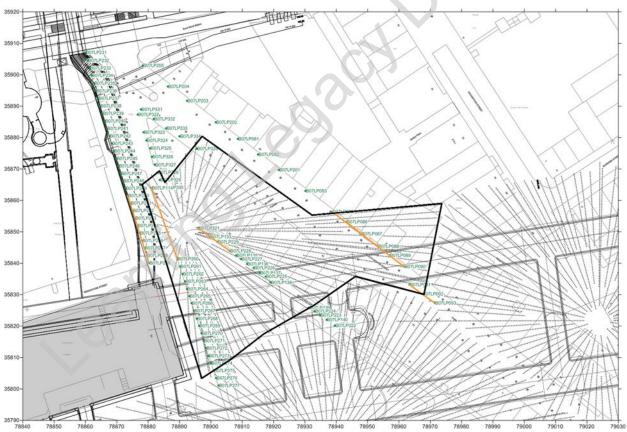
Figure 5.1.1 Locations where ground slope triggers have been exceeded.

- The northern part of South Molton Street is partly within the GS4 array (from distance 70m to 110m). The section of the PLP transect from 0m to 70m is just outside the plan extent of the GS4 arrays which terminate below the centre of South Molton Street: data from all points shown on Figure 5.1.1 are presented.
