C300/410  
Western Tunnels & Caverns Project  
**Report**

**Grouting Summary & I & M Final Report - TCR GS2**

CRL Document No. **C300-BFK-C4-RGN-CRT00\_ST005-51226**

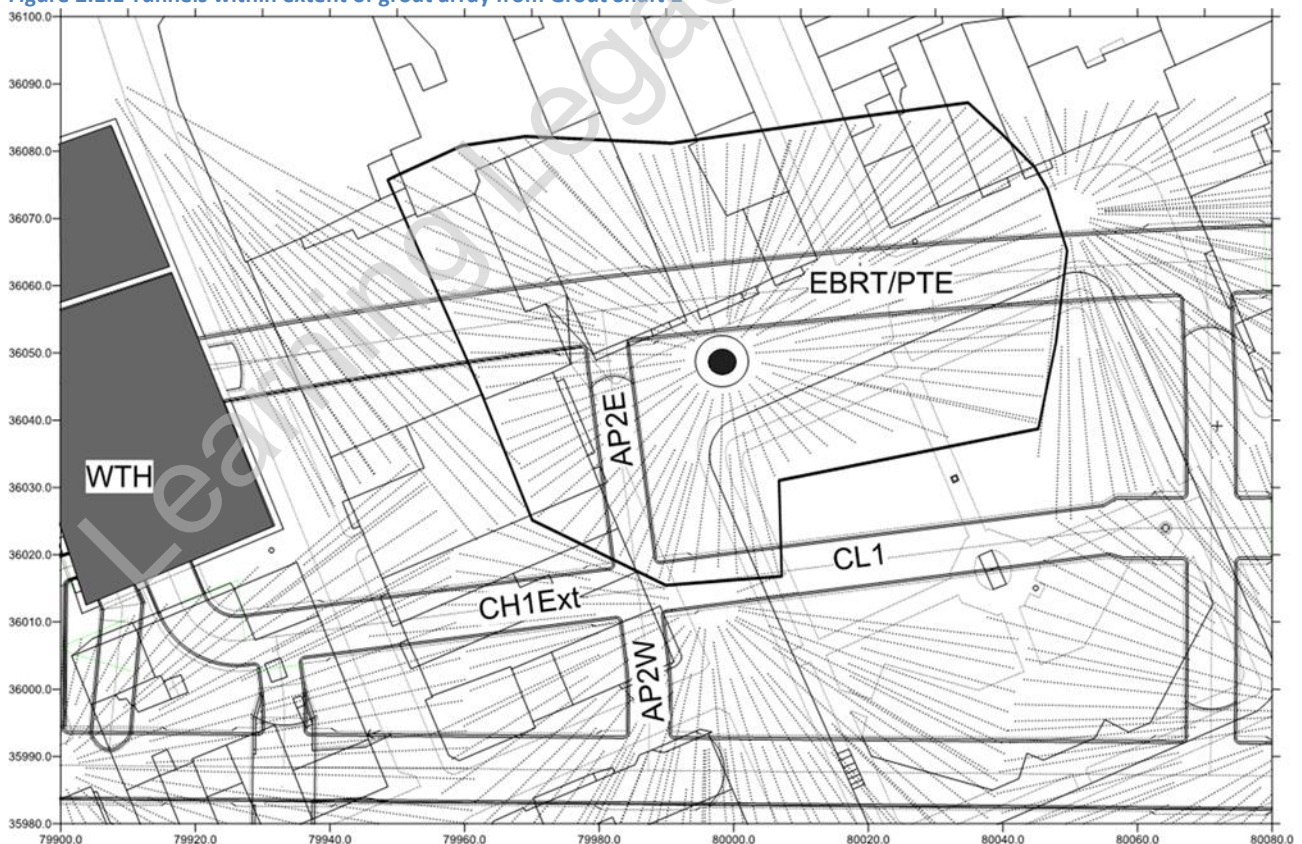
Figure 2.1.1 Tunnels within extent of grout array from Grout Shaft 2

Table 2.1.1 and Figure 2.1.1 show the tunnel construction works undertaken within the footprint of the compensation grouting arrays installed from Grout Shaft 2 at TCR Station.

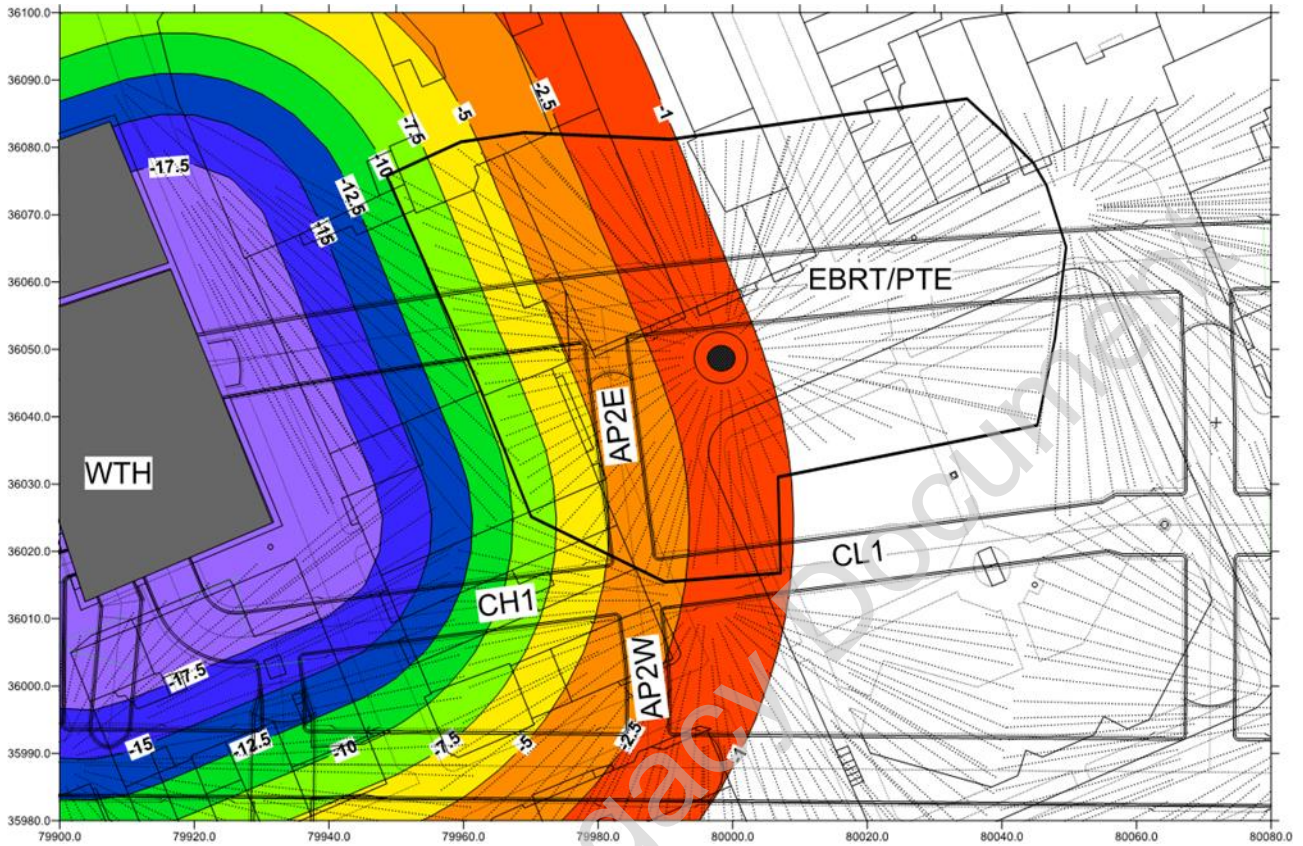
Figure 3.2.3. Period A: Total predicted greenfield settlement contours (supplied by C122)

The calculated short term movements associated with excavation of the Western Ticket Hall south box are shown in Figure 3.2.3 (as supplied by C122). Greatest settlement is ~20mm at the walls of the excavation. It is understood that this is intended to include wall installation effects. The observed settlements (adjusted to allow for movements prior to the start of BFK monitoring) are shown on Figure 3.2.4, which indicate much more localized and smaller movements with a maximum value of ~10mm and less than 1mm in the GS2 area.

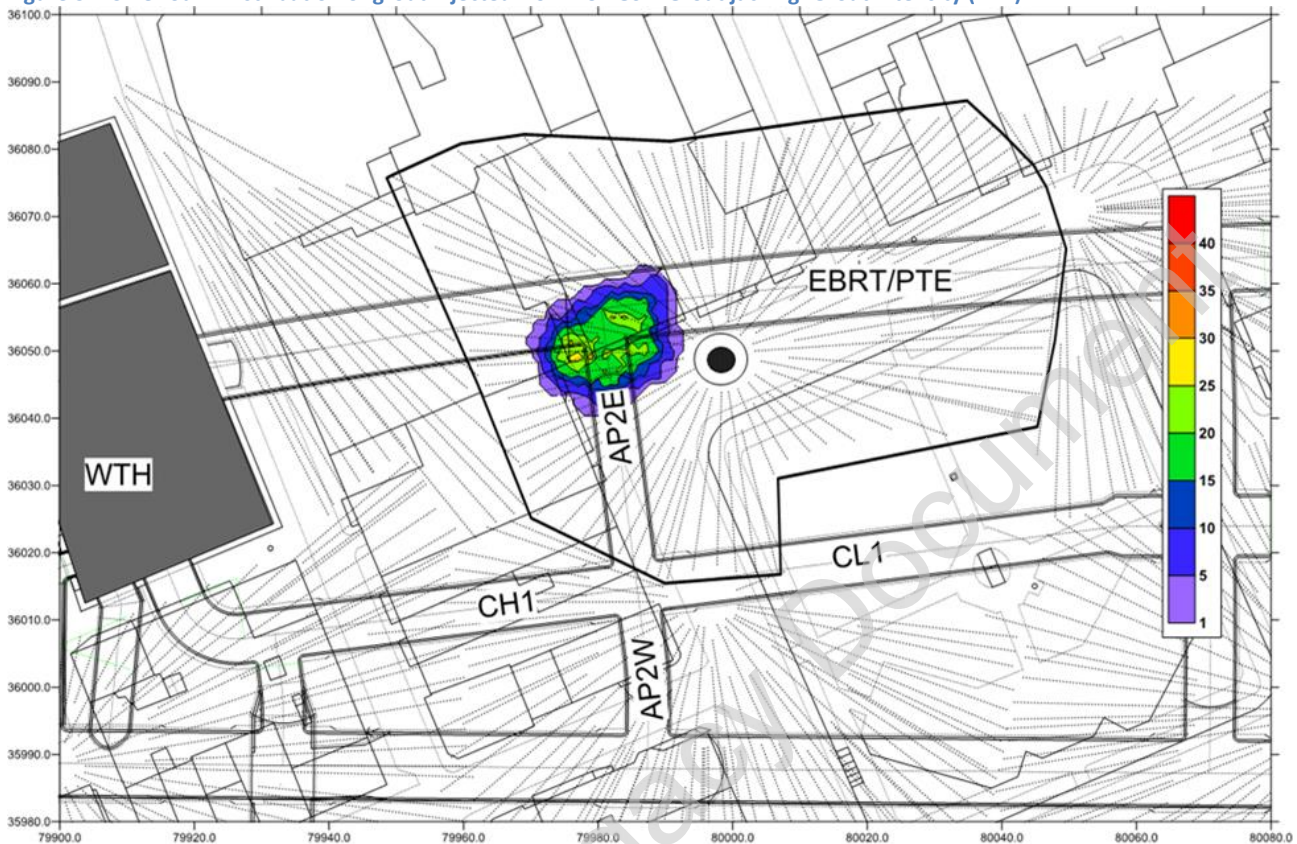
Figure 3.7.3 Period F: Distribution of grout injected from TCR GS2: Grout jacking. Grout Intensity (mm).

Since concurrent grouting was not practicable for the short length of the AP2E connection, a grout jacking episode was undertaken as shown in Figure 3.7.3.

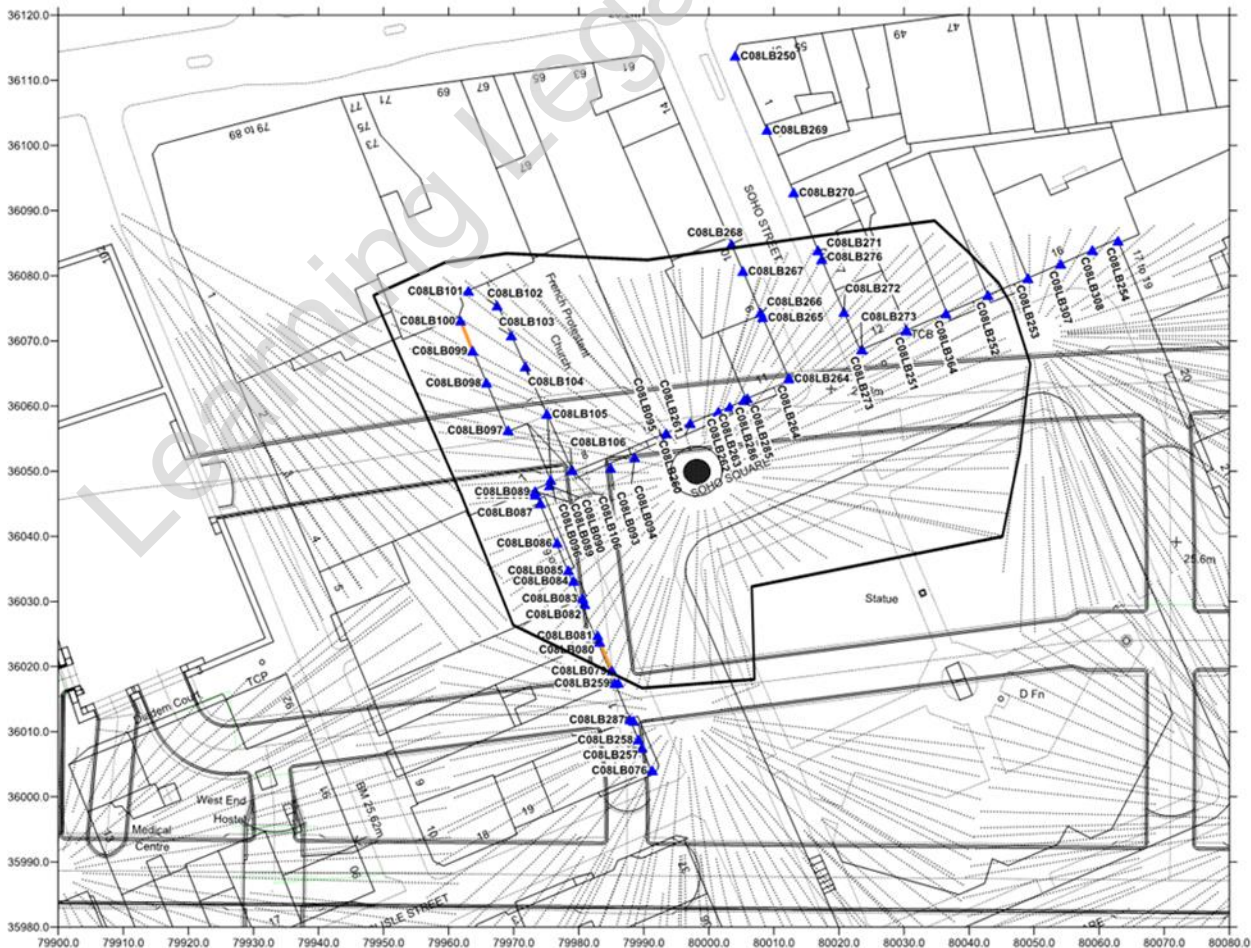
Figure 4.1.1 Locations where building slope triggers have been exceeded

BUILDING FACADES		Comment	Date exceeded	Maximum (mm/m)	Final (mm/m)
Soho Square - West					
C08LB079 - C08LB080	Amber	Borderline (16 readings of 149 >1.0 between 04/08/13 & 11/07/13 Mean 0.80)	04/08/13	1.09	0.98
C08LB099 - C08LB100	Amber	Max 1.01 during construction (Period F).	08/06/14	1.18	1.18

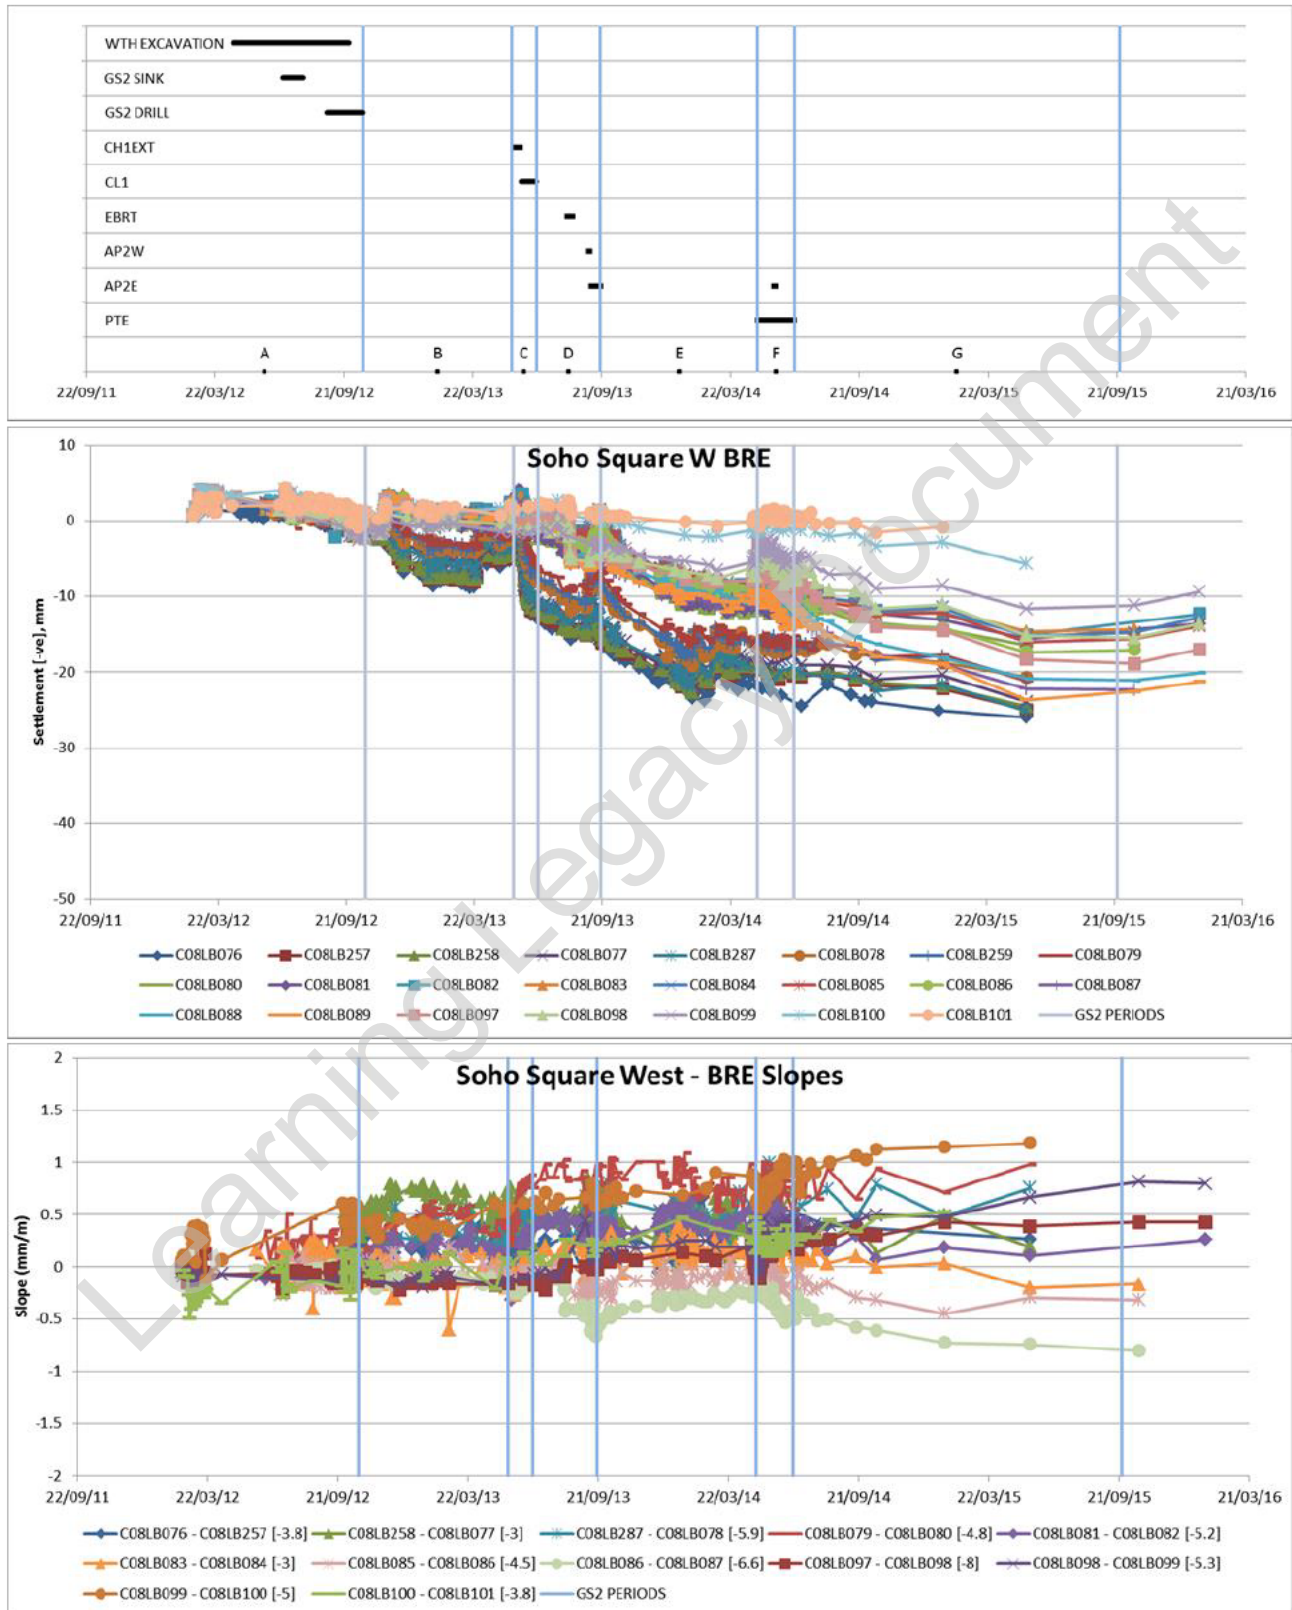
### 4.2. Soho Square West – north

- Only part of the façade is within the TCR GS2 array (from distance 17m): data from points north of Carlisle Street are presented as shown in Figure 4.1.1.

- The slope data plots show that occasional readings between points C08LB079 and C08LB080 exceeded the Amber trigger in Periods D and E. However, given the scatter in the data, the overall trend indicates that the trigger was not exceeded. An Amber slope trigger has been exceeded between C08LB099 and C08LB100 at the very northern end of the profile: it is notable that the slope reached 0.5mm/m in Period A when maximum movements were <5mm and access to these points was only rarely available.

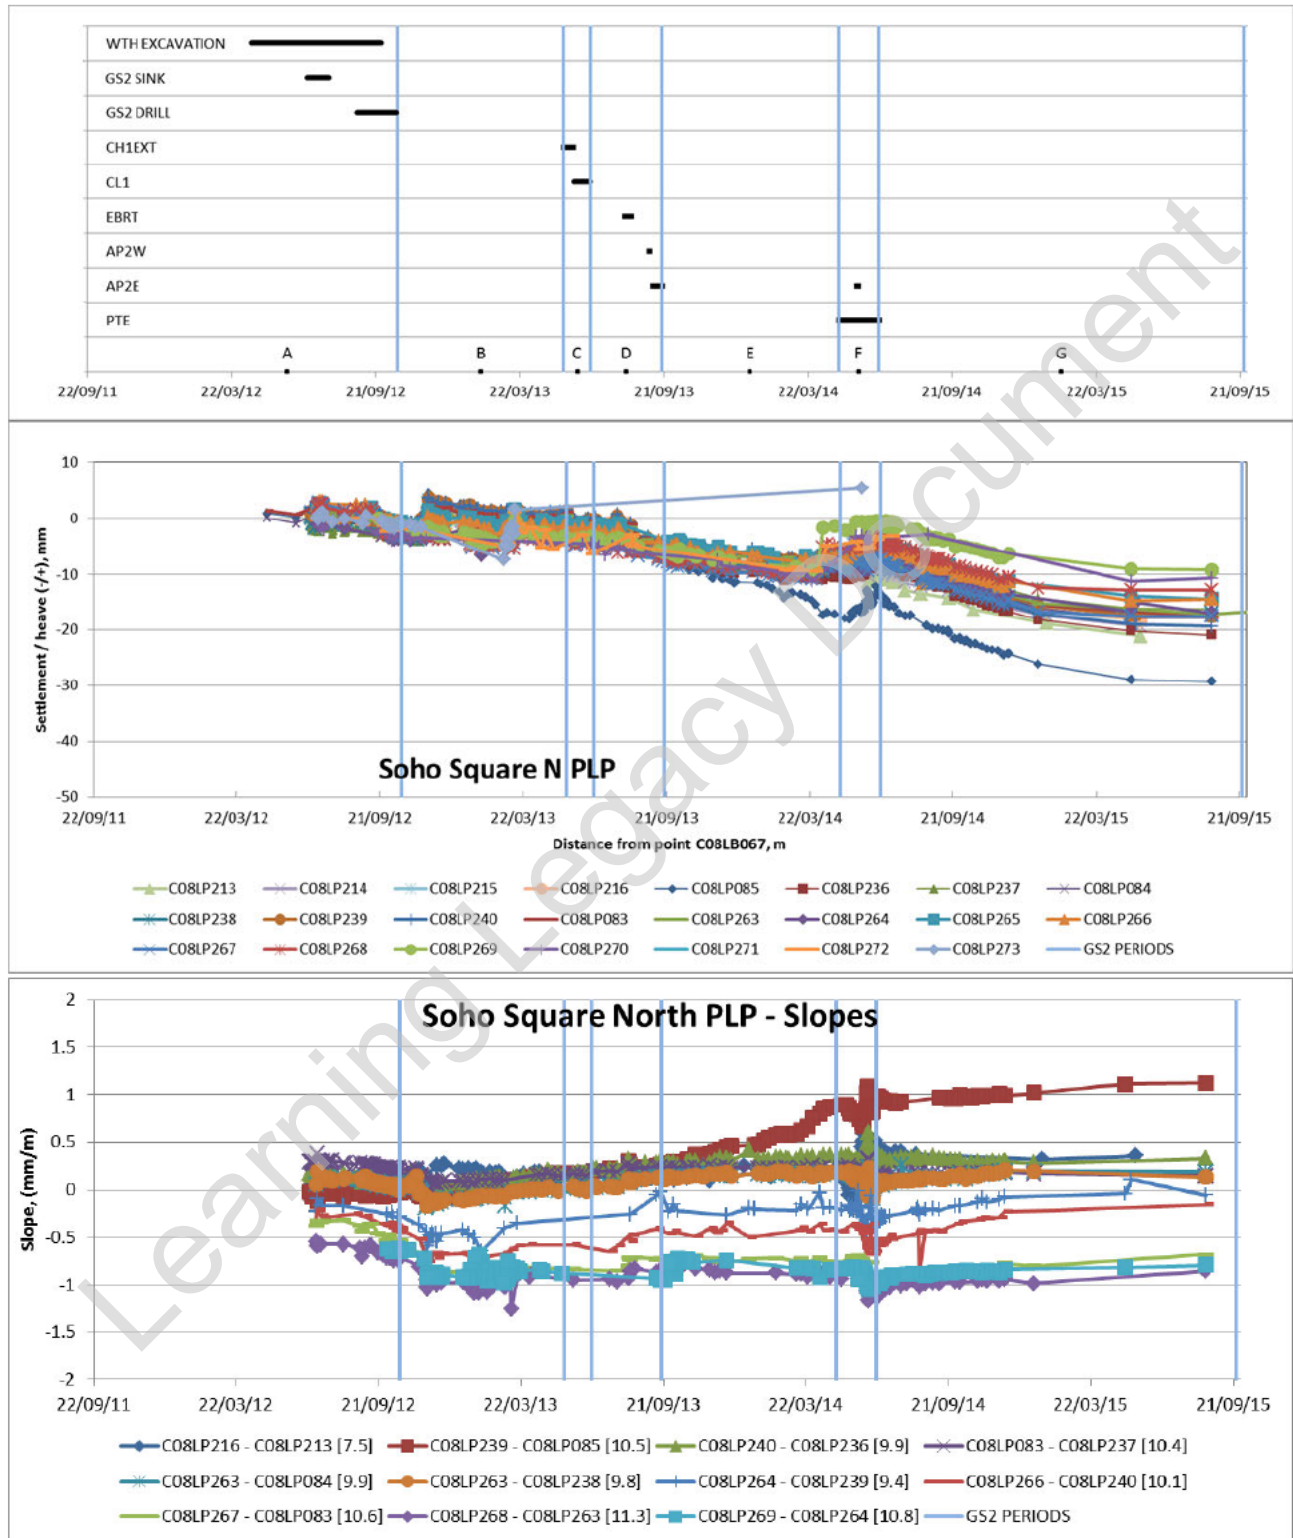
### 5.4. Soho Square North – outer

- Although part of the profile is not within the TCR GS2 array (up to distance 43m): data from points all points are presented as shown in Figure 5.1.1

- The profile plot confirms that the consolidation settlement is relatively uniform over a wide area resulting in little change in slopes.
- The slope data plots show that individual 10m Amber slope triggers have been exceeded between C08LP268 / C08LP263 and C08LP269 / C08LP264. These two are located at the eastern boundary of the GS2 array and extend within the 3m exclusion zone around GS4, thus it was not practical to generate significant uplift on these points. It is also noted that these triggers occurred prior to the commencement of any tunnelling work in the vicinity i.e. in Period B.

- A further slope trigger breach occurred in Period F between points C08LP239 / C08LP085. The slope had been increasing throughout Period E when no works were in progress. The concurrent grouting for PTE in Period F generated a small uplift which reduced the slope slightly initially but subsequent settlement caused it to increase. The slope has continued to increase post construction but appears to have stabilized at a value of about 1.1mm/m. It is noted that the increase in slope is primarily due to an increase rate of settlement on point C08LP085 located at the corner of Soho Square and Soho Street.
- In general, slopes have been stable since the end of construction.

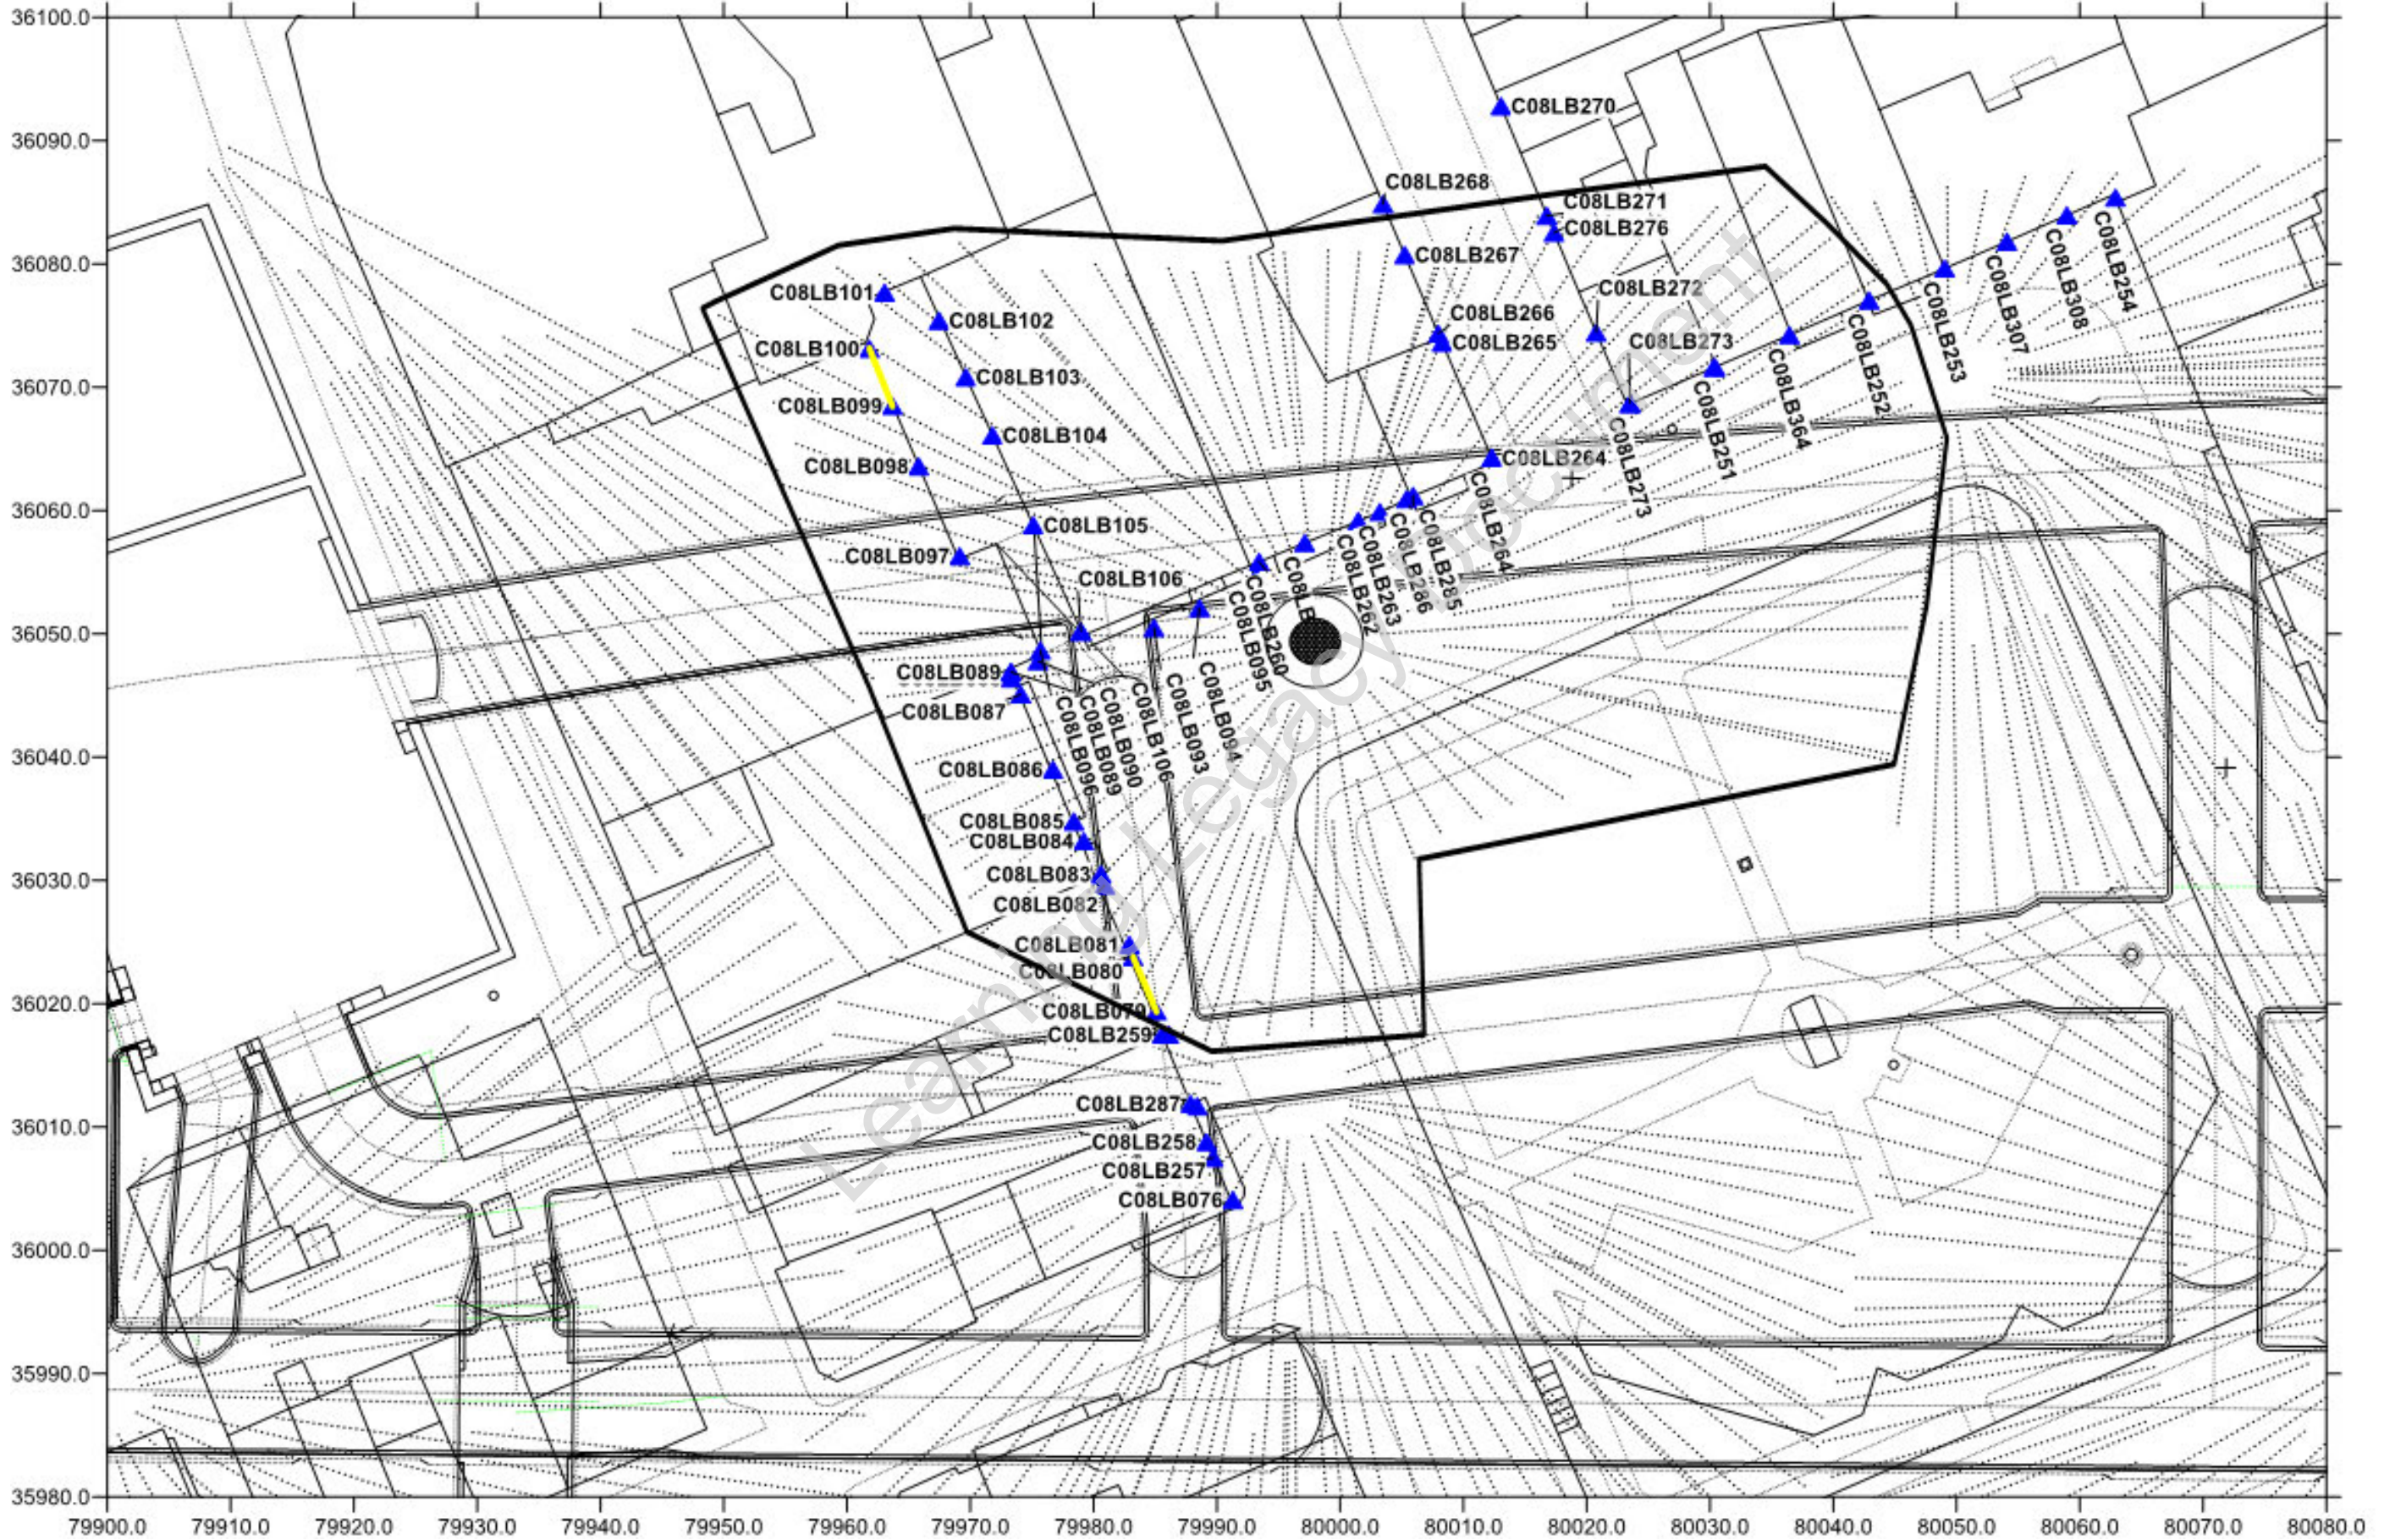
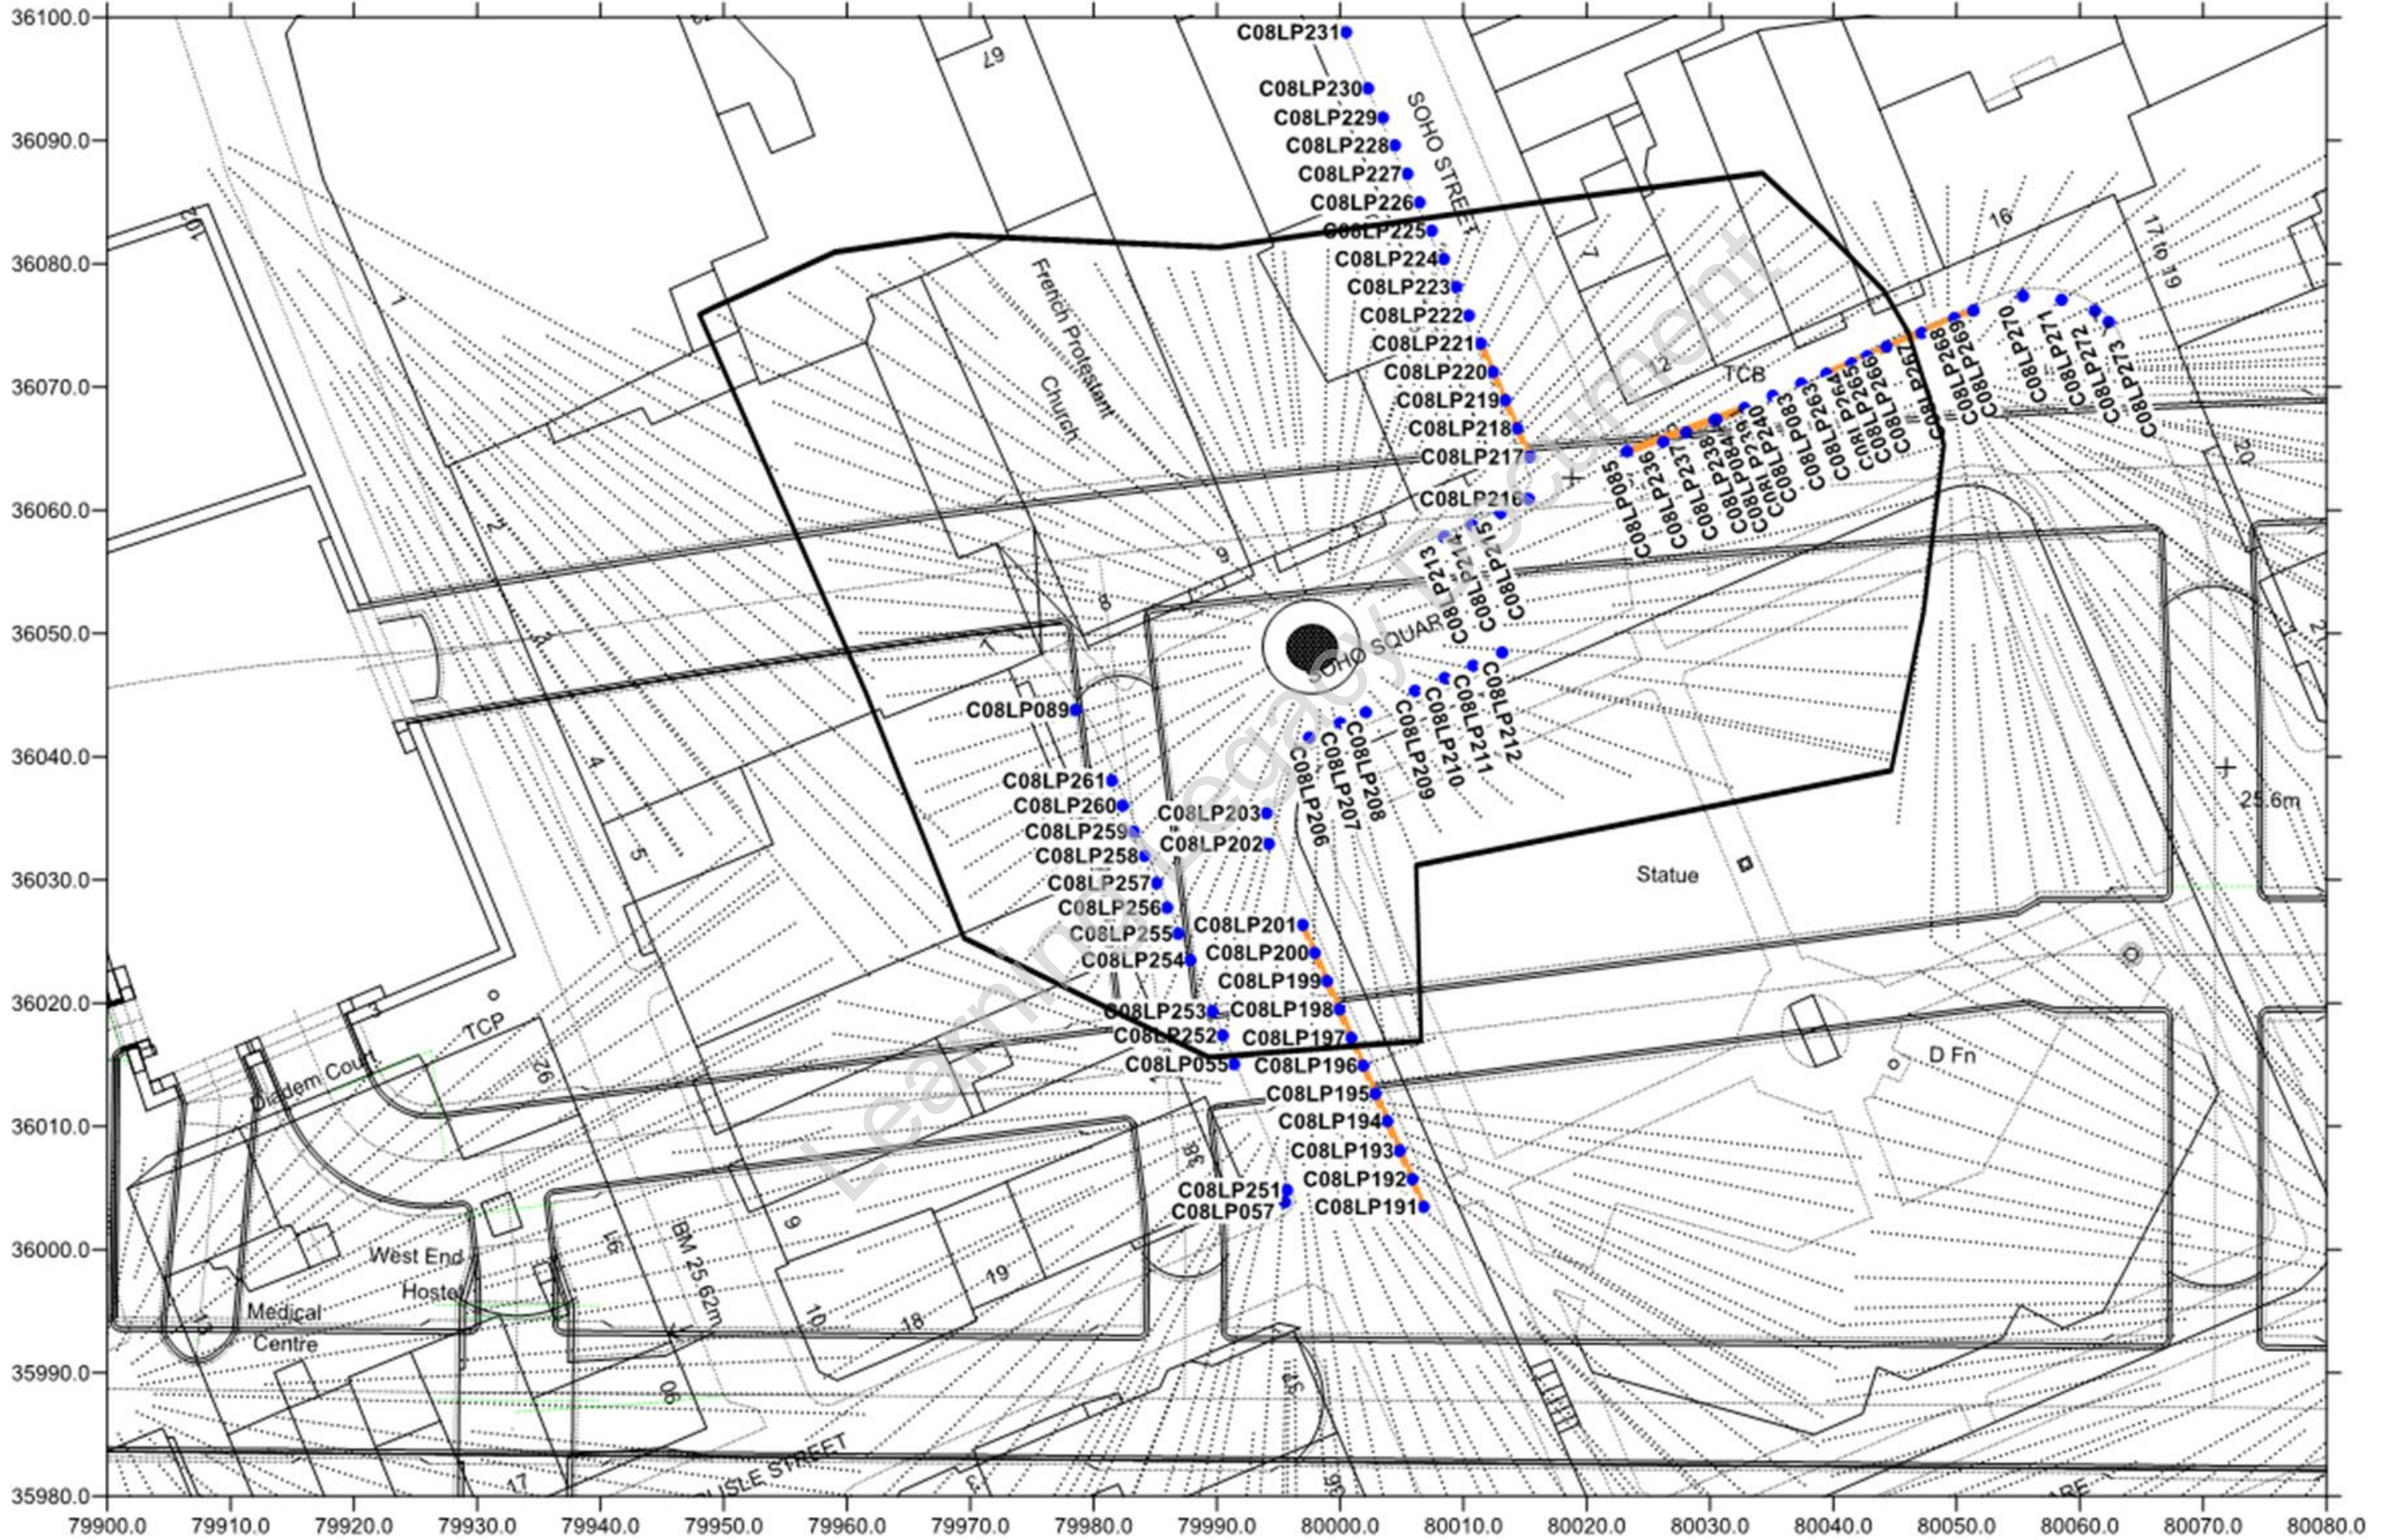
*Enlarged version of Figures 4.1 and 5.1 showing location of monitoring points and slope triggers*

The locations where slope triggers have been exceeded are shown for BRE monitoring of building facades on Figure 4.1.1. By inspection no deflection ratio triggers have been breached. A larger version of Figure 4.1.1. is included in Appendix C. Details are given in Table 4.1.1.
