C300/410
Western Tunnels & Caverns Project

Grouting Summary & I &M Final Report - TCR GS4

CRL Document No. **C300-BFK-C4-RGN-CRT00_ST005-51228**

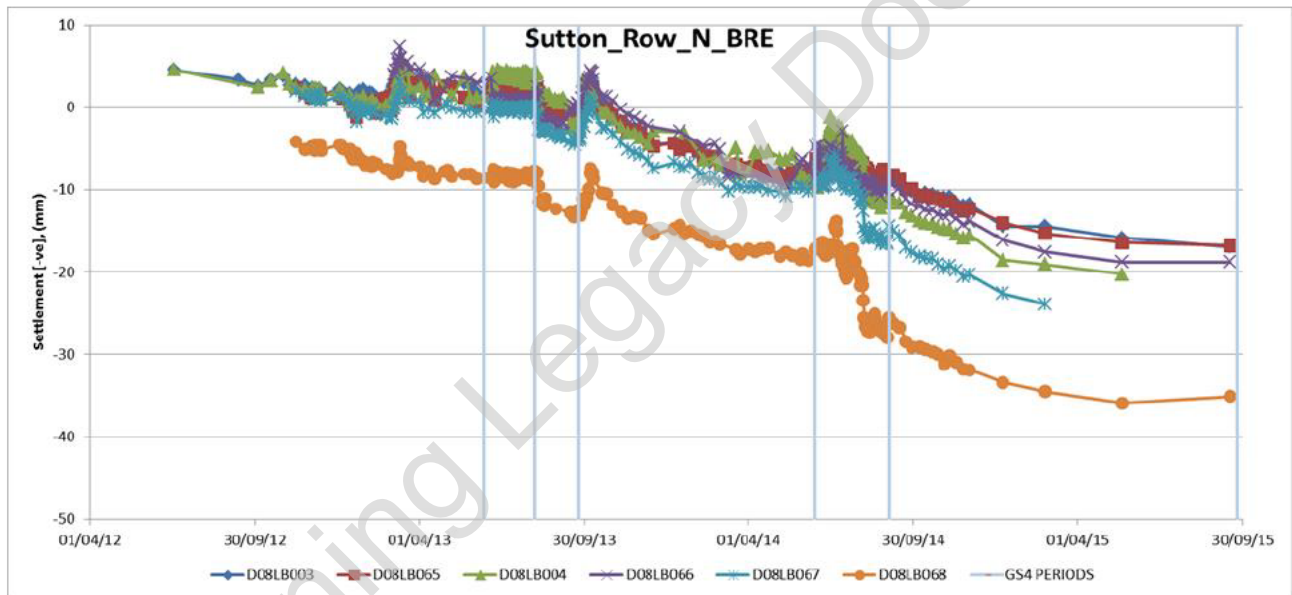
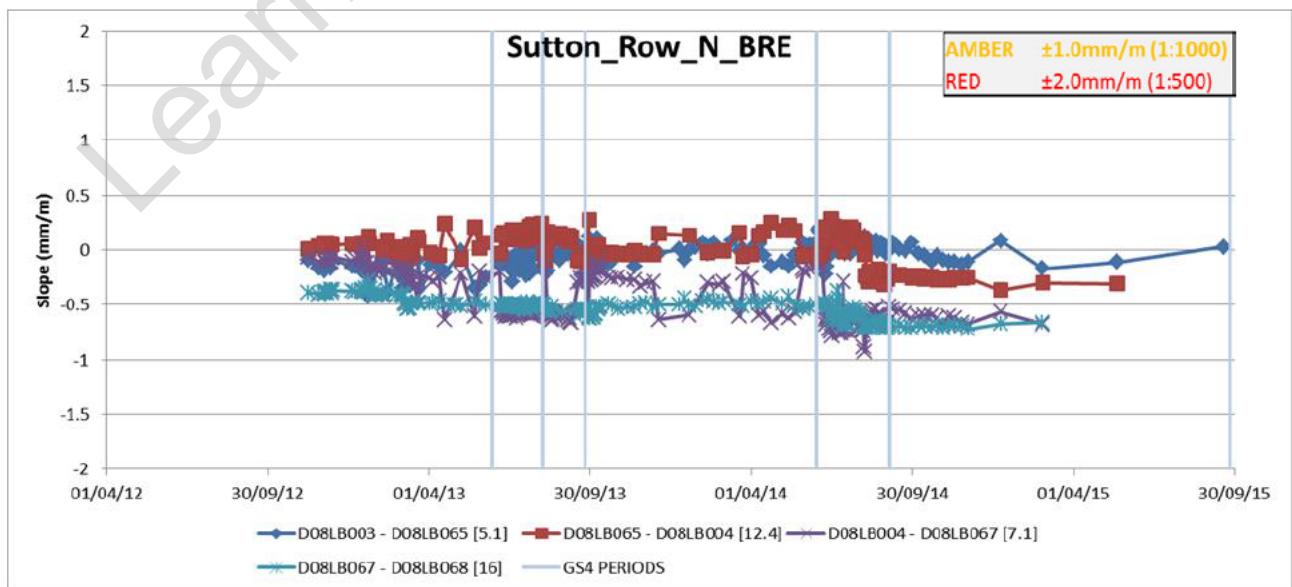
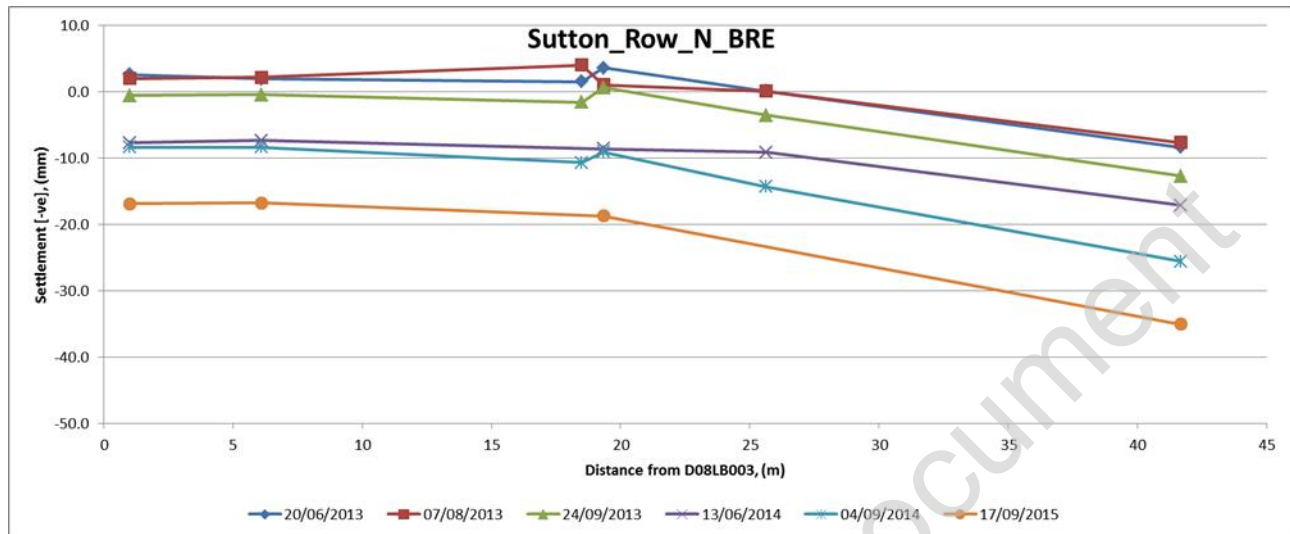
4.3. Sutton Row North

- Data are presented for the BRE located on the north façade of Sutton Row. All points are within the plan extent of the GS4 arrays.
- Significant differential movement had been generated by TCRSU works prior to any BFK works with local settlement at the corner of Falconberg Mews (at distance 42m) adjacent to the TCRSU worksite.

- Settlement associated with the junction with AP3E and AP4E was reversed by grout jacking resulting in negligible net change in movement. Overall a small increase in maximum settlement to ~27mm was observed in Period E.

- The rate of post construction settlement in Period F has reduced continually with the final readings showing near stable conditions with a final measured settlement of about 35mm.

- Slopes were less than the Amber trigger value throughout construction and subsequently during Period F.

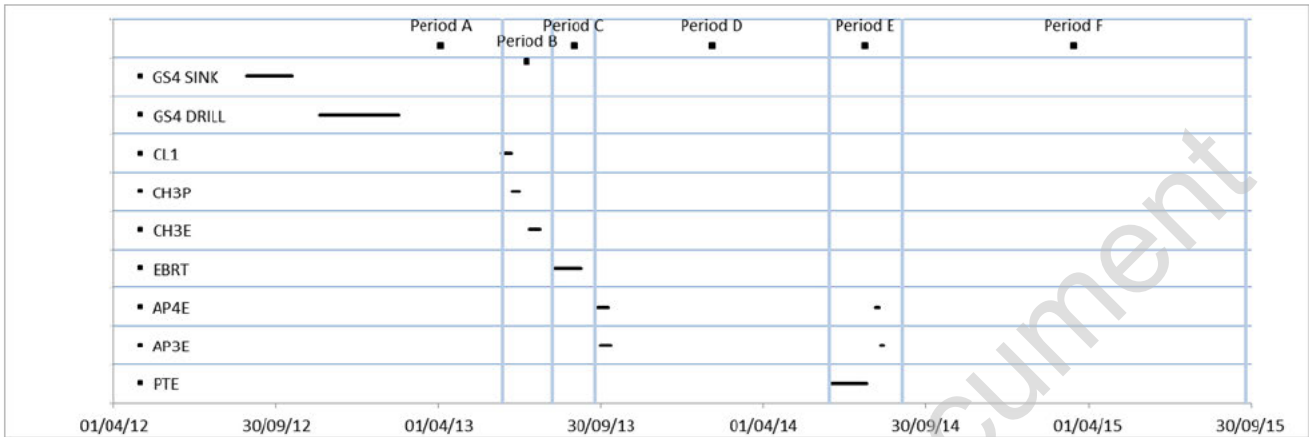
4.4. Falconberg Mews West - North

- Data are presented for the BRE located on the west façade of Falconberg Mews. Points up to 35m from Sutton Row (D08LB005) are within the plan extent of the GS4 arrays.

- Settlement associated with the junction with AP3E and AP4E was reversed by grout jacking resulting in negligible net change in movement. Overall a 10mm increase in maximum settlement to ~25mm was observed in Period E.

- The rate of post construction settlement in Period F has reduced continually with the final readings showing near stable conditions with a final measured settlement of about 32mm.

- Slopes were less than the Amber trigger value throughout construction but the value between D08LB017 and D08LB018 increased during Period E and grout jacking was undertaken which stabilized the slope at just below the Amber value. Subsequently, during Period F, the slope did exceed the Amber value but no further grout jacking was deemed necessary, since the rate of increase was slow and decreasing with time. Details are given in Table 4.1

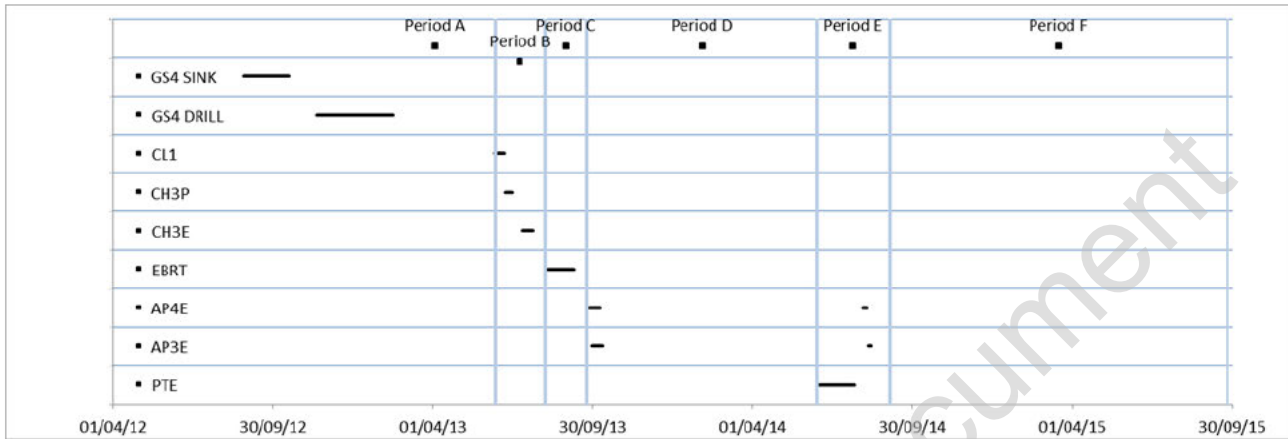
5.3. Sutton Row North

- Data are presented for the PLP located on the north kerb line of Sutton Row. All points are within the plan extent of the GS4 arrays.
- Significant differential movement had been generated by TCRSU works prior to any BFK works with local settlement at the corner of Falconberg Mews, from distance 30m, adjacent to the TCRSU worksite.

- Settlement associated with the junction with AP3E and AP4E was reversed by grout jacking resulting in negligible net change in movement. Overall a small increase in maximum settlement to ~28mm was observed in Period E.

- The rate of post construction settlement in Period F has reduced continually with the final readings showing near stable conditions with a final measured settlement of about 37mm.

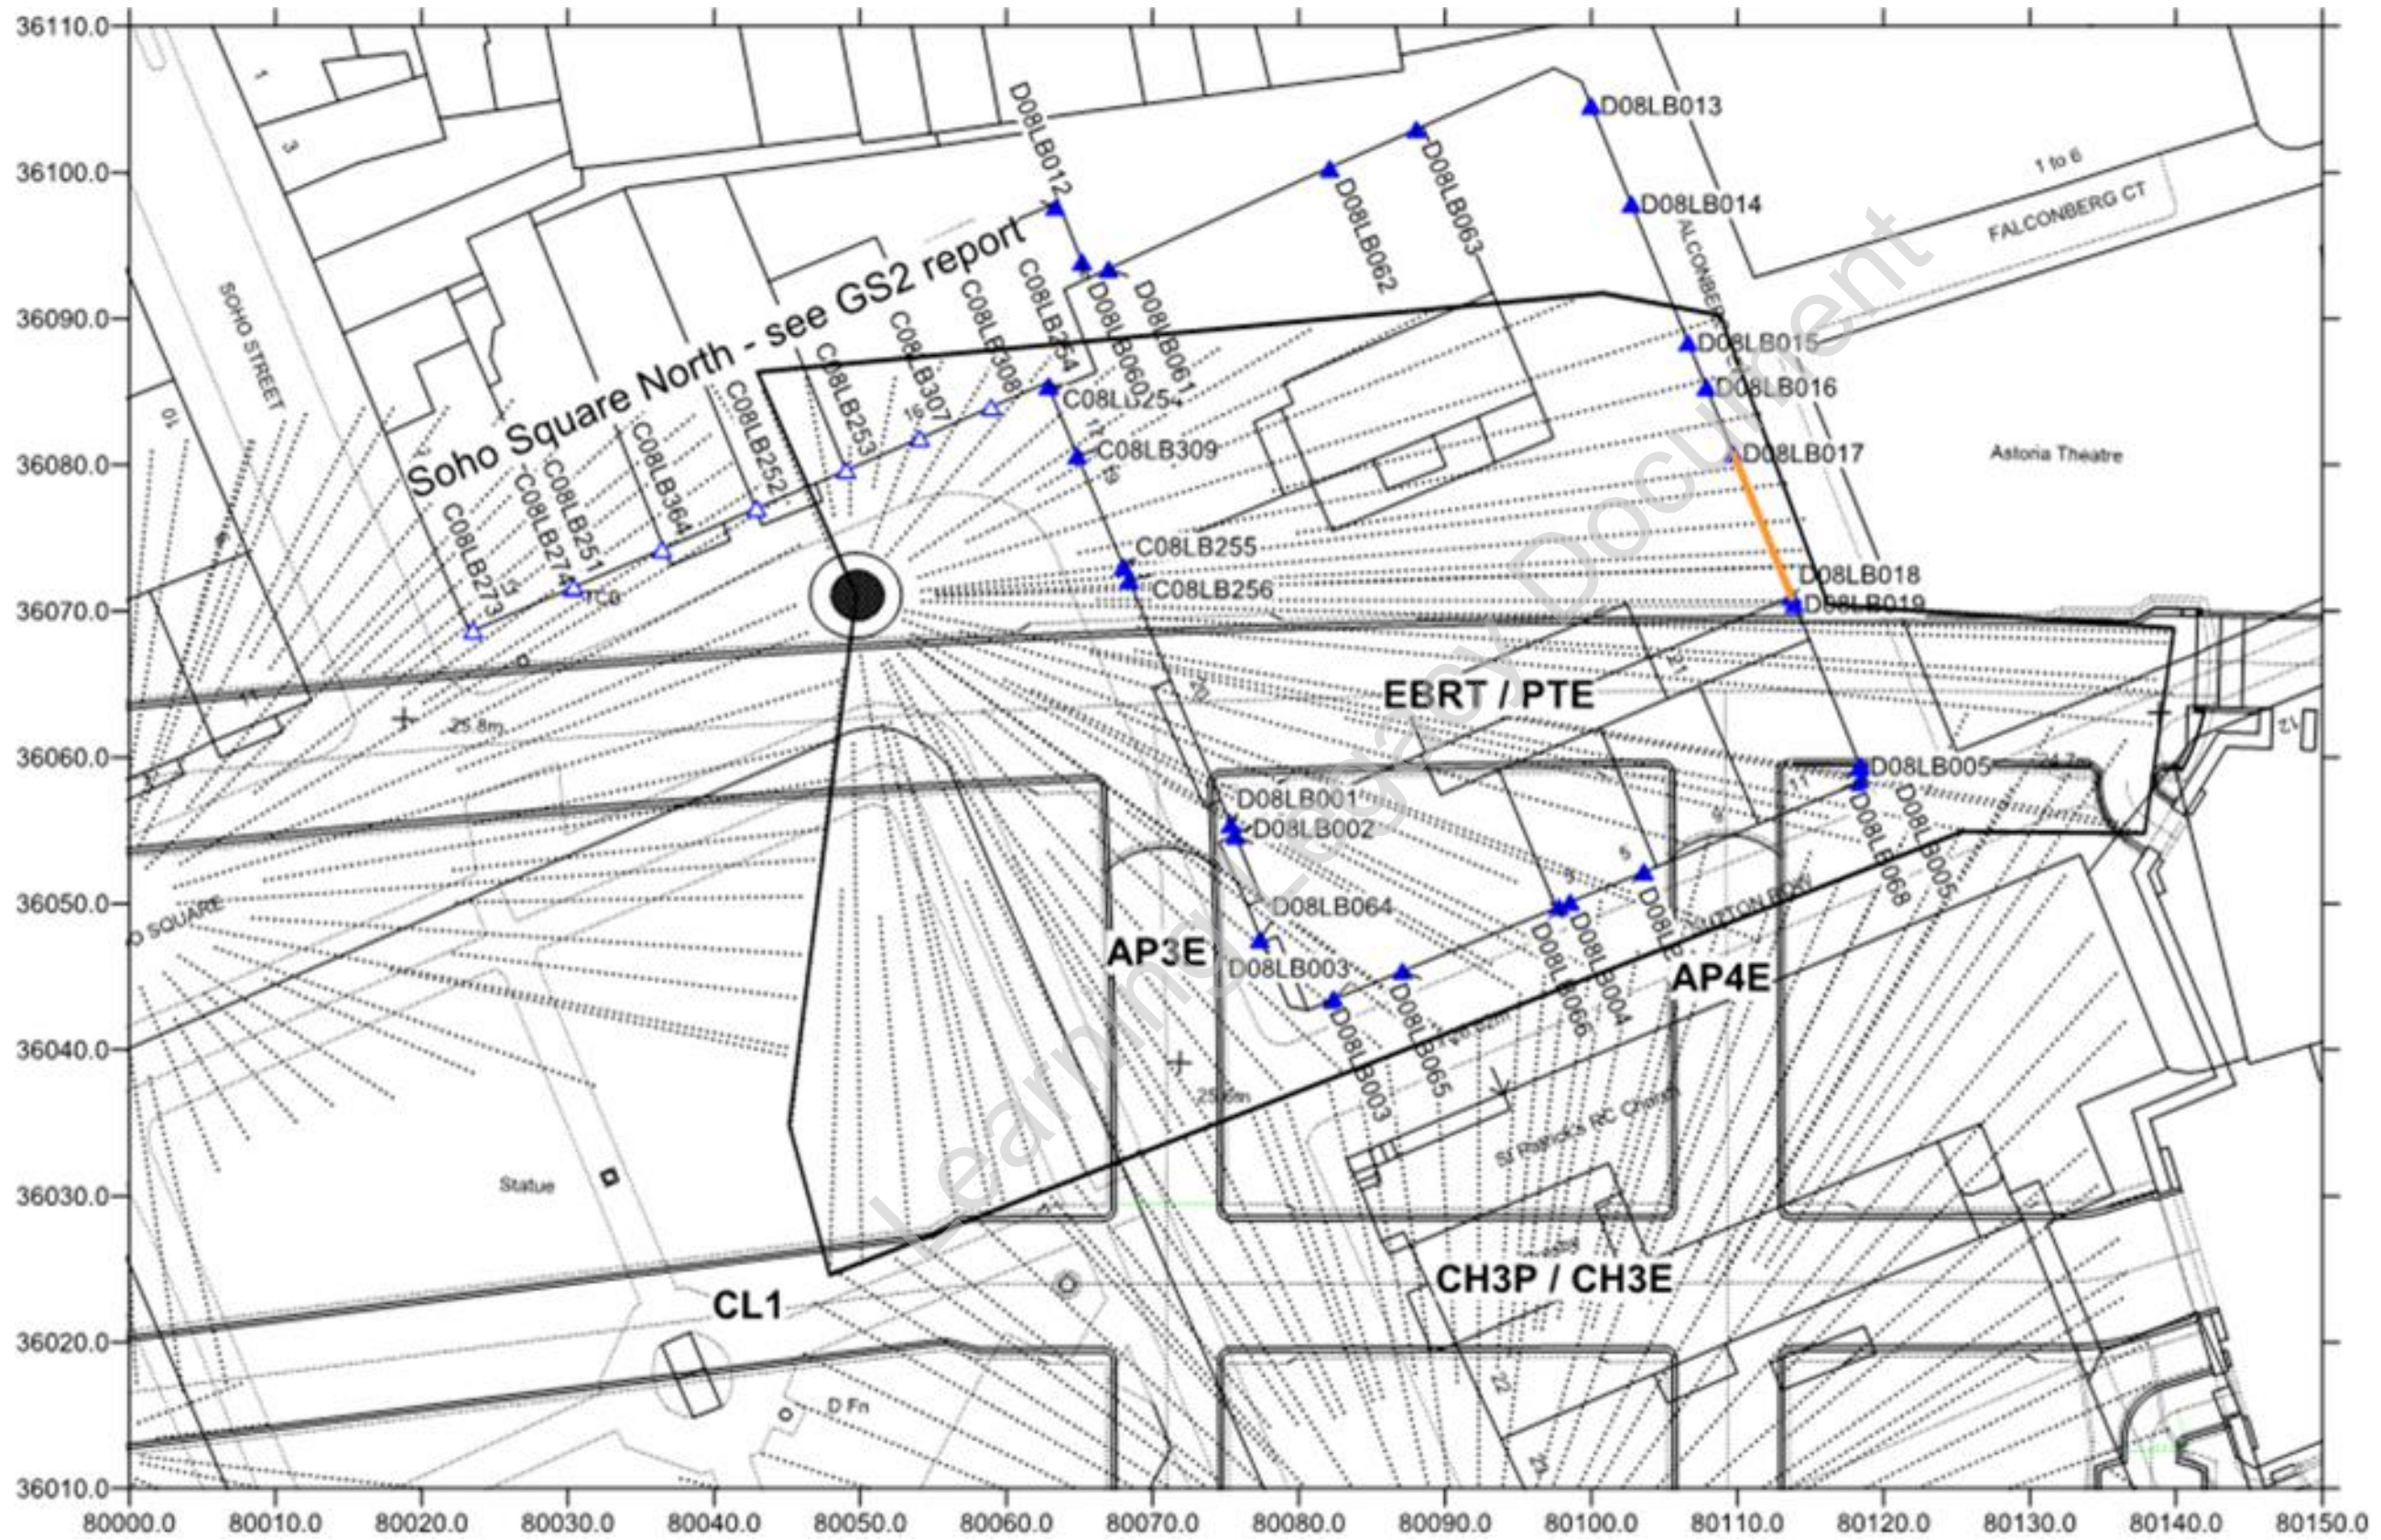
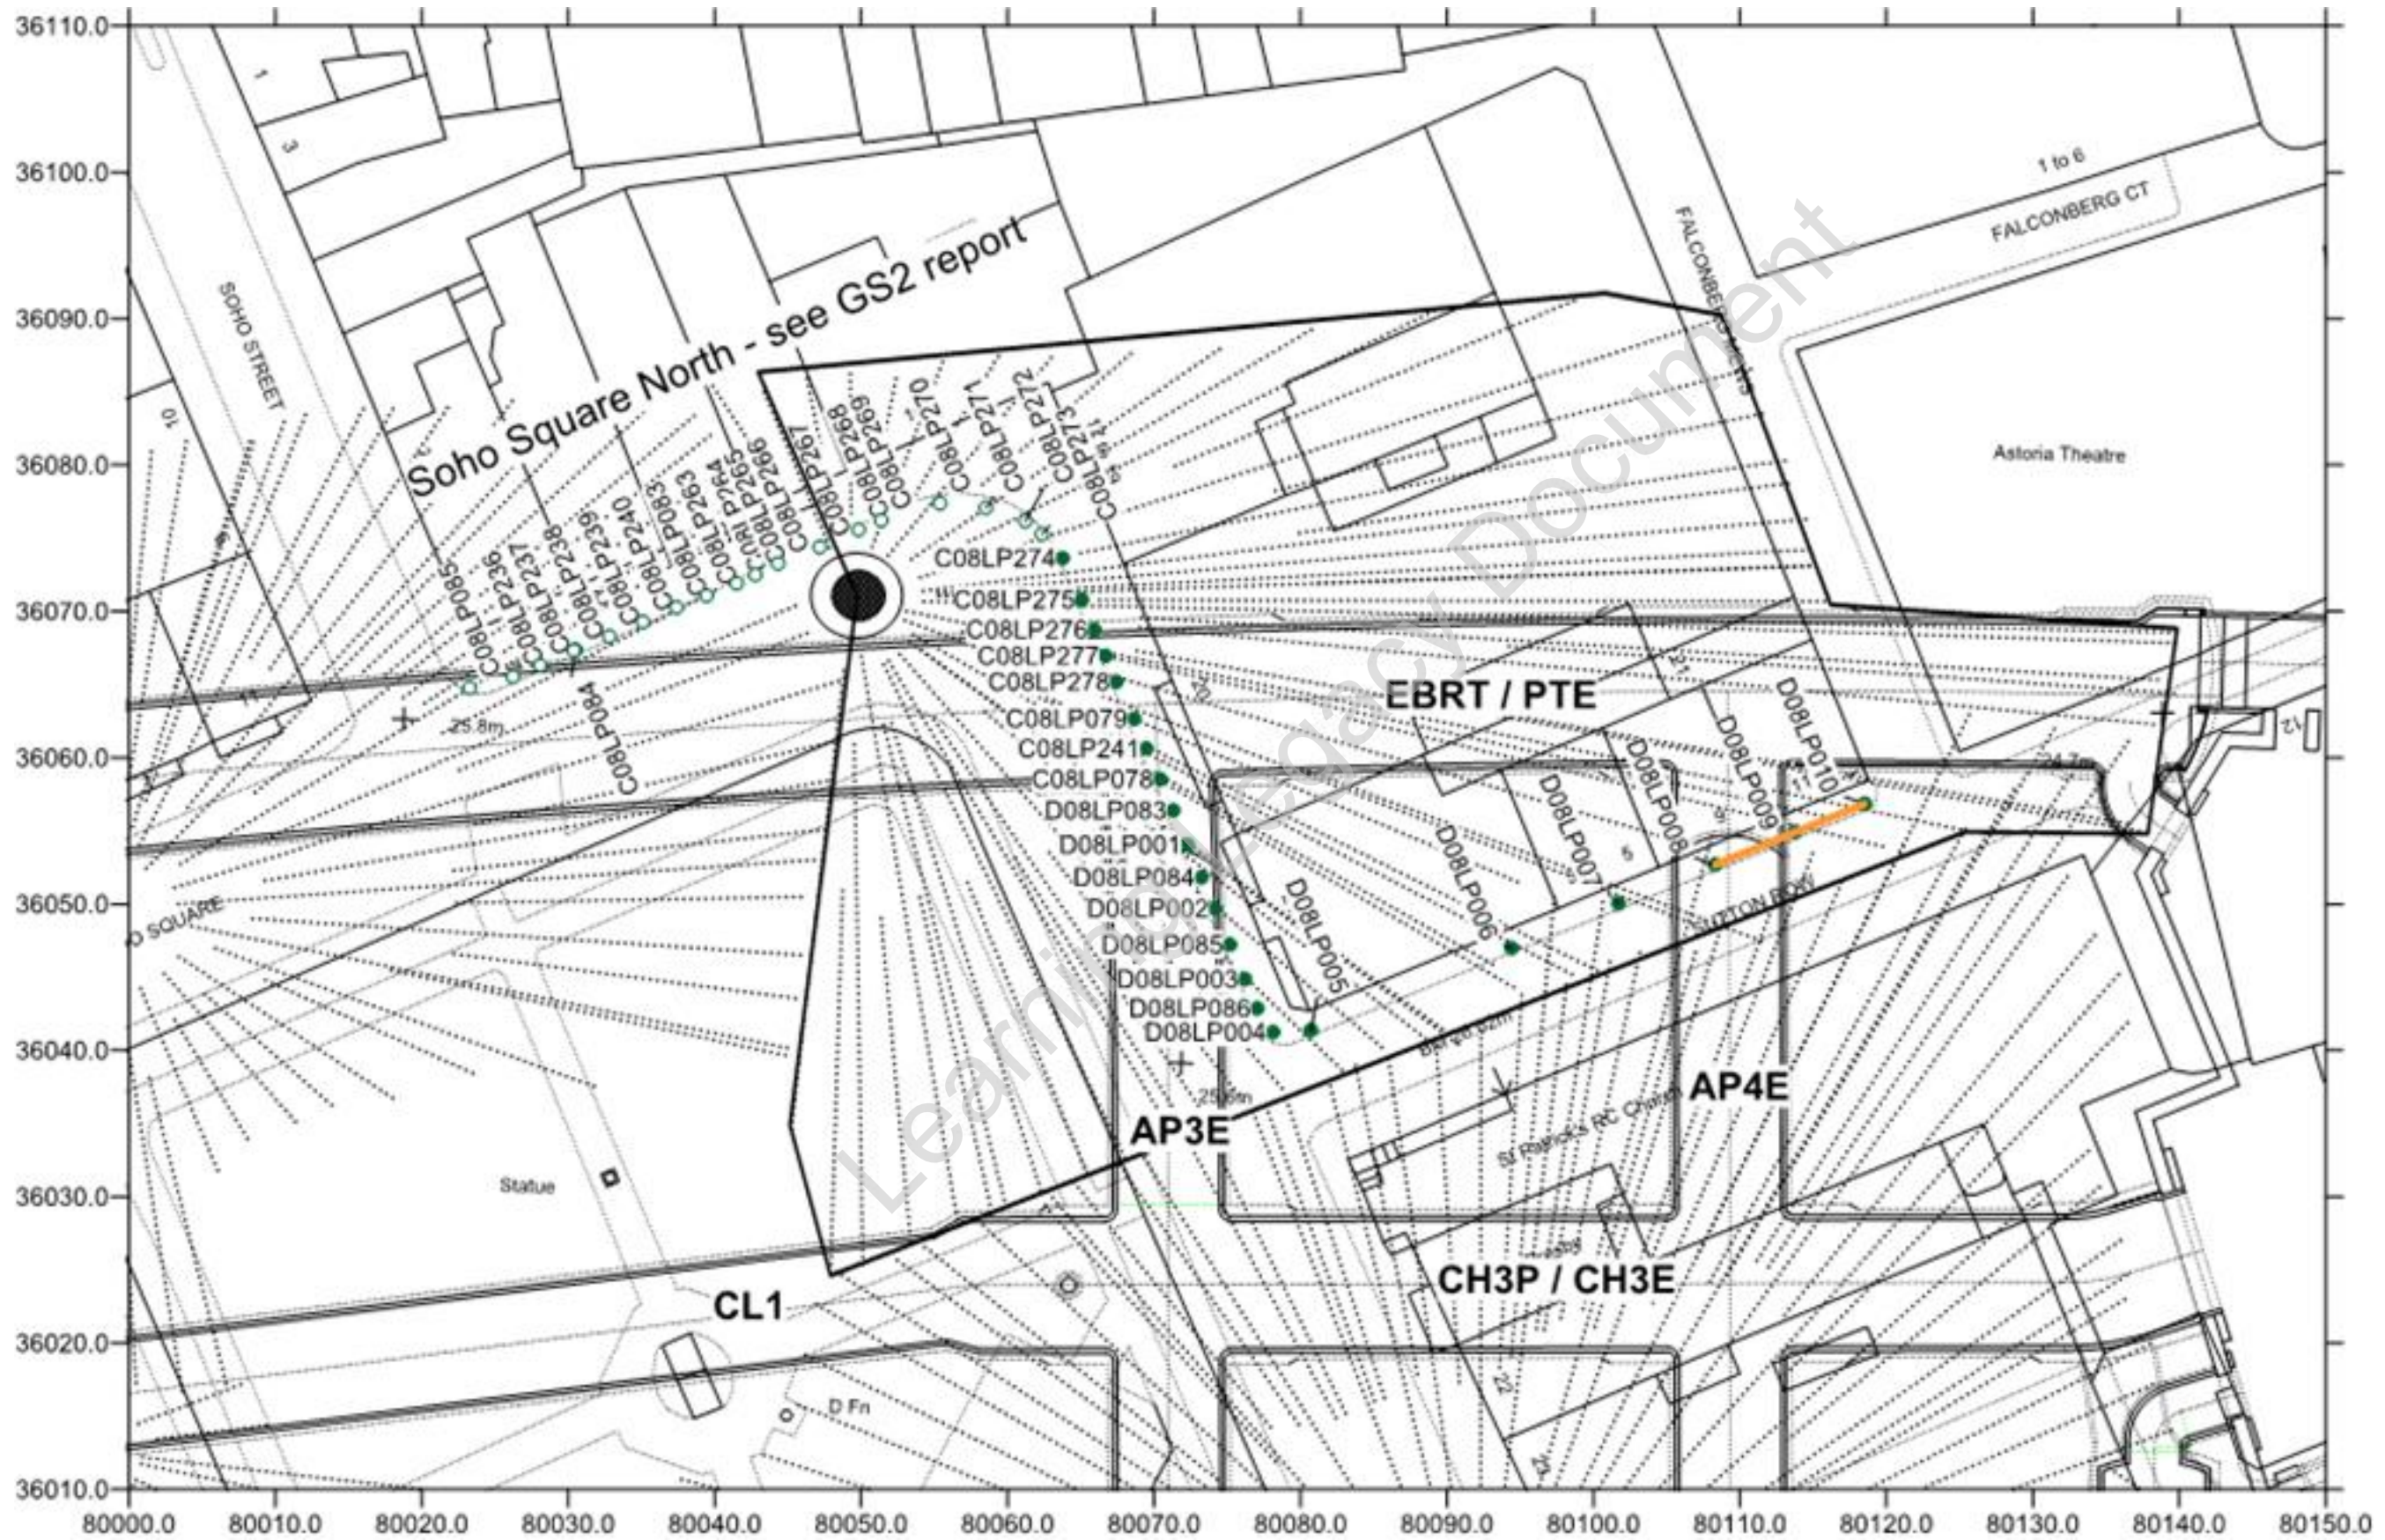
Enlarged version of Figures 4.1 and 5.1 showing location of monitoring point and slope triggers
