C300/410
Western Tunnels & Caverns Project

Grouting Summary & I & M Final Report - TCR GS5

CRL Document No. **C300-BFK-C4-RGN-CRT00_ST005-51229**

Learning Legacy Document

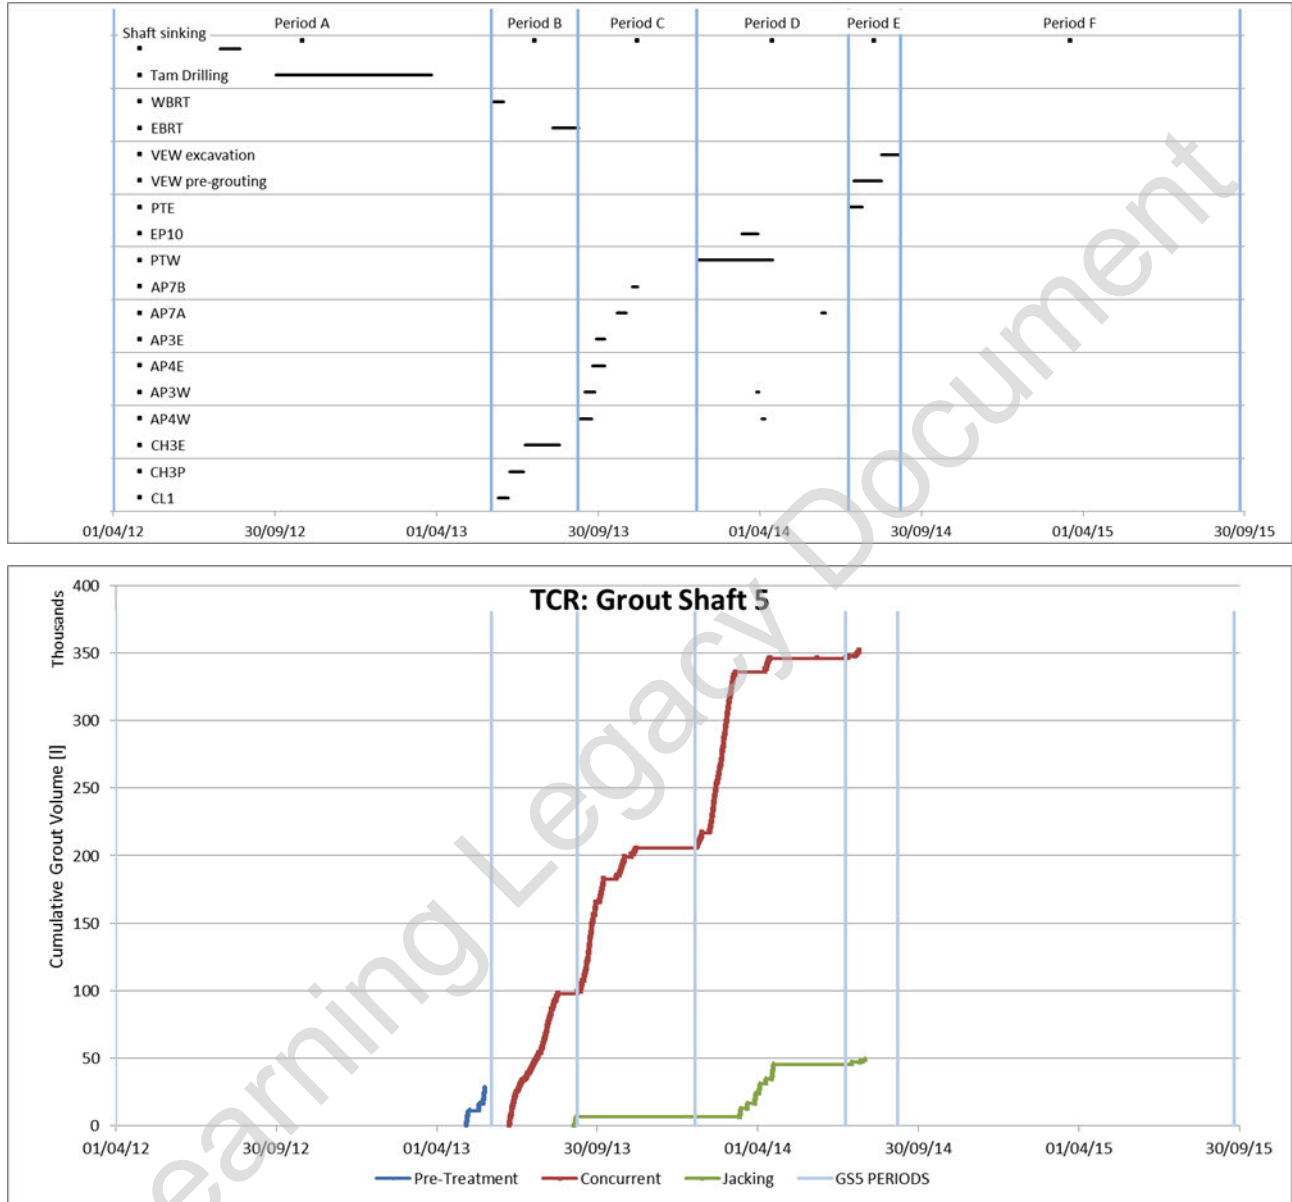
Figure 2.2 Volume of grout injected from TCR GS5 by grouting type.

The volume of grout injected from TCR GS5 is plotted against time on Figure 2.2 together with a plot of when each of the tunnels was constructed. Figure 2.2 shows that pre-treatment comprised approximately 30m³ injected prior to tunnelling, concurrent grouting over 350m³ and grout jacking 50m³. Concurrent grouting was undertaken with all tunnels except the WBRT, CL1 and the various junctions between Access Passages (AP). A VE proposal (C300-CCM-01519) was implemented to avoid any delays to the running tunnel drive which allowed grouting to be undertaken pre- and post-tunnelling – the volume of grout associated with this is included under grout jacking. The AP junctions are short lengths of tunnel and the extent of the exclusion zones over the tunnel face, as defined in the Specification for Control of Ground Movements (SCoGM), rendered concurrent

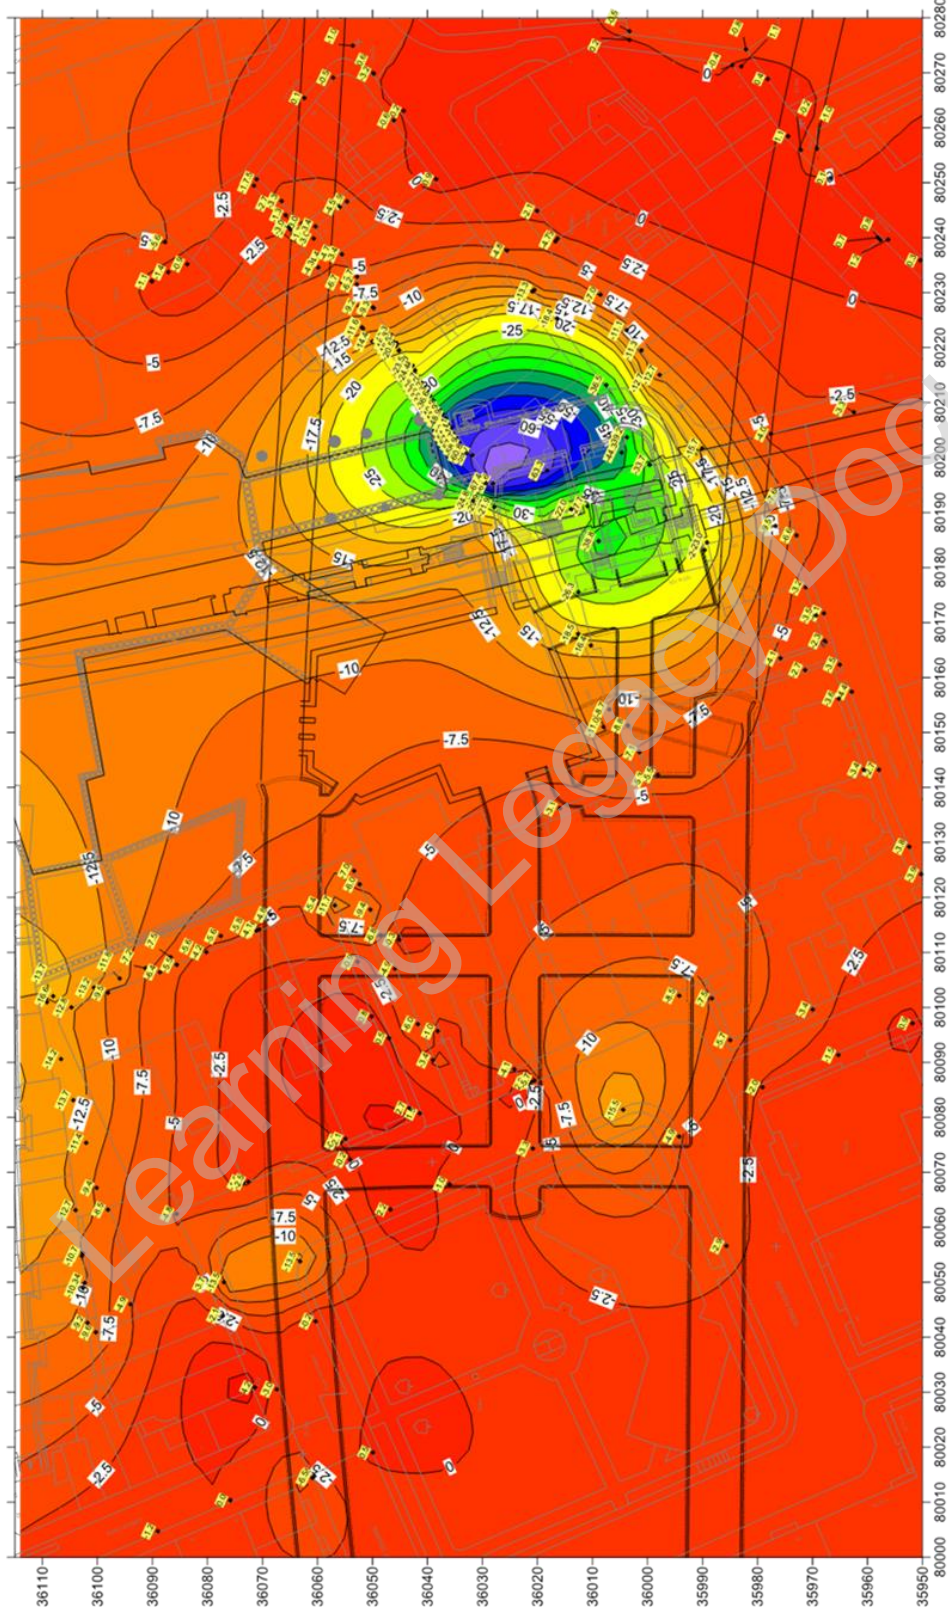
Figure 3.2.1 Contours of settlement from TCRSU works (at 24/04/13)

Period A includes all of the preparatory work prior to the commencement of tunnelling. BFK works comprised shaft sinking and the drilling of TaMs from TCR GS5. Significant movements were generated prior to and during BFK works by the adjoining London Underground TCR Station Upgrade project (TCRSU). Adjustments have been applied to the BFK monitoring based on the contour shown in Figure 3.2.1. The TCRSU works below and to the east of Charing Cross Road produced substantial movements but the impact within the GS5 area was limited to about 5mm settlement. The contour is based on monitoring data from TCRSU provided by CRL and on the results of joint surveys undertaken by BFK and the TCRSU contractor in April and May 2013. The contour represents the best estimate of movements at 24/04/13 at the completion of BFK shaft sinking and TaM drilling.

The observed settlements at the end of Period A (adjusted to include movements arising from TCRSU works prior to the start of BFK monitoring) are shown on Figure 3.2.2. In general, minor settlement is indicated with more than 5mm in a local area adjacent to the shaft.

The distribution of grout injected during pre-treatment is illustrated on Figure 3.2.3: the highest intensity is around the shaft with up to 20mm thickness. The intensity was varied to reflect the observed settlements.

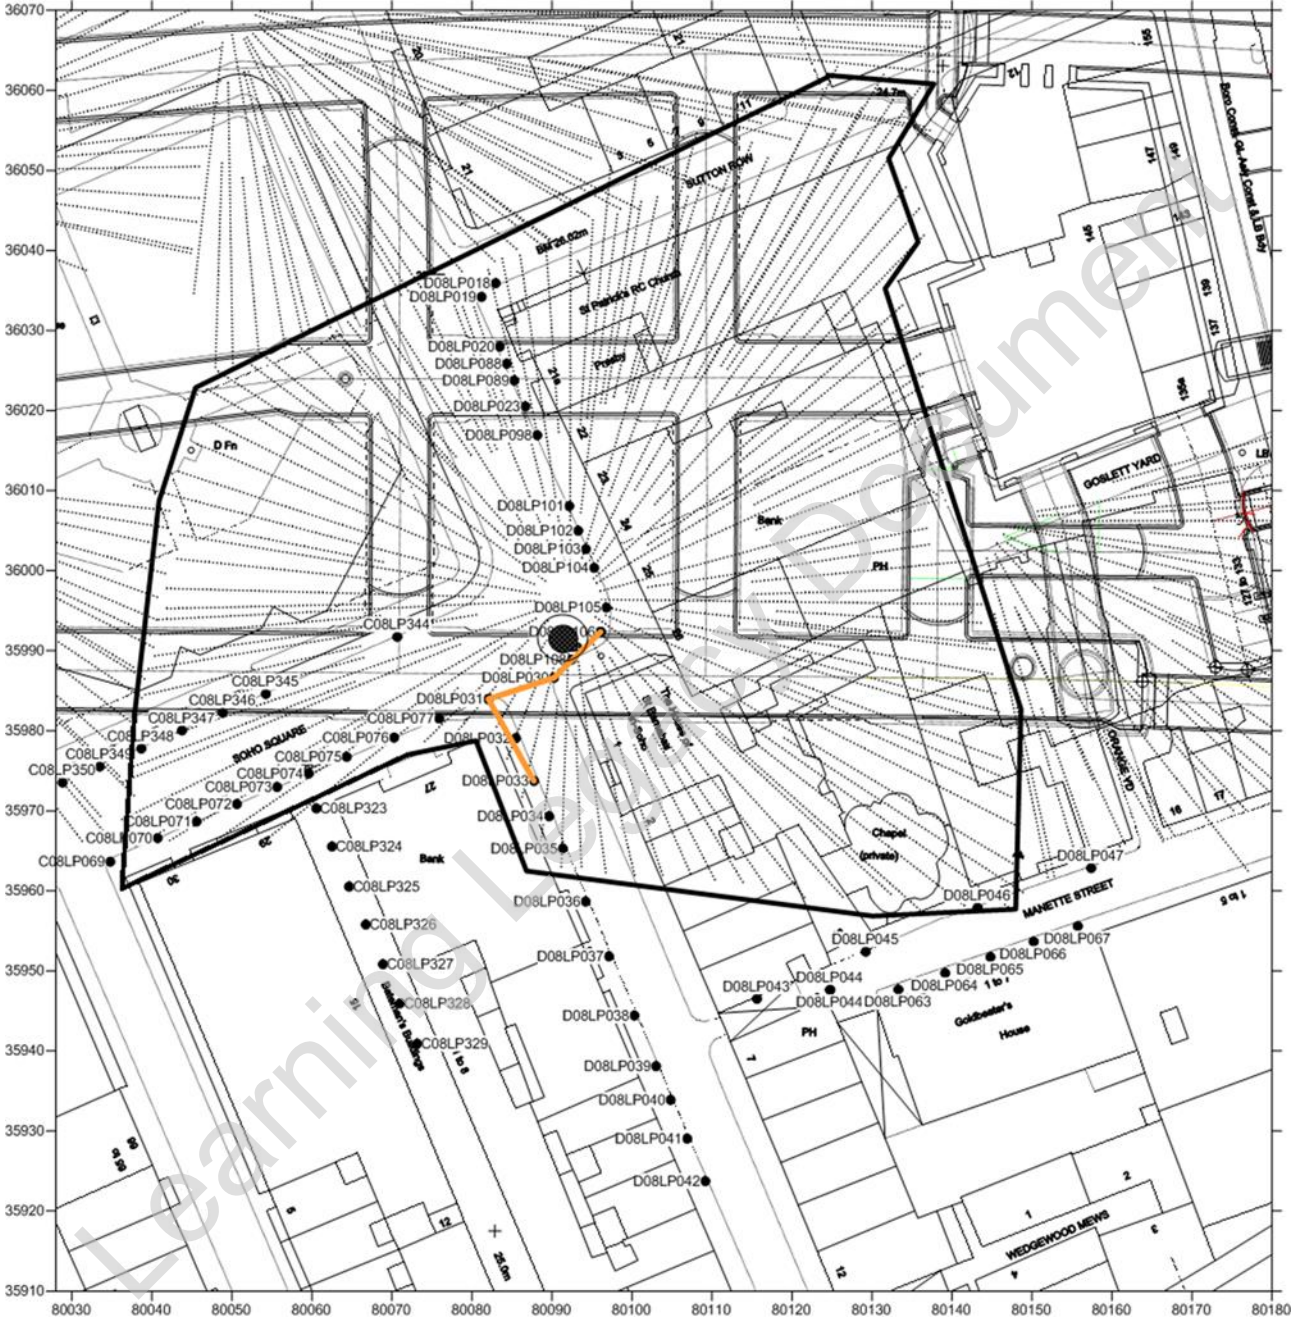
Figure 5.1 Location of PLP and Amber slope trigger breaches

Kerb Line		Comment	Date exceeded	Maximum (mm/m)	Final (mm/m)
Soho Square South - outer:					
D08LP30 – D08LP031	Amber-	PTW: Transitory within exclusion zone for PTW: below trigger from 09/04/14 onwards	20/03/14	1.09	0.70
D08LP106 – D08LP030	Amber-	POST CONSTRUCTION	24/07/15	1.16	1.12
Soho Square South - inner: NONE					
Bateman's Buildings: NONE					
Greek Street -West					
D08LP031 – D08LP033	Amber	POST CONSTRUCTION	28/01/15	1.16	1.16
Manette Street – North: NONE					
Manette Street – North : NONE					
Soho Square East - outer: NONE					
Soho Square East - inner: NONE

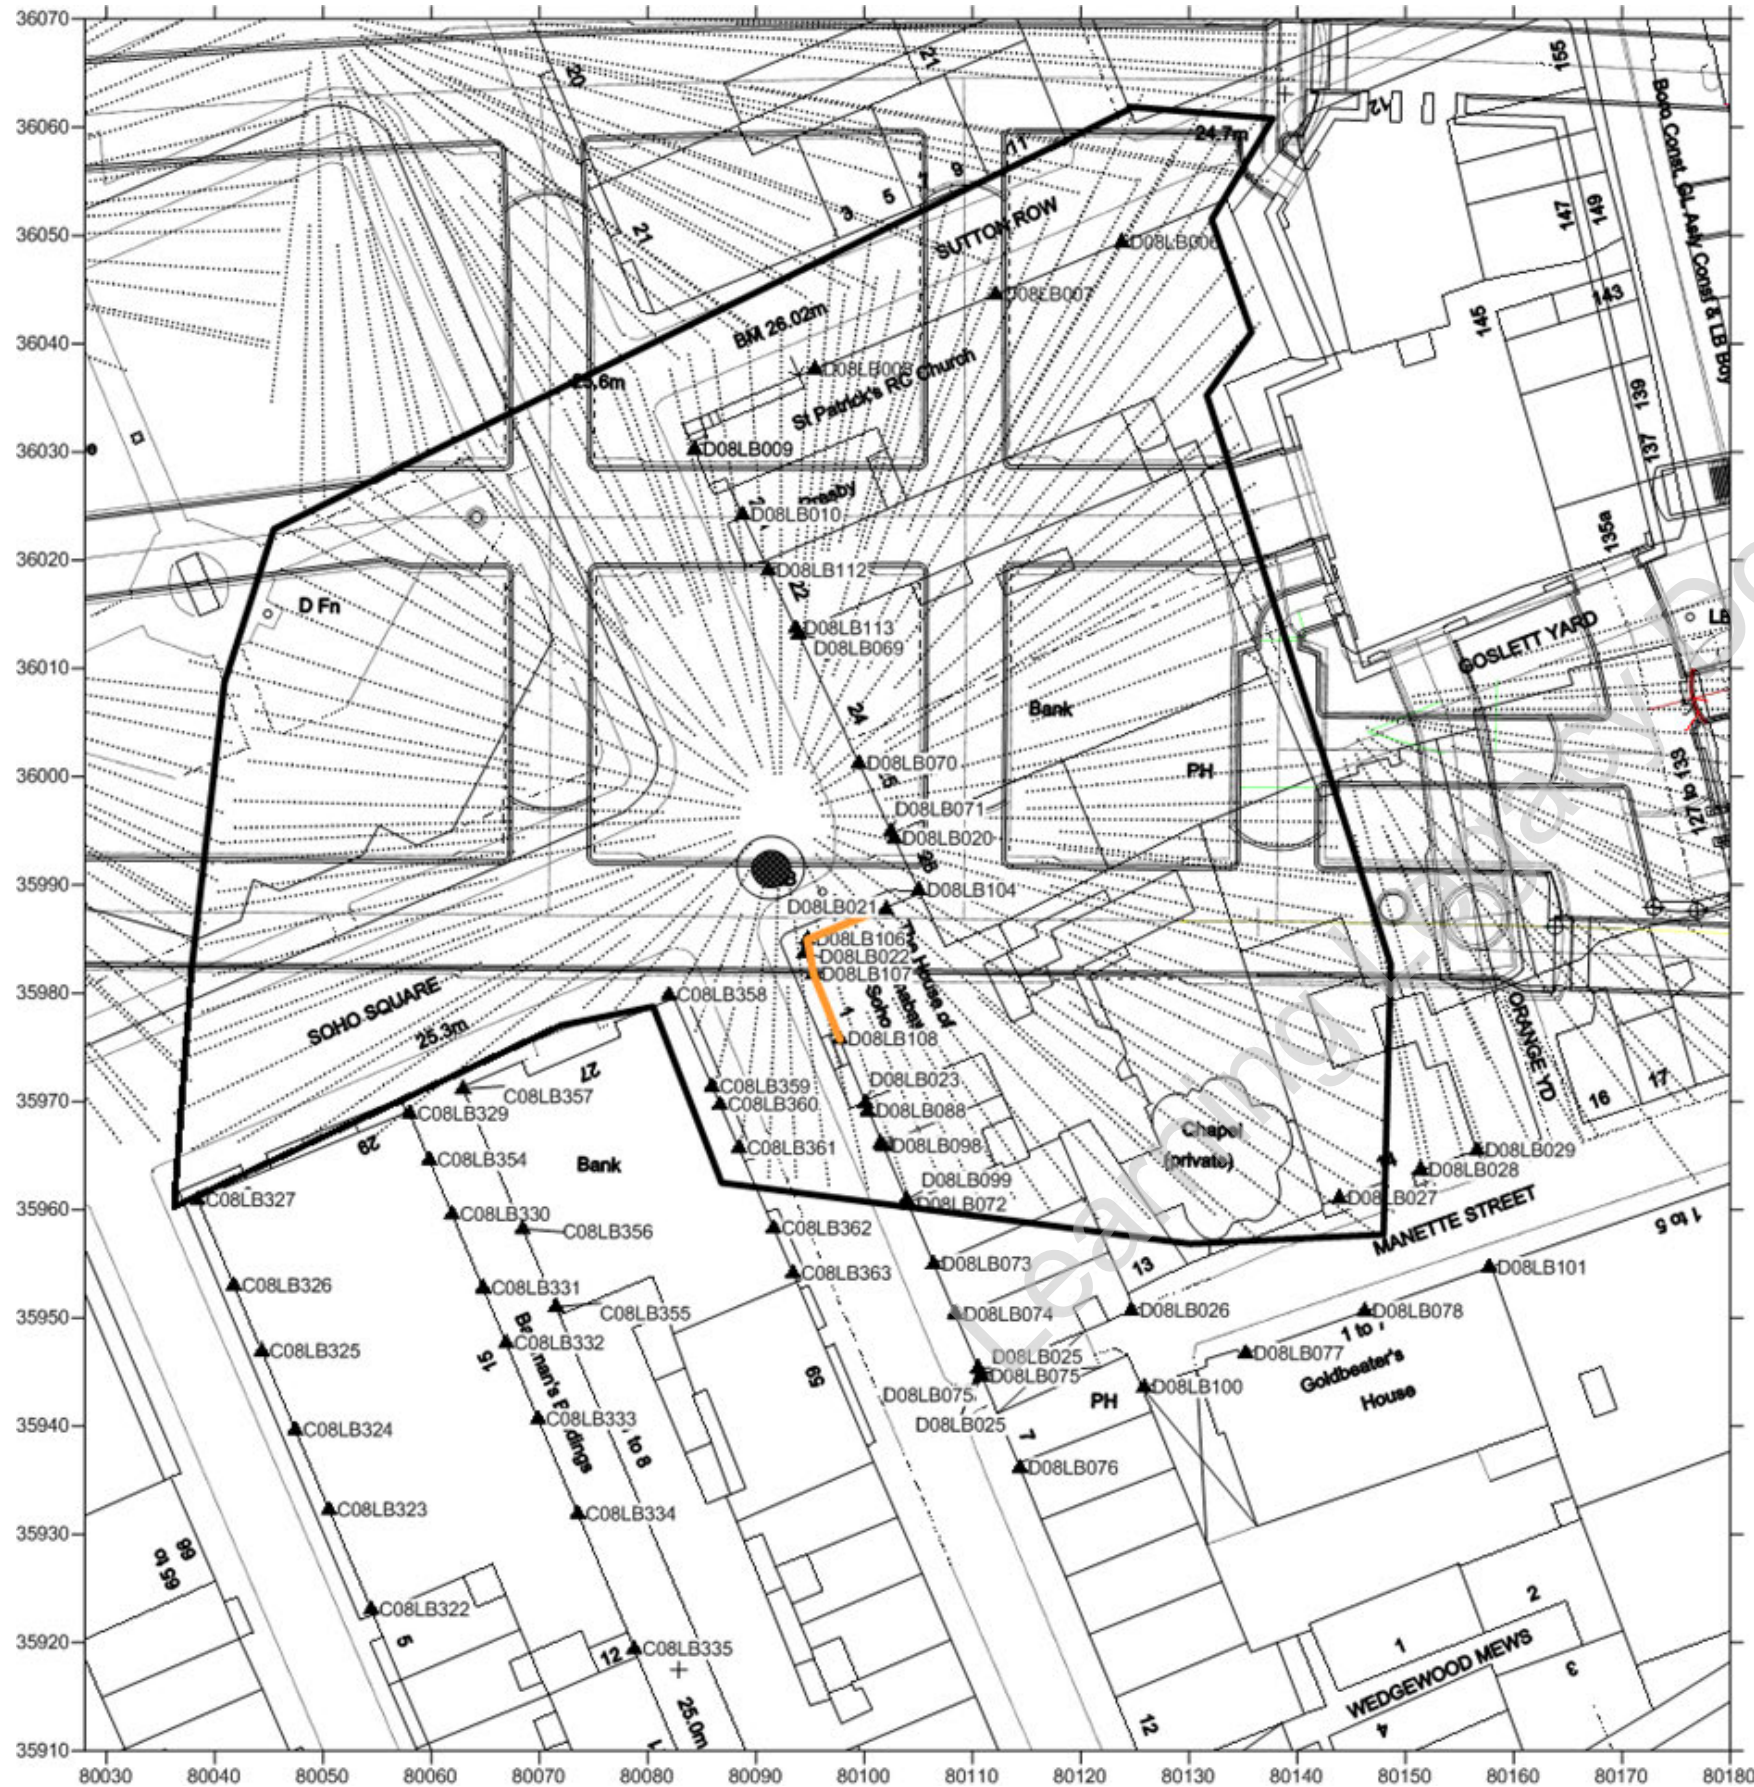
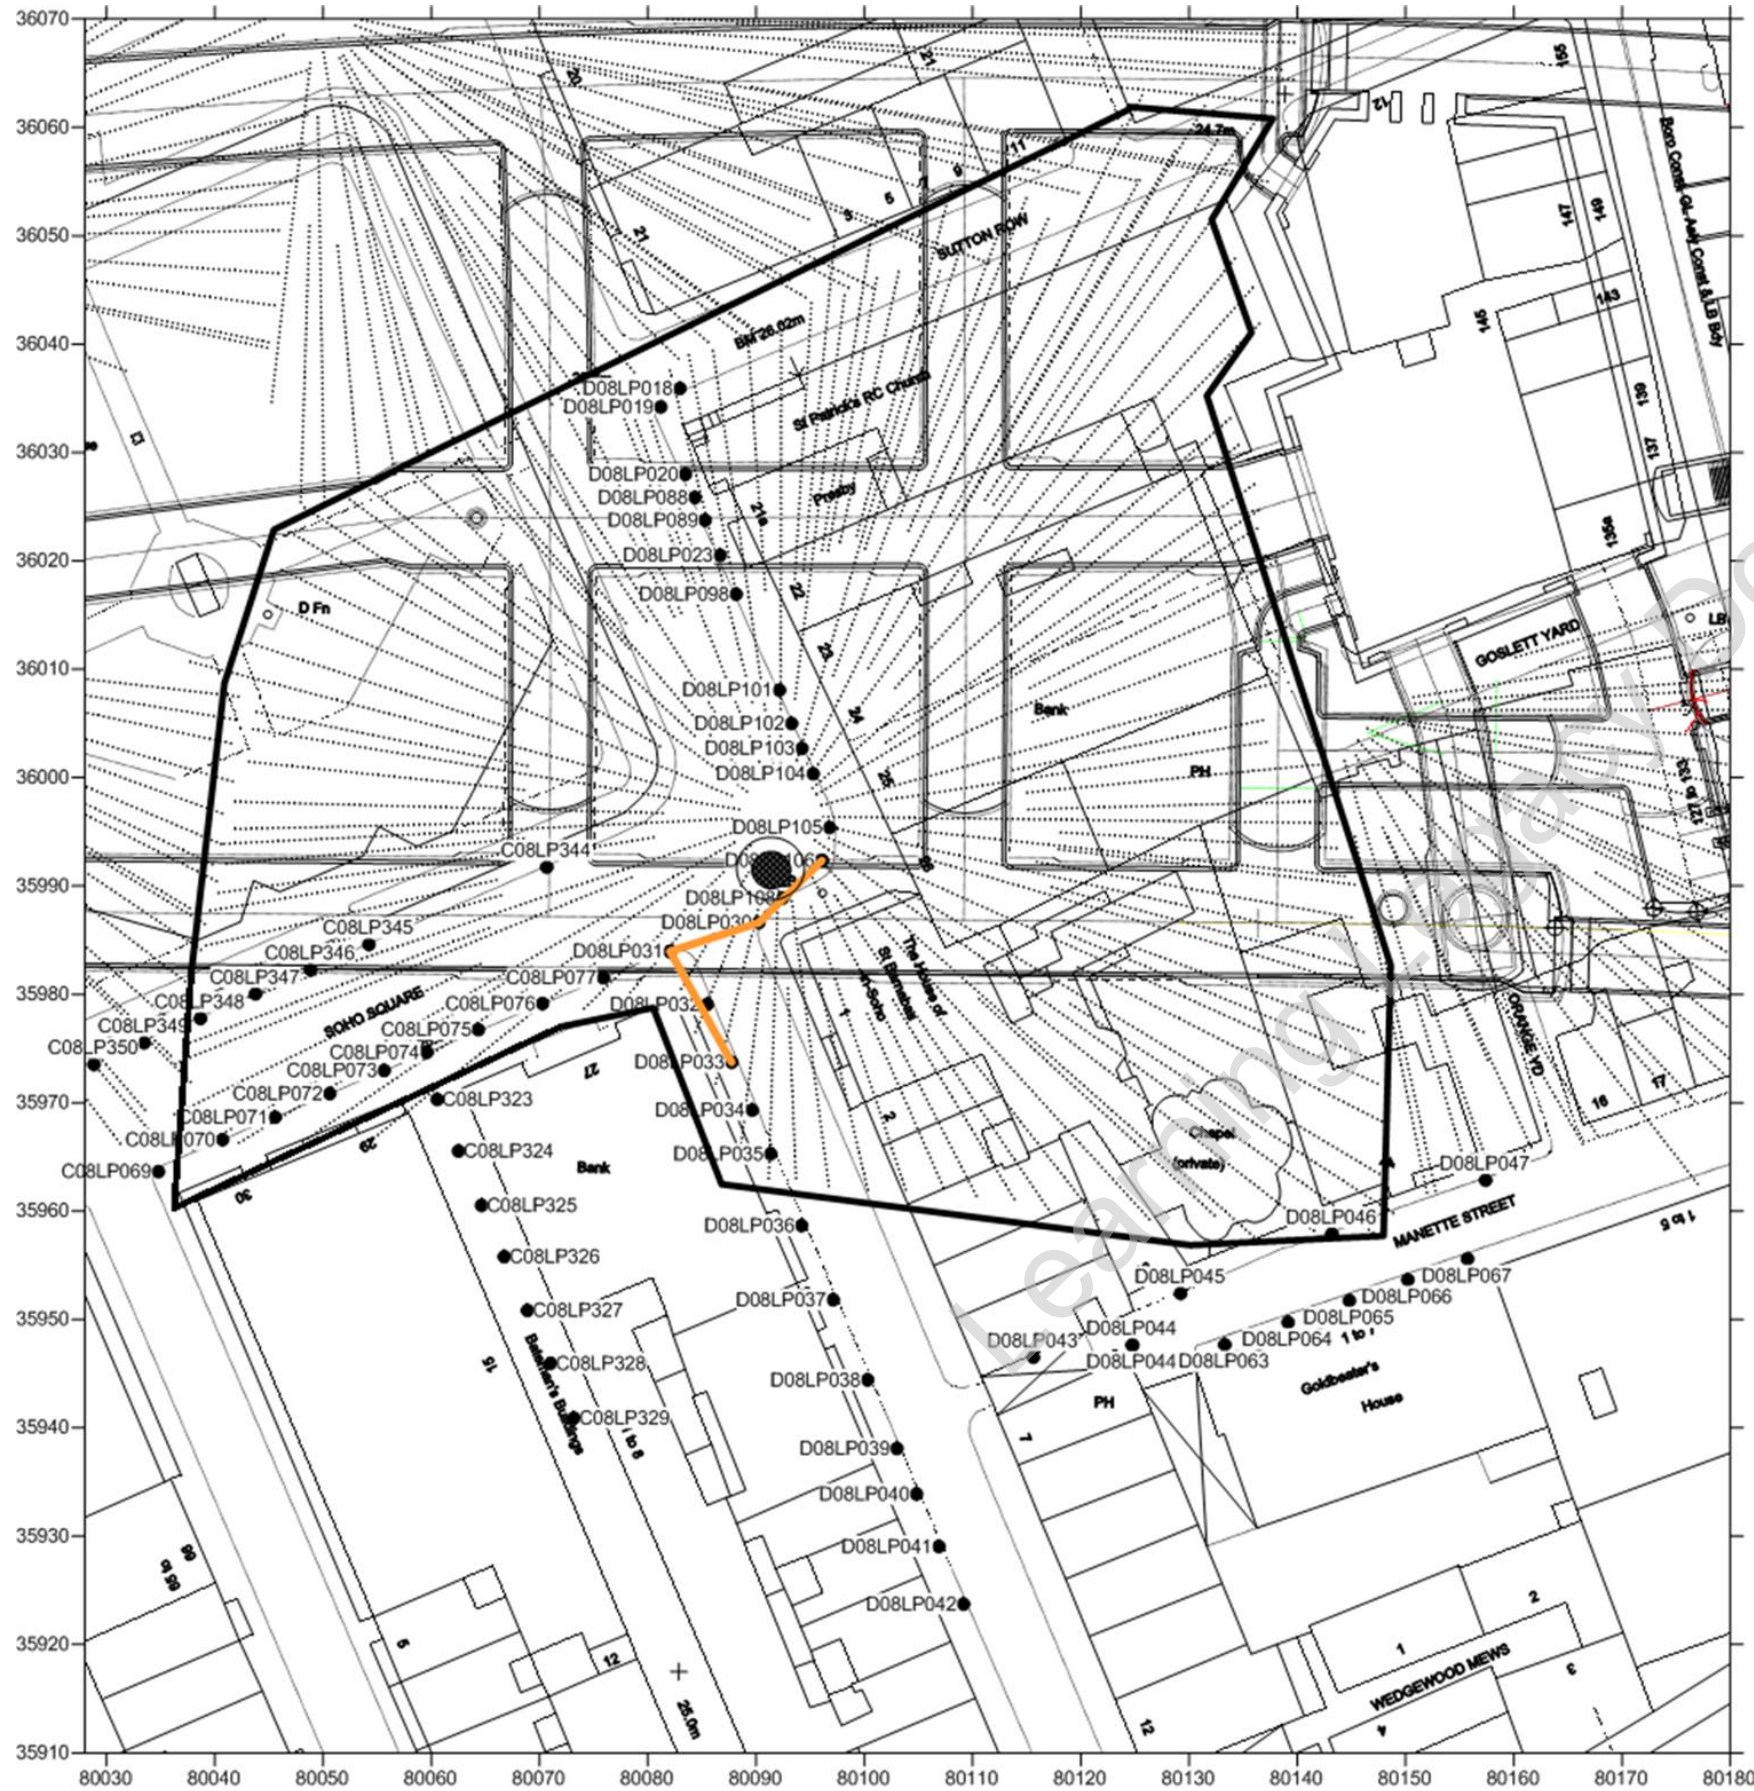
Enlarged version of Figures 4.1 and 5.1 showing location of monitoring points and slope triggers

The locations where slope triggers have been exceeded are shown for BRE monitoring of building facades on Figure 4.1. A larger version of Figure 4.1 is included in Appendix B. Details are given in Table 4.1. By inspection, no Deflection Ratio triggers have been breached.

Figure 4.1. Locations of BRE and building slope Amber trigger breaches.
