# Close-Out Monitoring Report

## FISHER STREET WORKS ~ Fisher Street Shaft

CRL Document No. **C300-BFK-C4-RGN-CRT00\_ST005-51234**

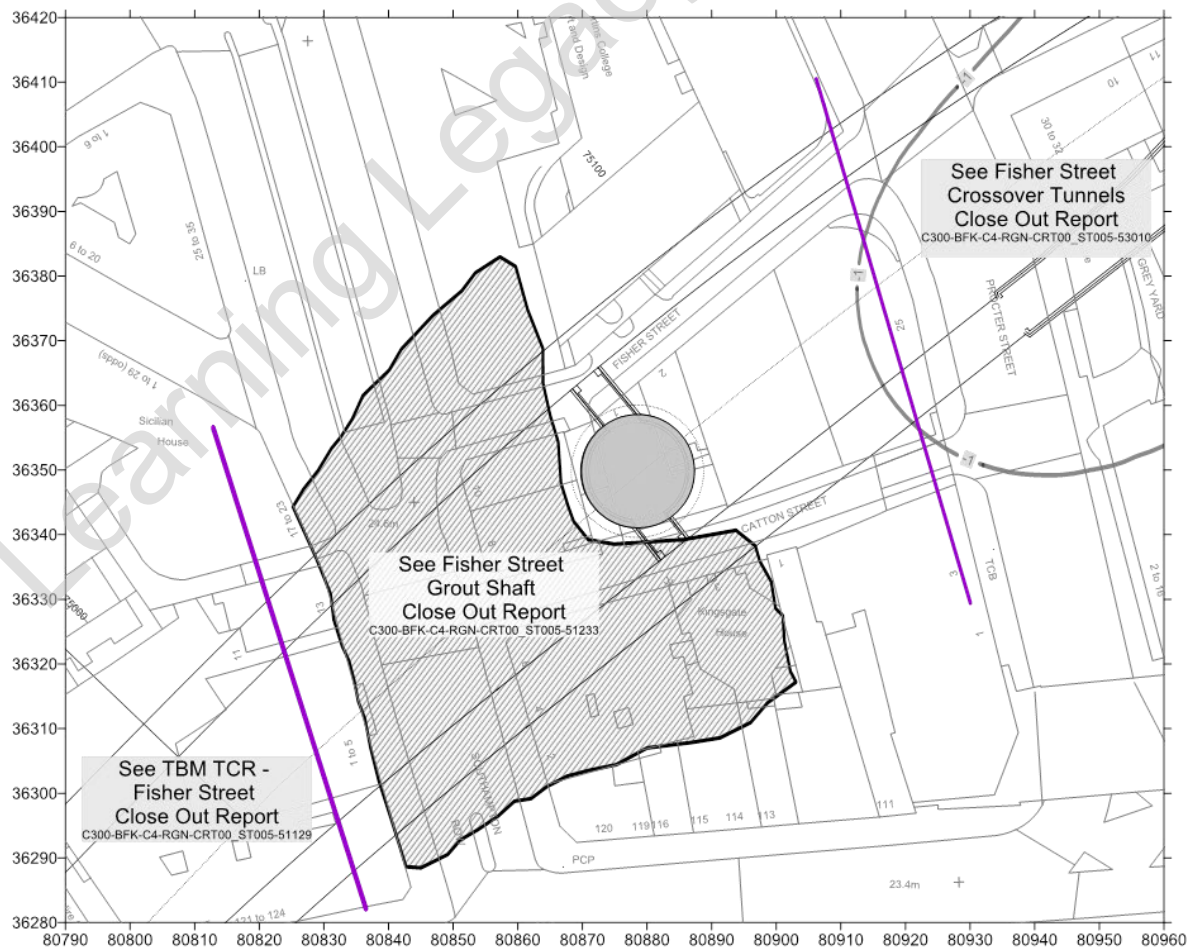
Figure 1: Location. General overview of the works on the Map

It is noted that monitoring has been progressively de-scoped by presentation of data at CTC meetings with subsequent confirmation under a number of RFIs. Extensive data for the area to the west of the shaft has also been presented in the Grout Shaft Close Out report (C300-BFK-C4-RGN-CRT00\_ST005-51233) and will not be repeated herein. To the east of the shaft, the western end of the crossover on the westbound running tunnel is below Proctor Street, consequently, data on and to the east of Proctor Street will be reported in the Crossover Tunnels Close Out Report (C300-BFK-C4-RGN-CRT00\_ST005-51234). The areas covered by the respective reports are shown in Figure 1. A further separate report will be prep

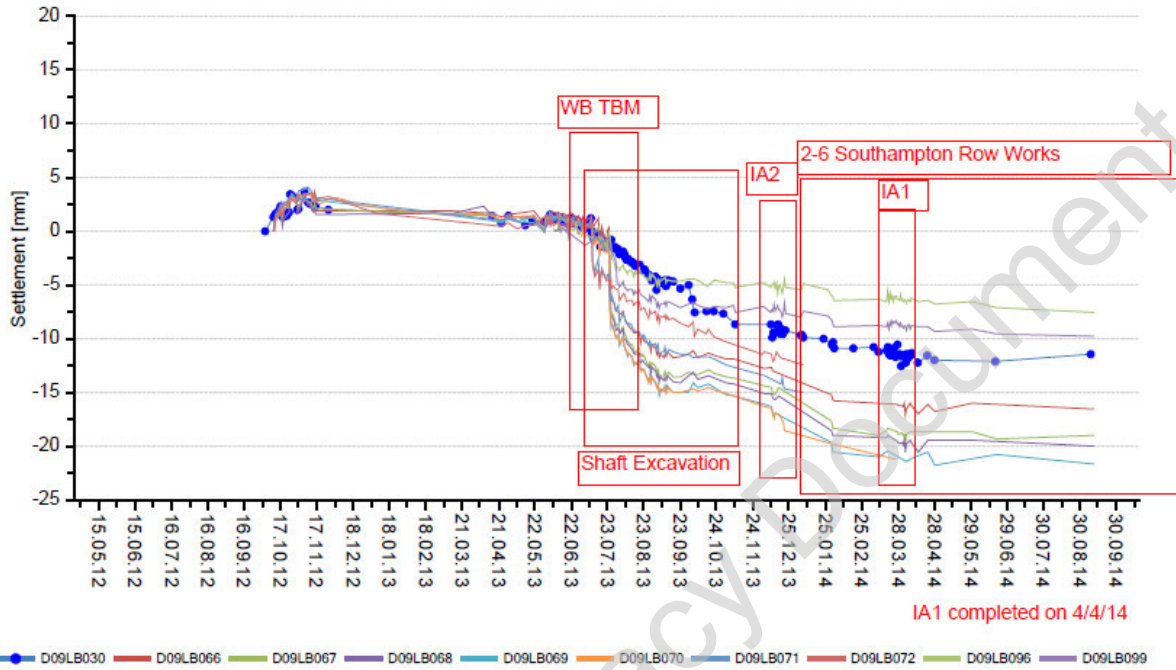
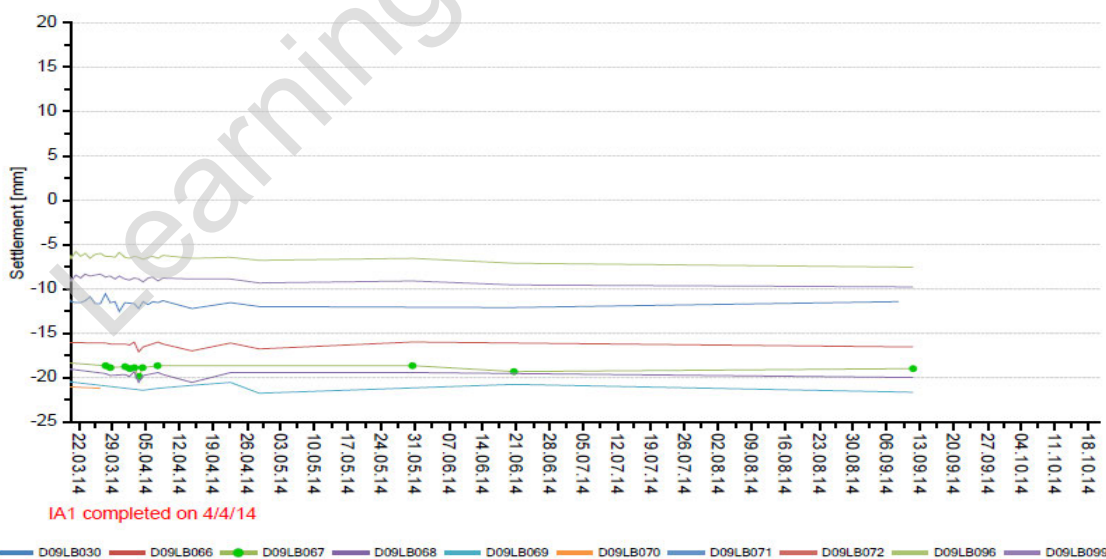
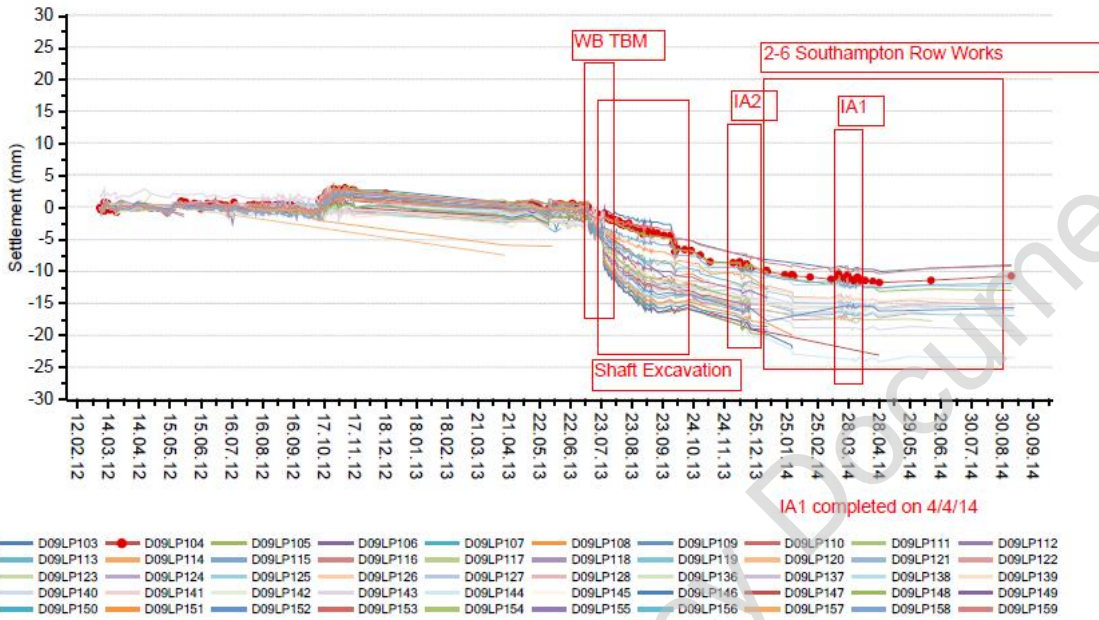
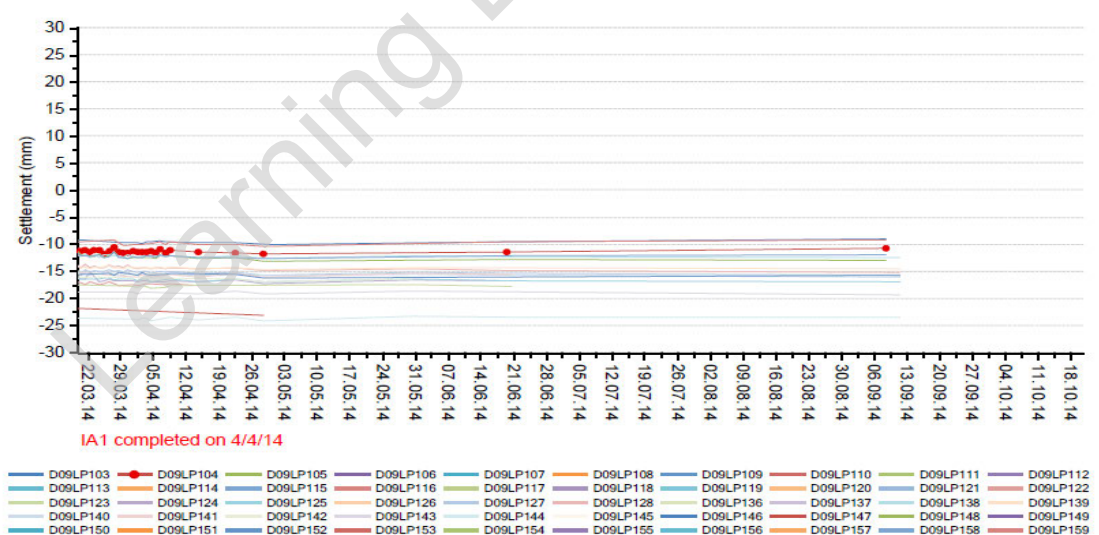
The points along Catton Street settled up to approx. 22mm. This resulted from a number of works in the area, whose effects are clearly visible as highlighted in the figures.

The time-plots are generally showing stability on the long term readings. The associated risk is considered negligible.

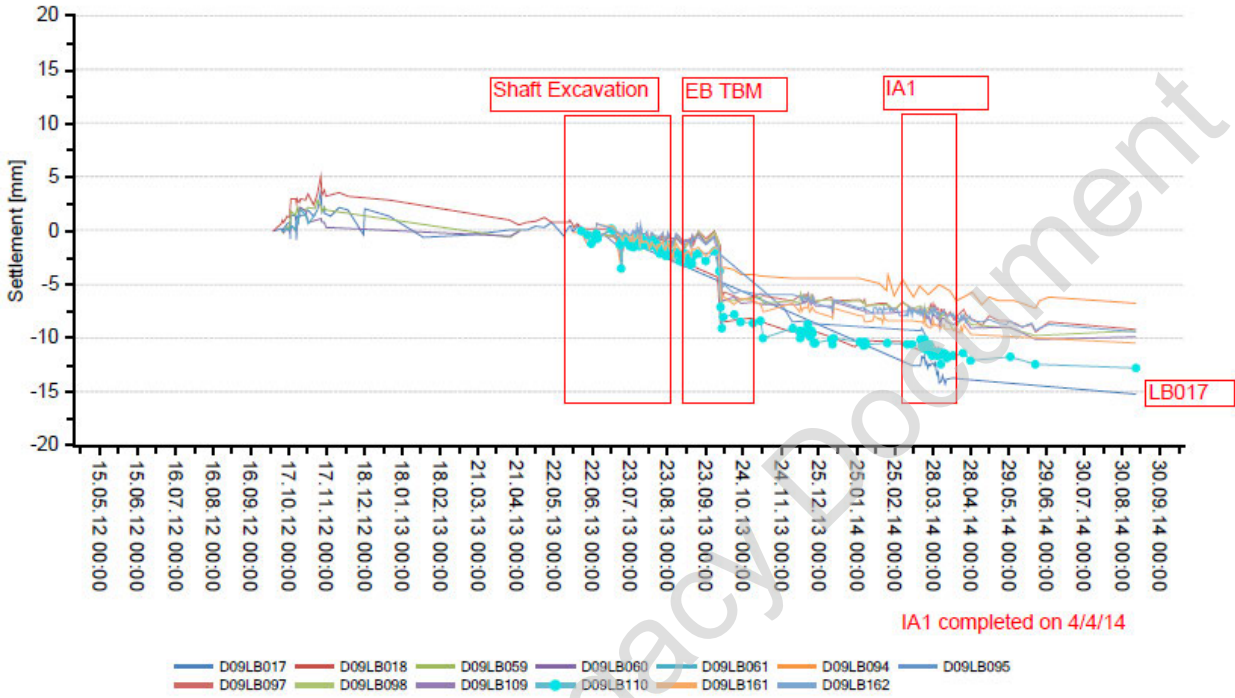
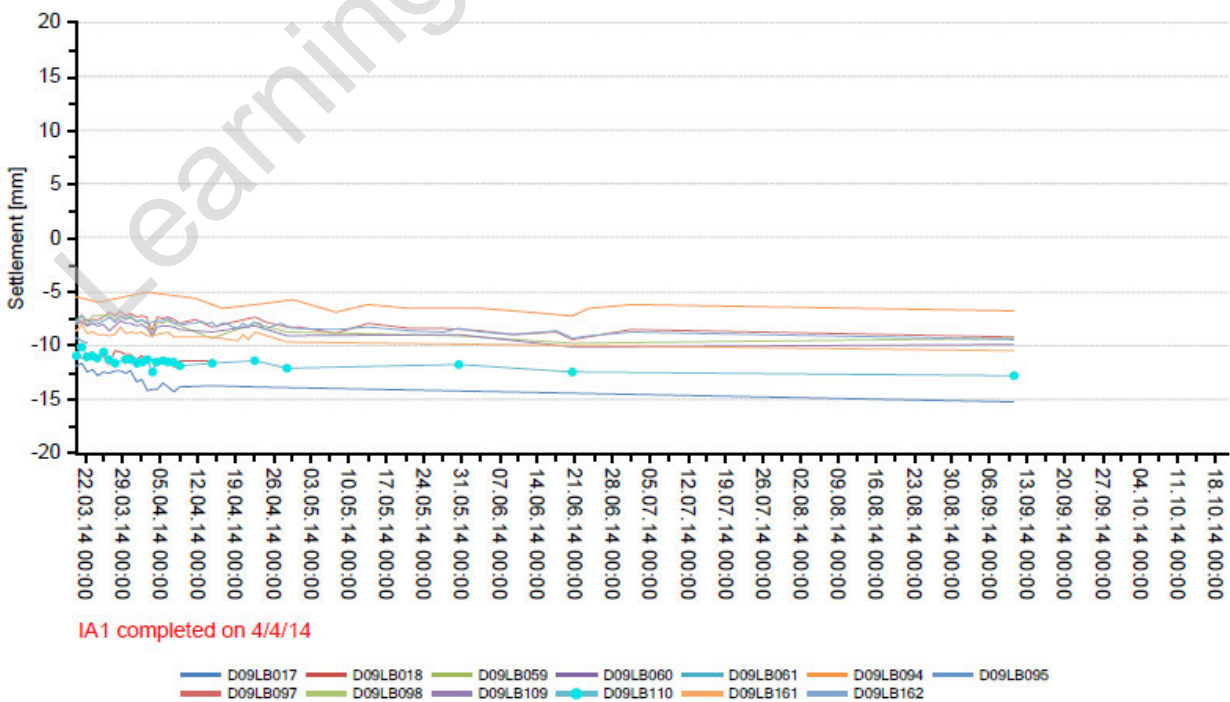
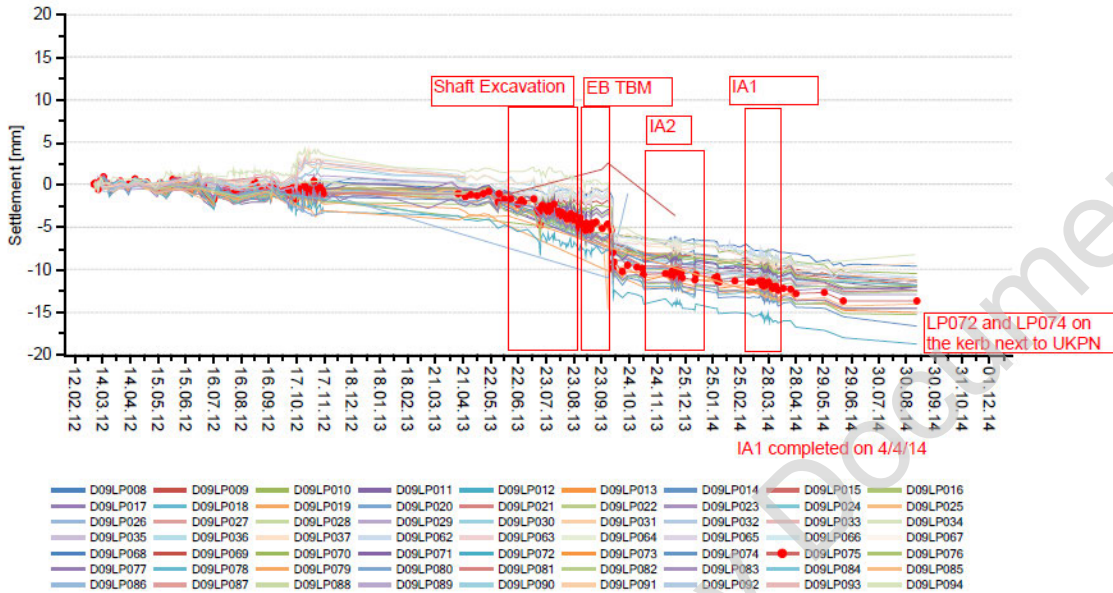
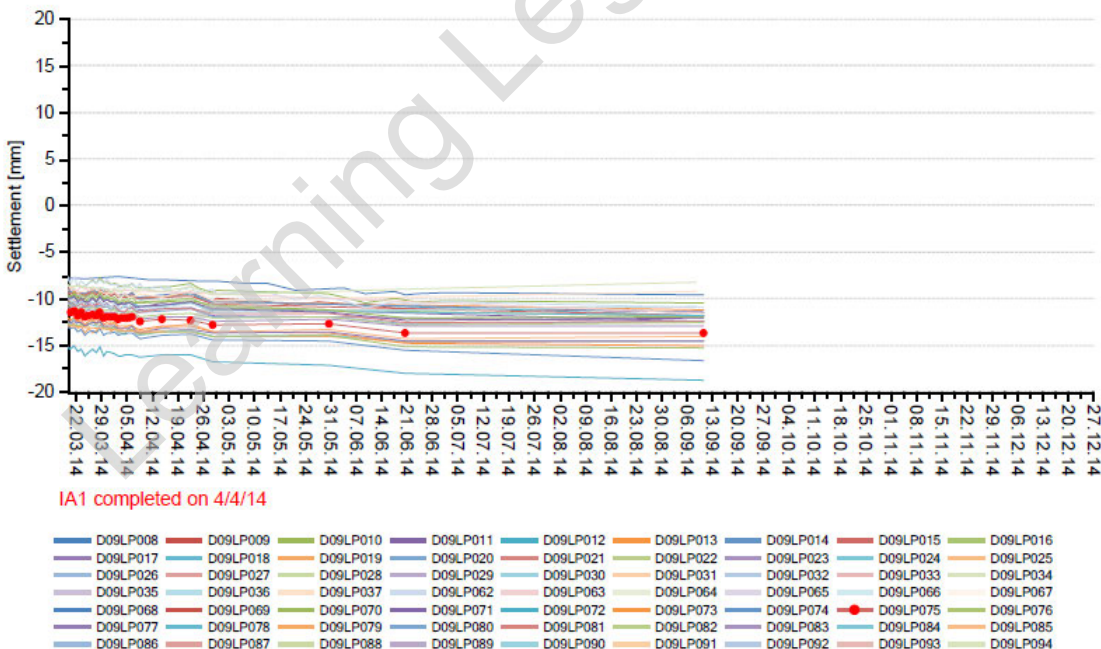
The points along Fisher Street settled up to approx. 20mm. This results from a number of works in the area, whose effects are clearly visible as highlighted into the charts. There was no effect from the WB TBM passage.

The time-plots are generally showing stability on the long term readings. The associated risk is considered negligible.

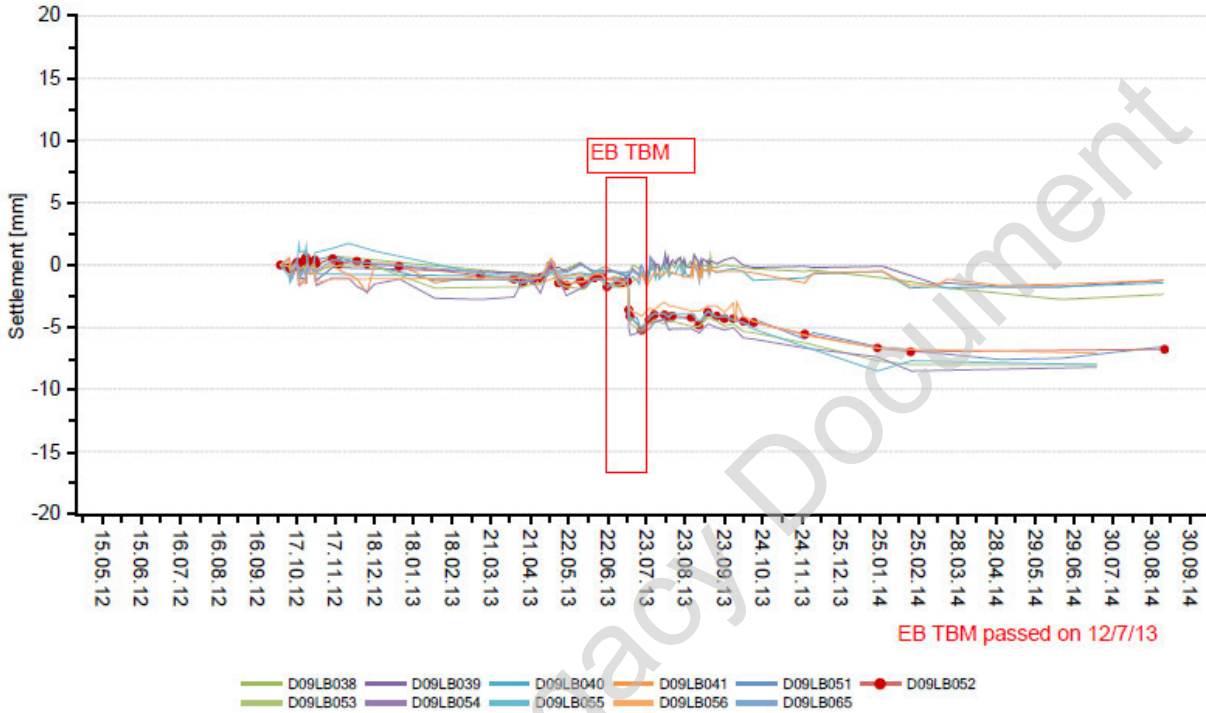
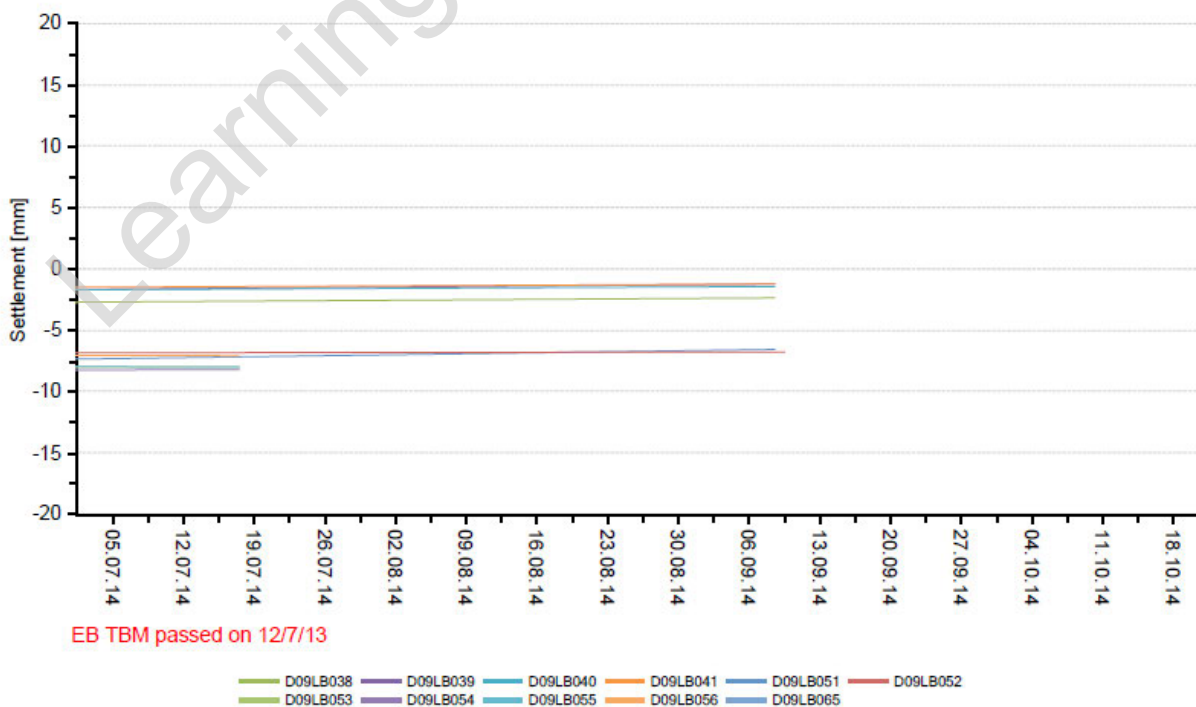
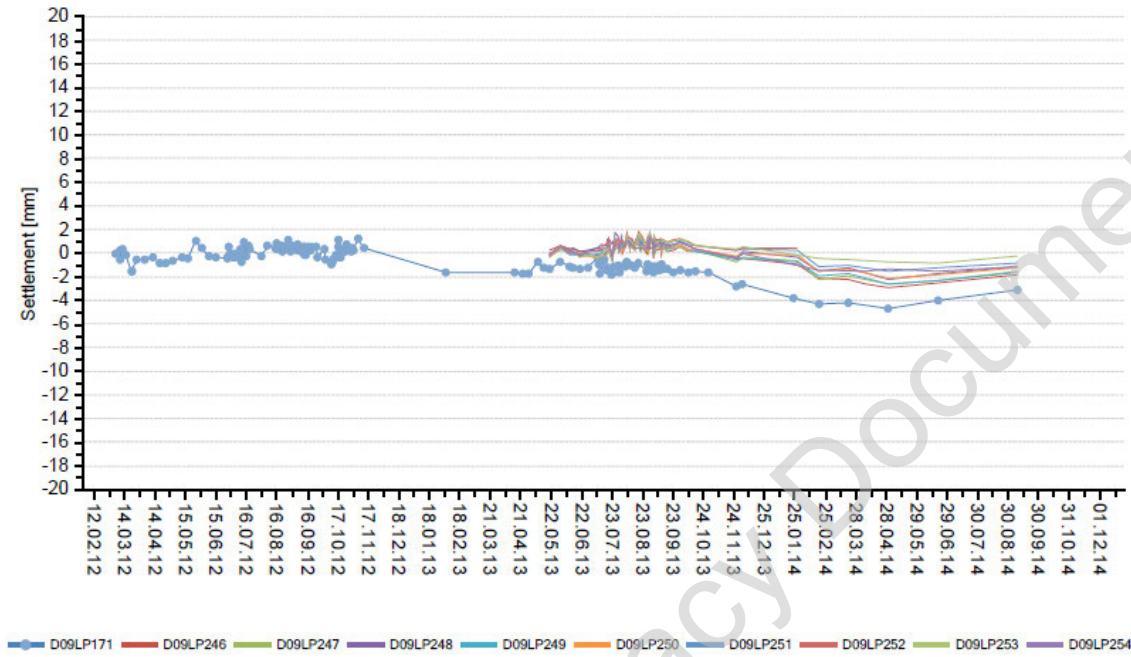
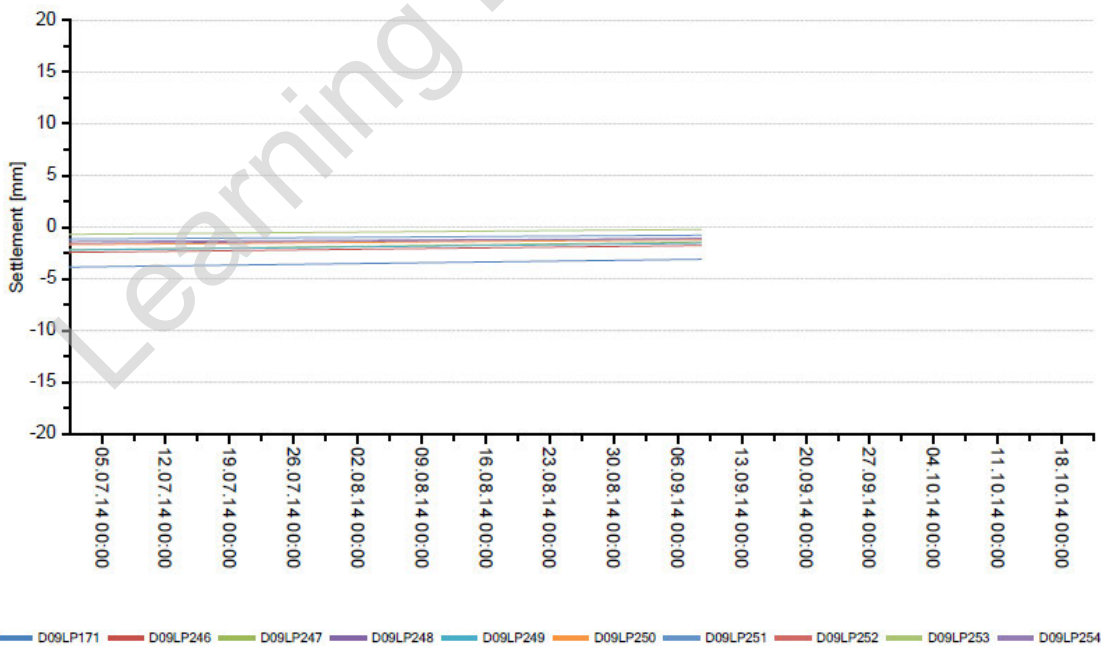
The points along High Holborn settled up to approx. 7mm, with a noticeable influence only from the EB TBM.

The time-plots are generally showing stability on the long term readings. The associated risk is considered negligible.

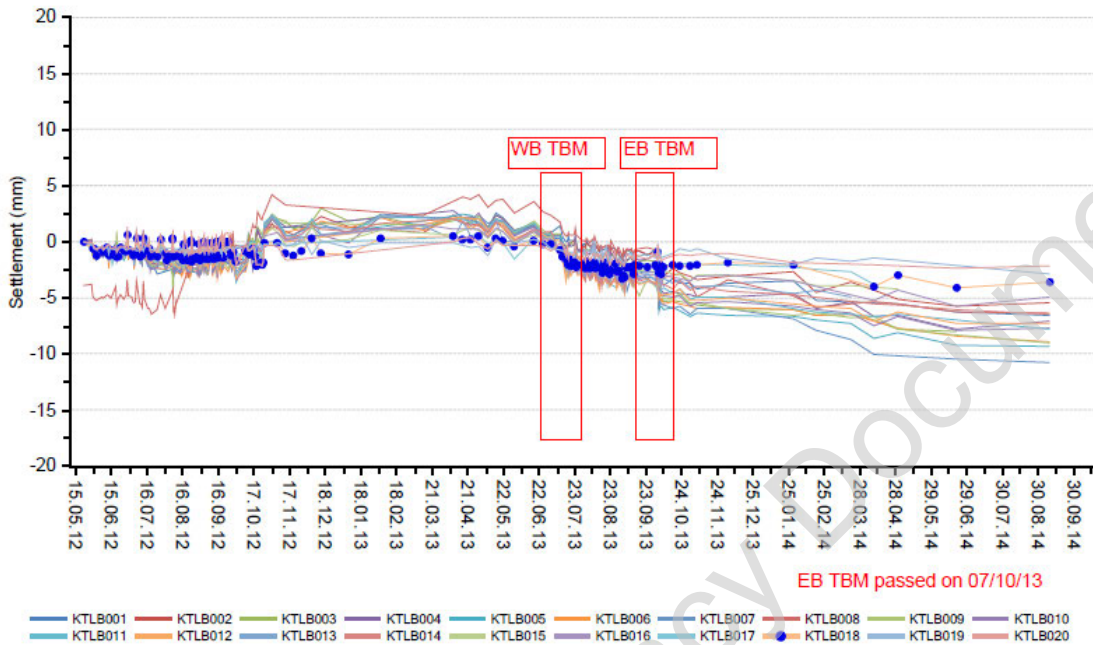
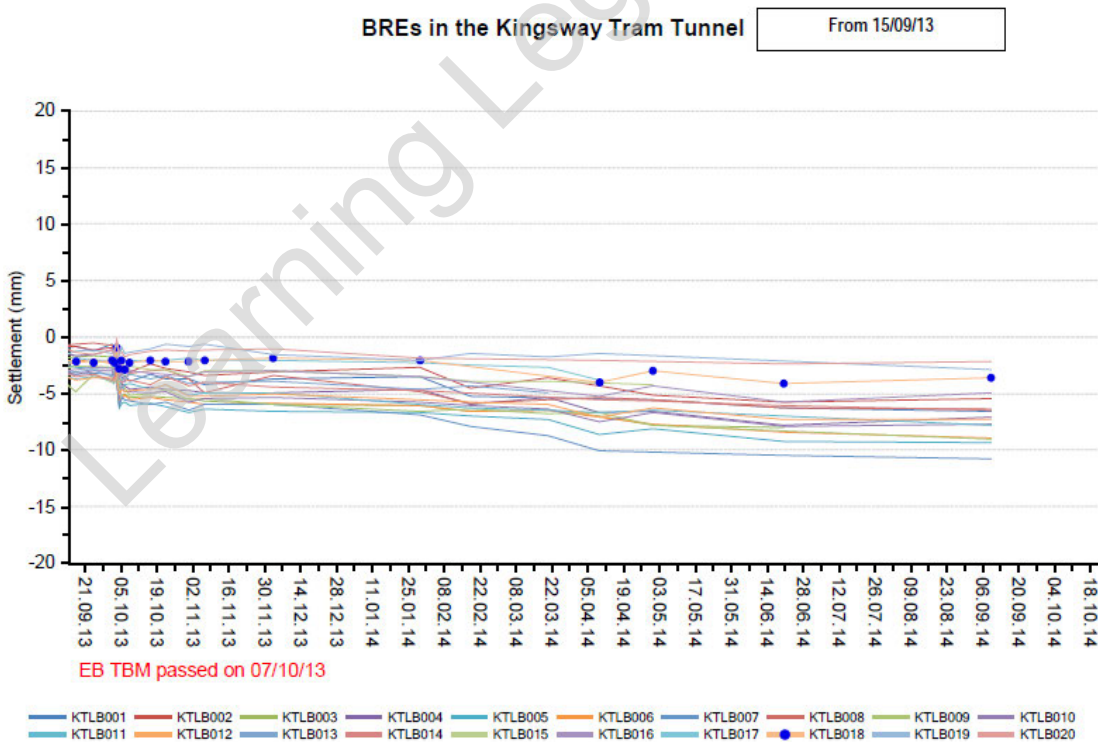
The points (BREs) inside the KTT settled up to approx. 11mm. The effects of both WB and EB TBMs are visible from the settlement time-plots. The time-plots are generally showing stability on the last readings. The associated risk is considered negligible.

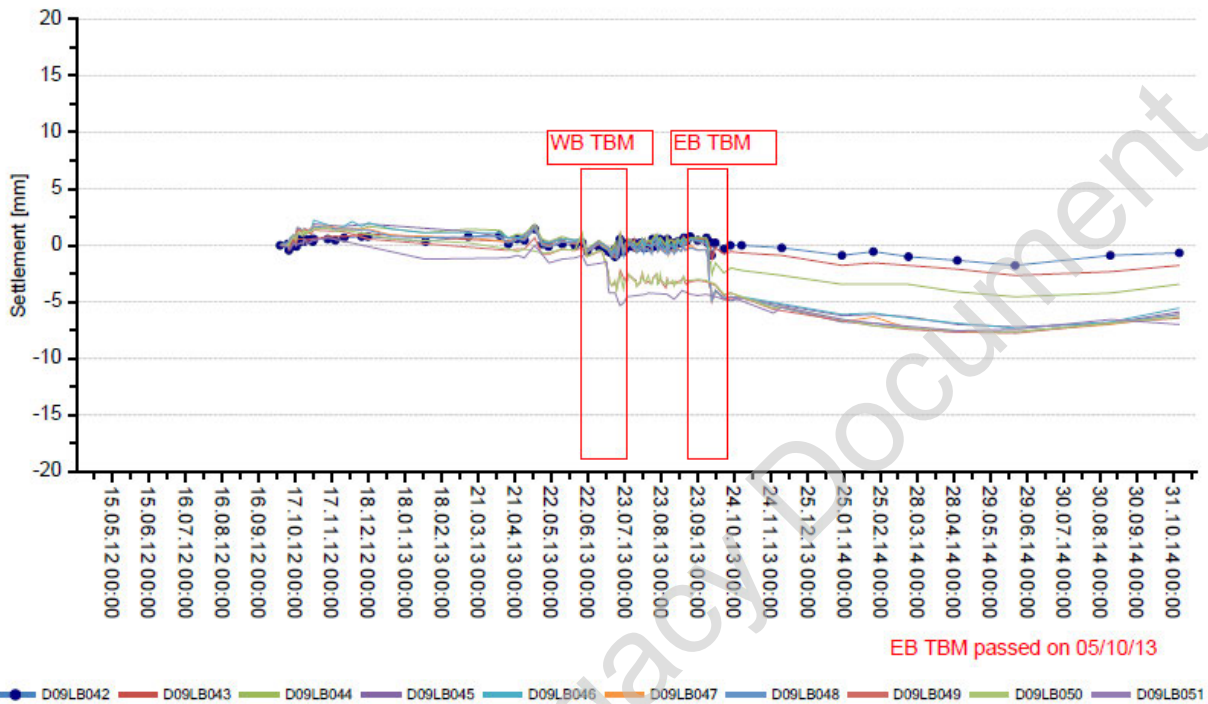
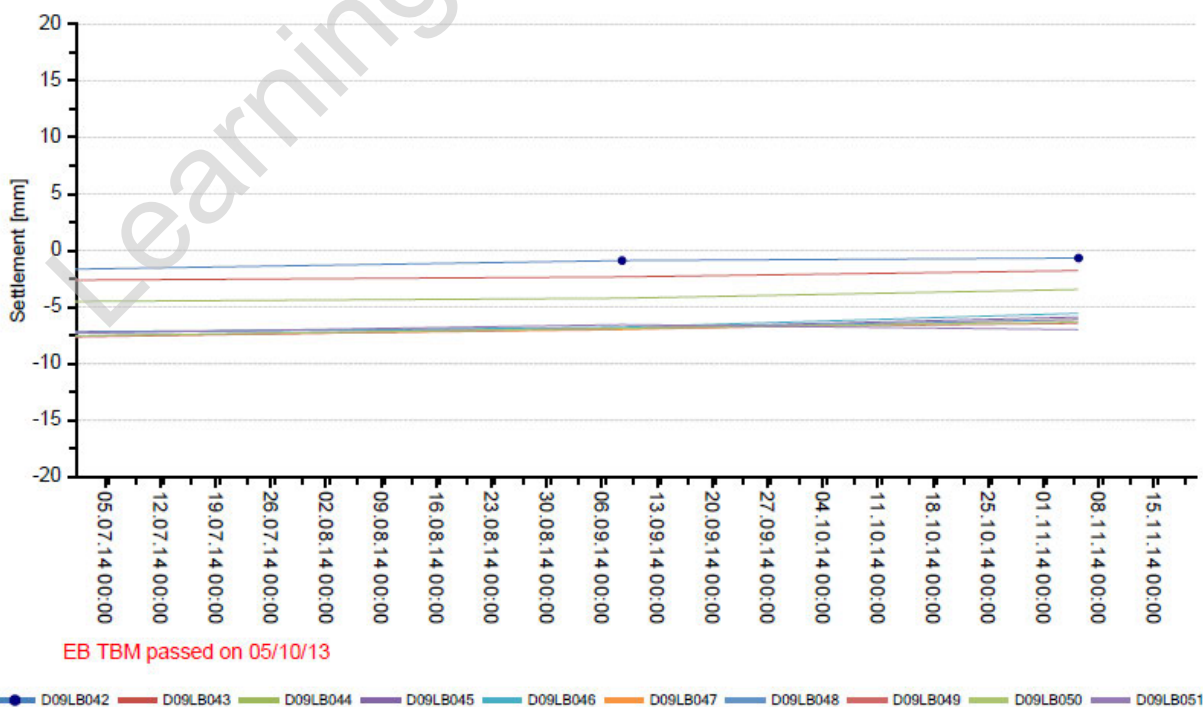
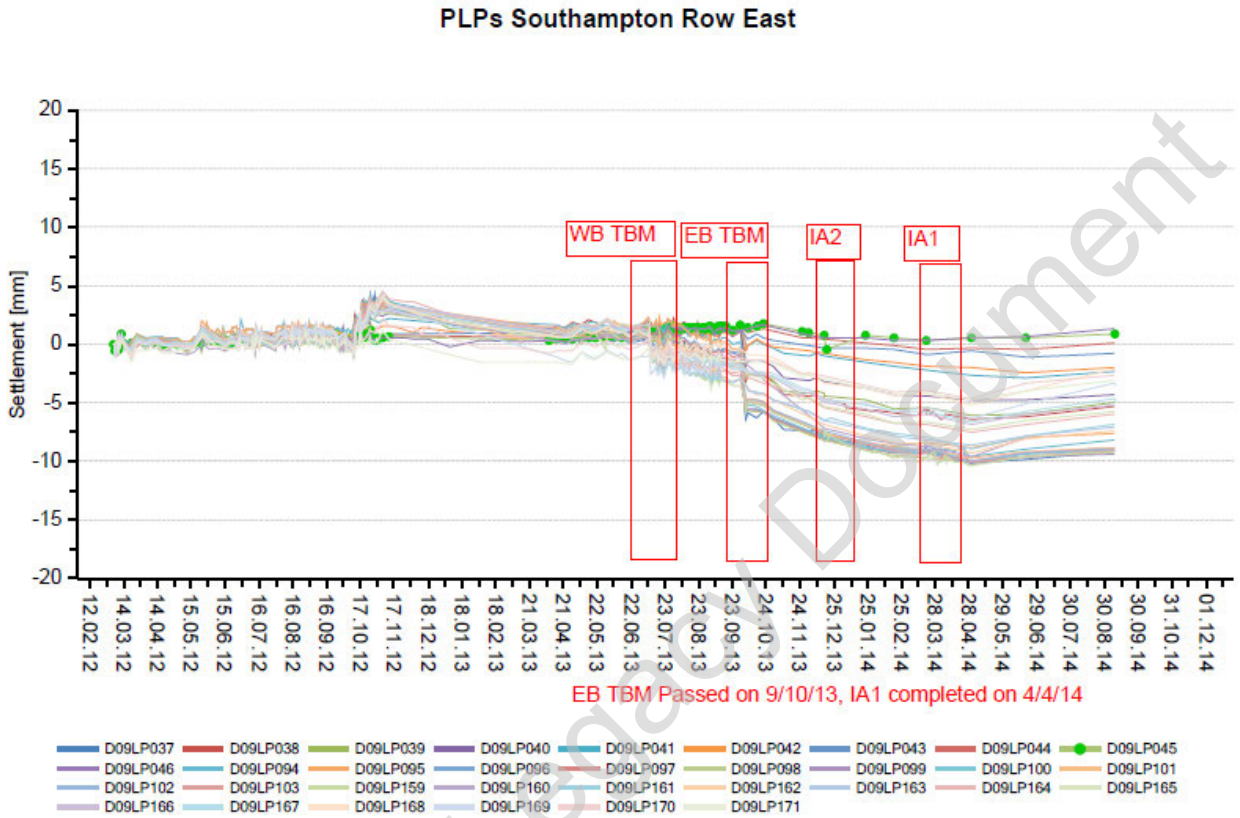
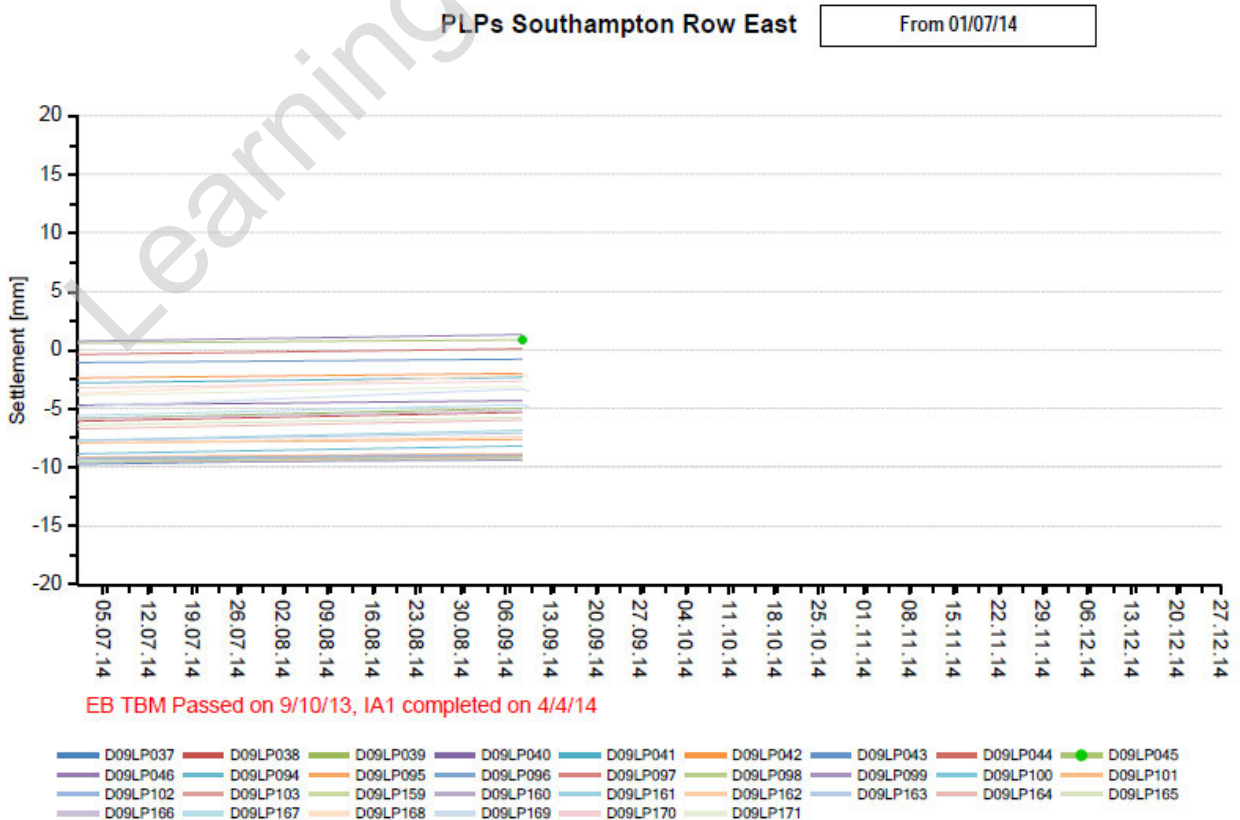
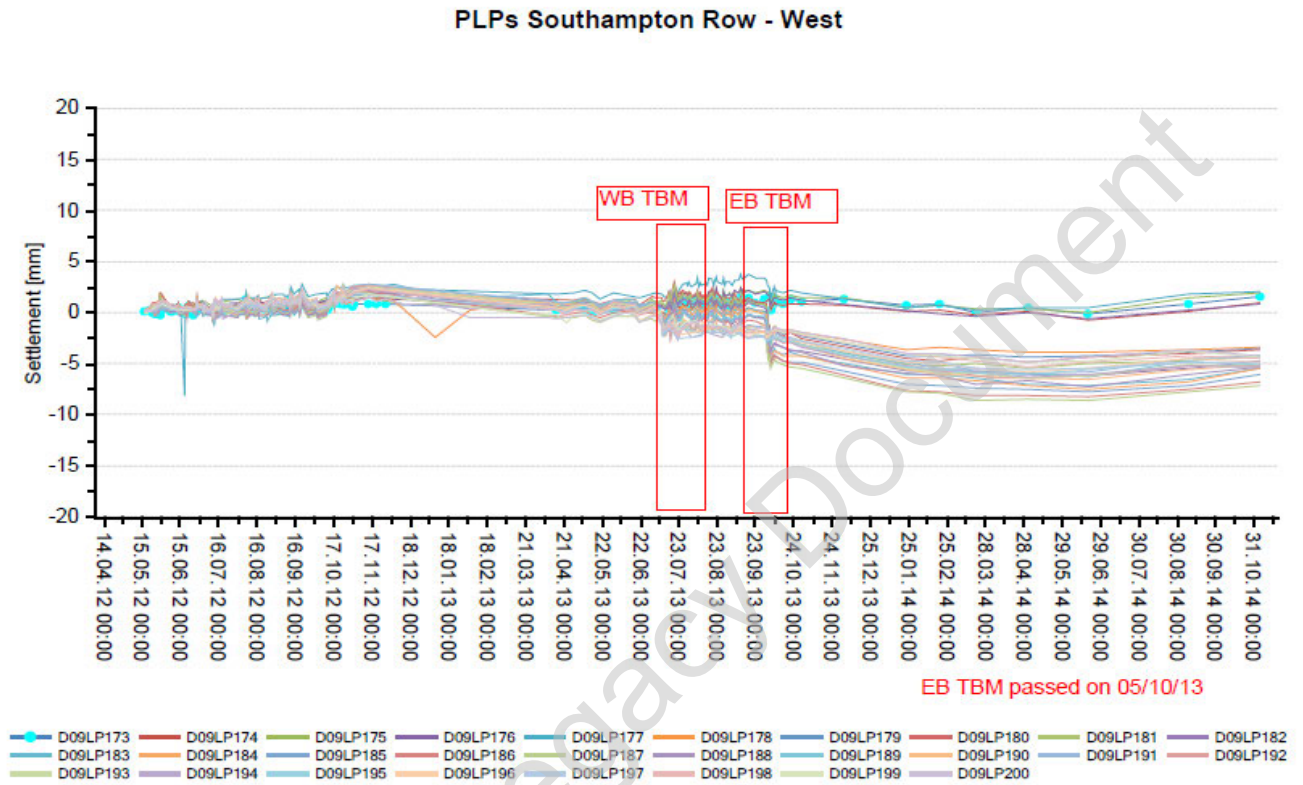
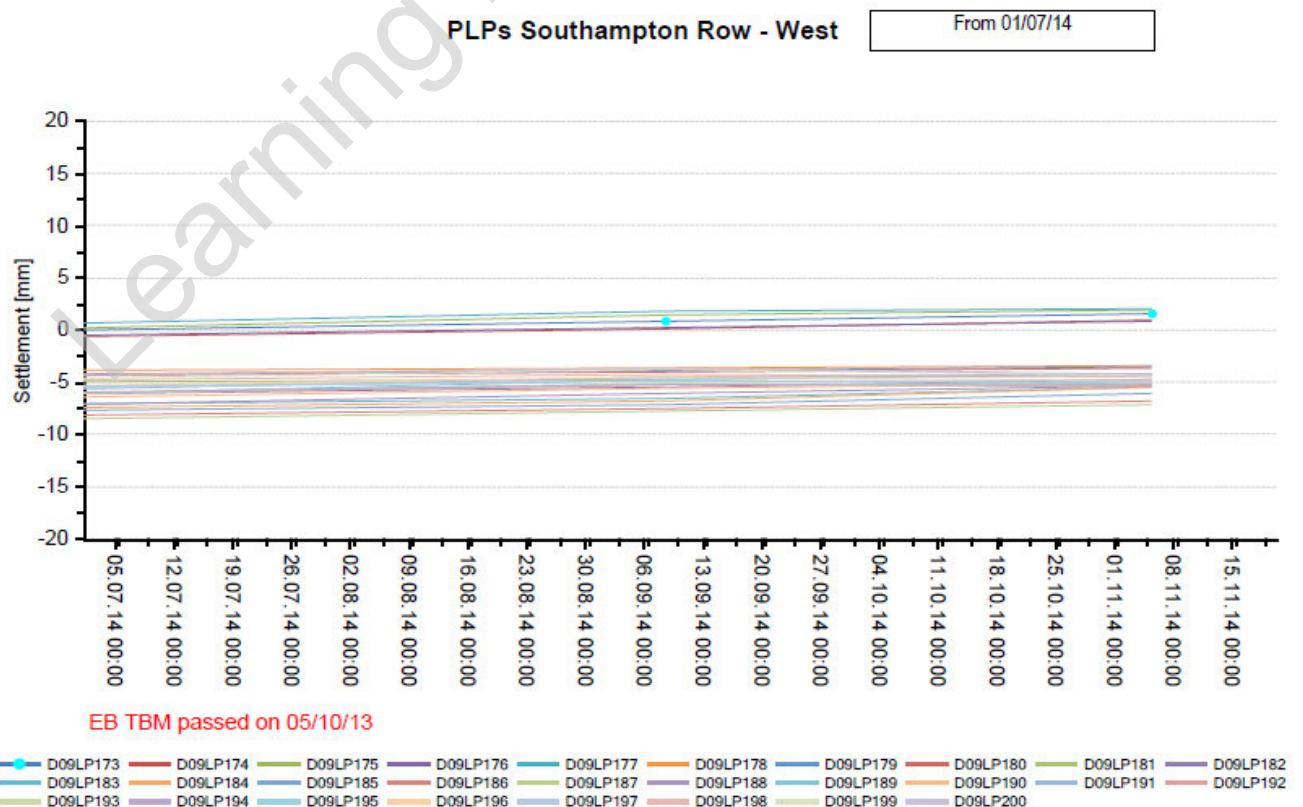
The points along Southampton Row settled up to approx. 10mm. The effects of both WB and EB TBMs are visible from the settlement time-plots, with little apparent influence from the shaft sinking.

The time-plots are generally showing stability on the last readings. The associated risk is considered negligible.

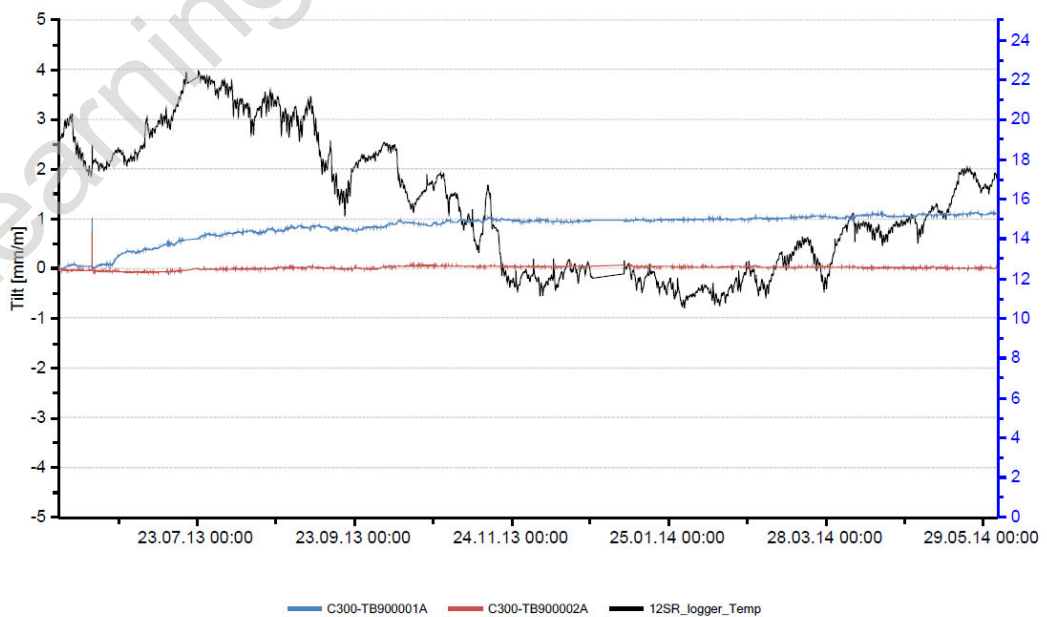
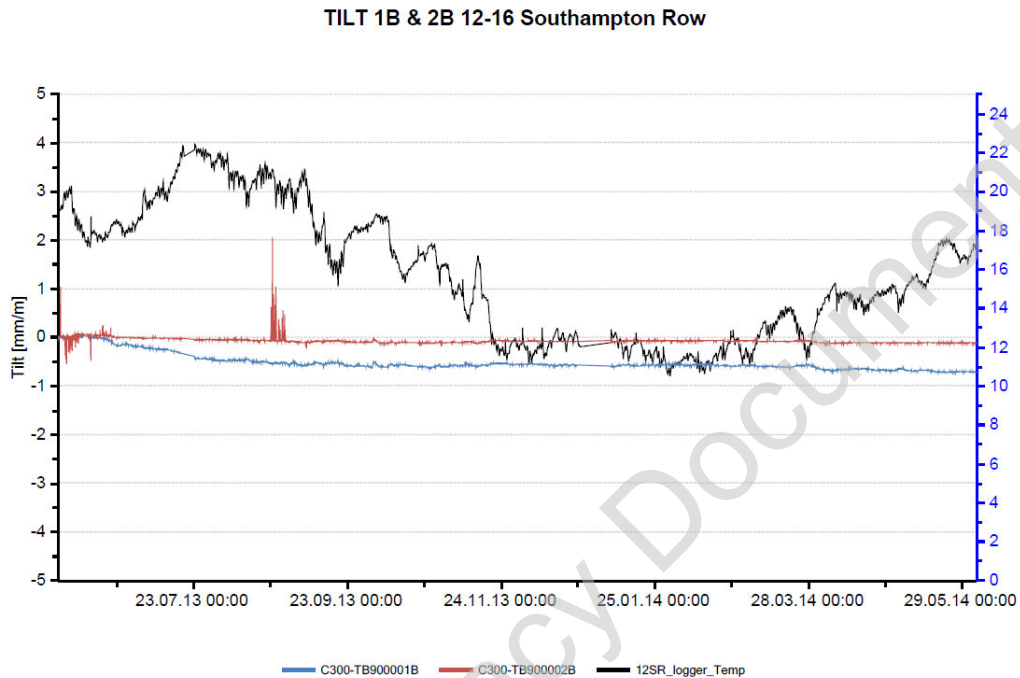
Tilt changed on one instrument (C300-TB00001) in both in directions between June and September 2013, but has remained essentially stable subsequently. The rotation is indicated to the east (+ve A direction) and to the north (-ve B direction). There has been no significant change in either direction on the other sensor.

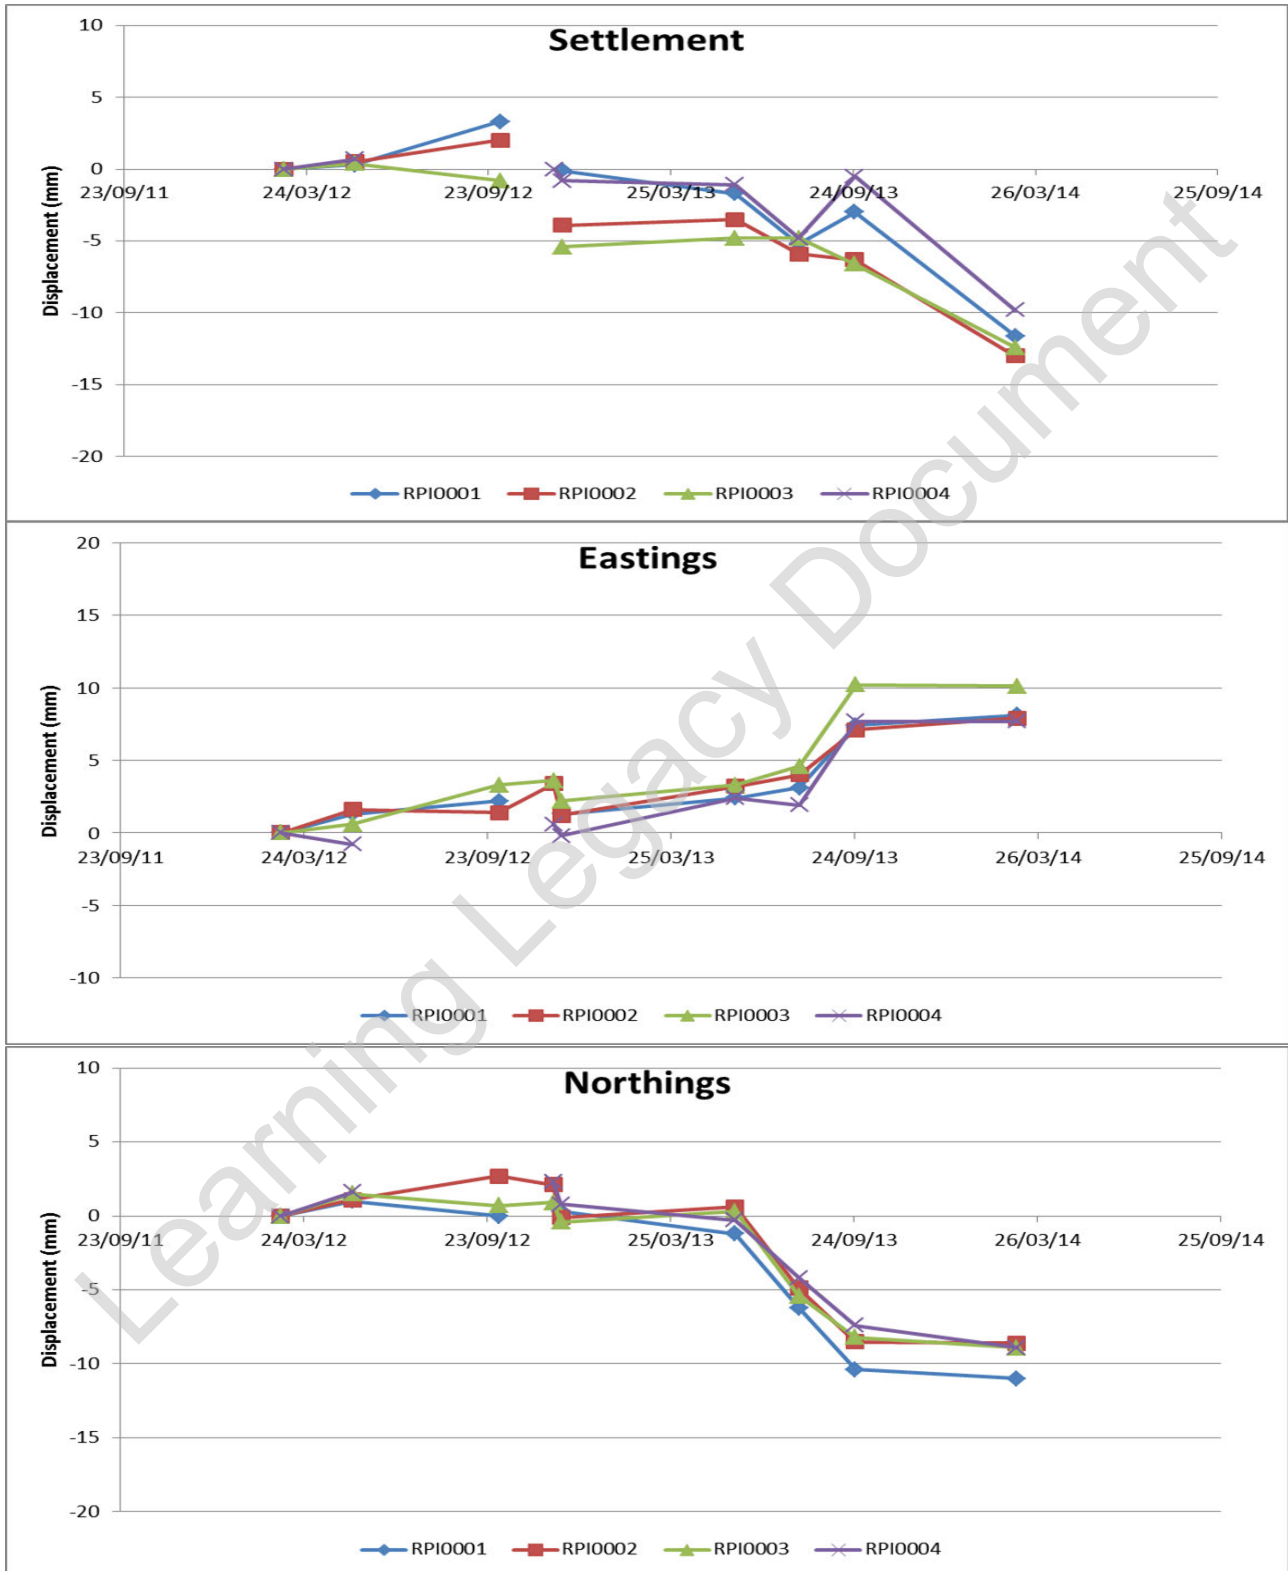
Figure 38 Internal prism data

All four prisms show similar behaviour within the accuracy of this type of monitoring, indicating negligible differential movements.
