# Close-Out Monitoring Report

## FISHER STREET WORKS ~ Fisher Street Shaft

CRL Document No. **C300-BFK-C4-RGN-CRT00\_ST005-51234**

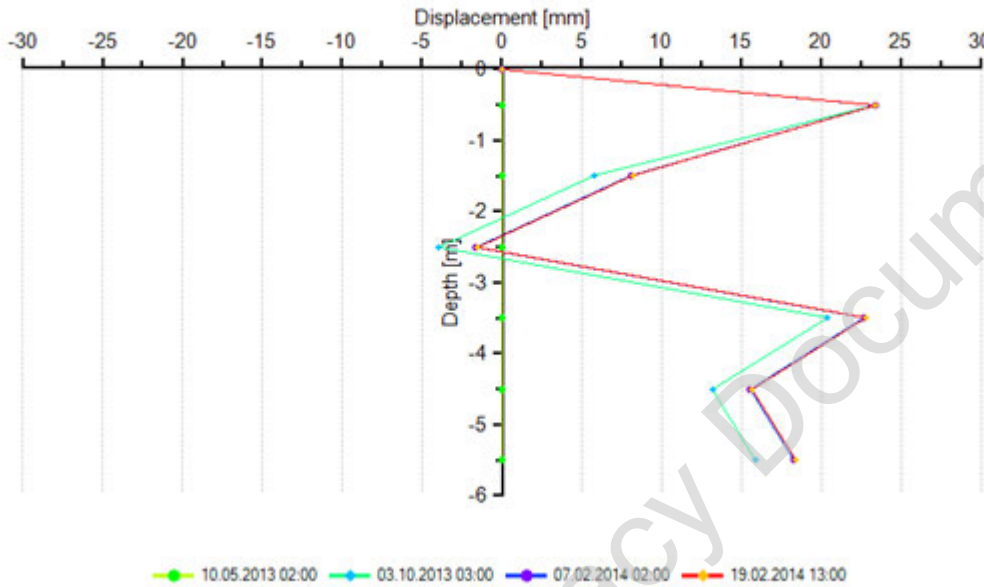
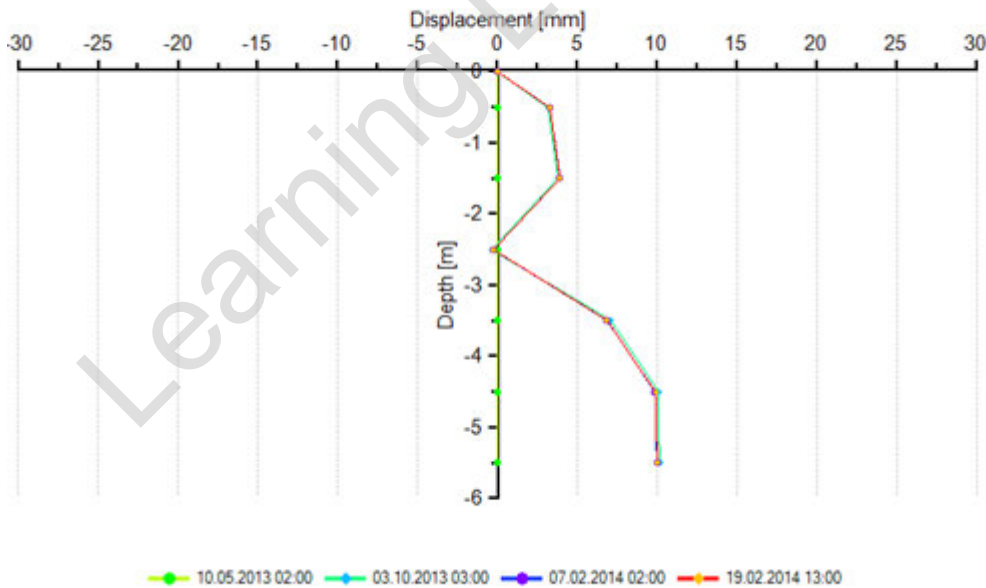
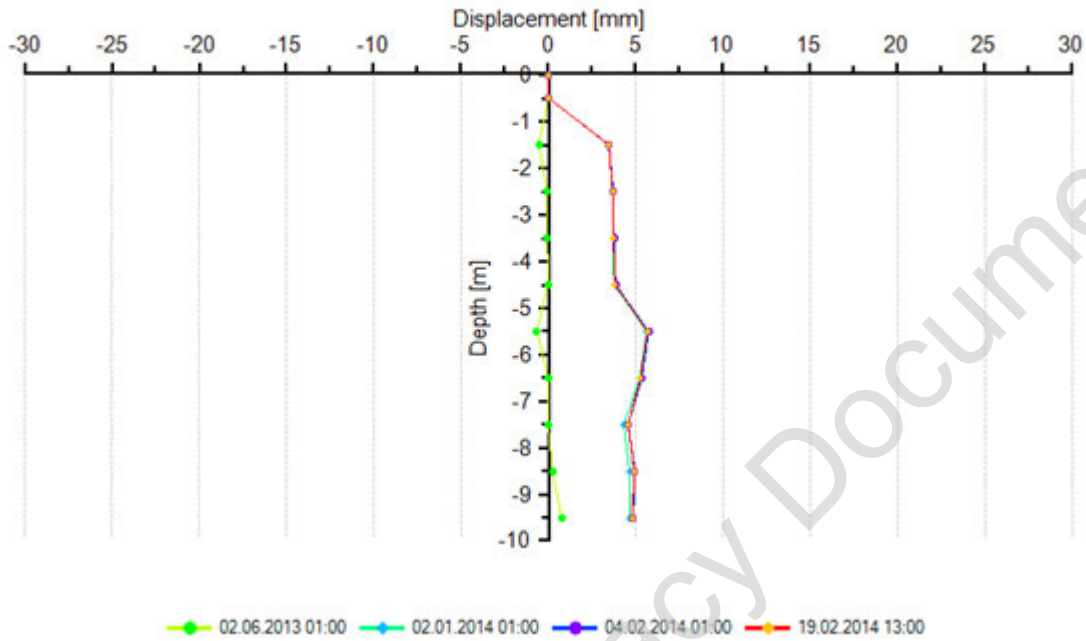
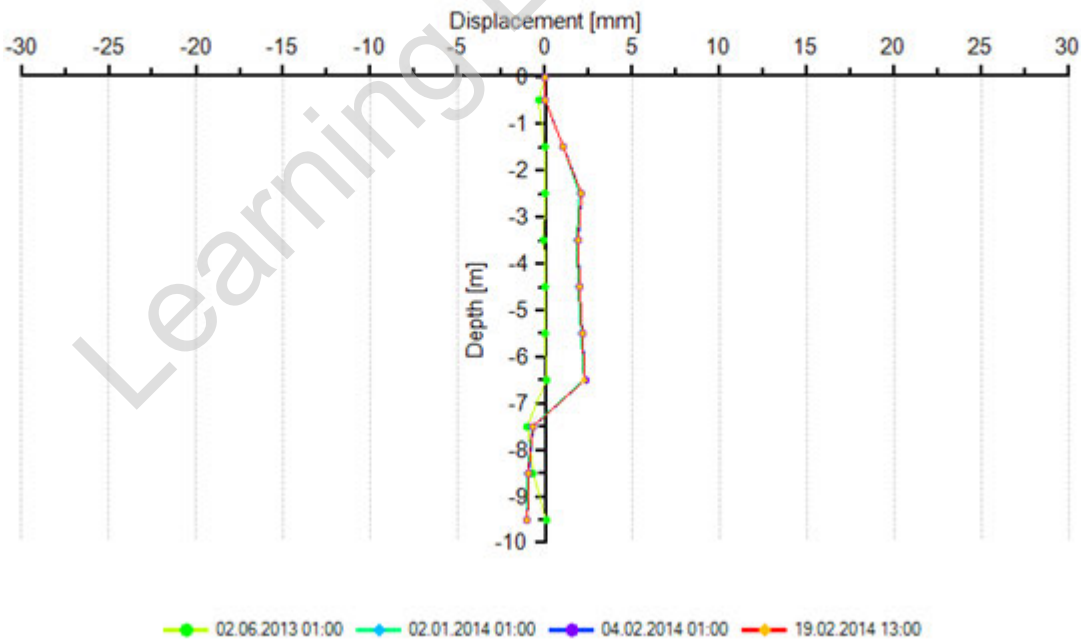
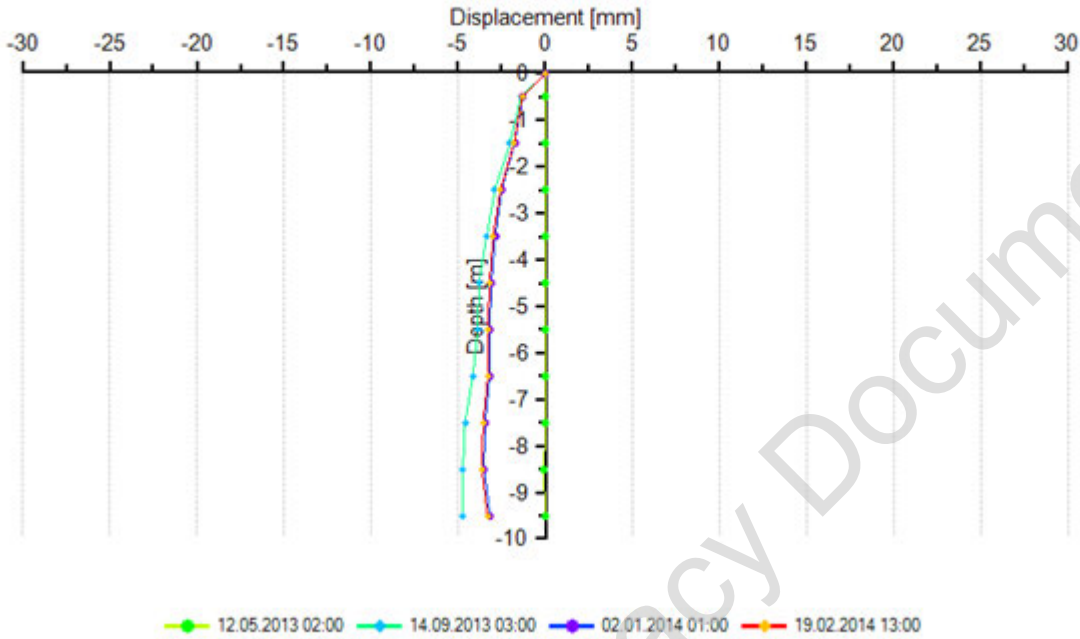
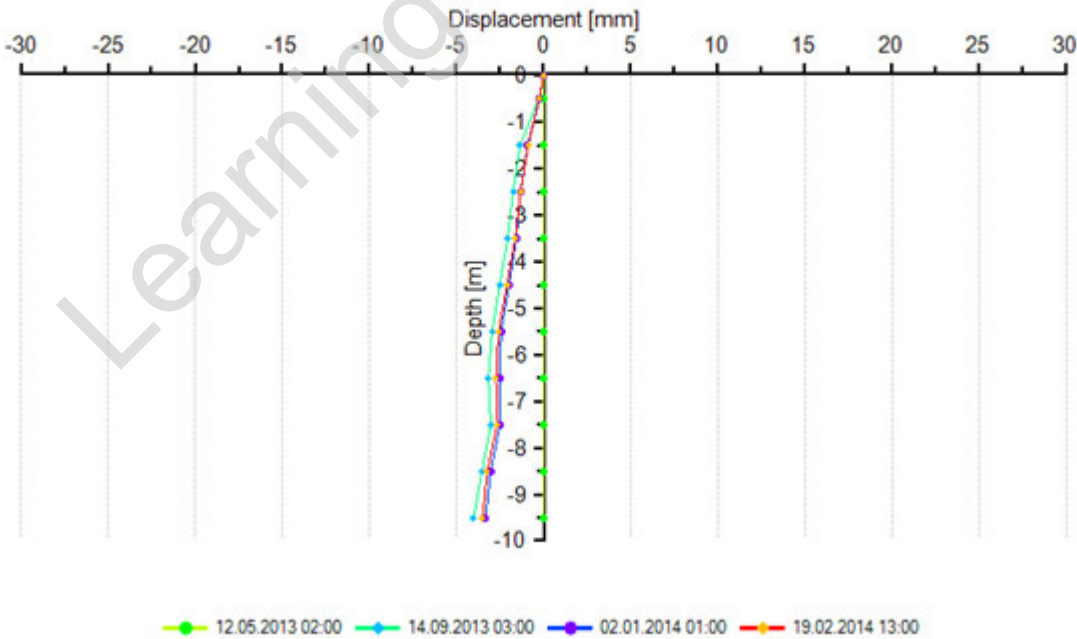
In general, all the monitoring data from the deep instruments are showing stable behaviour or very slow movement trends after the works.

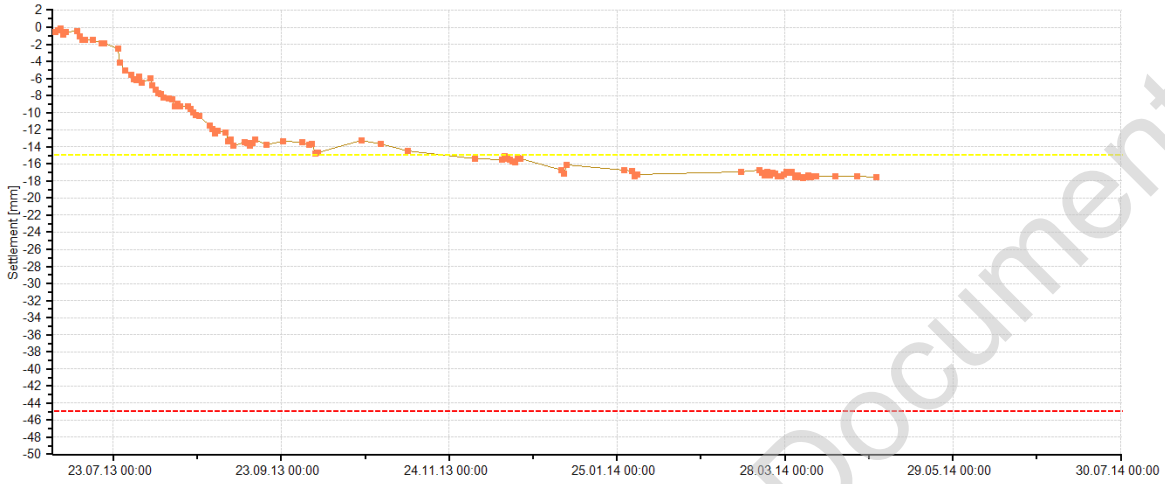
Profile: Measurement Point DP900027

3.10.3. Deep Pins data

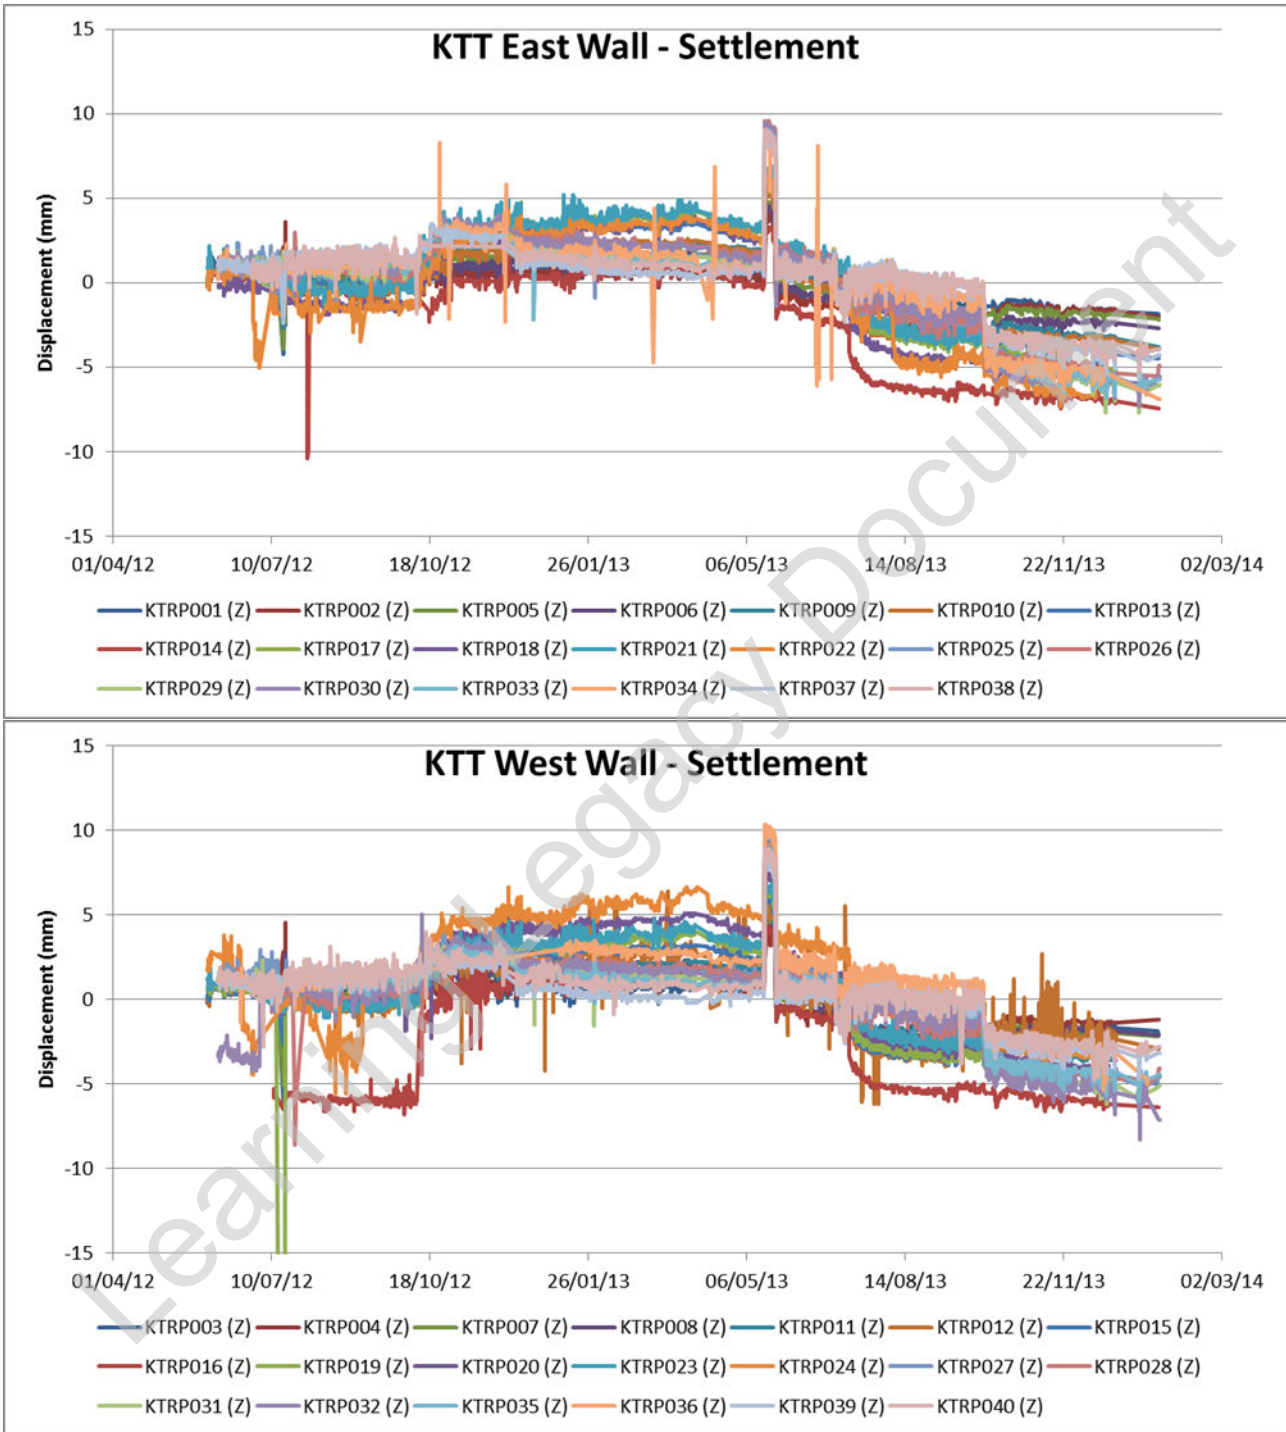
Figures 43, 44 and 45 show data from the prism installed in the Kingsway Tram Tunnel (KTT) for Eastings (X), Northings (Y) and settlement (Z). All of the plots show a “step” in some of the data at the same time in May 2013. An enlarged plot shows that this occurred between consecutive reading on 17<sup>th</sup> / 18<sup>th</sup> May 2013 with stable readings before and after the step. The values subsequent to the step do not represent real movement.
