Western Tunnels & Caverns Project

Final Monitoring Report

Tottenham Court Road Station - Manual Monitoring

Final Monitoring Report: C300-BFK-C4-RGN-CRT00_ST005-53006 Rev 5.0

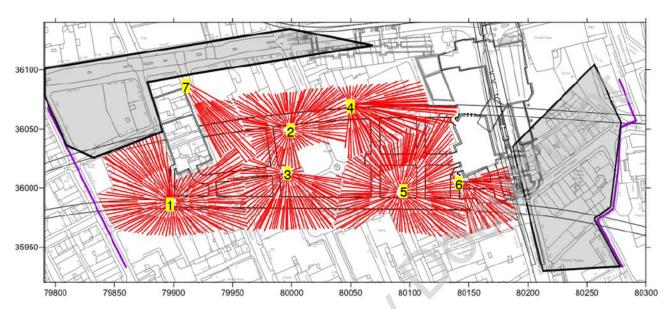
There are two areas not covered in the Grout Shaft Close Out reports as shown on Figure 1. These comprise:

- 1. Great Chapel Street (north of Hollen Street) and Oxford Street
- 2. East of Charing Cross Road

Figure 1 Extent of West and East areas not covered by Grout Shaft reports

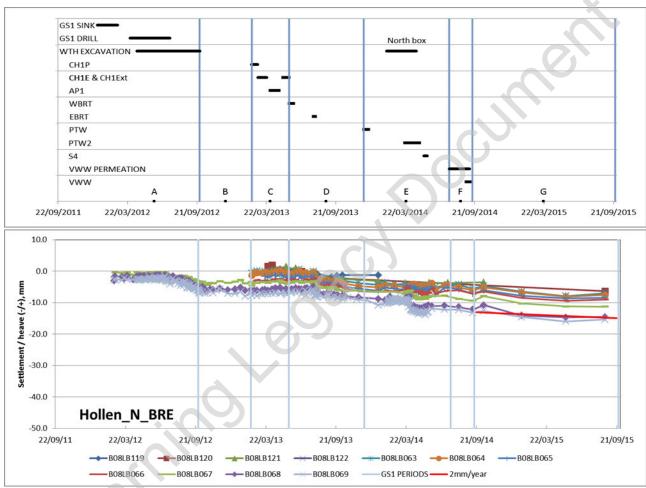
Figure 2: Data time-plot: comparison against 2mm/year settlement rate (long-term)

The points on the north façade of Hollen Street settled up to 12mm at the end of C300 Works. Settlement of ~3mm was recorded due to C421 works prior to BFK monitoring. No change is evident in the settlement during TaM drilling. Small effects associated with the WTH south box, the EB TBM and the WTH north box are visible from the settlement time-plot. It is noted that most of the BRE were installed after the South Box was excavated due to an ongoing re-development of 16-18 Hollen Street. Minor adjustments of up to 4mm were applied to points (B08LB064 to 066) at distances in excess of 40m on the profile plot, based on the observed distribution of movement. There is a potential impact from C422 works following completion of the C300 works.

The overall long term behaviour gives a settlement rate of 2mm/year. By inspection of the profile plot, no slope triggers have been exceeded. The residual risk associated with long-term settlements is considered to be negligible.

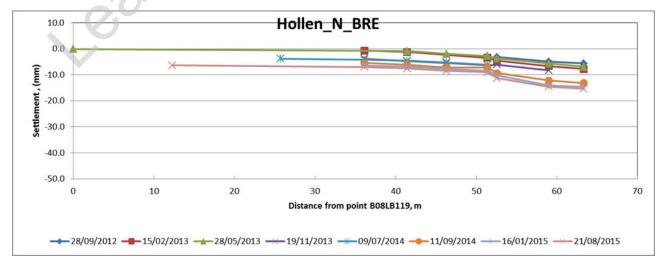
Figure 3: Profile plot: Hollen Street North façade

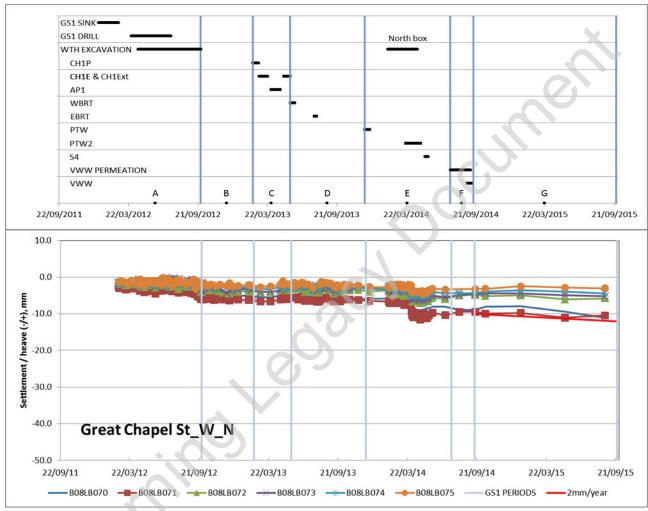
Figure 4: Data time-plot - comparison against 2mm/year settlement rate (long-term)

The points on the west façade of Great Chapel Street settled up to 11mm due to the C300 works. Small effects (~5mm) associated with the WTH South Box and the WTH North Box are visible from the settlement time-plot.

The overall long term behaviour gives a settlement rate of 2mm/year. By inspection of the profile plot, no slope triggers have been exceeded. The residual risk associated with long-term settlements is considered to be negligible.

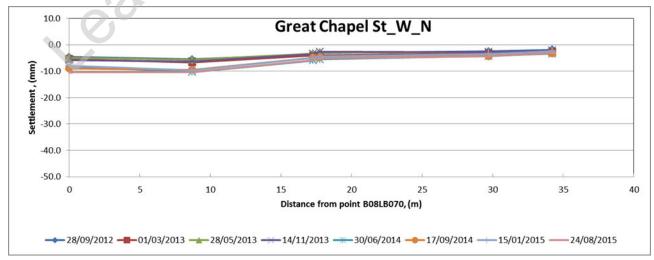
Figure 5: Profile plot: Great Chapel Street North façade

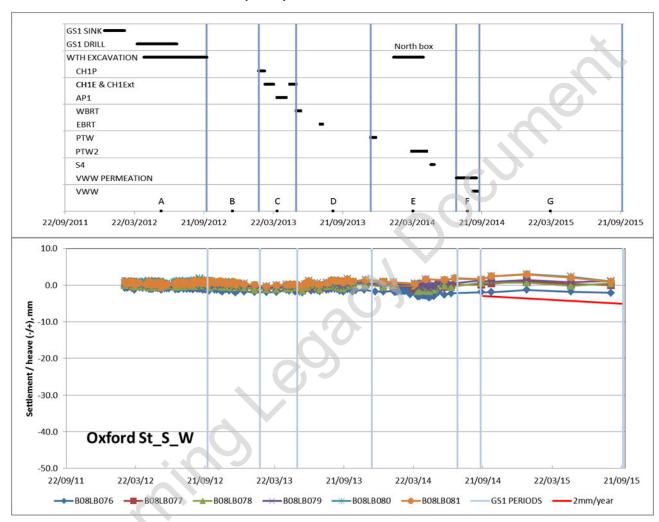
Figure 6: Data time-plot - comparison against 2mm/year settlement rate (long-term)

The points on the south façade of Oxford Street west of Great Chapel Street show negligible movement throughout construction and subsequently in the settlement time-plot.

The overall long term behaviour gives a settlement rate of less than 2mm/year. By inspection of the profile plot, no slope triggers have been exceeded. The residual risk associated with long-term settlements is considered to be negligible.

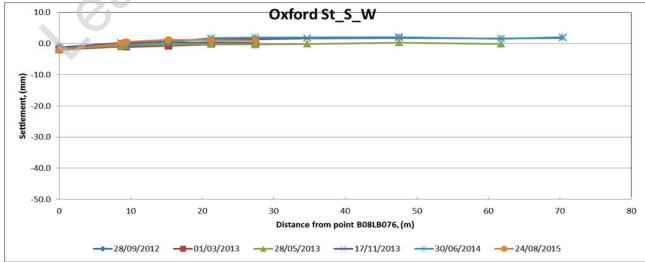
Figure 7: Profile plot: Oxford Street South façade (west)

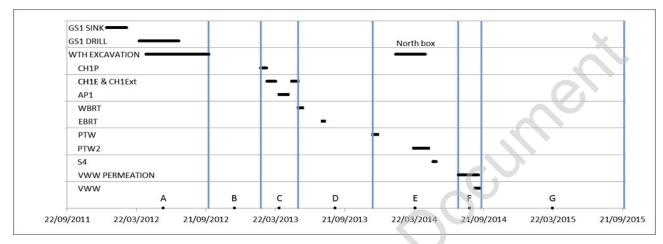
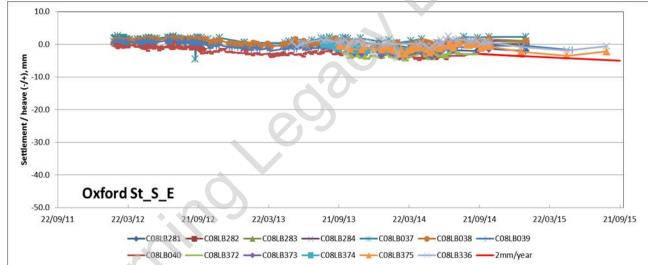
Figure 8: Data time-plot - comparison against 2mm/year settlement rate (long-term)

The points on the south façade of Oxford Street east of Great Chapel Street show negligible movement throughout construction and subsequently in the settlement time-plot.

The overall long term behaviour gives a settlement rate of less than 2mm/year. By inspection of the profile plot, no slope triggers have been exceeded. The residual risk associated with long-term settlements is considered to be negligible.

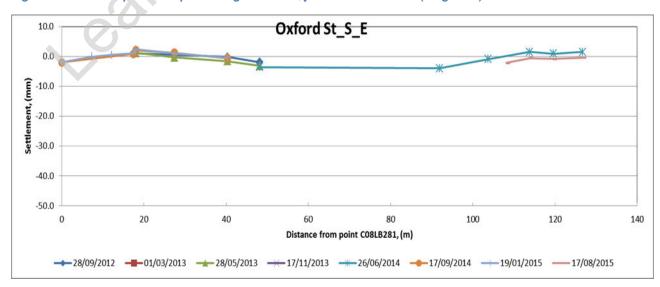
Figure 9: Profile Plot: Oxford Street South façade (east)

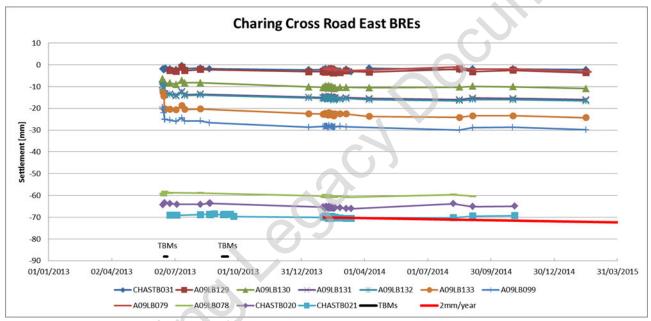
Figure 10: Data time-plot - comparison against 2mm/year settlement rate (long-term)

The points on the façade on east side of Charing Cross Road had settlement of up to 70mm prior to C300 works, attributable to TCRSU works. A small increase in settlement (~6mm) is evident from the first (WB) TBM, and the overall maximum increase in settlement over the whole C300 monitoring period is 10mm. However, no increase in settlement was noted on the points with the greatest settlement from TCRSU works. Hence the impact of C300 works is negligible compared to that from the TCRSU works.

The overall long term rate of settlement is less than 2mm/year. The residual risk associated with long-term settlements is considered to be negligible.

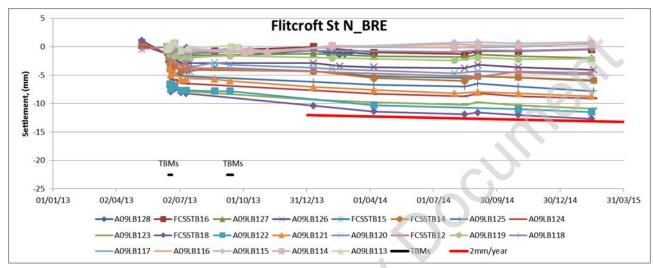
Figure 11: data time-plots - comparison against 2mm/year settlement rate (long-term)

The points on the north façade of Flitcroft Street settled up to 8mm due to the first C300 WB running tunnel drive. There is no visible effect from the second, EB, TBM drive on the settlement time-plot.

The long term behaviour shows a gradual increase to 13mm at a rate of about 2mm/year. By inspection of the profile plot, no slope triggers have been exceeded. The residual risk associated with long-term settlements is considered to be negligible.

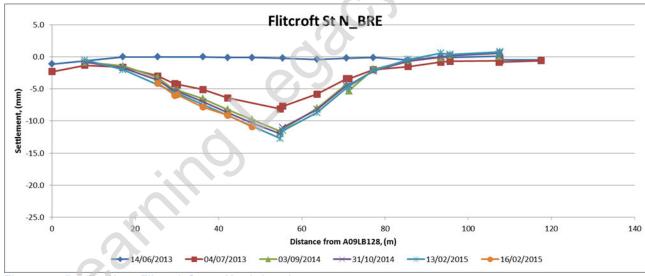
Figure 12: Profile-plot - Flitcroft Street North facade

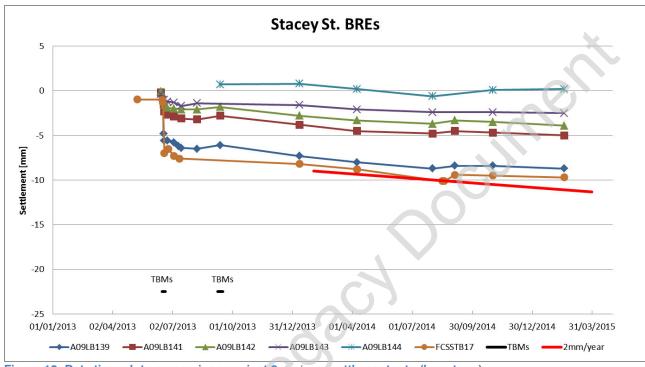
Figure 13: Data time-plot - comparison against 2mm/year settlement rate (long-term)

The points on the west façade of Stacey Street settled up to 8mm due to the first C300 WB running tunnel drive. There is no visible effect from the second, EB, TBM drive on the settlement time-plot.

The long term behaviour shows a gradual increase to 10mm at a rate of less than 2mm/year. By inspection of the profile plot, no slope triggers have been exceeded. The residual risk associated with long-term settlements is considered to be negligible.

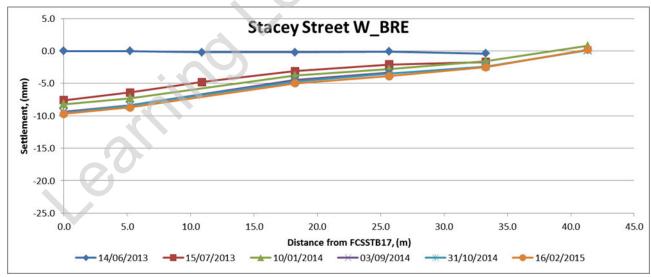
Figure 14: Profile Plot: Stacey Street West facade

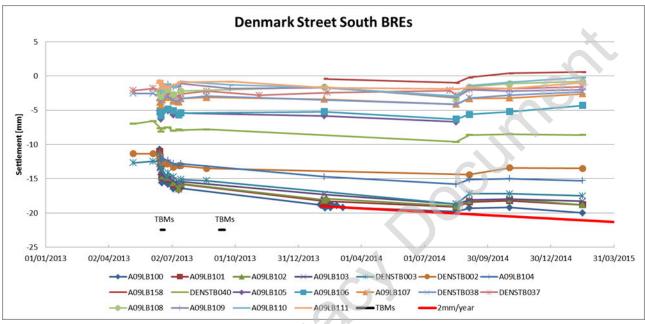
Figure 15: Data time-plot - comparison against 2mm/year settlement rate (long-term)

The points on the façade on south side of Denmark Street had settlement of up to 13mm prior to C300 works, attributable to TCRSU works. A small effect is evident from the first (WB) TBM, but the maximum increase in settlement is 5mm. Hence the impact of C300 works is negligible compared to that from the TCRSU works.

The overall long term rate of settlement is less than 2mm/year, with a maximum recorded movement of 20mm, an increase of \sim 7mm on the TCRSU movements. The residual risk associated with long-term settlements is considered to be negligible.

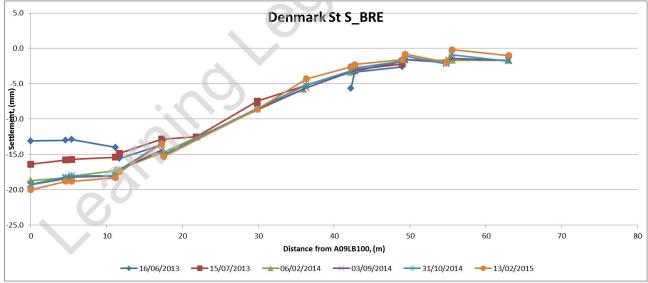
Figure 16: Profile Plot: Denmark St. South facade

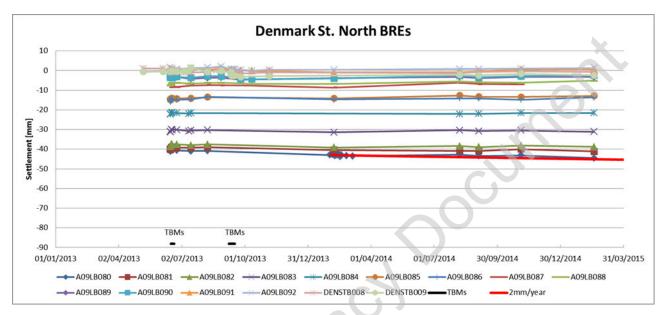
Figure 17: Data time-plot - comparison against 2mm/year settlement rate (long-term)

The points on the façade on north side of Denmark Street had settlement of up to 40mm prior to C300 works, attributable to TCRSU works. No effect is evident from the first (WB) or second (EB) TBM. The maximum increase in settlement is 5mm over the duration of the C300 monitoring. Hence the impact of C300 works is negligible compared to that from the TCRSU works.

The overall long term rate of settlement is less than 2mm/year. The residual risk associated with long-term settlements is considered to be negligible.

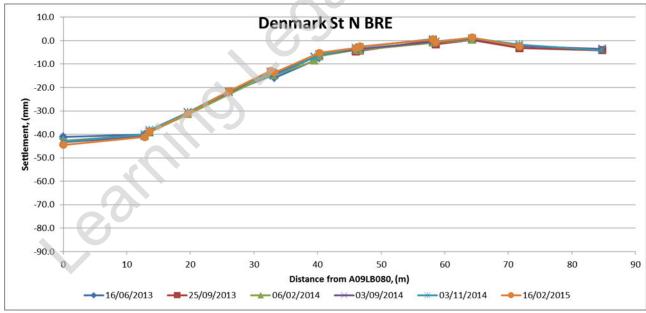
Figure 18: Profile Plot: Denmark Street North facade

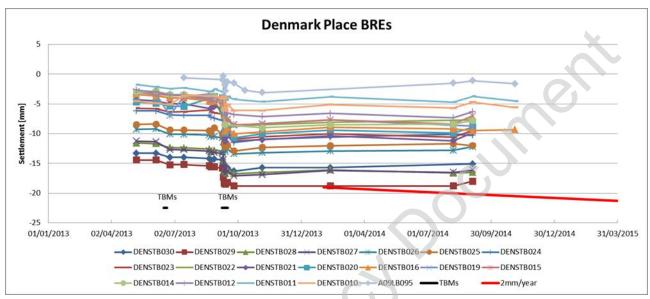
Figure 19: Data time-plot - comparison against 2mm/year settlement rate (long-term)

The points on the façade on south side of Denmark Place had settlement of up to 14mm prior to C300 works, attributable to TCRSU works. A small effect is evident from the second (EB) TBM, but the maximum increase in settlement is ~3mm. Hence the impact of C300 works is negligible compared to that from the TCRSU works.

The overall long term rate of settlement is less than 2mm/year, with a maximum recorded movement of 18mm, an increase of ~4mm on the TCRSU movements. The residual risk associated with long-term settlements is considered to be negligible.

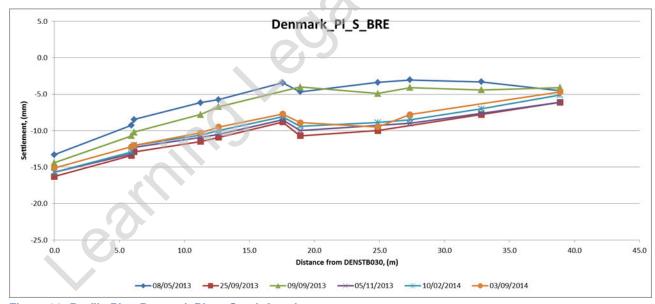
Figure 20: Profile Plot: Denmark Place South facade

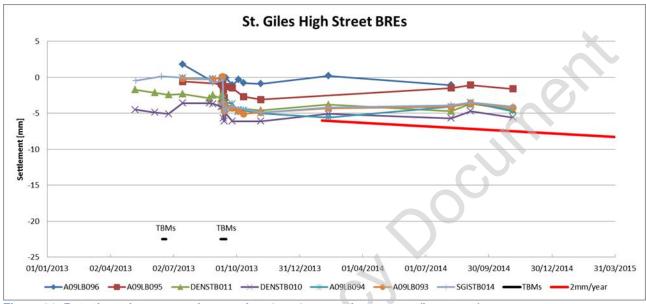
Figure 21: Data time-plot - comparison against 2mm/year settlement rate (long-term)

The points on the façade on west side of St. Giles High Street settled by up to 6mm during the second (EB) TBM, with negligible increase thereafter.

The overall long term rate of settlement is less than 2mm/year. The residual risk associated with long-term settlements is considered to be negligible.

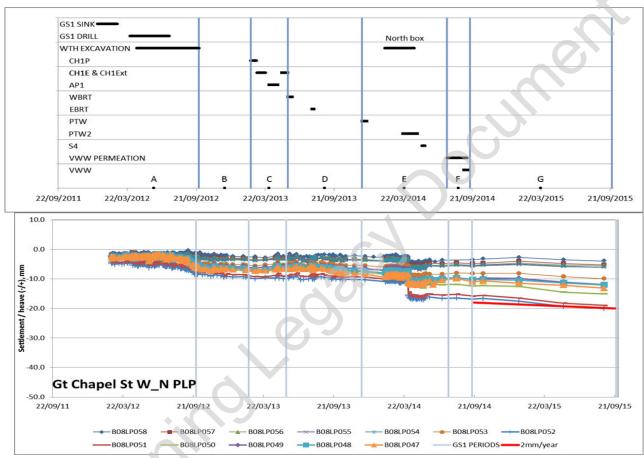
Figure 22: Data time-plot - comparison against 2mm/year settlement rate (long-term)

The points on the west kerb line of Great Chapel Street (north of Hollen Street) settled up to 5mm prior to C300 works, from the installation of diaphragm walls and piles for the WTH and Over Site Development by C421. Settlement increased by about 3mm by the end of the WTH South Box excavation. A somewhat larger effect is evident in the settlement time plot associated with the WTH north box increasing the maximum settlement by about 8mm to 18mm. Post-construction, the overall long term behaviour gives a settlement rate of about 2mm/year.

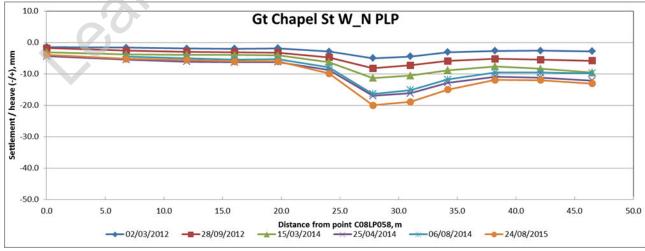
Figure 23 Profile Plot: Great Chapel Street PLP

By inspection of the profile plot, significant slopes have developed with a localised feature produced from C421 works and persisting and increasing throughout C300 works and post-construction. The development of slopes along this transect are shown on Figure 23. Two slopes (B08LP054 – B08LP051 and B08LP055 – B08LP052) approached the Amber trigger level (1mm/m) during excavation of the WTH north box and have subsequently exceeded the trigger due to post-construction movements.

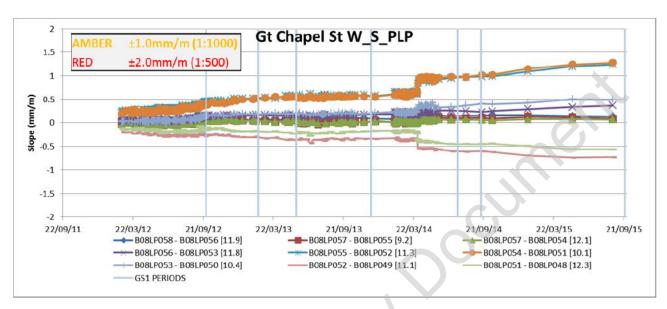
Figure 24 Slope time plot: Great Chapel Street PLP

The rate of settlement is about 2mm/year and as such the residual risk associated with long-term settlements is considered to be acceptably low.

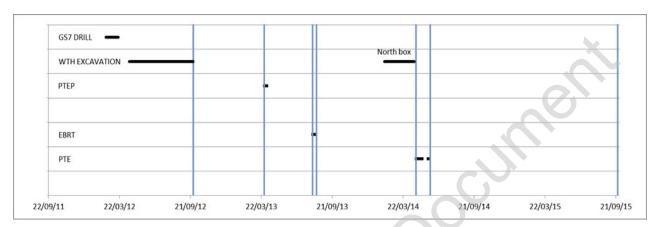
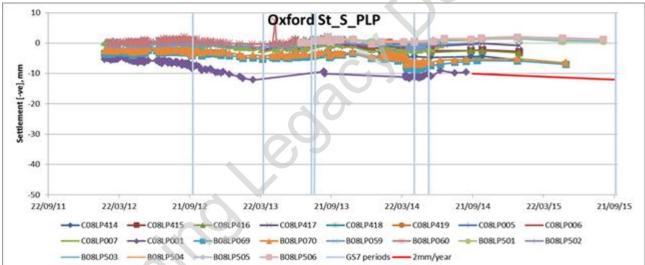
Figure 25: Data time-plot - comparison against 2mm/year settlement rate (long-term)

The points on the south kerb line of Oxford Street show up to 6mm settlement prior to C300 works from the installation of diaphragm walls and piles for the WTH and Over Site Development. The point with maximum movement continued to settle during excavation of the South Box and subsequently reaching a maximum of 12mm, some 6 months later. There was negligible movement on this point throughout the remainder of construction and subsequently. A minor increase in the settlement of 2 points during excavation of the North Box (B08LP069 and B08LP070) is evident time-plot and in the profile plot. By inspection, no slope triggers have been exceeded.

The overall long term behaviour gives a settlement rate of less than 2mm/year. The residual risk associated with long-term settlements is considered to be negligible.

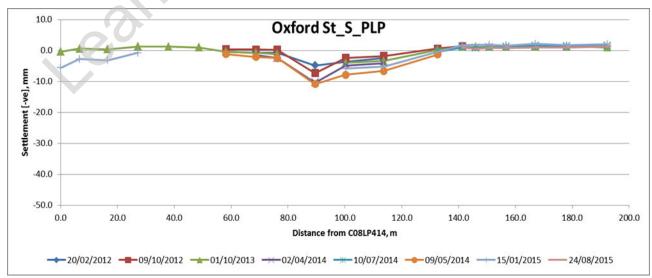
Figure 26 Profile Plot: Oxford Street South PLP

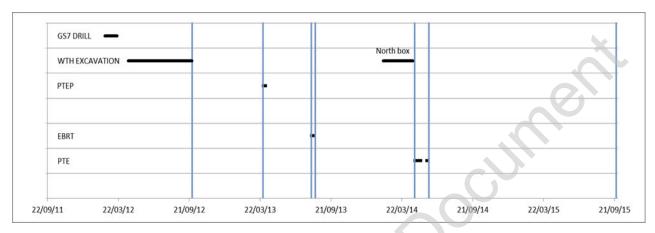
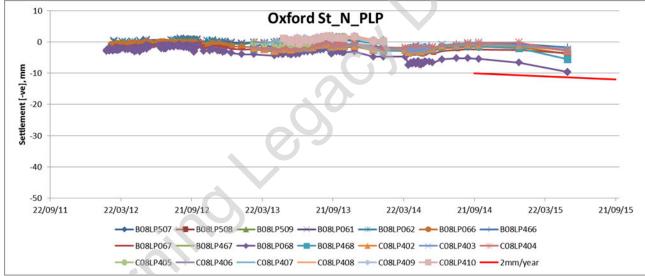
Figure 27 Data time-plot - comparison against 2mm/year settlement rate (long-term)

The points on the north kerb line of Oxford Street show up to 3mm settlement prior to C300 works during the installation of diaphragm walls and piles for the WTH and Over Site Development. A minor increase in the settlement of 2 points after excavation of the North Box (B08LP068 and B08LP468) is evident in both the time-plot and the profile plot. It is not clear how localised movements of 1 or 2 points at distances over 30m from the WTH North Box could be associated with these works. An enlarged plot of the central section of the profile is shown in Figure 28. It is noted that there were a lot of street works undertaken during this period.

The overall long term behaviour generally has a settlement rate of less than 2mm/year. The residual risk associated with long-term settlements is considered to be negligible.

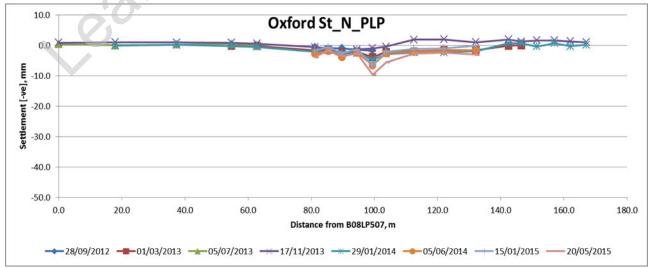
Figure 28 Profile Plot: Oxford Street North PLP

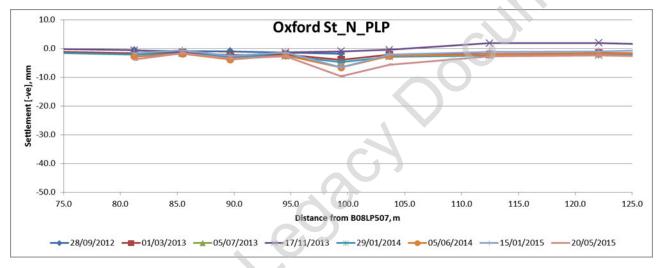
Figure 29 Profile Plot: Oxford Street North PLP (central section)

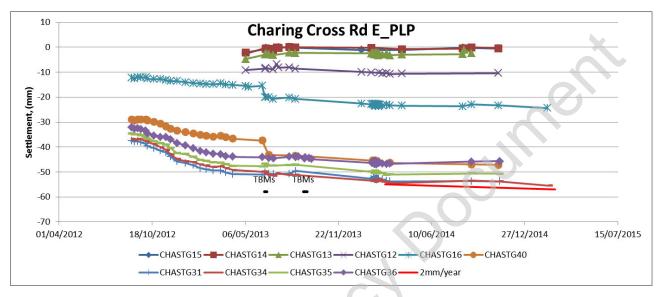
Figure 30 Data time-plot - comparison against 2mm/year settlement rate (long-term)

The points on the kerb line on east side of Denmark Place had settlement of up to 40mm prior to C300 works, attributable to TCRSU works. A small effect is evident from the first (WB) TBM, but the maximum increase in settlement is ~7mm. Hence the impact of C300 works is negligible compared to that from the TCRSU works.

The overall long term rate of settlement is less than 2mm/year, with a maximum recorded movement of \sim 70mm. The residual risk associated with long-term settlements is considered to be negligible.

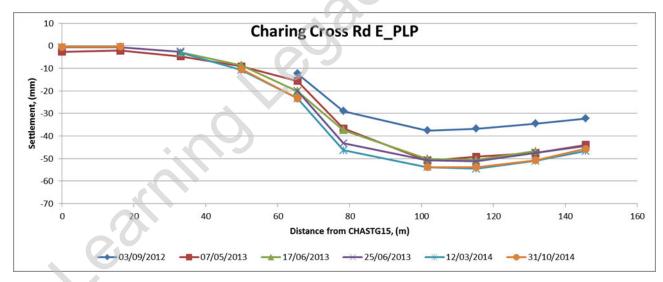
Figure 31 Profile Plot: Charing Cross Road East PLP

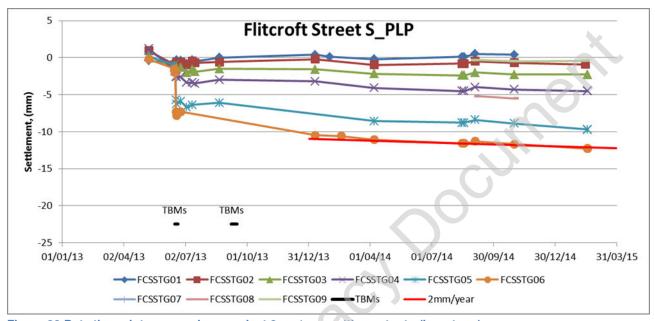
Figure 32 Data time-plot - comparison against 2mm/year settlement rate (long-term)

The points on the south kerb line of Flitcroft Street settled up to 8mm due to the first C300, WB, running tunnel drive. There is no visible effect from the second, EB, TBM on the settlement time-plot.

The long term behaviour shows a gradual increase to 13mm at a rate of about 2mm/year. The residual risk associated with long-term settlements is considered to be negligible.

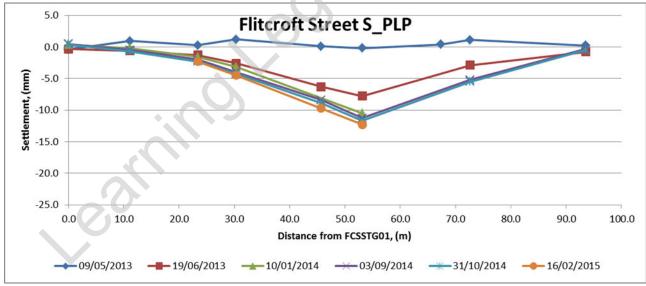
Figure 33 Profile Plot: Flitcroft Street South PLP

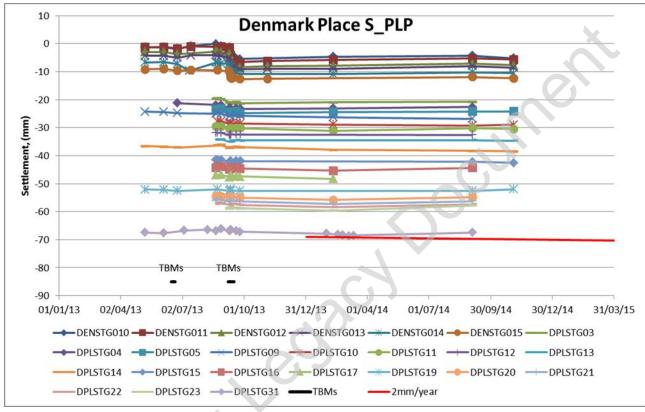
Figure 34 Data time-plot - comparison against 2mm/year settlement rate (long-term)

The points on the kerb line on south side of Denmark Place had settlement of up to 70mm prior to C300 works, attributable to TCRSU works. A small effect is evident from the second (EB) TBM, but the maximum increase in settlement is ~5mm. Hence the impact of C300 works is negligible compared to that from the TCRSU works.

The overall long term rate of settlement is less than 2mm/year, with a maximum recorded movement of ~70mm. The residual risk associated with long-term settlements is considered to be negligible.

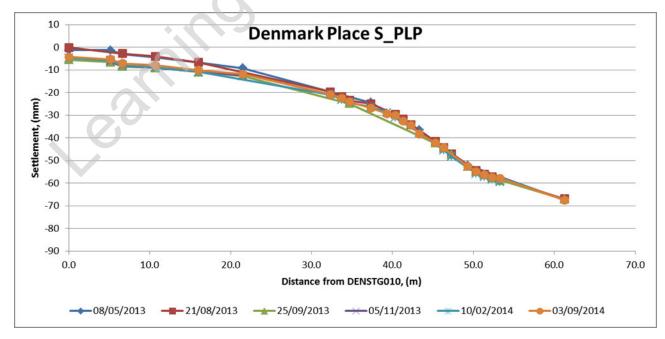
Figure 35 Profile Plot: Denmark Street South PLP

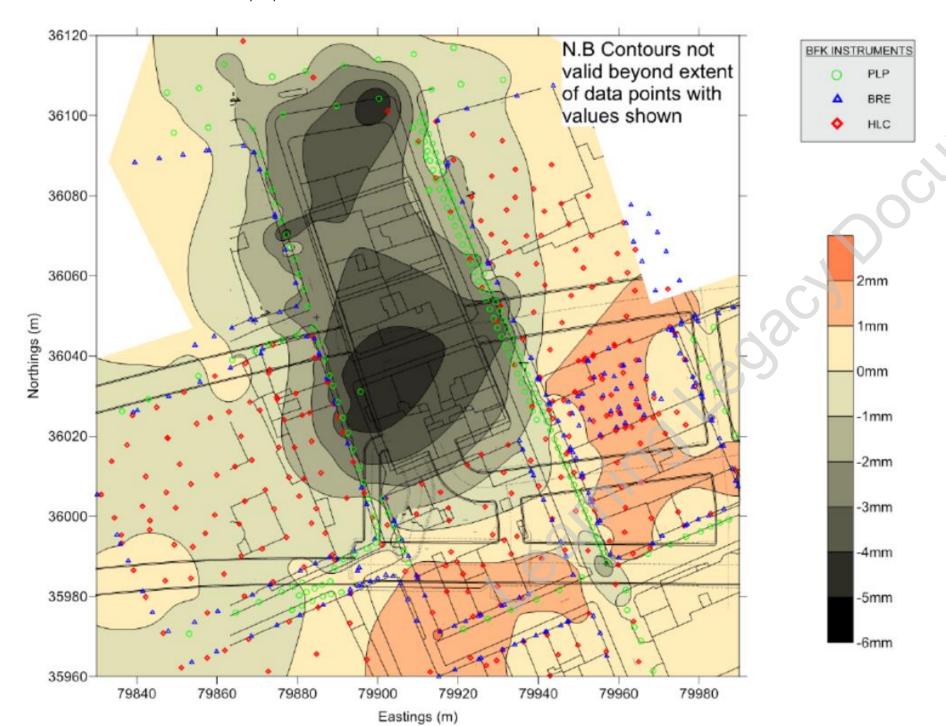
Appendix 2. Initial Settlement adjustments and summary of TCRSU works progress West Area – C421 data 08 & 09/02/12

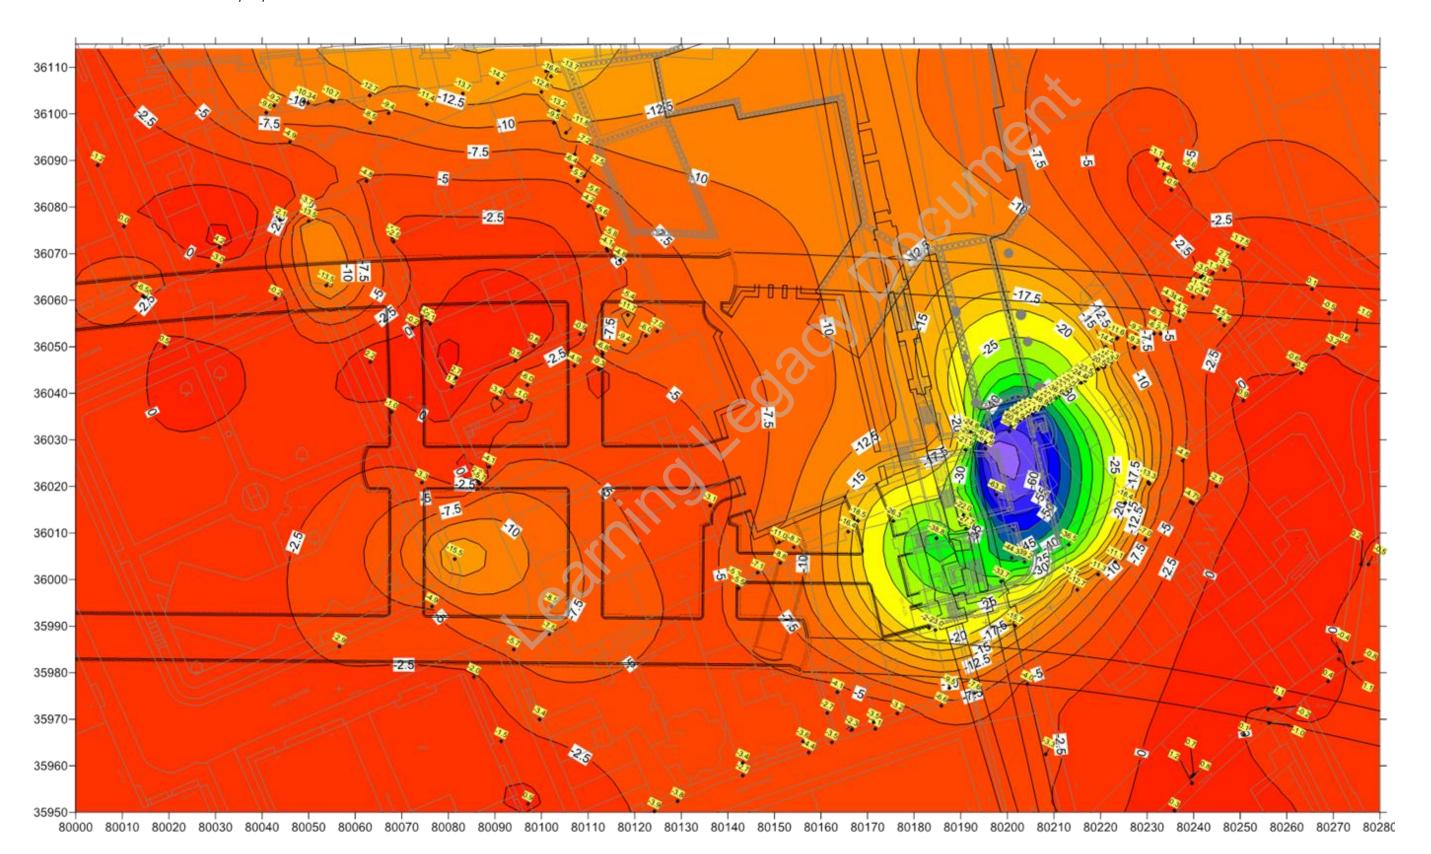
East Area - TCRSU data 24/04/13

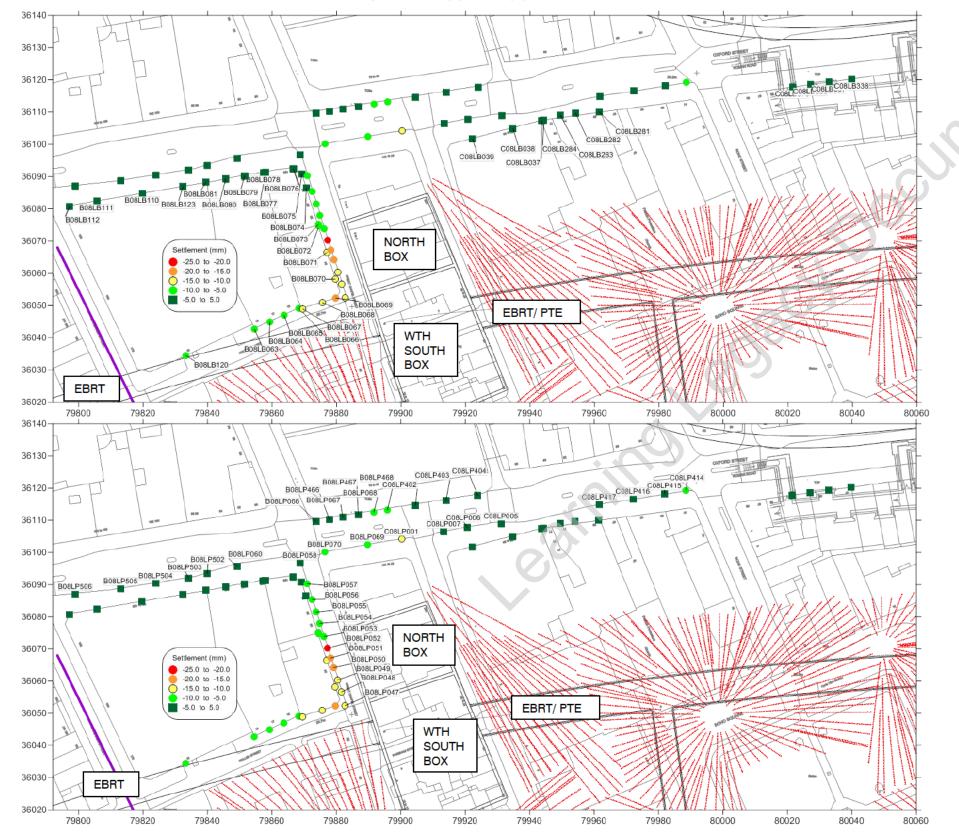
West Area: Location and Final Settlement for data presented (a) BRE; (b) PLP

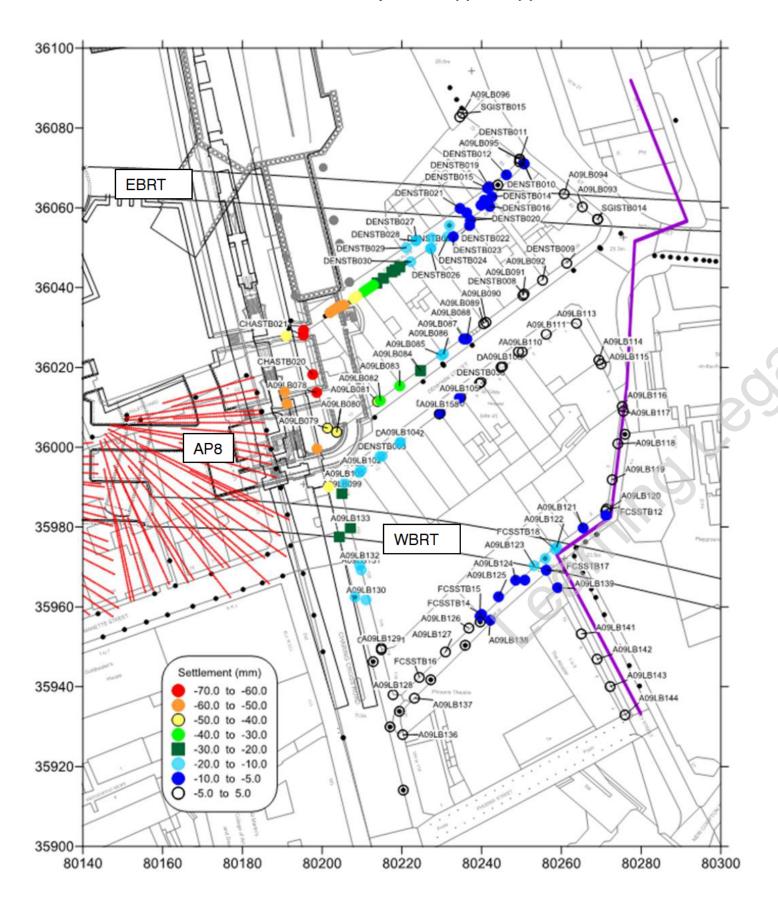
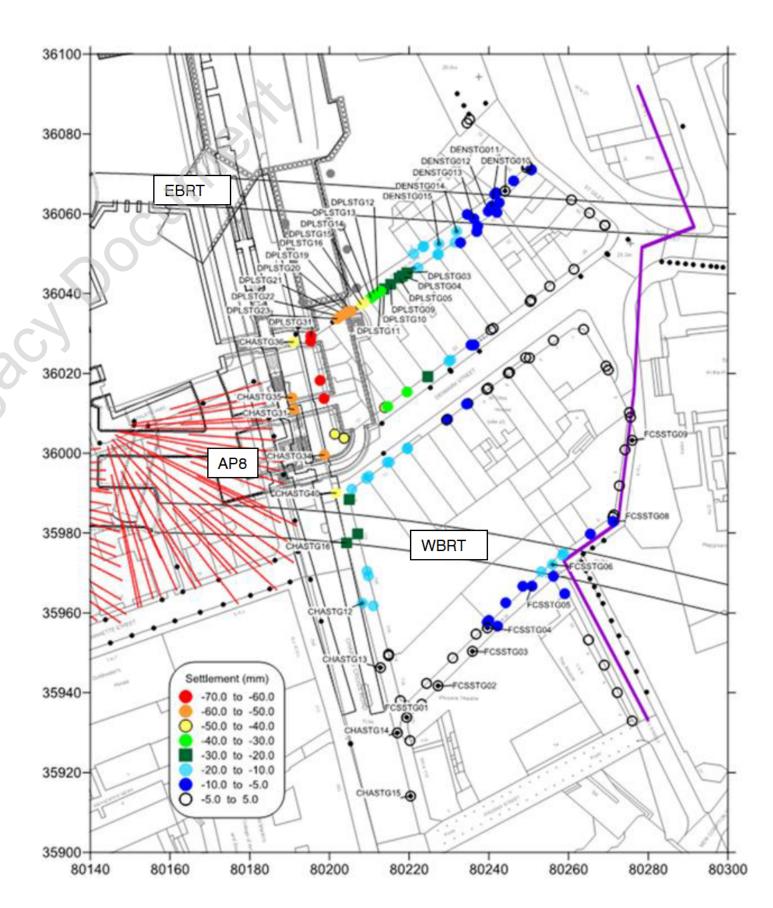
East Area: Location and Final Settlement for data presented (a) BRE; (b) PLP
