<b>C310 THAMES TUNNEL REPORT</b>		
EMPLOYER	CROSSRAIL	eB NO	C310-HTM-C-RGN-CR148-50035	Rev 2.0
TITLE	Monitoring Close-Out Report for North Kent Line (NKL)

The purpose of this report is to summarise the monitoring data related to the Network Rail North Kent Line (NR24), running adjacent to the Plumstead Portal construction activities. In addition this data is utilised to demonstrate that no further ground movements due to the nature of ongoing and further C310 works would be expected to impact the Network Rail assets.

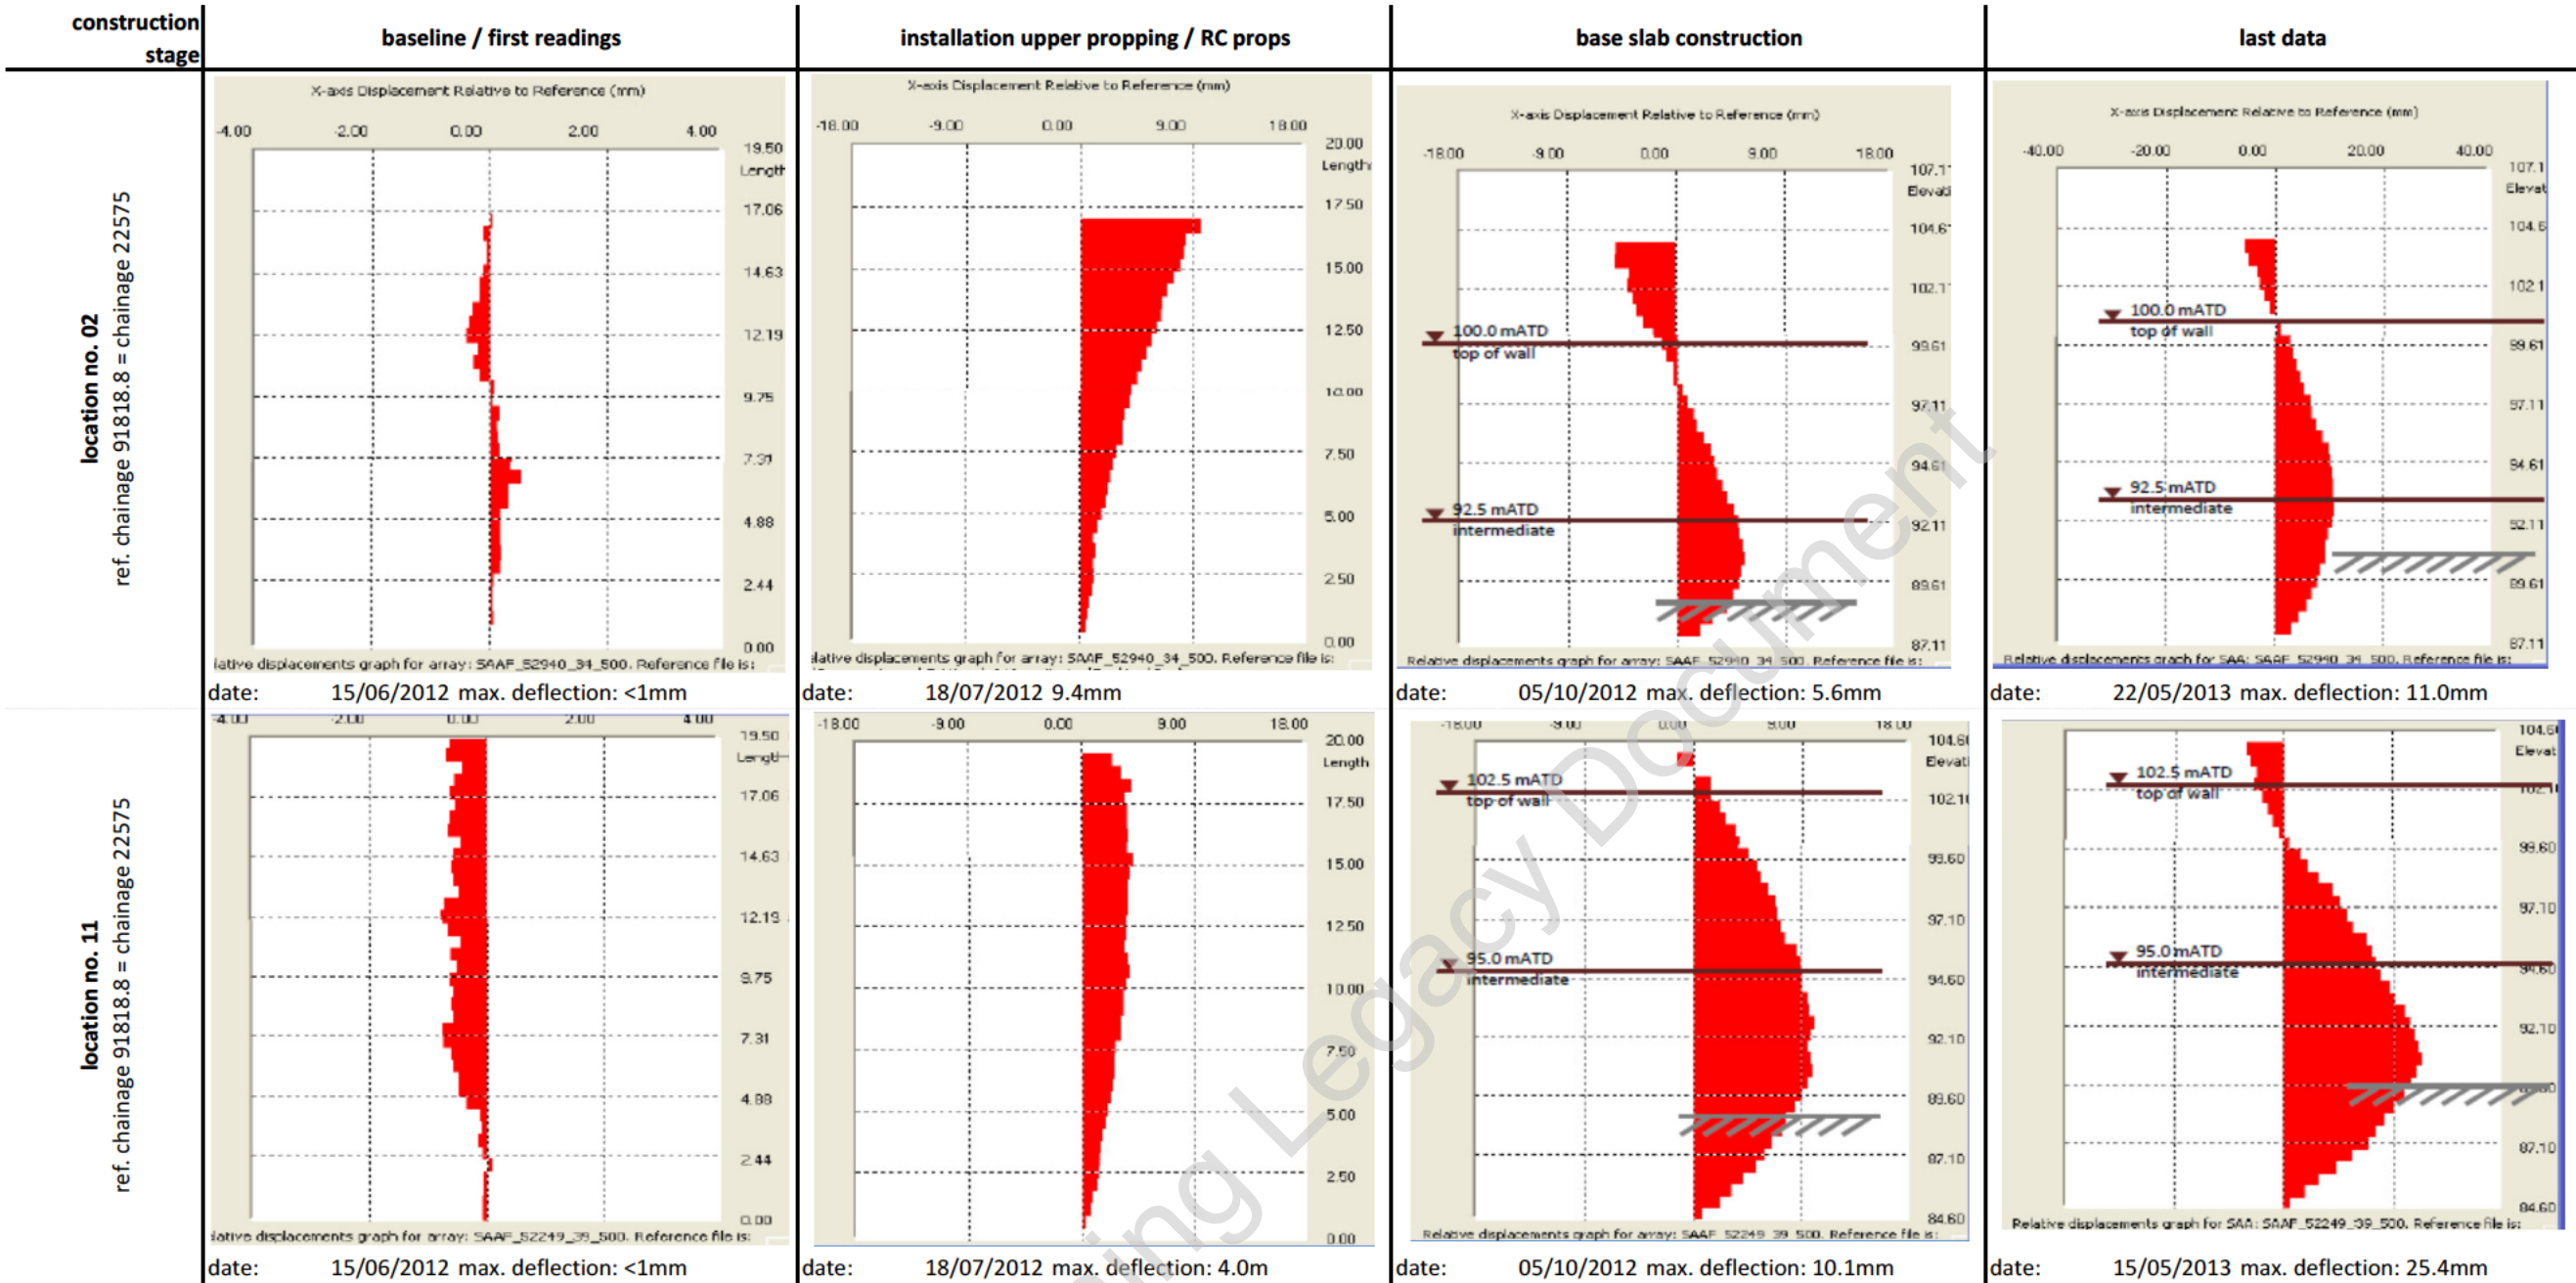
SAA Monitoring data – Extract from C310-HTM-C-RGN-CR148-50028

- Shape Accelerator Array (SAA) - Appendix 01 shows the last readings of the retaining wall adjacent to the track. The green trigger value is 43mm. A maximum deflection of 25.4mm was recorded, no trigger value was exceeded.

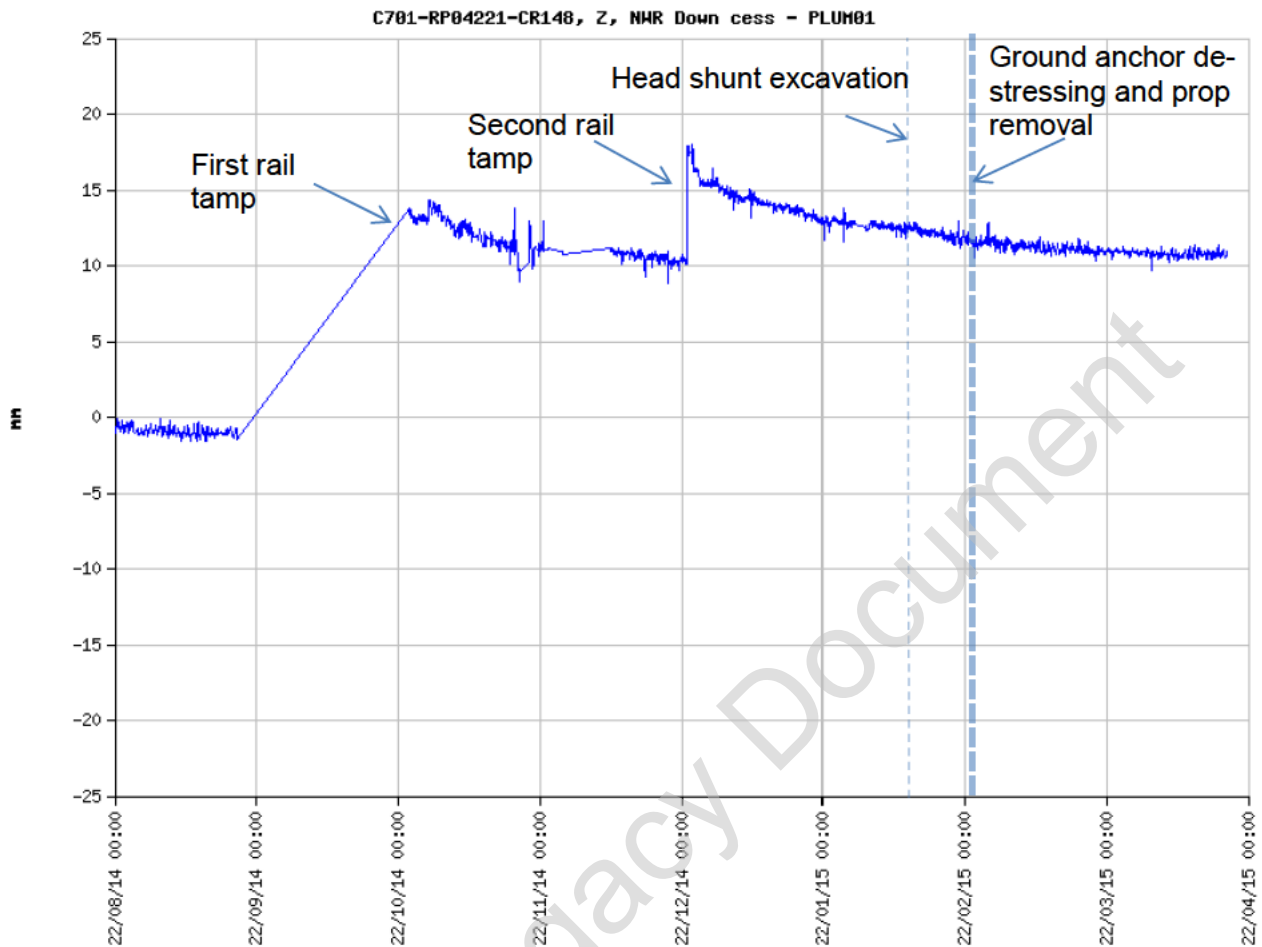
**Prop removal/ground anchor de-stressing/head shunt excavation (Down Line)**

- Prism located on Down line cess rail, close to location of the head shunt excavation and prop removal/ground anchor de-stressing
- Down line track replaced in August 2014. Prisms installed and baselined following this.

- Prism shows clearly the two steps and subsequent settlement caused by the rail works on the possessions of the 19<sup>th</sup> October and 21<sup>st</sup> December 2014

- Slight possibility of a further trend discernable related to the removal of the props and de-stressing of ground anchors on the 24-27<sup>th</sup> of February. This is very small however and is within the monitoring accuracy. This potential settlement has ceased and the overall trend is still due to the rail works and not related to CRL works. Also current trends indicate all movements have stabilised

The heave and subsequent settlement of the track prisms that is observed in the Down line is attributed to the rail tamps on the 19<sup>th</sup> of October and 21<sup>st</sup> of December 2014. This can be corroborated by checking a prism from the same array on the Up line over the same period. Since no movements are recorded in the Up line at the time of the movements observed on the down line the heave can only be attributed to rail works as opposed to works occurring on the CRL work site.

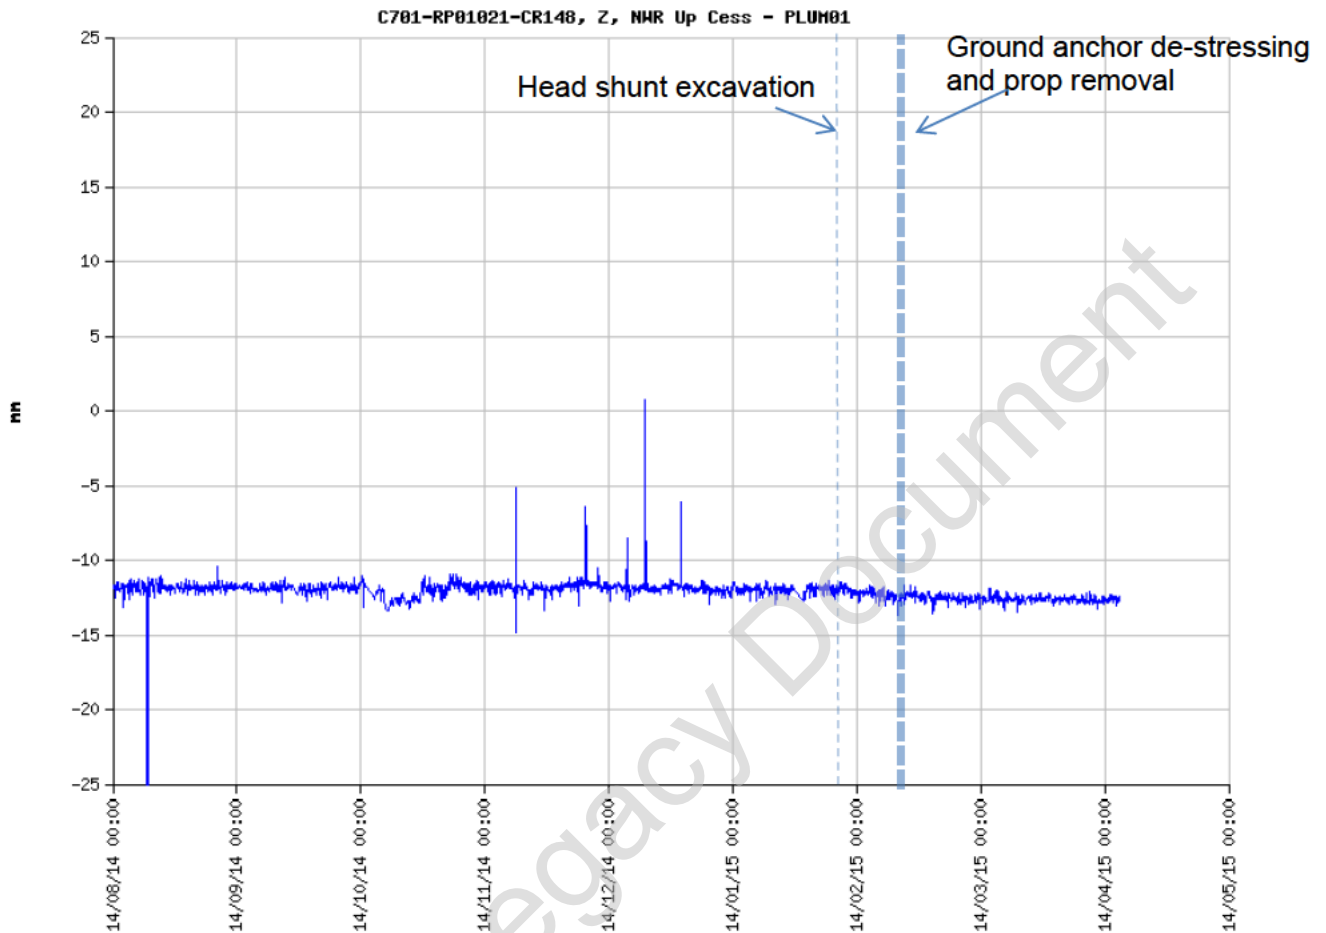
**Prop removal/ground anchor de-stressing/head shunt excavation (Up Line)**

- Prism located on Up line cess rail adjacent to RP04221 on previous page, close to location of the head shunt excavation and prop removal/ground anchor de-stressing

- Prism starting at -12mm as the Up Line was not replaced when along with the Down in August. Settlement to date is a reflection of earlier works. This will be addressed in the contractor's close out report.

- Prism shows no discernable trend compared to the down line on the same array indicating that the movements observed are due to the track works and not CRL related works. If the settlement observed on the down line were due to CRL construction activity these movements would be visible on the up line also.

- Slight possibility of a further trend discernable related to the removal of the props and de-stressing of ground anchors on the 24-27<sup>th</sup> of February. This is very small however and is within the monitoring accuracy. This potential settlement has ceased and the overall trend is still due to the rail works and not related to CRL works. Also current trends indicate all movements have stabilised

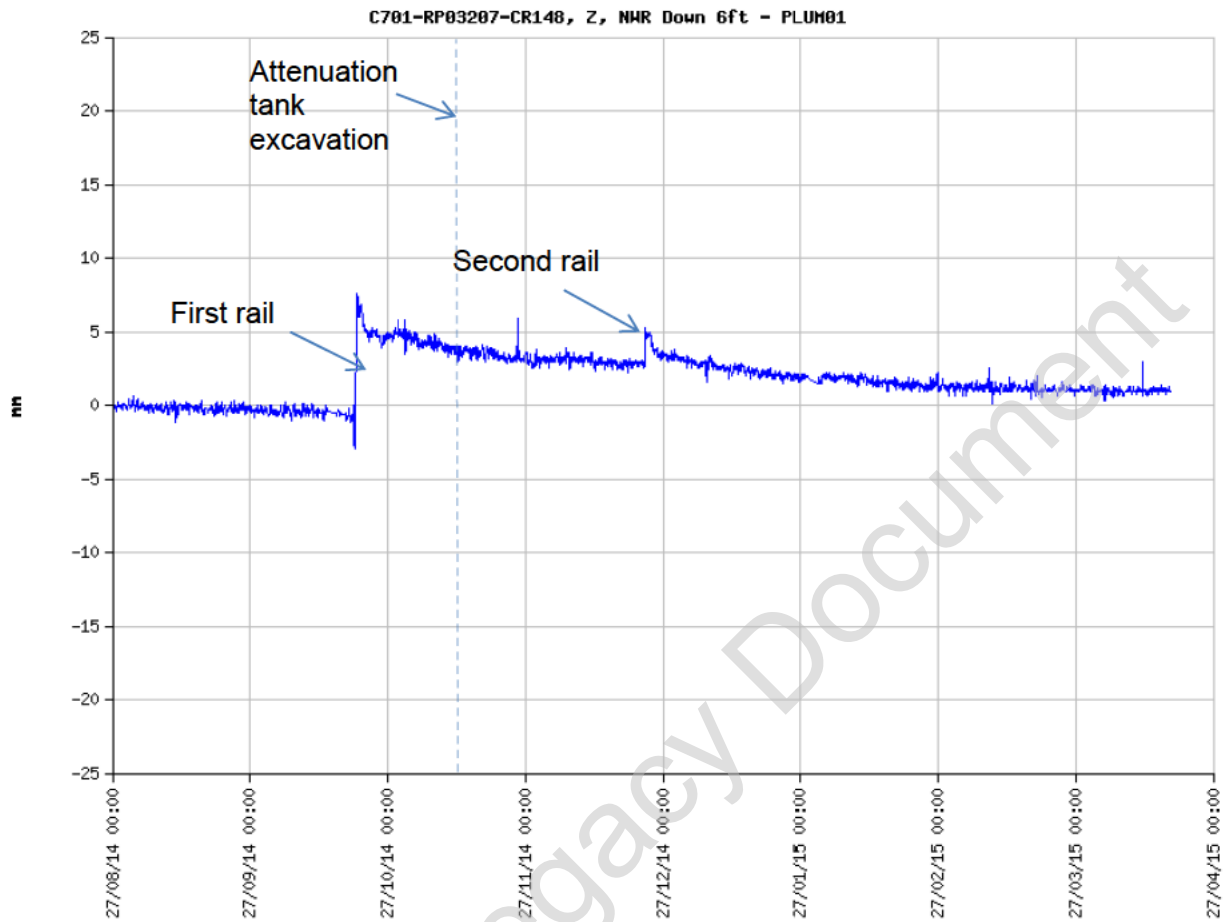
### Attenuation tank removal

- Prism located on Down line 6ft rail, close to location of the attenuation tank excavation.
- Prism shows clearly the two steps and subsequent settlement caused by the rail works on the possessions of the 19<sup>th</sup> October and 21<sup>st</sup> December 2014
- Current trends indicate all movements have stabilised.
- The excavation of the attenuation tank on the 18<sup>h</sup> of November does not seem to have affected the track.

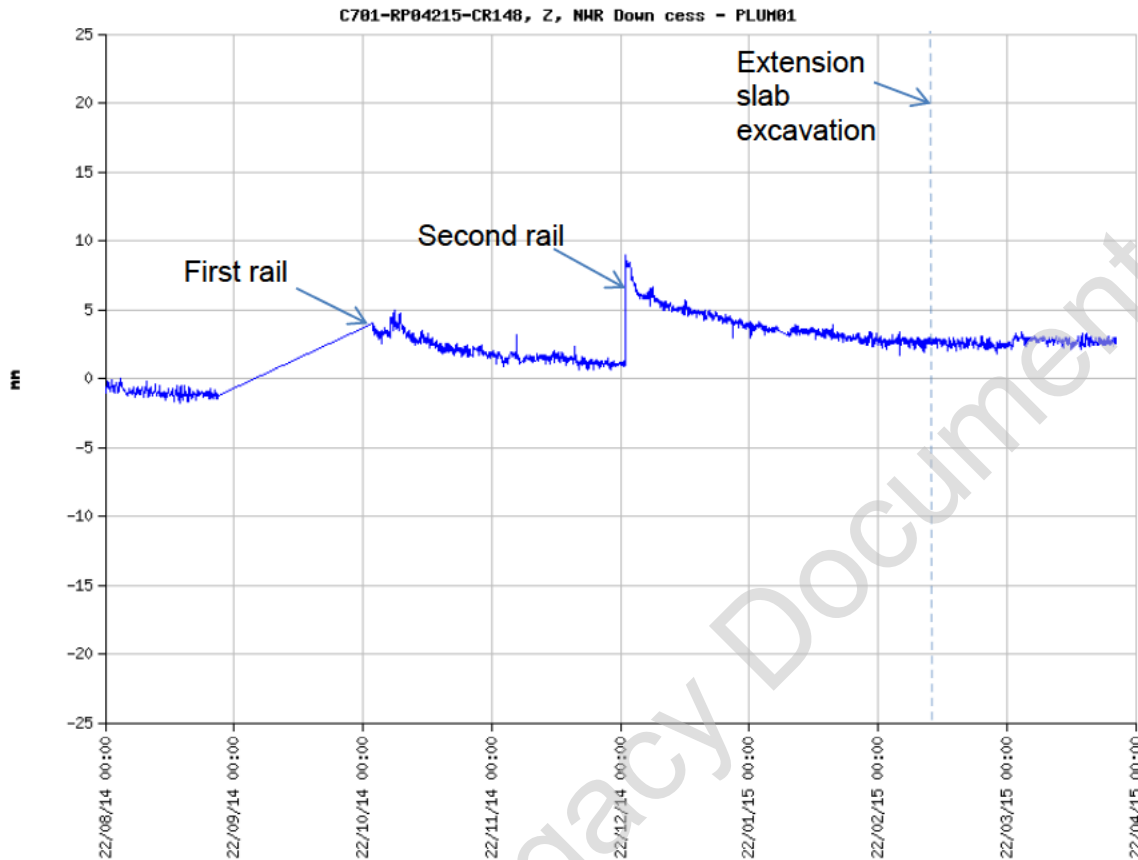
### Extension slab excavation

- Prism located on Down line cess rail, close to location of the extension slab excavation.
- Prism shows clearly the two steps and subsequent settlement caused by the rail works on the possessions of the 19<sup>th</sup> October and 21<sup>st</sup> December 2014
- Current trends indicate all movements have stabilised
- The excavation of the extension slab on the 2<sup>nd</sup> of March does not seem to have affected the track

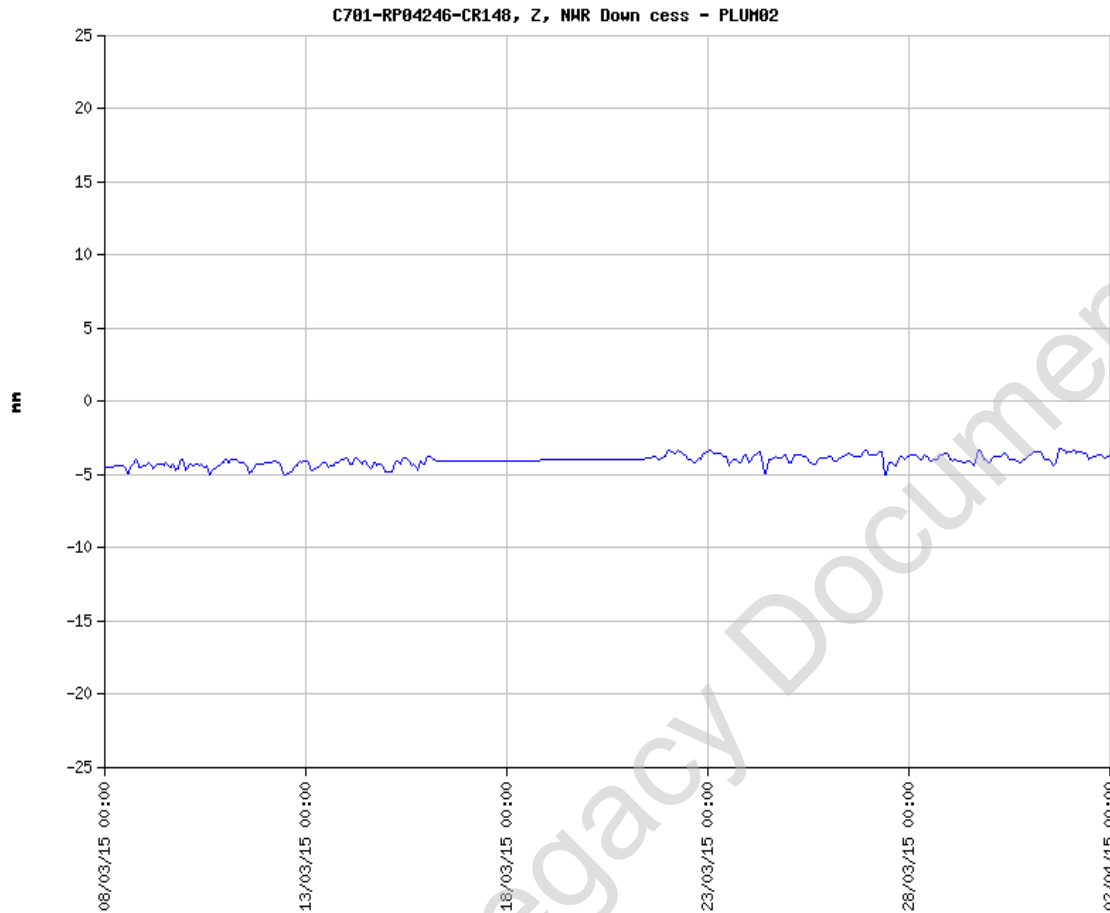
**Asset protection barrier post removal**

- Prism located on Down line cess rail, close to location of asset protection barrier post removal works.
- The works were carried out on the weekend of the 21st/22nd march 2015.
- The data shows that the tracks did not move in response to these works.

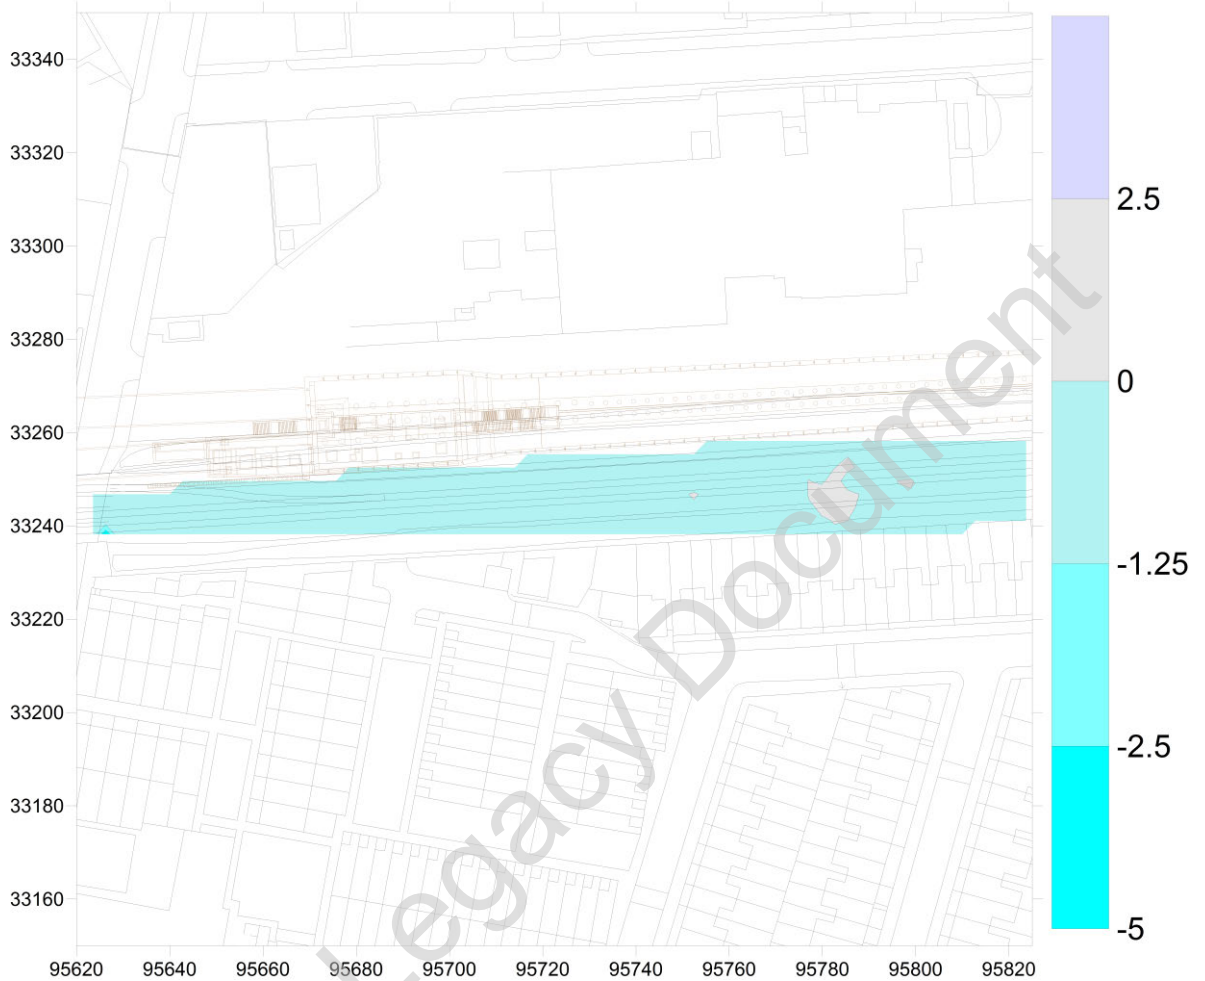
**Differential Movement Z (mm) from February 2015 to March 2015**

- Daily median of settlement recorded between February and March 2015
- Any movements observed within the monitoring accuracy of the system (+/- 2mm)

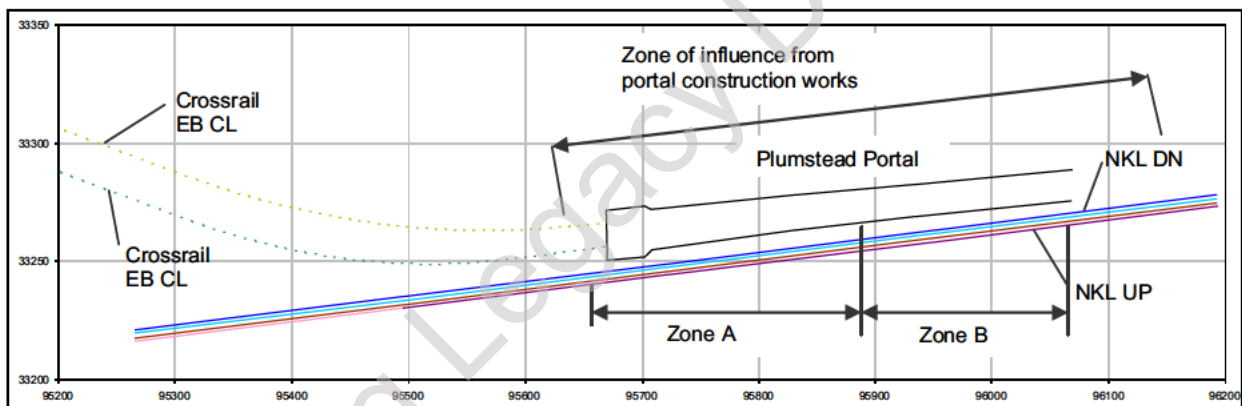
- DN N - North Kent Line Down Line Near Rail
- DN F - North Kent Line Down Line Far Rail
- UP N - North Kent Line Up Line Near Rail
- UP F - North Kent Line Up Line Far Rail

'Near' and 'Far' is in reference to distance from the Crossrail works.

**Figure 1 – General arrangement of the NKL Up and Down lines, Crossrail works and zone of influence of the portal construction works. Zone A and Zone B indicate the extent of diaphragm wall construction and secant pile wall construction respectively.**

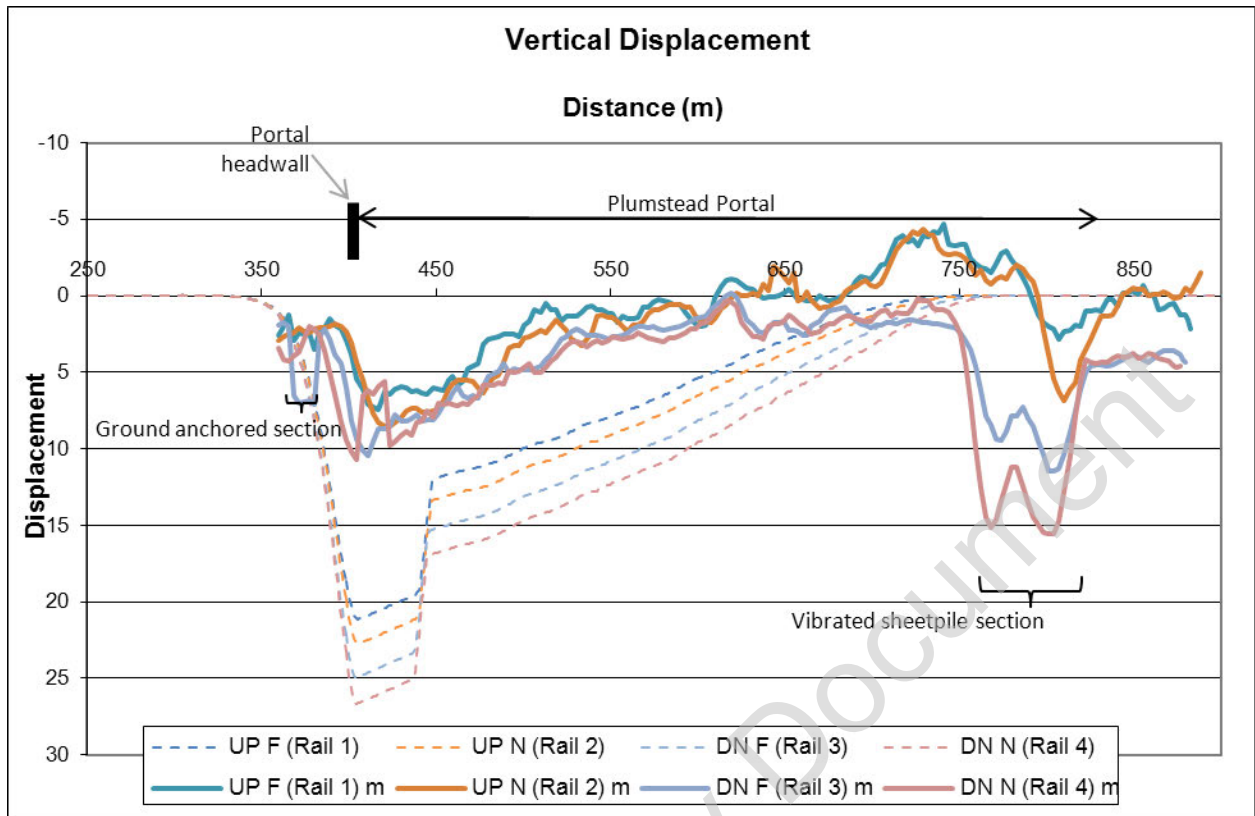
The predicted movements given in Figure 2 represent the maximum calculated movements (dashed lines), including the effects of wall installation. Measured displacements of the rails, as of December 2012 (continuous lines), were taken after substantial completion of Plumstead Portal but before the launch of the westbound TBM drive.

**Figure 2 - Calculated 'greenfield' vertical displacements and measured vertical displacements of NKL rails due to construction of Plumstead Portal**

Suffix 'm' is in reference to monitored movements (December 2012). Trend lines for a 5 point rolling average have been indicated.

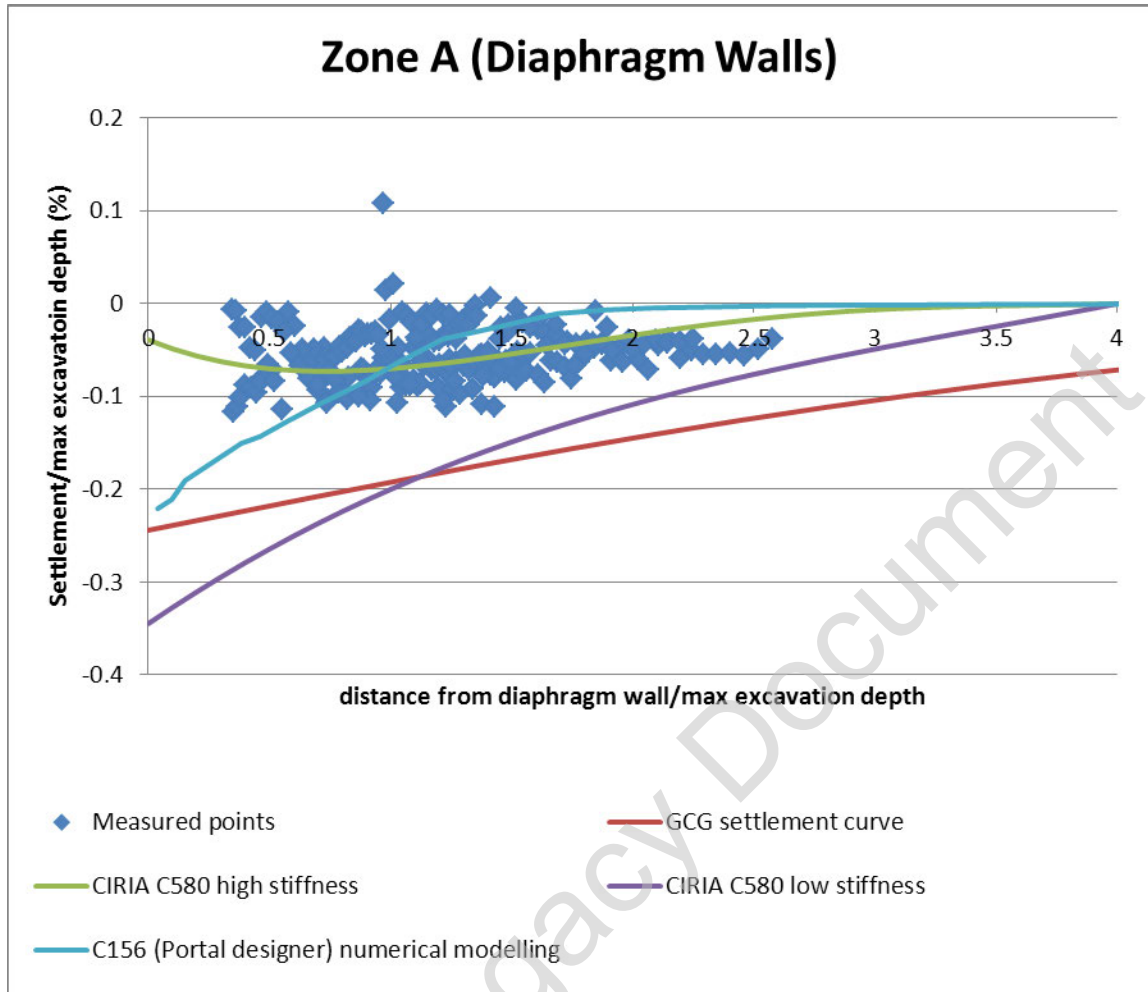
The figures present settlement normalised by depth of excavation for all the monitored points behind the diaphragm walls and secant pile walls. Actual ground movement values and an extract from the I&M drawing showing the general layout of the instrumentation are shown in Appendix C. Other curves giving predicted deflection are shown for comparison. Shapes of the trend lines in Figure 3 and 4 best fits CIRIA C580 high stiffness curve.

**Figure 3 – Plot showing settlements along south diaphragm wall of Plumstead Portal normalised by depth of excavation and comparison against various ground movement curves. The extent of Zone A is shown on Figure 1.**

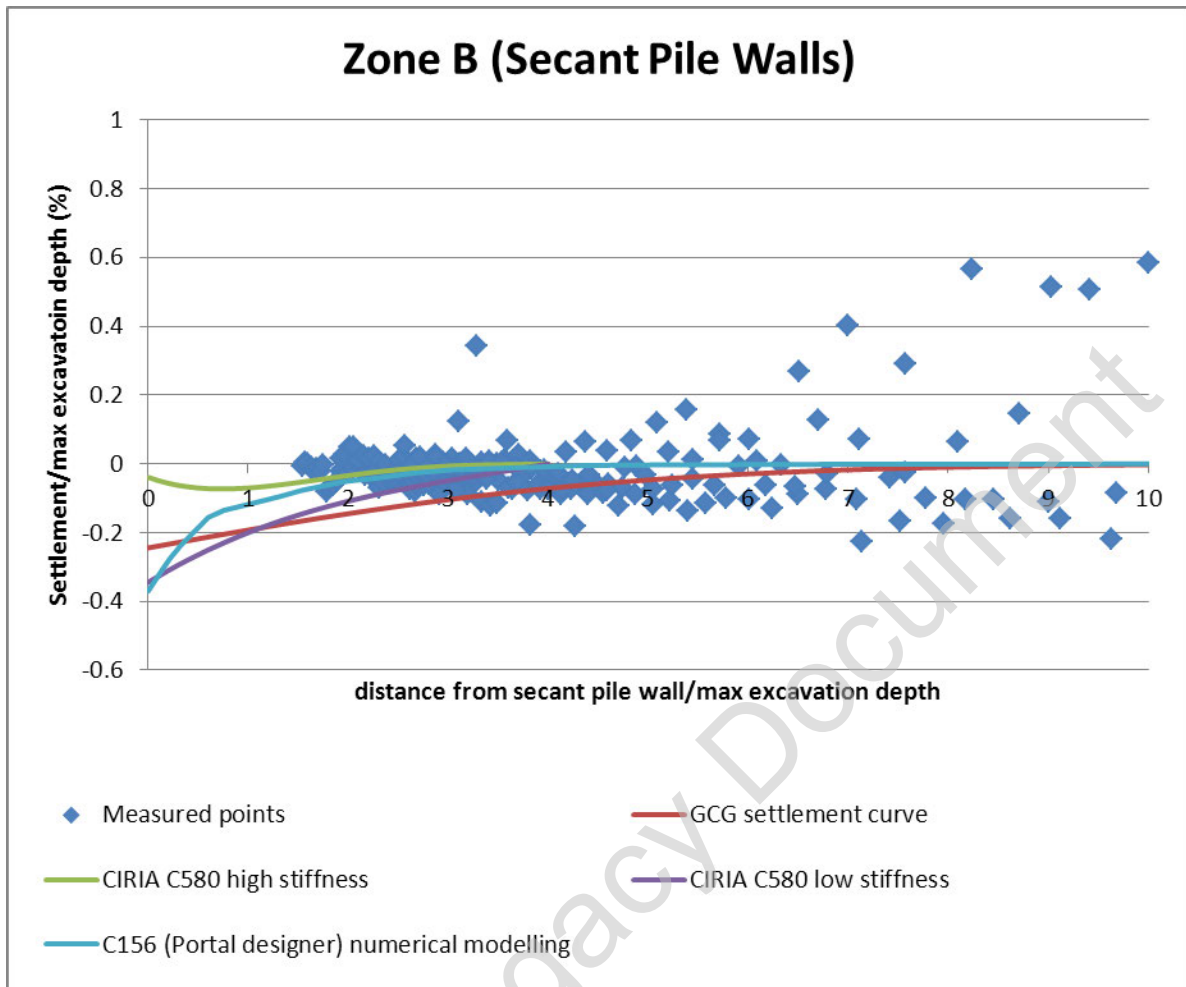
**Figure 4 - Plot showing settlements along south secant pile wall of Plumstead Portal normalised by depth of excavation and comparison against various ground movement curves. The extent of Zone B is shown on Figure 1.**

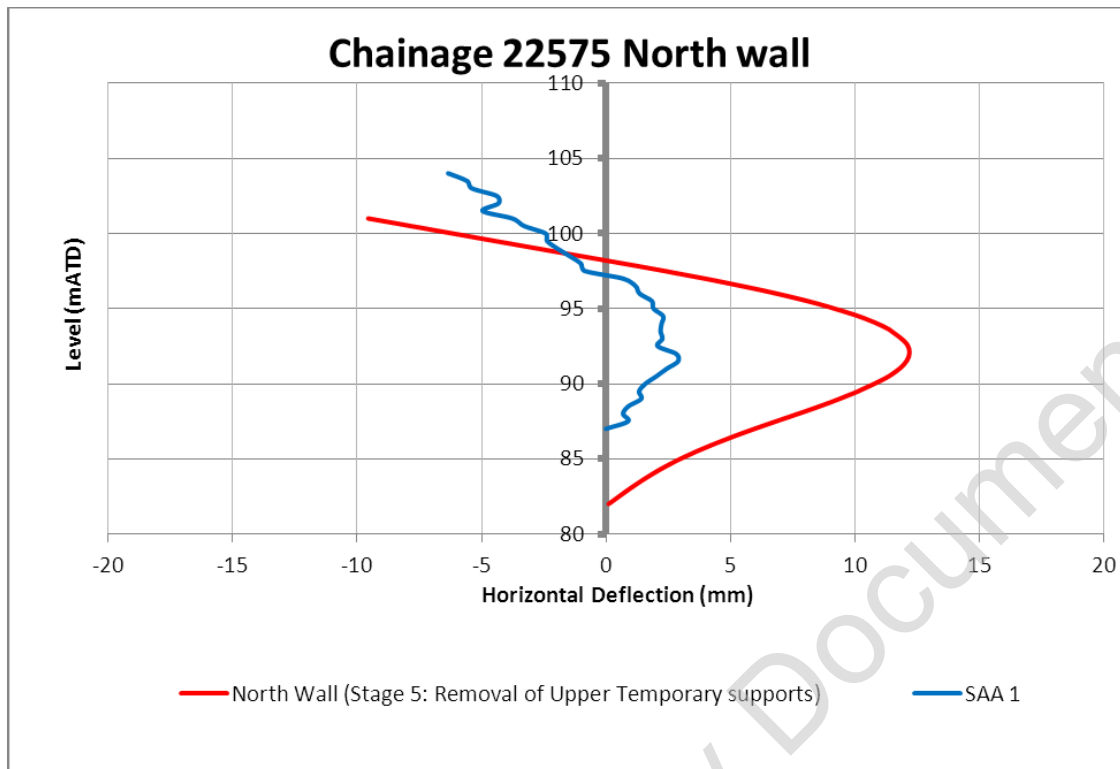
Figure 7 - Plot showing comparison between predicted and monitored diaphragm wall deflections at Chainage 22575 for SAA 1.

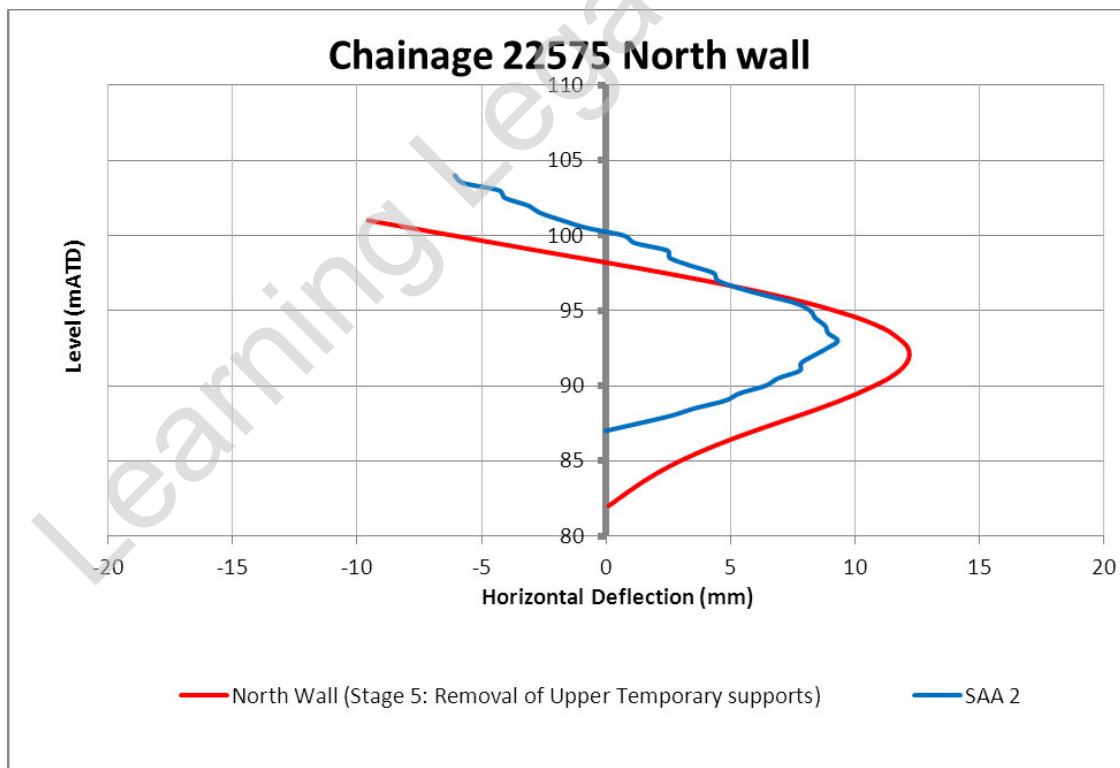
Figure 8 - Plot showing comparison between predicted and monitored diaphragm wall deflections at Chainage 22575 for SAA 2.

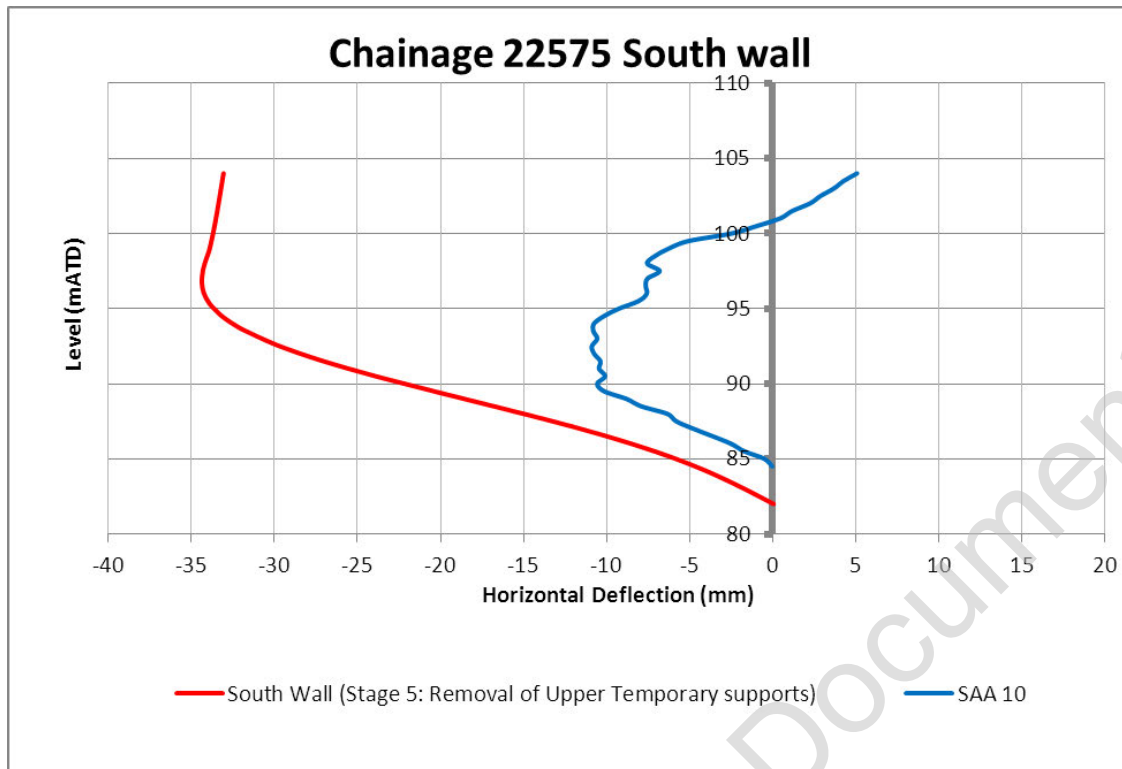
**Figure 9 - Plot showing comparison between predicted and monitored diaphragm wall deflections at Chainage 22575 for SAA 10.**

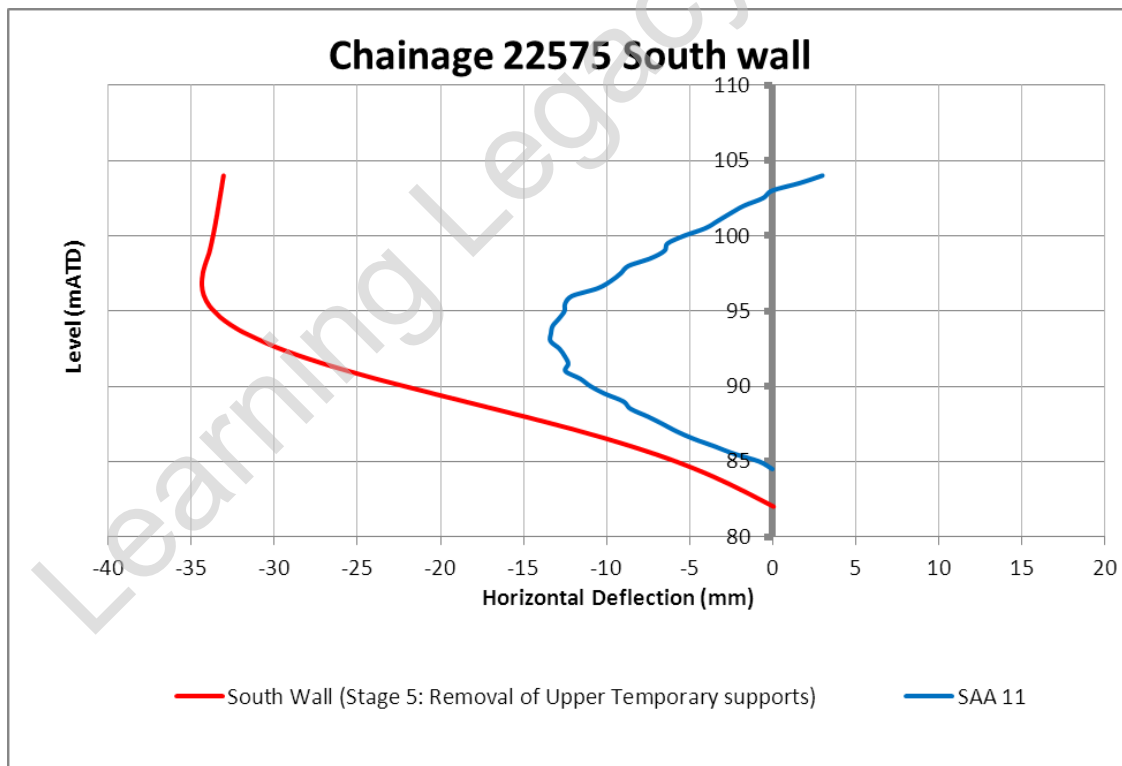
**Figure 10 - Plot showing comparison between predicted and monitored diaphragm wall deflections at Chainage 22575 for SAA 11.**

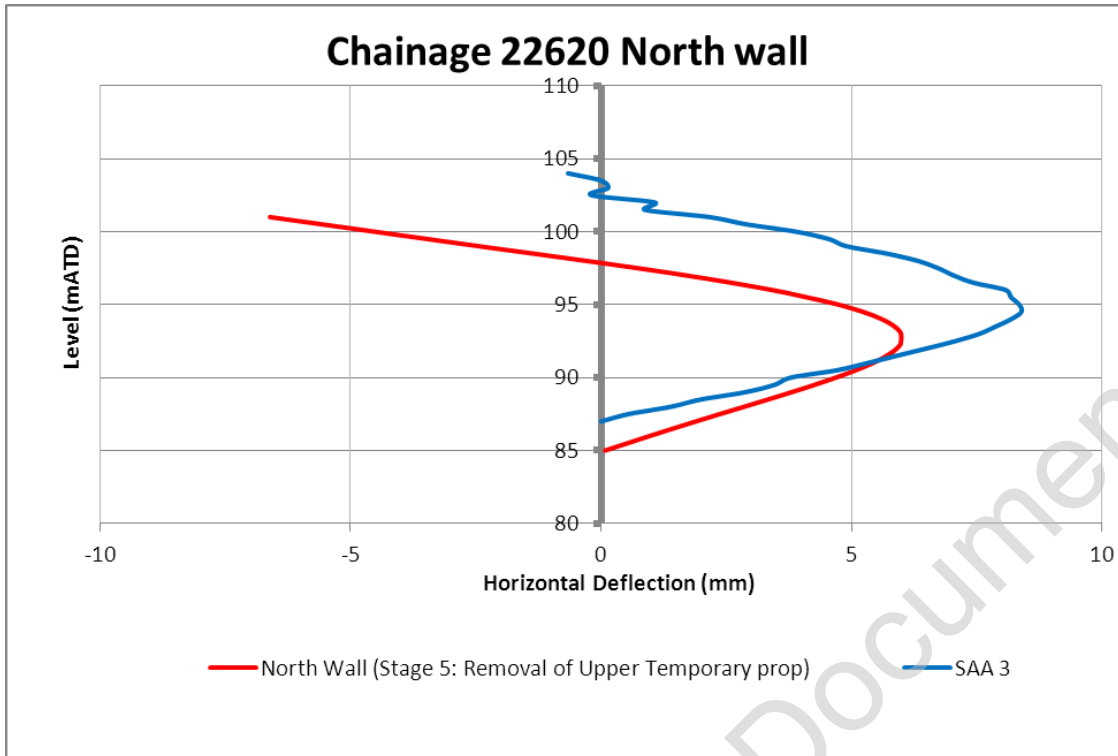
Figure 11 - Plot showing comparison between predicted and monitored diaphragm wall deflections at Chainage 22620 for SAA 3.

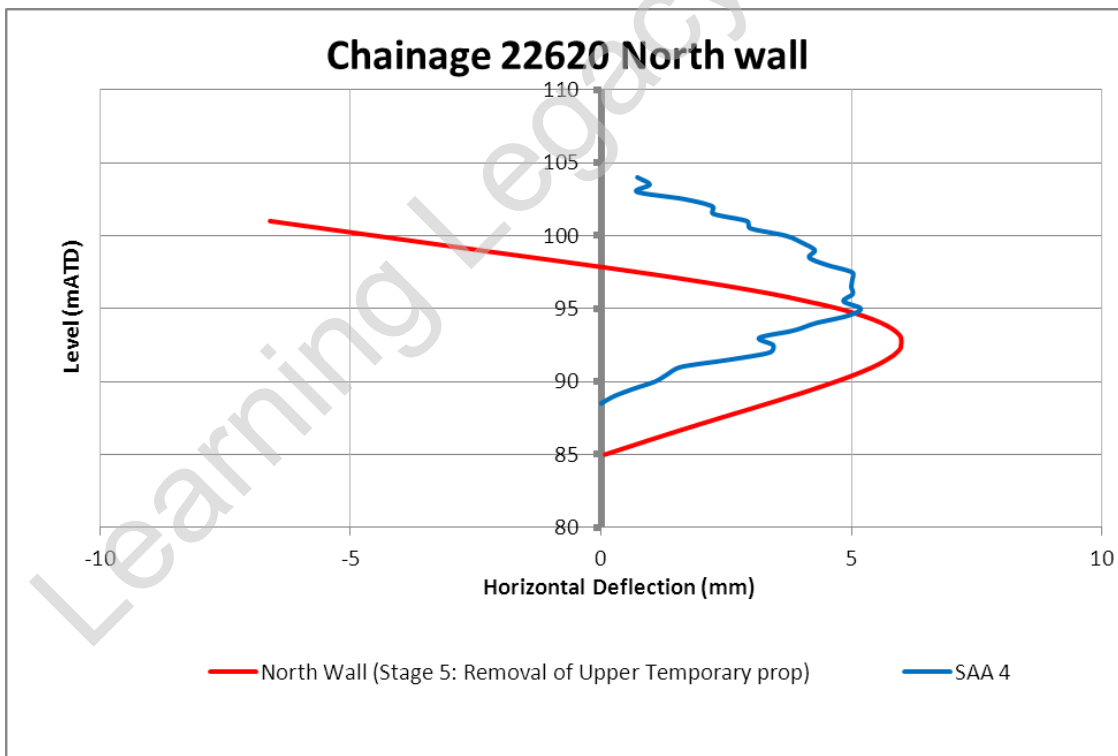
Figure 12 - Plot showing comparison between predicted and monitored diaphragm wall deflections at Chainage 22620 for SAA 4.

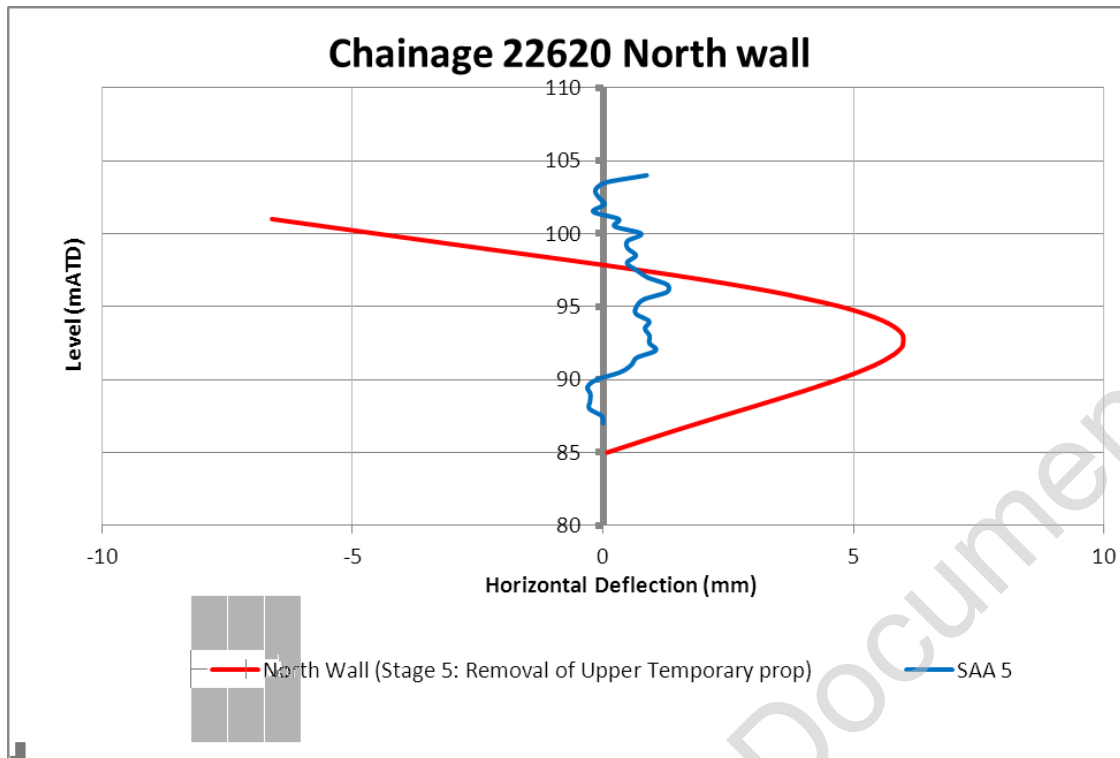
Figure 13 - Plot showing comparison between predicted and monitored diaphragm wall deflections at Chainage 22620 for SAA 5.

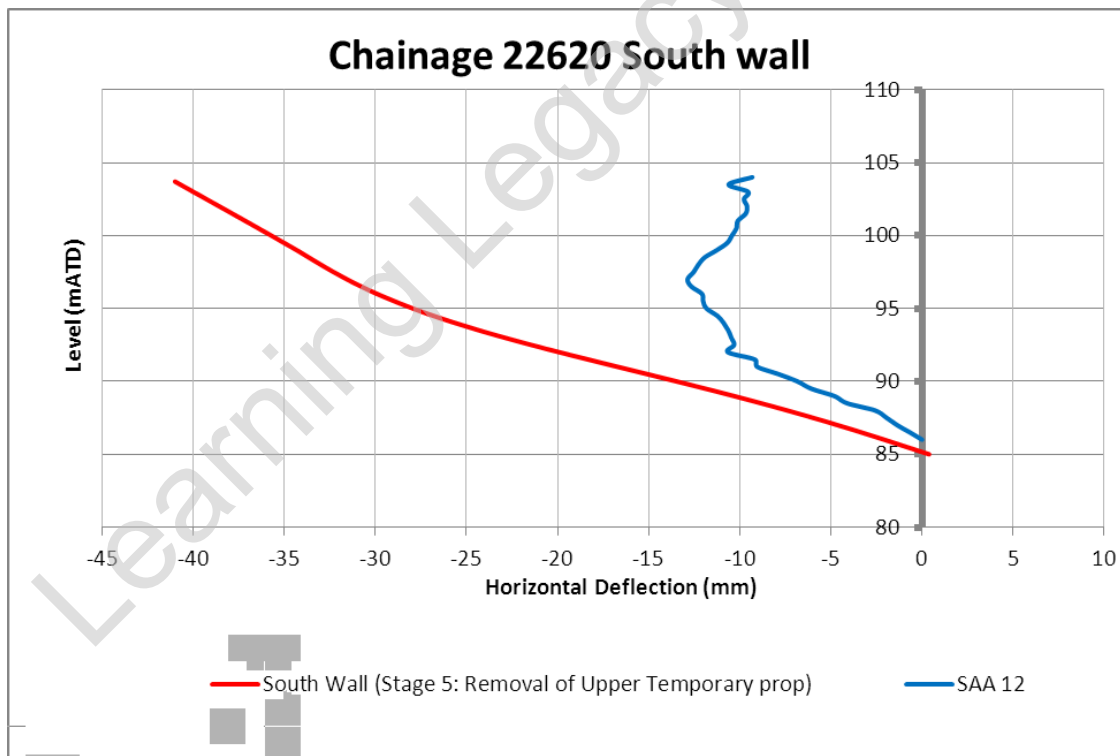
Figure 14 - Plot showing comparison between predicted and monitored diaphragm wall deflections at Chainage 22620 for SAA 12.
