<b>C310 THAMES TUNNEL REPORT</b>		
EMPLOYER	CROSSRAIL	eB NO	C310-HTM-C-RGN-CR148-50035	Rev 2.0
TITLE	Monitoring Close-Out Report for North Kent Line (NKL)

The purpose of this report is to summarise the monitoring data related to the Network Rail North Kent Line (NR24), running adjacent to the Plumstead Portal construction activities. In addition this data is utilised to demonstrate that no further ground movements due to the nature of ongoing and further C310 works would be expected to impact the Network Rail assets.

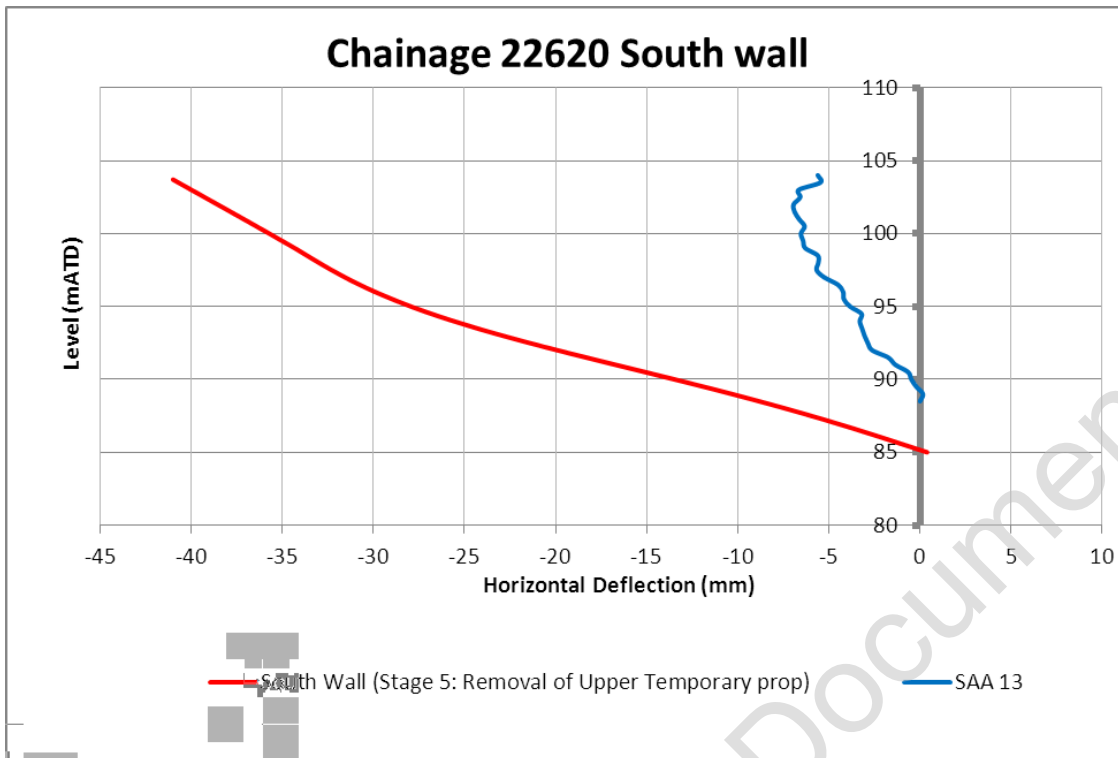
Figure 15 - Plot showing comparison between predicted and monitored diaphragm wall deflections at Chainage 22620 for SAA 13.

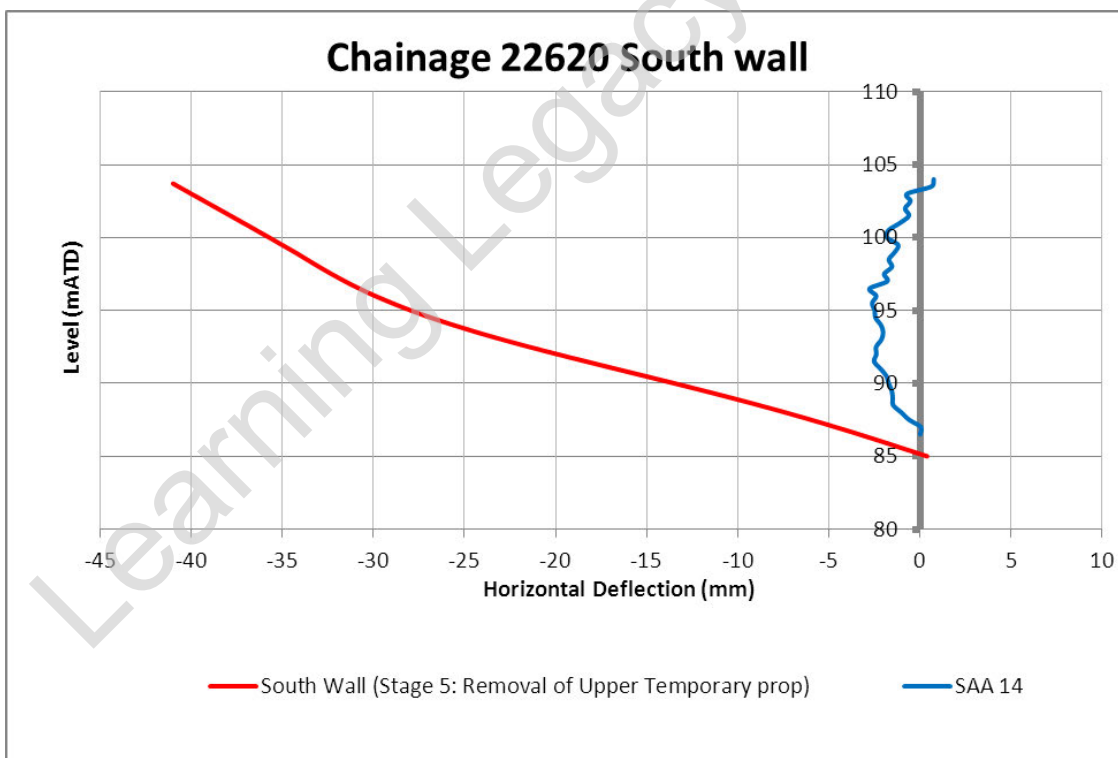
Figure 16 - Plot showing comparison between predicted and monitored diaphragm wall deflections at Chainage 22620 for SAA 14.

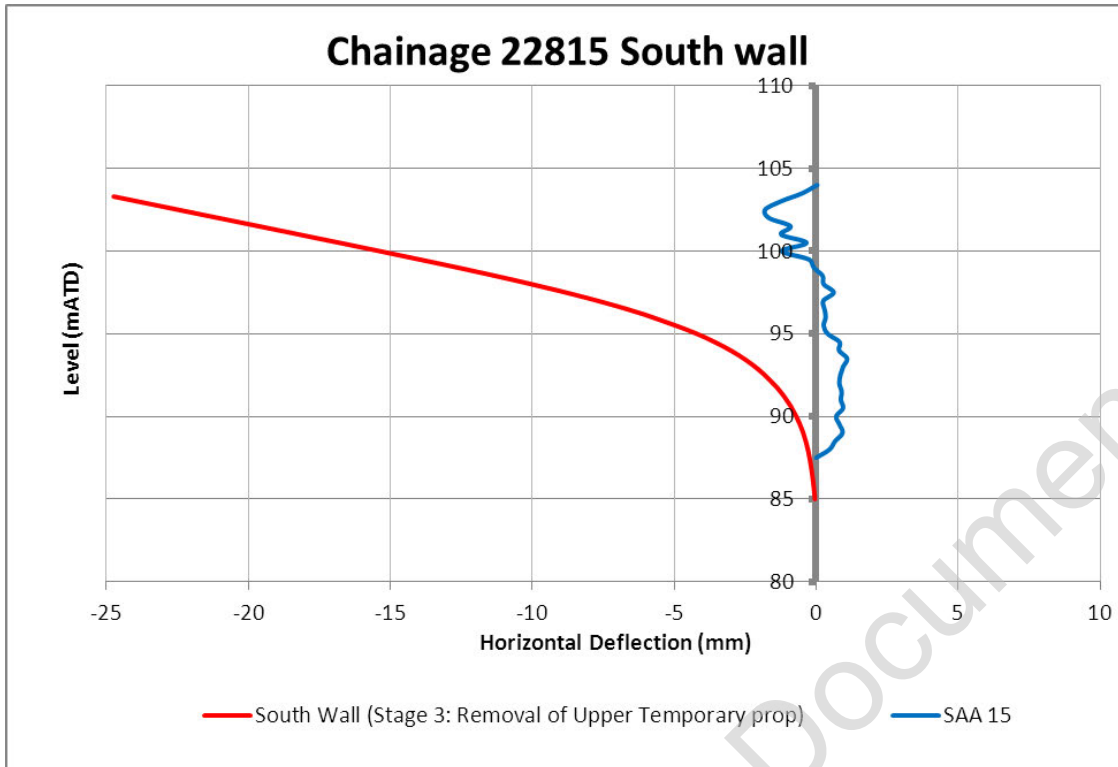
Figure 17 - Plot showing comparison between predicted and monitored diaphragm wall deflections at Chainage 22815 for SAA 15.

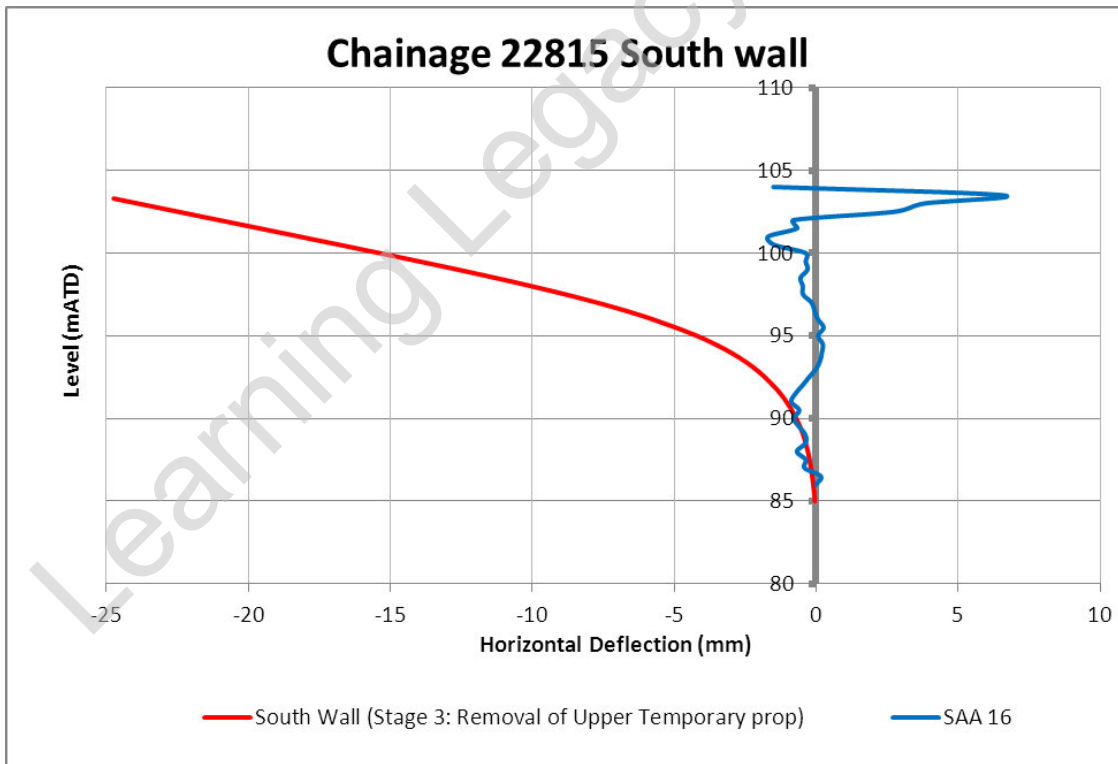
Figure 18 - Plot showing comparison between predicted and monitored diaphragm wall deflections at Chainage 22815 for SAA 16.

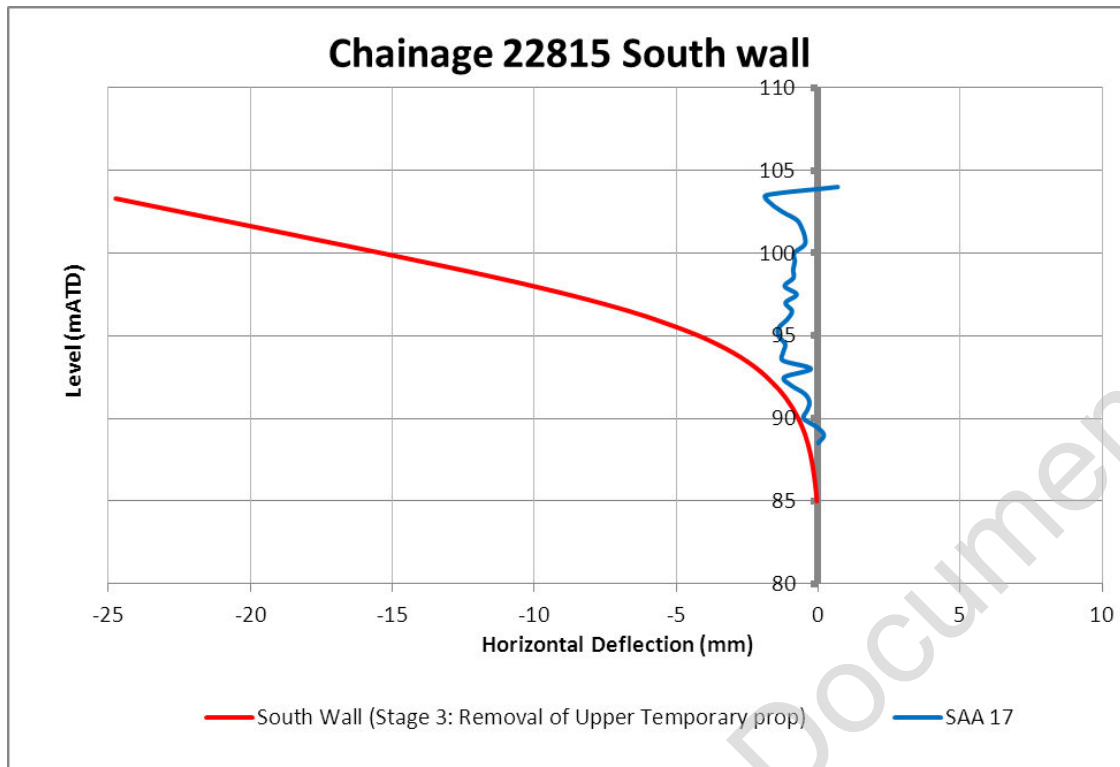
Figure 19 - Plot showing comparison between predicted and monitored diaphragm wall deflections at Chainage 22815 for SAA 17.

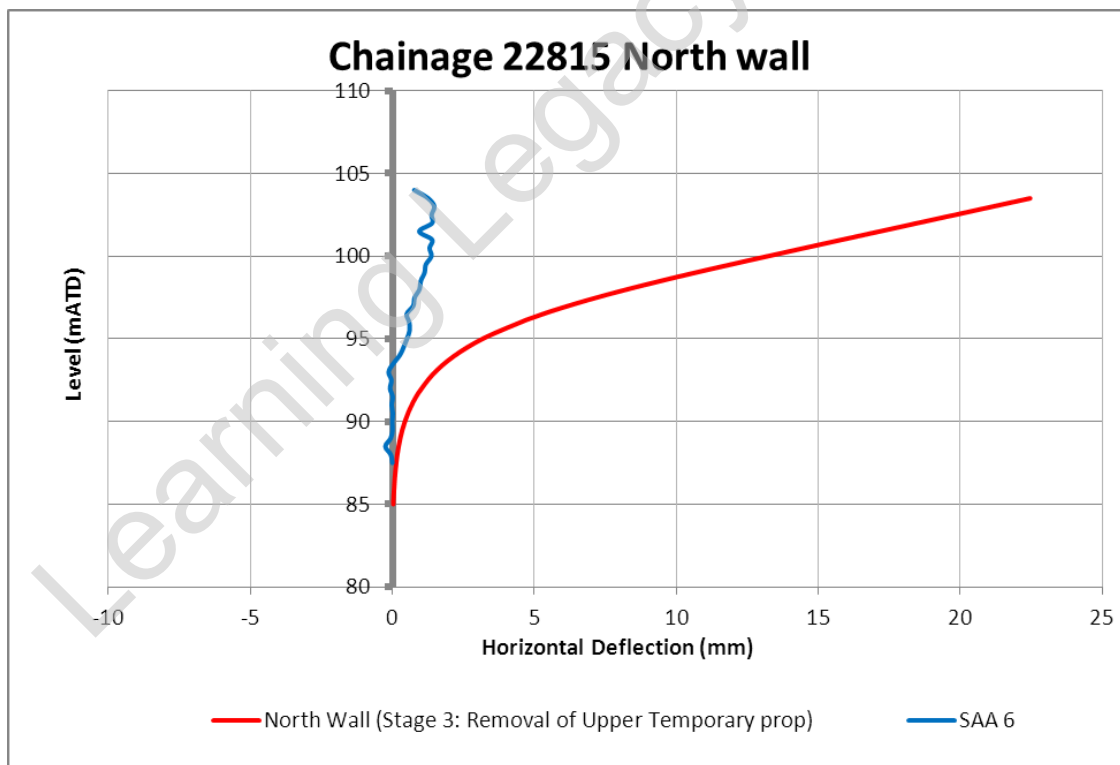
Figure 20 - Plot showing comparison between predicted and monitored diaphragm wall deflections at Chainage 22815 for SAA 6.

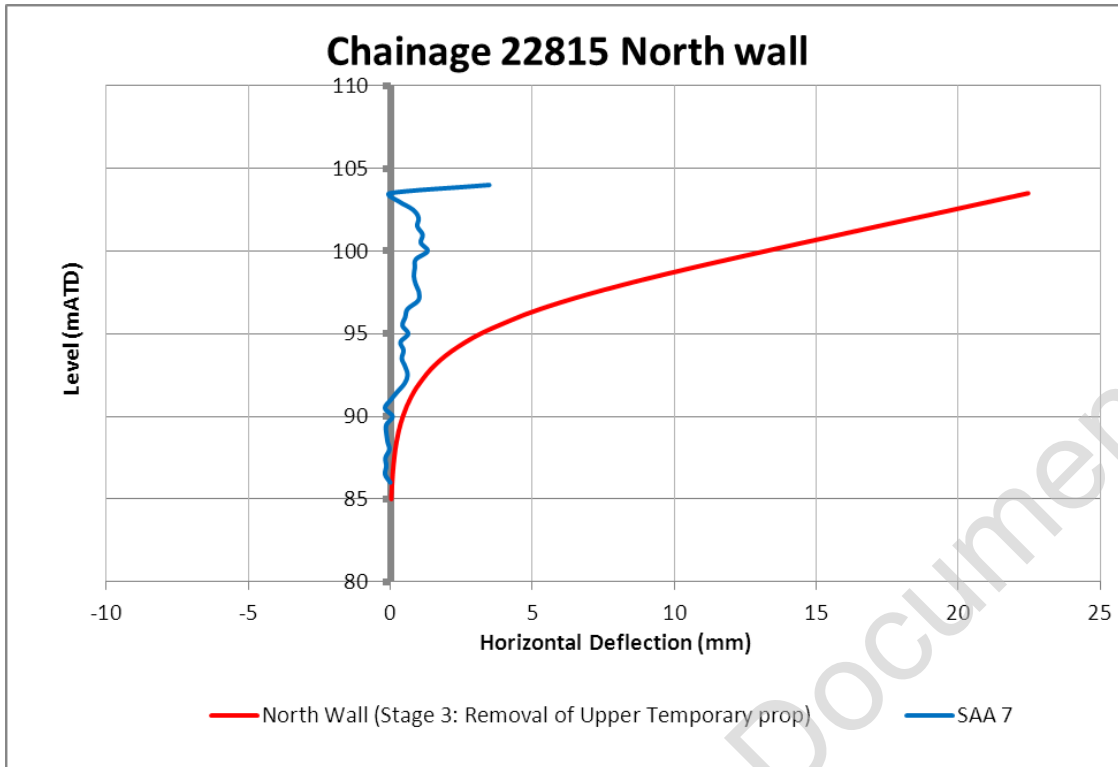
Figure 21 - Plot showing comparison between predicted and monitored diaphragm wall deflections at Chainage 22815 for SAA 7.

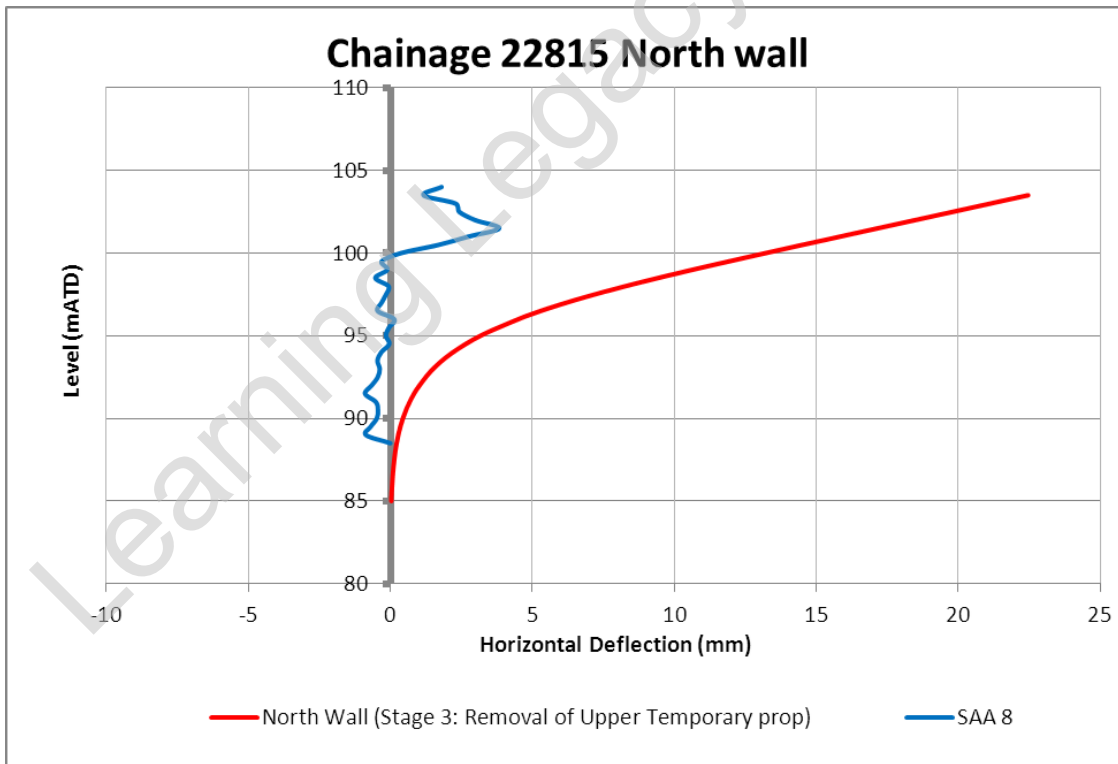
Figure 22 - Plot showing comparison between predicted and monitored diaphragm wall deflections at Chainage 22815 for SAA 8.

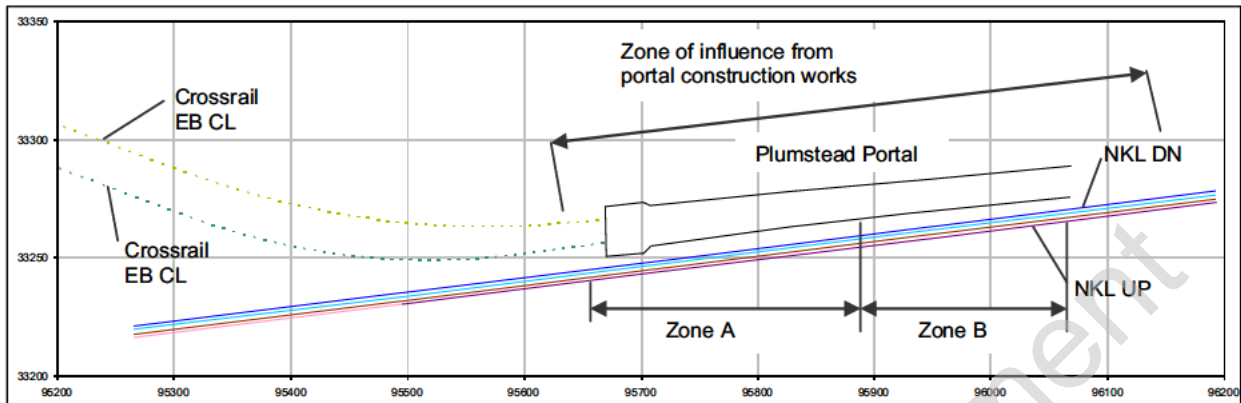
Figure 23 – General arrangement of the NKL Up and Down lines, Crossrail works and zone of influence of the portal construction works. Zone A and Zone B indicate the extent of diaphragm wall construction and secant pile wall construction respectively.

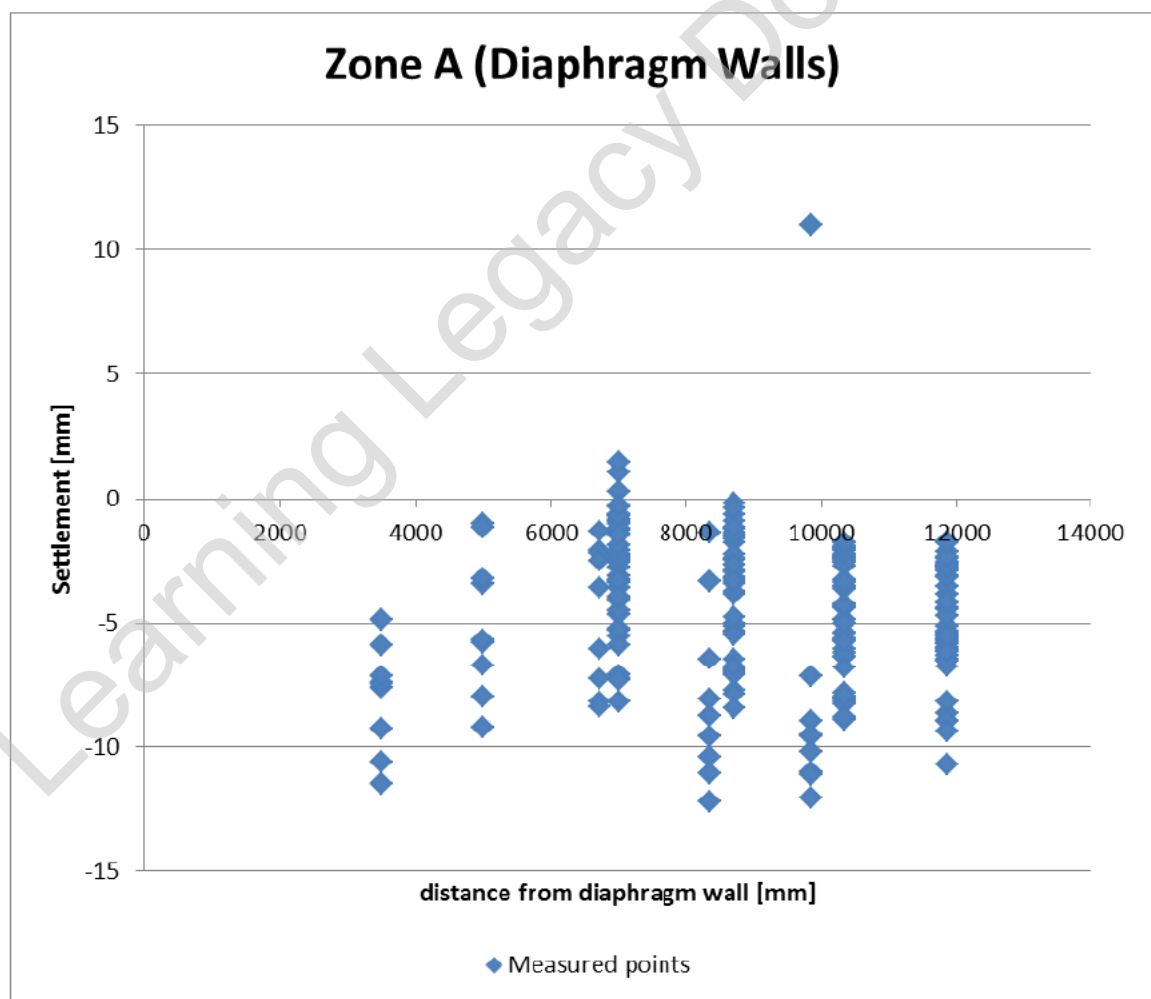
Figure 24 – Plot showing settlements along south diaphragm wall of Plumstead Portal

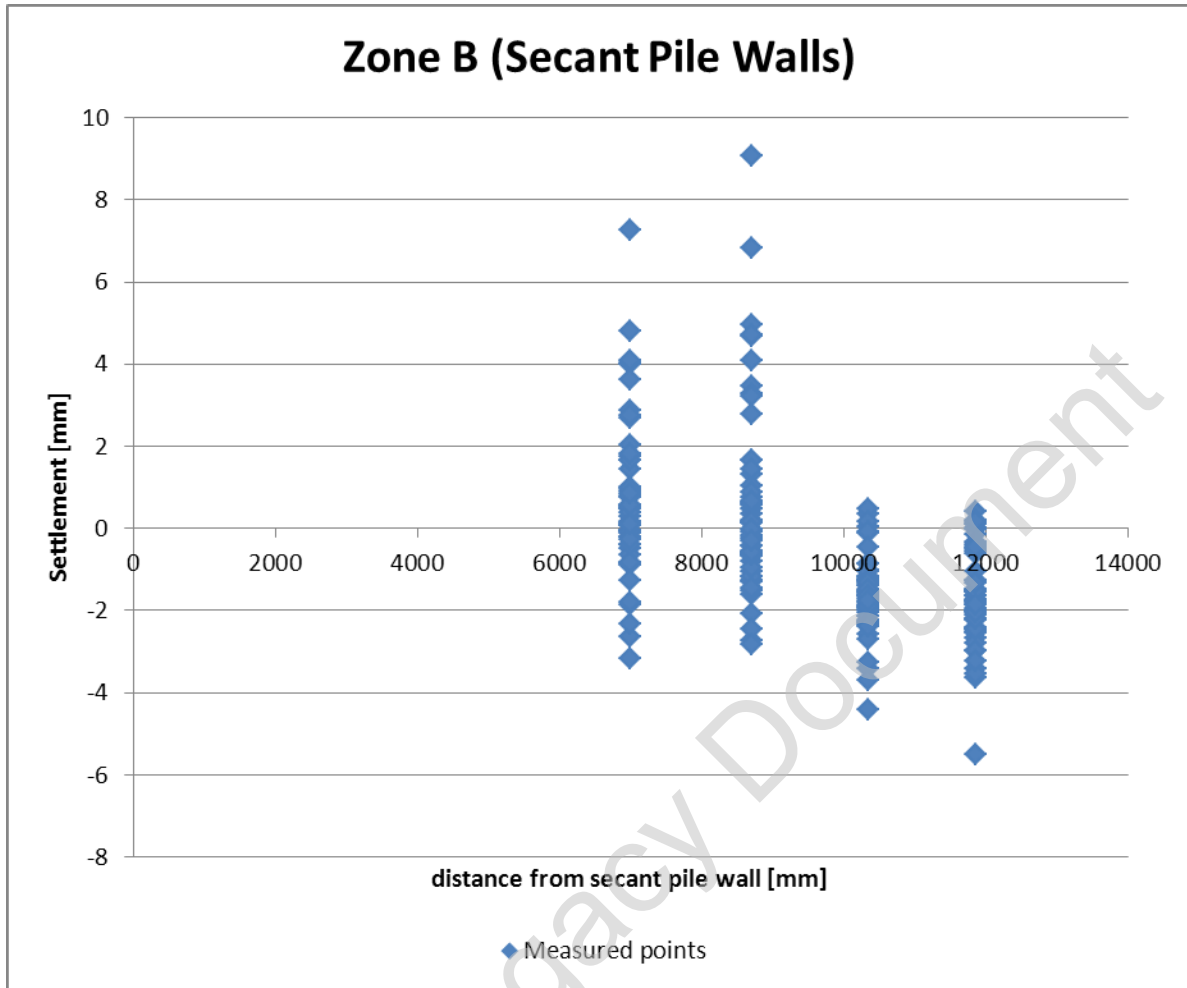
Figure 25 - Plot showing settlements along south secant pile wall of Plumstead Portal
