# C435 Farringdon Main Station

## Monitoring Close-Out Report: Automated Total Station at 20 Farringdon Road (ATS 51) and 3D Targets read by ATS 51. CRL Document Number: C435-BFK-C2-RGN-M123-51050

Contract MDL reference C14.022

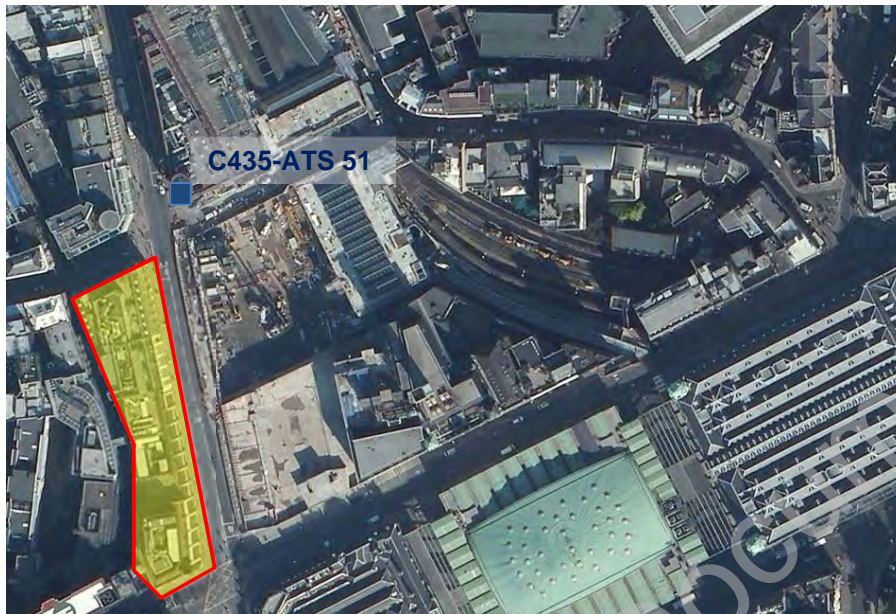
Figure 1 – Map showing the Location of ATS 51 and 3D Targets read by ATS 51.

As you can see from the Figure 1 below, the instruments described in Section B.1 are located in Farringdon Road area. A drawing showing the location of these devices can be found in the Appendix A.

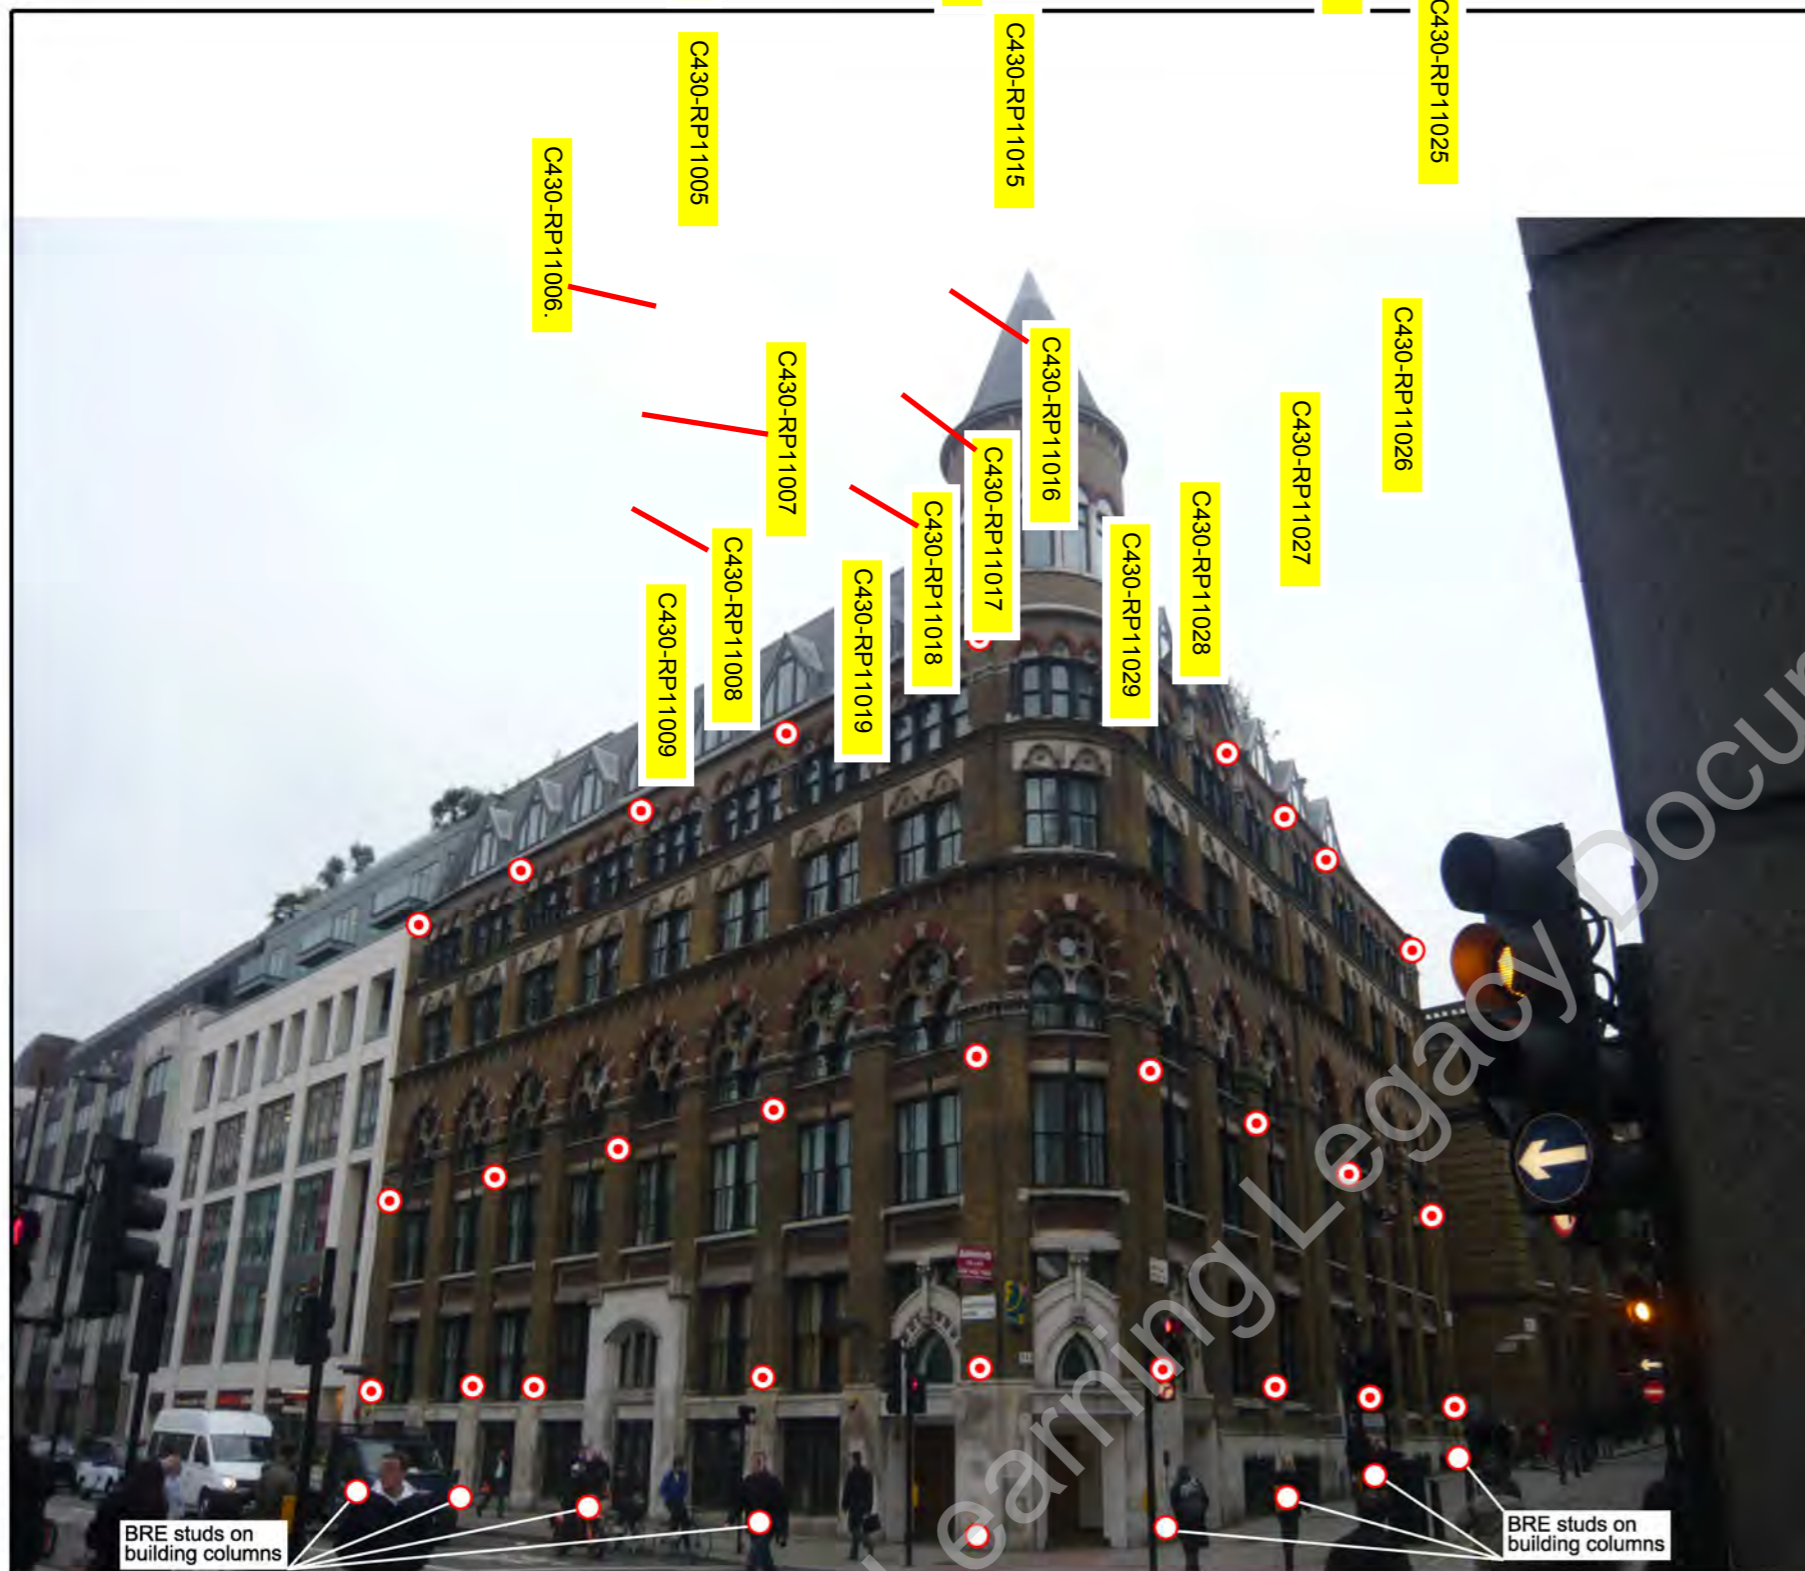
Drg No : C122-OVE-C2-DDJ-CR001\_Z-39602

**Geodetic Prism:**  
Geodetic prisms are supported on brackets. They are read remotely using Total Stations

**BRE Levelling Stud:**  
Levelling stud screws into BRE socket within wall. Manually read levelling staff placed onto stud.

**Vibrating Wire Crackmeter:**  
Vibrating Wire Crackmeters measure the expansion and contraction across existing cracks and joints. They are read from a transmitter box located on the façade.

Title : Proposed Building Instrumentation  
Farringdon Station  
25-27 Farringdon Road MDC2\_00329 1 of 2

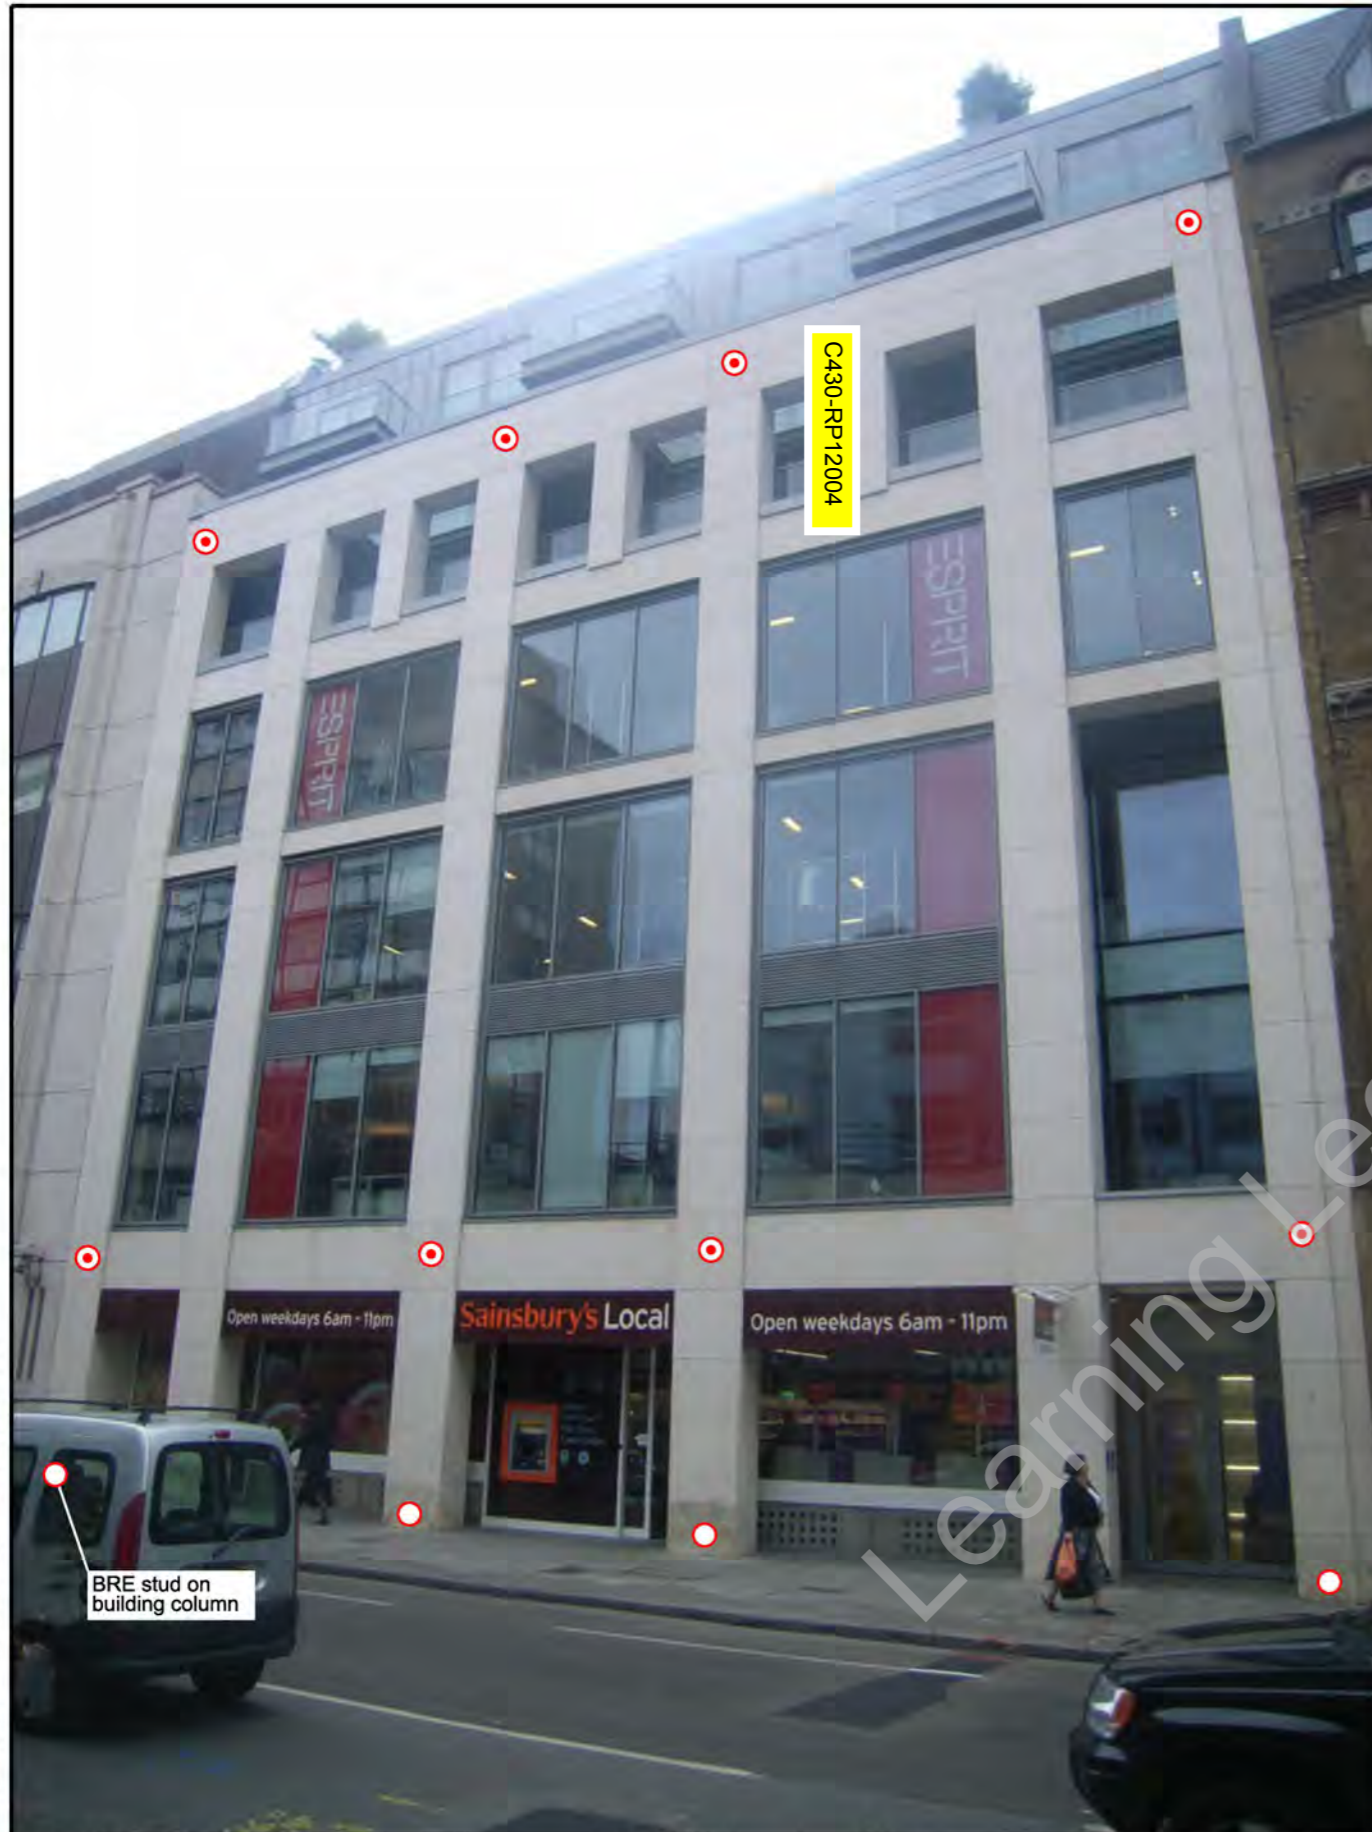
**Geodetic Prism:**  
Geodetic prisms are supported on brackets. They are read remotely using Total Stations

**BRE Levelling Stud:**  
Levelling stud screws into BRE socket within wall. Manually read levelling staff placed onto stud.

**Vibrating Wire Crackmeter:**  
Vibrating Wire Crackmeters measure the expansion and contraction across existing cracks and joints. They are read from a transmitter box located on the façade.

Contract : Bored Tunnels (Alignment and Track)	
Originator : Ove Arup & Partners Limited	
Location : Crossrail General	
Title : Proposed Building Instrumentation Farringdon Station 17-23 Farringdon Road MDC2_01896	By : [Redacted] Chk : [Redacted] App : [Redacted] Auth : [Redacted]
Scale : NTS @ A3	Drg No : C122-OVE-C2-DDJ-CR001_Z-39606 Rev : C01 Suit : A Auth : [Redacted]

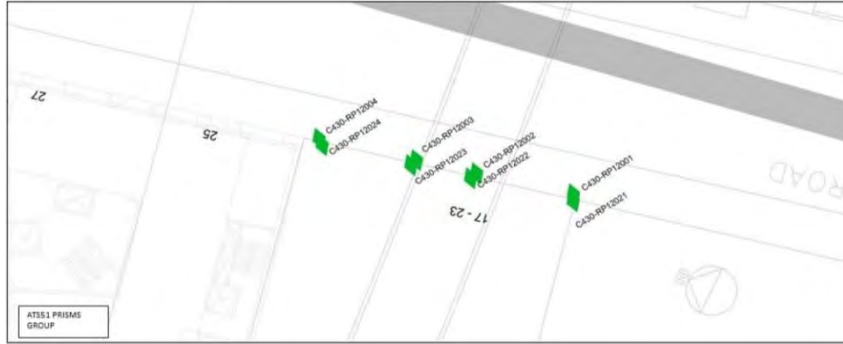
Building: 17-23 FARRINGDON ROAD

REPORT Automatic Prisms  
 AREA Farringdon Station  
 DEVICE 3D Target

- 17-23 Farringdon Road: monitoring data for 3D Targets installed on the east facade of this building located directly above the crown of the WB TBM is shown in Appendix B. This WB TBM passage caused a maximum settlement around 5mm. During the EB TBM passage, the enlargement of STW1 and STW3 and the SH-W2 shaft excavation works no significant movement was observed on these 3D Targets.
- 19 Charterhouse Street: monitoring data for 3D Targets installed on the east facade of this building is shown in Appendix B. The WB TBM passage caused a maximum settlement around 3mm. During the EB TBM passages, the enlargement of STW1 and STW3 and the SH-W2 shaft excavation works no significant movement was observed on these 3D Targets.

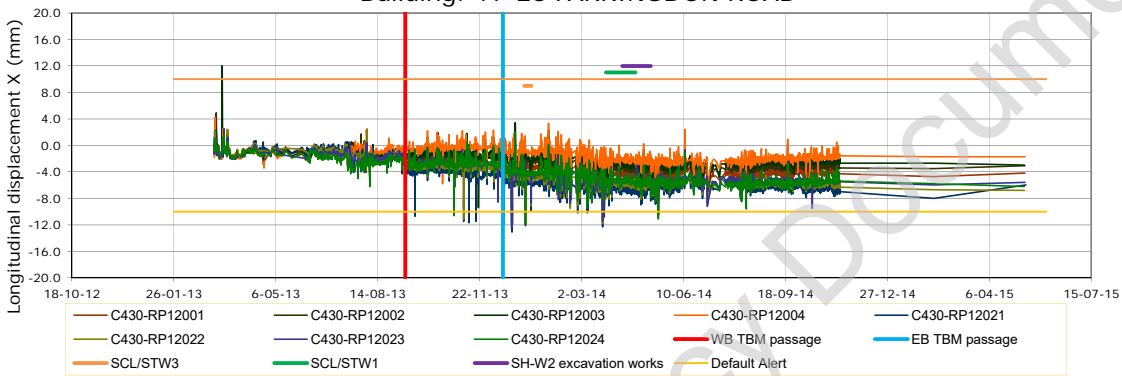
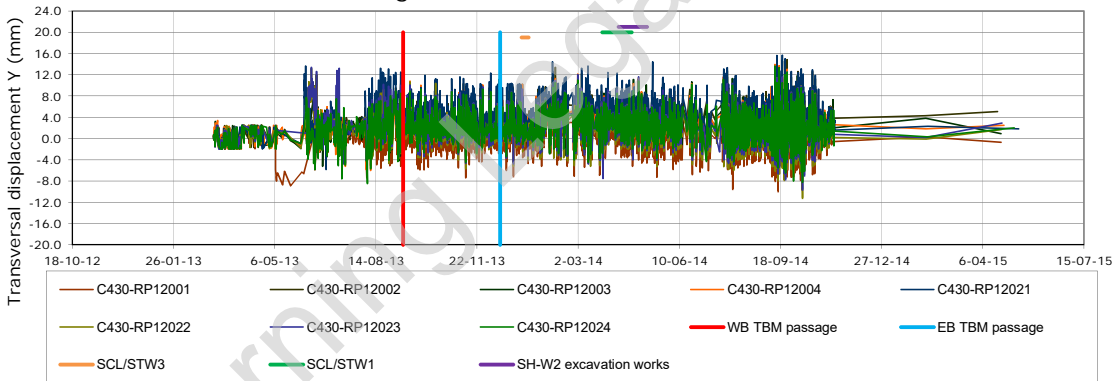
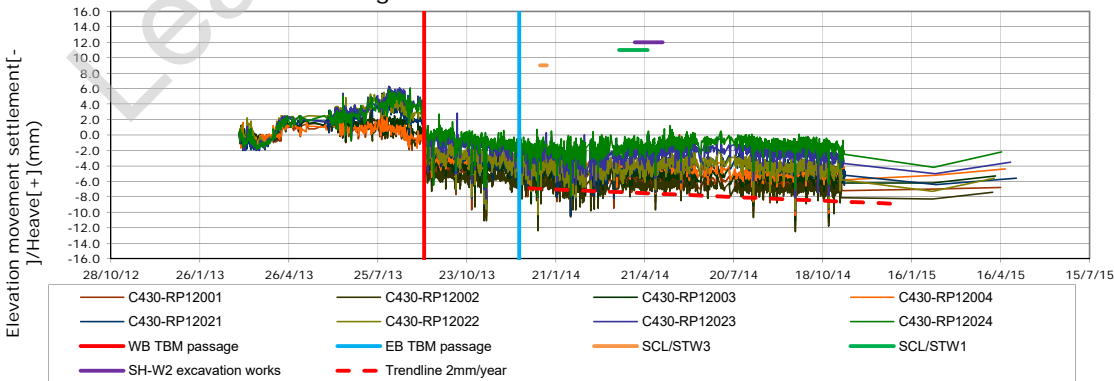
20-02-2014: Gap in the readings due to software issues  
 Baseline done by C430. First reading from C435 was done at 07-02-2013 (handover date) keeping C430's historical data.  
 The jump in the data is because we start to work with the global Network.

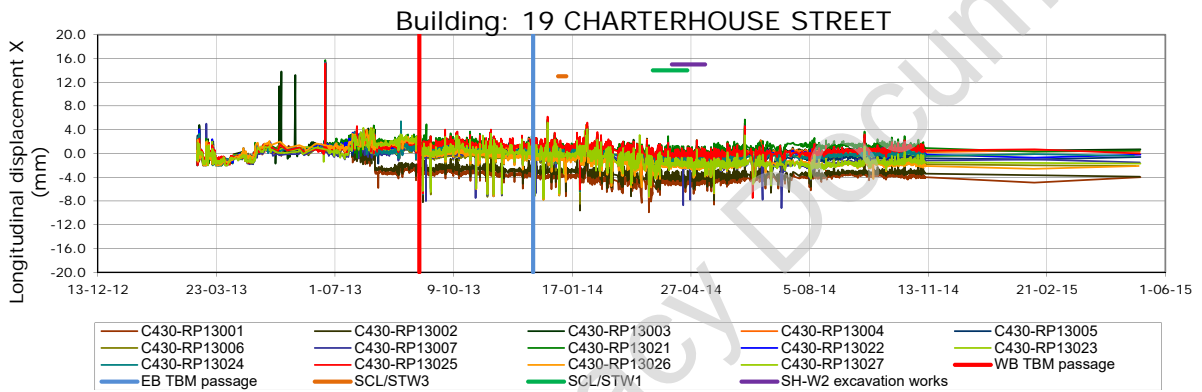
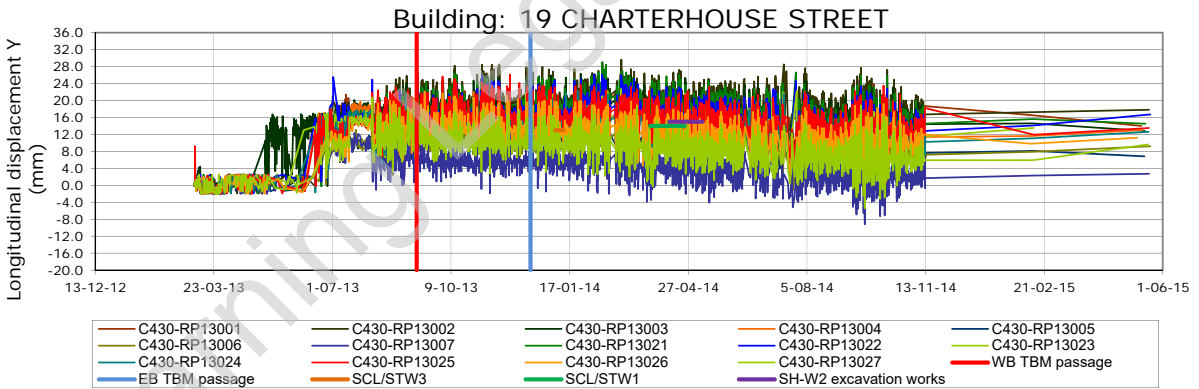
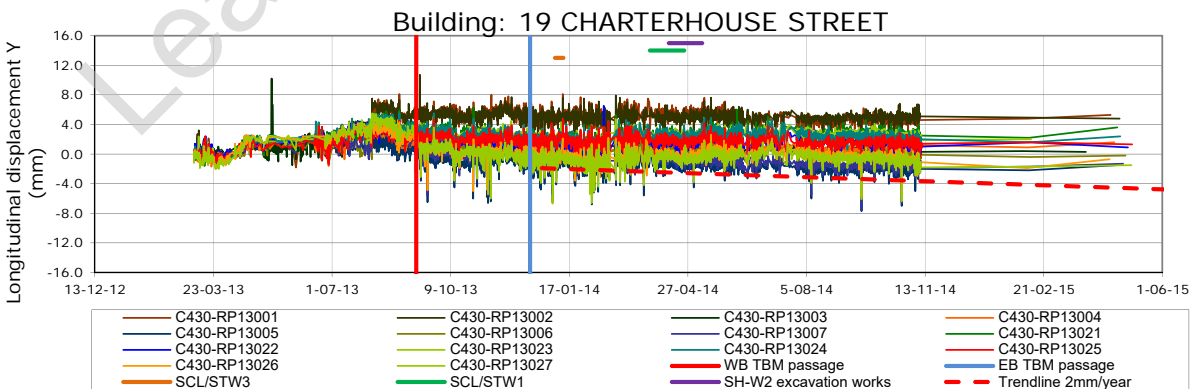
The jump in the data is because we start to work with the global Network.

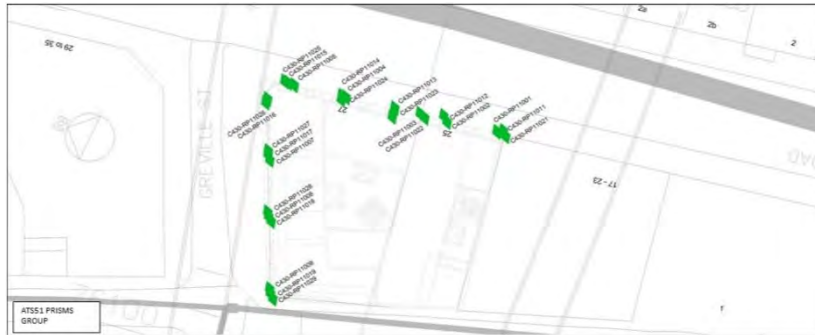
Building: 25-27 FARRINGDON ROAD

REPORT Automatic Prisms  
 AREA Farringdon Station  
 DEVICE 3D Target

- 25-27 Farringdon Road: monitoring data for 3D Targets installed on the north and east facades of this building located between the crowns of the EB and WB TBMs is shown in Appendix B. The WB TBM passage caused a maximum settlement around 2mm and the EB one a maximum settlement of 3mm. During the enlargement of STW1 and STW3 and the SH-W2 shaft excavation works no significant movement was observed on these 3D Targets.
- Farringdon Road – Rider Main: monitoring data for 3D Targets installed to control this utility located along Farringdon Road as is shown in Appendix B. These 3D Targets were uninstalled at the same time than the rider main on 18/09/2013 after the C300 WB TBM passage, recording a maximum of 4mm settlement for this activity, showing stability before being removed.

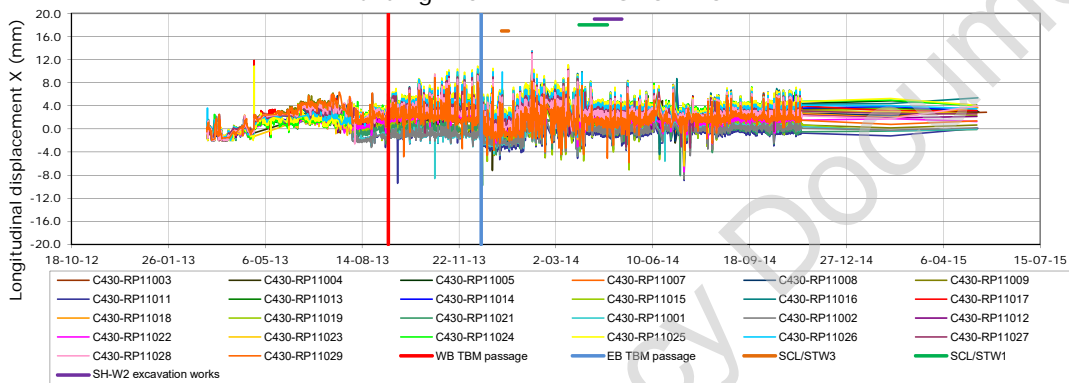
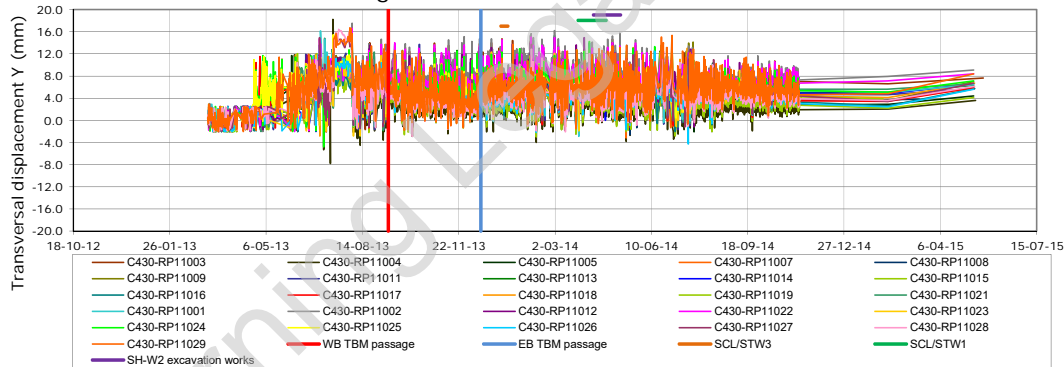
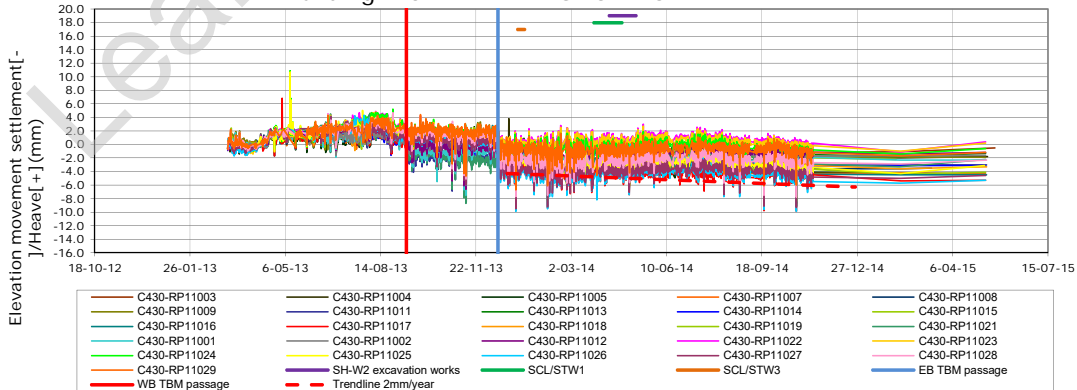
01-09-2013: Prisms C430-RP19001, C430-RP19004 and C430-RP19005 are covered.  
 18-02-2014: ATS 52 is being calibrating. Readings will be recovered  
 20-02-2014: Gap in the readings due to software issues  
 Baseline done by C430. First reading from C435 was done at 07-02-2013 (handover date) keeping C430's historical data.  
 The jump in the data is because we start to work with the global Network.

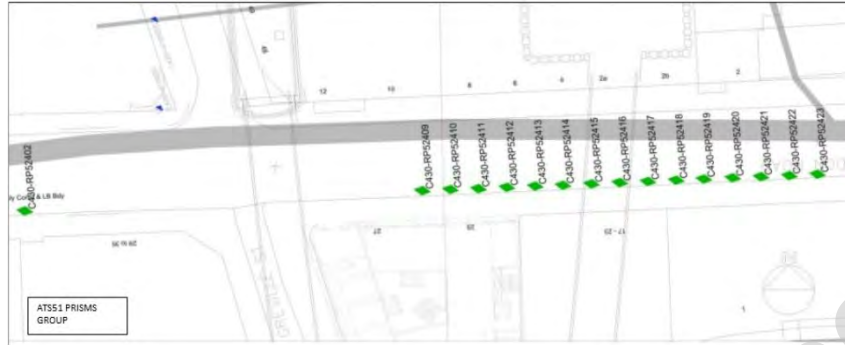
Building: FARRINGDON RD. RIDER MAIN

REPORT Automatic Prisms  
 AREA Farringdon Station  
 DEVICE 3D Target

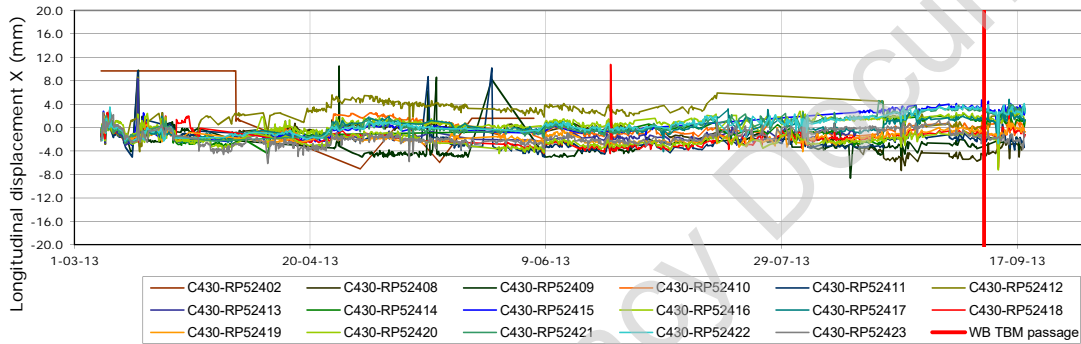
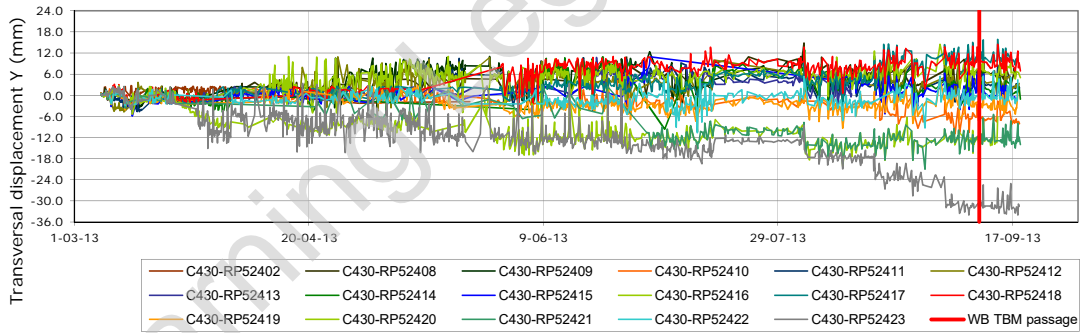
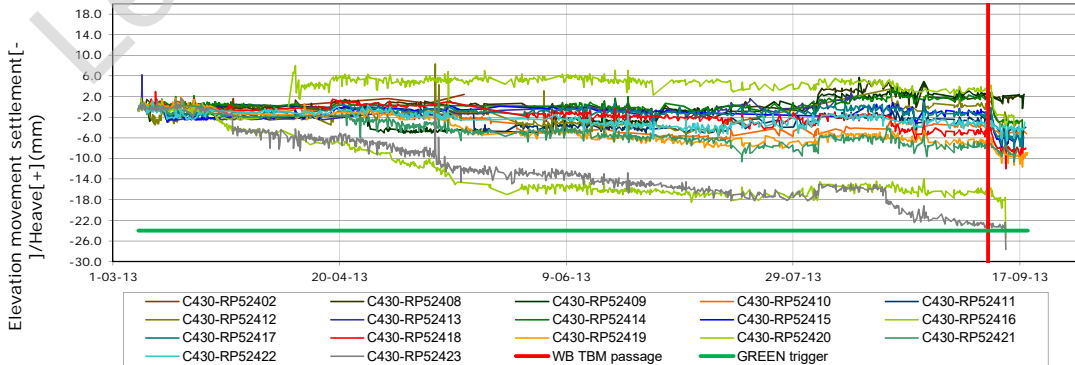
01-09-2013: Prisms C430-RP19001, C430-RP19004 and C430-RP19005 are covered.  
 Baseline done by C430. First reading from C435 was done at 07-02-2013 (handover date) keeping C430's historical data.  
 The last reading for these prisms was on 17-03-2013 because the structure where the prisms were installed was remove.
