## C435 Farringdon Main Station

### Monitoring Close-Out Report: Automated Total Station ATS 01 and 3D Targets read by ATS 01.

**CRL Document Number: C435-BFK-C2-RGN-M123-51610**

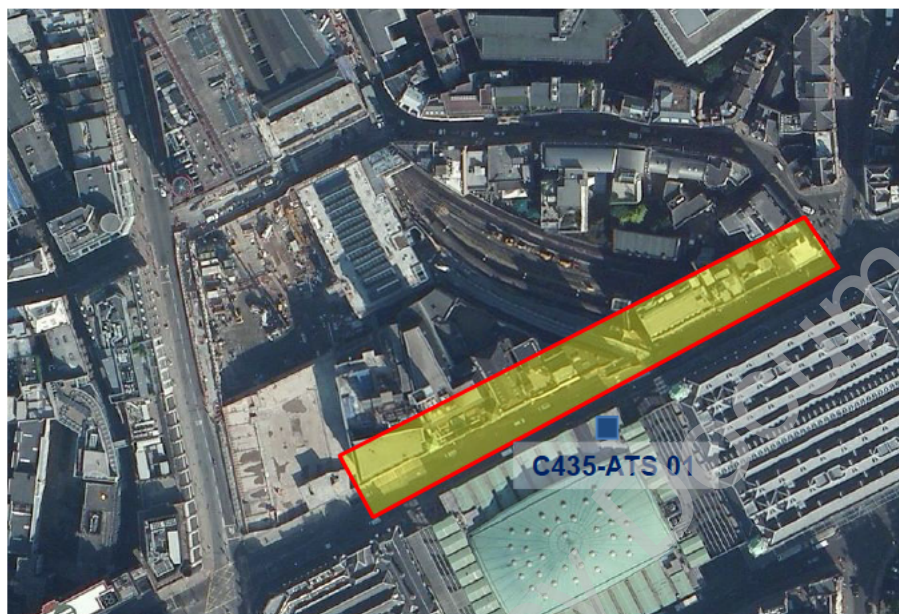
Figure 1 – Map showing the Location of ATS 01 and 3D Targets read by ATS 01.

As you can see from the Figure 1 below, the instruments described in Section B.1 are located in Charterhouse Street western area. A drawing showing the location of these devices can be found in the Appendix A.

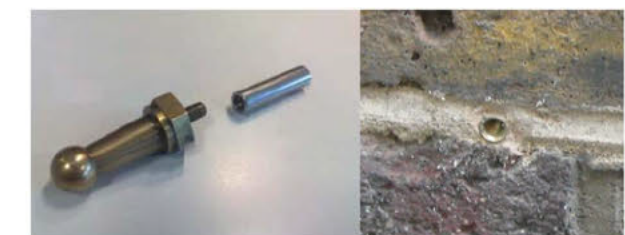
**Geodetic Prism:**

Geodetic prisms are supported on brackets. They are read remotely using Automatic Total Stations fixed to structures nearby.

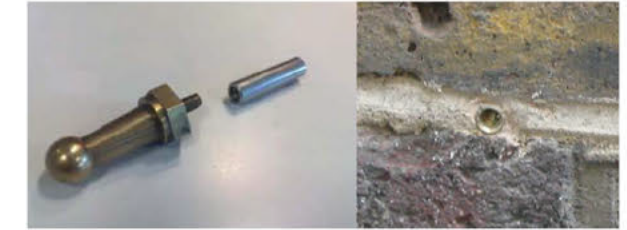
**Geodetic Prism:**  
Geodetic prisms are supported on brackets. They are read remotely using Total Stations

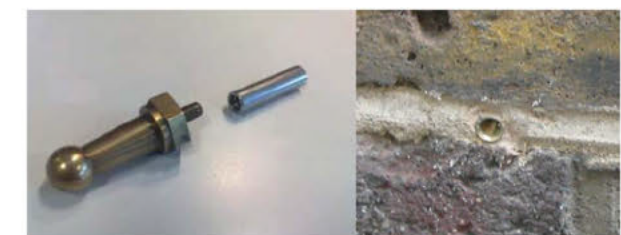
Geodetic prisms are supported on brackets. They are read remotely using Automatic Total Stations fixed to structures nearby.

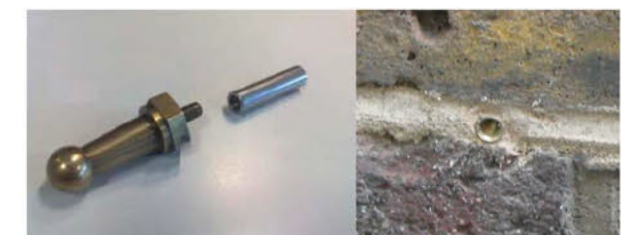
Geodetic prisms are supported on brackets. They are read remotely using Automatic Total Stations fixed to structures nearby.

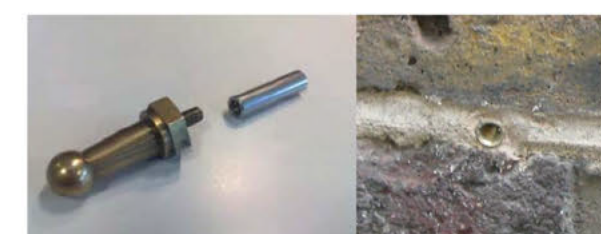
Geodetic prisms are supported on brackets. They are read remotely using Automatic Total Stations fixed to structures nearby.

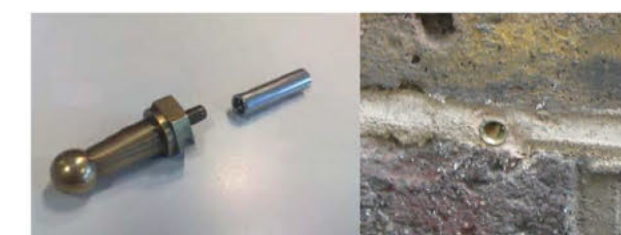
Geodetic prisms are supported on brackets. They are read remotely using Automatic Total Stations fixed to structures nearby.

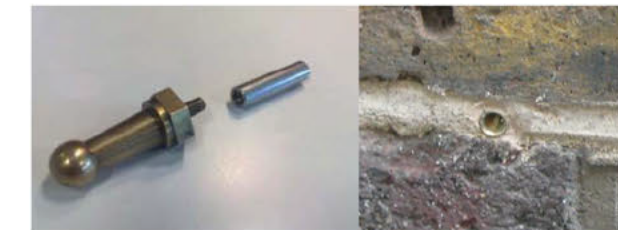
Geodetic prisms are supported on brackets. They are read remotely using Automatic Total Stations fixed to structures nearby.

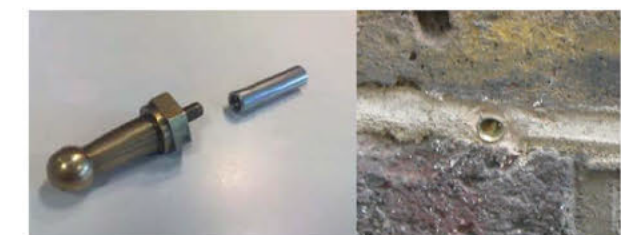
Geodetic prisms are supported on brackets. They are read remotely using Automatic Total Stations fixed to structures nearby.

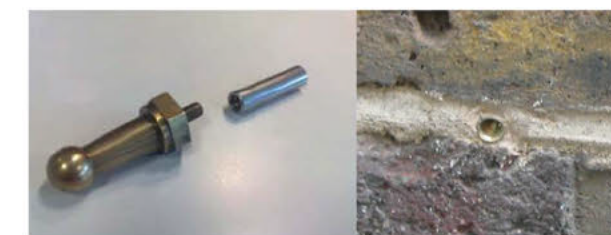
Geodetic prisms are supported on brackets. They are read remotely using Automatic Total Stations fixed to structures nearby.

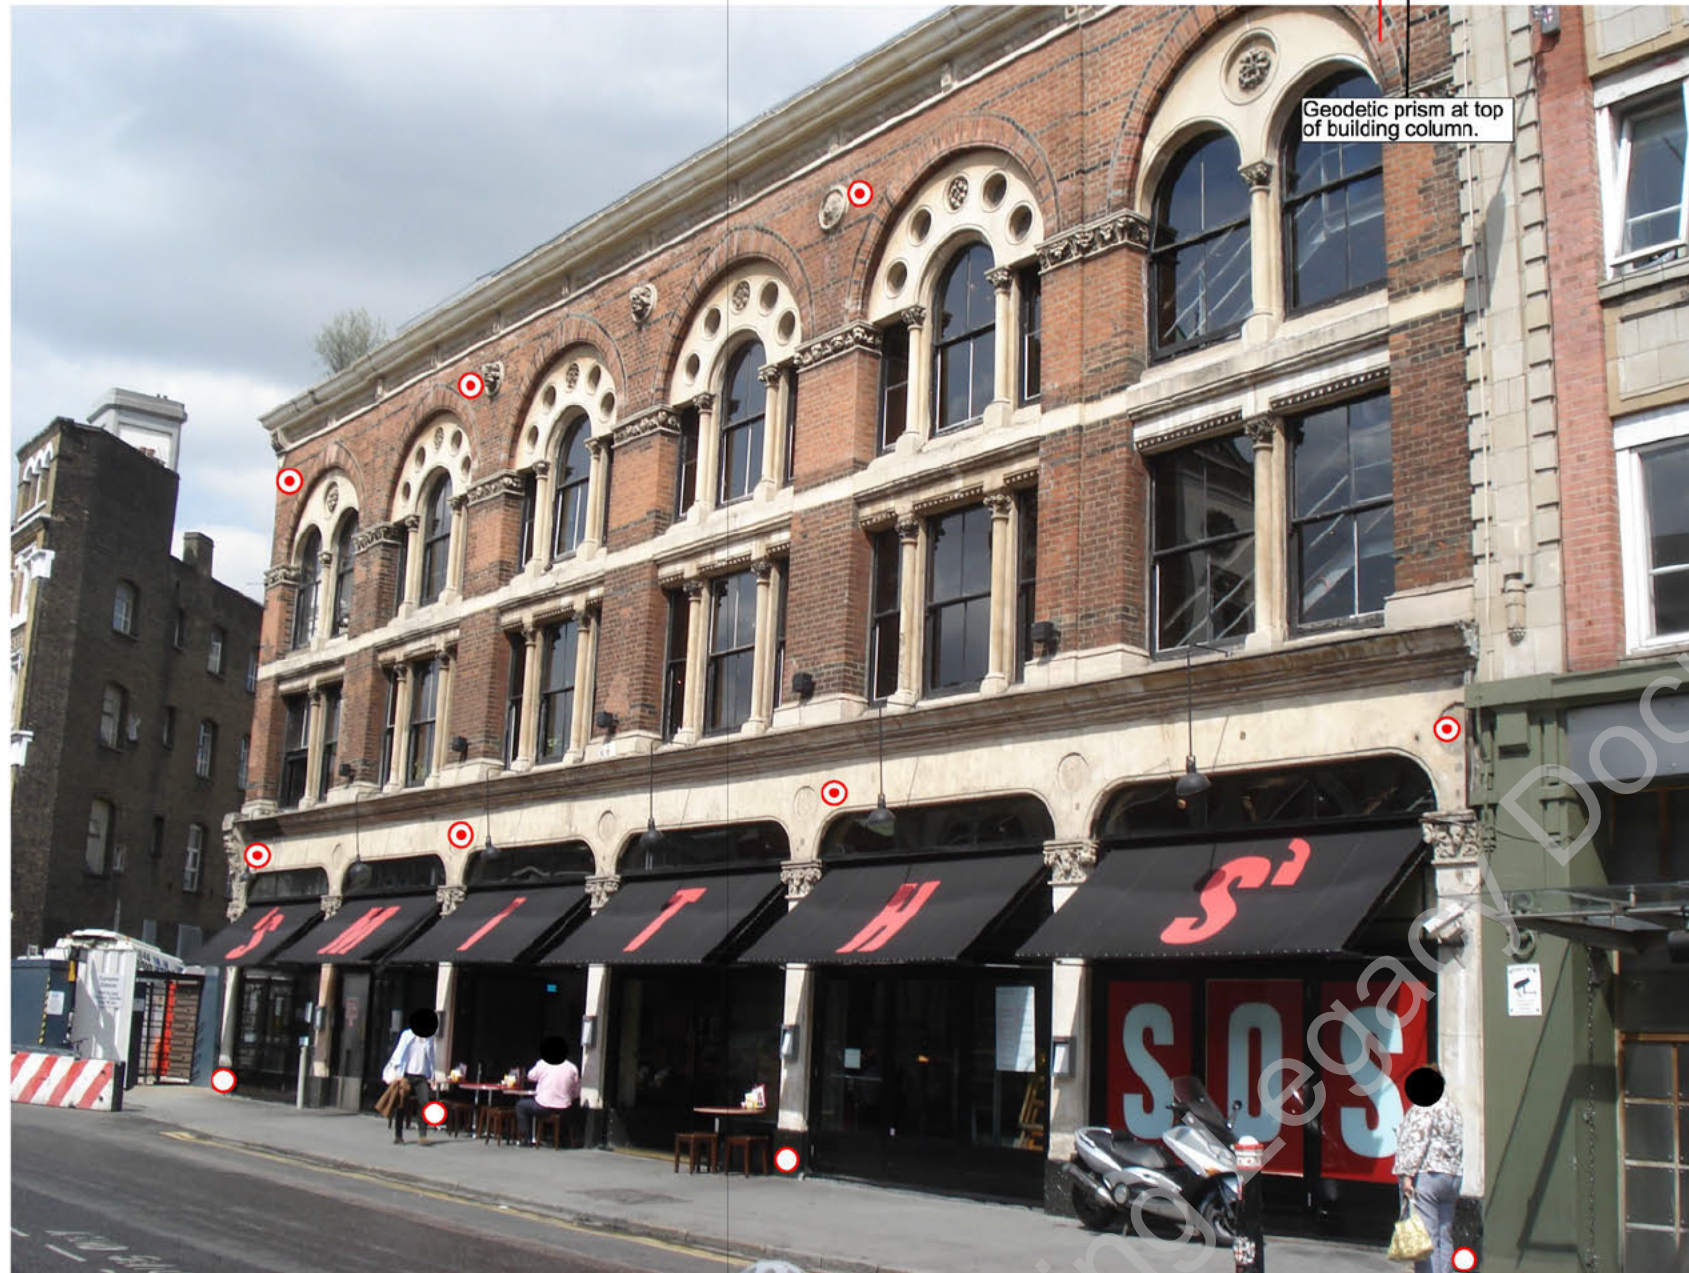
Geodetic prism at top of building column.

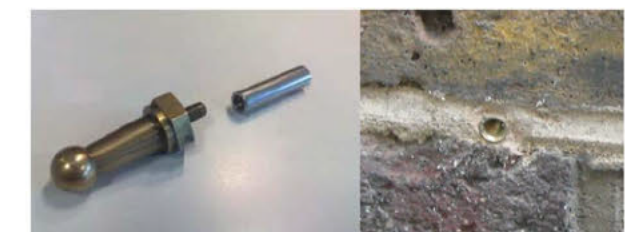
Geodetic prisms are supported on brackets. They are read remotely using Automatic Total Stations fixed to structures nearby.

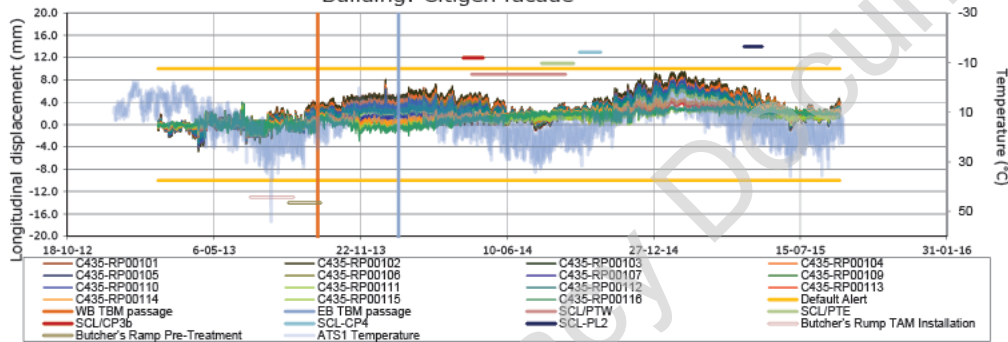
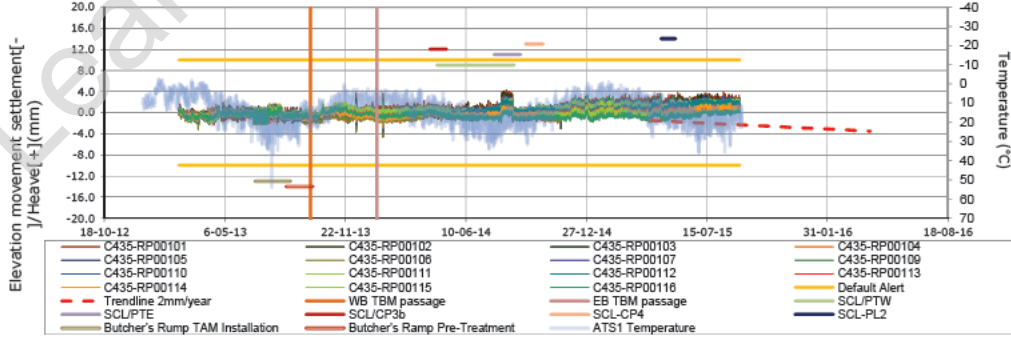
Building: Citigen facade

**REMARKS**  
 2mm heave recorded on 08/08/2014 not real and amended applying a posterior offset on 26/08/2014

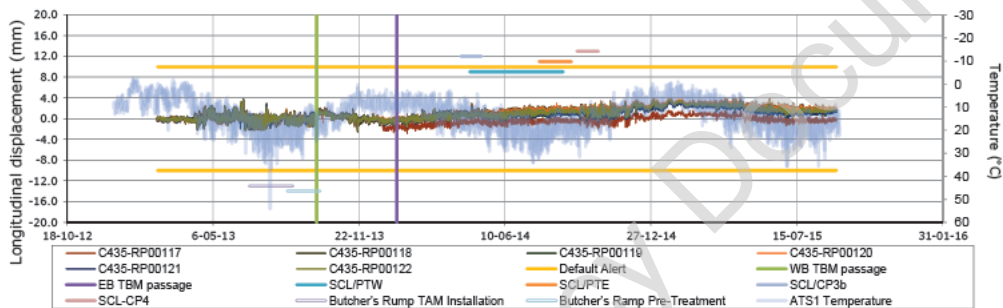
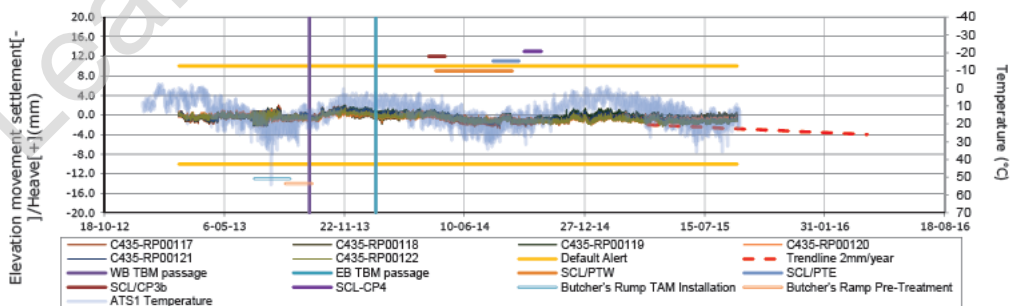
Building: 55 CHARTERHOUSE STREET FACADE

- 55 Charterhouse Street:  
data for 3D Targets installed on the Charterhouse Street facade of this building is shown in Appendix B. During both WB and EB TBM passage, PTE and PTW enlargement and CP3b cross passage excavation works no significant movement was observed on these 3D Targets. The only trend of movement historically recorded from these devices has been due to the temperature fluctuation, clearly seen in all directions.

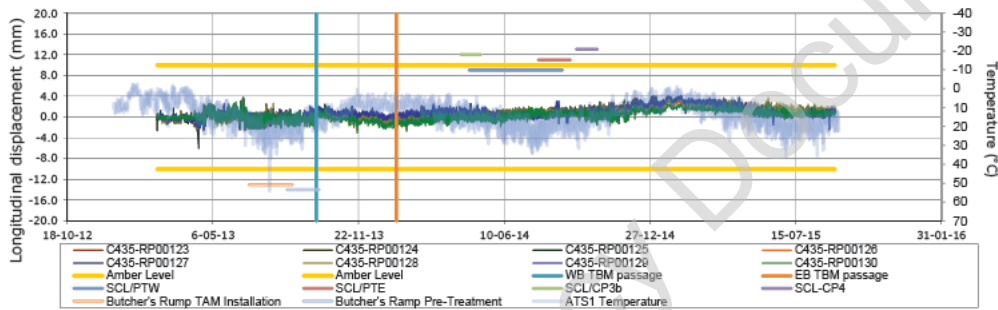
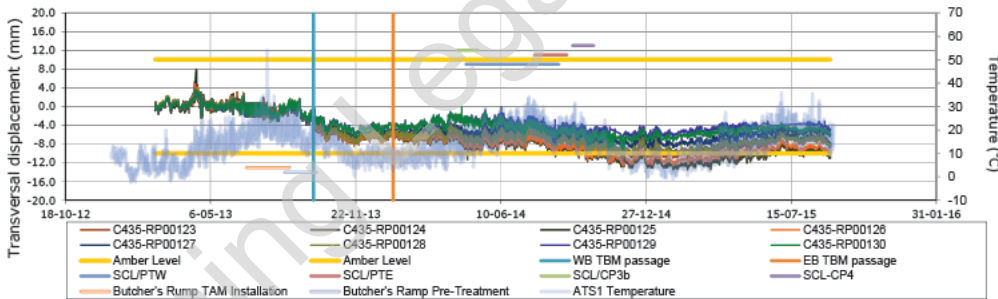
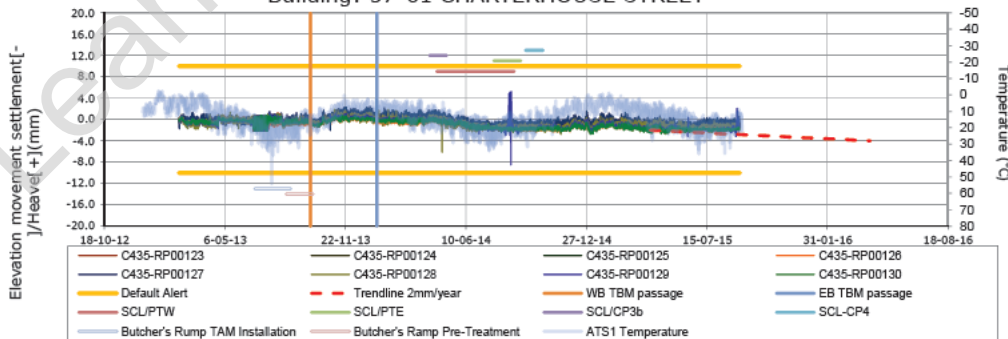
Building: 57-61 CHARTERHOUSE STREET

- 57-61 Charterhouse Street:  
data for 3D Targets installed on the Charterhouse Street facade of this building is shown in Appendix B. During both WB and EB TBM passage, PTE and PTW enlargement and CP3b cross passage excavation works no significant movement was observed on these 3D Targets. The only trend of movement historically recorded from these devices has been due to the temperature fluctuation, clearly seen in all directions.

**REMARKS**  
 These prisms are read by 2 different ATS with different references (ATS N.1 and N.17)  
 01-10-2013: Settlement due to TBM passage  
 These prisms are read by 2 different ATS with different references (ATS N.1 and N.14)  
 02-10-2013: Settlement due to TBM passage

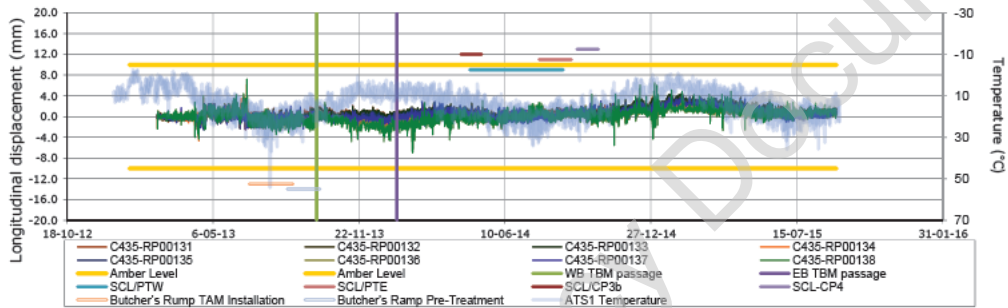
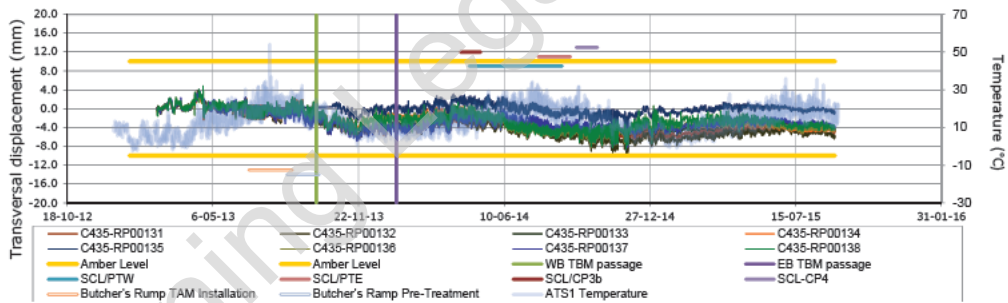
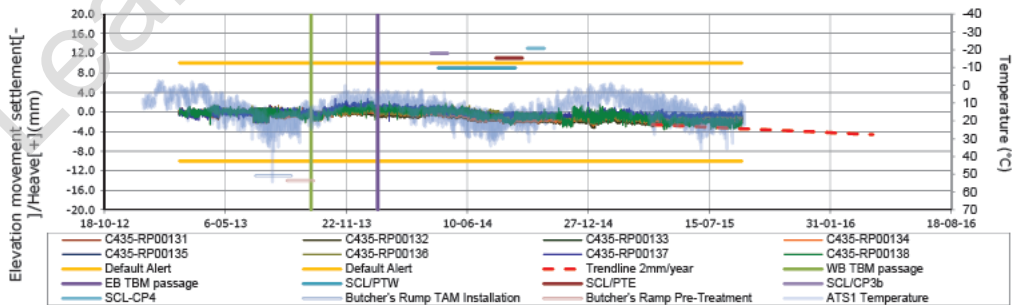
Building: 63 CHARTERHOUSE STREET

- 63 Charterhouse Street:  
data for 3D Targets installed on the Charterhouse Street facade of this building is shown in Appendix B. During both WB and EB TBM passage, PTE and PTW enlargement works no significant movement was observed on these 3D Targets. The only trend of movement historically recorded from these devices has been due to the temperature fluctuation, clearly seen in all directions.

01-10-2013: Settlement due to TBM passage

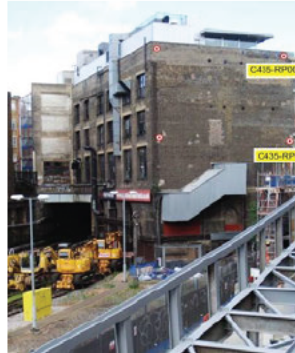
Building: 67-77 CHARTERHOUSE STREET

- 67-77 Charterhouse Street:  
data for 3D Targets installed on the Charterhouse Street facade of this building is shown in Appendix B. WB TBM passage caused around 3mm settlement and the EB TBM around 1.5mm. SCL-PTW enlargement works caused a maximum settlement around 3mm and the PTE enlargement ones around 1.5mm. Almost 4mm heave recorded during Pre-Treatment works carried out from Moorgate Spur Shaft No.3. Historical trend of movement has been recorded from these devices as result of temperature fluctuation, clearly seen in longitudinal and transversal displacement specially.

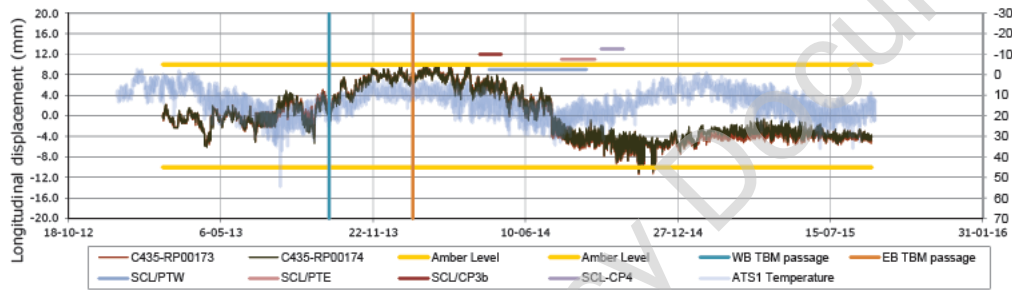
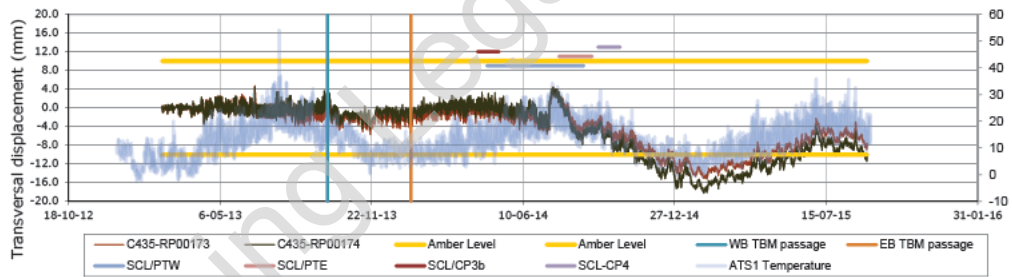
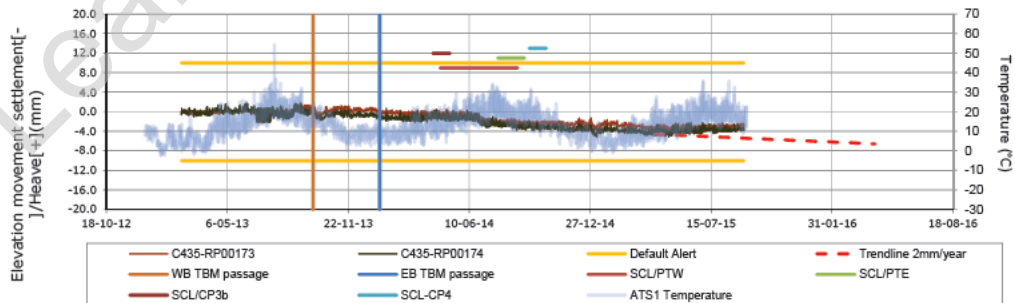
These prisms are read by 2 different ATS with different references (ATS N.1 and N.17)  
 01-10-2013: Settlement due to TBM passage  
 These prisms are read by 2 different ATS with different references (ATS N.1 and N.14)  
 02-10-2013: Settlement due to TBM passage

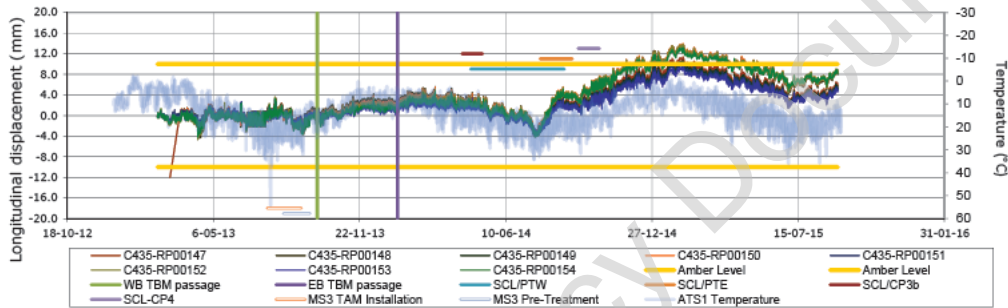
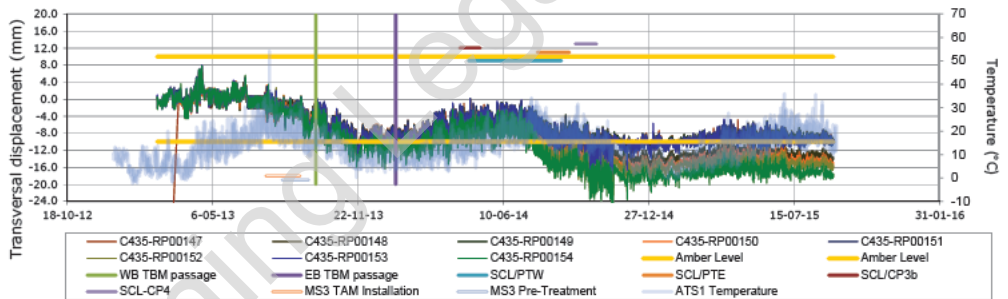
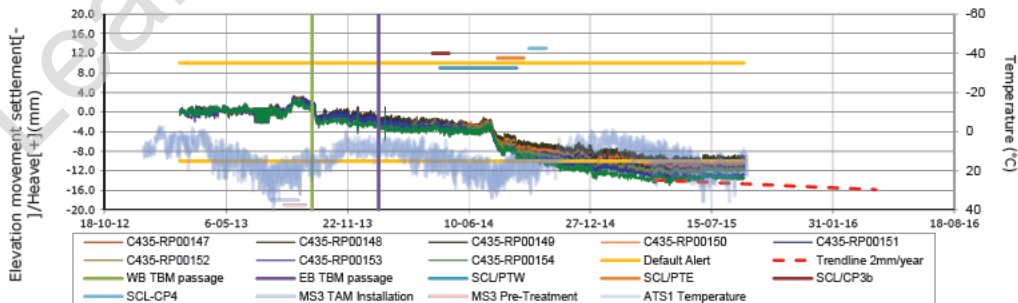
Building: 77a CHARTERHOUSE STREET

- 77a Charterhouse Street:  
data for 3D Targets installed on the Charterhouse Street facade of this building is shown in Appendix B. WB TBM passage caused around 6mm settlement and the EB TBM around 2.5mm. SCL-PTW enlargement works caused a maximum settlement around 7mm and the PTE enlargement ones around 3mm. Almost 4mm heave recorded during Pre-Treatment works carried out from Moorgate Spur Shaft No.3. Historical trend of movement has been recorded from these devices as result of temperature fluctuation, clearly seen in all directions.

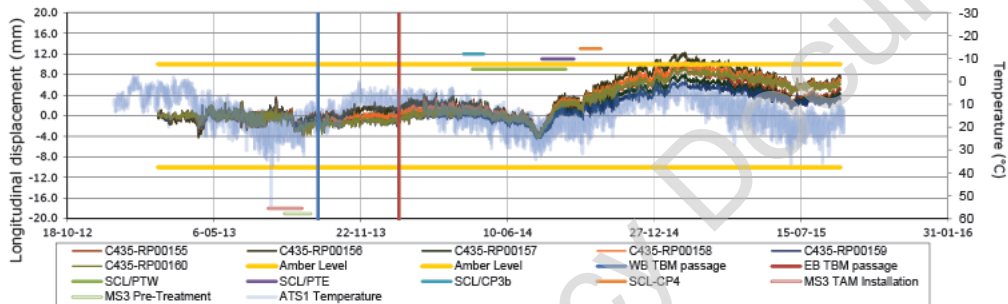
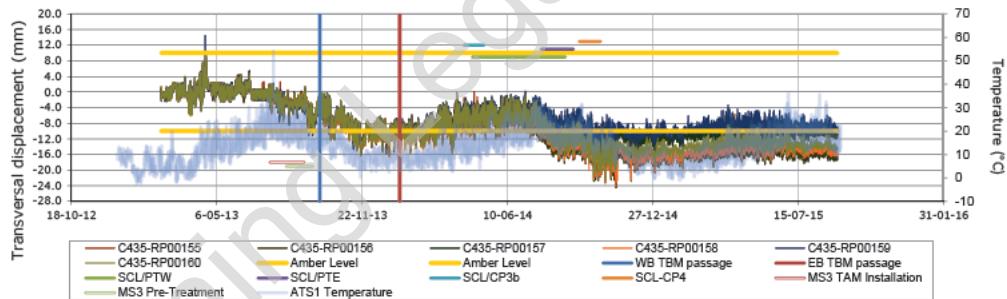
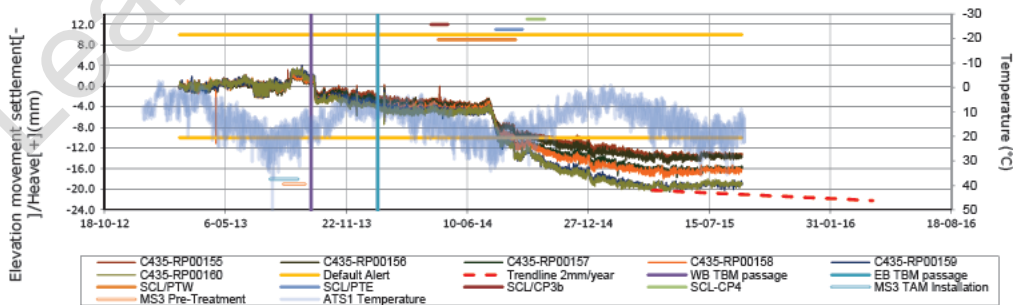
Building: 79-83 CHARTERHOUSE STREET

- 79-83 Charterhouse Street:  
data for 3D Targets installed on the Charterhouse Street facade of this building is shown in Appendix B. WB TBM passage caused around 6mm settlement and the EB TBM around 1.5mm. SCL-PTW enlargement works caused a maximum settlement around 8mm and the PTE enlargement ones around 3mm. SCL cross passage CP4 caused around 3mm of settlement recorded from these 3D Targets. Almost 4mm heave recorded during Pre-Treatment works carried out from Moorgate Spur Shaft No.3. Historical trend of movement has been recorded from these devices as result of temperature fluctuation, clearly seen in all directions.

**REMARKS**  
 These prisms are read by 2 different ATS with different references (ATS N.1 and N.17)  
 01-10-2013: Settlement due to TBM passage

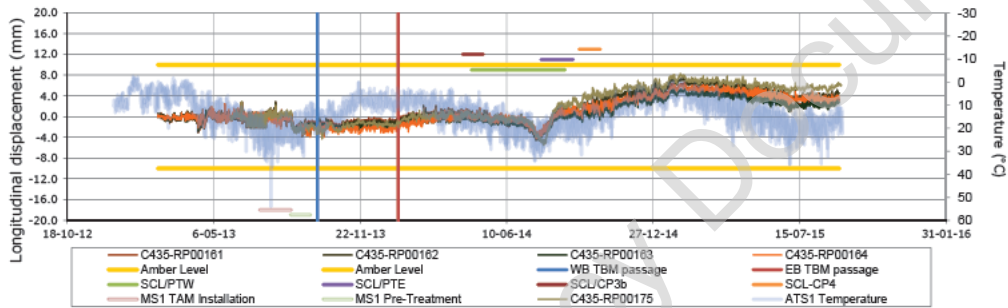
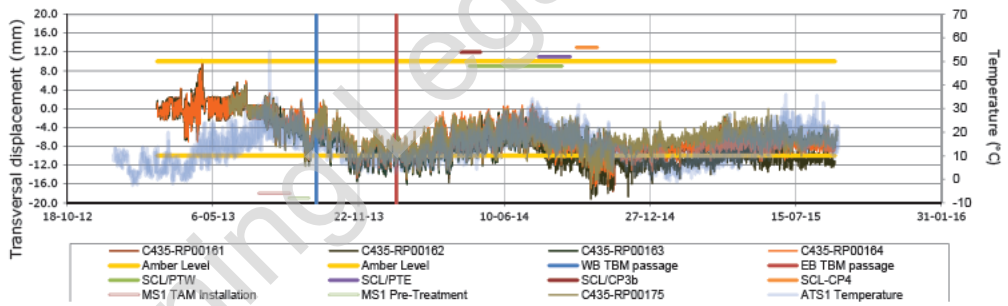
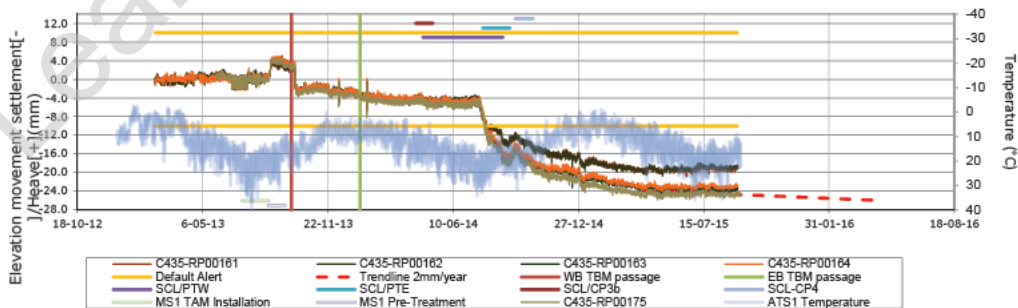
Building: 85 CHARTERHOUSE STREET

- 85 Charterhouse Street:  
data for 3D Targets installed on the Charterhouse Street facade of this building is shown in Appendix B. WB TBM passage caused around 7mm settlement and the EB TBM around 1.5mm. SCL-PTW enlargement works caused a maximum settlement around 13mm and the PTE enlargement ones around 3mm. SCL cross passage CP4 caused around 3mm of settlement recorded from these 3D Targets. Almost 4mm heave recorded during Pre-Treatment works carried out from Moorgate Spur Shaft No.1. Historical trend of movement has been recorded from these devices as result of temperature fluctuation, clearly seen in all directions.

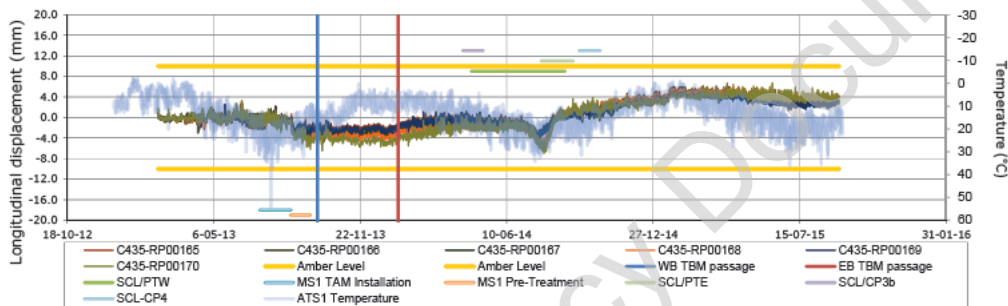
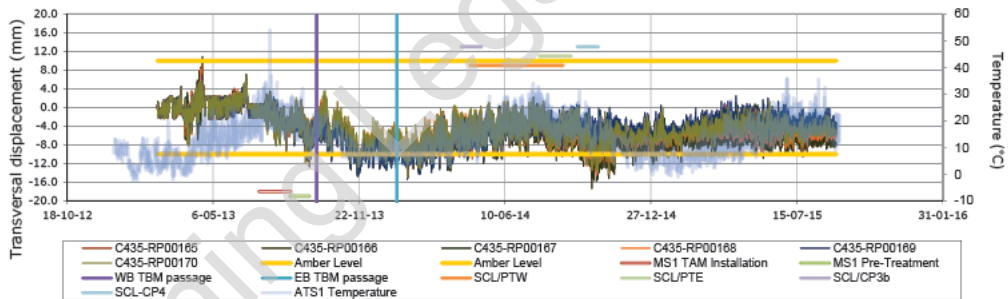
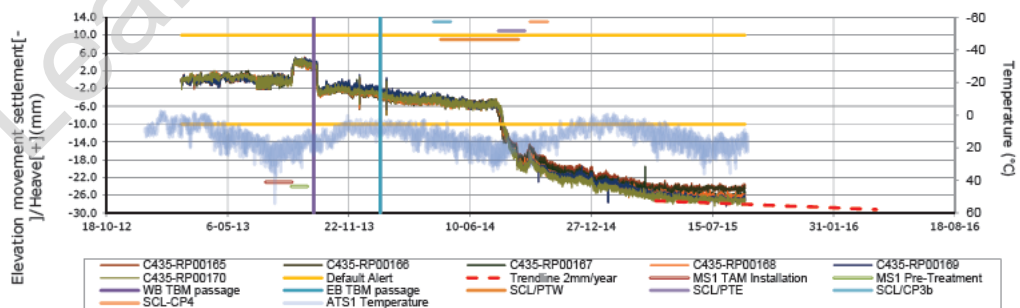
Building: 87 CHARTERHOUSE STREET

- 87 Charterhouse Street:  
data for 3D Targets installed on the Charterhouse Street facade of this building is shown in Appendix B. WB TBM passage caused around 6mm settlement and the EB TBM around 1.5mm. SCL-PTW enlargement works caused a maximum settlement around 16mm and the PTE enlargement ones around 3mm. SCL cross passage CP4 caused around 3mm of settlement recorded from these 3D Targets. Almost 6mm heave recorded during Pre-Treatment works carried out from Moorgate Spur Shaft No.1. Historical trend of movement has been recorded from these devices as result of temperature fluctuation, clearly seen in all directions.
