# C435 Farringdon Main Station

## Monitoring Close-Out Report: Automated Total Station ATS 17 and 3D Targets read by ATS 17.

**CRL Document Number: C435-BFK-C2-RGN-M123-51622**

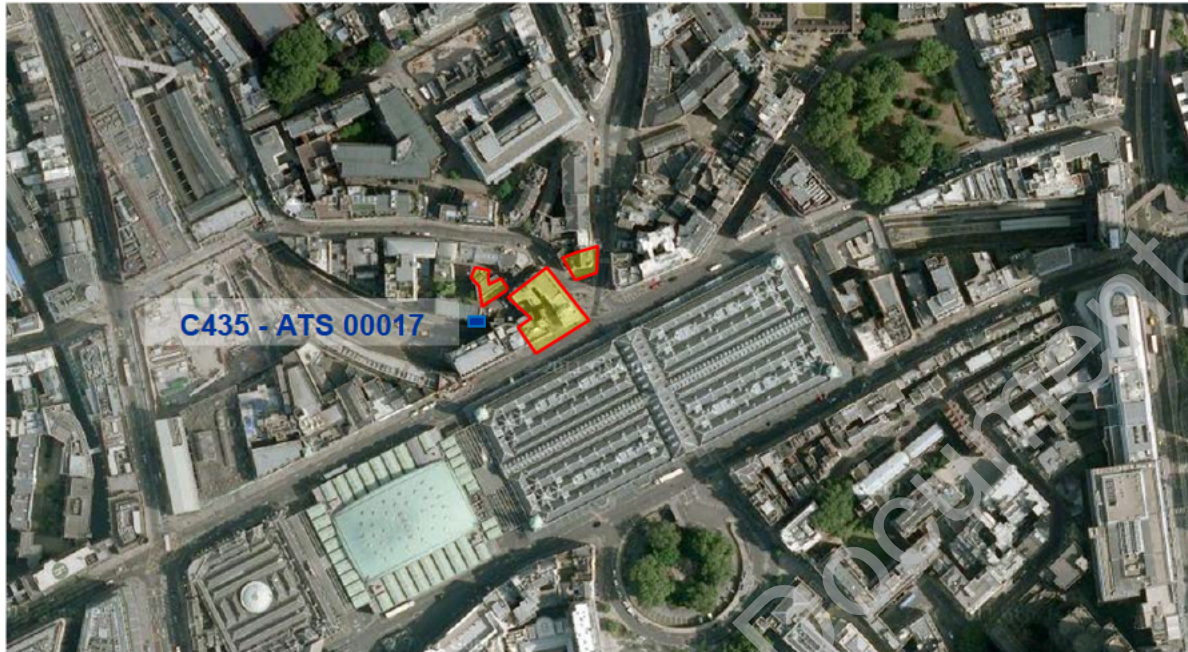
Prisms associated with ATS17 are located on the plan below highlighted in yellow.

Figure 1 – Plan showing the Location prisms read by ATS17.

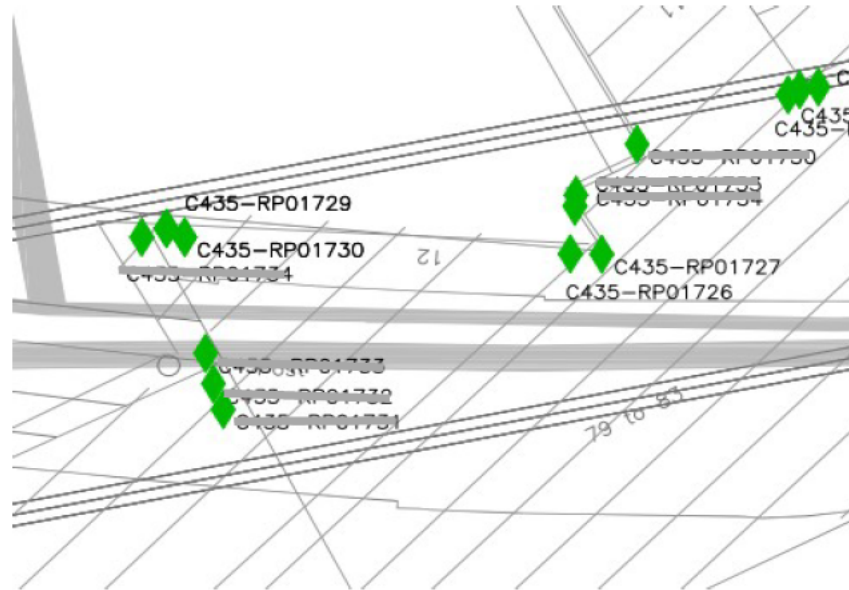
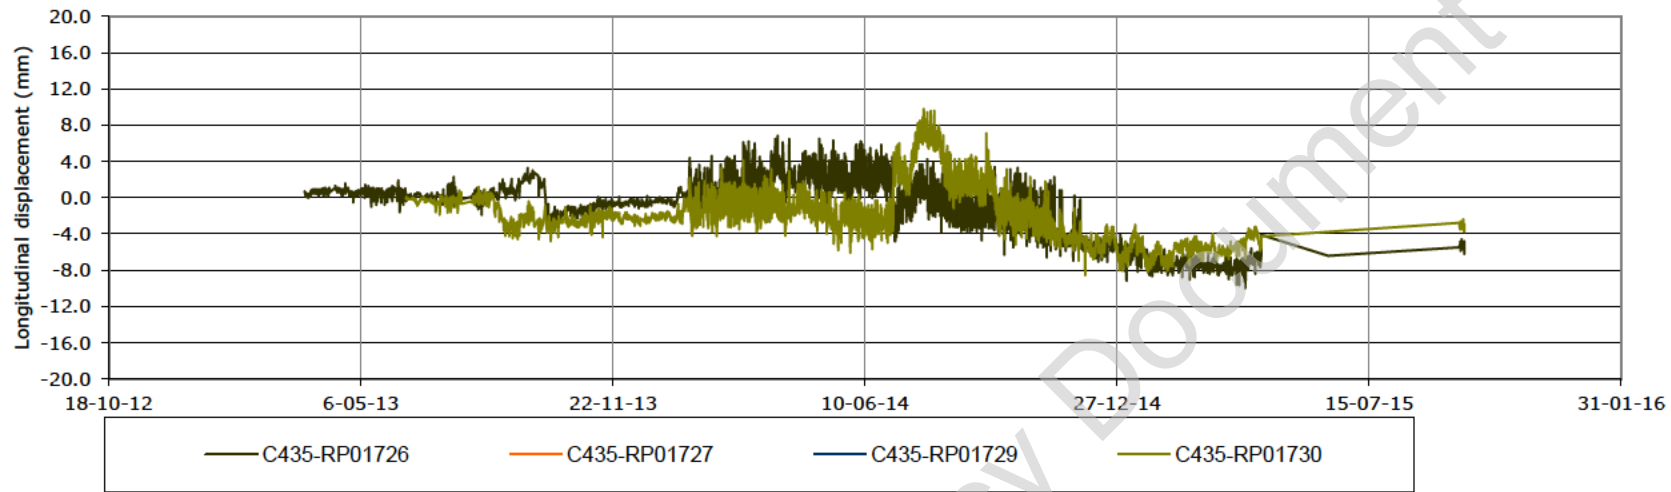
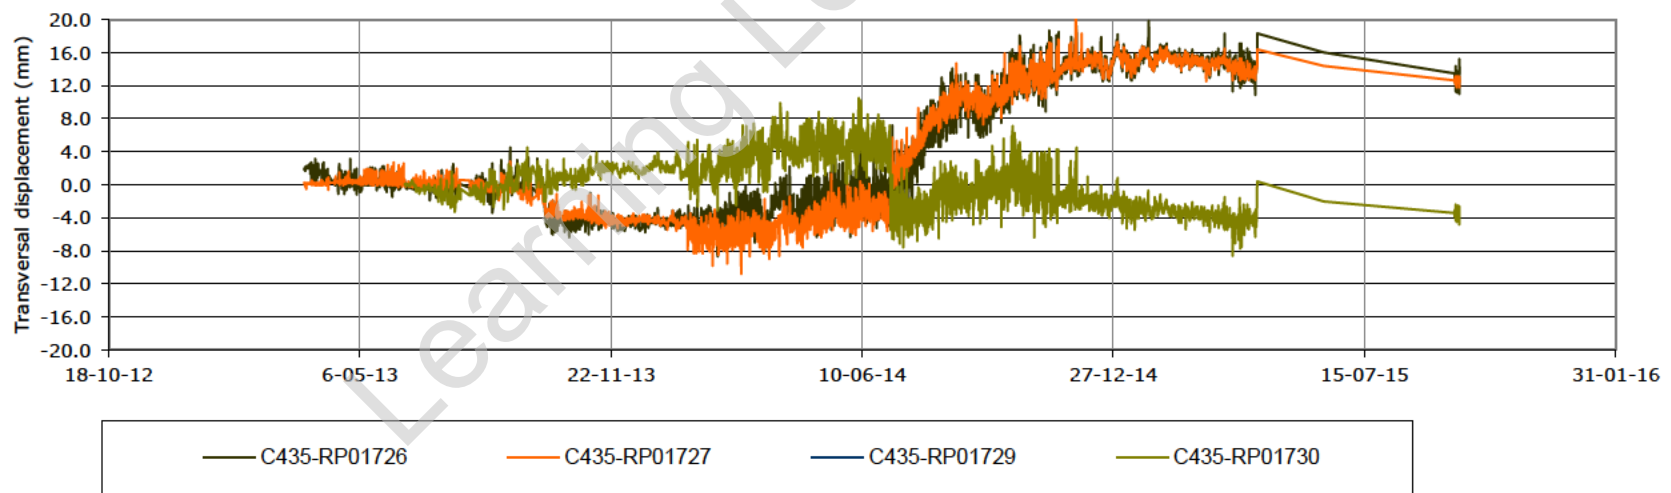
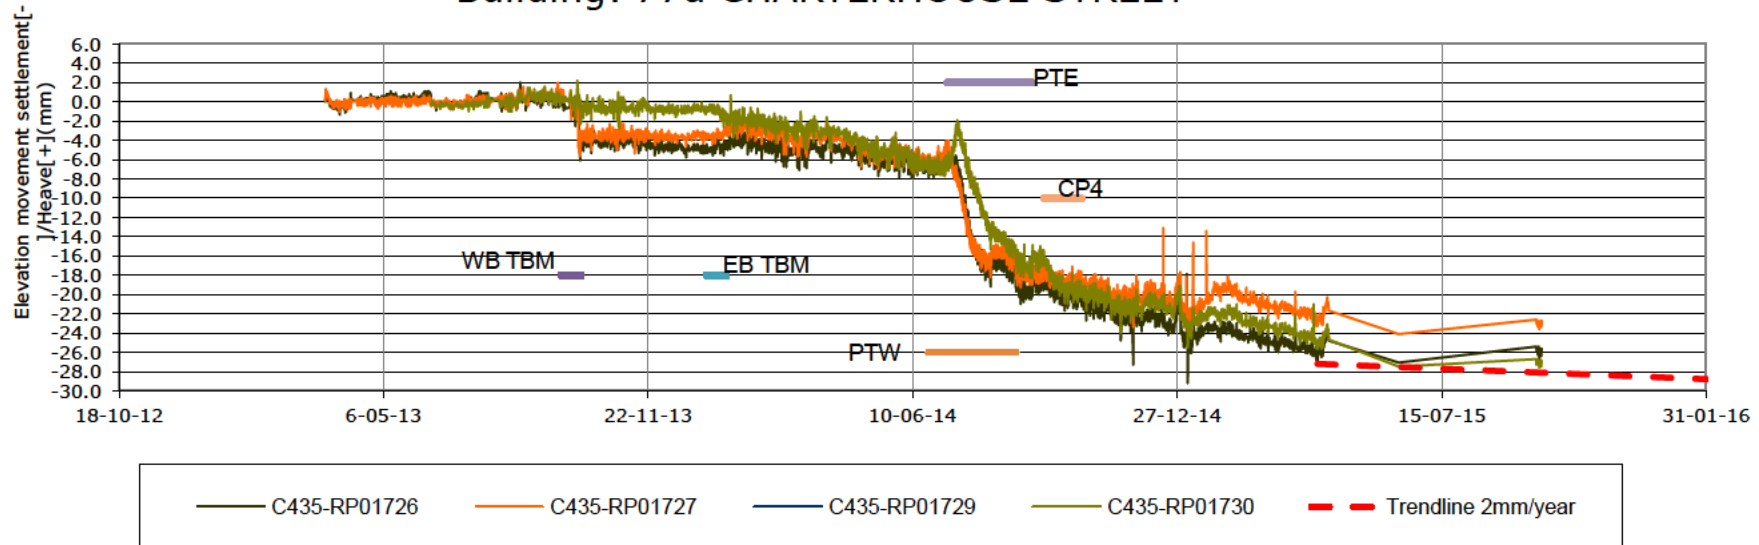
Building: 77a CHARTERHOUSE STREET

- WB TBM caused maximum 4mm of settlement from 25-09-2013 to 26-09-2013.
- EB TBM caused maximum 2mm of settlement from 13-01-2014 to 14-01-2014.
- Residual settlement caused maximum 5-6mm.
- Compensation grouting from Moorgate Shaft 3 caused maximum 5-6mm of heave from 01-07-2014 to 13-07-2014.
- The combination between PTW and PTE works caused maximum 15-17mm of settlement from 22-6-2014 to 09-09-2014.
- Compensation grouting caused maximum 2-3mm of heave from 30-08-2014 to 13-09-2014.
- CP4 construction caused maximum 4-5mm of settlement from 17-09-2014 to 16-10-2014.
- Residual settlement caused 2-3mm.
- Compensation grouting caused maximum 3-4mm of heave from 04-01-2015 to 01-02-2015.
- Maximum Longitudinal displacement -8mm.
- Maximum Transversal displacement 16mm.
- Maximum settlement captured at the end of the works -26mm.

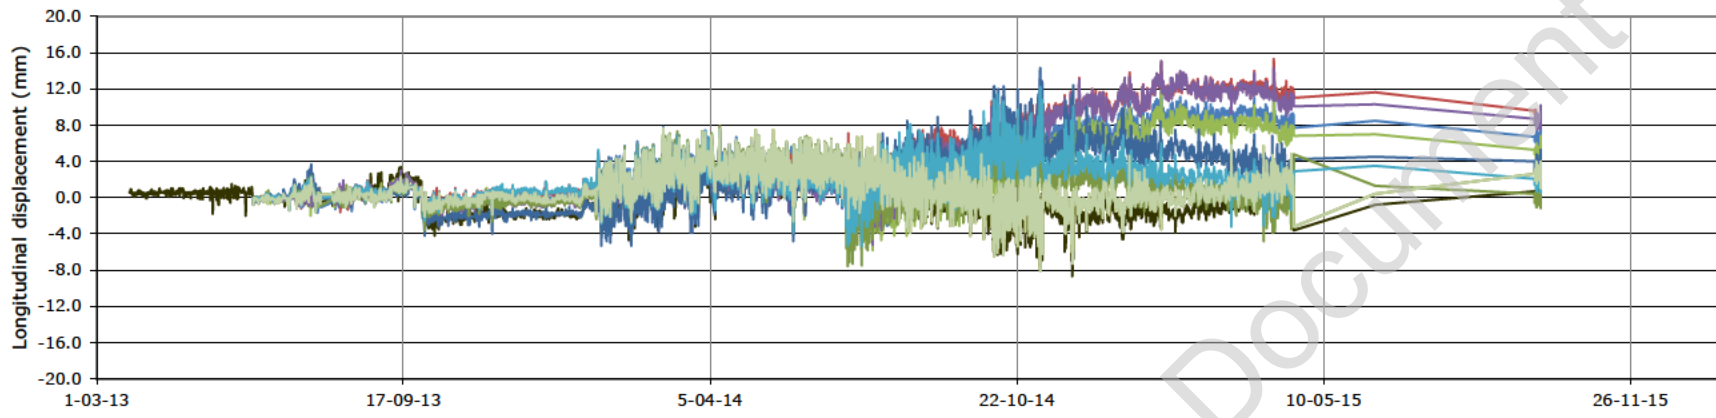
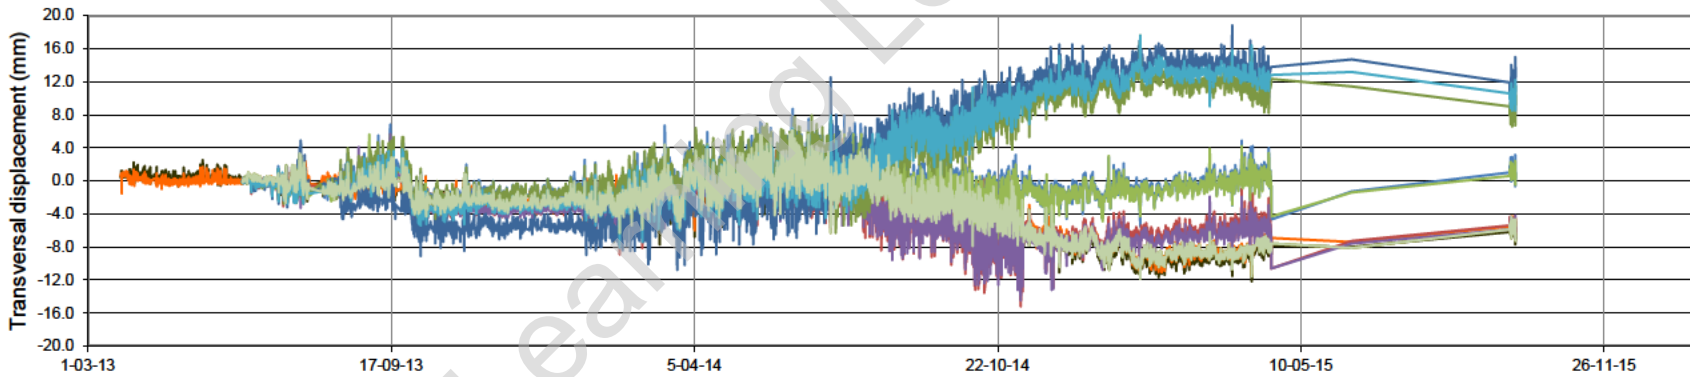
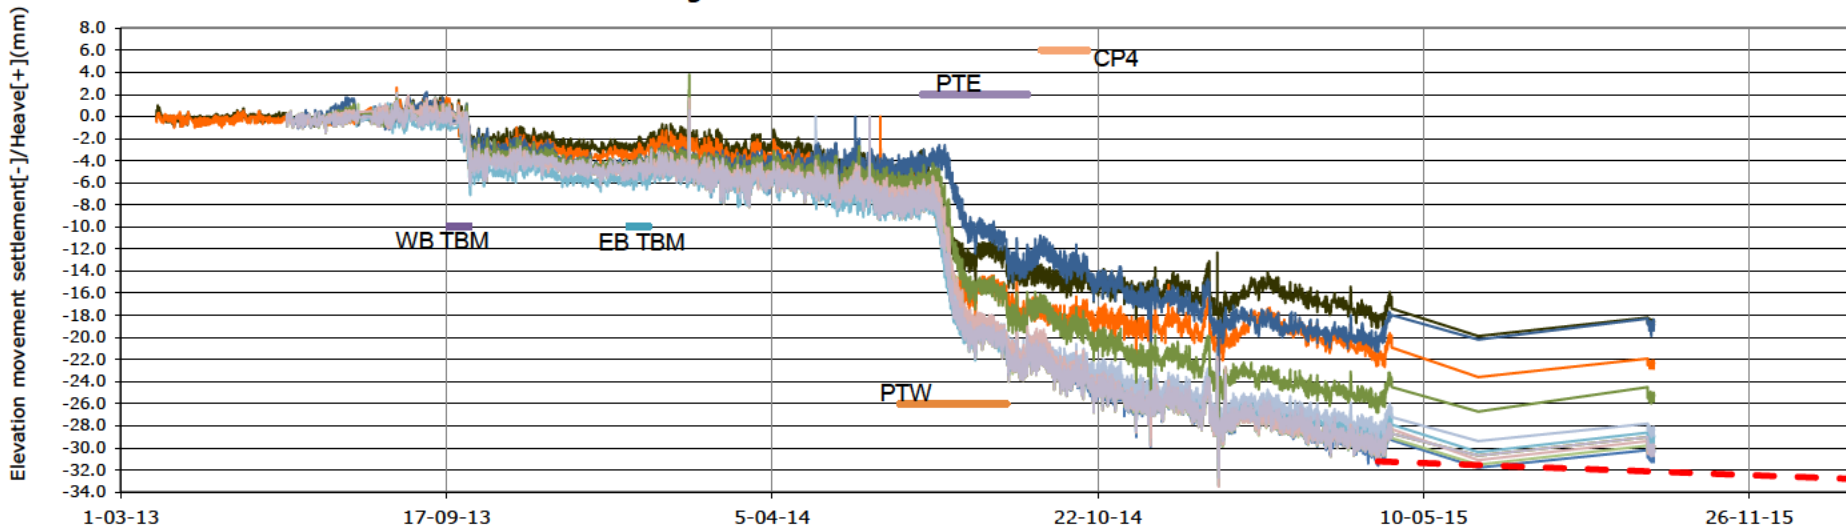
Building: 79-83 CHARTERHOUSE STREET

- WB TBM caused maximum 5-6mm of settlement from 25-09-2013 to 26-09-2013.
- No movements caused by the EB TBM.
- Compensation grouting from Moorgate Shaft 3 caused maximum 2-3mm of heave from 12-07-2014 to 17-07-2014.
- The combination between PTE and PTW caused maximum 14-16mm of settlement from 22-06-2014 to 09-09-2014.
- Compensation grouting caused maximum 2mm of heave from 04-09-2014 to 14-09-2014.
- CP4 construction caused maximum 3-4mm of settlement from 17-09-2014 to 16-10-2014.
- Compensation grouting caused maximum 3-4mm of heave from 08-01-2015 to 31-01-2015.
- Maximum Longitudinal displacement 12mm.
- Maximum Transversal displacement 14mm.
- Maximum settlement captured at the end of the works -30mm.

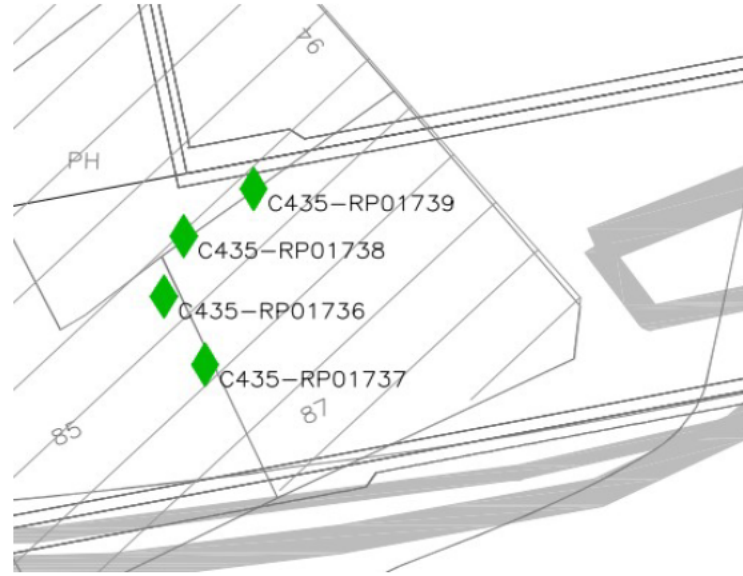
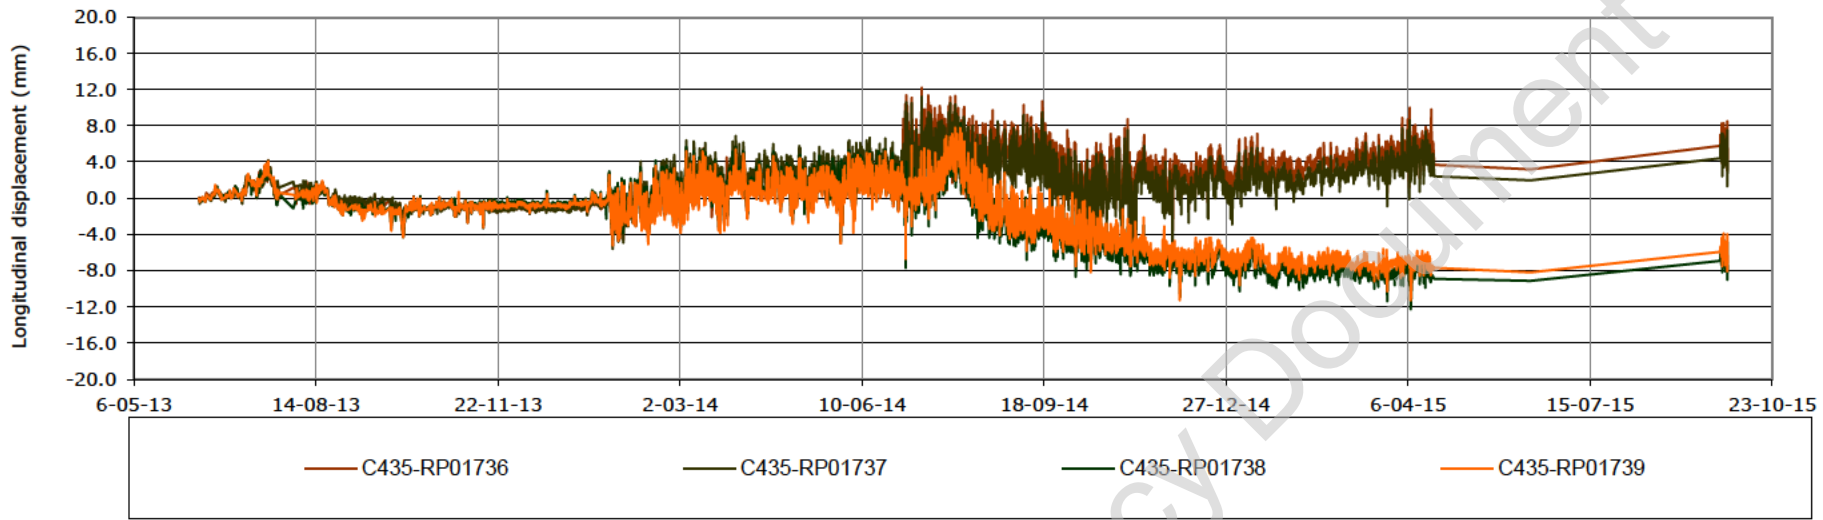
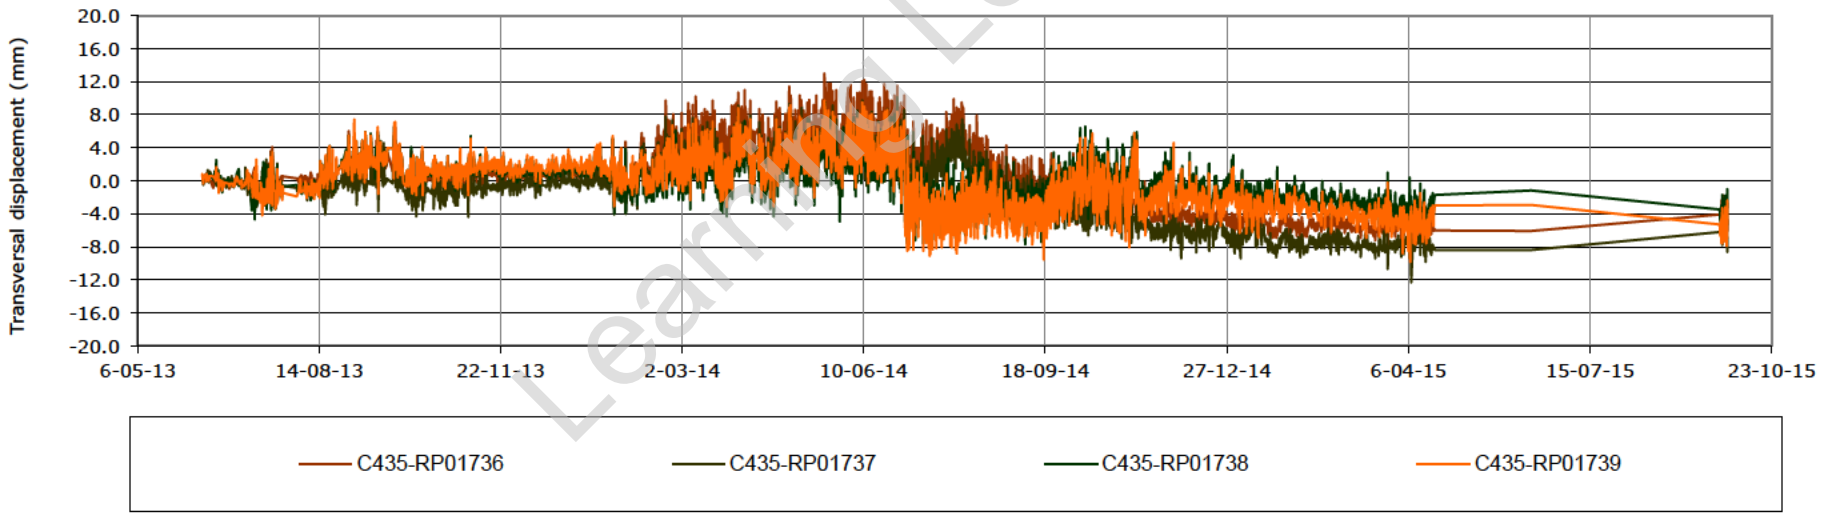
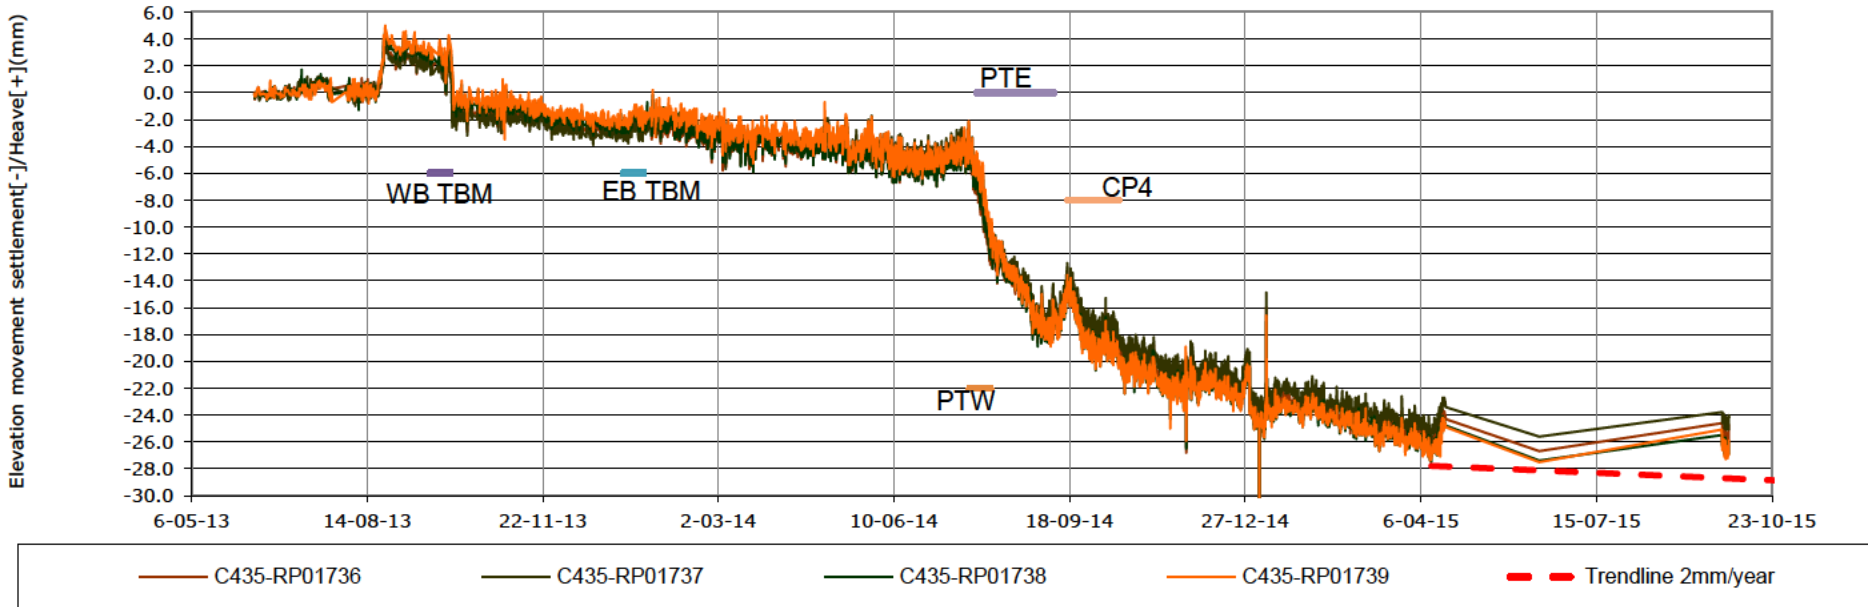
Building: 87 CHARTERHOUSE STREET ROOF

- TaM's installation from Moorgate Shaft 1 caused maximum 4-5mm of heave from 18-08-2013 to 27-08-2013.
- WB TBM caused maximum 4mm of settlement from 25-09-2013 to 26-09-2013.
- Residual settlement caused 2mm.
- No movements caused by the EB TBM.
- Compensation grouting from Moorgate Shaft 1 caused maximum 2-3mm of heave from 08-07-2014 to 22-07-2014.
- The combination between PTW and PTE caused maximum 14-15mm of settlement from 23-07-2014 to 09-09-2014.
- Compensation grouting caused maximum 4-5mm from 03-09-2014 to 18-09-2014.
- CP4 works caused maximum 5-6mm of settlement from 17-09-2014 to 16-10-2014.
- Maximum Longitudinal displacement -8mm.
- Maximum Transversal displacement -8mm.
- Maximum settlement captured at the end of the works -29mm.

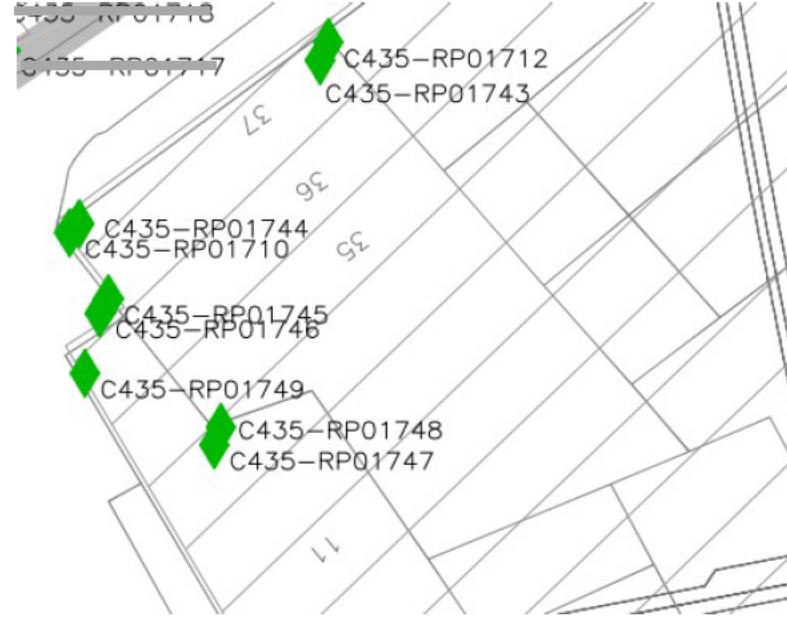
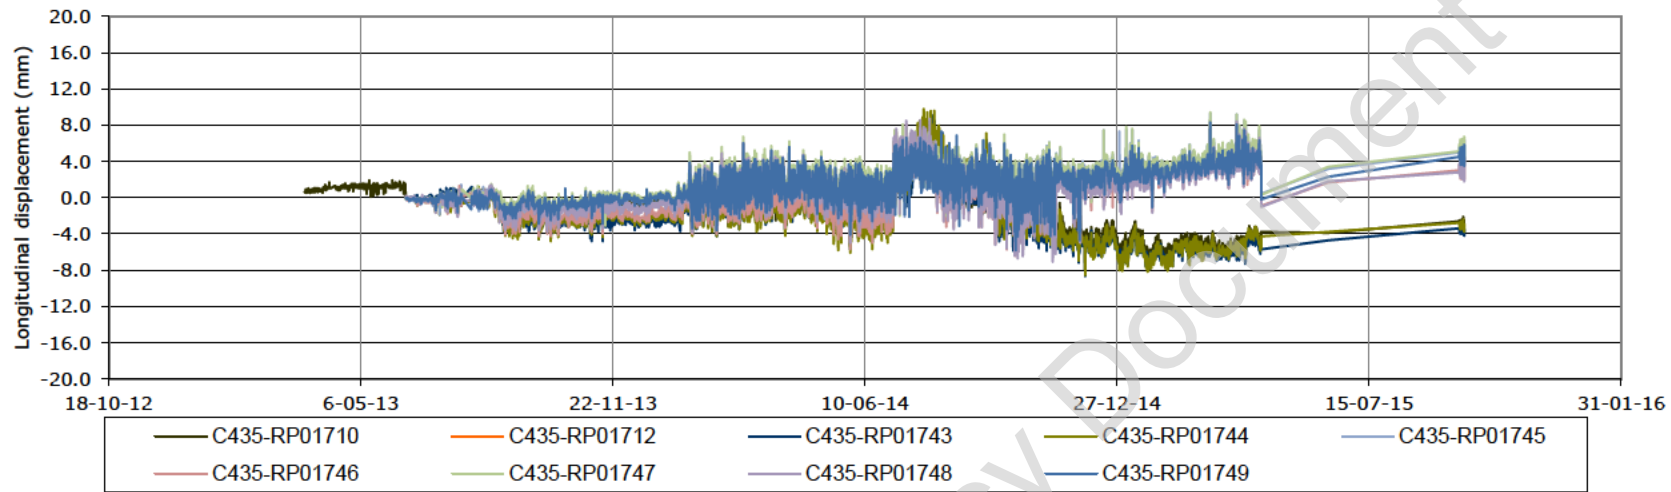
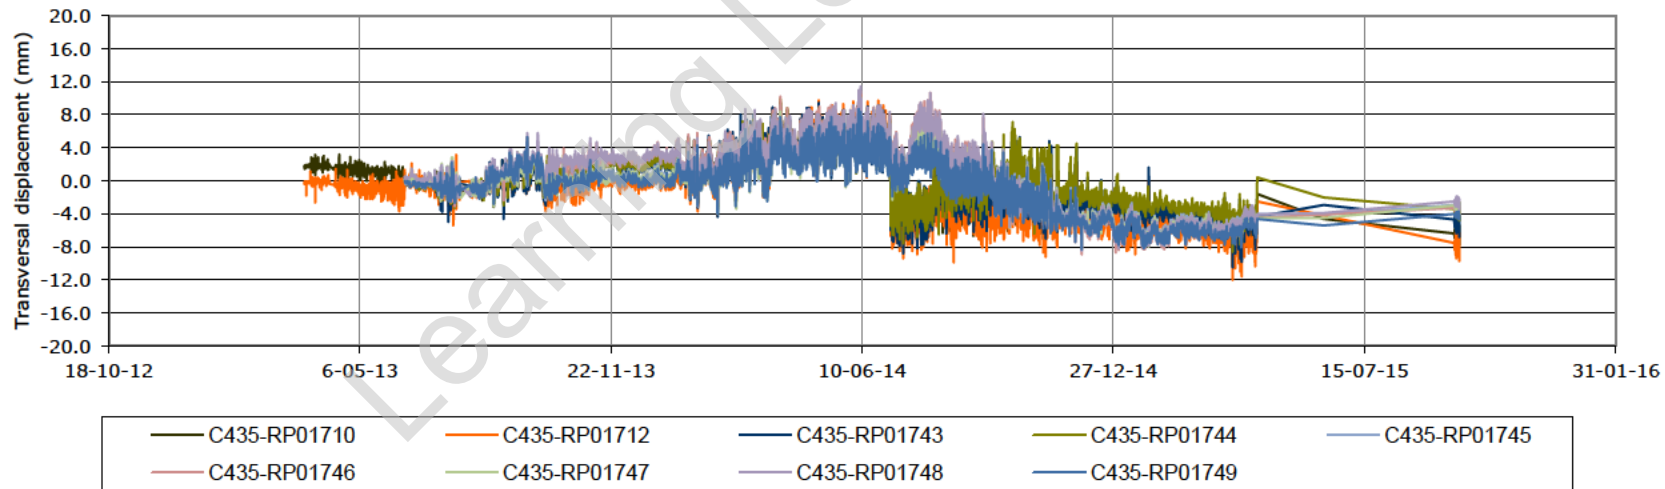
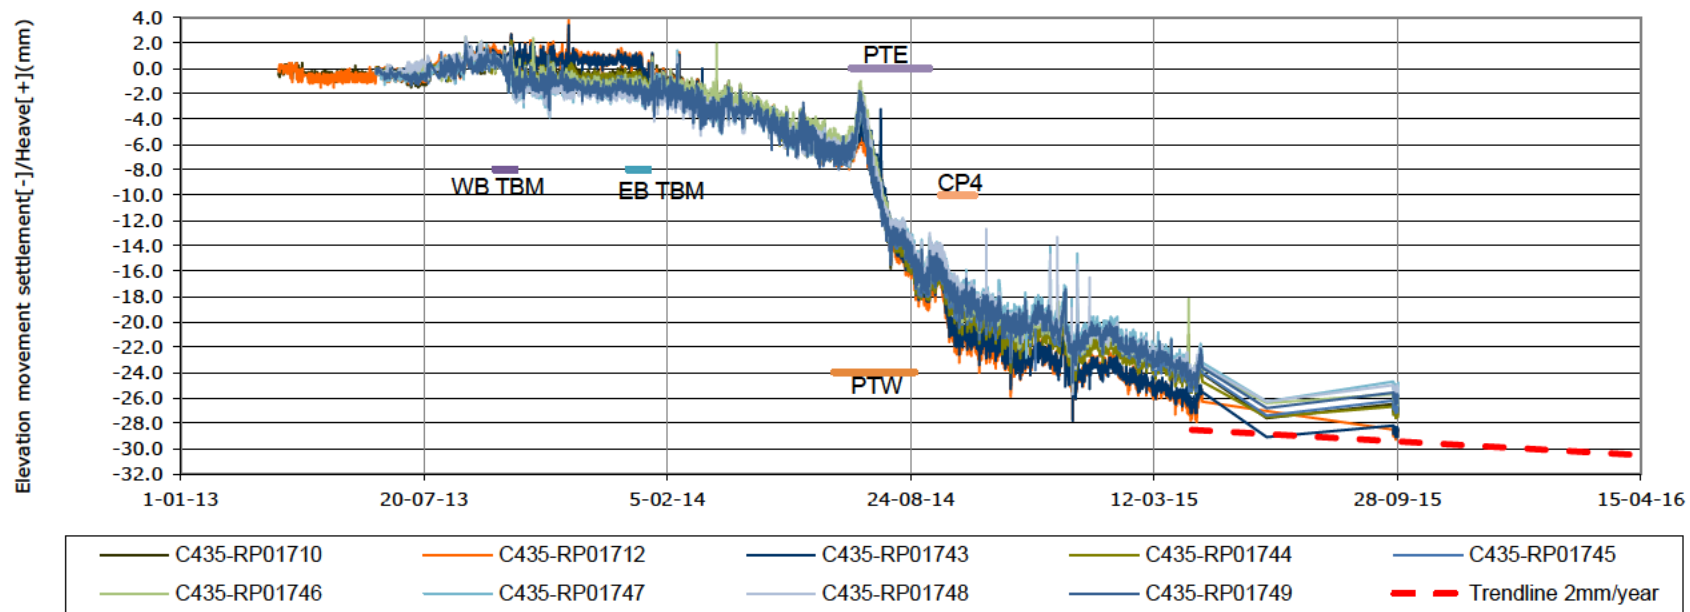
Building: 35-37 GREENHILL'S RENTS

- TaM's installations from Moorgate Shaft 3 caused maximum 2-3mm of heave settlement from 23-07-2013 to 04-09-2013.
- WB TBM caused maximum 2mm of settlement from 25-09-2013 to 26-09-2013.
- EB TBM caused maximum 2-3mm of settlement from 13-01-2014 to 14-01-2014.
- Residual settlement caused 5-6mm.
- Compensation grouting from Moorgate Shaft 3 caused maximum 6-7mm of heave from 04-07-2014 to 13-07-2014.
- The combination between PTW and PTE caused maximum 14-16mm of settlement from 22-06-2014 to 09-09-2014.
- Compensation grouting caused maximum 5-6mm of heave from 06-09-2014 to 14-09-2014.
- CP4 construction works caused maximum 8-10mm of settlement from 17-09-2014 to 16-10-2014.
- Maximum Longitudinal displacement -6mm.
- Maximum Transversal displacement -9mm.
- Maximum settlement captured at the end of the works -30mm.

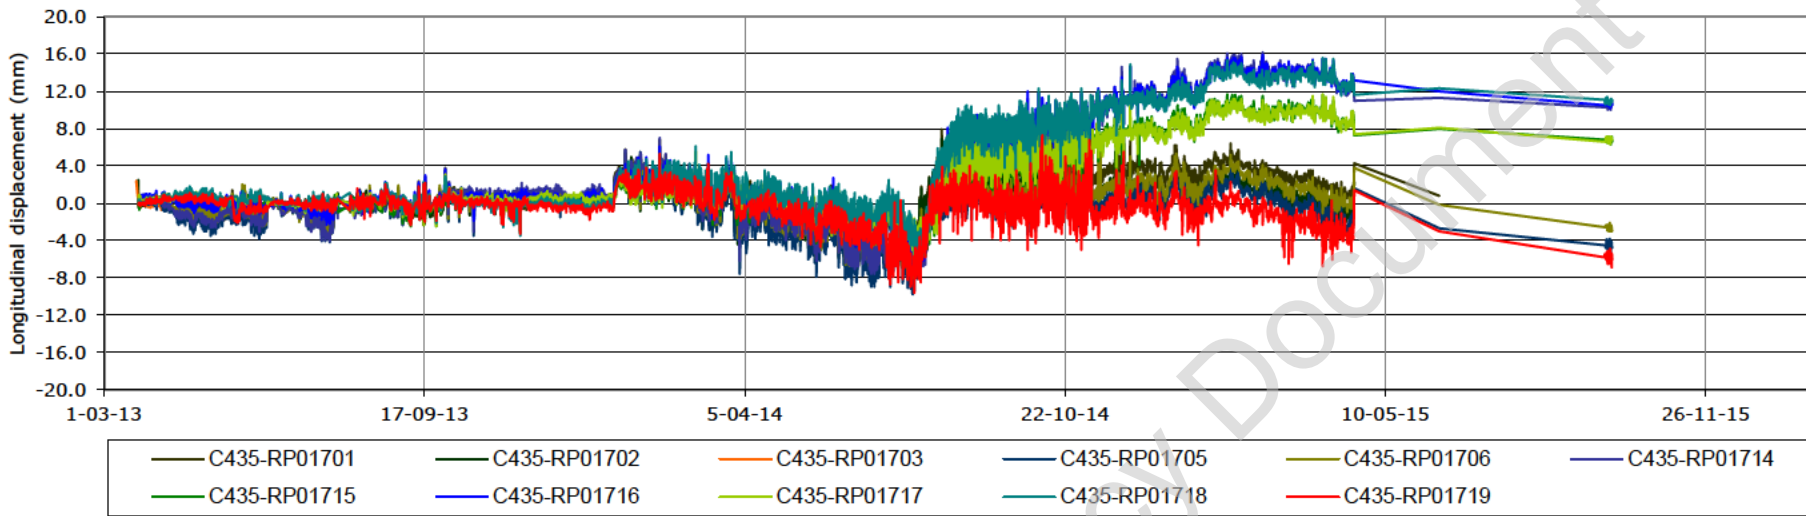
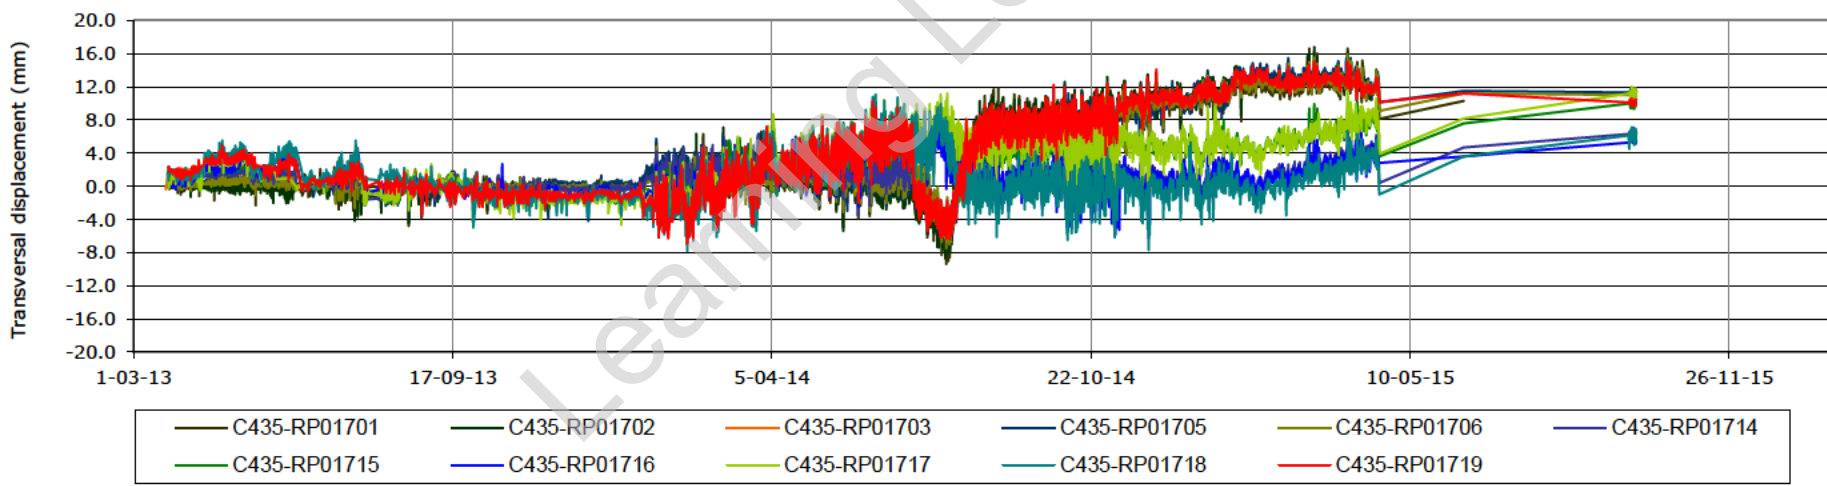
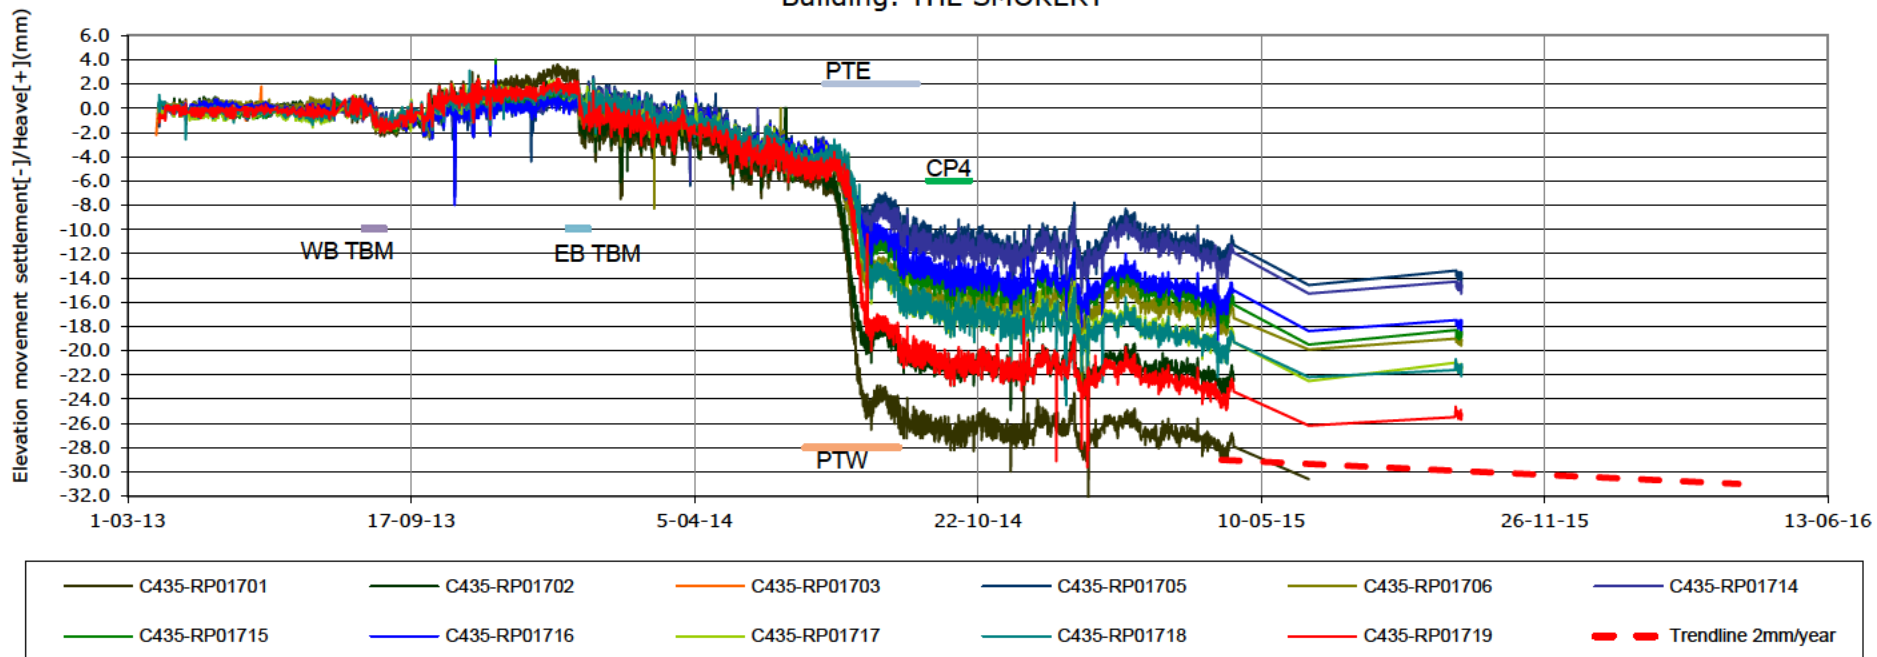
Building: THE SMOKERY

- WB TBM caused maximum 2mm of settlement from 22-08-2013 to 24-08-2013.
- EB TBM caused maximum 3-4mm of settlement from 13-01-2014 to 15-01-2014.
- Residual settlement caused 4-5mm.
- The combination between PTW and PTE caused maximum 20-22mm of settlement from 22-06-2014 to 09-09-2014.
- CP4 caused maximum 2-3mm of settlement from 17-09-2014 to 16-10-2014.
- Maximum Longitudinal displacement 16mm.
- Maximum Transversal displacement 15mm.
- Maximum settlement captured at the end of the works -30mm.

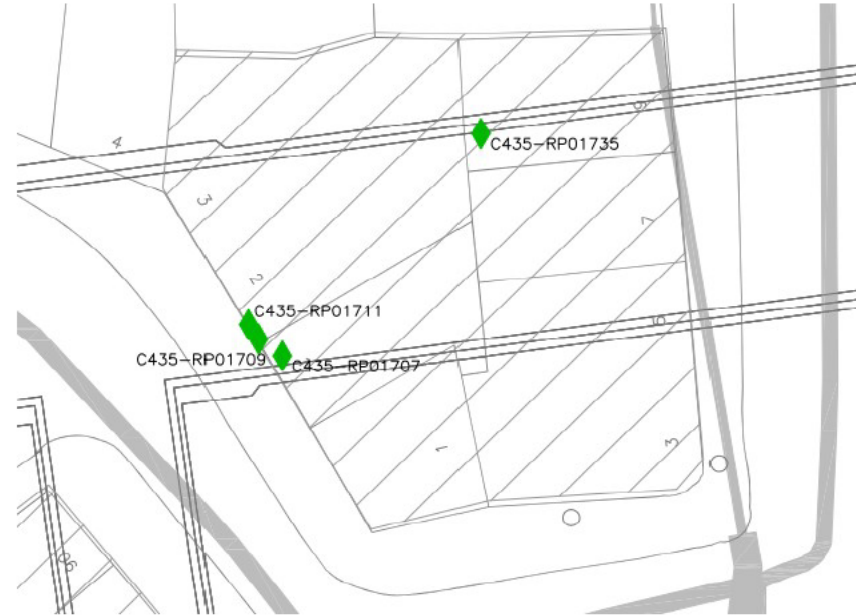
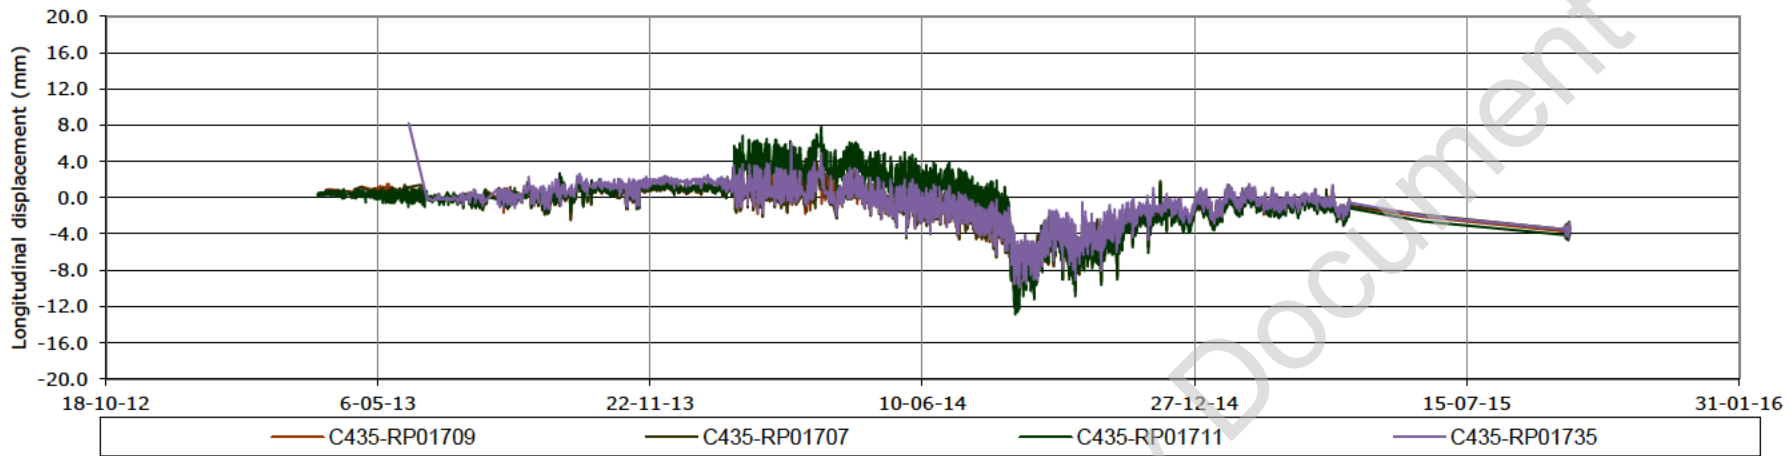
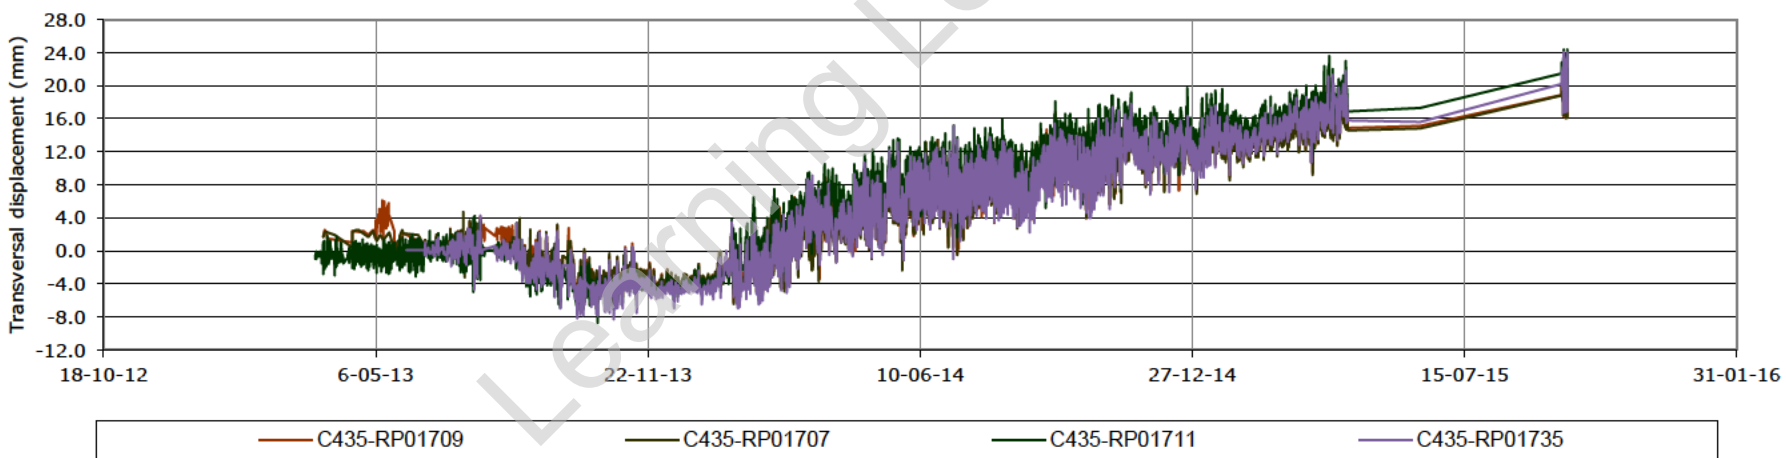
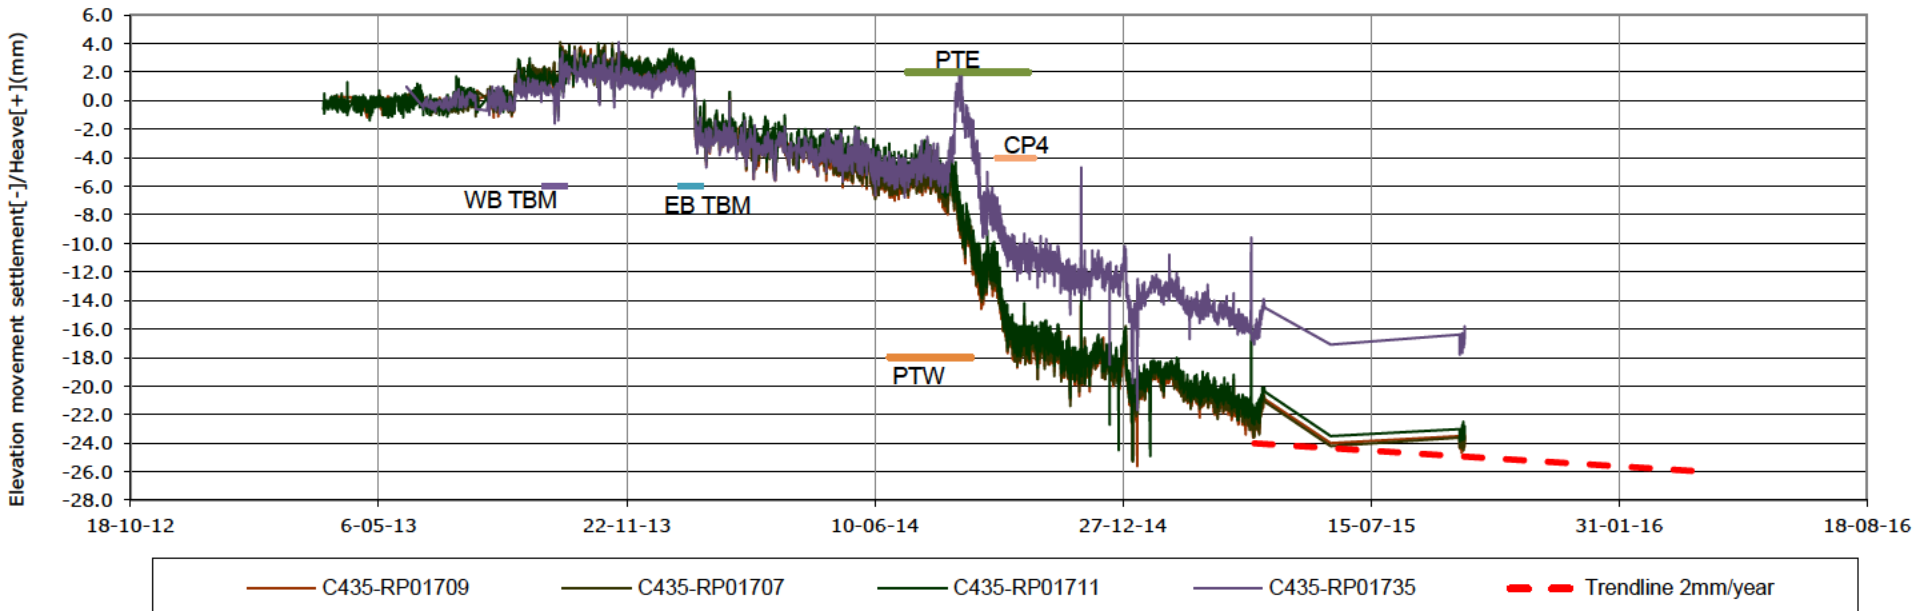
Building: 2-3 COWCROSS STREET

- TaM's installations from Moorgate Shaft 1 caused maximum 2-3mm of heave from 27-08-2013 to 14-01-2014.
- No movements caused by the WB TBM.
- EB TBM caused maximum 4-5mm of settlement from 13-01-2014 to 14-01-2014.
- Residual settlement caused 4-5mm.
- Compensation grouting from Moorgate Shaft 1 caused maximum 7-8mm of heave from 06-08-2014 to 17-08-2014.
- The combination between PTW and PTE caused maximum 13-14mm of settlement from 22-06-2014 to 12-10-2014.
- CP4 construction works caused 4-5mm of settlement from 17-09-2014 to 16-10-2014.
- Maximum Longitudinal displacement -12mm.
- Maximum Transversal displacement 18mm.
- Maximum settlement captured at the end of the works -24mm.
