C435 Farringdon Main Station

Monitoring Close-Out Report: Automated Total Station ATS 05 and 3D Targets read by ATS 05.

CRL Document Number: C435-BFK-C2-RGN-M123-51640

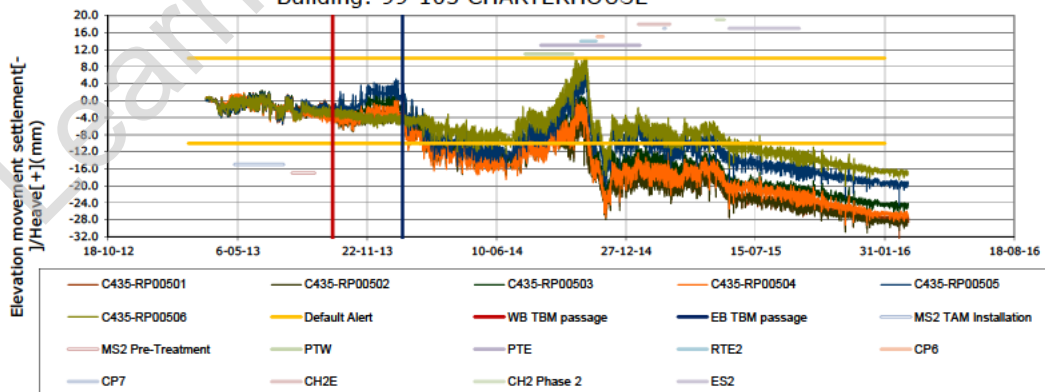
Building: 99-103 CHARTERHOUSE

- WB TBM caused 3mm maximum of settlement on 30-09-2013
- Compensation grouting caused 3-4mm maximum of heave from 22-11-2013 to 08-01-2014.
- EB TBM caused 4-5mm of settlement on 16-01-2014.
- Compensation grouting caused 8mm maximum of heave from 02-07-2014 to 01-08-2014.
- Ground treatment caused 14-15mm of heave in October 2014
- PTE and CP6 construction caused 16-18mm of settlement from 17-08-2014 to 18-01-2015.
- CH2 caused 8-10mm of settlement maximum from 15-01-2015 to 28-05-2015.
- Maximum Lateral displacement was -18mm
- Maximum Transversal displacement was 18mm
- Maximum settlement at the end of the works was -28mm

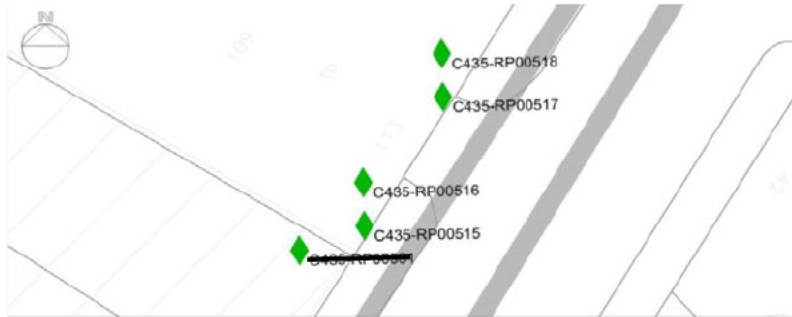
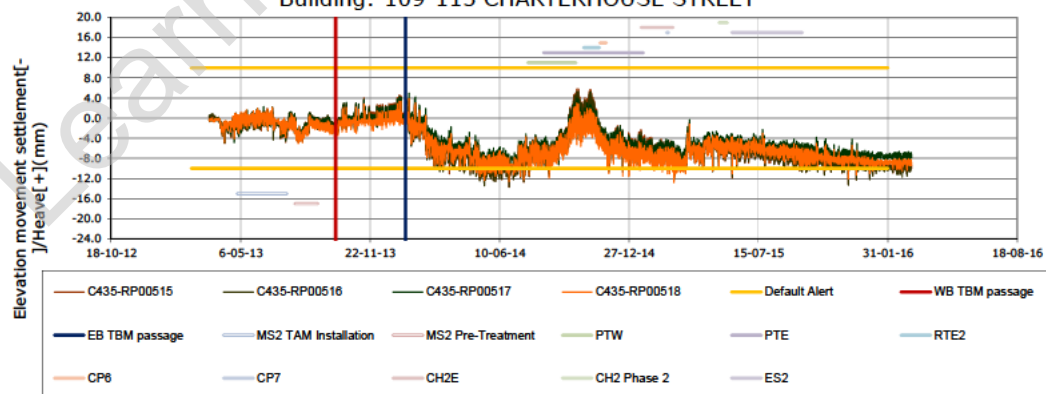
Building: 109-113 CHARTERHOUSE STREET

- EB TBM caused maximum 2-3mm of settlement on 16-01-2014.
- Compensation Grouting from Moorgate Shaft 2 caused 4-5mm of heave from 01-07-2014 to 03-09-2014.
- Ground treatment caused 12-14mm of heave in October and November 2014.
- PTE and CP6 caused 14-16mm of settlement from 17-08-2014 to 22-11-2014.
- CH2 caused 2-3mm maximum of settlement from 15-01-2015 to 05-03-2015.
- Maximum Lateral displacement was 8mm
- Maximum Transversal displacement was 16mm
- Maximum settlement at the end of the works was -8mm

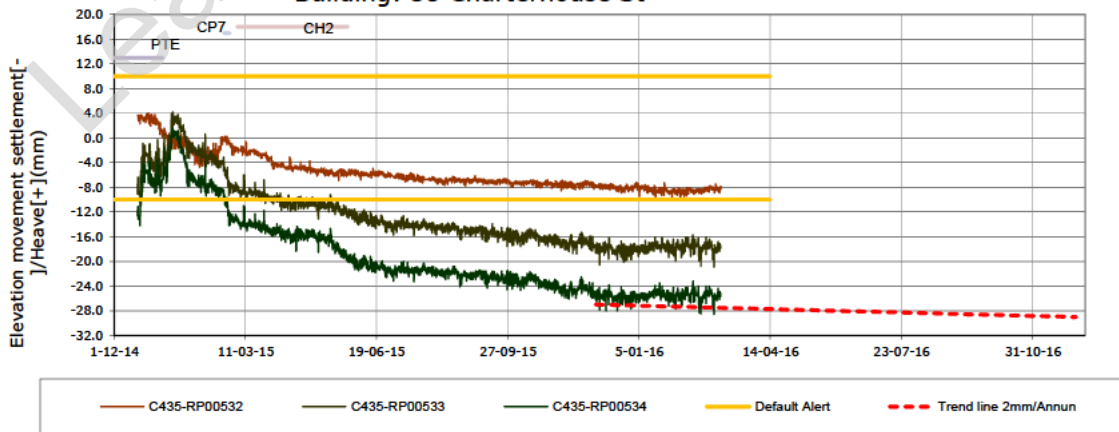
Building: 38 Charterhouse St

Monitoring data for these prisms is shown in Appendix B. These prisms were installed by C430 to be read manually. C435 change the orientation for these prisms to be read automatically on 19-12-2014. For this reason the history of the movements for these prisms start on 19-12-2014.

- PTE enlargement works caused maximum 4mm from 20-12-2014 to 13-01-2015.
- Compensation grouting from Moorgate Shaft 2 caused maximum 8mm of heave between 10-01-2015 and 16-01-2015.
- CP7 construction caused 2-3mm of settlement from 23-02-2015 to 27-02-2015.
- CH2 works caused maximum 4-5mm of settlement from 05-03-2015 to 28-05-2015.
- Maximum Lateral displacement was 10mm
- Maximum Transversal displacement was 16mm
- Maximum settlement at the end of the works was -26mm
